Wolfe Ranch
Historic Structures Report
Arches National Park

Prepared for Arches National Park

by
James R. McDonald Architects
Historical Research Associates, Inc.
October, 1999

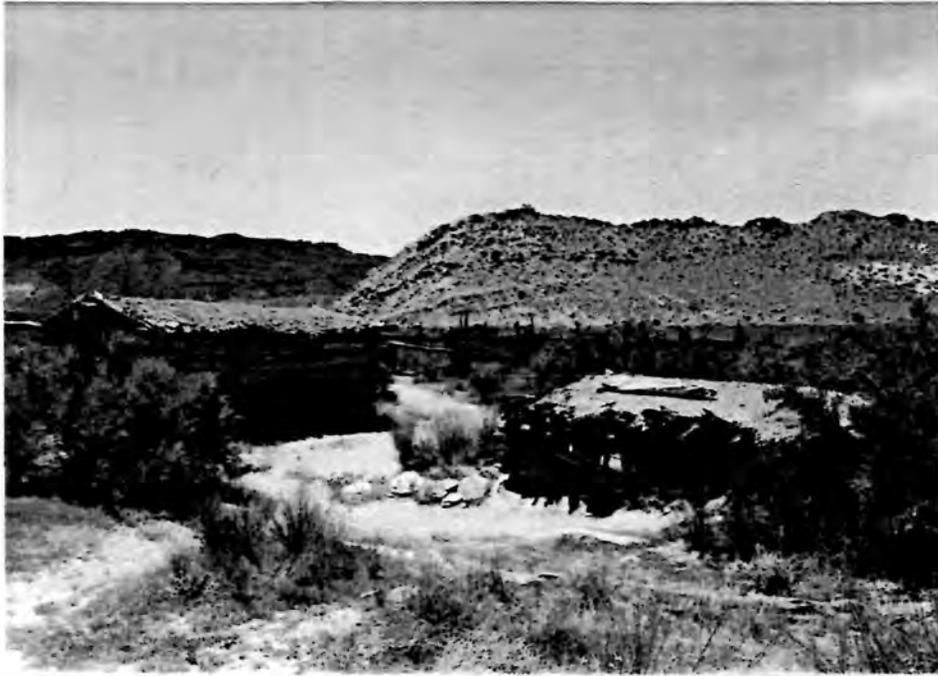
Figure 15. Looking southwest at the cabin (HS-1) and dugout (HS-2) with the corral (HS-3) in the background. Note the sandy, eroded trails around the buildings. (1998 photo)

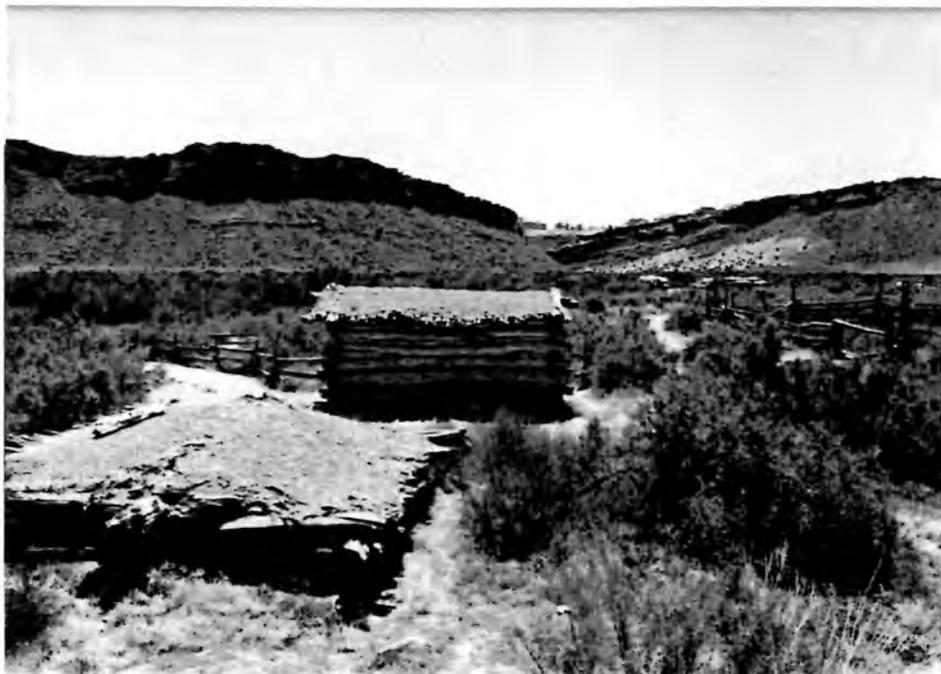
Figure 18. Looking south at the dugout (HS-2) and cabin (HS-1) with the corral (HS-3) to the right. Note the greasewood and high grasses around the structures. (1998 photo)

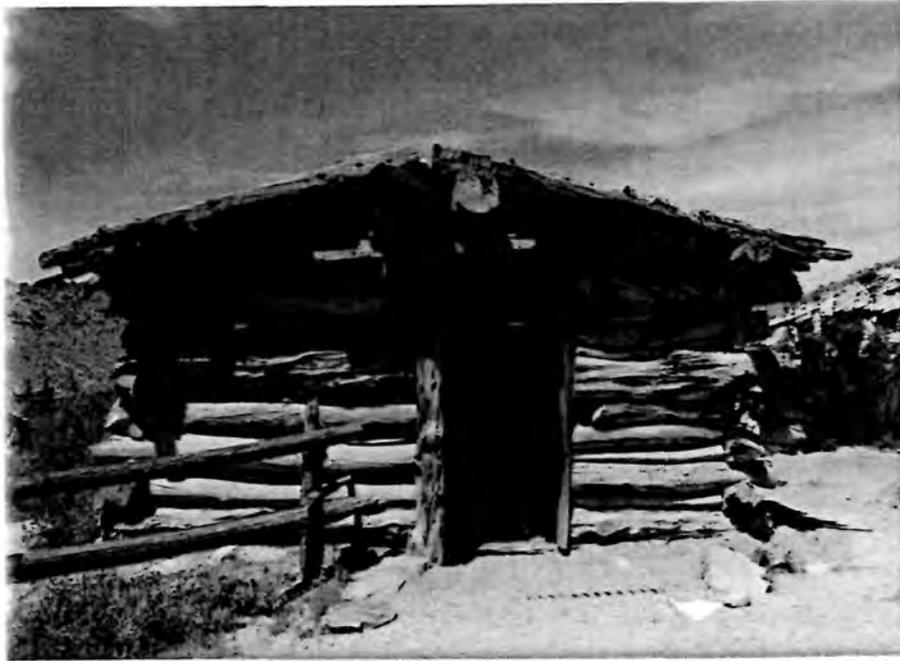
Figure 28. Looking west at the front elevation of the cabin (HS-1). Note the grade up over the right side of the sill log. (1998 photo)

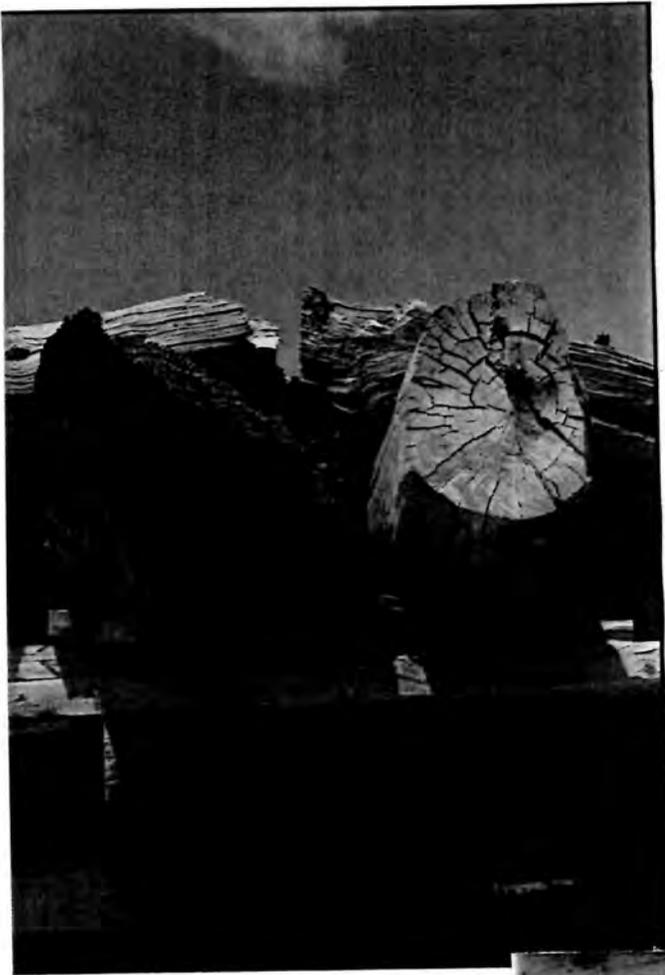
Roof: The roof, rebuilt in 1976, is beginning to fail (both the structure and the covering). It appears that the layers of juniper bark hold the moisture against the oak *vigas* causing them to rot from the top. The ridge appears to be opening up causing water to penetrate into the ridge beams — again resulting in some rot in the beams. Water appears to be leaking into the structure through holes in the covering, even though the interior was dry at the time of the survey.

Figure 30. Looking west at the ridge beams and post. Note the separation of the roof at the top. Water is falling onto the logs at this point causing rot in the structure and wall members. (1998 photo)

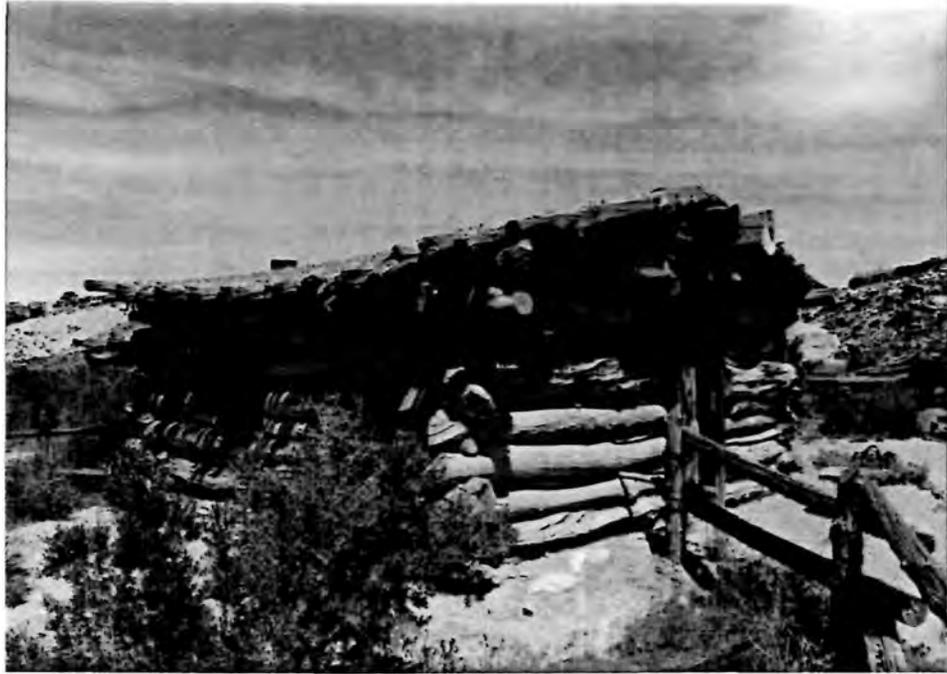
Foundation: The stone foundation piers appear to be in place but the stones that were added between the piers have fallen out from under the logs. The grade on all sides does not provide positive drainage away from the building. The corrugated metal pipe installed to improve drainage away from the site has silted-in.

Figure 32. Looking northwest at the cabin (HS-1). Note the fence to keep people out of this side of the site. Also, note that the stones along the base of the cabin have fallen away. (1998 photo)

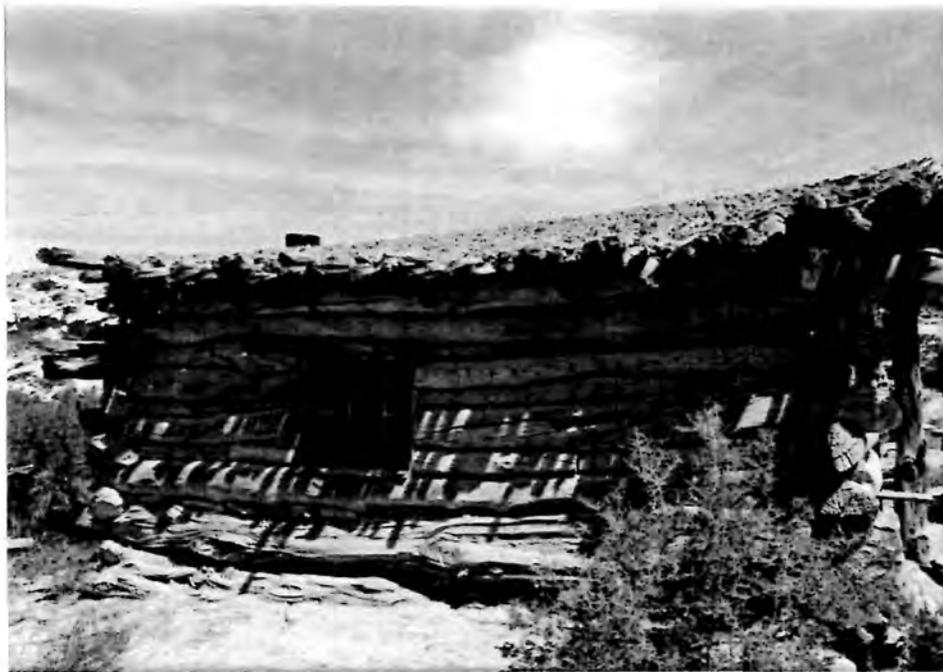
Walls: The walls appear to be mostly original to the building with new material limited to the log chinking. The logs of the north and east walls and part of the south wall all have surface rot, and both sill logs are also rotten. Termite activity was apparent in the north and east walls at the time of the survey, possibly due to these walls staying wet longer after rain or snow. Although the south and west walls did not exhibit termite damage, the infestation may spread to these walls. Even though this area is semi-arid and the humidity and moisture is low, it appears that the texture and nature of the logs allows even the limited amount of available precipitation to penetrate the surface. Rot, along with the termite infestation, has contributed to the failure of the wall logs.

Figure 33. Looking north at the cabin (HS-1). Note the sill log partially covered with dirt and the juniper bark roof. Both are rotted due to moisture. (1998 photo)

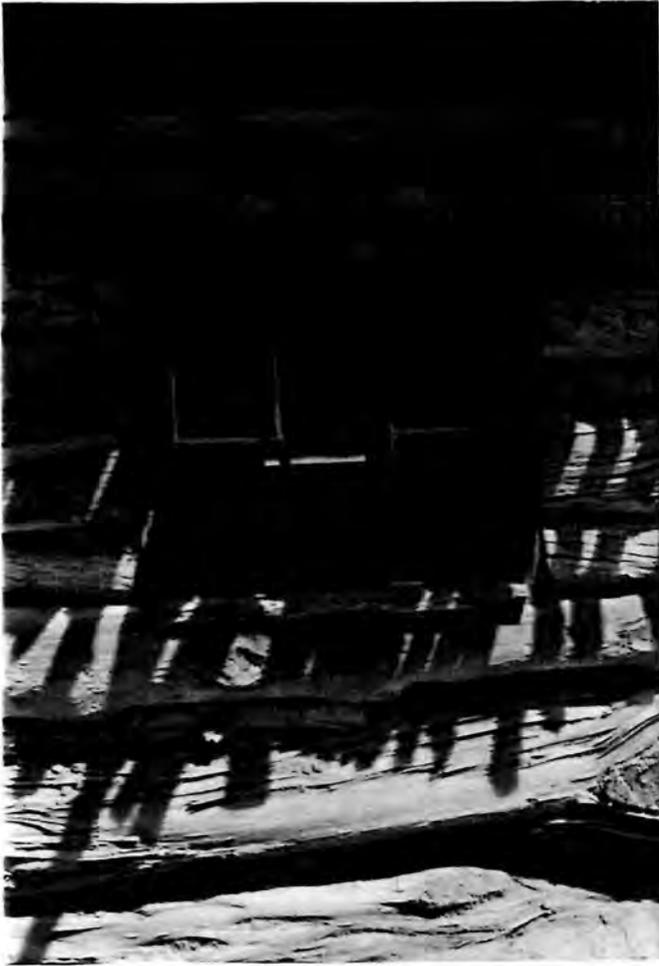
Figure 34. Looking north at the window. Note the rough and missing glazing compound. The wood is weathered and checked. (1998 photo)

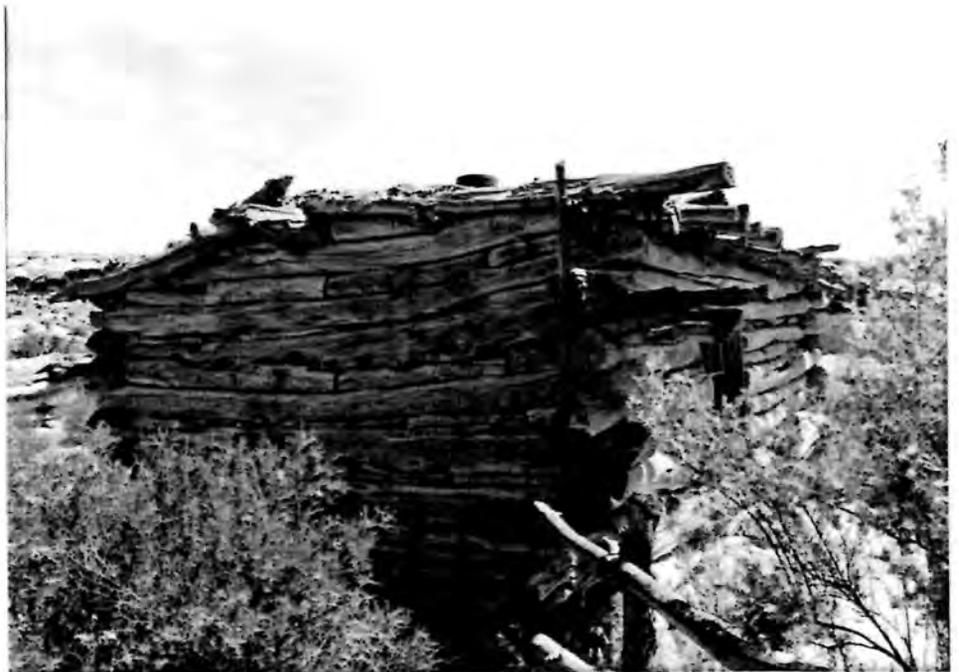
Figure 36. Looking east at the rear of the cabin (HS-1). Note the short sections of logs and chinking used to fill the spaces between the wall logs. (1998 photo)

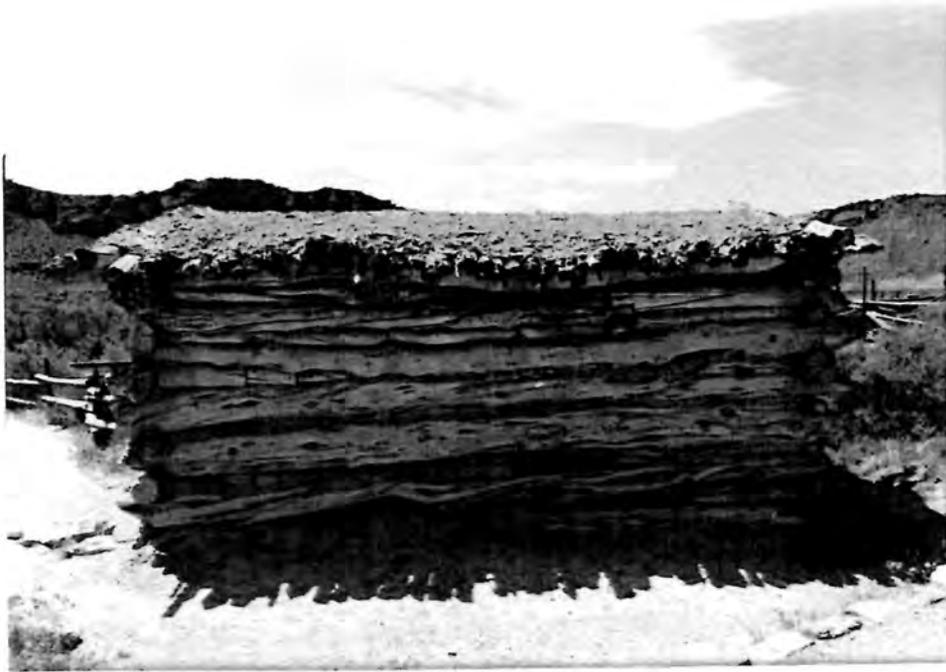
Figure 38. Looking south at the north side elevation of the cabin (HS-1). Note the missing chinking and rotted logs near the top of the wall. Also, note the juniper bark roof. (1998 photo)

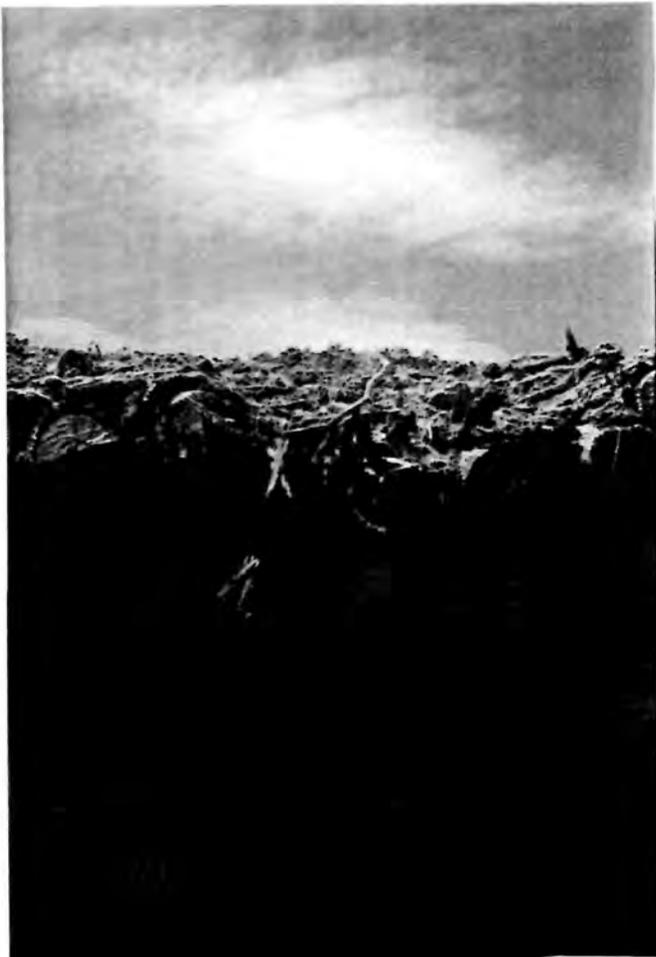
Figure 39. Looking south at a detail of the roof and rot in the upper wall logs. (1998 photo)

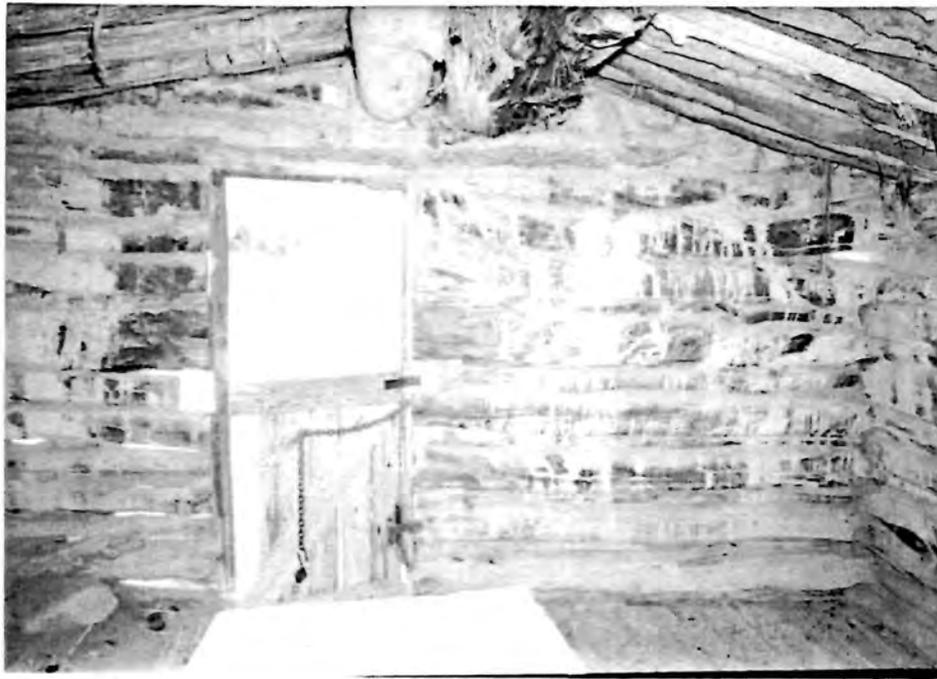
Walls: Some of the chinking and daubing has fallen out, and the wall logs are water stained.

Figure 42. Looking east at the interior of the cabin and the main entrance. Note the staining on the walls from water penetrating the interior. (1998 photo)

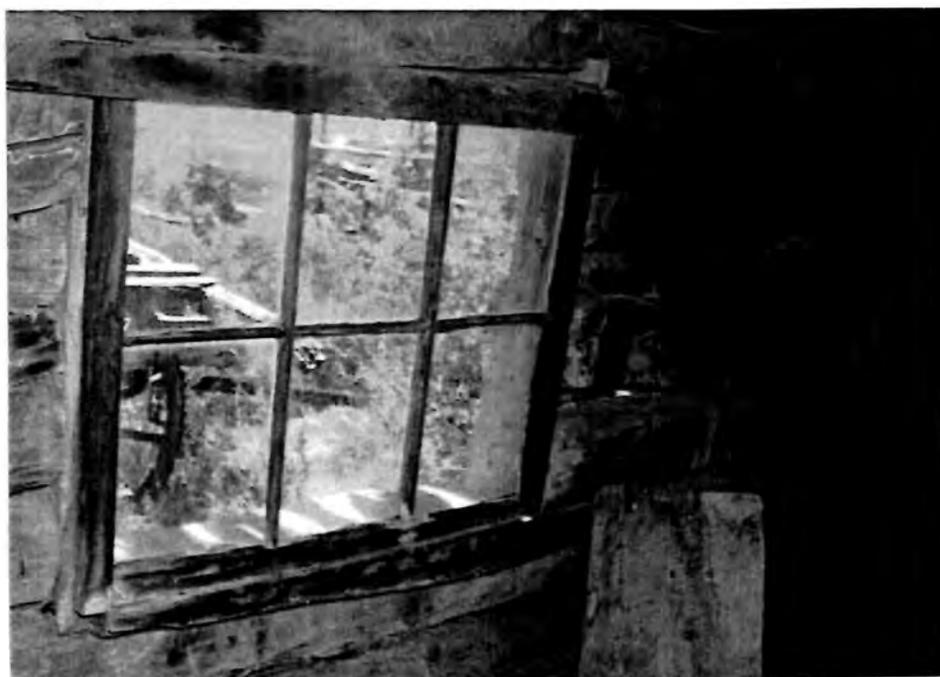
Windows and Doors: The interior window sill and door frame are badly deteriorated.

Figure 45. Looking south at the inside of the window. Note the weathered and rotted sill. (1998 photo)

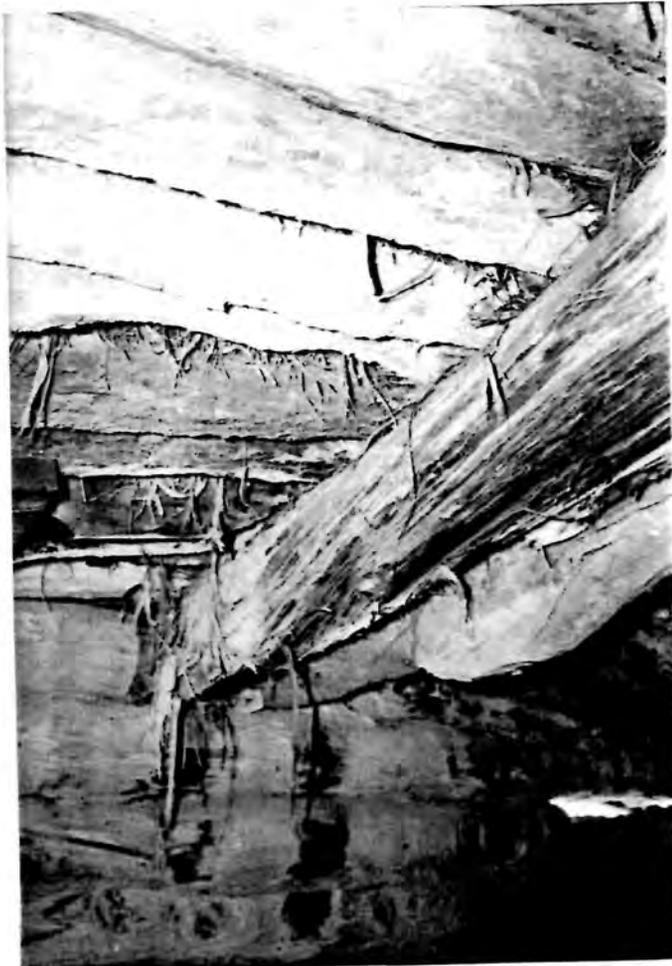
Figure 49. Looking west at the roof beams. The left (south) beam is rotted. The right (north) beam was replaced in 1976. (1998 photo)

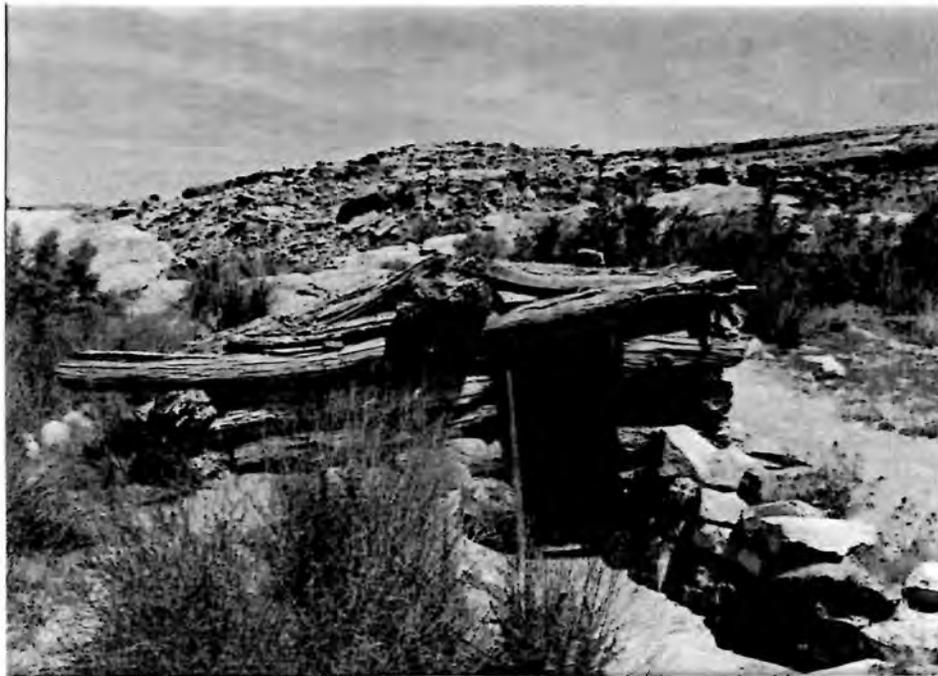
Figure 54. Looking north at the entrance to the dugout (HS-2). Note the settlement of the structure on west corner. (1998 photo)

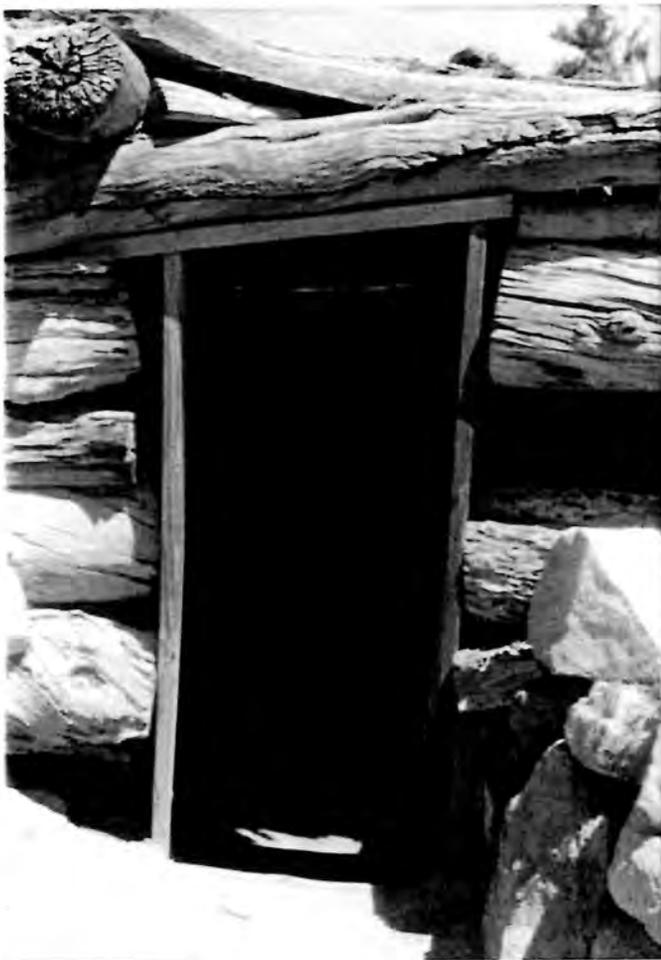
Windows and Doors: The building is once again out of plumb causing the door frame to pull apart.

Figure 55. Looking north at the entrance to the dugout (HS-2). Note the slope of the headpiece. Also, note the silt has covered the sill of the doorway. (1998 photo)

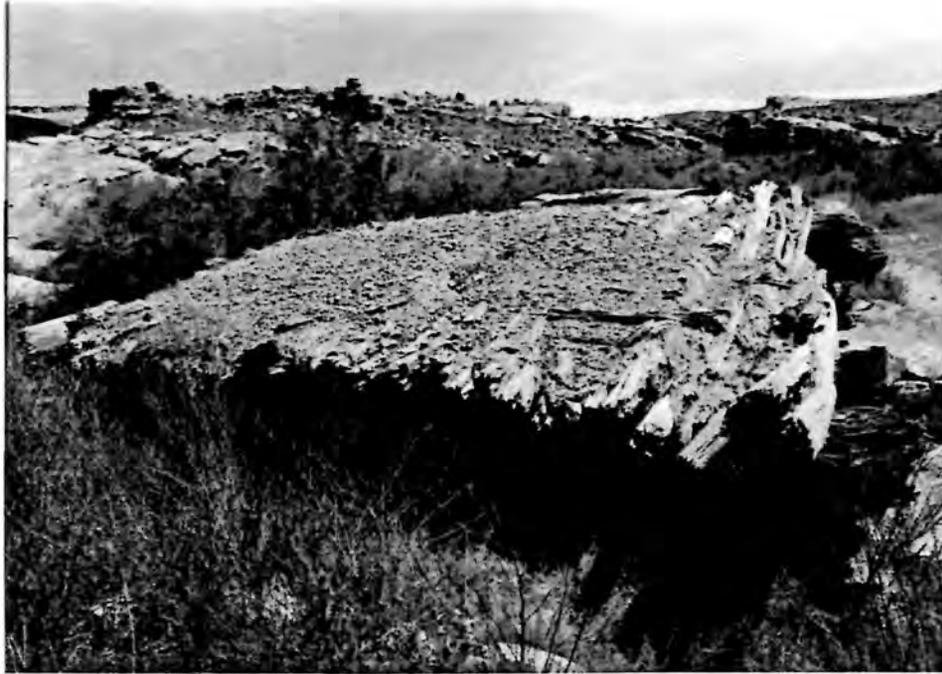
Figure 58. Looking east at the dugout (HS-2). Note the holes in the roof where bark is missing and sections of the logs have collapsed. (1998 photo)

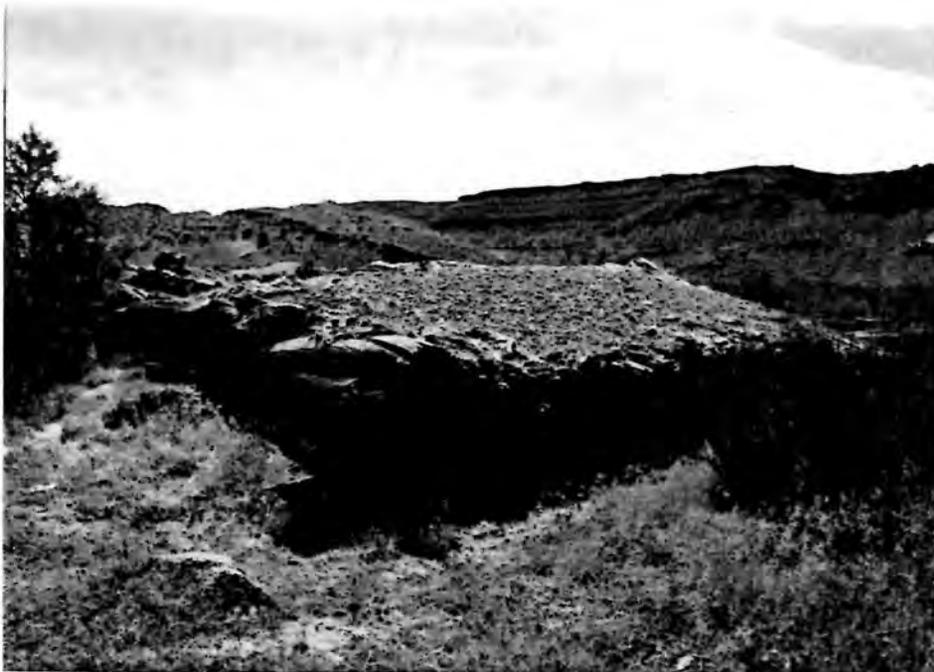
Figure 59. Looking southeast at the dugout (HS-2). Note the high grade around these two sides of the structure. (1998 photo)

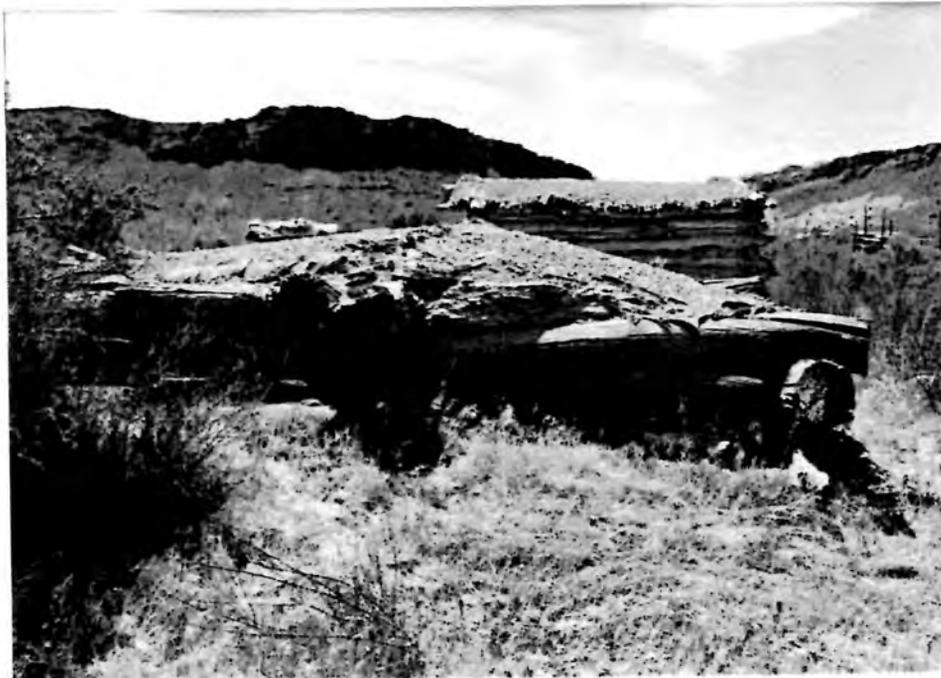
Figure 61. Looking south at the dugout (HS-2). Note the sag in the roof and the open area where the top log is rotted. (1998 photo)

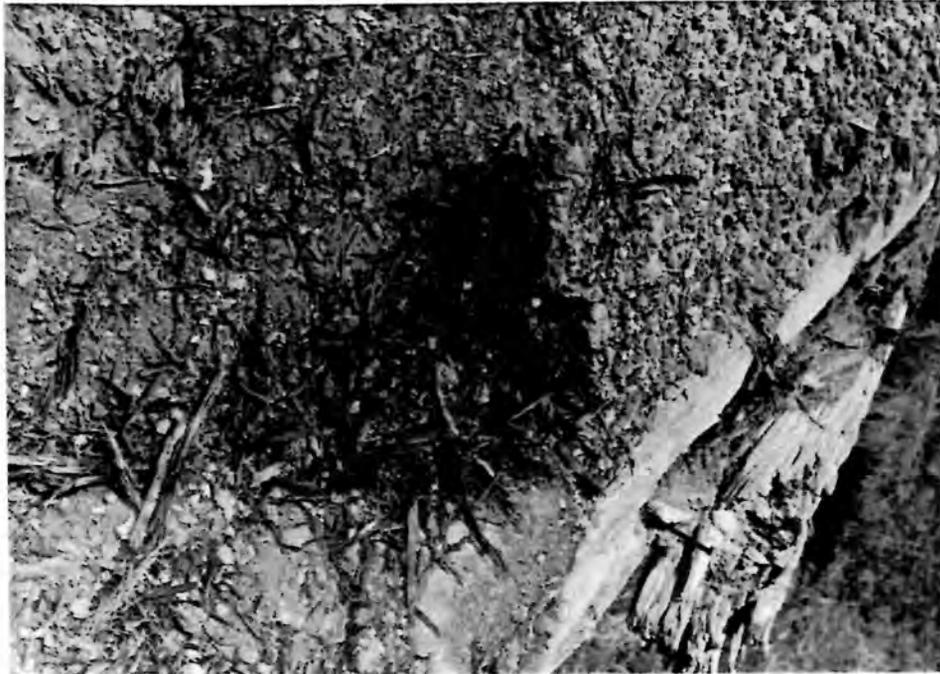
Figure 62. Detail of damage to roof. Note exposed juniper bark. (1998 photo)

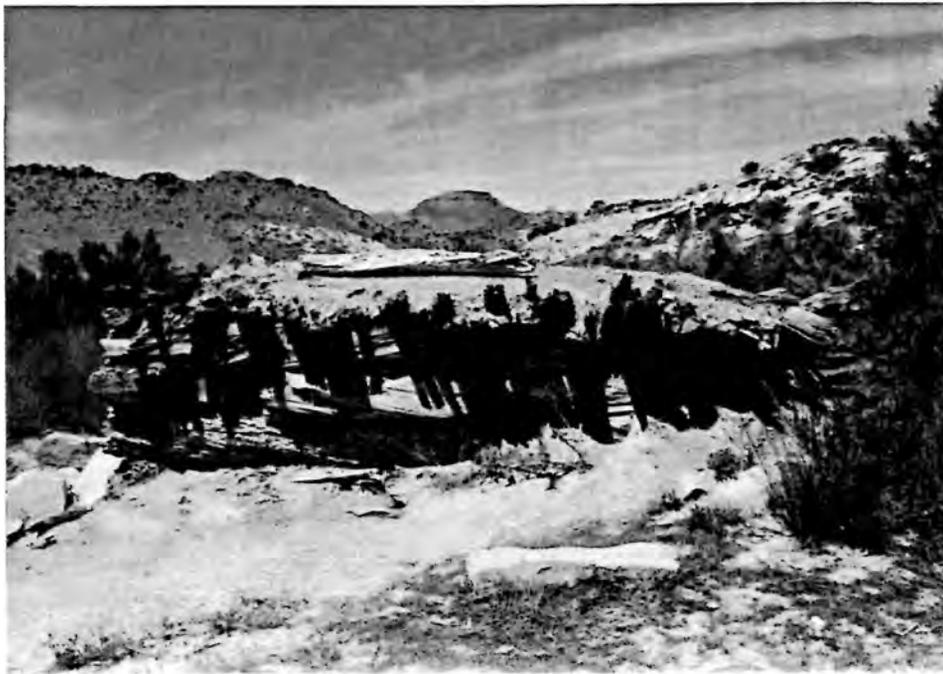
Figure 63. Looking west at the dugout. Note the missing section of wall to the left and the high grade along the base to right. (1998 photo)

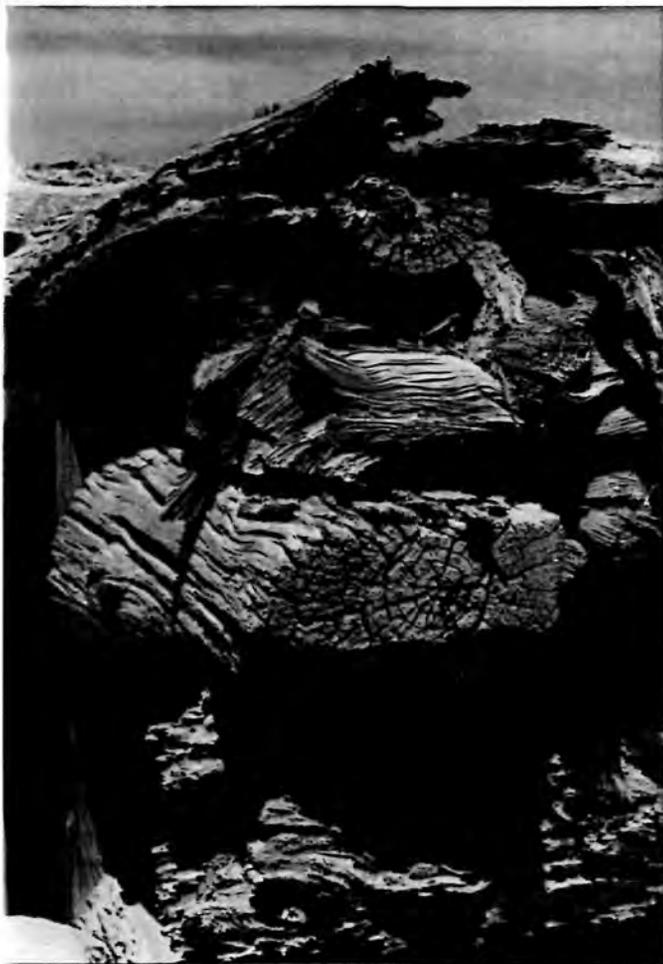
Figure 65. Looking northwest at a typical corner notch detail. Note the rotted and missing end notches. (1998 photo)

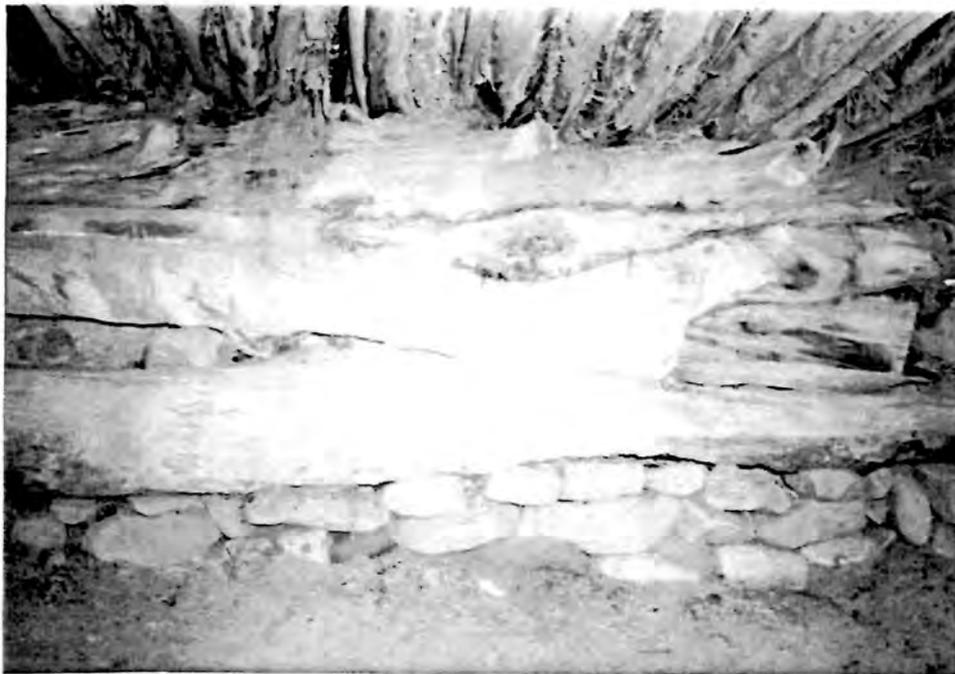
Figure 71. Looking west at the log wall with the stone foundation. Note the rotted roof structure. (1998 photo)

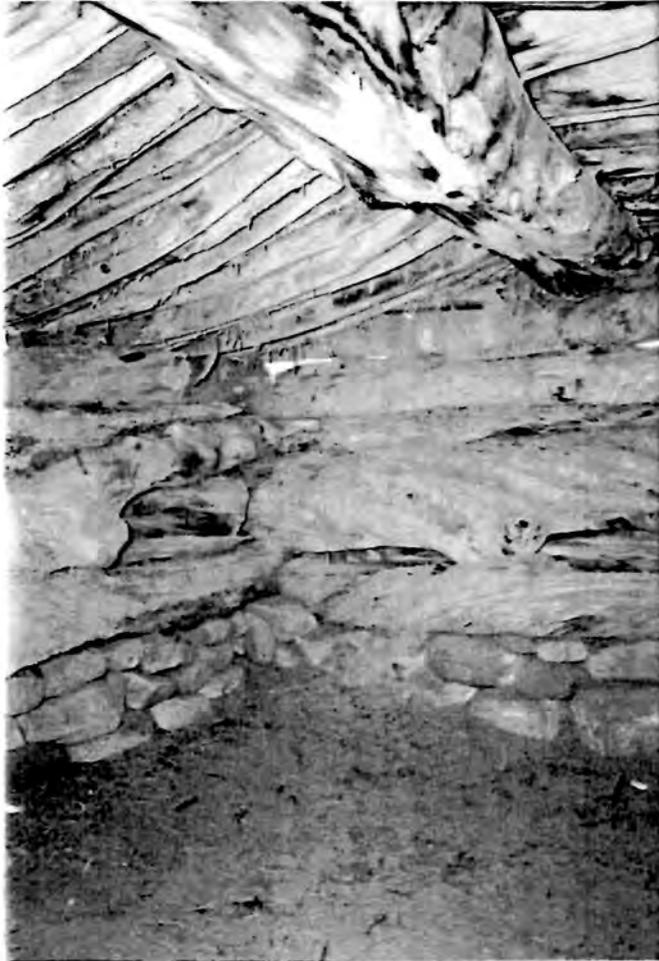
Figure 72. Looking northwest at the interior of the dugout. Note the rotted roof structure. (1998 photo)

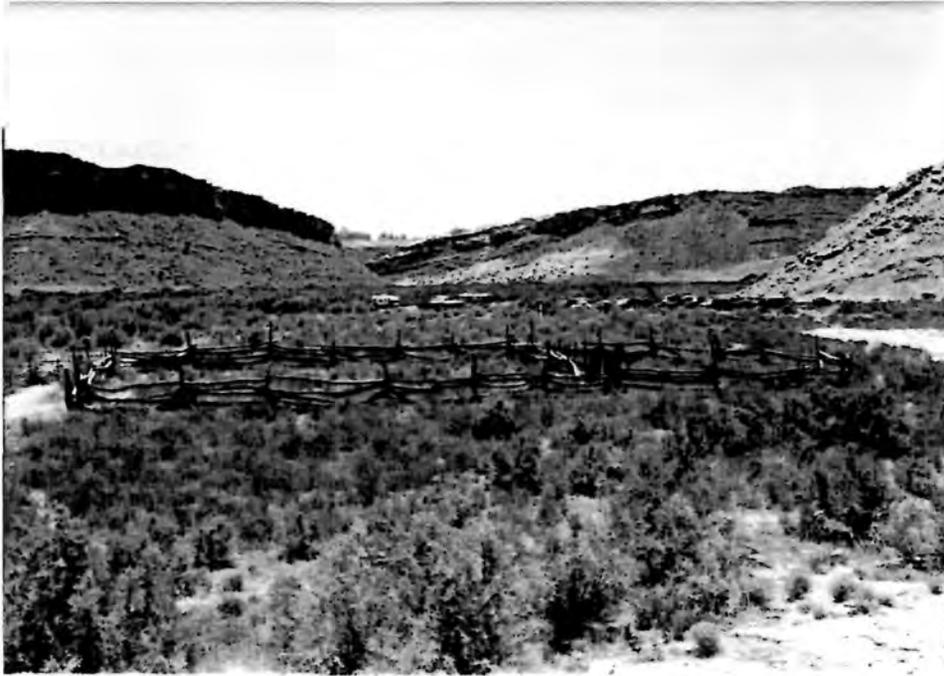
The corrals were completely rebuilt during the 1967 restoration effort. Although salvageable material was reused, currently there is no way to determine which material is new and which material came from the cannibalized BLM corral. Currently, the corrals are once again in poor condition with rotted posts, broken horizontal rails, and broken wire connections. The deterioration appears to be due to a simple lack of maintenance.

Figure 74. Looking south at the corral. Note the sagebrush and greasewood that has grown up inside and outside of the fence. (1998 photo)

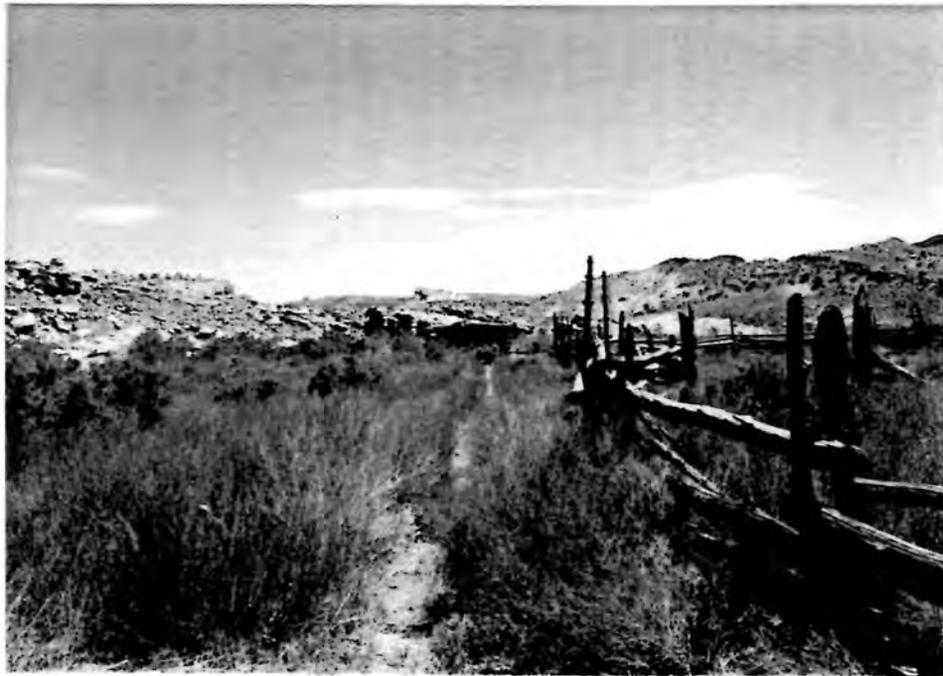
Figure 75. Looking east along the corral. Note the sagging and broken rails. (1998 photo)

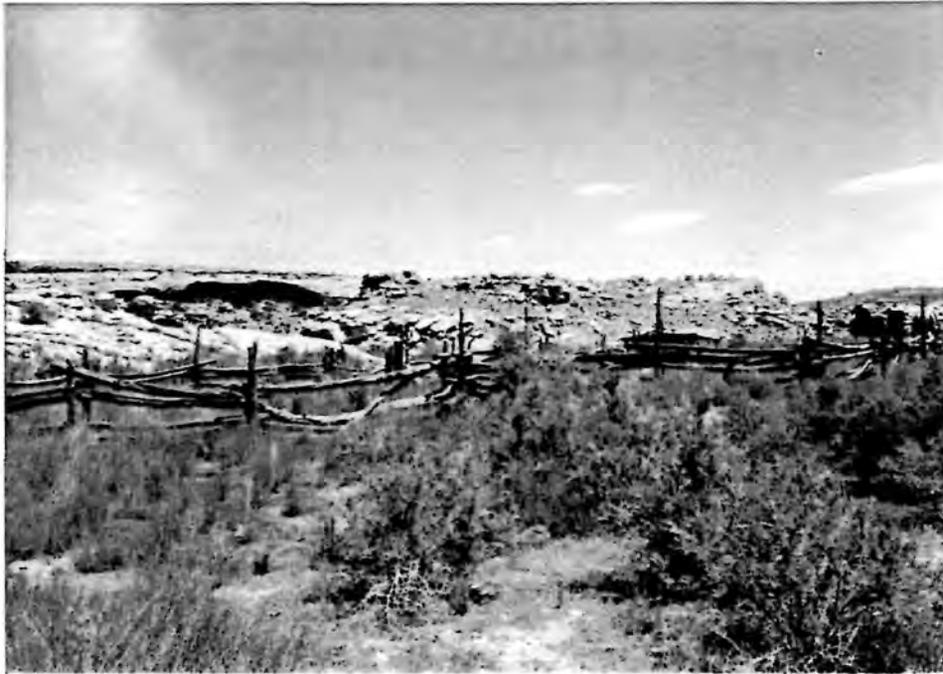
Figure 76. Looking north at the corrals. Note the sagging and broken rails. (1998 photo)
