HILLSBORO
(Cedarvale)

HSR PART III ARCT DATA

Bighorn Canyon National Recreation Area

III. ARCHITECTURAL DATA - HILLSBORO

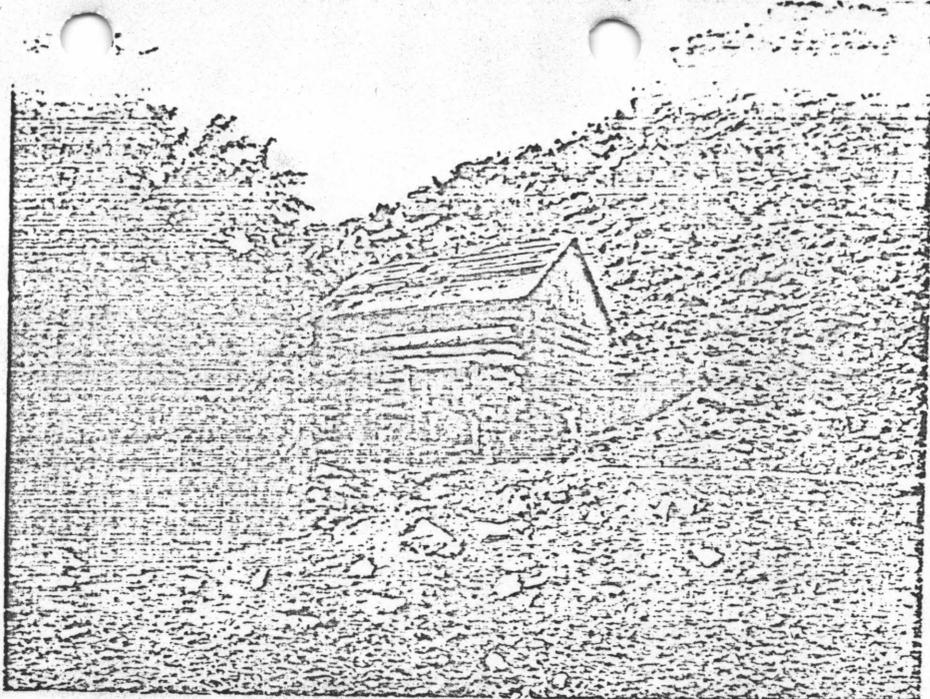
Plate 2 - Building No. 5, Hillsboro Post Office,
South Elevation

Built into the hillside north of Hillsboro trace, at the gate to the ranch, the Post Office is a two-story log building with a second story door once reached by an exterior stair on the west (see plates 2 and 3). The roof and gables have probably always been protected with tar paper. The east gable has one glazed opening, and the south elevation has its original door and a pair of double hung sash. The sturdy plank door was made on site. All trim, interior and exterior, retains traces of original green paint. There is a single room on each floor.

Overall, dimensions for the building are 18' x 12'10". The roof leaks, no glazing remains and the building is open to vandalism. While not in danger of collapse, the structure has shifted to the south, a condition which would have to be corrected before any restoration.

C. Building No. 5, Post Office. Repair and secure sash with new non-breakable acrylic glazing. Reroof with tar-paper roofing secured by metal strips. Restore board flooring. Paint existing wood trim and windows with preservative. No structural work appears necessary at this time. The second story door should remain locked.

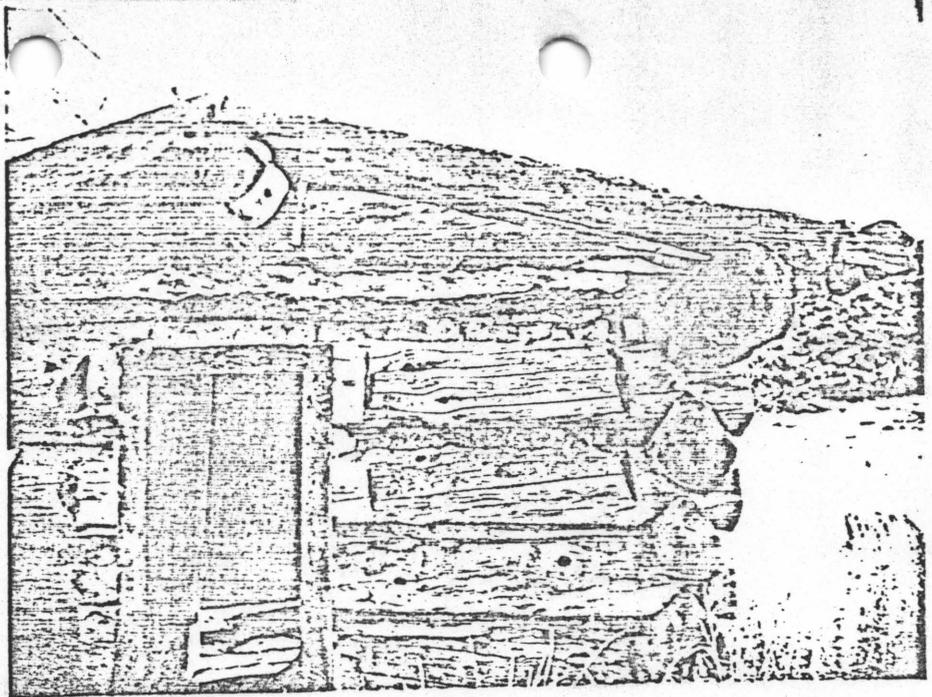
Plate 4 - Building No. 6, Dude Cabin, West Elevation

The principal remaining structure is a dual purpose log structure of which the western portion was built first. Probably begun around 1903, exceptionally large logs were available for its construction. The south elevation has a pair of double hung sash, and the west has a single doorway (see plates 4 and 5). Exterior and interior trim was painted brown. The cabin measures 16' x 20' on the exterior. The interior room has a board floor and once had walls hung with muslin on which a wallpaper was glued. Nails anchoring the muslin to the wall had "washers" of folded newsprint to prevent the nails from pulling through. Newsprint dates from 1909 (Alaska Pacific Train Schedule, October 6, 1909).

D. Building No. 6, Hulbert's Blacksmith Shop and Dude Cabin. Restore board floors only. Install sod roof, but do not remove fabric, etc. from ceiling poles when dirt is removed to accommodate waterproof metal roof. Use 6 inch maximum thickness sod. Repair and secure sash with new glazing as in Part C.

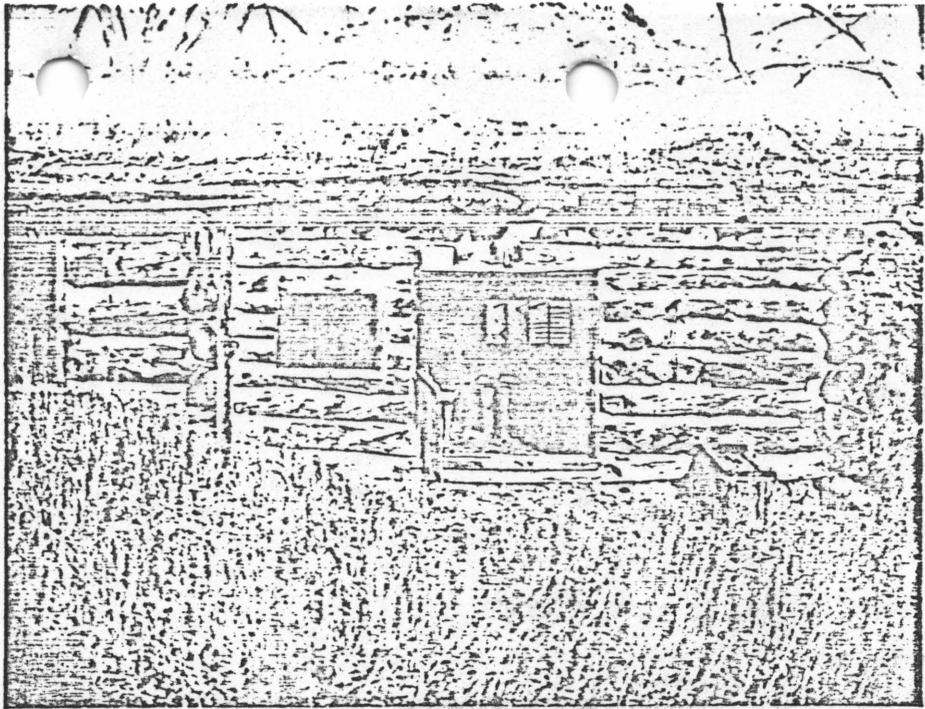
Plate 6 - Building No. 6, Hulbert's Blacksmith Shop,
Eastern Cabin, South Elevation

The eastern portion of this building may not have always been a blacksmith shop, however, other uses could not be discerned. At present the single dirt-floored interior room contains work benches and many tools and artifacts left by the blacksmith (plates 6 and 7).

Beside the large southern door is a ring used for hitching horses while they were being shod. Large windows on all three sides were cut or enlarged at different times to provide light by which to work. The remaining sash slide on a horizontal track. The interior is blackened by the forge, while the exterior had the same brown trim as the western portion. The blacksmith shop measures 18'4" x 16'5" on the exterior.

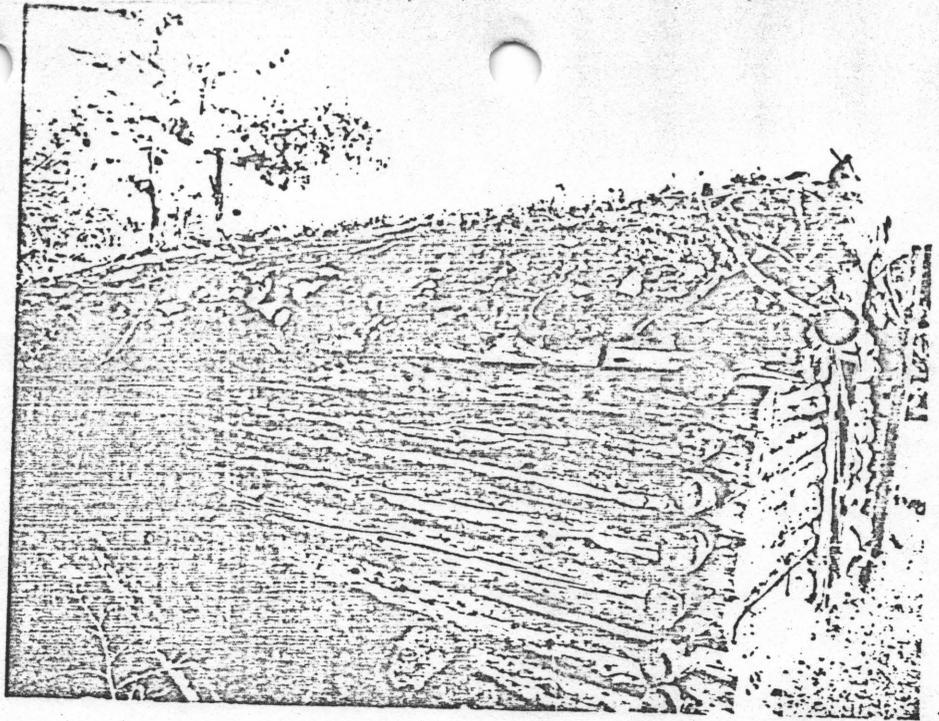
Plate 8 - Building No. 7, Big Chicken House,
Southwest Corner

Built into a hillside at the northeast corner of the ranch site, the Big Chicken House is a sod-roofed log structure. It measures 14' x 15' and has a single door facing south. The sod roof is collapsing (see plates 8 and 9). It appears to have always been a chicken coop and could serve that purpose again with roof repair and a rescreened door.

E. Building No. 7, Big Chicken House. Install sod roof supplementing pole ceiling where necessary. Securely nail in place loose building elements. No structural work or further restoration is recommended.

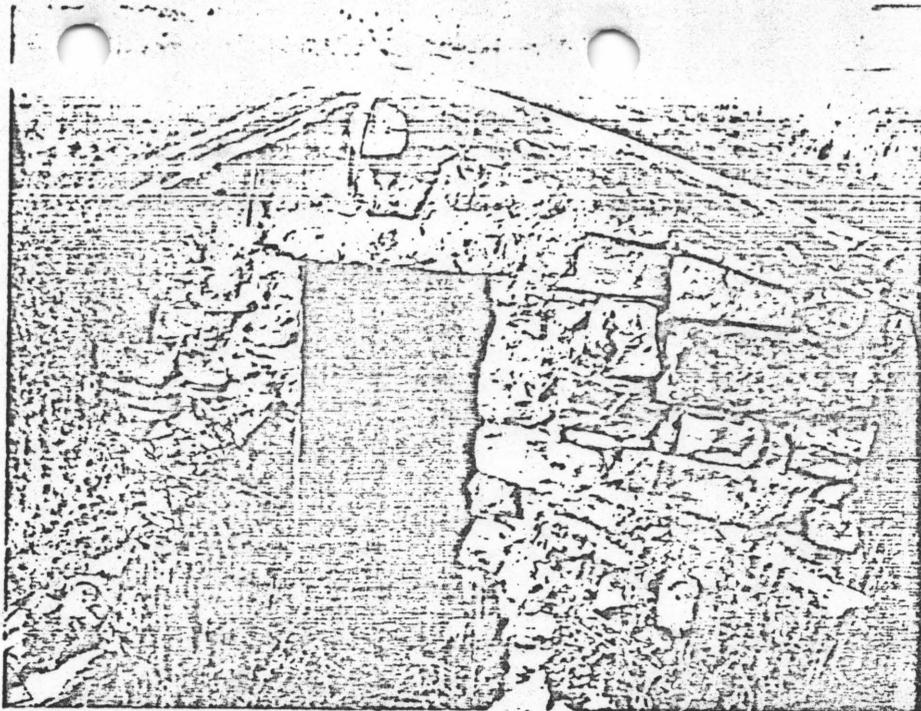
Plate 10 - Building No. 8, Milk House, East Elevation

This stone storage room is constructed three fourths below grade. The roof is sod carried on a pole beam and ceiling poles. The masonry has now lost most of its mortar but was laid very well initially. Some early (though not original) doors and shelving remain. Digging out of the interior and reconstruction of the roof will be necessary to preserve the structure. Some masonry repair has occurred which is inappropriate and possible harmful to the structure, having much less flexibility than the original mud and lime mortar (see plate 10).

F. Building No. 8, Milk House. Remove loose or cracked cement mortar and repoint with chinking mortar mixture. Reattach butting poles. Secure interior support in place and supplement present ceiling poles. Supplement present sod.

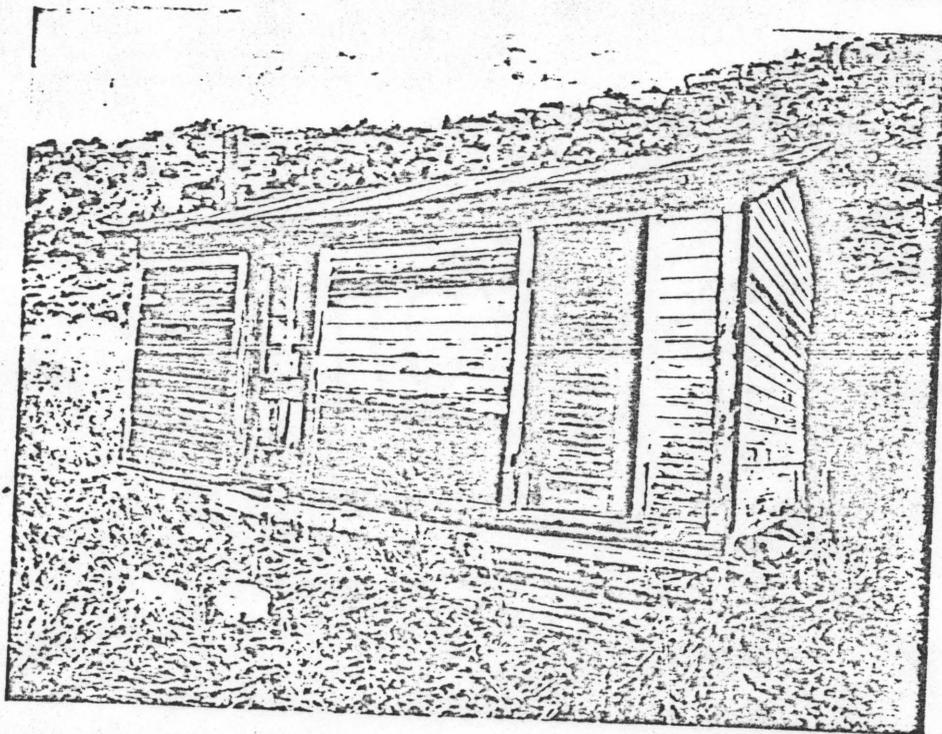
Plate 11 - Building No. 9, Hulbert's Cabin,
South Elevation

The stud frame walls are covered with coarse canvas and clapboard on the exterior and tongue and groove sheathing, muslin and wallpaper on the interior. All except the wallpaper is in good condition.

Exterior trim has always been dark brown, the clapboards white. Floor joists and crawl space supports in contact with the earth have begun to rot. However, very little work is necessary to stabilize the structure (see plate 11).

G. Building No. 9, Eddie Hulbert's Cabin. Mortar supporting piers to provide level bearing for the floor structure and supplement all sagging members with new lumber. Add roofing material as needed, protecting eaves and barge boards. Paint unprotected exterior sash, trim and unpainted siding with wood preservative.

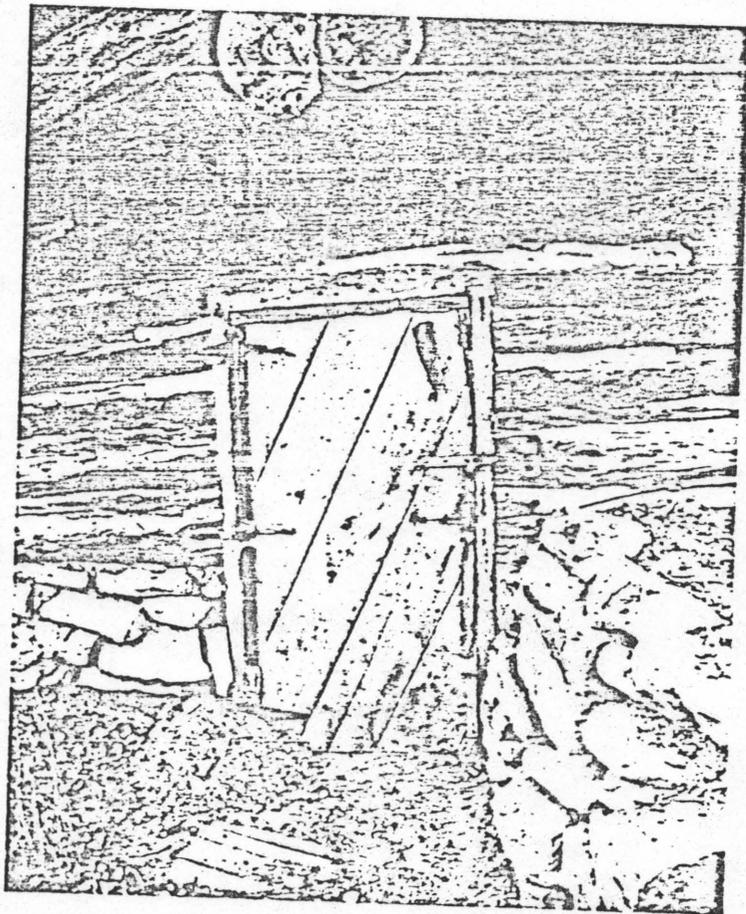
Plate 13 - Building No. 11, Root Cellar, North Elevation

This well-preserved log and stone storage room is built into the south side of the "draw", on the slope opposite all other extant structures. It measures 14'6" across the north elevation which has a single door. A particularly handsome piece of workmanship, the door and surrounding trim are painted green, but were originally gray (see plate 13).

Repair of the mortar for stonework and chinking is all that is necessary to preserve the structure. Its sod roof which blends into the hillside appears strong and stable.

I. Building No. 11, Root Cellar. Removing small sections of the footing wall at a time, remortar into original position. Supplement pole ceiling and install new sod. Insert new interior supporting post.

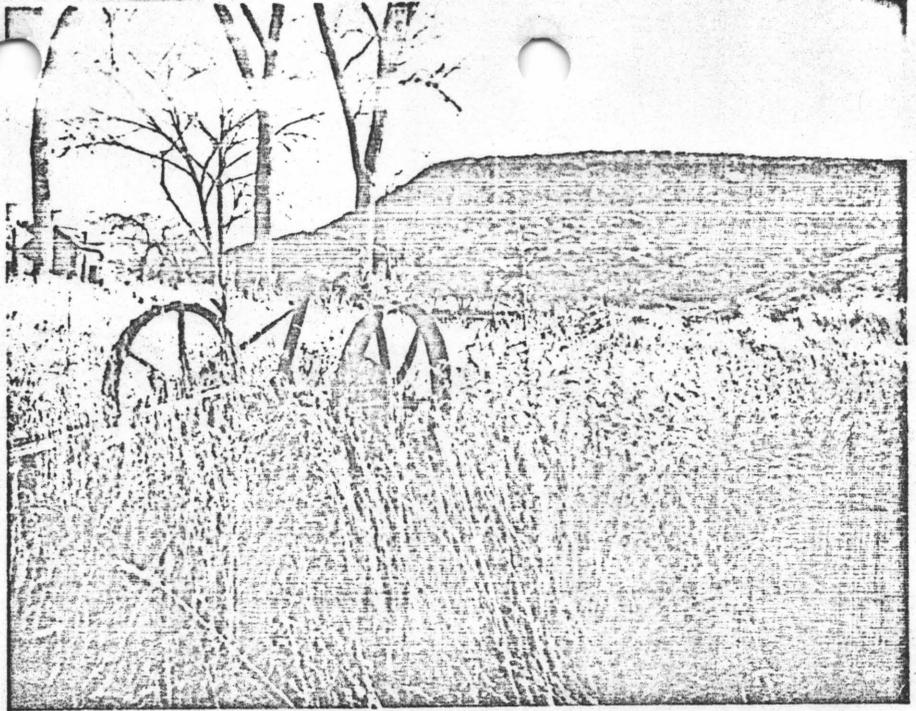
Blacksmith tools, hardware of ranch manufacture and abandoned farm equipment at Hillsboro are vulnerable and in danger of being "collected". These artifacts are part of the park's historic resource and deserve consideration for protection (see plate 14).

Plate 14 - Artifacts remain scattered in the fields and abandoned in the cabins. Pictured are a mowing machine and hay rake.
