# Long-term Monitoring after Restoration of Kantishna's Placer-Mined Streams

## Stream restoration at Glen Creek

## Long-term monitoring after restoration

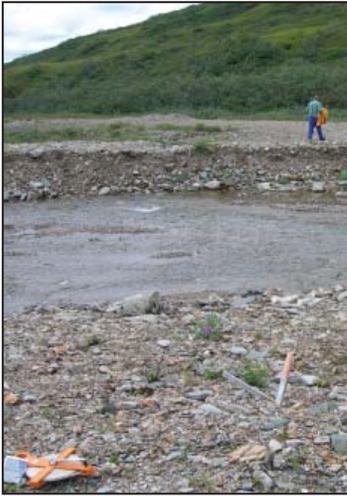
The channel and floodplain of Caribou Creek (2007 ground view) was restored in 2002.

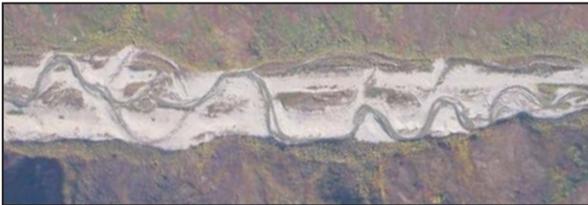
Lack of vegetation is visible at Caribou Creek in this 2008 aerial photo. Vegetation recovery after restoration can be delayed or prevented by rapid bank erosion, widening stream channels, and lack of fine sediments and nutrients.

In 2007, Densmore was able to survey seven cross-sections and the channel location, and two vegetation transects. Other monitoring was impossible due to difficult access logistics (Caribou Creek is more remote than Glen Creek). So, Densmore also used aerial and satellite photos to confirm the widespread instability in stream channel morphology and the slow plant regrowth. In many areas, the stream channel has widened and become shallower, with considerable bank erosion, deposition of new gravel bars, and sparse revegetation (see photo at left). However, some streambanks were relatively stable, with willows, dwarf fireweed, and a crust of bacteria and lichens.

**More restoration, more monitoring**  
Caribou Creek is slated for additional restoration to address deficiencies in the reconstruction already completed, and to reduce erosion and sediment load in a reach further upstream. Monitoring at Caribou, Glen Creek, and other restored streams will continue to provide valuable feedback to help park managers adapt and improve restoration protocols. Ultimately, the monitoring efforts are aimed at finding out the effects of the project on the ecological conditions of the stream and its riparian zone.

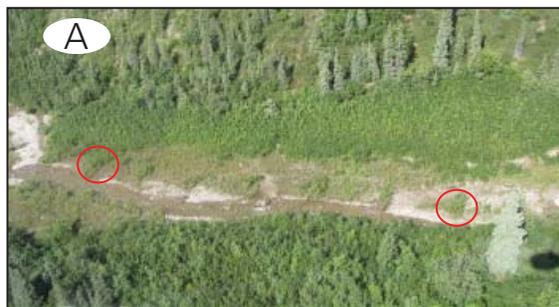
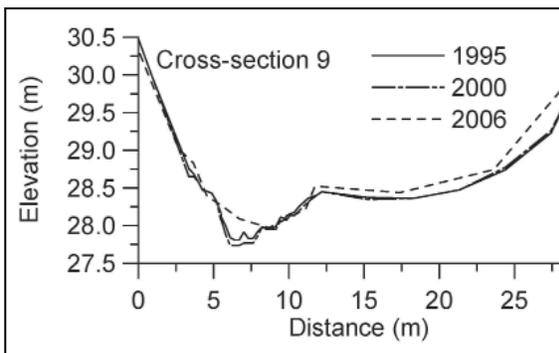
The flood caused immediate and significant changes in many areas of the stream project, while other areas withstood the flood. Figure A shows a reach that remained stable during and after the flood. The vigorous growth of fertilized willows in the brush bars and brush layering helped reduce erosion. In contrast, in the lower reach, one-third of the reconstructed floodplain was completely eroded when the floodwaters cut through naturally revegetated areas behind the brush bars. Figure B shows how the stream continued to become wider and shallower after flooding.

A. Successful restoration is indicated by stable channel and vegetation even after a major flood. Note brush bars between the red circles.

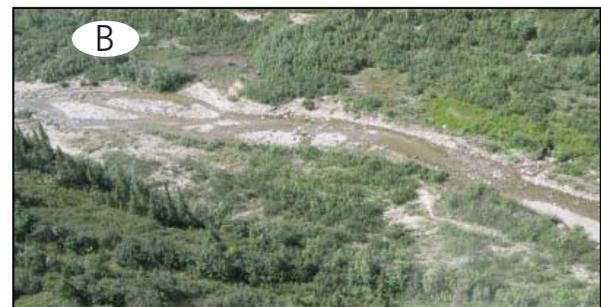
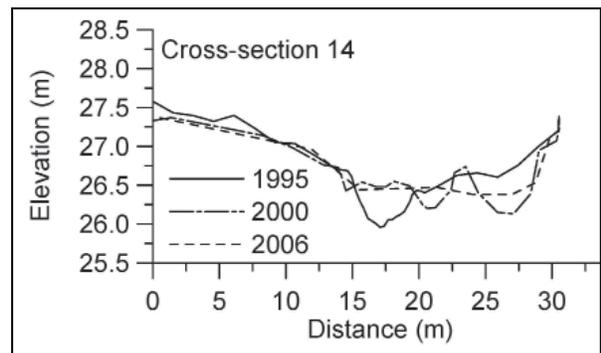
Two design flaws were revealed as a result of this long-term monitoring: (1) an underestimate of sediment volume moving downstream from the upper part of Glen Creek, both during floods and on an annual basis, and (2) an overestimate of the rate of natural regrowth in the low-nutrient gravels—regrowth was too slow to stabilize stream banks within the five to ten years the design relied on. As a result of these lessons, Denali has completed another project at Glen Creek to reduce excess sediment erosion from large piles of mine tailings near the Glen Creek headwaters.

B. Following the flood, one-third of the lower reach's new floodplain was washed away. In cross-section 14, the stream channel was widened (see dotted line). This failure helped the park modify new reconstruction.
