Fort Point National Historic Site  
Golden Gate National Recreation Area

# Abbreviated Fort Point Historic Structure Report

September 2006

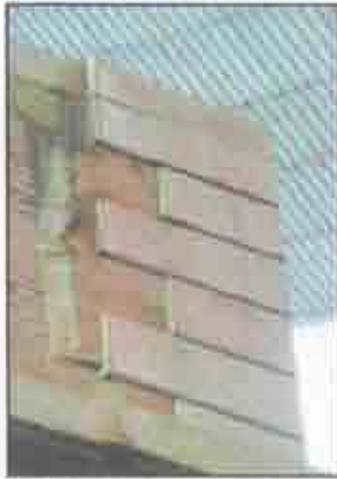
Lateral displacement is evident in the south flank parapet. (Jane Lehman, 2005)

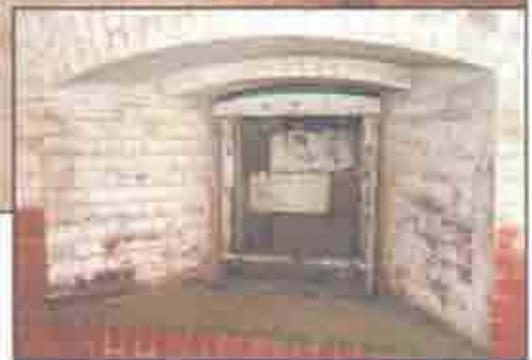
Most of the iron embrasures have deteriorated over the years and the openings have been infilled with brick and block for security purposes. (John Martini, 2005)

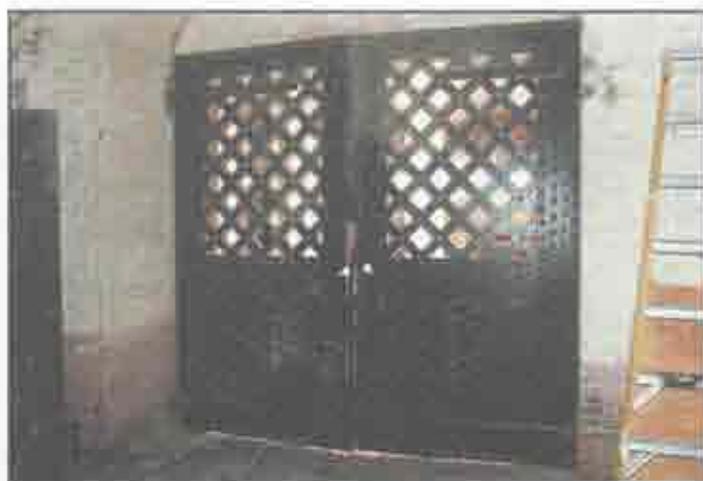
The rivets on the original wood doors rust quickly in the marine environment. (John Martini, 2005)

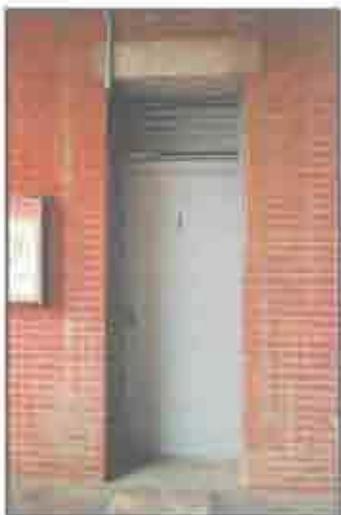
The transom windows above the 3rd tier gallery doors were replaced with wood louvers. These louvers need to be replaced because they are all installed backwards. (John Martini, 2005)

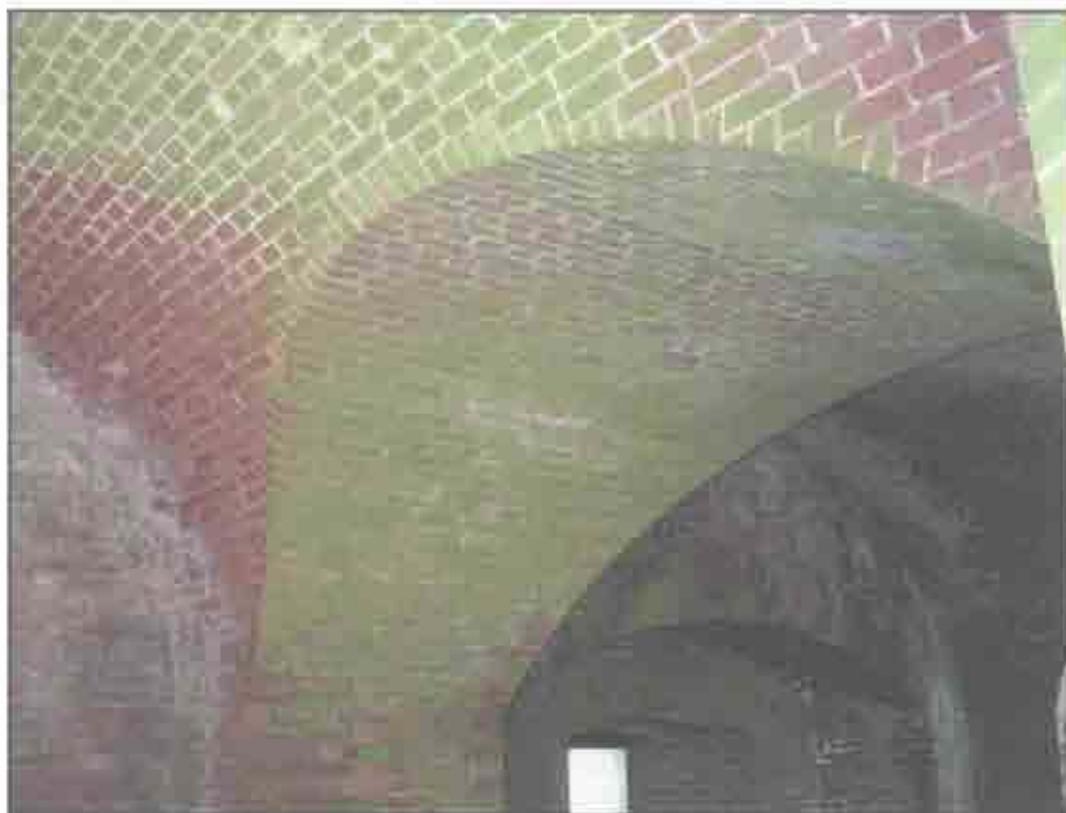
Condition Photo 2:  
Intersecting Arch of Casements  
98 and 99; Biological growth and  
efflorescence settle on masonry  
surfaces. (Courtesy of ARG, 2003)

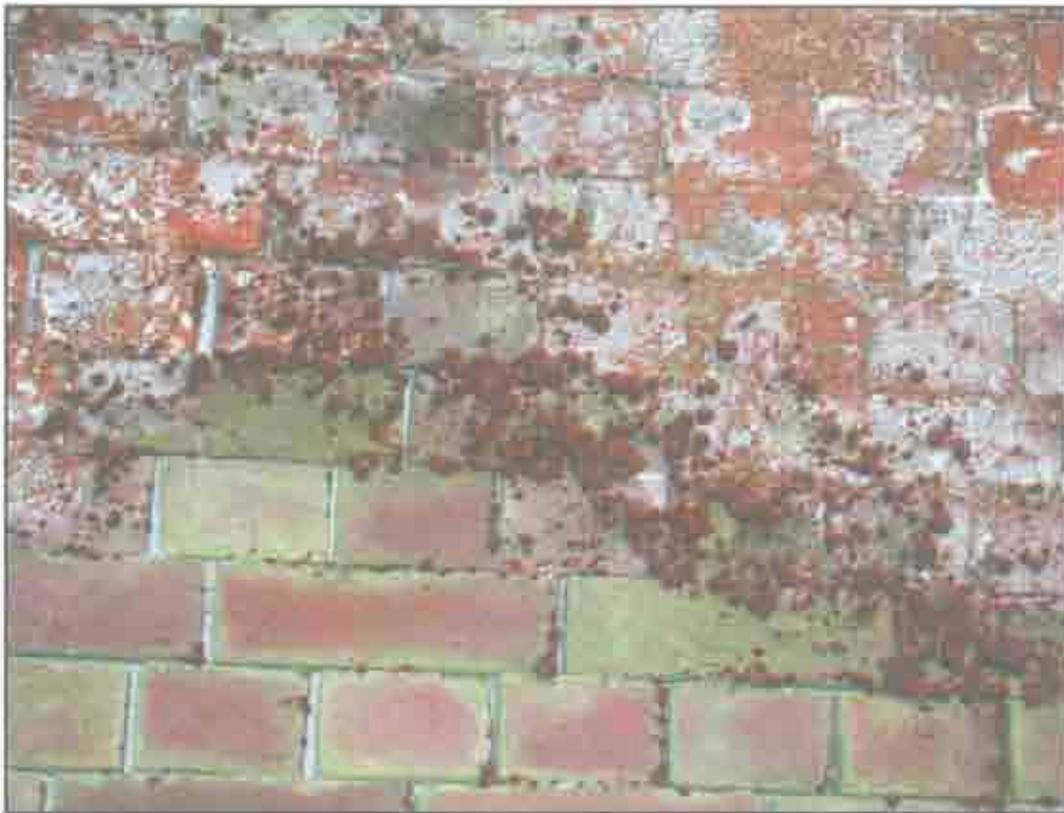
Condition Photo 3:  
Casemate 101; Calcium deposits  
are draining from open joints  
and coasting is no longer extant.  
(Courtesy of ARG, 2003)

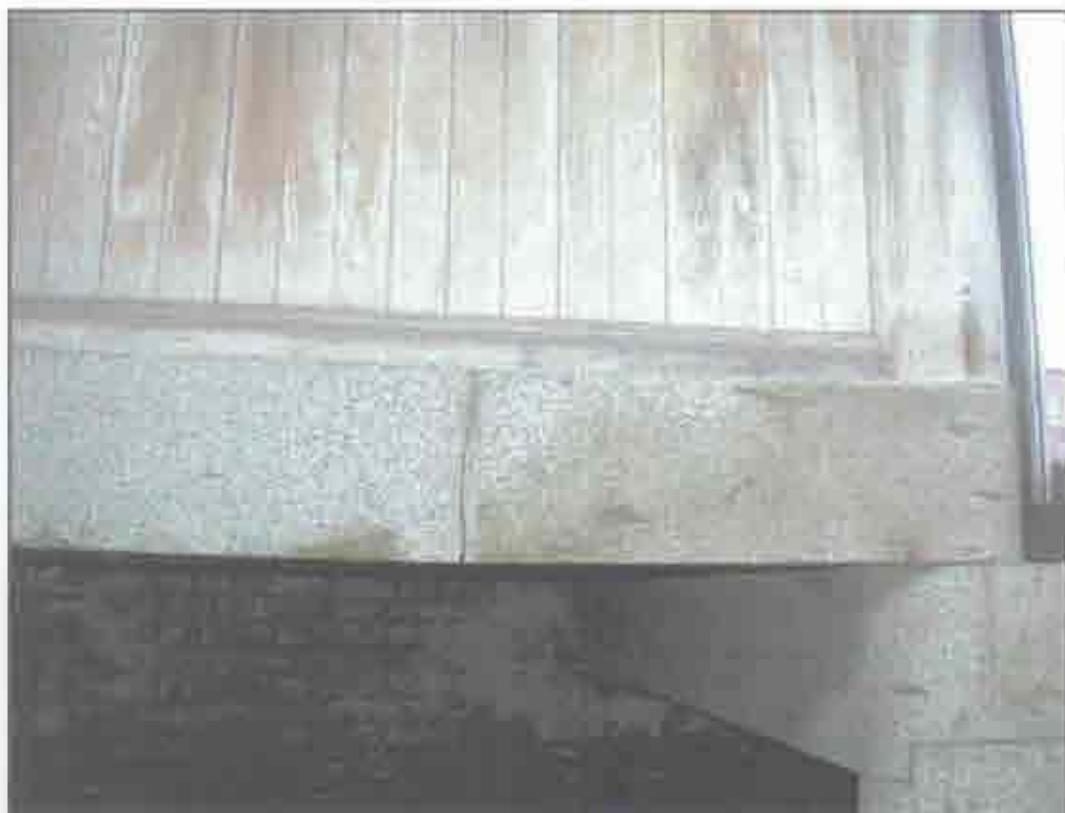
Condition Photo 6:  
Top Landing at Barbetta Tier; Crack  
in granite. (Courtesy of ARG, 2003)

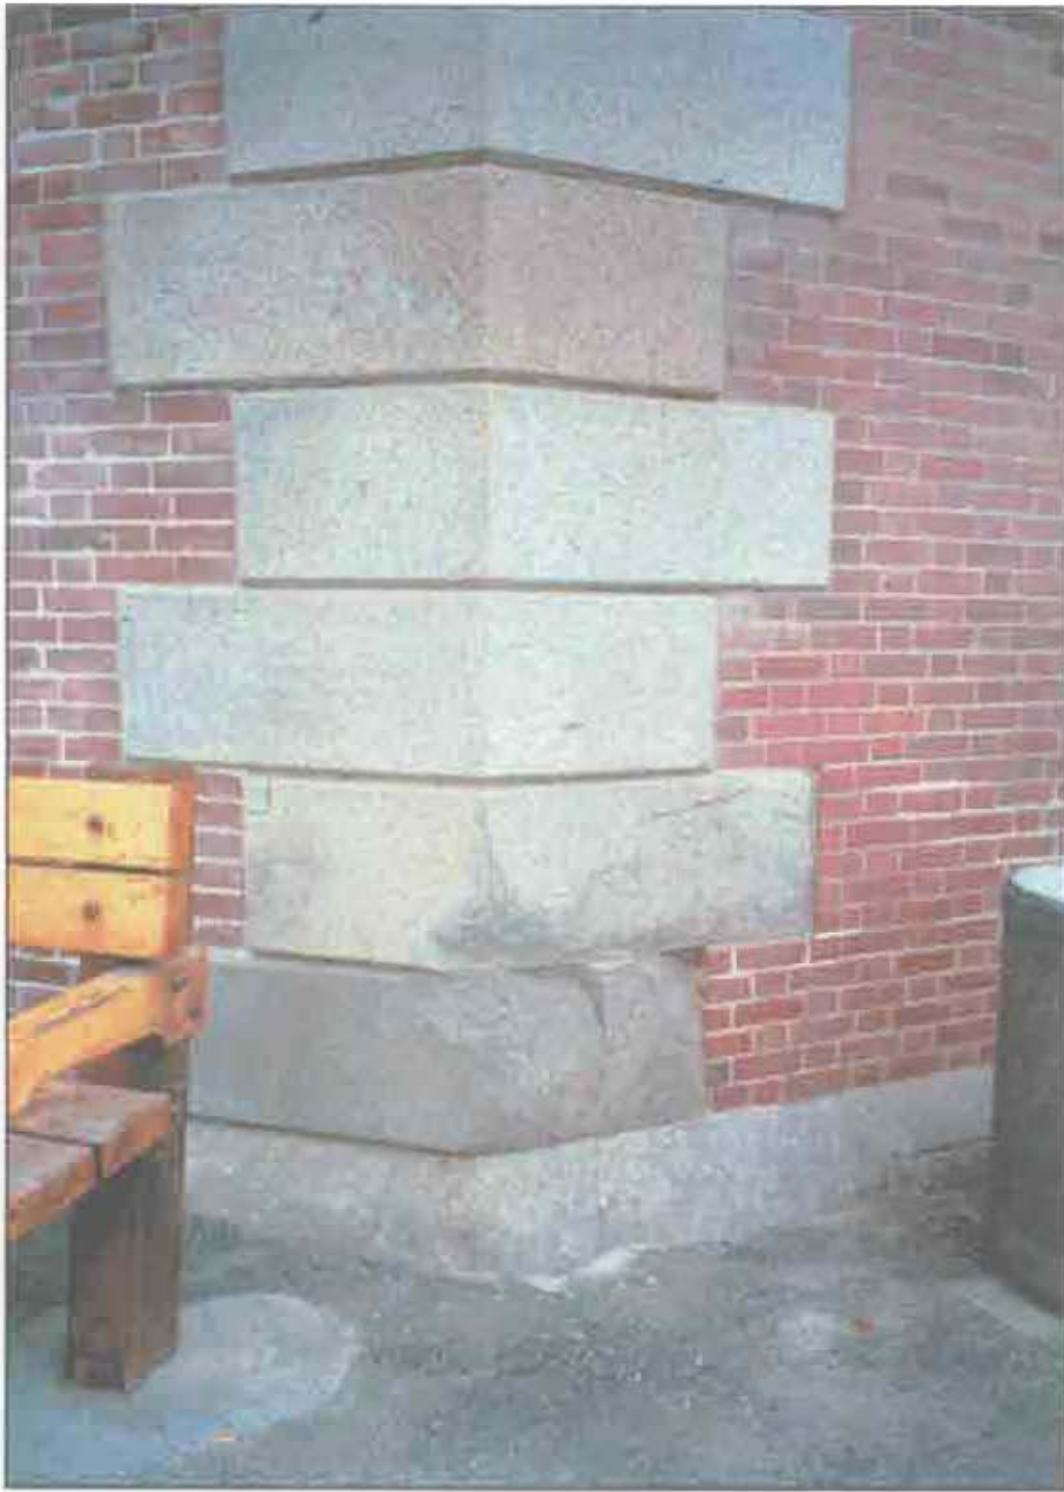
Condition Photo 7:  
East Bastion—East Flank; impact  
damage at granite quoins and base.  
(Courtesy of ARG, 2003)

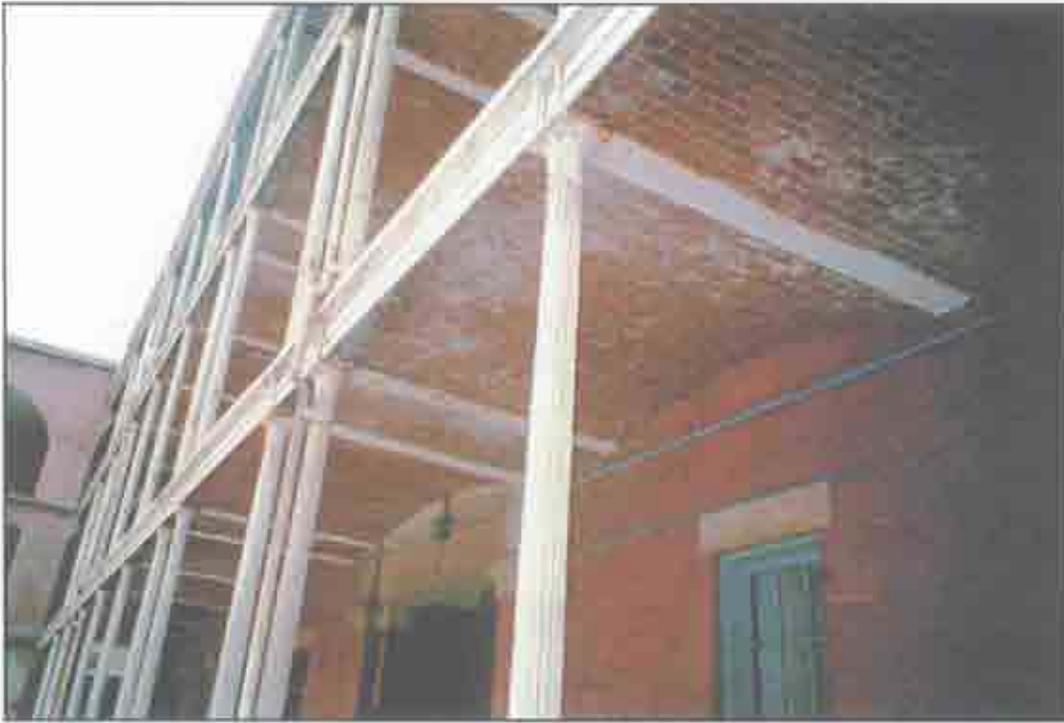
Condition Photo 10:  
Southwest Face Courtyard; Corroding  
metal columns and walkway  
supports. Missing metal railings in  
this photo have been reinstalled.  
(Courtesy of ARG, 2003)

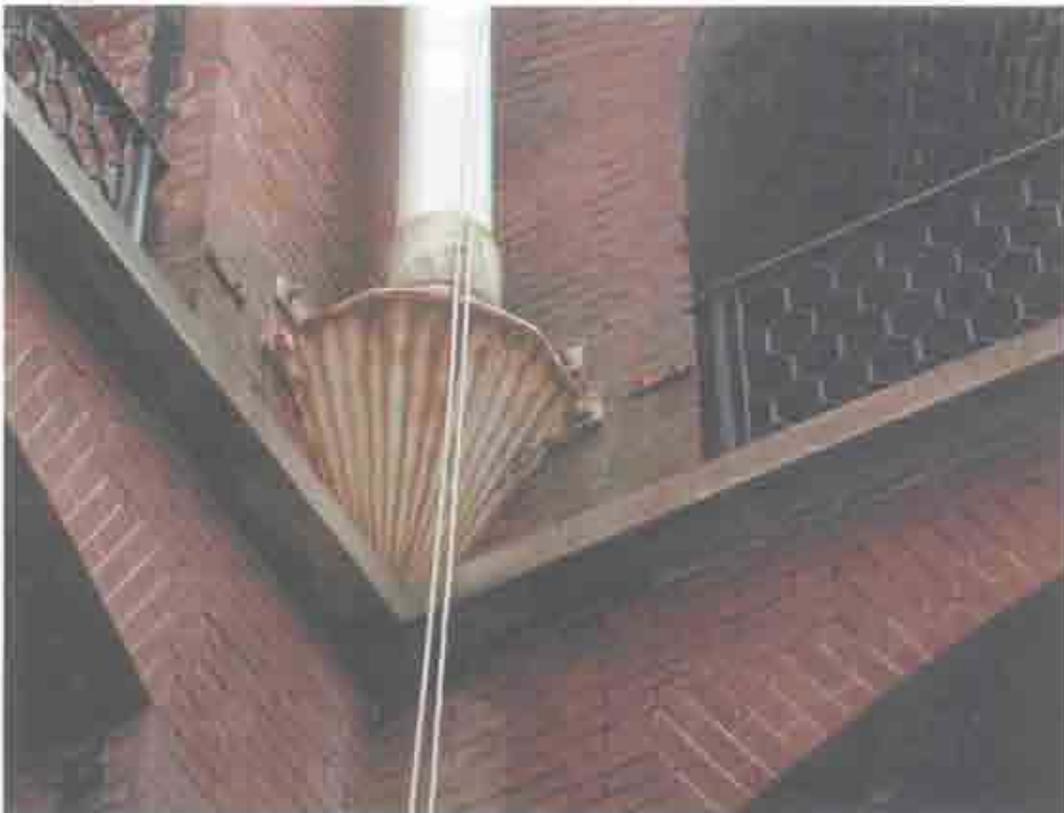
Condition Photo 11:  
Biological growth on flange.  
(Courtesy of ARG, 2003)

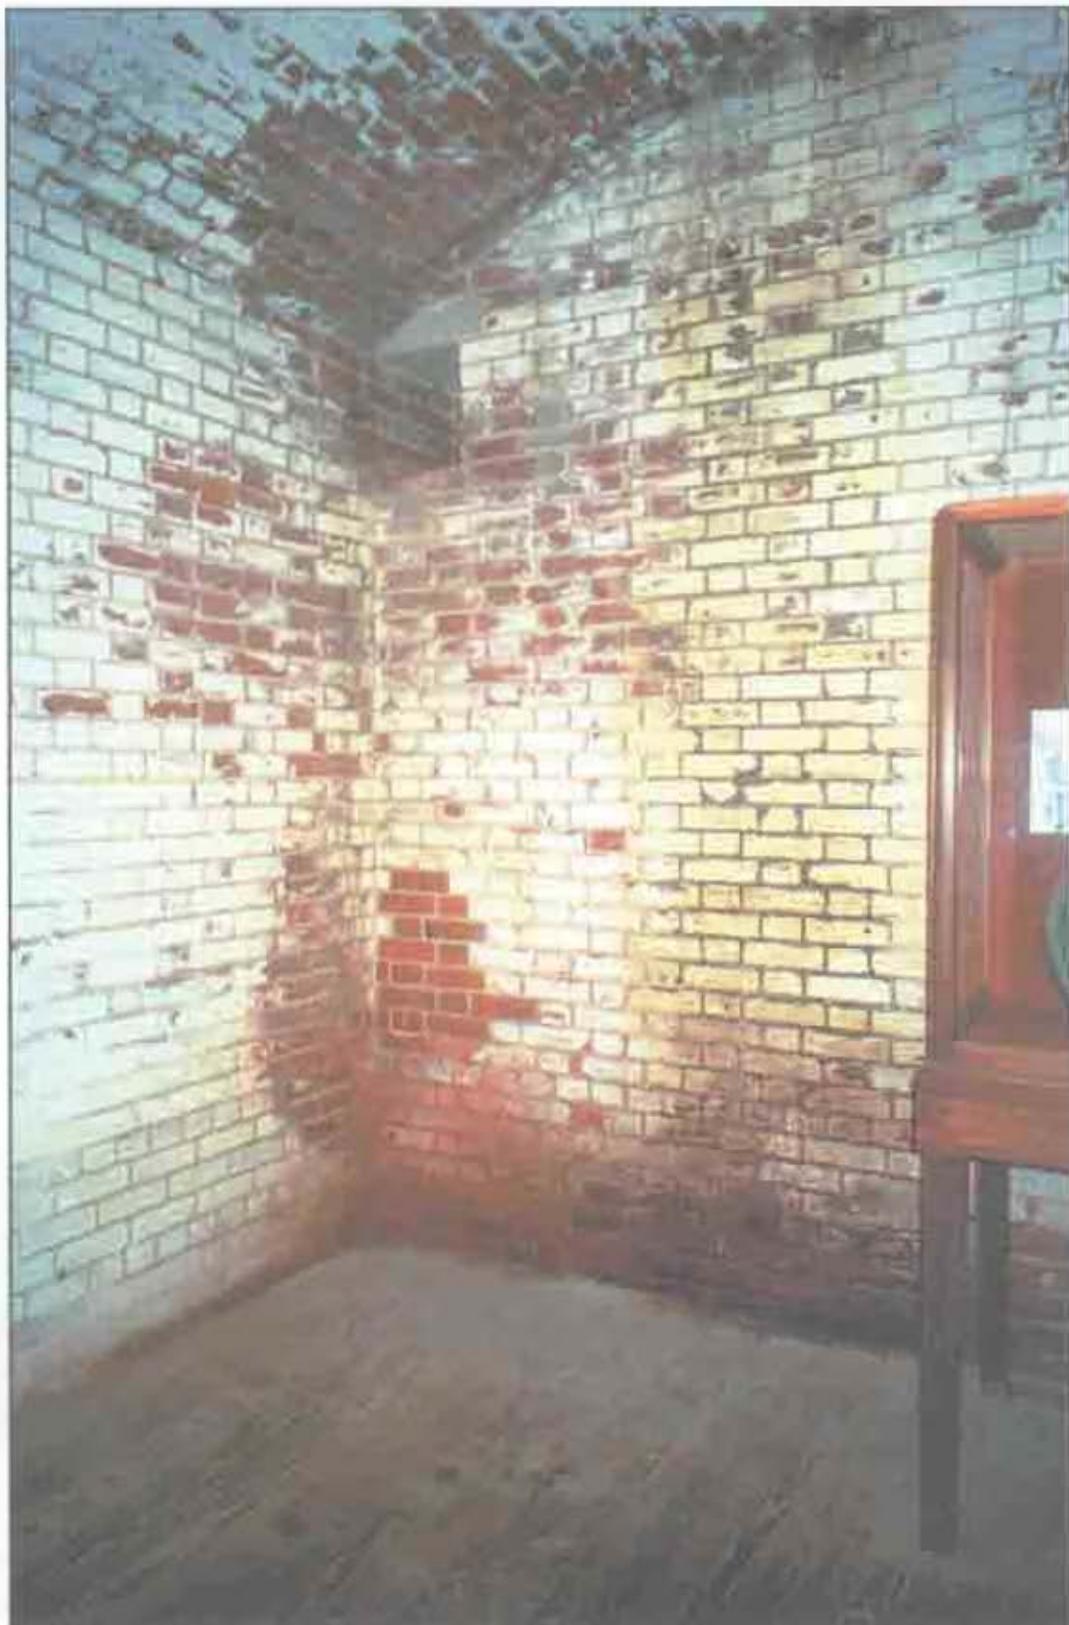
Condition Photo 16:  
Casemate 11; Open joints at the  
brick masonry and heavy water  
infiltration. Biological growth on  
the interior brick. (Courtesy of ARG,  
2003).

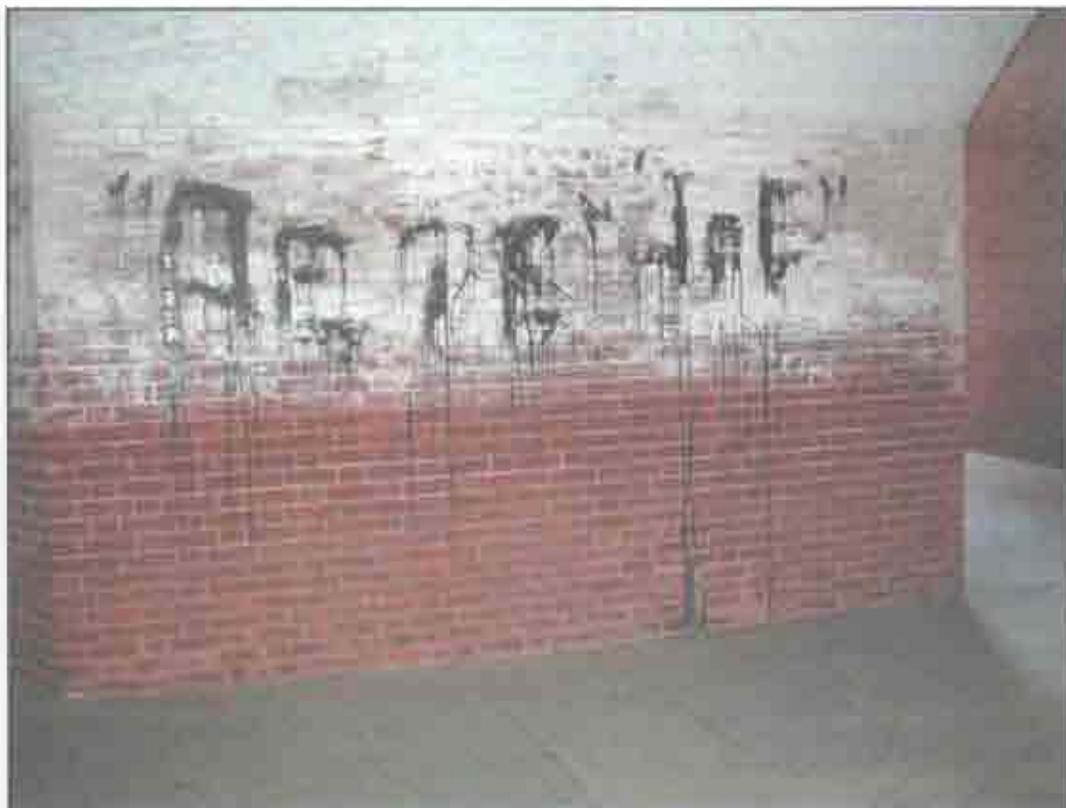
Condition Photo 18:  
Casemate 68A—Second Tier: Graffiti  
noted on masonry wall.  
(Courtesy of ARG, 2003)

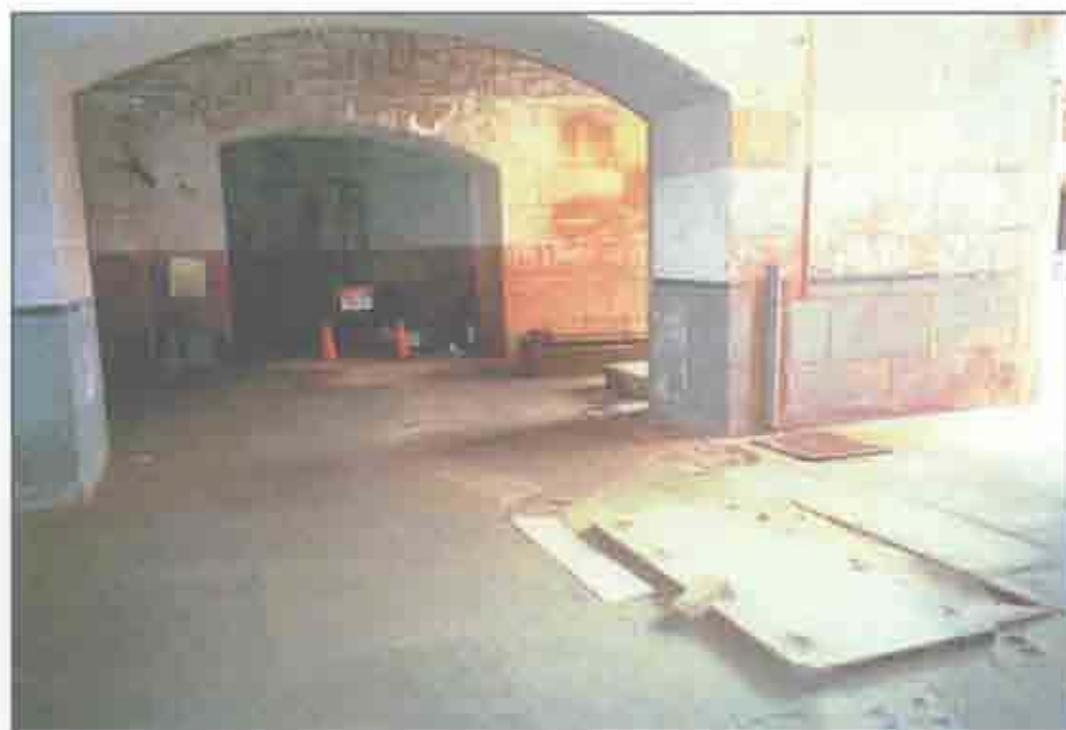
Condition Photo 19:  
Casemate 34: Uneven surfaces, open  
holes and potential tripping hazards.  
(Courtesy of ARG, 2003)

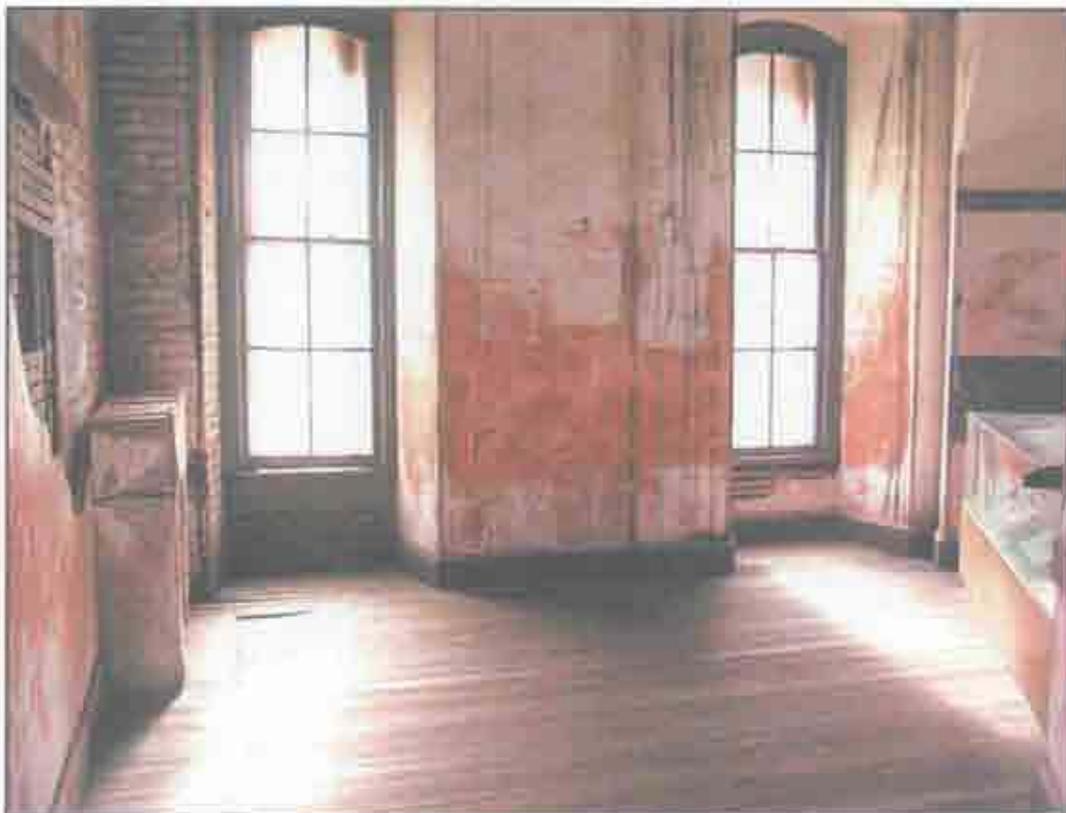
Condition Photo 23:  
Stained plaster at Casemate 21.  
(Courtesy of ARG, 2003)
