Historic Structures Report

Fort Point US Coast Guard Station
Gulf of the Farallones National Marine Sanctuary

April 1, 2008

by
Carey & Co. Inc.

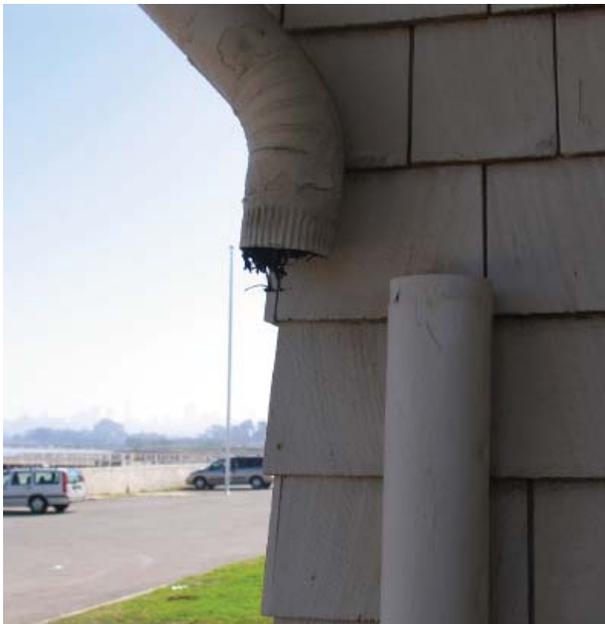
Fig. 27 : Clogged drain at the 1890 Boathouse.

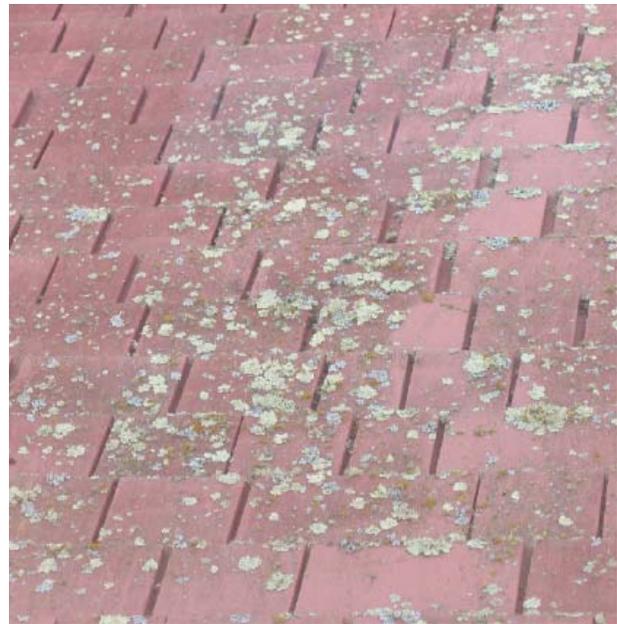
Fig. 28 : Biological growth on the roof at the Main Boathouse.

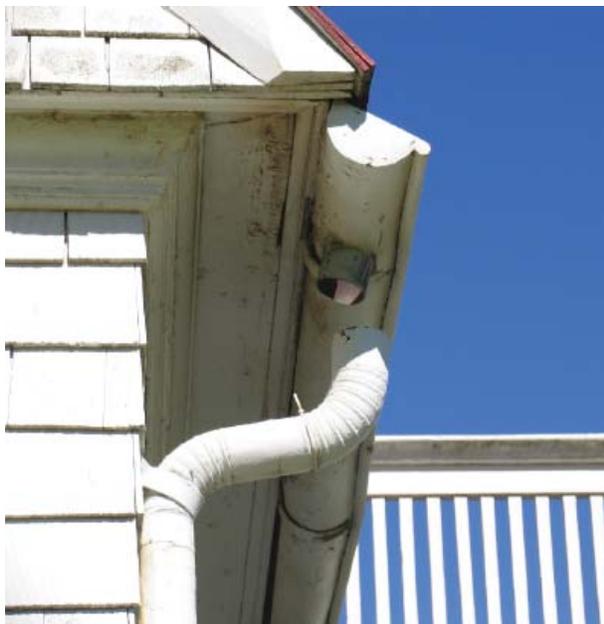
Fig. 29 : Disconnected drain spout at the Officer in Charge Quarters.

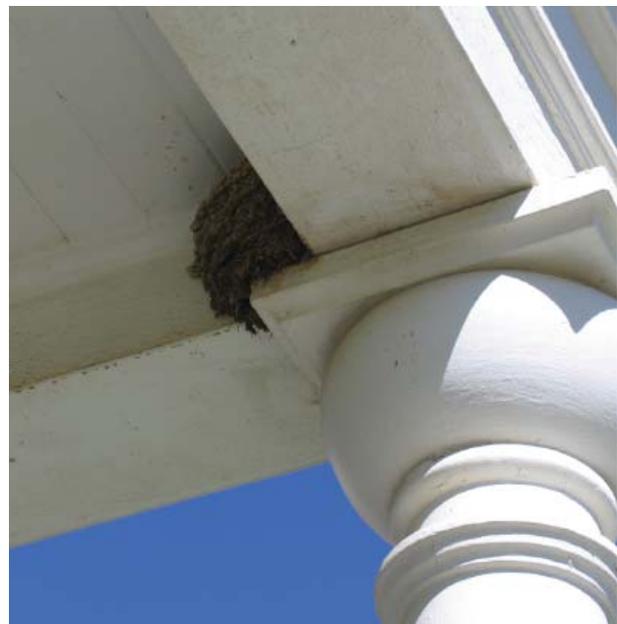
Fig. 30 : Mud Swallows nesting in the eaves of the porch at the Officer in Charge Quarters.

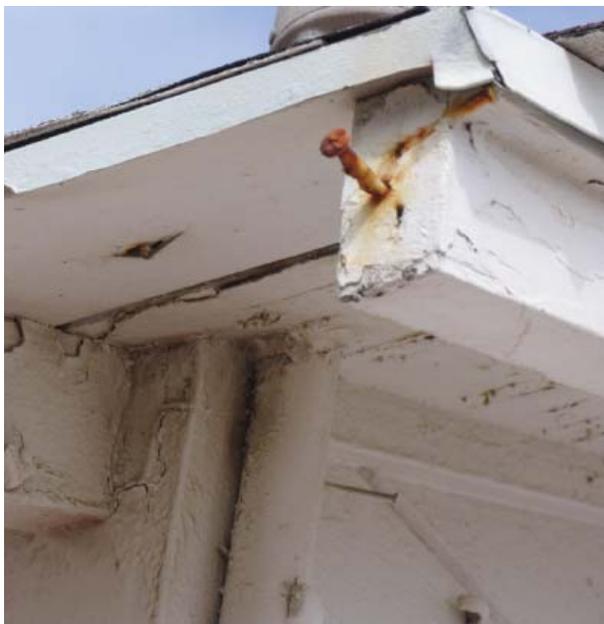
- Figure 31. Photograph: Buoy Shack, 2007. Corroded ferrous metal attachments in rafter tails. Carey & Co., Inc.
- Figure 32. Photograph: Buoy Shack, 2007. Deteriorated substrate below paint layer. Carey & Co., Inc.

Fig. 31 : Corroded ferrous metal hardware at the Buoy Shack.

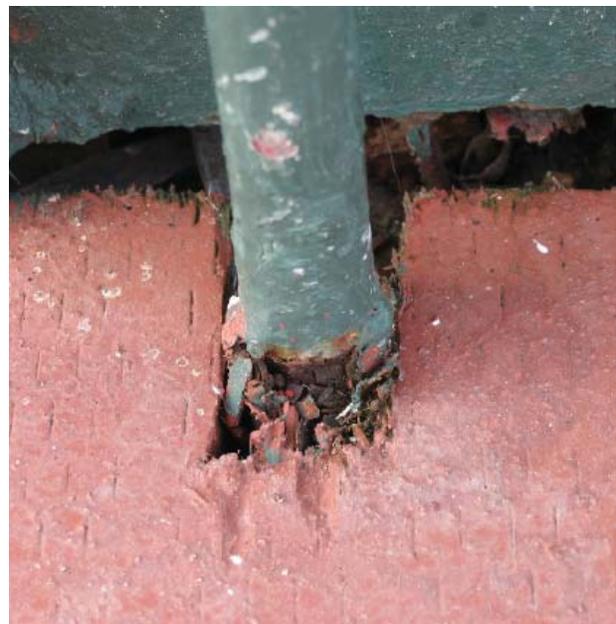
Fig. 32 :Substrate underneath deteriorated paint is deteriorating from rot.

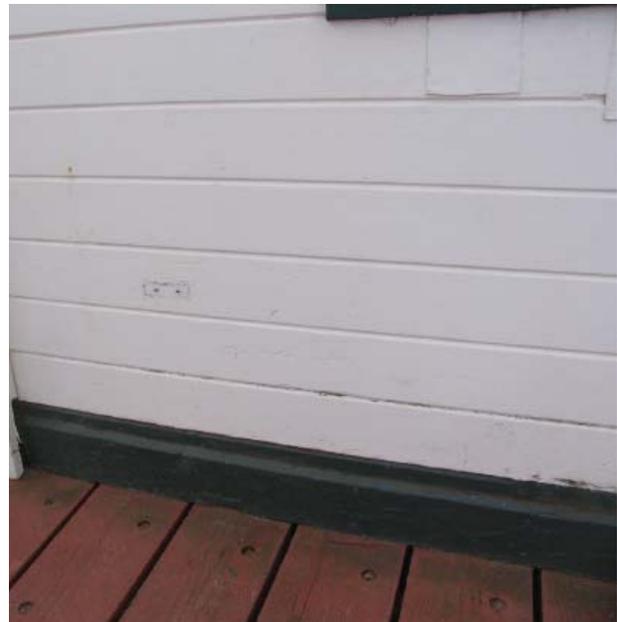
- Figure 44. Photograph: Buoy Shack, 2007. Inappropriate patching on clapboard wall. Carey & Co., Inc.
- Figure 45. Photograph: Shop & Garage, 2007. South garage doors exhibiting the mechanical deterioration associated with cross-grain dragging and water infiltration. Carey & Co., Inc.

Fig. 44: Inappropriate patching on clapboard wall at the Buoy Shack..

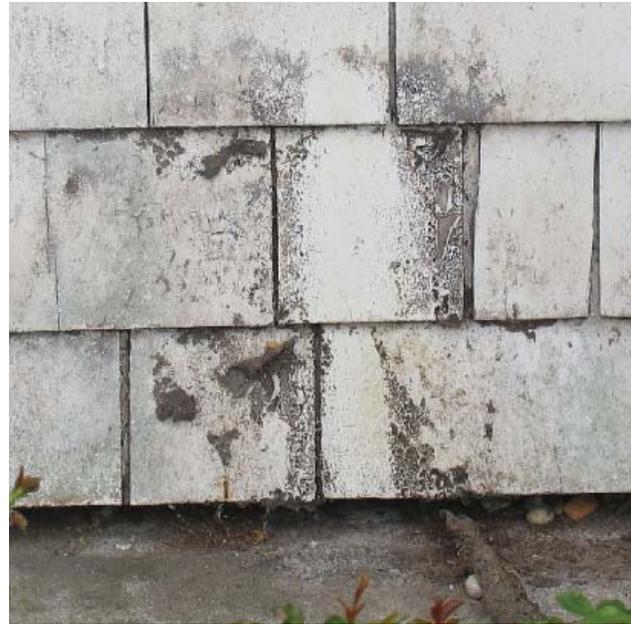
- Figure 50. Photograph: Main Boathouses, 2007. Detail showing shingle deterioration and soiling. Carey & Co., Inc.
- Figure 51. Photograph: Main Boathouse, 2007. Detail of four-over-four lite window on east elevation. Carey & Co., Inc.

Fig. 50: Shingle soiling and deterioration at the Main Boathouse.

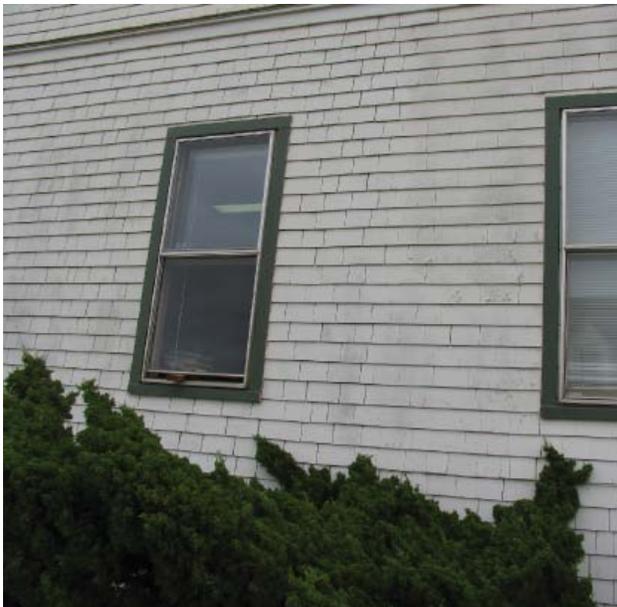
Fig. 55: Vegetation at the south wall of the Main Boathouse.

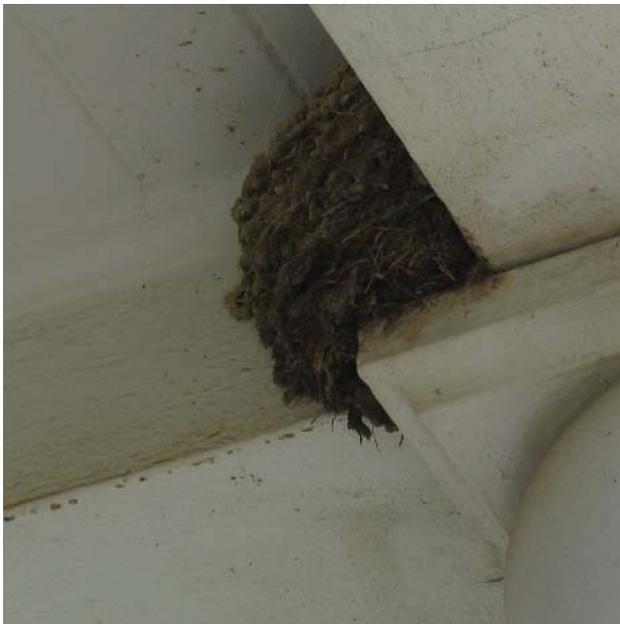
Fig. 57: Mud Swallow nests at the front porch of the Officer in Charge Quarters.

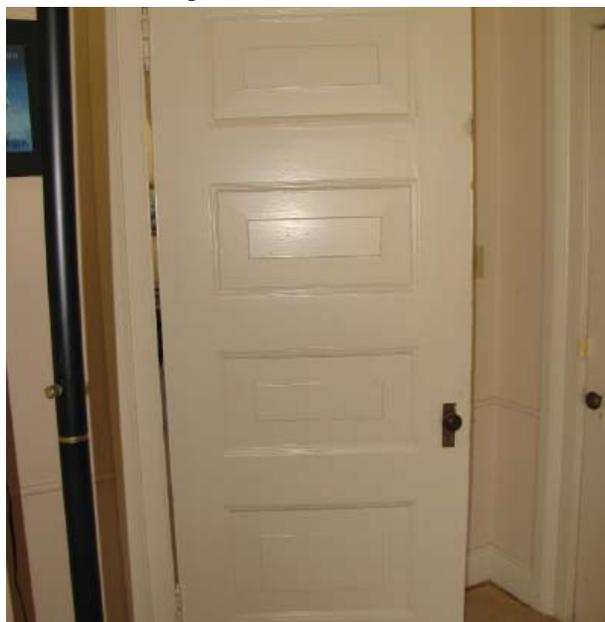
Fig. 67 : Most of the doors appear to be in good condition, with only minor repairs needed.

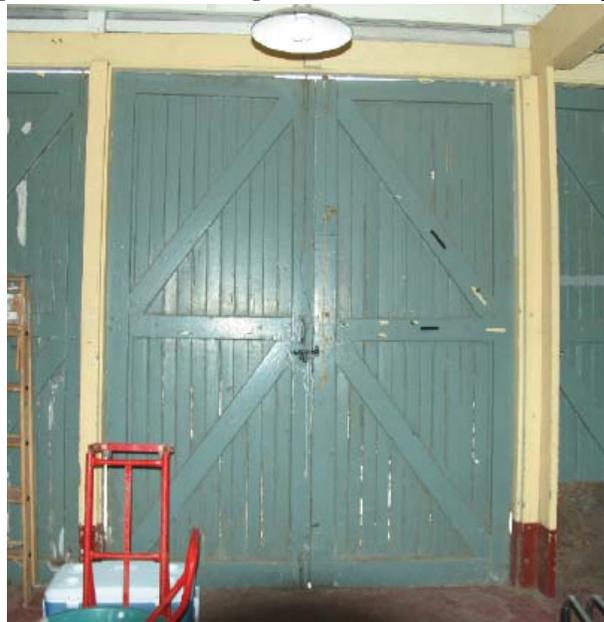
Fig. 68 : The doors at the Shop & Garage appear to be in fair condition.
