HISTORIC STRUCTURES REPORT  
for  
VANCOUVER BARRACKS, WEST BARRACKS  
Vancouver National Historic Reserve

**PART II: TREATMENT AND USE**

Leavengood Architects  
Seattle, Washington

November 15, 2002

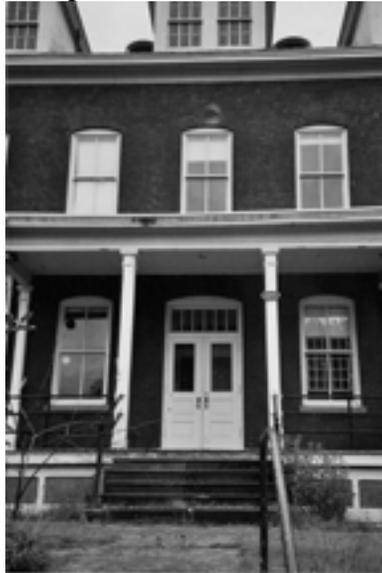
The front porch of the hospital is in poor condition. The gutters are not working properly and the concrete steps are broken.

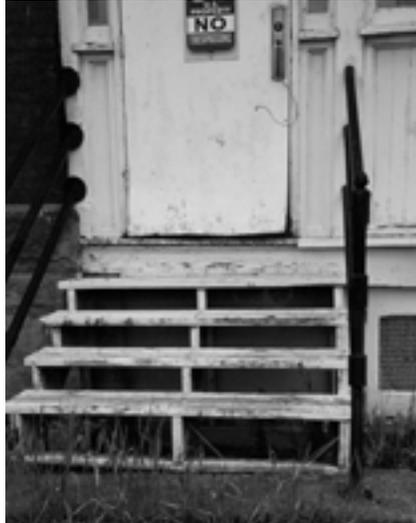
The exits from the porches are in poor condition.

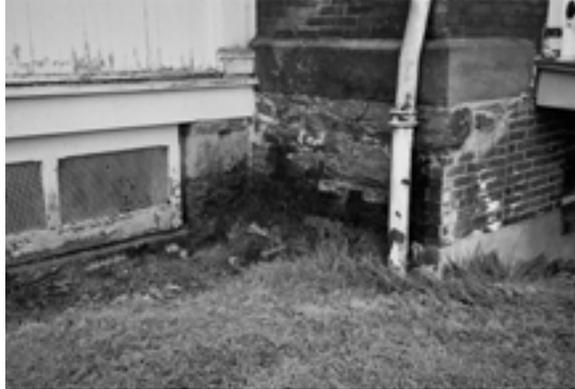
The south porch where it meets the relocated Annex shows a lot of damage.

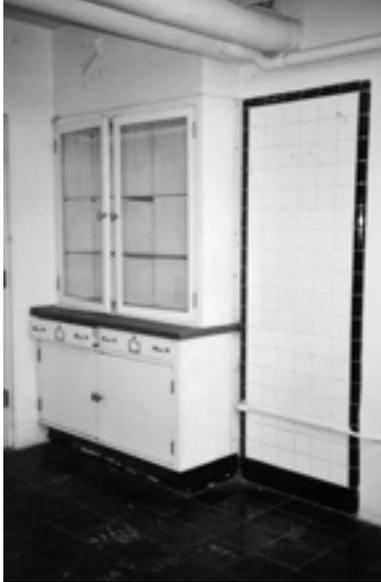
Room 9 in the basement has metal cabinetry and a tile wall.

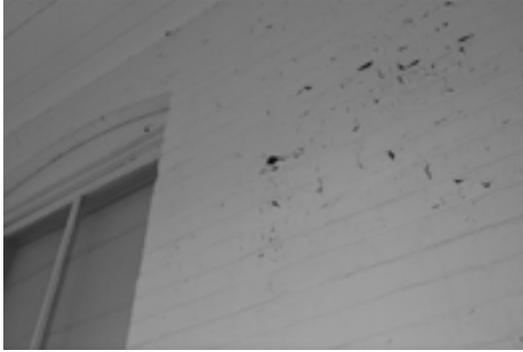
The exterior wall of one of the ward wings has paint peeling on the brick wall.

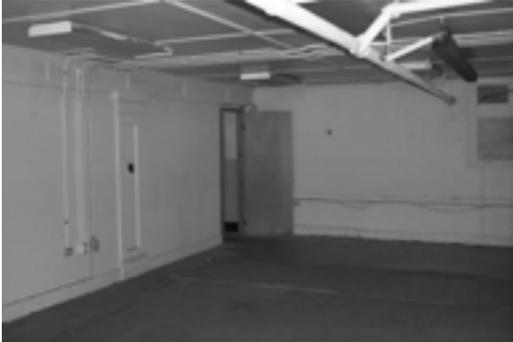
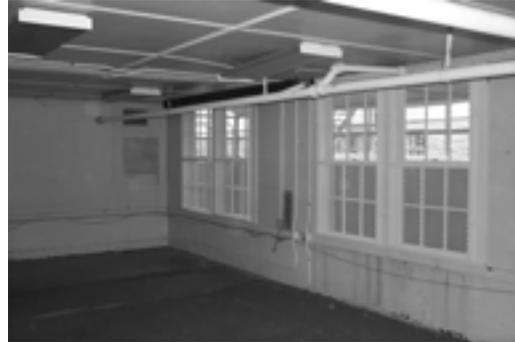
Basement Billiard Hall room shows columns engulfed by the partition wall. Surface mounted conduit and plumbing run helter-skelter throughout. The windows open onto a generous light well but are currently covered with security grating.

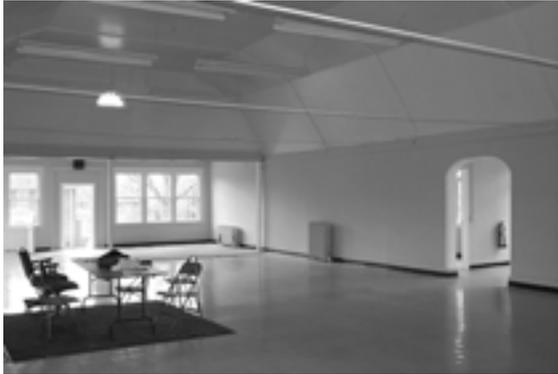
The Auditorium was opened up to the south porch (seen on the left of the photo) and the west wall doorways were filled in (seen on the right of the photo). The collar ties can be seen at the top of the photo.
