**1998 Summary Report:  
Archaeological Site Monitoring and Management  
Along the Colorado River  
Corridor Below Glen Canyon Dam**

Submitted by  
Grand Canyon National Park/Northern Arizona University  
Glen Canyon National Recreation Area

September, 1998

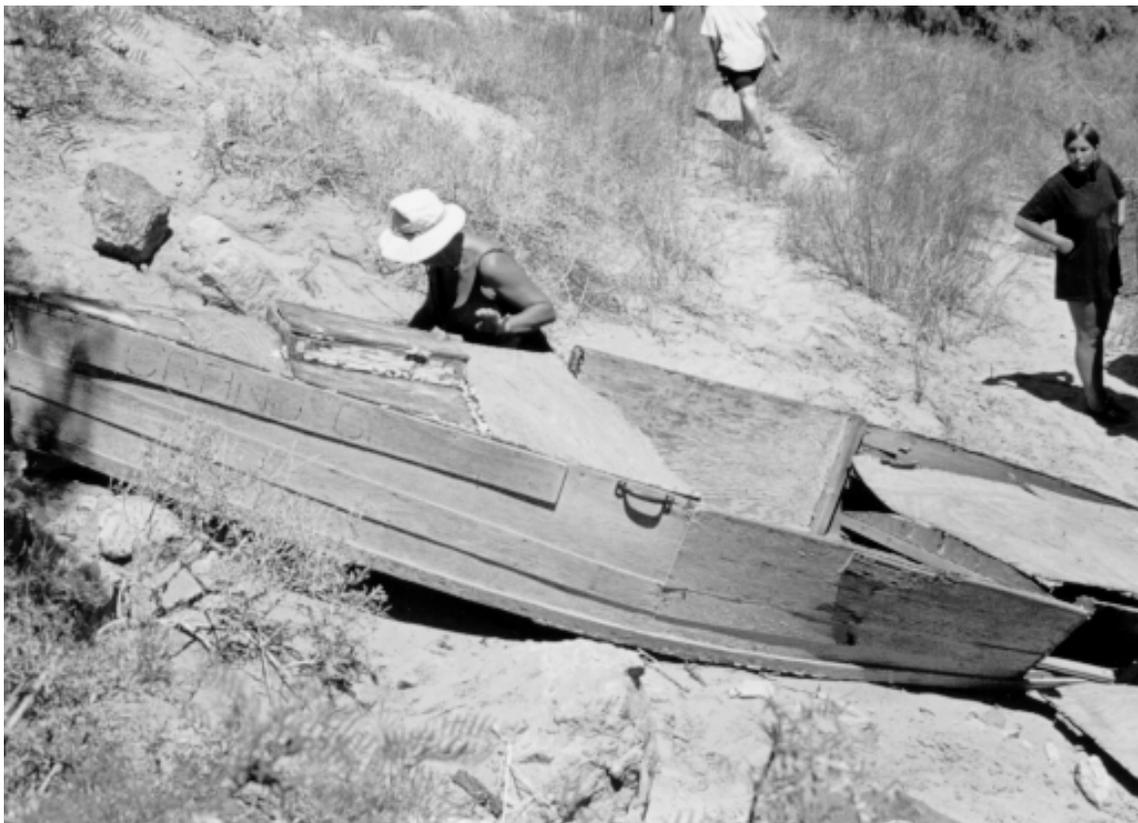
Long-term replication of early photographs often depicts the methodical destruction of sites through time. Figures 4 and 5 are replications illustrating 27 years of visitor-related impacts to site AZ C:09:034. Although weathering is a factor, time series photographs have recorded the gradual dismantling of Bert Loper's boat. This location is a popular stop for many river trips as evidenced by a heavily traveled trail.

Figure 4. 1969 Photograph of Bert Loper's boat.

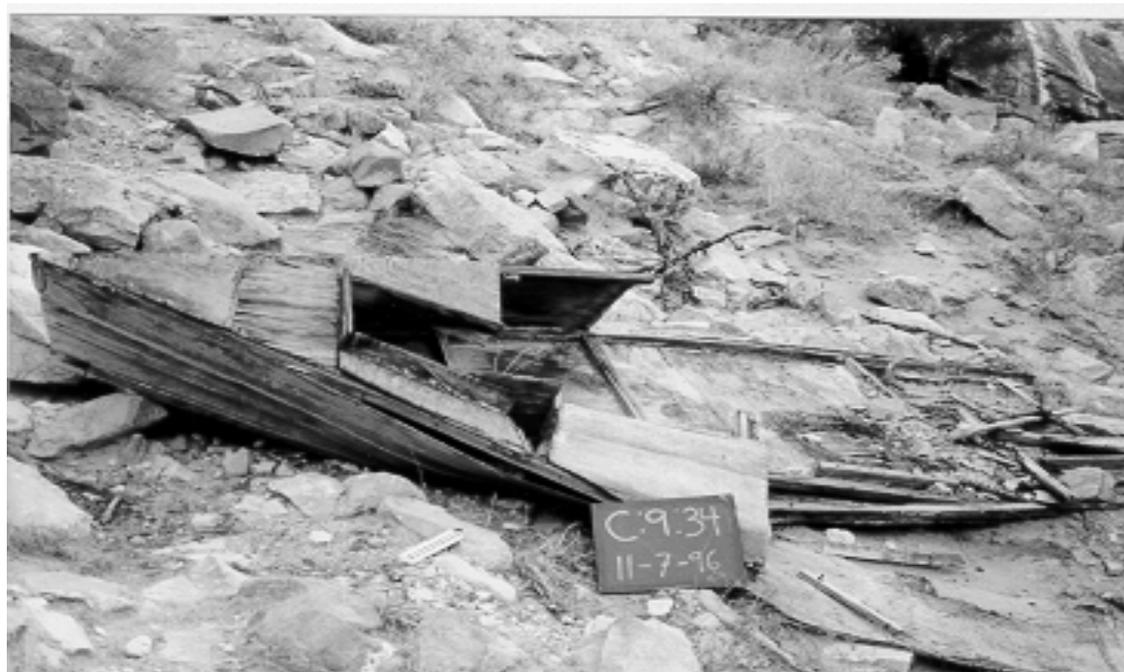
Figure 5. 1996 Photograph of Bert Loper's boat.
