Fiscal Year 2002
Archaeological Site Monitoring and Management
Activities Along the Colorado River in Grand Canyon
National Park.

CHAPTER ONE

EXECUTIVE SUMMARY

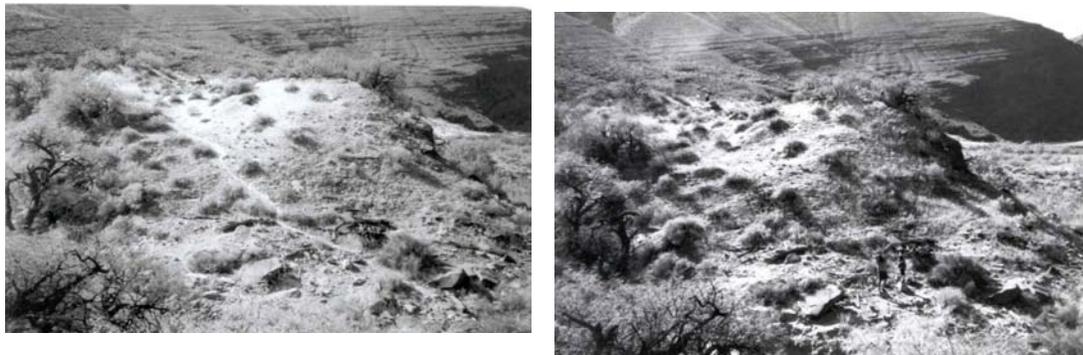
Figure 9. Trail Obliteration Work Completed at C:13:070 on a CRT trip.

The site was originally recorded in 1973 and re-recorded in 1991 by NPS personnel (Fairley, et al. 1994). The site was monitored in previous years by GRCA, and more recently monitored under the RCMP: semi-annually from FY94 – FY96 and annually from FY97 to the present (Coder, et al. 1994b, Coder, et al. 1995a, Coder, et al. 1995b, Leap, et al. 1997a, Leap, et al. 1996b, Leap, et al. 1998d, Leap and Kunde 2000b, Leap, et al. 2000a, [Dierker, 2001 #459]). In FY95 medium format photographs were taken for drainage documentation. In FY95 PA members wanted RCMP staff to select certain sites to measure artifact movement within one-meter square. These surface analysis units were removed in FY96 as per discussions with PA representatives (Leap, et al. 1996). The results of one year were inconclusive and highly subjective. In May 1996 the Zuni Cultural Resource Advisory Team (ZCRAT) monitored the site and their recommendation was to install several checkdams. A total station map of Loci B, C and D was completed in September 1997 in anticipation of some type of preservation treatment (Leap and Kunde 1997b). Upon further assessment in FY97 and FY99 with the ZCT personnel, it was determined that installing checks "would be a time consuming, expensive and a risky effort." It was determined that the arroyo systems were (are) too advanced for any practical stabilization effort. In FY99 samples were taken from the charred logs (possible roof fall) in Locus D. Carbon samples from Locus D have dates of 870 +/- 60 BP and 790 +/- 60 BP. This site was also included in the studies conducted by K. Thompson and A. Potochnik (Thompson and Potochnik 2000). The PEP participants stopped at this location in March, 2000. Trail obliteration work was completed on a CRT trip in November 2001 (see Figure 9).

Active gullying and arroyo cutting are present. The channel at Locus D continues to downcut. Surface erosion is minor at Loci B and C. Artifacts at Locus A have been rearranged to create an alignment. Data recovery at Locus D has been a recommendation since FY99. RCMP personnel will continue annual site monitoring due to the likelihood of identifying newly exposed cultural materials.

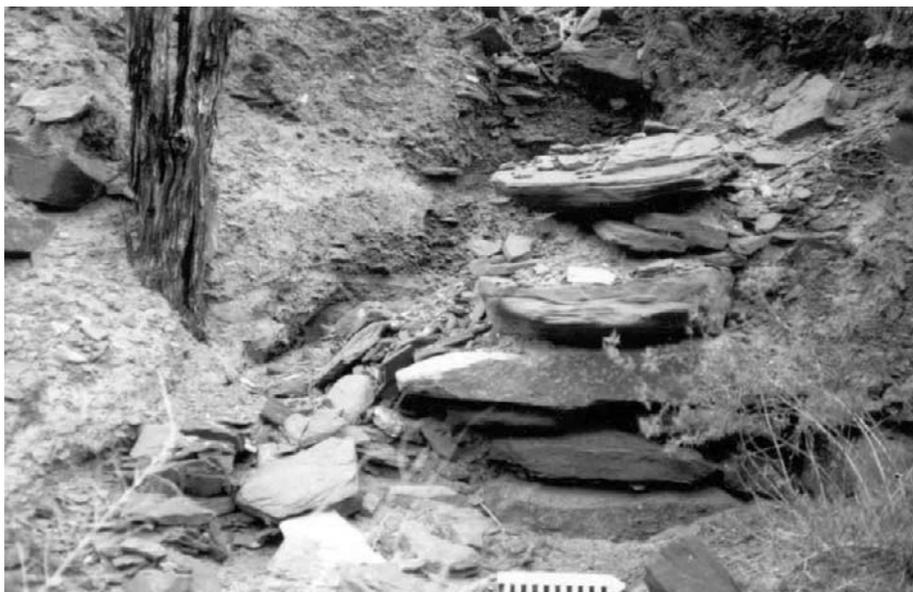
Channel initiation of approximately ten centimeters occurs at Feature 5. This channel has passed through the trail obliteration work completed in December 2000, depositing new fill in the structure. Channel initiation of approximately five centimeters is present at Feature 3. Features 1 and 4 are located within an active arroyo and the features continue to be impacted, see Figure 10. A mano and metate have slumped downslope from Features 1 and 4. RCMP personnel recommend annual trail maintenance for the trail below the site especially after the proposed experimental flows. The recommendation for data recovery at Features 1, 3, and 4 continues, as does annual monitoring.

Figure 10. Continued Impact to Feature 1 through Active Gullying.

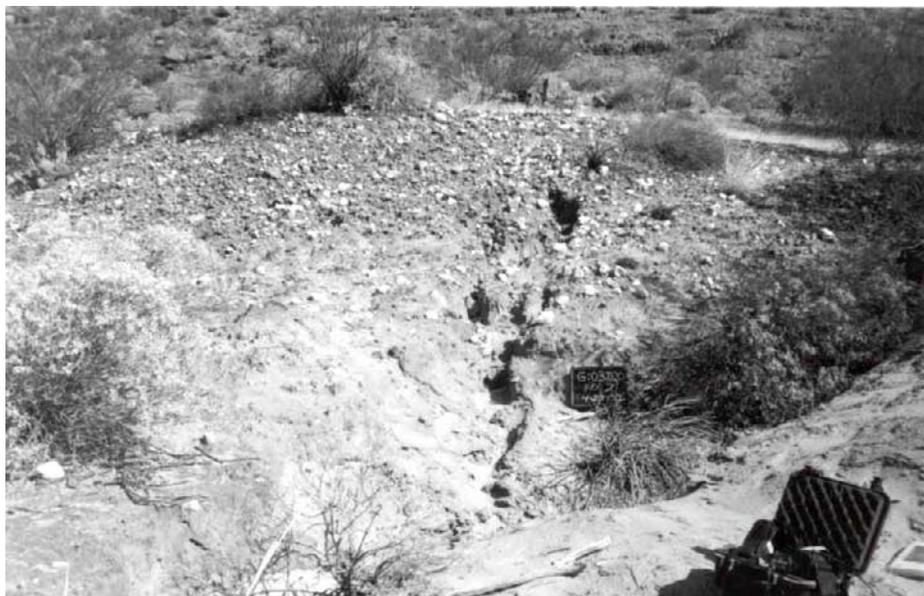
Features 5 and 6 are stable with no signs of surface erosion. Cryptogamic soils are abundant and have anchored fire-cracked rock at both features. There are several piping holes at Feature 1 and increased exposure of fire-cracked rock with slump of artifacts downslope. Headward migration of the gully at Feature 2 has resulted in only 2.5 meters between the headcut and the lip of the center depression at Feature 2, see Figure 11. A gully west of Feature 2 is almost to the talus slope, and joining with the east gully, threatening to surround and isolate Feature 2. Data recovery has been recommended at Features 2 since November 1998. Joel Pederson's work may be very useful at this location. RCMP personnel will continue annual site monitoring.

Figure 11. Continued Headward Migration of Gully toward the Center of Feature 2.

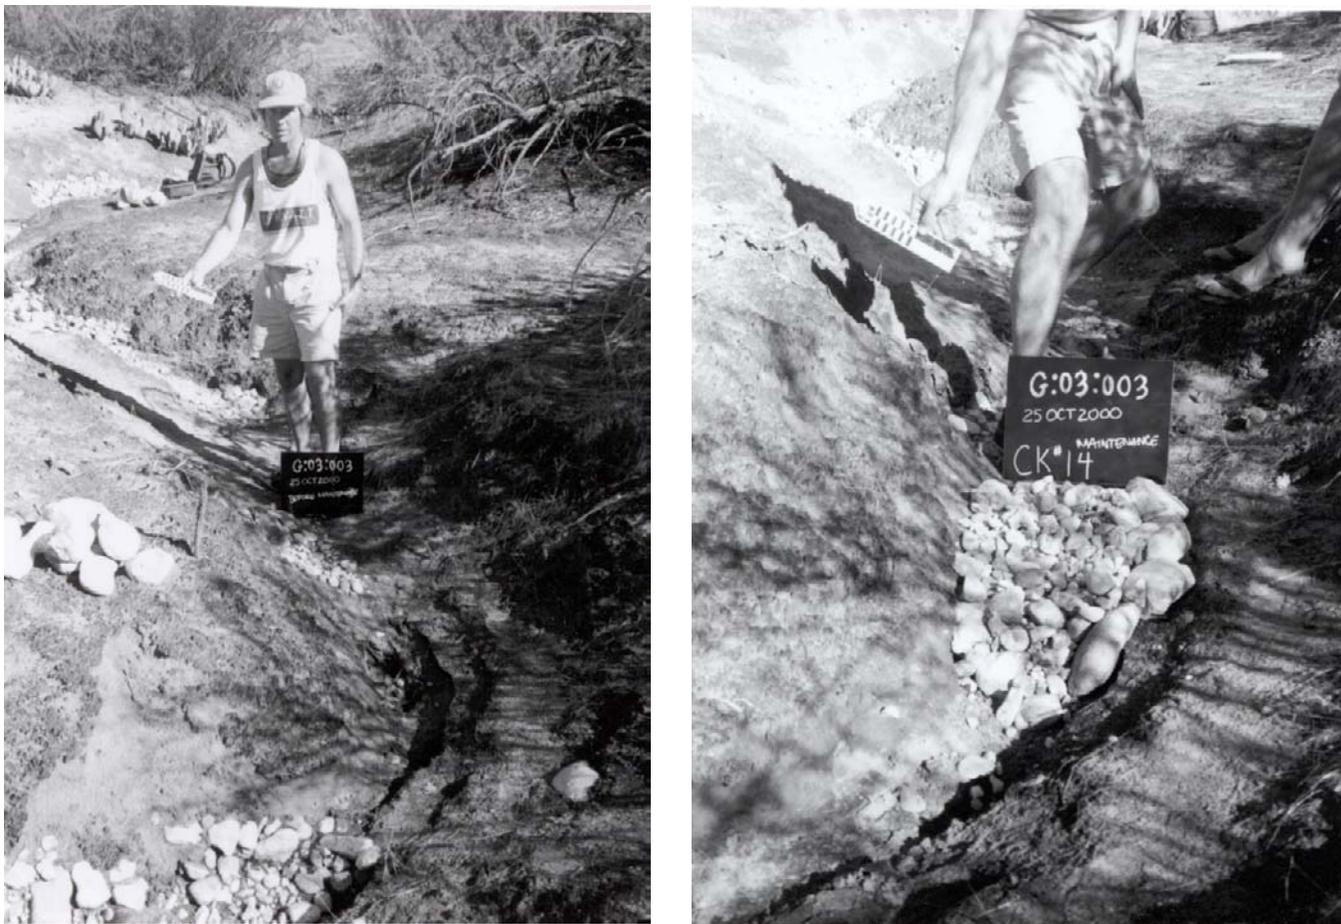
Figure 12. Main Drainage at G:03:003 Before and After Construction of a New Checkdam.

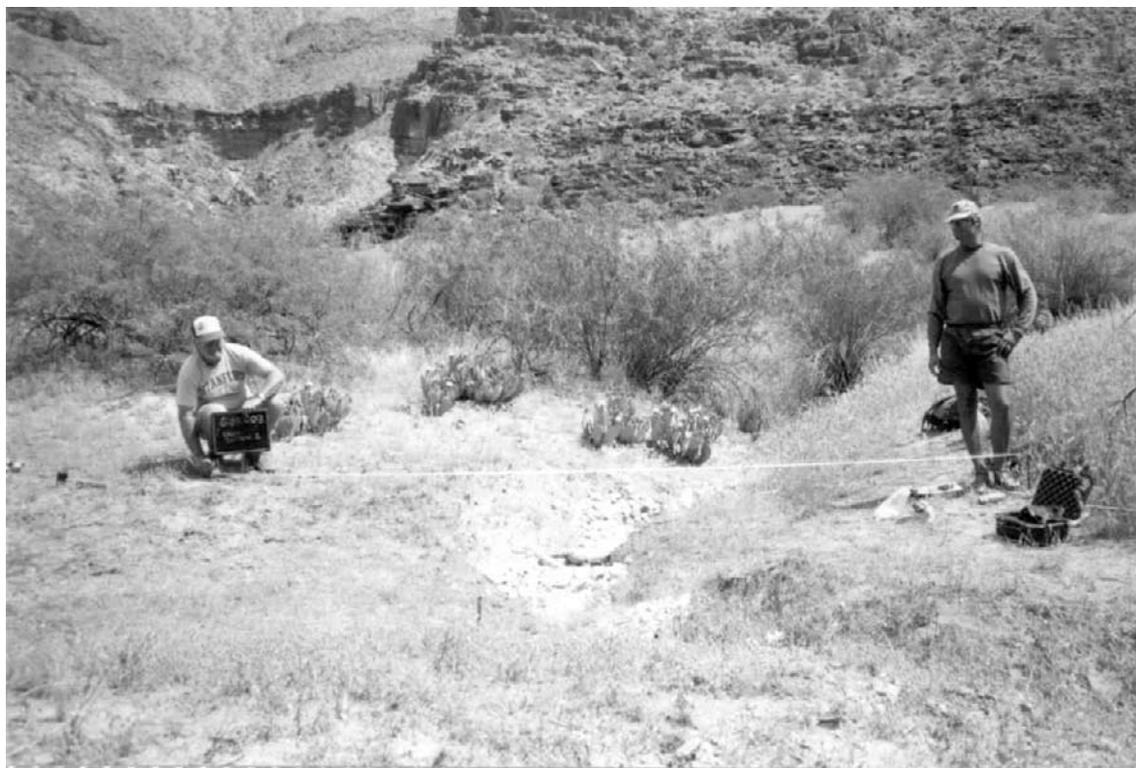
Figure 16. Overview of Cross-Section 1 at G:03:003.

All three cross-sections located in the same river-based gully were remapped. Profile 1, the furthest upstream and above Checkdam 2 is shown in Figure 16. Profile 2 is located between Checkdams 8 and 9. Profile 3 is situated just above Checkdam 5 (see Appendix D). There was sediment deposition at all three cross-section locations. Checkdam 2 had 0.028 sq. m of deposition, the area between Checkdams 8 and 9 showed 0.621 sq. m. of deposition, and Checkdam 5 had 0.760 sq. m. of deposition.

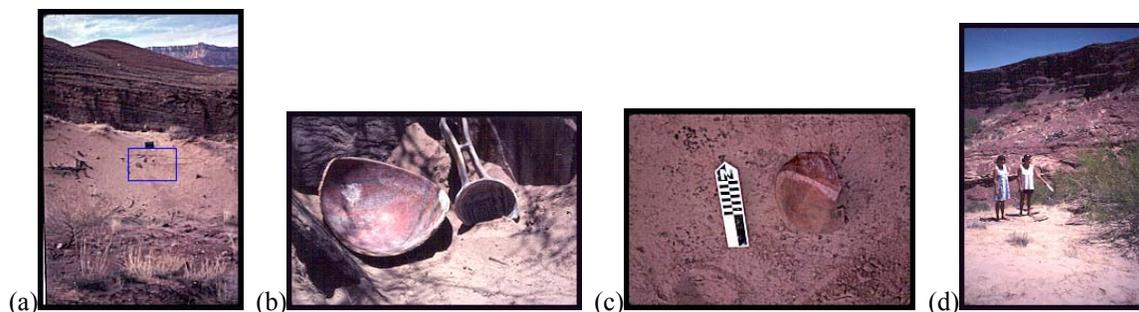
In the spring of 2000, a scientist notified the RCMP office of the presence a prehistoric bowl eroding from an alluvial dune (site C:13:386). In May 2000 Dierker and Leap visited this location and documented the findings – a partial bowl and a ladle were exposed from the dune. Measures were taken to fully document the items. They were reburied on-site in a more stable location. In December 2000, Leap visited the site on a river trip and noticed another partial bowl eroding from the same location. The item was properly documented and reburied in the same location as the other two items. All vessels were removed under the provisions provided under the Archaeological Resources Protection Act (43 CFR) and NPS responsibilities under the National Historic Preservation Act (section 110). At the time of their exposure it was not known they were associated funerary objects. See Figure 19.

Figure 19. C:13:386 (a) location of the exposed materials: (b) two vessels exposed and reburied in May 2000: (c) vessel exposed and reburied in December 2000: (d) location of reburial, located 6 meters north of their origin.

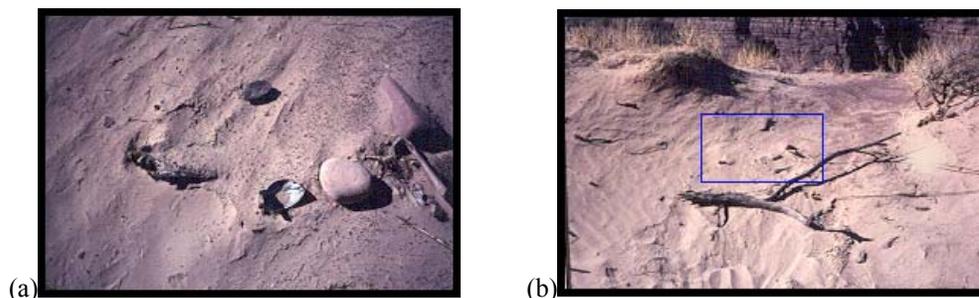
On November 9, 2001 Dierker and Leap visited the site and a fourth vessel was exposed at the same location, but this time fragments of bone were exposed just below the fourth vessel and about 10 cm to the south of the vessel. Photographs were taken and the vessel and bone were disguised by covering them up with dune sand. A minor attempt was made to stabilize the dune below the newly exposed items by placing a moderately sized mesquite log below the items. See Figure 20.

Figure 20. C:13:386 November 9, 2001 (a) exposure of a fourth vessel and probable human bone: (b) interim treatment of findings.

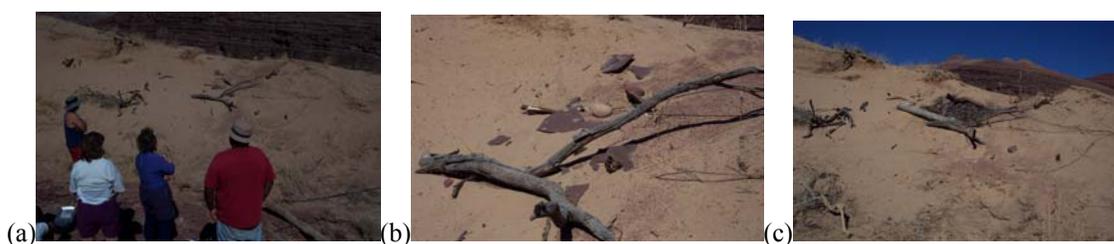
Upon field evaluation of the site during the April river trip, we determined that excavation was unnecessary to confirm the presence of human remains. The remains were exposed enough to allow field staff to confirm that they are human in origin and situated in an archaeological feature. The exposed bone is a long bone, probable femur and it appears to be located in a slab-lined structure. The slabs are of Dox Sandstone. No collections were made and no destructive analyses occurred. Jan Balsom, Lisa Leap, Jennifer Dierker, Andres Cheama (Zuni representative) and Lawrence Snow (Paiute representative) concluded that the remains could be preserved in place until cultural affiliation is determined. Therefore, stabilization of the area took place during this same visit. The remains were covered with dead brush and some logs, covering approximately a 1.5 m area. This type of preservation will trap blowing sediments in the brush thus covering the remains through eolian processes. See Figure 21 for happenings on the April, 2002 river trip.

Figure 21. C:13:386 visit on April 29, 2001. (a) discussions with tribal representatives: (b) exposed long bone in a dox-lined feature and a fourth vessel: (c) stabilization with brush and logs.

The three vessels reburied 6 meters north of their original location are now considered funerary objects. Lawrence Snow, Paiute representative, expressed the desires of his tribe to stabilize the burial in place, if possible, and to reunite the vessels with the human remains. The Hopi Tribe has currently shared this same request. However, as Snow recognized by being there, reuniting the vessels with the remains would only cause additional erosion due to the fragile dune setting.
