Addicks Cabin and Adamless Eden
Elkmont Historic District
Great Smoky Mountains National Park

Historic Structure Report

September 2010
for
Great Smoky Mountains National Park
Southeast Region, National Park Service
by
Joseph K. Oppermann–Architect, P.A.
539 N. Trade Street Winston-Salem, NC 27101

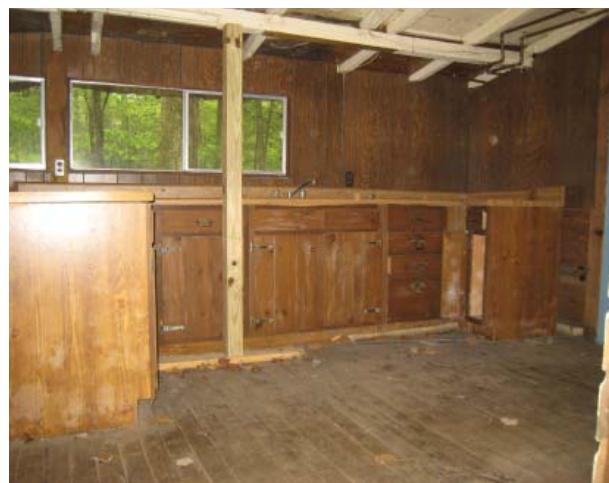
Today, the Addicks Cabin remains largely intact since that c. 1970 remodeling. The cabin is in fair condition. There are several urgent concerns. Most pressing, the roof framing that create the last two extensions of the kitchen are undersized and have poor connections. They constitute a safety hazard. The east wall of the kitchen constitutes the most serious deterioration.

Figure 39, Modern c. 1970 kitchen cabinets on east wall of kitchen.

- Remove the deteriorated east wall of kitchen and associated roof framing. Construct anew at pre-1970 location. Add supplemental framing for retained roof framing.
- Replace in-kind the 5-V metal roof and install new gutters and downspouts.
- Repair damages to front porch. Add supplemental roof framing.
- Perform routine repairs to building envelope and repaint.
- Install emergency lighting, security and fire detection systems.

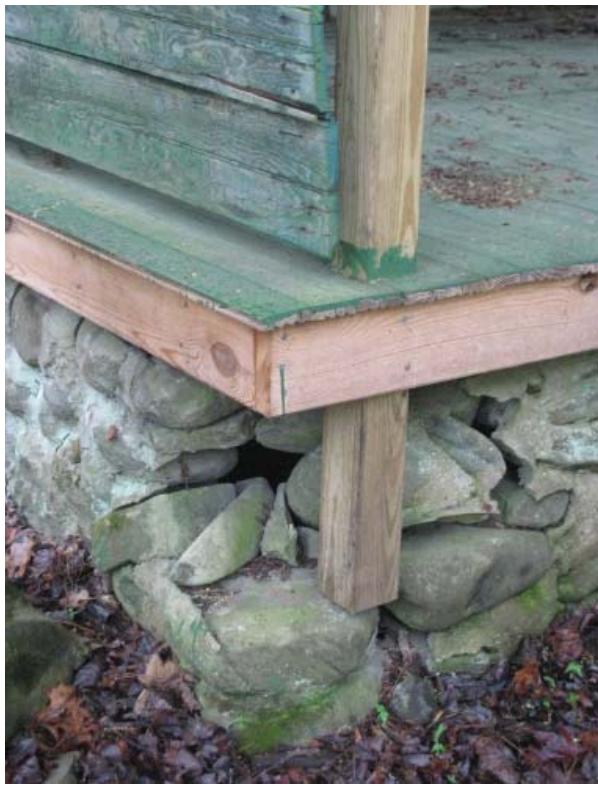
are deteriorated. Temporary shoring has been installed. The entire exterior envelope needs minor repairs and repainting.

Figure 77, Temporary shoring of front porch.

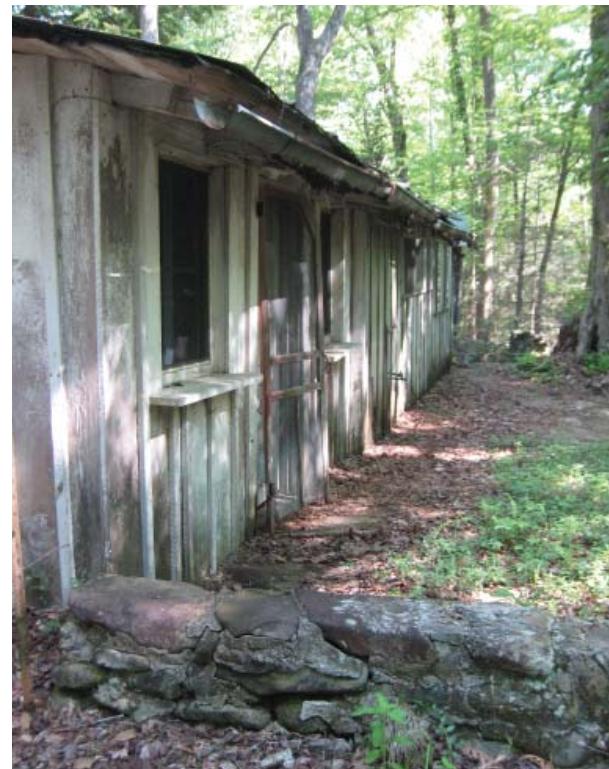
This condition is caused in large part by the complete failure of roof gutters, downspouts and water dispersal system at grade. Also a safety concern is the roof framing of the front porch. Like the rafter framing of the back porch, these rafters are undersized, inadequately spaced and have poor connections; fortunately the spans are not as long as at the back porch. Some posts

Figure 78, Failed roof gutters, unpainted and deteriorated wood elements and loose stone site features.
