CHAPMAN-BYERS CABIN

**Great Smoky Mountains National Park
Elkmont Historic District
Sevier County, TN**

HISTORIC STRUCTURE REPORT

February 17, 2009

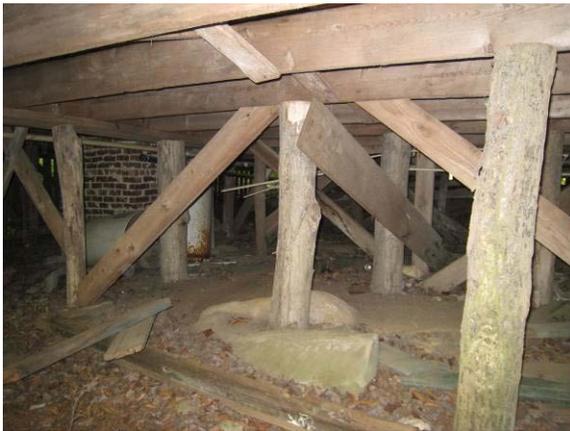
Foundations: At first glance, the wood piers supporting the house, except at the perimeter, appear to lack a predetermined sense of order. Numerous posts, beams and diagonal braces in various configurations support slumping, first-level, floor joists. On closer inspection, there are two rows of posts and beams at about the one-third points of the joist spans; the irregular addition of other additional posts and bracing give the array its haphazard appearance.

Figure C- 2. A variety of support posts and bracing in the crawl space.

At the time this report was being prepared, many of the presumably original posts along the north and east extremities were severely damaged by rot where the posts come into contact with grade. Treated wood posts measuring 5½" x 5½", each sitting on a 4" x

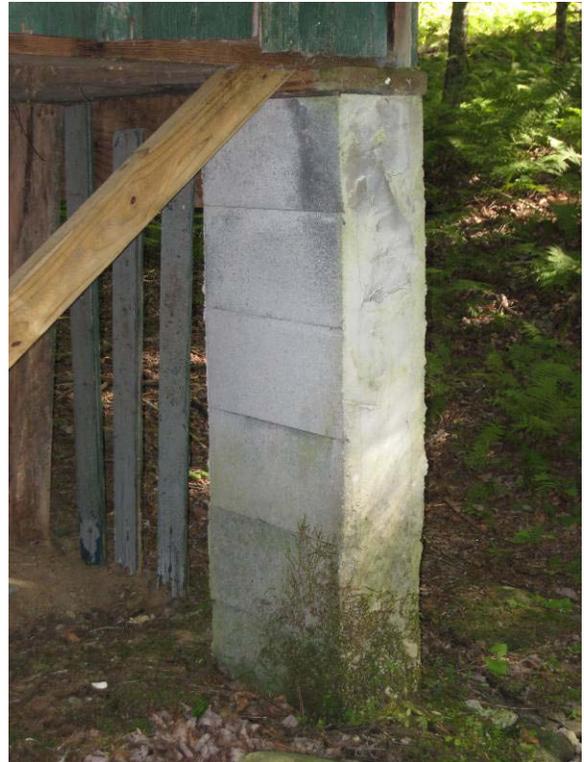
Piers of stuccoed CMUs have in been added in recent years beneath the south exterior wall, and treated wood posts added beneath part of the east exterior wall and east porch.

Figure C- 3. New CMU pier.

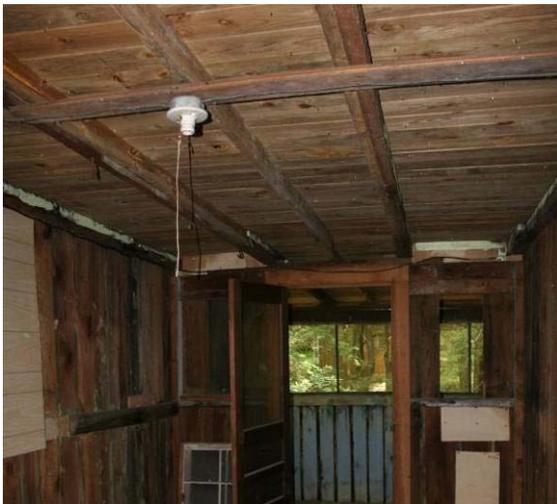
Figure C- 5. Second floor hall looking east with roof framing visible.

Except at roof leaks, primarily along the lower roof on the west elevation and around the chimney, the framing appears sound where visible.

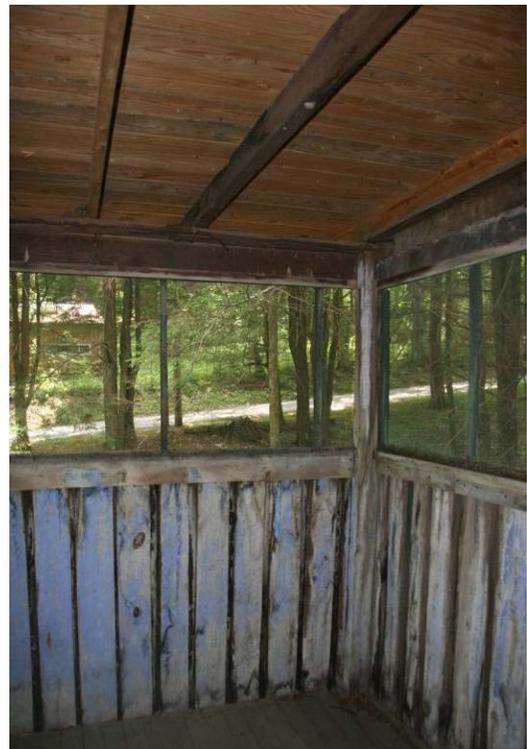
The roof framing over the second floor east porch consists of five rafters set at various intervals. Four rafters were initially installed at an unknown date when the porch was added. Three of the four, each measuring 2" x 4", remain; the southernmost rafter was replaced with one measuring 1½" x 3½", probably when the roof was replaced and the new roof deck installed. The fifth rafter, located in the center, also is modern and measures 1½" x 3½"; it, too, was probably installed when the roof deck was replaced. The deck and rafters appear to be in sound condition.

Figure C- 6. Roof framing of East Porch.

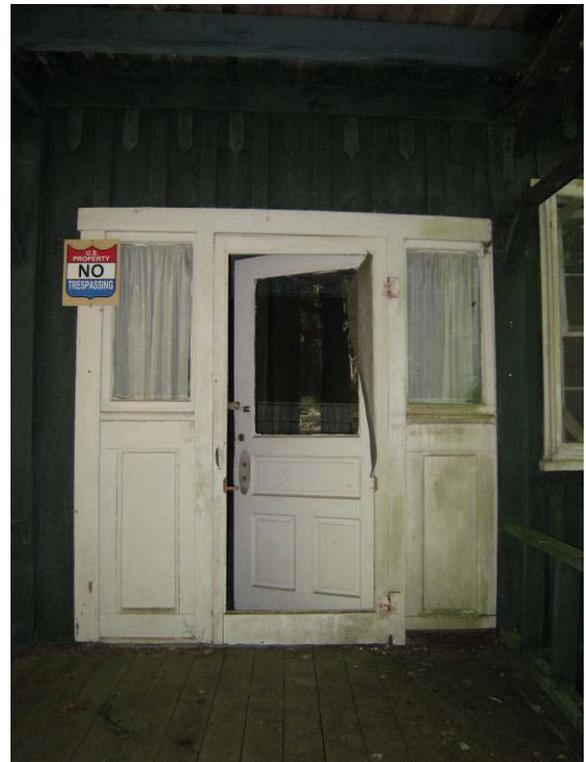
The door appears to be in fair condition with only minor nicks.

The screen door consists of a simple wood frame and screen and measures 2'-10½" x 6'-9" x 1⅛". This screen door is missing its screen and is fixed in place.

Figure C- 7. Front screen and exterior door.

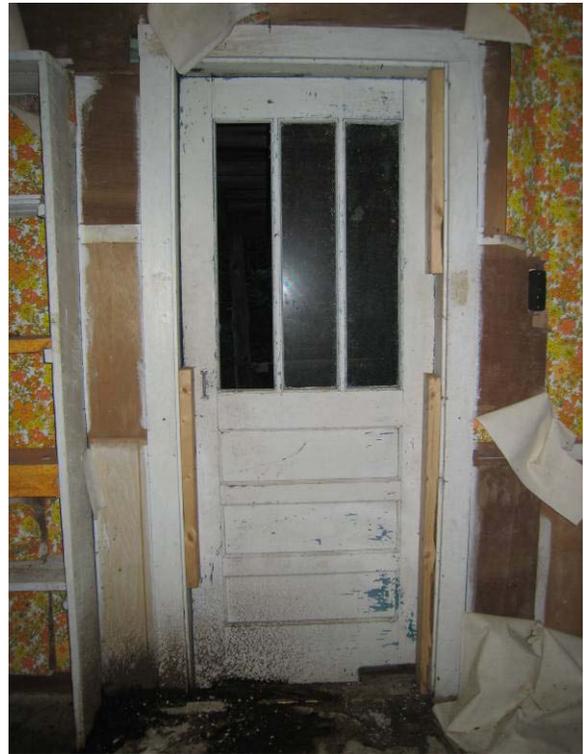
There is an exterior wood paneled sash door leading out from Room 102 to the back deck. The door measures 2'-8" x 6'-8" x 1½" and has three horizontal panels below with three lights above, which are divided by two vertical muntins. This door is currently fixed in place and not operable. The door appears to be in fair condition with a few nicks, scratches, some loose joints and missing sash-light.

Figure C- 9. Exterior Door in Room 102.

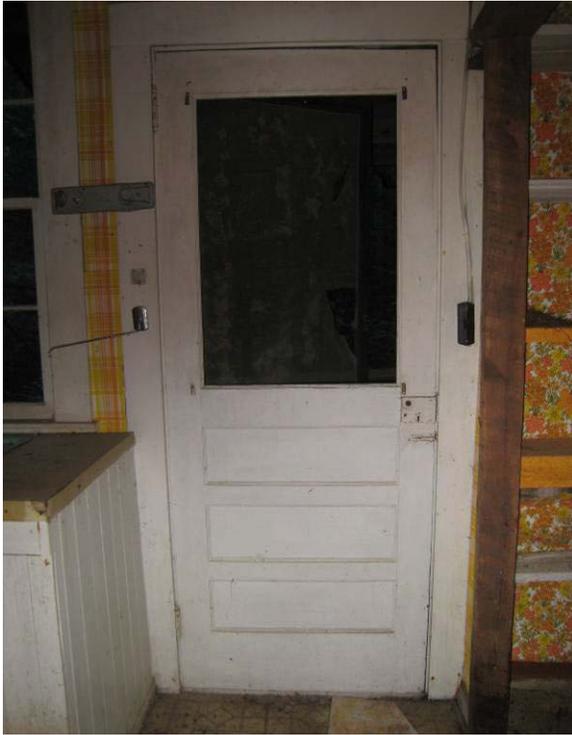
The exterior door measures 2'-8" x 6'-8" x 1¼" and consists of three horizontal panels below with a single light sash above. The door appears to be in fair to good condition with only minor nicks and scratches.

Figure C- 10. Exterior Door in Room 103.

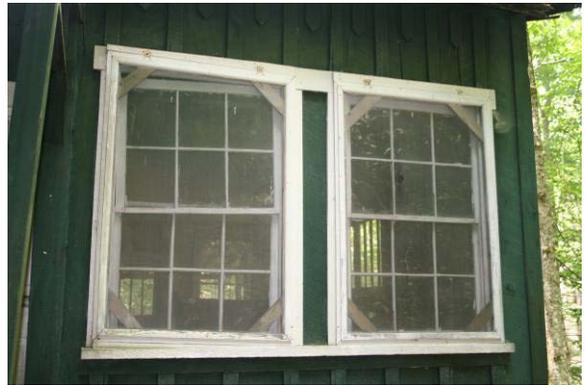
Window type W-1 is a six-over-six double-hung wood window. This is the most common window type on the cabin and measures approximately 2'-10" x 4'-6". The windows are in typically fair condition with loose joints, displaced sash and have quite a few nicks and scratches.

Figure C- 12. Window type W-1.

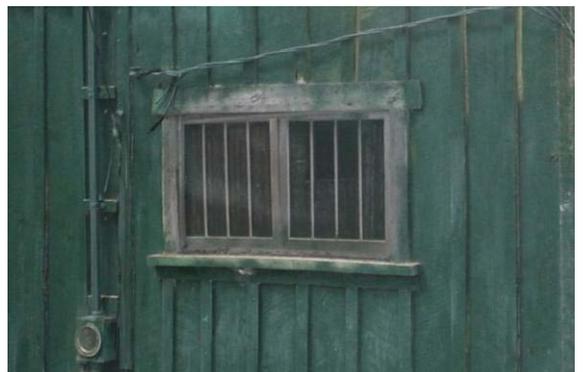
Window type W-2 consists of two sliding sashes. The window sashes each are divided into four lights by vertical muntins and slide on an interior wood track. The entire window unit measures approximately 2'-4" x 4'-8" (total width). The windows are in fair condition.

Figure C- 13. Window type W-2.

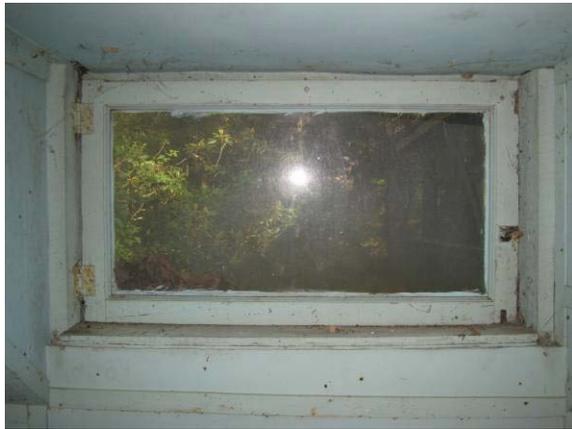
Window type W-4 is a single-light wood casement window and are found in both second floor bedrooms. The window measures approximately 1'-7½" x 3'-0". The window swings into the room and its hardware consists of two, three-knuckle, 2½" high, metal, butt hinges, with a ball at the ends of the pin, and a catch. The windows appear to be in fair to good condition.

Figure C-14. Window type W-4.

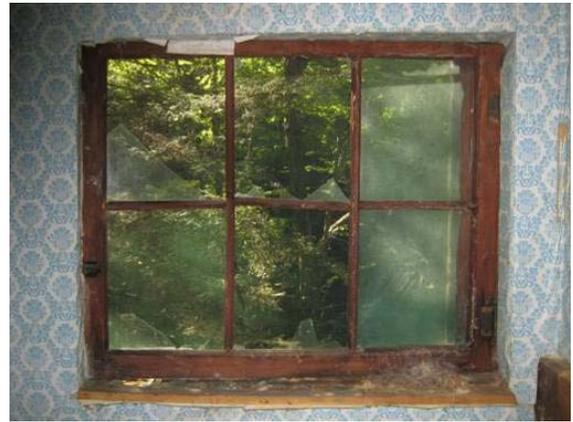
Window type W-5 is a six-light wood casement window. The window measures approximately 2'-10" x 2'-4" and swings into the room. The hardware consists of two, five-knuckle, 2½" high, metal, butt hinges, with a ball at the ends of the pin, and a catch. The window is in fair to poor condition with some missing or broken lights, displaced or broken muntins and minor wood rot.

Figure C-15. Window type W-5.

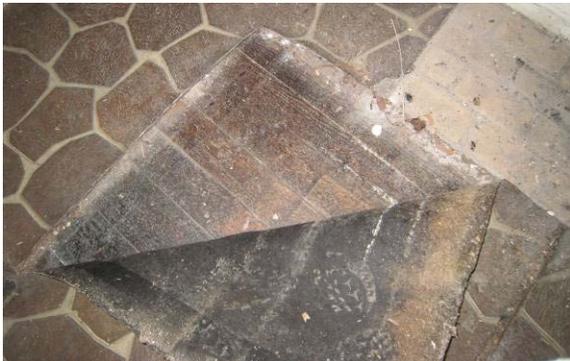
Figure C- 17. Original hardwood floor under sheet vinyl flooring in Room 101.

Flooring: The floor surface is sheet vinyl, with a stone pattern laid over tongue-and-groove wood boards of random width (4 $\frac{1}{4}$ ", 4 $\frac{1}{2}$ ", 5" x $\frac{7}{8}$ ") and there is no sub-floor. The boards run north-to-south. A metal threshold separates Room 101's floor from Room 102's. The sheet vinyl is in poor condition being well worn, buckling in areas, and has generally lost its adhesion to the underlying wood floor. It appears to

date from the last quarter of the twentieth century. Based on areas where the wood floor is exposed, it appears in good condition.

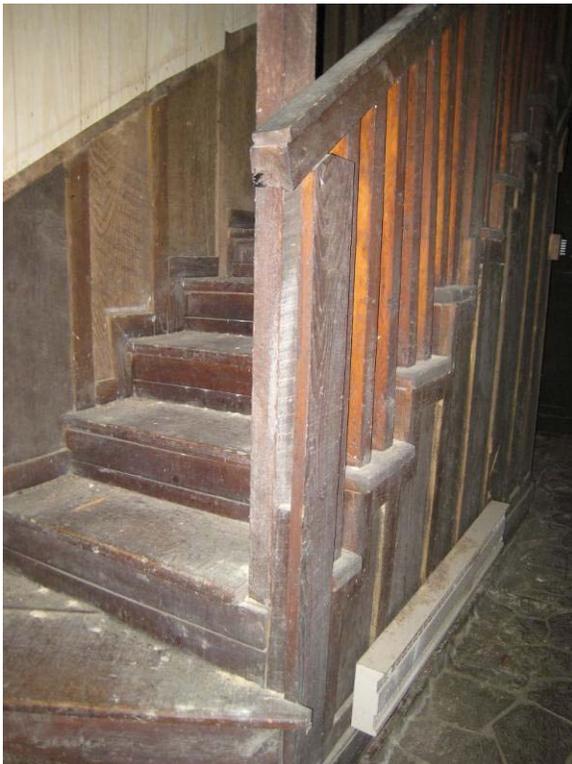
At the south end of the room is a wood stairway to the second floor with square newel post, square 1½" x 1¾" picket balusters, and composite handrail. The handrail has a 2" w x 2¾" h core, with two flat 2½" x ¾" boards on either side and one along the top. This top board is offset and projects away from the stair by ½" and is notched around the 4" x 4" posts. The top of the handrail is 2'-9" above the stair. The baluster is stained the same color as the wood wall battens while the stair risers and treads are painted the same color as the wall boards. The stairway is in fair to good condition.

Figure C- 20. Stairway in Room 101.

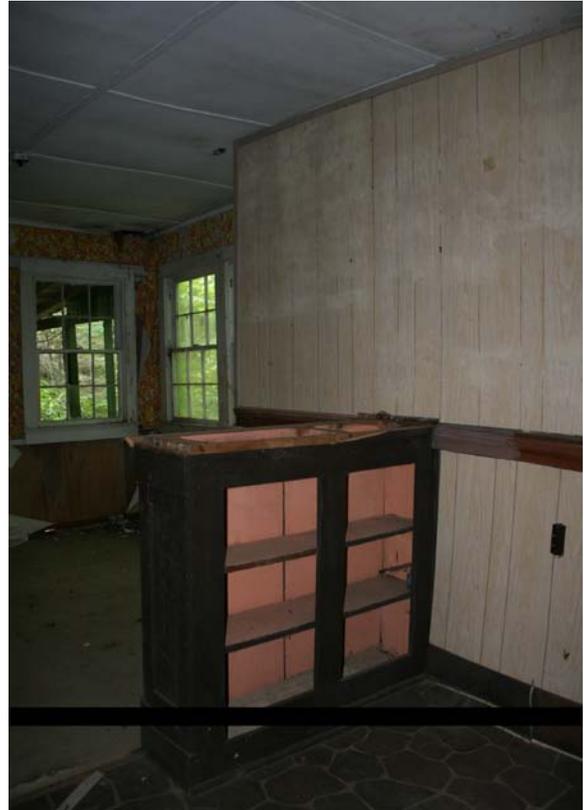
Within the cabinet are painted wood shelves. The cabinet is missing its countertop and appears to have had glass doors which are also missing.

Figure C- 21. Cabinet at northwest corner of Room 101.

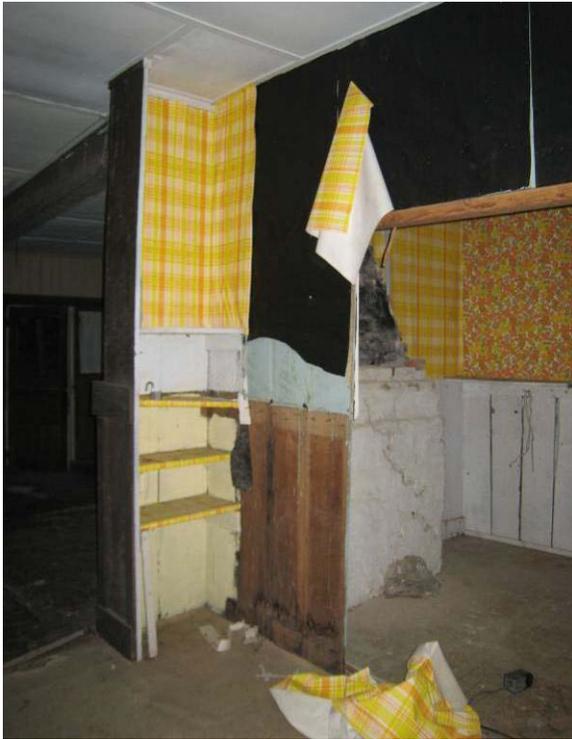
The wall covering is in generally fair to poor condition with much of the wallpaper either loose or missing. The cause of the problem appears to be exposure to the elements and water damage due to ceiling leaks.

Figure C- 23. Room 102, looking at the southeast corner.

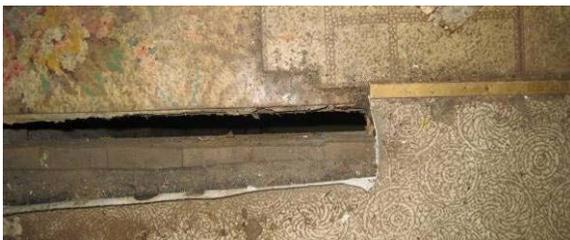
Flooring: Tongue-and-groove floor boards, that run north-to-south, are covered by a couple layers of vinyl flooring. The bottom, floral patterned, vinyl flooring dates from to or after 1967 based on newspaper remnants that were laid between the wood and vinyl flooring. The vinyl flooring appears to be in fair condition with considerable staining and some of the tiles are loose or missing.

Figure C-26. Multiple layers of vinyl flooring in the Room 103 (top half) and Room 102 (bottom half).

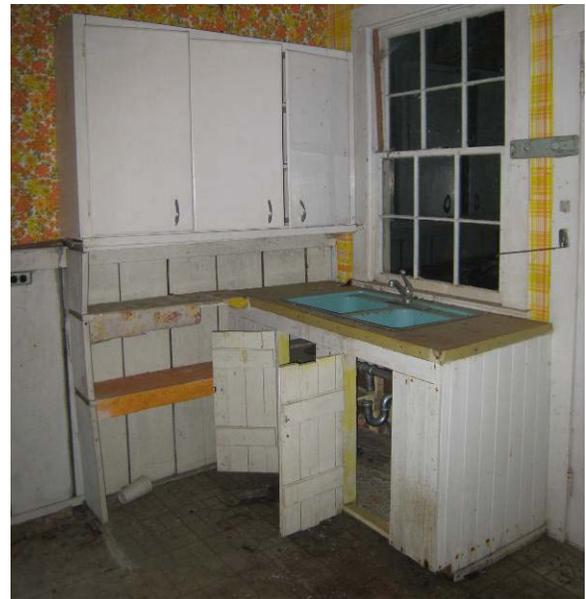
At the south wall are wall-mounted cabinets with three doors with pull-handles. The cabinets measure approximately 12" x 5'-0" and were presumably added after the base cabinet. The cabinets are in fair to good condition.

Figure C- 28. Kitchen cabinetry and sink in Room 103.

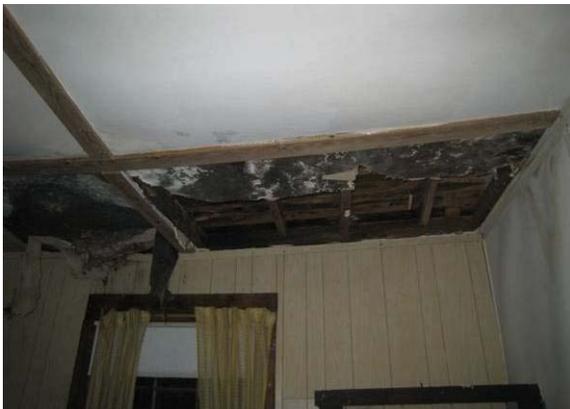
The ceiling is in poor condition. A large section of the ceiling along the west wall has suffered water damage and fallen into the room. The water damage has resulted in significant mold growth in adjacent sections.

Figure C- 31. Water damage to ceiling in Room 104.

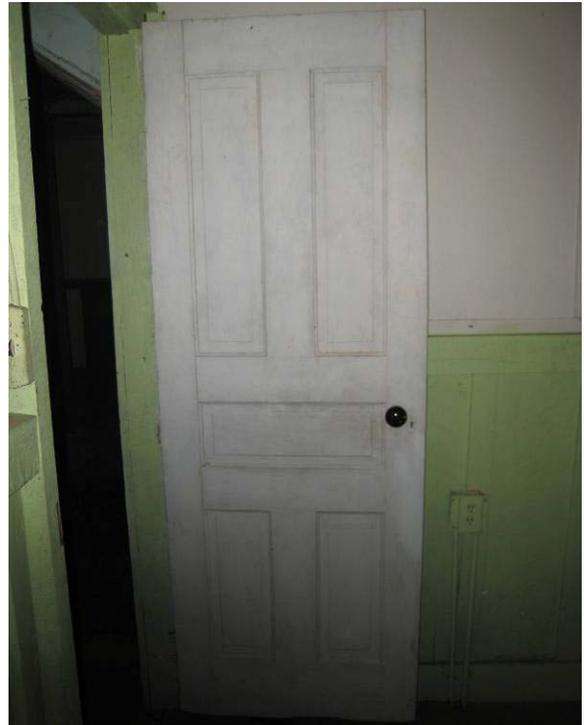
rim lock, which are missing screws and pulled away from the door.

Figure C- 37. Door to Room 107.

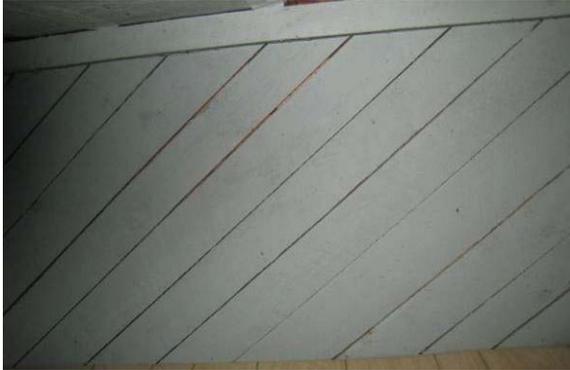
Ceiling: The ceiling is 9'-6½" above finished floor and consists of the diagonal subfloor for the second story. The floorboards show evidence of being circular sawn. It is in typically good condition.

Figure C- 39. Diagonal deck boards for floor above.
