**Cook Cabin
Elkmont Historic District
Great Smoky Mountains National Park
Historic Structure Report**

March 2016

The Jaeger Company

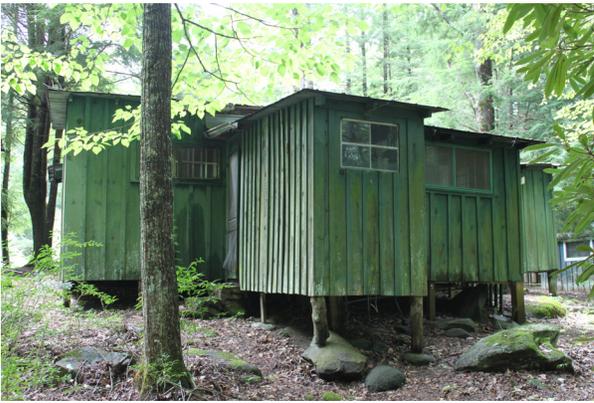
The house's post-and-beam foundation consists of sawn wood members supported with a mix of unmilled log, CMU, and sawn timber piers. (*Figure 15*) The floor framing of the west front half of the main core under Room 101 is 2" by 8" joists extending east-west. The front porch floor is framed with 2" by 6" joists running north-south; the north side section of the front porch is framed with 2" by 6" joists running east-west. Some of the framing is newly replaced 2" by 8" members.

Figure 15: Unmilled log piers under Room 110.

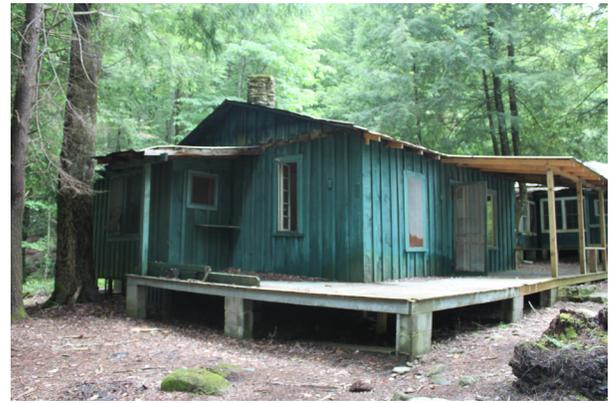
Figure 17: Side-gabled roof of the main core and remnant of shed porch roof.

Roof Framing—(See *Roof Plan* in Appendix.) The side-gabled roof is framed with 2" by 4" rafters spaced at 30" on center and covered with wide board decking. The rafter ends are visible along the west front elevation at the junction with the shed porch roof. (Figure 17)

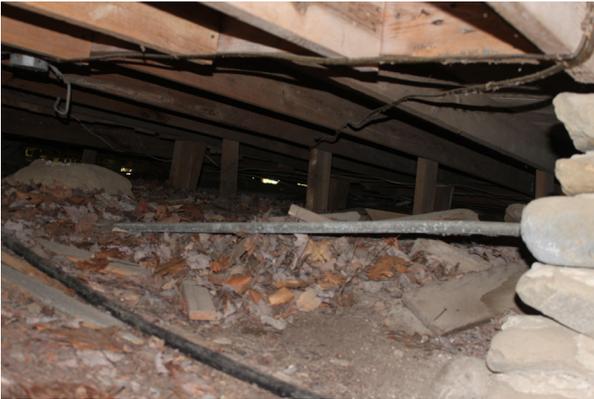
Figure 16: Foundation piers and floor framing under Rooms 101 and 104.

The east rear half of the main core is framed with 2" by 8" joists running north-south. The joists of the addition to Room 104 are framed separately. The west half of Room 105 is framed with 2" by 8" joists running north-south, while the east half is framed with 2" by 6" joists, also running north-south. The framing of Room 107 and 109 is 2" by 6" joists running north-south. The joists of Room 110 are 2" by 6" and run east-west. The floor framing under Room 108 was not accessible because it is so close to grade. (Figure 16)

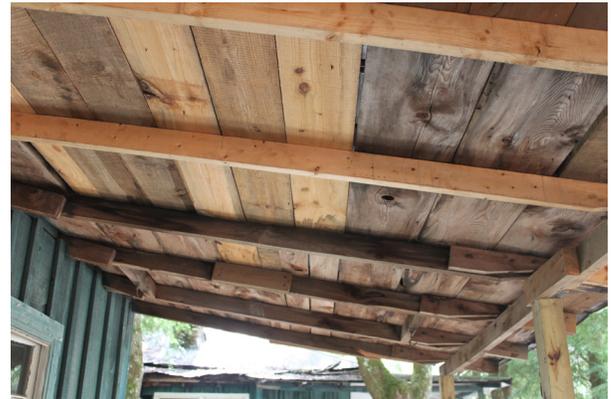
Figure 18: Roof framing of front porch shed roof.

The front porch shed roof is also framed with 2" by 4" sash sawn rafters at 30" on center. The rafters are nailed to the exterior wall and to the sides of the gabled rafter ends. Some of these rafters, as well as some of the variable width board decking, are recent replacements. (Figure 18)

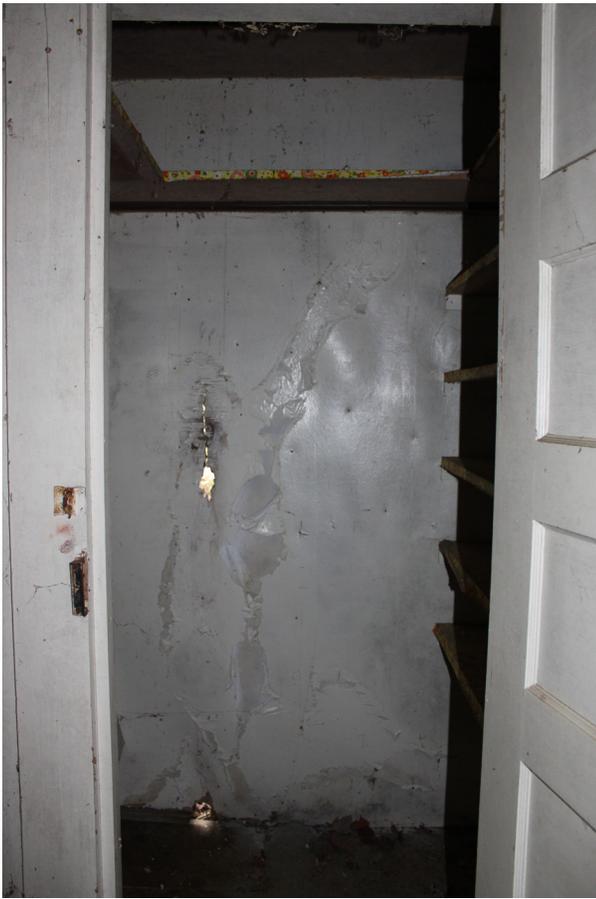
Figure 38: Interior of closet in Room 103, note hole in exterior wall.

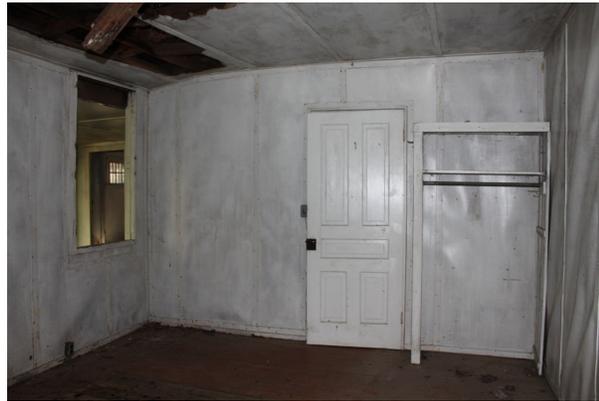
Figure 40: Room 104 looking south toward hallway, note window opening.

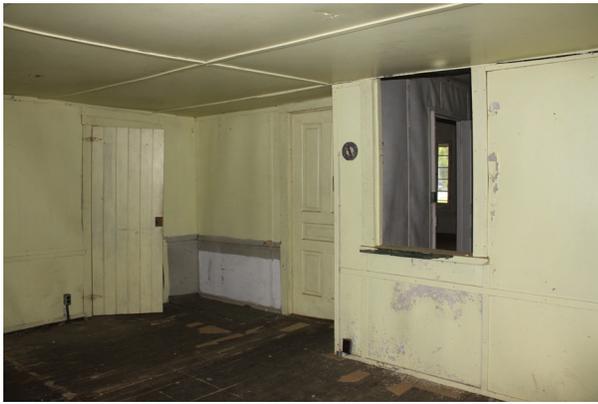
Figure 44: Room 105 looking southwest toward hallway, note window opening.

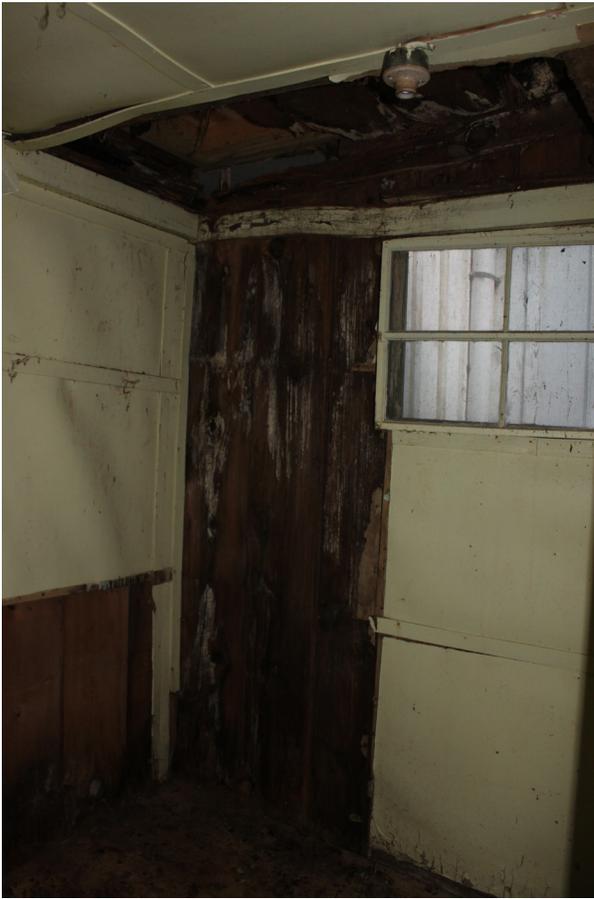
Figure 46: Room 106, exterior wall and junction with Room 107.

Walls—The walls are finished with ⅛” thick fiberboard panels with 2” wide by ⅛” thick fiberboard strips covering the edges and seams between panels. Several of the wall panels have fallen off due to moisture deterioration. (Figure 46)
