Smith Cabin
Elkmont Historic District
Great Smoky Mountains National Park
Historic Structure Report

September 2014

JOSEPH K. OPPERMAN-ARCHITECT, P.A.
539 N. Trade Street Winston-Salem, NC 27101
www.jkoa.net office@jkoa.net

Historic Structure Report

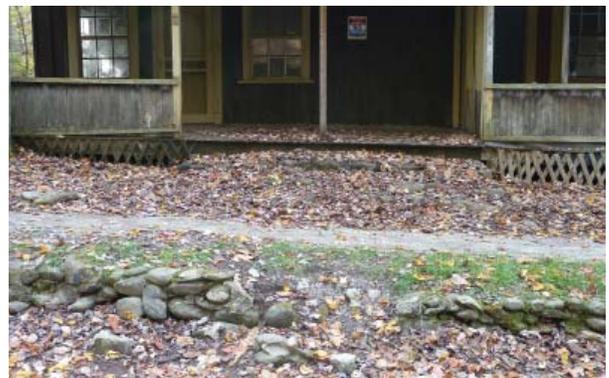
Figure 28. Partial collapse of retaining wall in front of Smith Cabin.

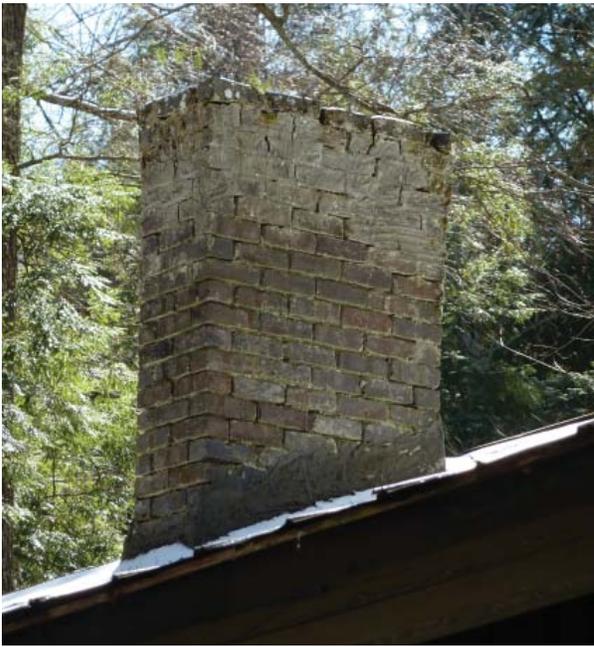
Associated with the roof leaks are leaks at the chimney. Problems are evident at the flashing at the base of the chimney and in the repointing that holds the bricks of the chimney together. The flashing has failed and the chimney mortar is in need of repointing. Significant water damage is evident on the ceiling around the chimney, particularly in the northeast living room. The weathering of the protective exterior paint coating is likewise well advanced, leaving the wood architectural elements susceptible to moisture in all its forms.

Figure 58. Brick chimney near east side of cabin.

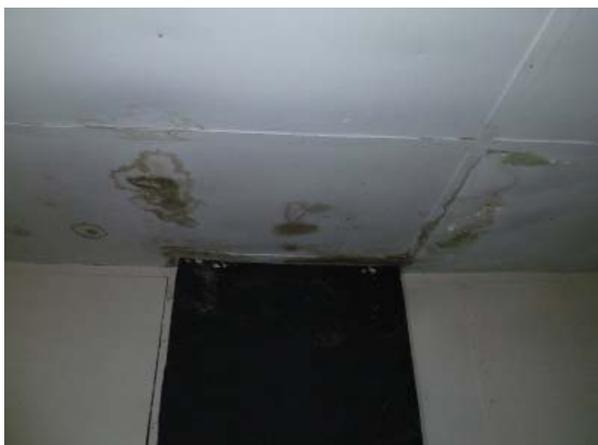
Figure 71. Severe deterioration of ceiling at chimney.

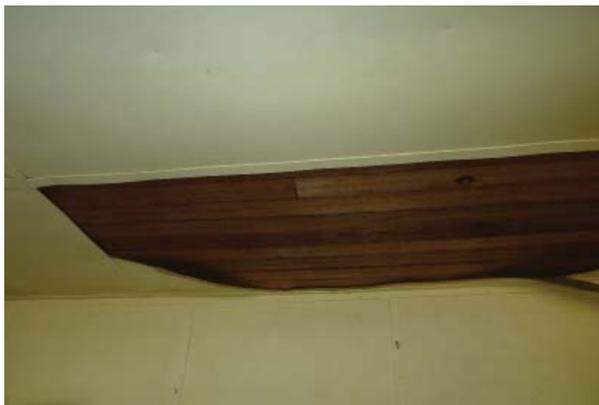
Figure 76. Damaged finish material in southwest corner of ceiling.

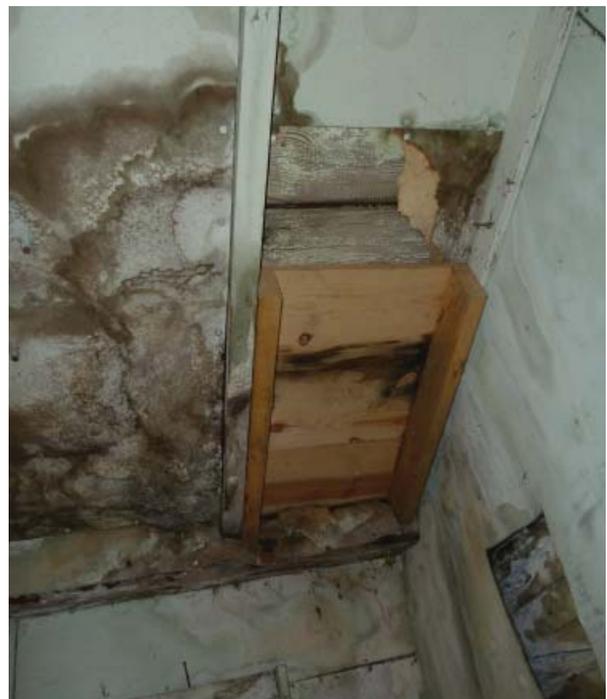
Figure 79. Severe deterioration in northeast corner of the ceiling.
