SPENCE CABIN

**Great Smoky Mountains National Park
Elkmont Historic District
Sevier County, TN**

HISTORIC STRUCTURE REPORT

February 17, 2009

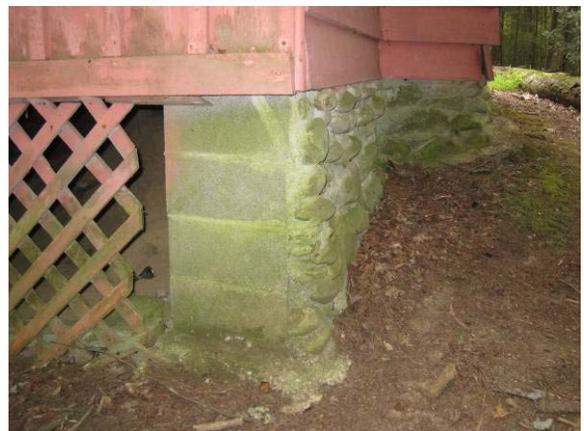
At the northwest corner of the west perimeter wall of the west wing, the original foundation wall stonework has been partially rebuilt. The rebuilt stonework is backed with CMUs and all the wall is set on a poured-concrete footing. This repair appears to be fairly recent, probably dating to the last half of the last century. It was probably executed in response to washout of the bank along the north elevation of the west wing.

Figure C- 16. Rebuilt stonework with CMU backup at northwest corner.

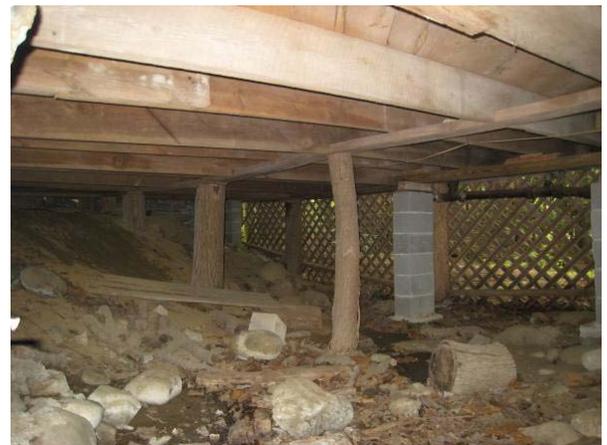
Additional supplemental support has also been added just inside the north wall of the west wing extension. Two piers made of CMUs each supports a short section of a beam which in turn support a group of joists. These piers were probably added at the same time the northwest corner of the stone foundation wall was rebuilt. Together, the two piers and rebuilt foundation wall counteract the deflection along the north perimeter caused by the washout at grade from rainwater runoff, a threat that still is not completely resolved.

Figure C- 18. Looking northwest in the west wing crawl space at added CMU piers.

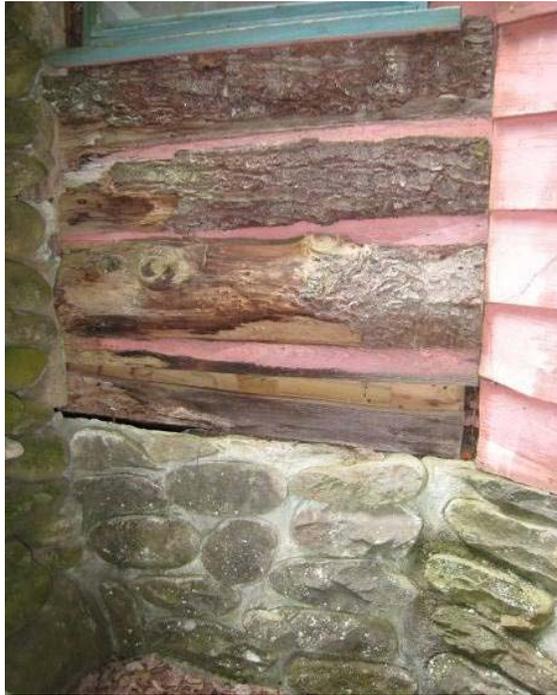
Figure C-19. Bark-on-log boards of the center pavilion. Note deterioration of lower boards.

All the exterior walls are constructed with stud framing and are approximately 5½" deep. The exposed south, east and west walls of the pavilion are covered with its original siding of boards with an exterior surface of bark. Most lower logs show some deterioration, mostly loss of bark and some rot, apparently due to splash from rain.

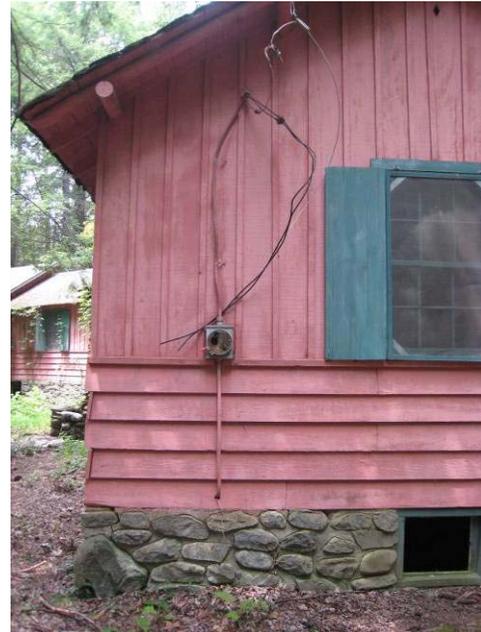
pavilion 101) has only lap siding. The screened porch extension 107 has both lap siding and board-and-batten siding. Both the lap and board-and-batten siding are generally sound with minor areas of deterioration.

Figure C-20. East end of the east wing showing horizontal lap siding and vertical board-and-batten siding above.

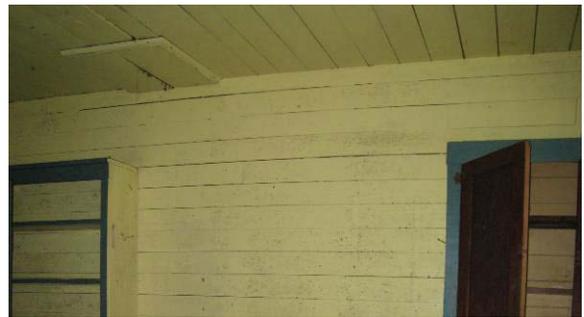
Besides these two existing chimneys, it appears that there may have been a chimney along the west wall of the kitchen, Room 109. A ceiling patch, approximately 1'-6" x 1'-6" is now in place.

Figure C- 25. Room 109 wood ceiling patch in the kitchen.

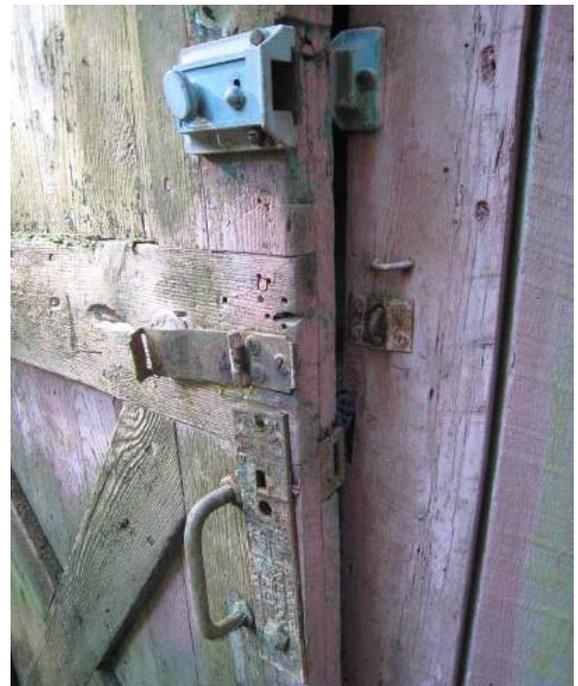
A variety of locks and pulls have been added to the exterior door over the years. At the exterior side, there is an older pull, back plate, and latch which may all be original. The pull appears to have been removed from the back plate and relocated next to it. Above the latch is a padlock and above the padlock is a later deadbolt. A ghost line of a previous lock can be observed around the keyhole. Above the deadbolt are also patched holes from earlier hardware.

Figure C- 40. Miscellaneous hardware on door to Room 001.

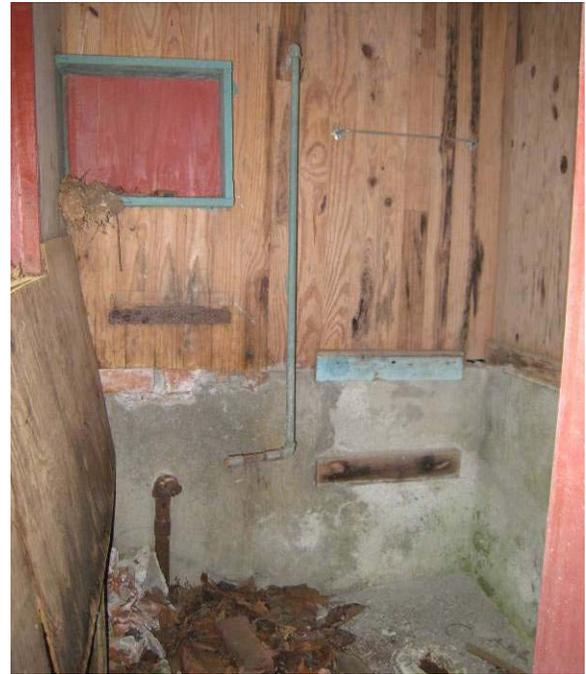
Room 002 is a rectangular shaped room located under the northwest corner of the enclosed porch, Room 106. The room measures approximately 4'-6½" x 4'-4½". Access to the bathroom is through a doorway at the west wall which leads to Room 001. The door is now missing. The room originally was a half-bathroom with a

lavatory and toilet, both of which are now missing.

Figure C- 41. View of Room 002 east wall.

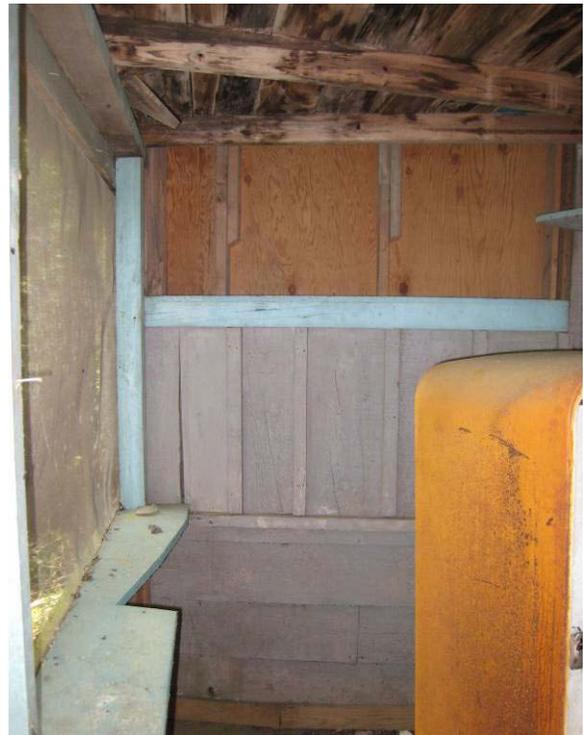
Figure C- 58. Room 107 looking at east wall. Note the backside of the plywood panel and framing used to in-fill the original screened-in opening.
