Harry S Truman National Historic Site Truman Farm

Cultural Landscape Report Historic Structure Report & Environmental Assessment

1, DEZ, 2013

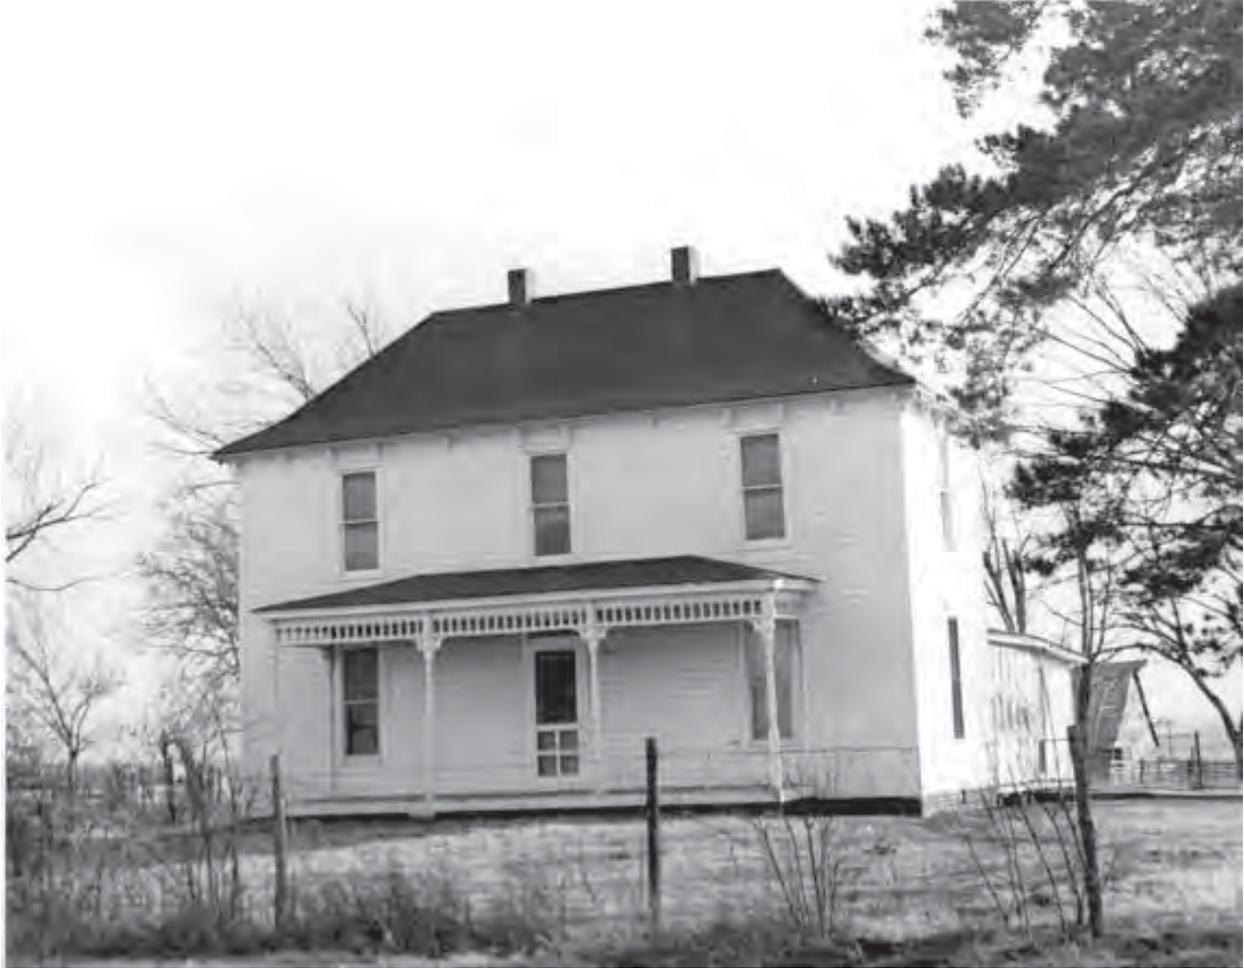
Figure 2-20. By the 1960s, the setting of the Farm Home had deteriorated. The maple grove had been mostly destroyed by a tornado in 1957, the rose arbor was in disrepair, and adjacent development filled the previously open landscape. The Solomon Young barn, right of Farm Home, had been modified by the addition of an extended gable roof which obscured the earlier hayhoods/dormers. HSTL 61-66-01, 1961

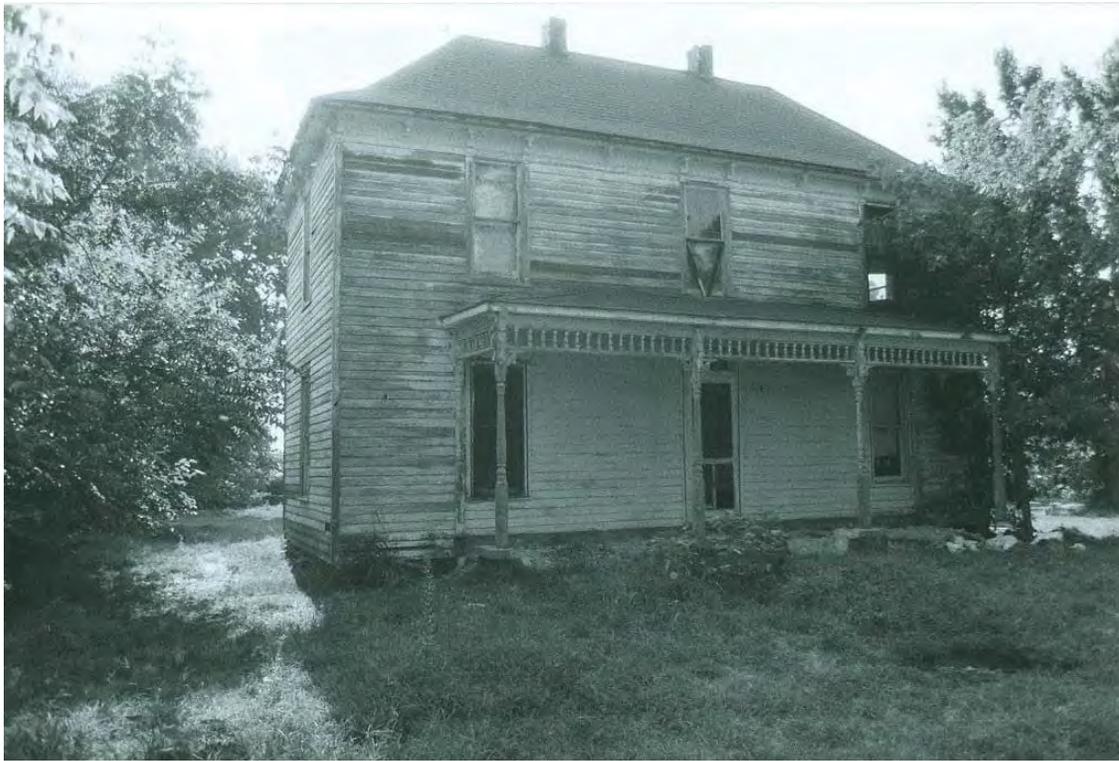
Figure 2-24. In 1984 the Farm Home and adjacent landscape were repaired. The Farm Home was in poor condition and the adjacent vegetation had overgrown obscuring the historic appearance of the farm landscape. Al O'Bright 1983

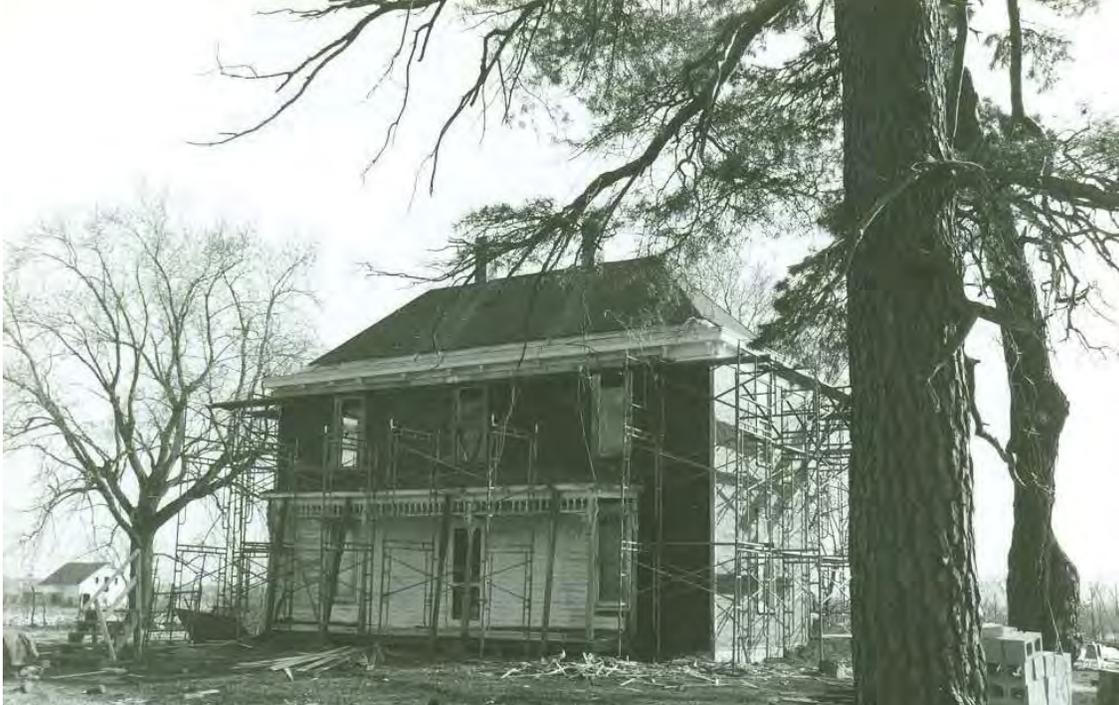
Figure 2-25. The Farm Home and adjacent landscape underwent extensive repair in 1984. Much of the Farm Home's wood exterior was replaced, interior portions were repaired, and more recent additions removed. Outside, the sugar maple grove was replanted and an outhouse and smokehouse were added to the site to convey to visitors the farm landscape, although they were not placed in historically accurate locations. (The milk barn is visible in the background at the left). Jill O'Bright 1984

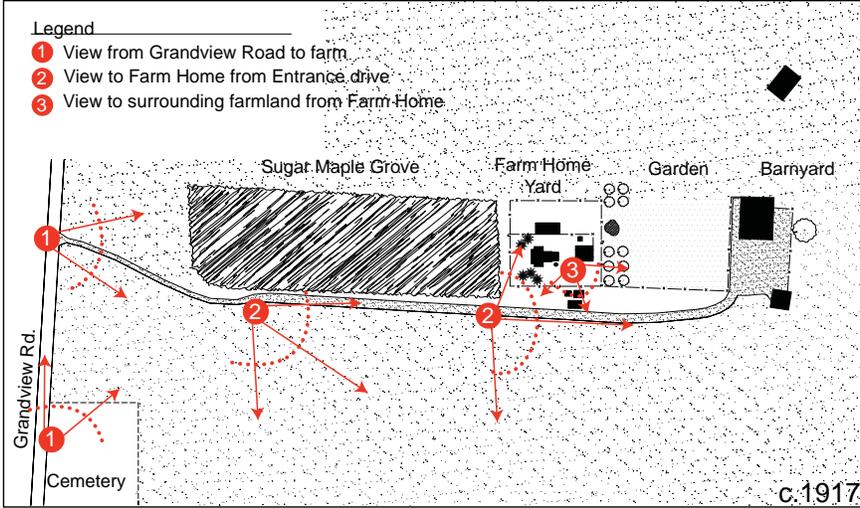
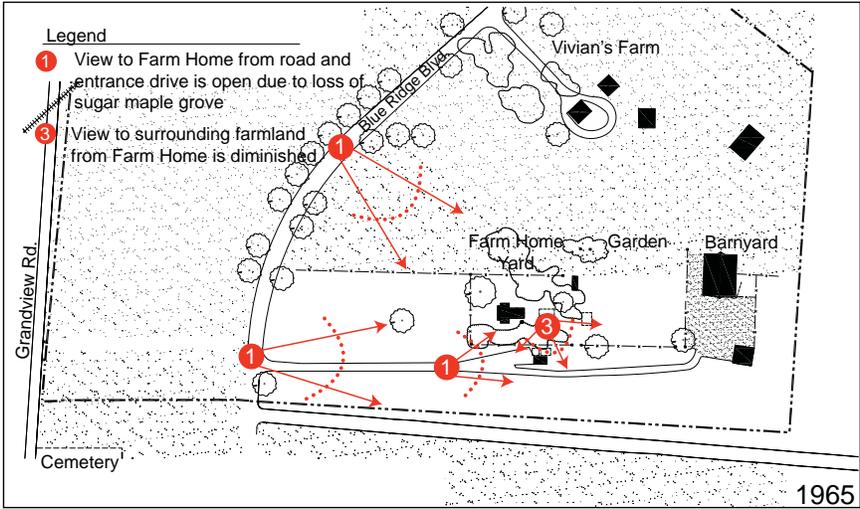
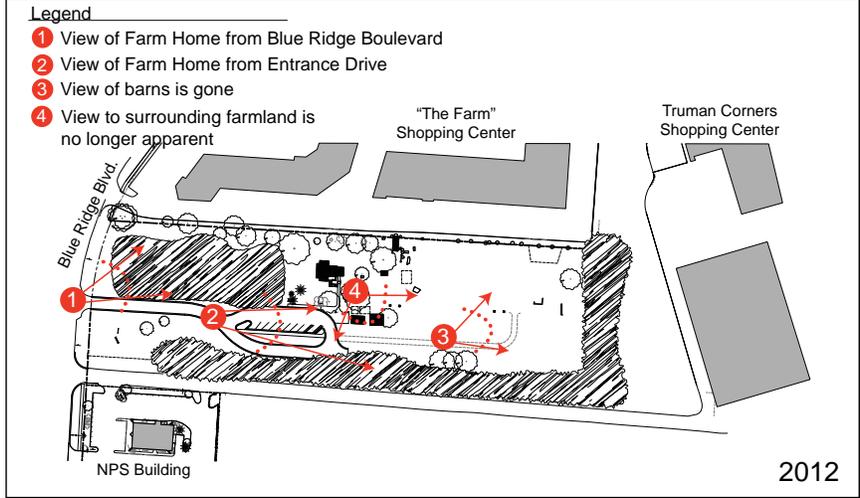
Figure 3-15. Views historically were open across the large acreage of the farm, while the sugar maple grove directed views along Grandview Road and the entrance drive. The loss of the sugar maple grove opened the views to the Farm Home in 1965, just as commercial development encroached upon the views to surrounding farmland. Today, views are obstructed by vegetation and adjacent buildings. MBD

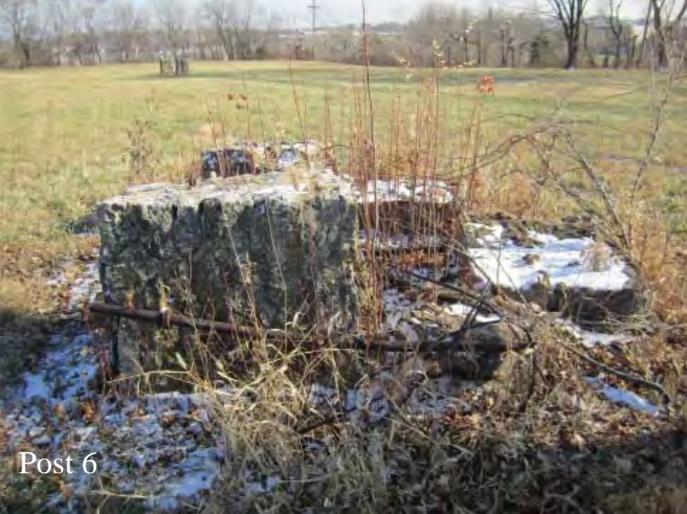
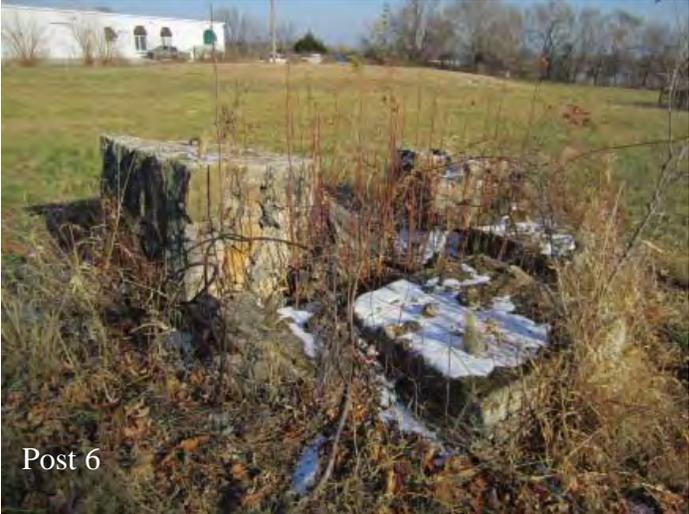
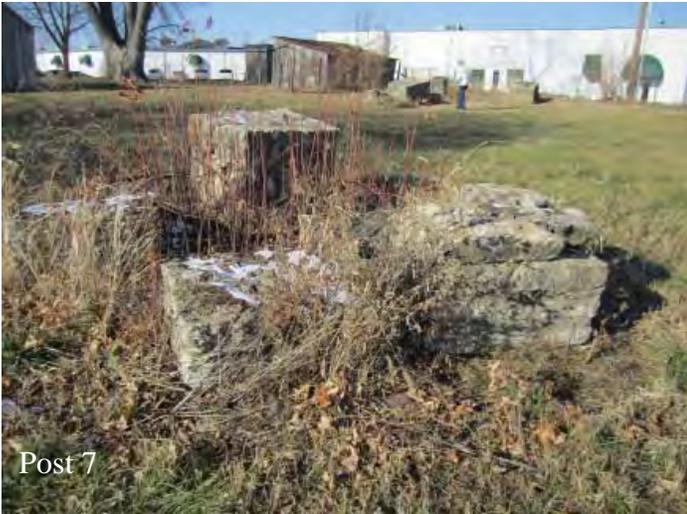
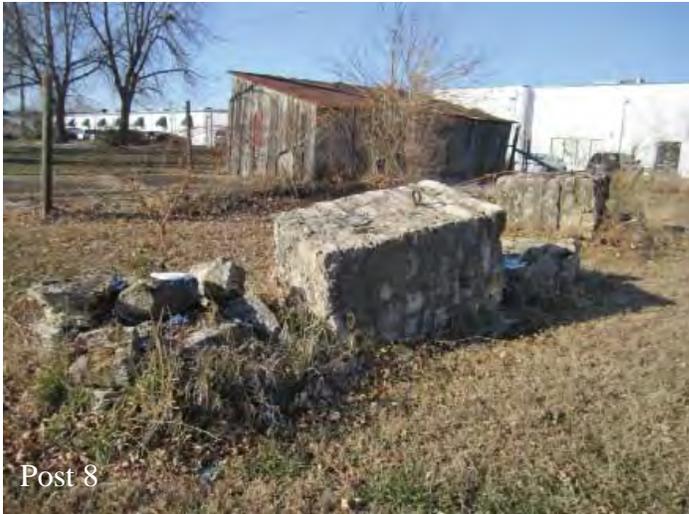
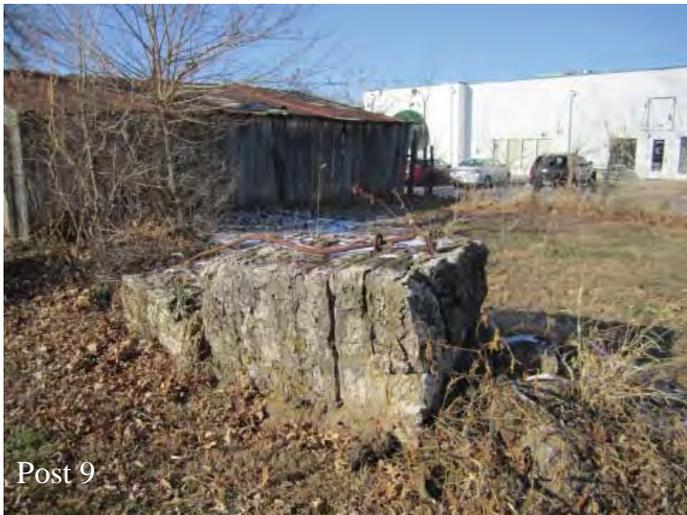
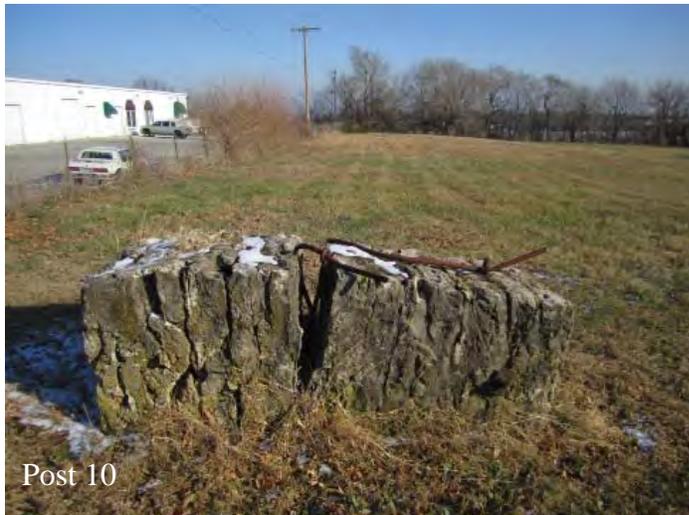
Figure 3-29. Five posts were removed during the 1987 construction of the Truman Farm Shopping Center on the land north of the Truman Farm that was historically Vivian Truman's farm. They were placed in the field east of the Farm Home. Posts 6 through 10 are broken and lying on their sides. SS 12/6/11

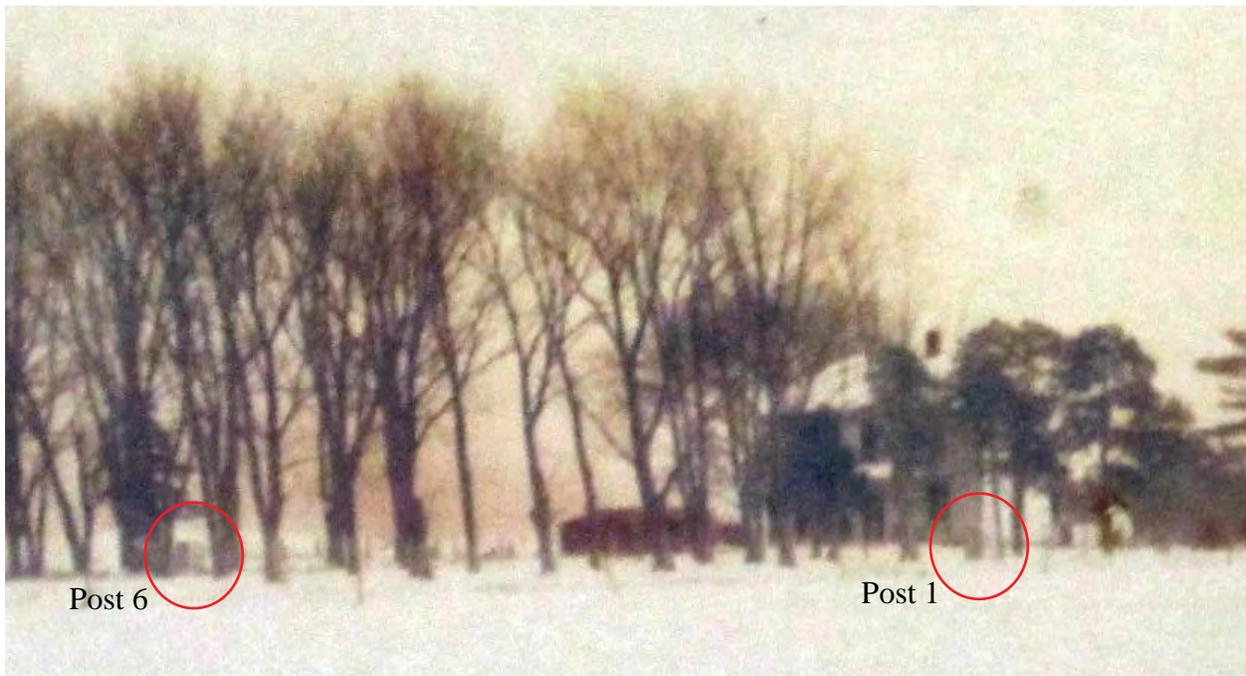
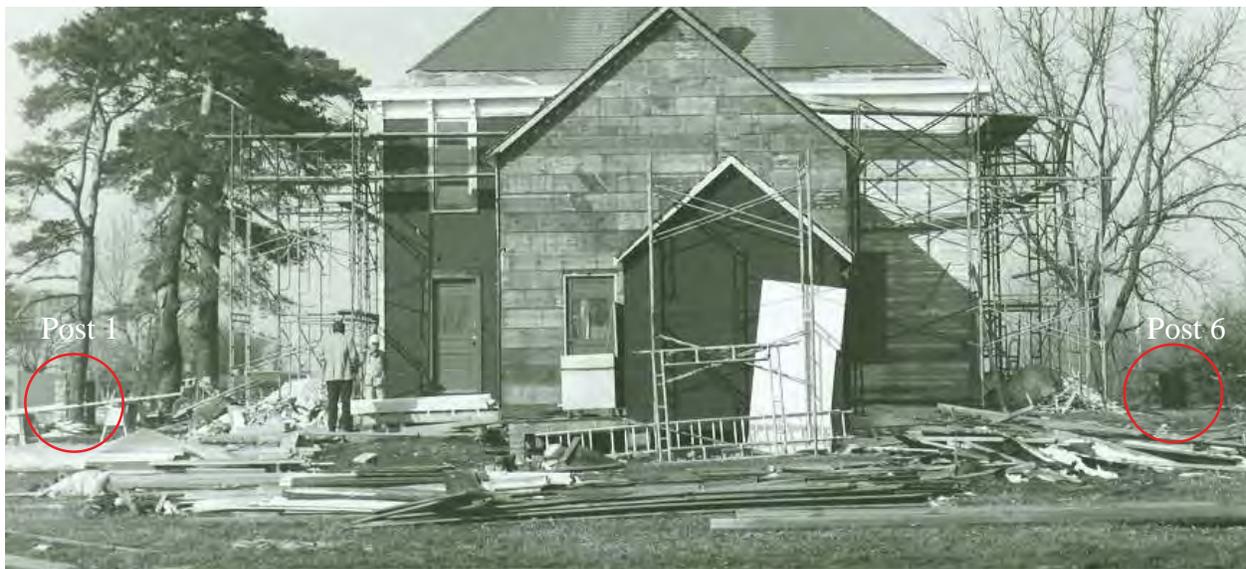
Figure 3-30. During the period of significance Posts 1 and 6 supported a fence that framed the front of the Farm Home yard (top). At some point the fence was removed but the stone posts remained into the 1980s (bottom). In 1987, the north post, Post 6, was removed for development of the adjacent property. HSTL 2 83-127, c.1920-1930; Jill O'Bright 2/84

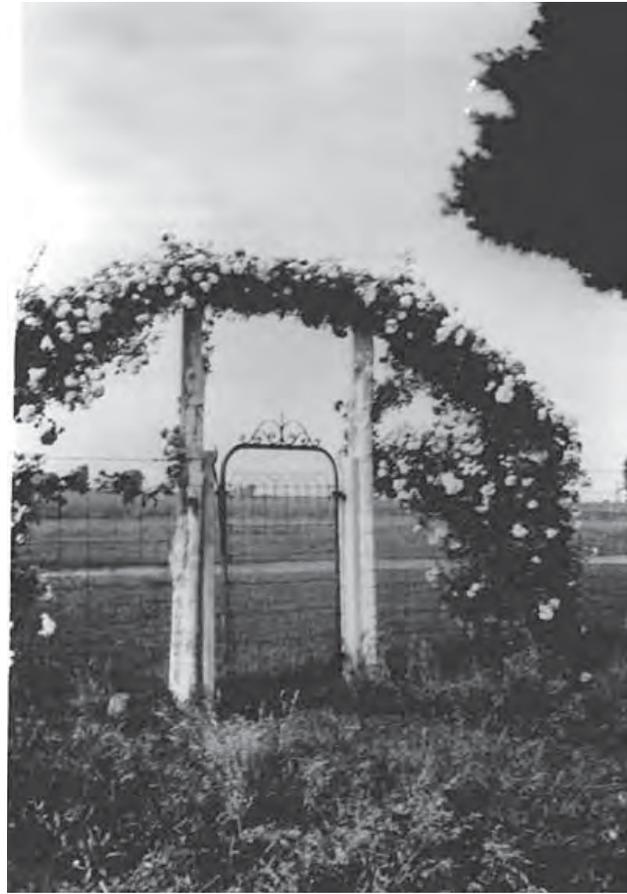
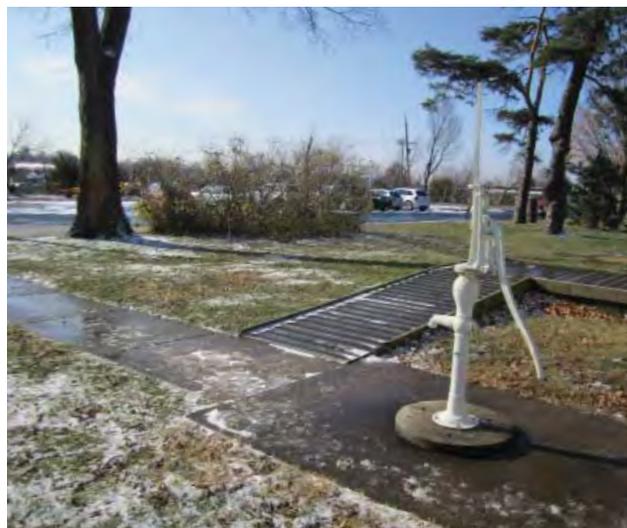
Figure 3-37. Rose arbors grew along the fence that bordered the Farm Home yard. One was over the south gate (top). These rose arbors were present between the 1920s and 1950s, but today no indication of their presence remains (bottom). HSTL 84-82-1, c.1930; SS 12/6/11
