National Park Service  
U.S. Department of the Interior

Natchez Trace Parkway  
Tupelo, MS

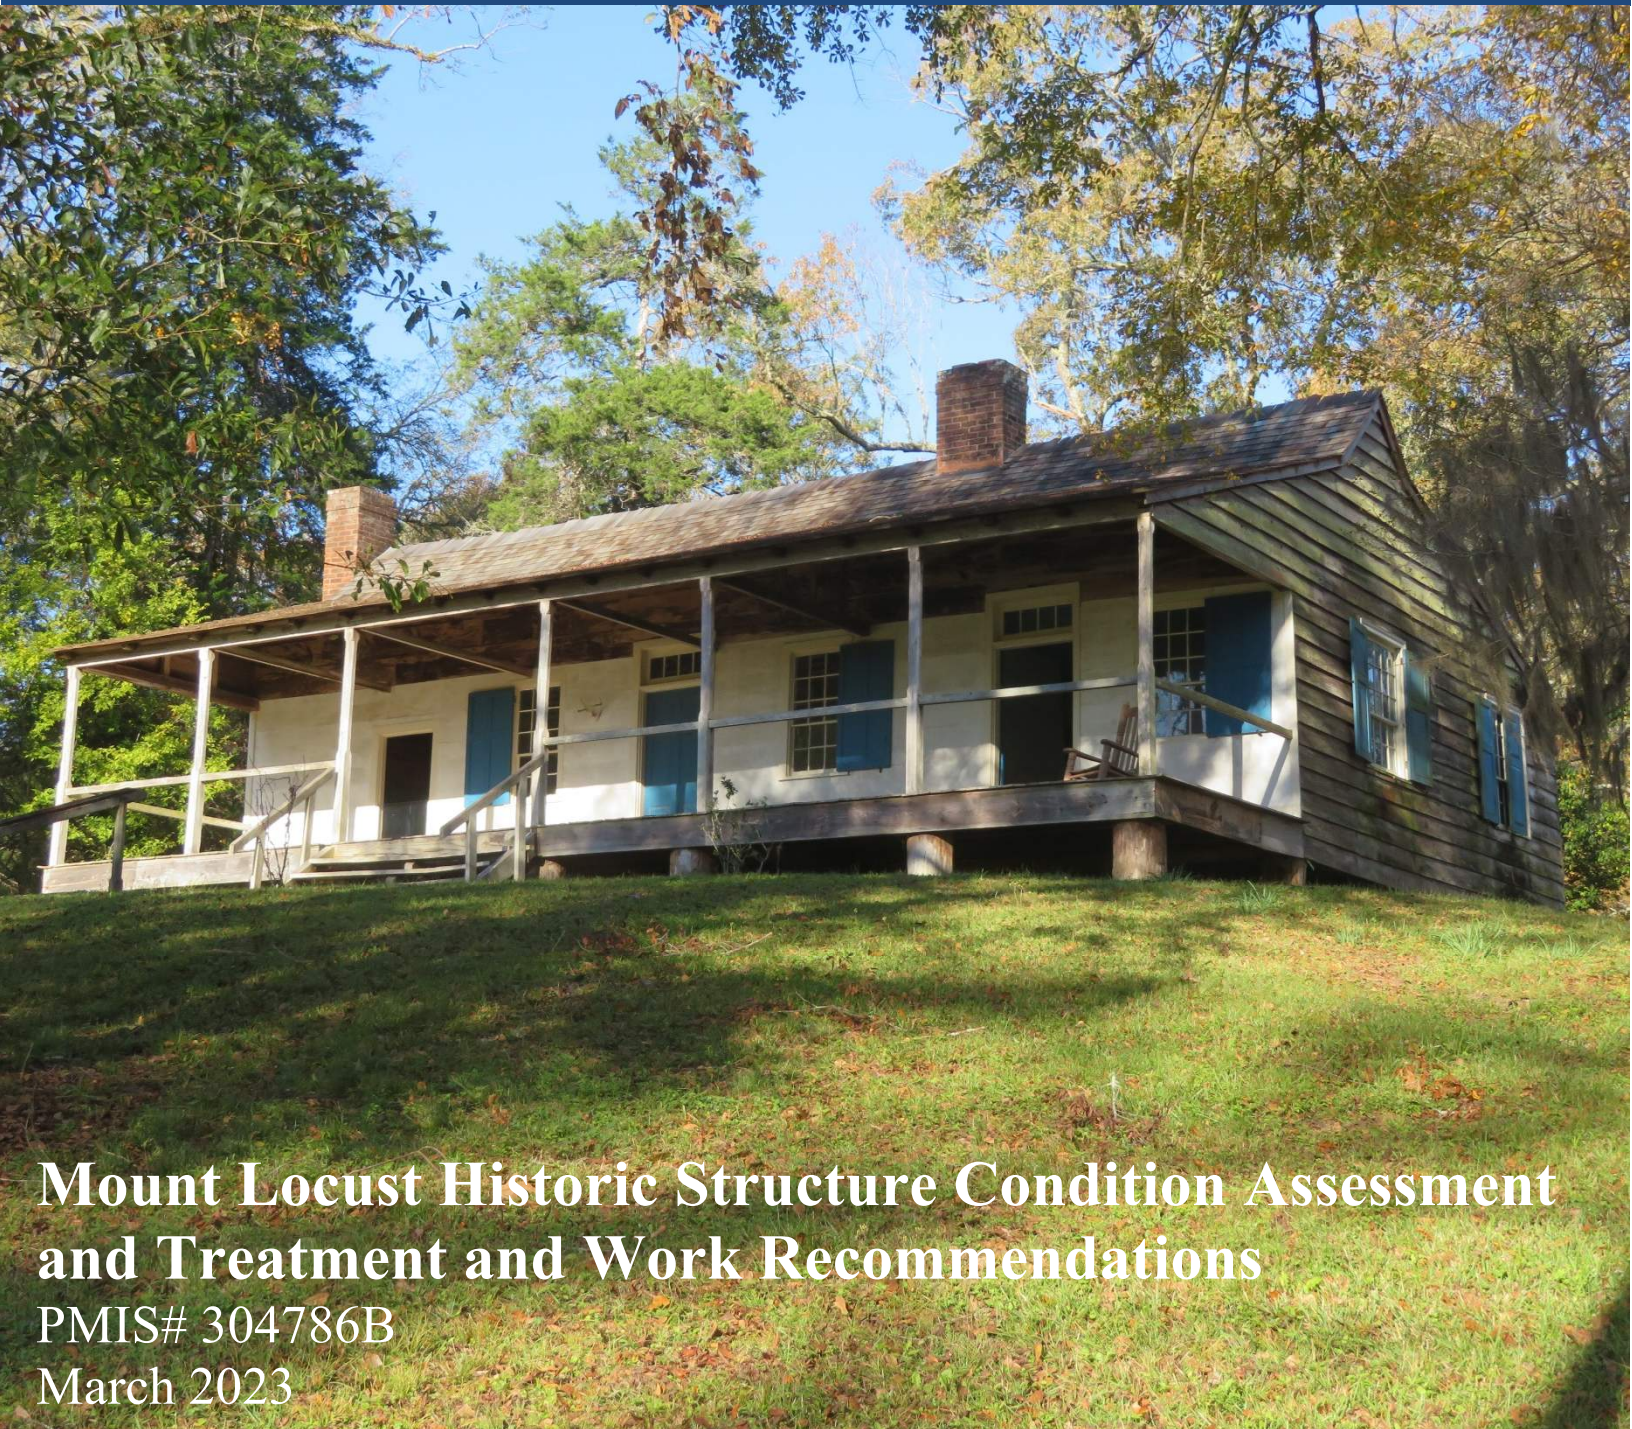
# Mount Locust Historic Structure Condition Assessment and Treatment and Work Recommendations

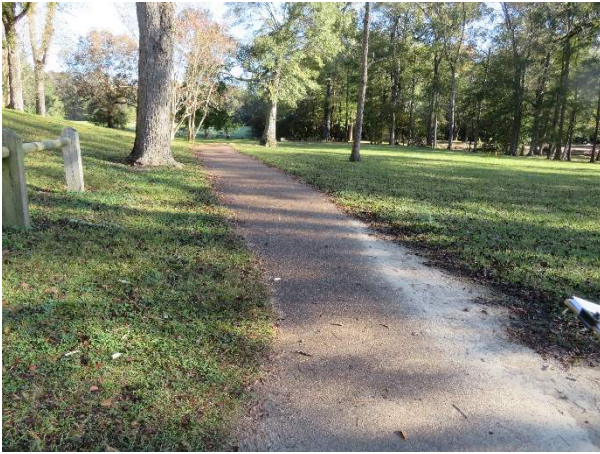
Photo 6. Paved walkway from the Information Center to the house, looking northeast towards the Information Center.

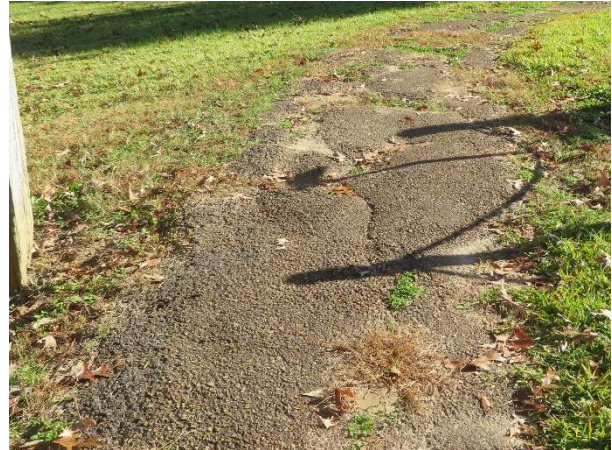
Photo 7. Paved walkway on north side of house, showing cracked and uneven paving.

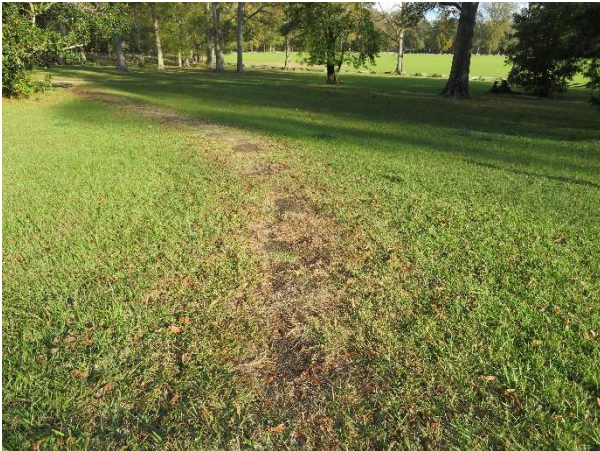
Photo 8. Paved walkway from main walk to the grape arbor, showing deteriorated and uneven paving.

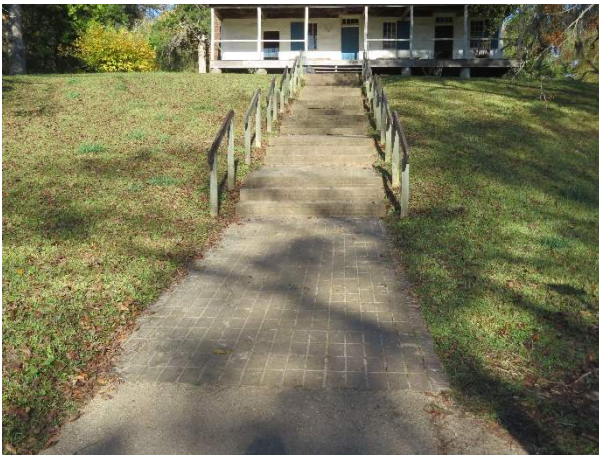
Photo 9. Main stairs, looking north to house.

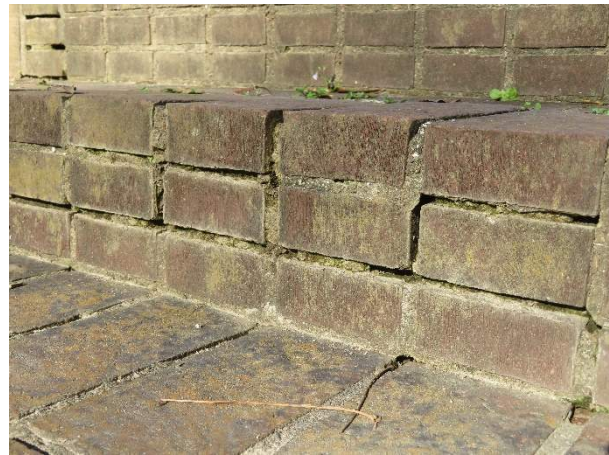
Photo 10. Localized deterioration of mortar joints between paving bricks.

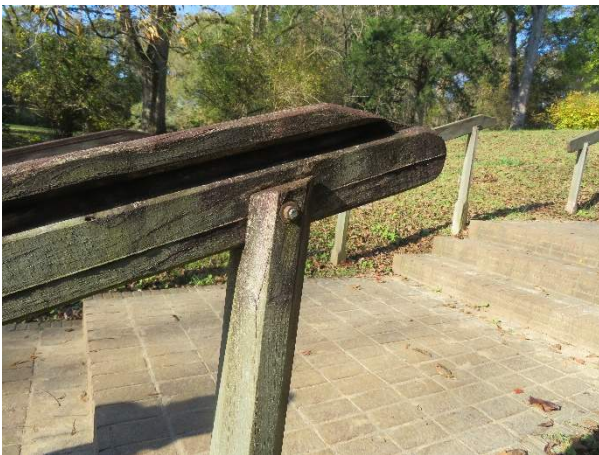
Photo 11. End of handrail at an intermediate landing, showing lack of extension and the “notch” for gripping.

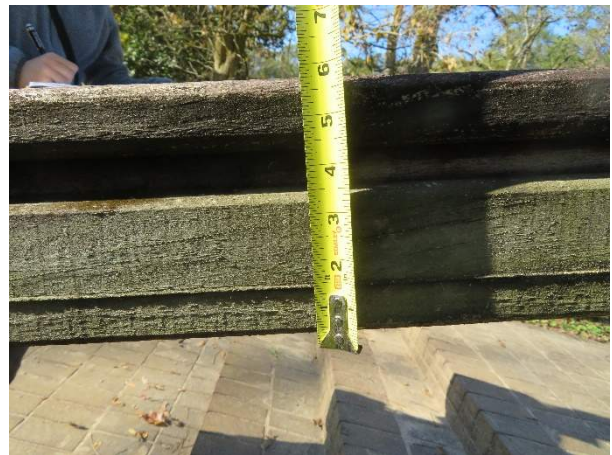
Photo 12. Typical top rail showing dimensions of notch for gripping.

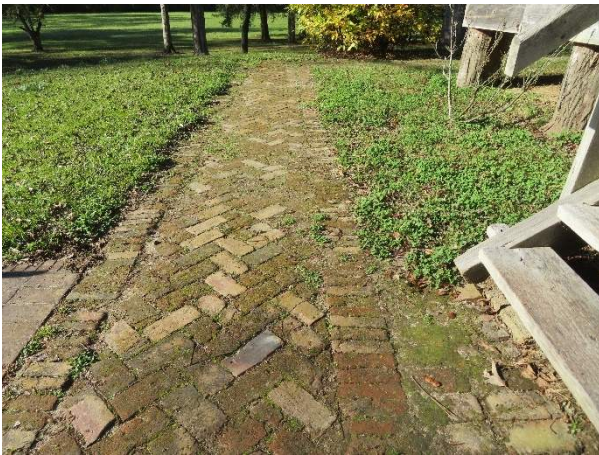
Photo 13. Brick paver walkway at the south side of the house.

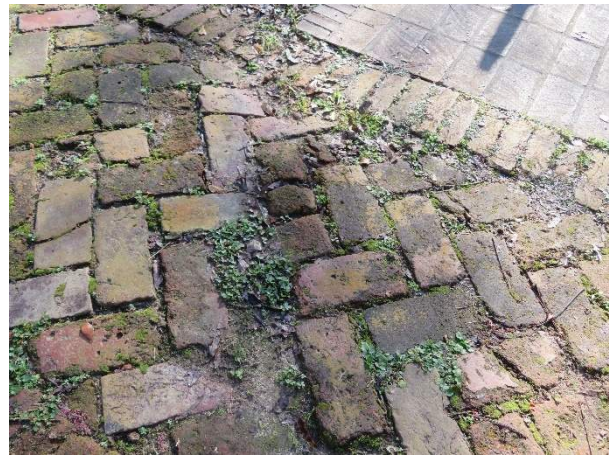
Photo 14. Displacement and deterioration of brick pavers.

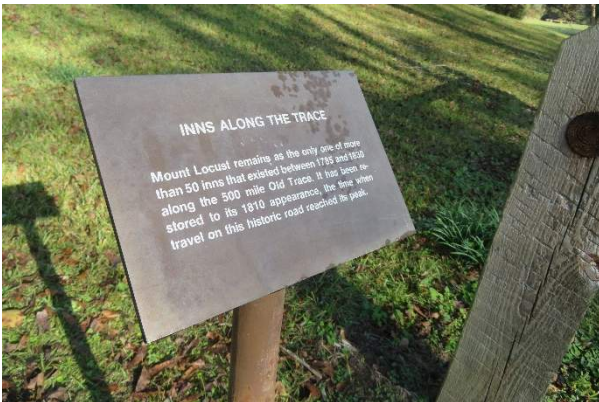
Photo 15. “Inns Along the Trace” interpretive signage.

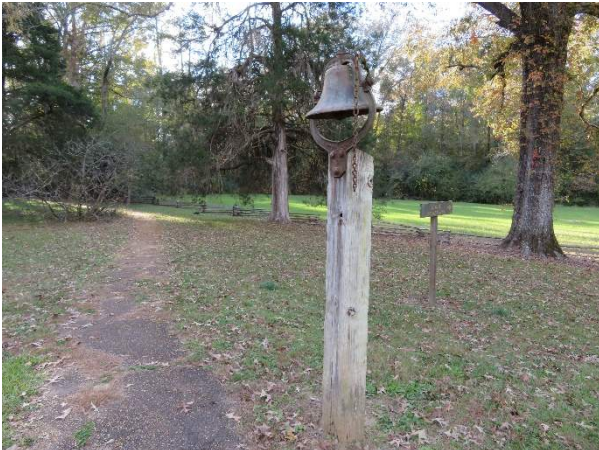
Photo 19. Bell and post northwest of the main house.

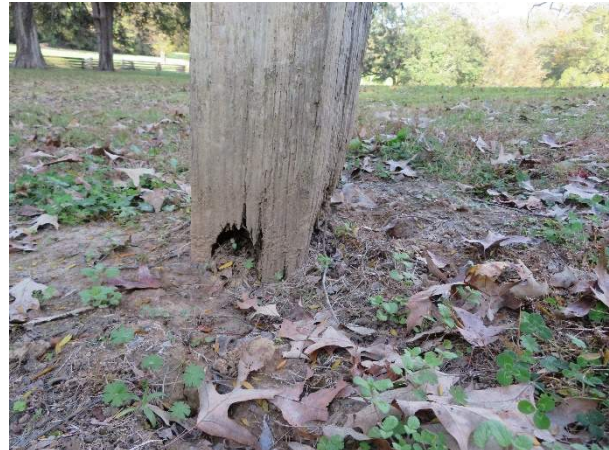
Photo 20. Deterioration of the wood post at grade.

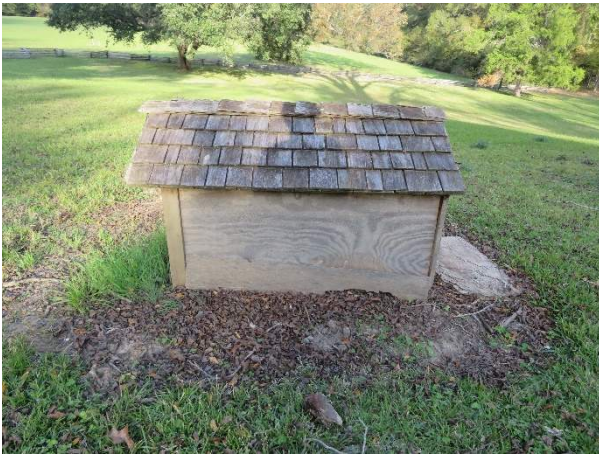
Photo 21. Wood shed over fire hydrant.

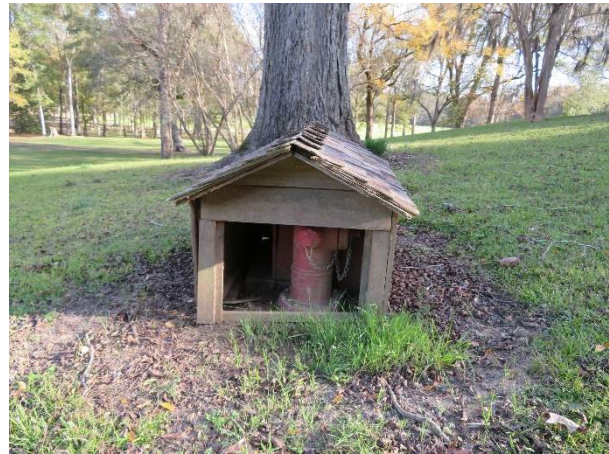
Photo 22. Wood shed over fire hydrant.

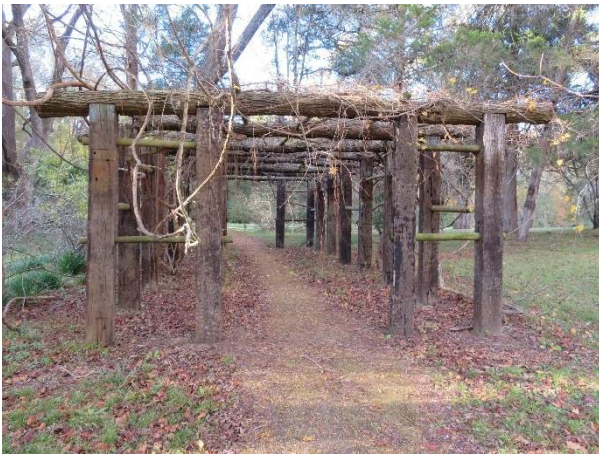
Photo 23. Grapevine grape arbor to the southwest of the main house.

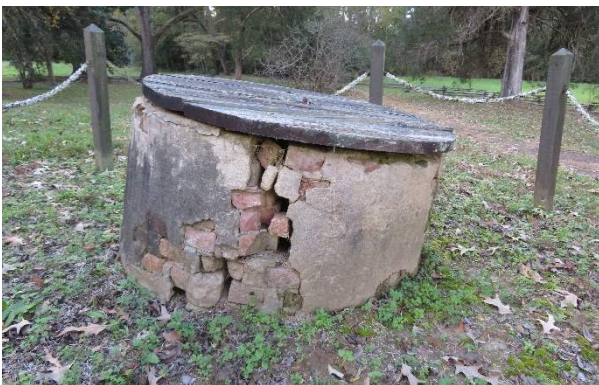
Photo 25. Cistern #1 to the northwest of the main house has failed.

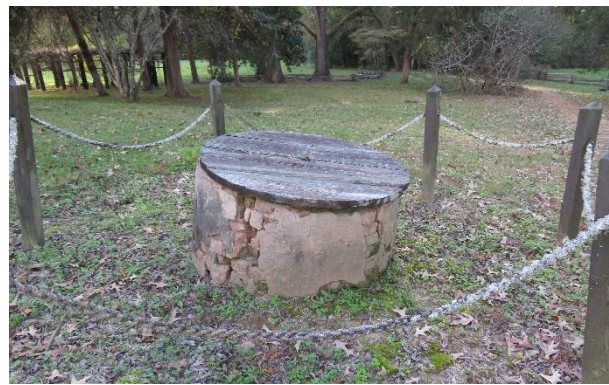
Photo 26. Cistern #1 to the northwest of the main house has failed.

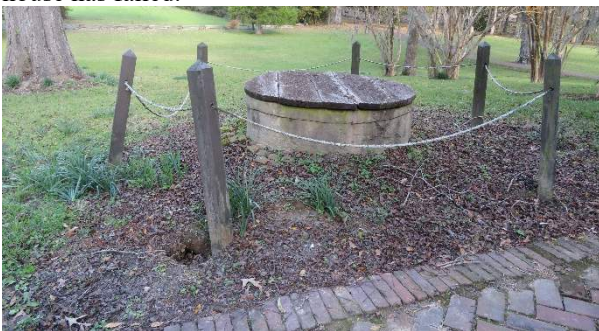
Photo 27. Cistern #2 to the northeast of the main house.

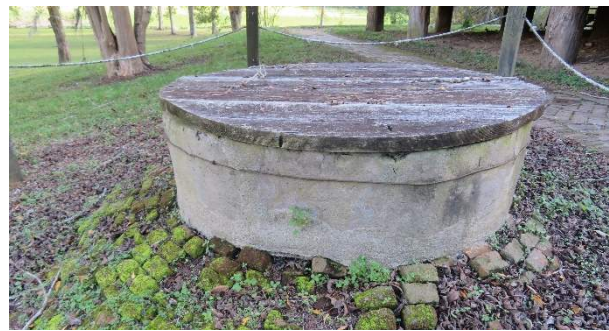
Photo 28. Cistern #2 to the northeast of the main house.

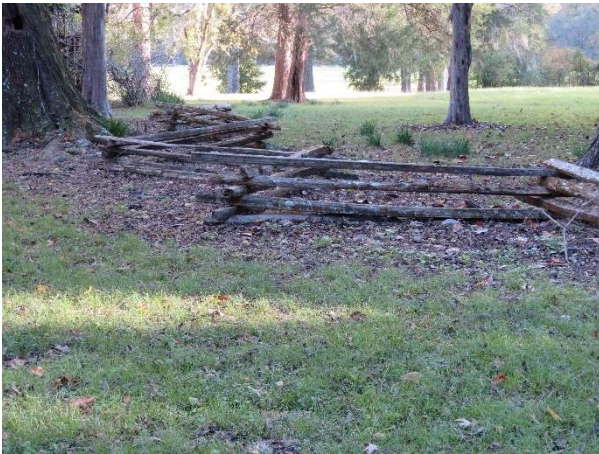
Photo 29. Split rail site fences.

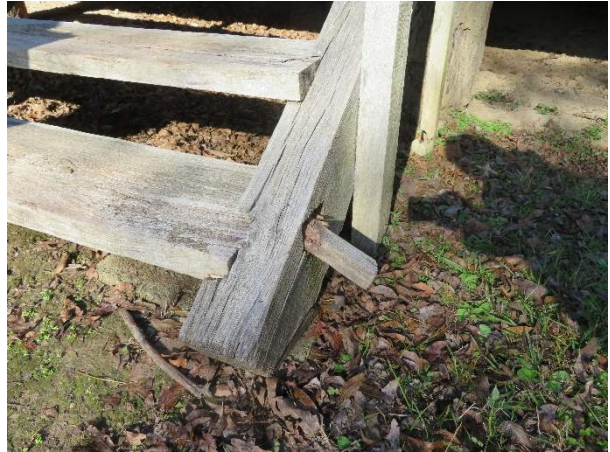
Photo 32. Deterioration of tread connection.

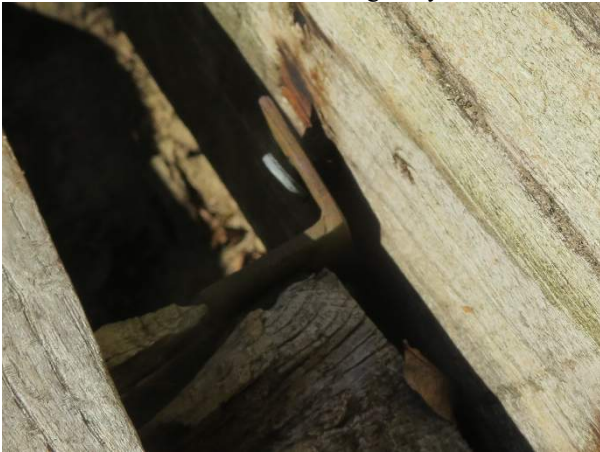
Photo 33. Distress to stair support at gallery rim joist.

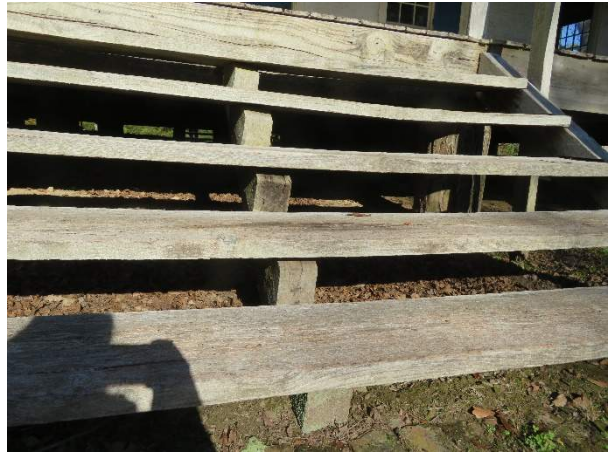
Photo 34. Displacement of center stringer and deflection of treads.

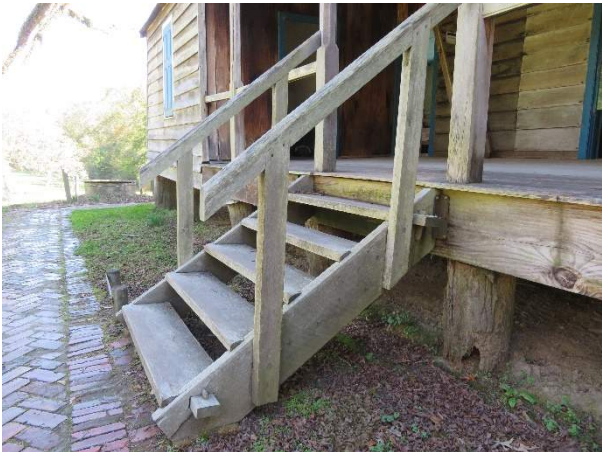
Photo 35. Exterior stairs to north gallery.

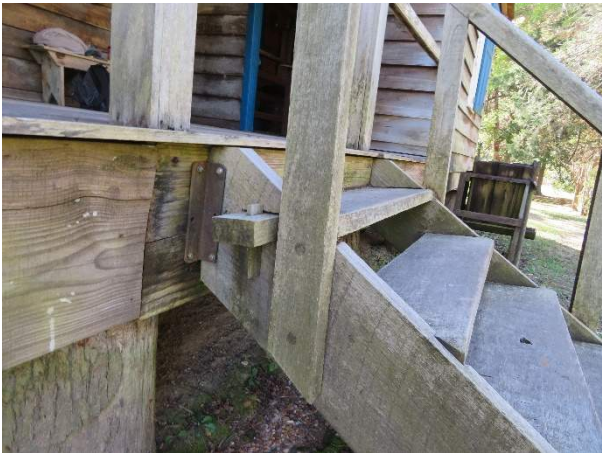
Photo 37. Distress to stair support at gallery rim joist.

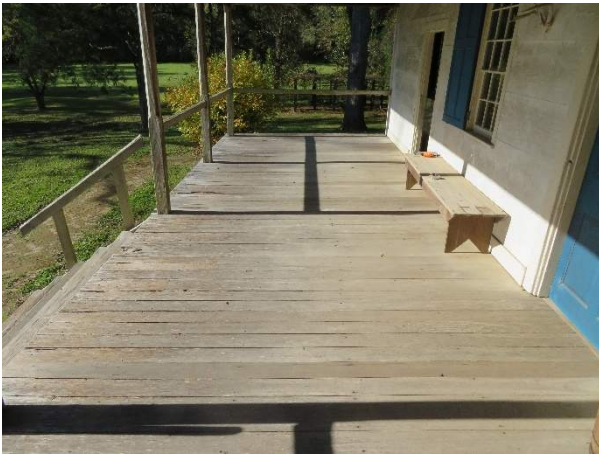
Photo 38. Decking of south gallery, showing wear and deterioration at stairs.

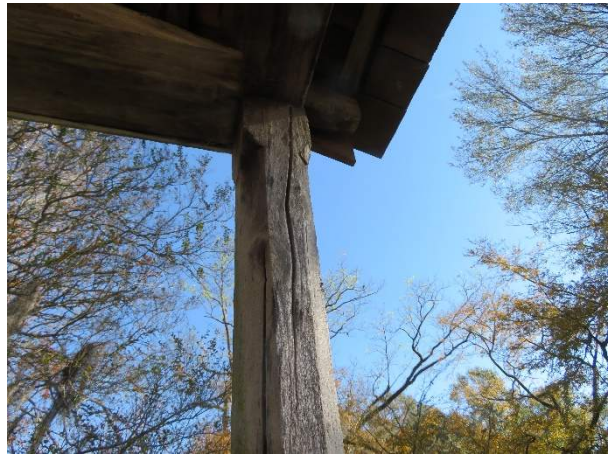
Photo 39. Checking of south gallery posts.

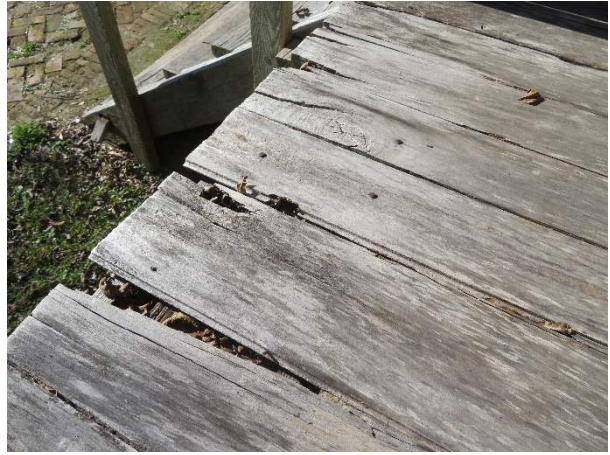
Photo 43. Deterioration of gallery decking.

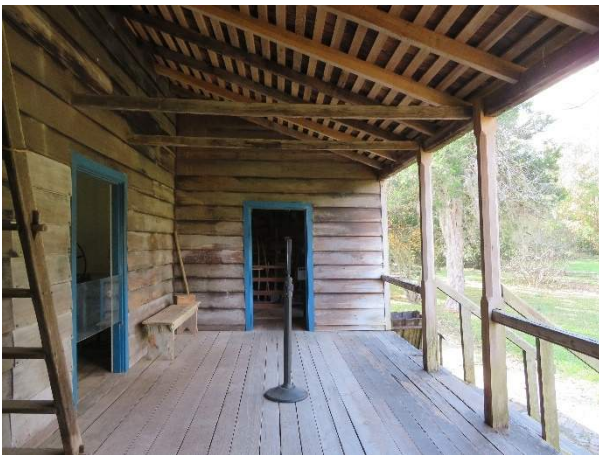
Photo 44. North gallery, looking west.

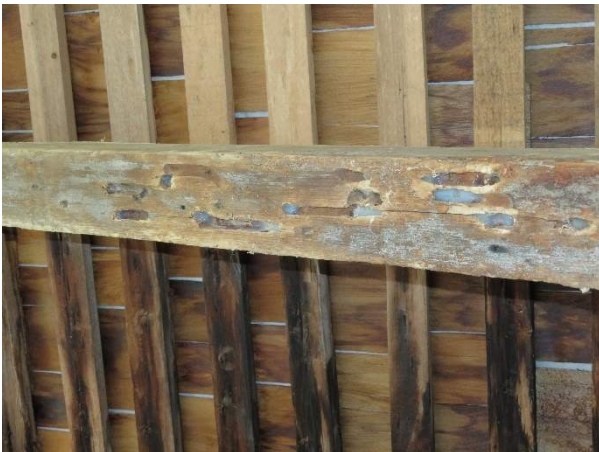
Photo 46. Carpenter bee damage to gallery beams.

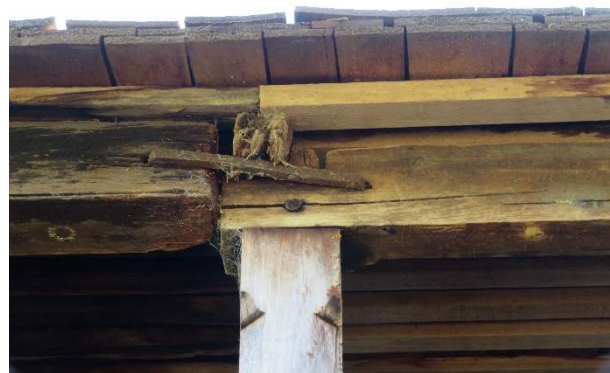
Photo 47. Distress to gallery top plate splice.

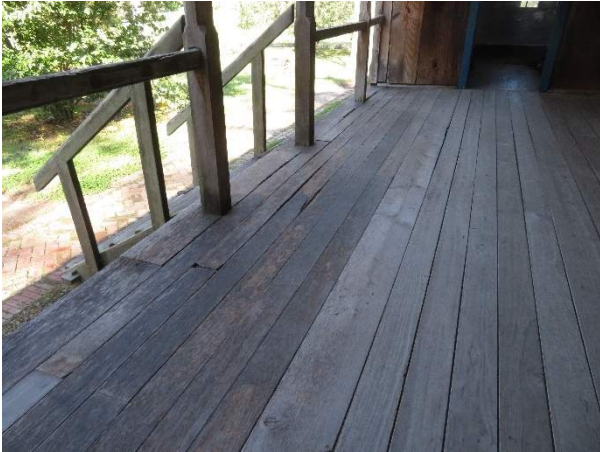
Photo 48. Deterioration of gallery decking.

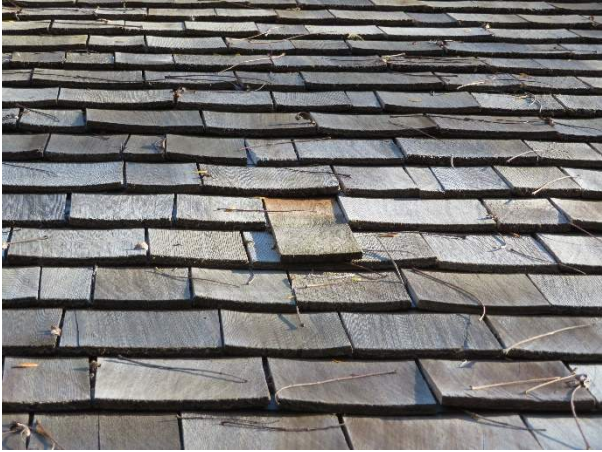
Photo 51. Loose shake.

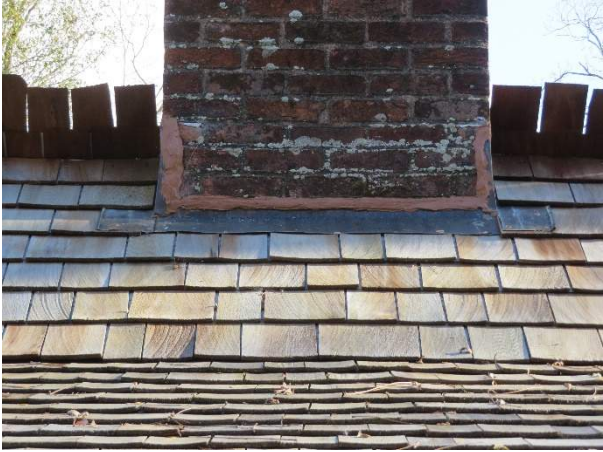
Photo 52. Flashing and sealant at chimney.

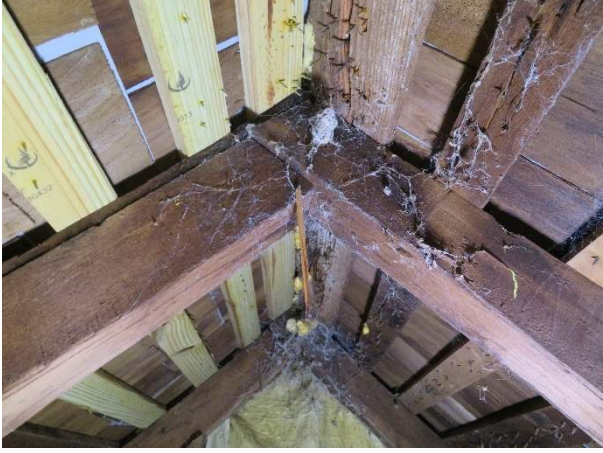
Photo 54. Spaced sheathing at ridge, with recent replacement boards on the left.

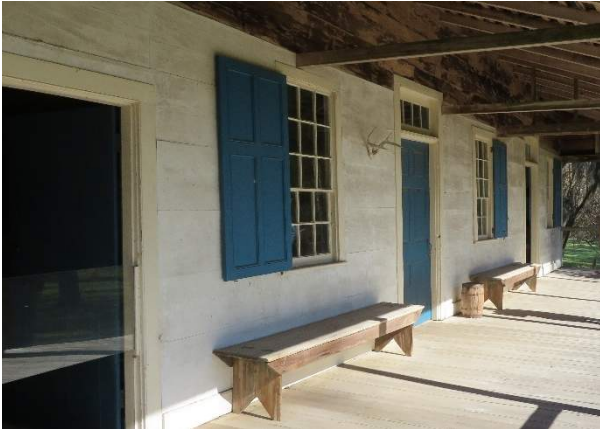
Photo 55. South elevation board siding.

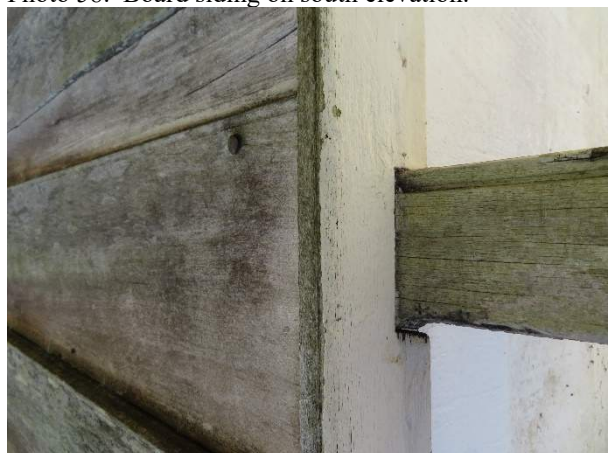
Photo 60. West rail connection at board siding and corner trim.

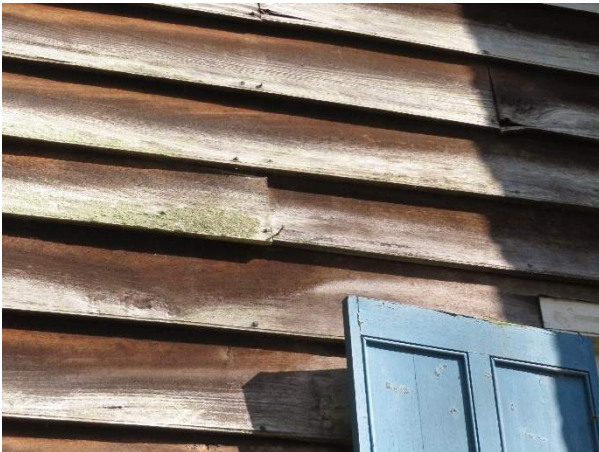
Photo 61. Warping and age-related deterioration of weatherboard siding at east wall.

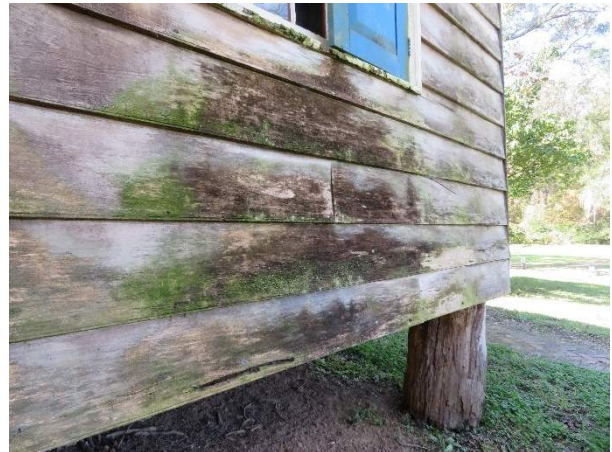
Photo 62. Biological growth and severe deterioration of weatherboard siding at northeast corner.

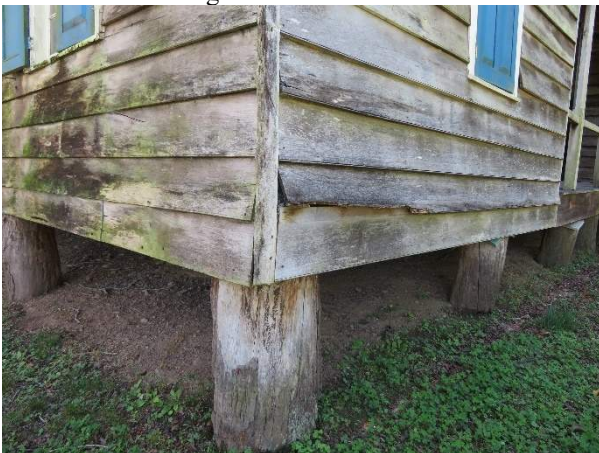
Photo 63. Biological growth and severe deterioration of weatherboard siding at northeast corner.

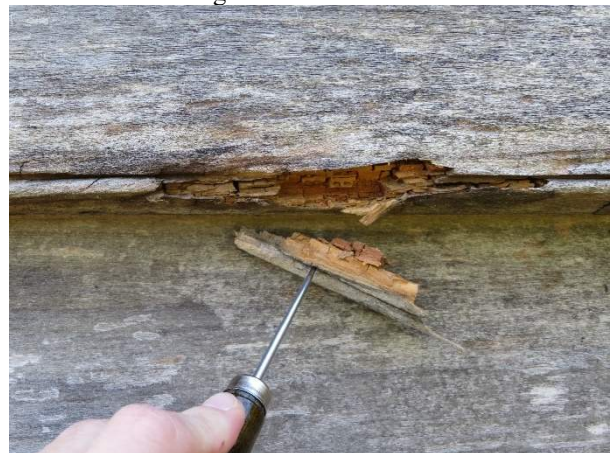
Photo 64. Deterioration of wood.

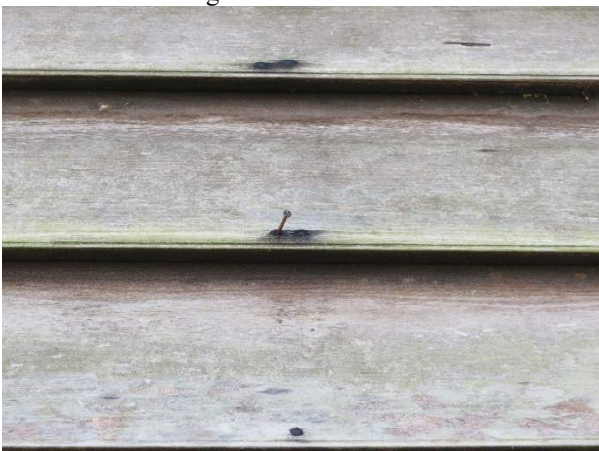
Photo 65. Warping and fastener backout of weatherboard siding.

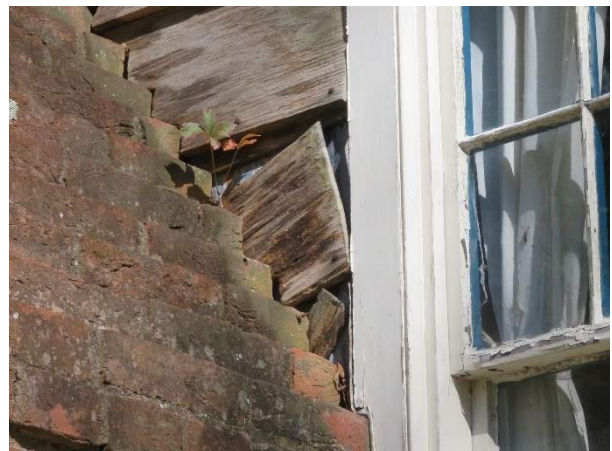
Photo 66. Loose and deteriorated siding at west wall behind brick chimney.

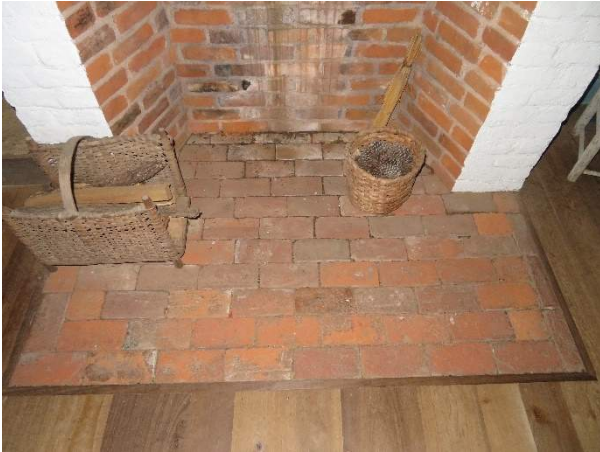
Photo 67. Brick hearth in Room 7 (107).

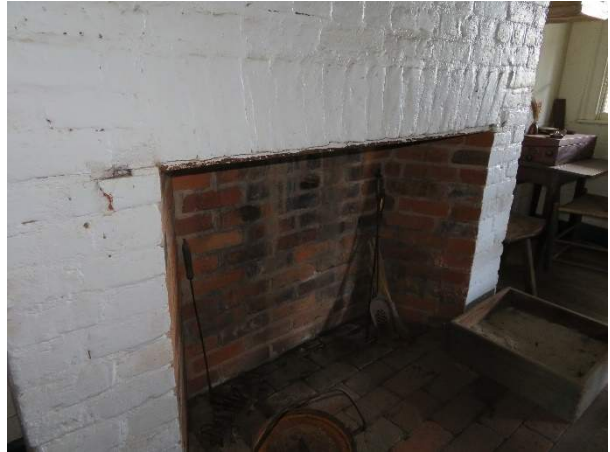
Photo 68. Distress and displacement of brick due to corrosion of steel lintel in Room 1 (101).

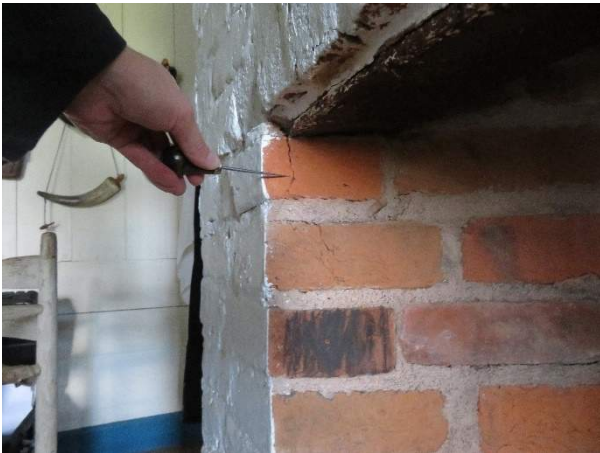
Photo 69. Distress and displacement of brick due to corrosion of steel lintel in Room 1 (101).

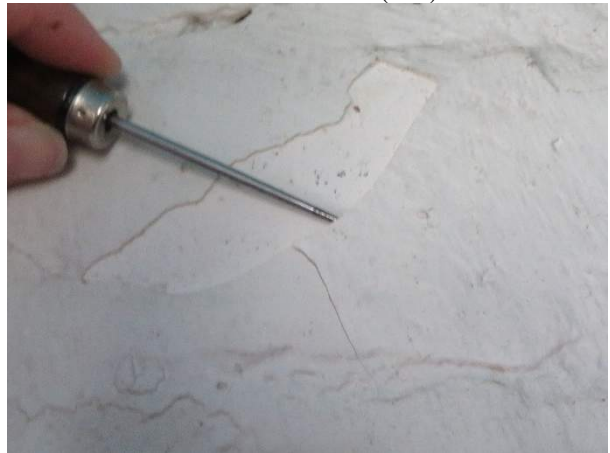
Photo 70. Paint surface failure, exposing lower layers of white paint in Room 7 (107).

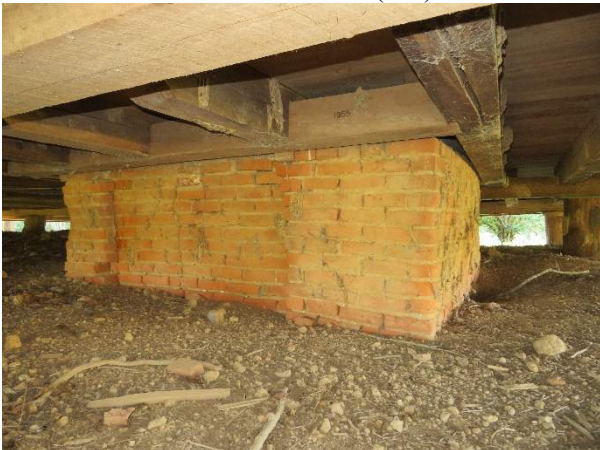
Photo 71. Foundation of central chimney, showing mortar loss with minor cracking and animal burrow.

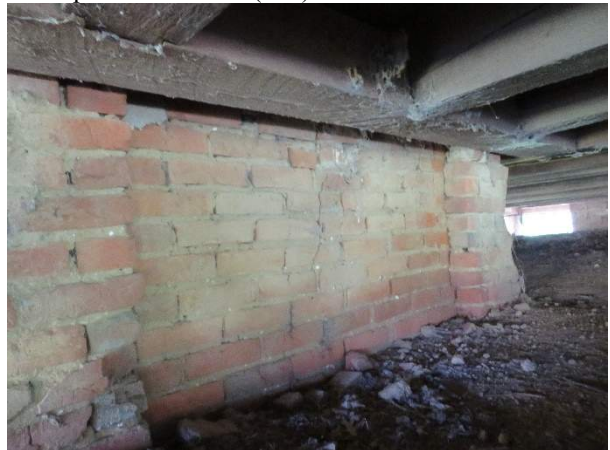
Photo 72. Foundation of central chimney, showing mortar loss and minor cracking.

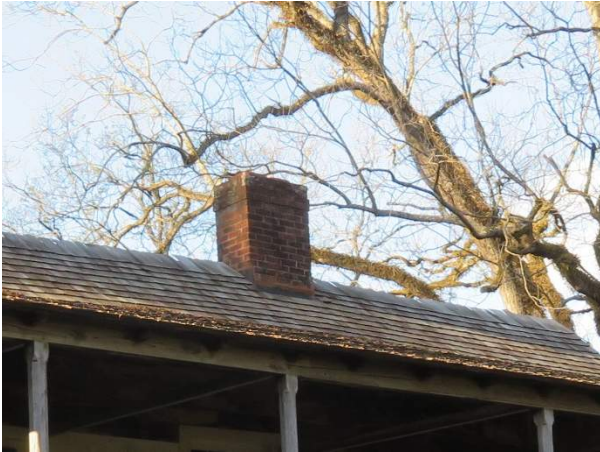
Photo 73. Central chimney above roof, south face.

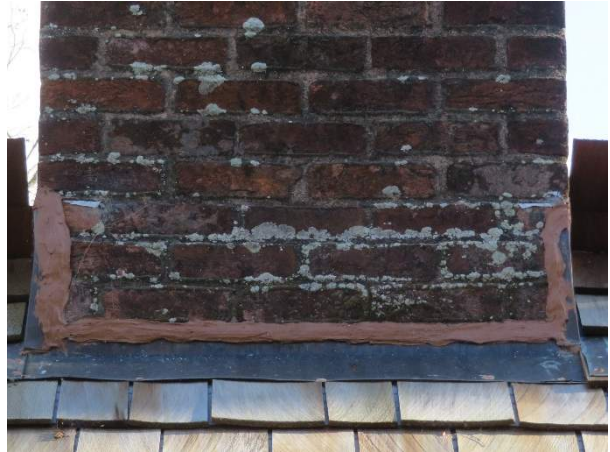
Photo 74. Central chimney above roof, which lichen growth on the north face.

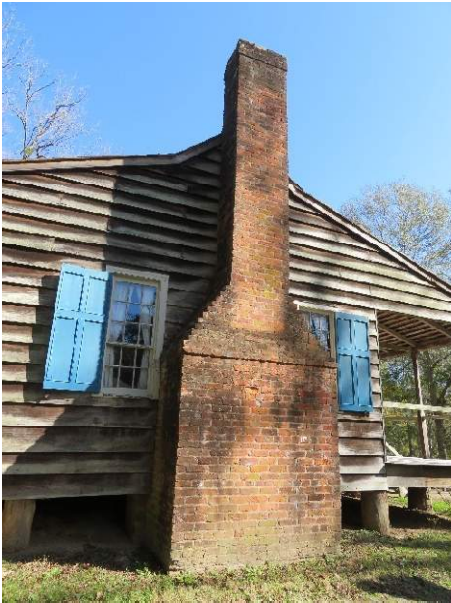
Photo 75. West chimney.

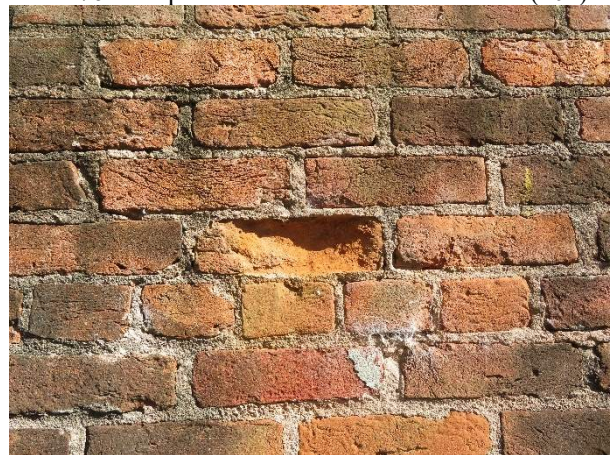
Photo 78. Localized deterioration of brick units at west chimney.

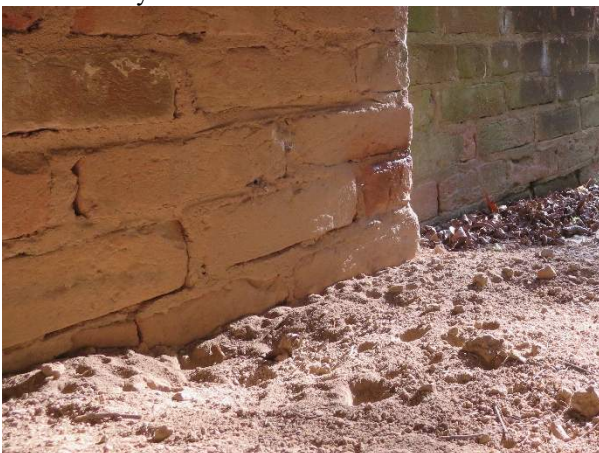
Photo 79. Mortar loss at base of west chimney.

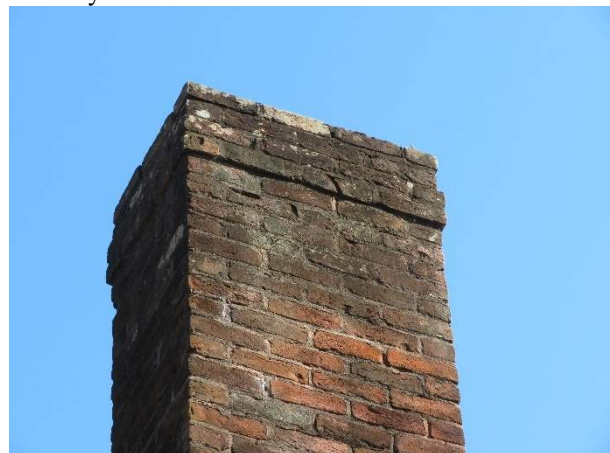
Photo 80. Deterioration of mortar at top of west chimney.

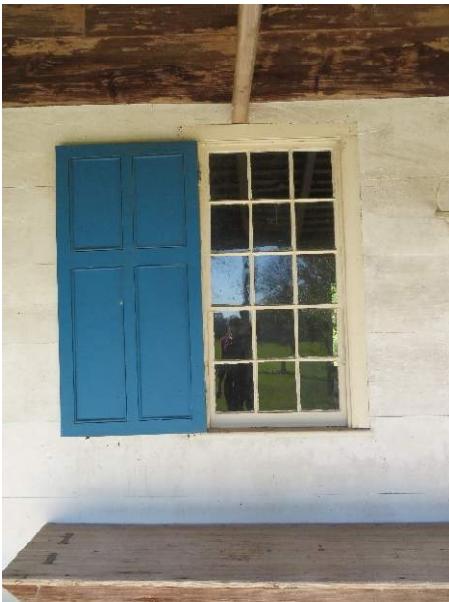
Photo 81. Window W100, overall.

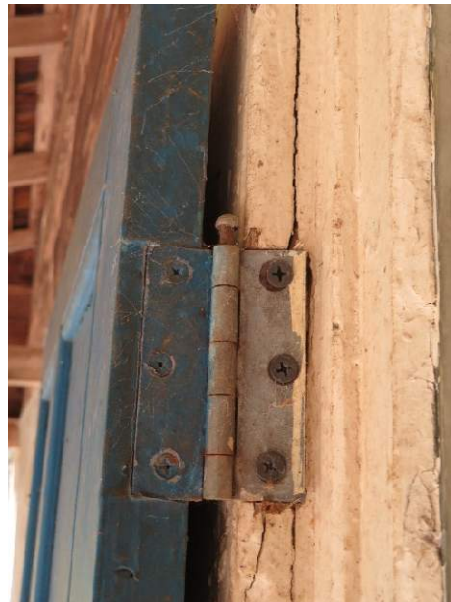
Photo 82. Distress to jamb at replacement shutter hardware.

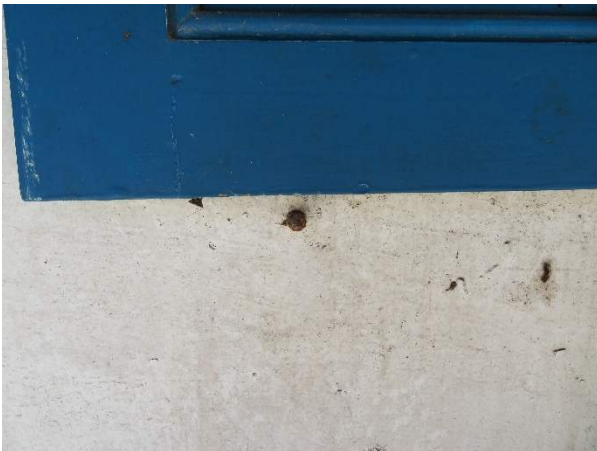
Photo 83. Missing shutter dog.

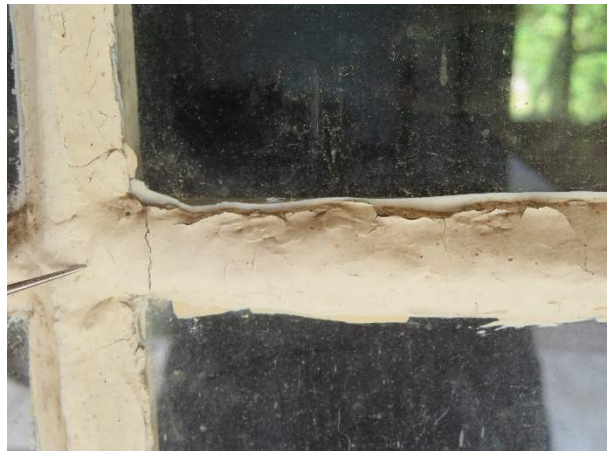
Photo 84. Failed replacement glazing putty.

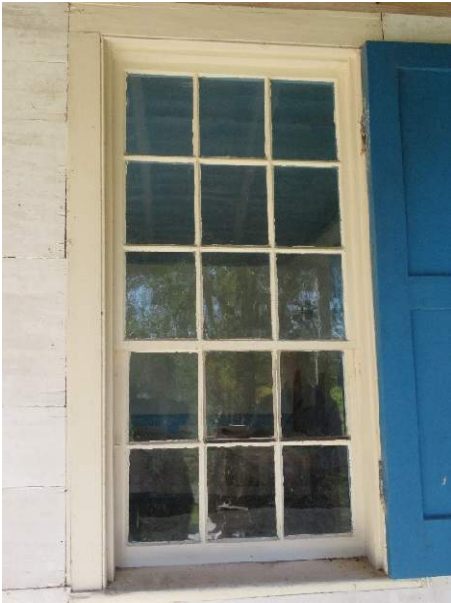
Photo 85. Window W101.

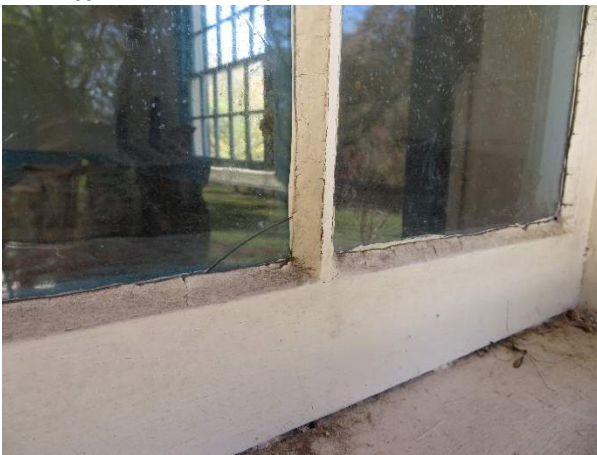
Photo 87. Small crack in glazing in lower sash.

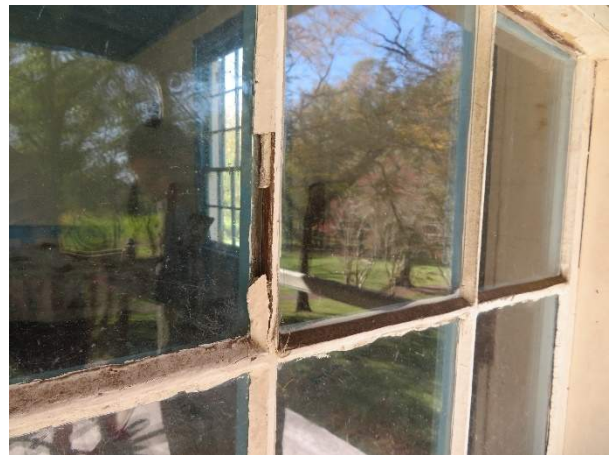
Photo 88. Failed glazing putty.

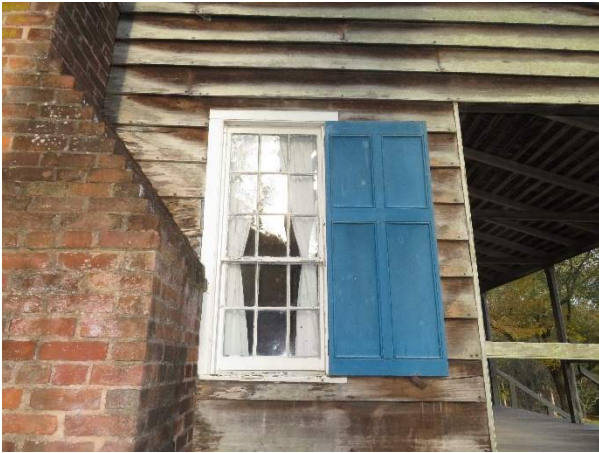
Photo 89. Window W200, overall.

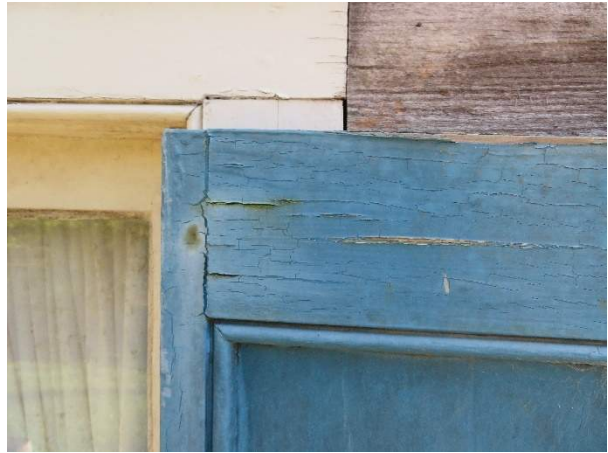
Photo 90. Minor deterioration of upper rail and stile of shutter.

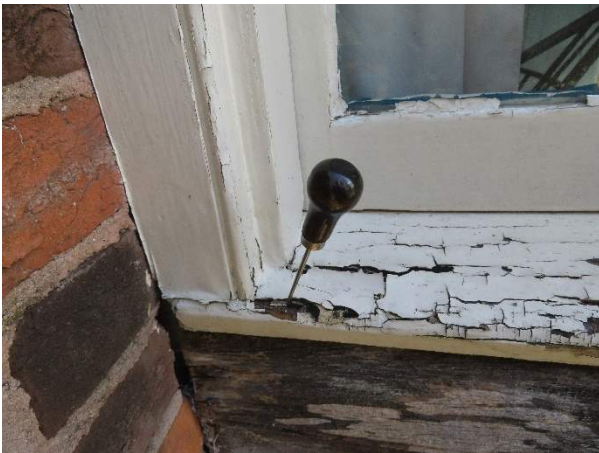
Photo 91. Severe deterioration of the sill.

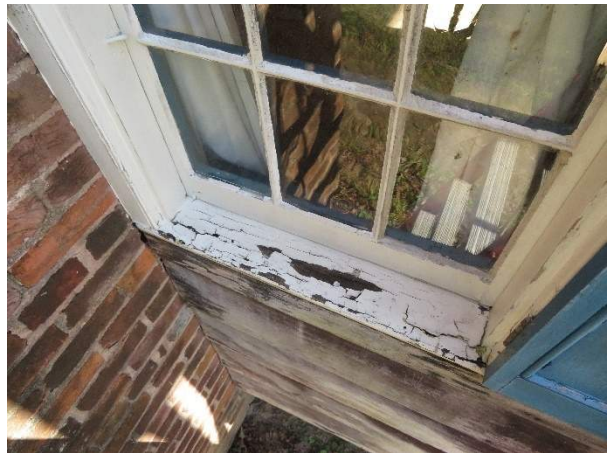
Photo 92. Severe deterioration of the sill.

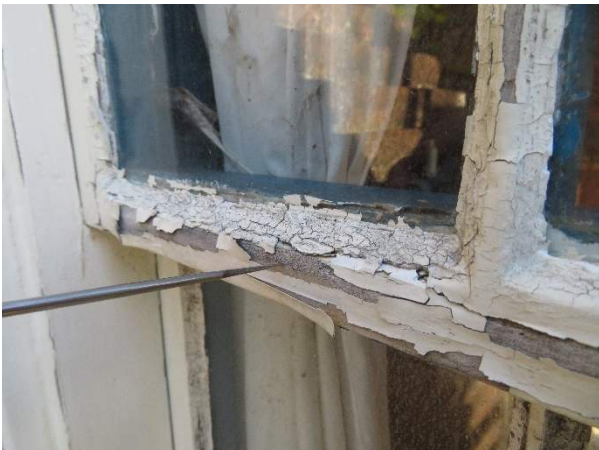
Photo 93. Failed glazing putty and minor deterioration of the upper sash meeting rail.

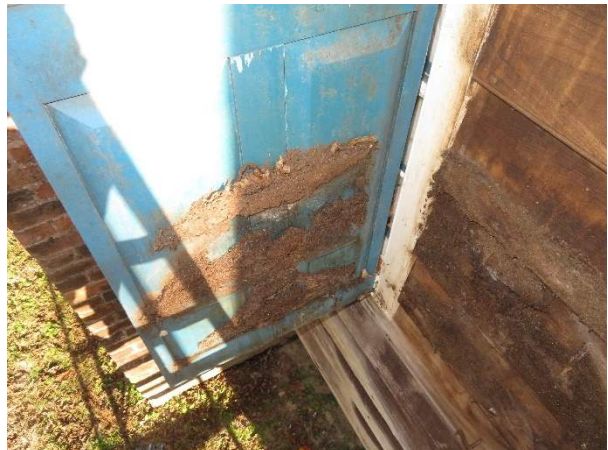
Photo 94. Soiling and guano from bats roosting being the shutters.

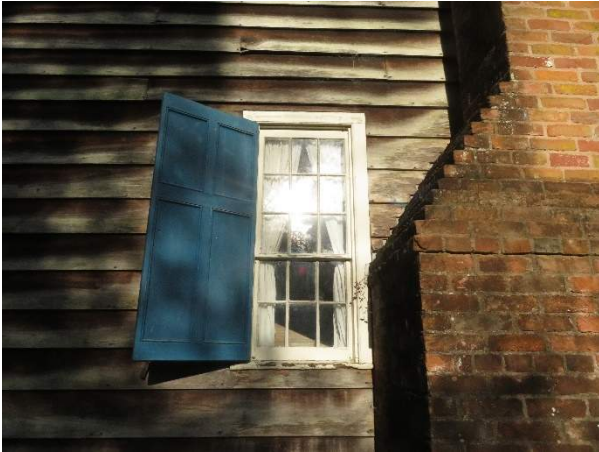
Photo 95. Window W201, overall.

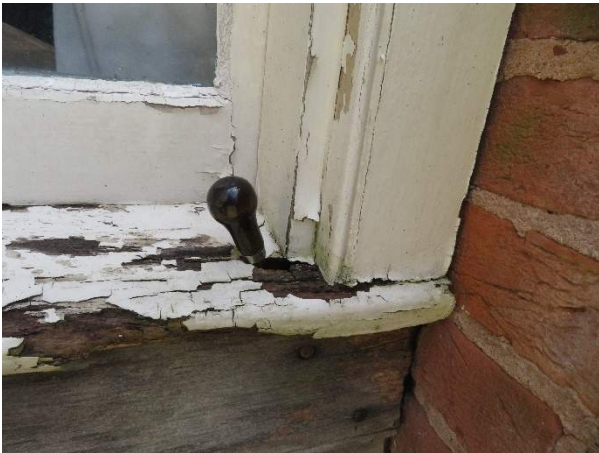
Photo 97. Severe deterioration of the sill and lower right jamb.

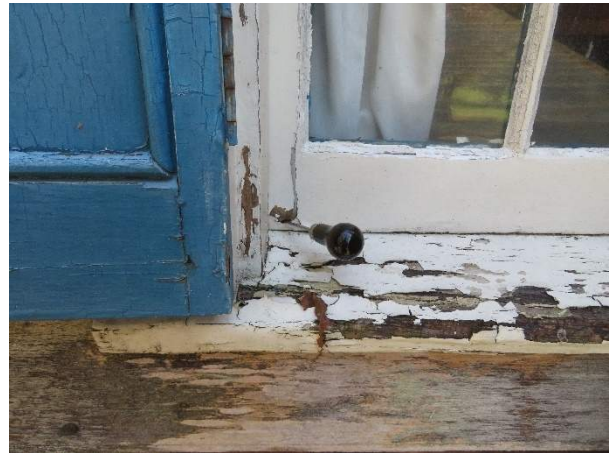
Photo 98. Severe deterioration of the sill and lower left jamb.

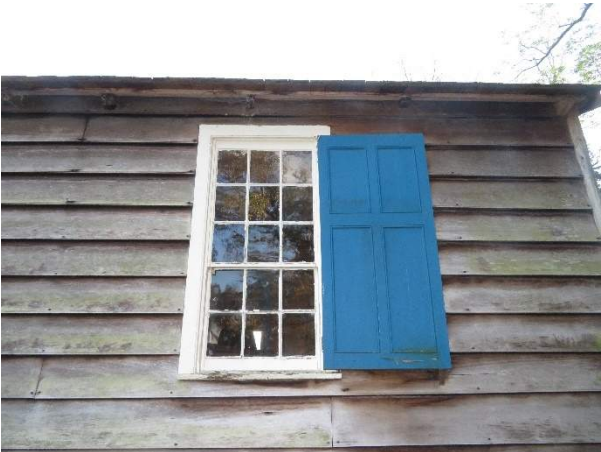
Photo 99. Window W300, overall.

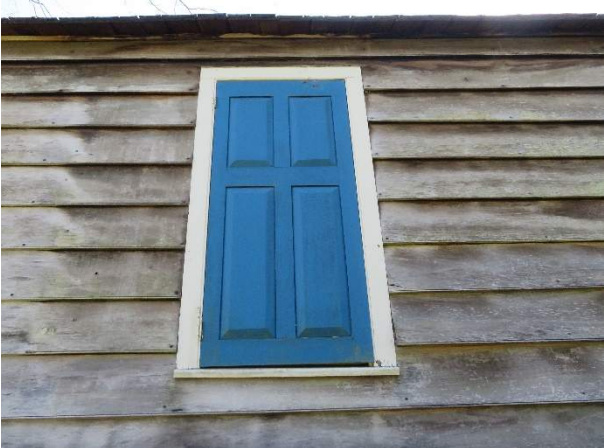
Photo 100. Window W600, overall.
