National Park Service  
U.S. Department of the Interior

Natchez Trace Parkway  
Tupelo, MS

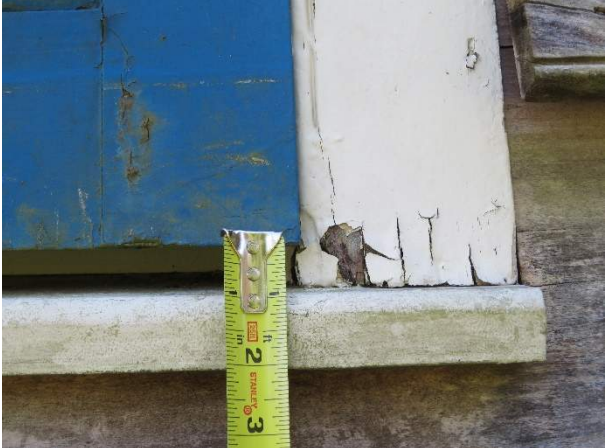
Photo 101. Deterioration of jamb.

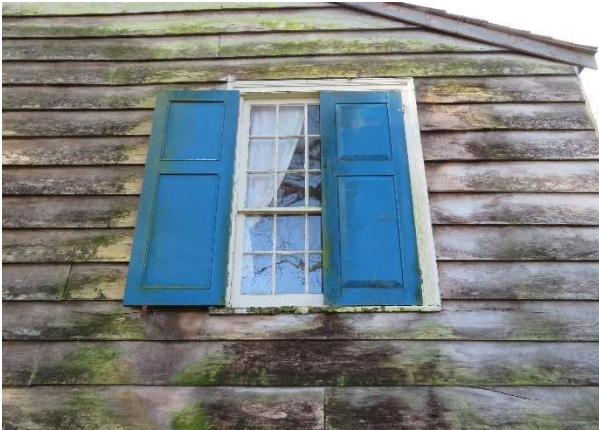
Photo 102. Window W601, overall.

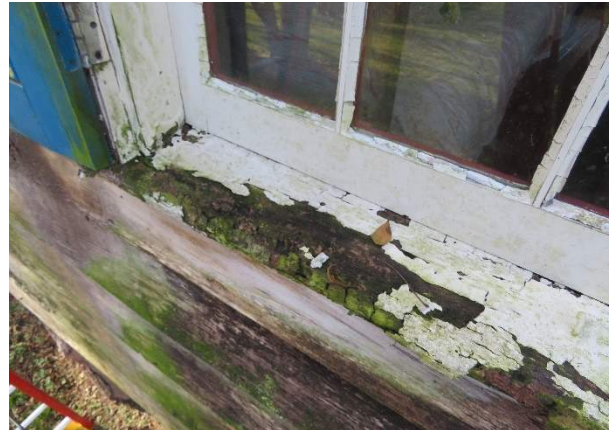
Photo 103. Severe deterioration of the sill.

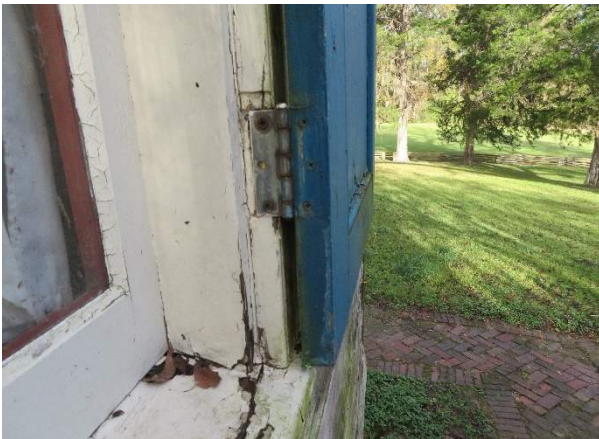
Photo 104. Deterioration of the sill and distress to the jamb at replacement hardware for right shutter.

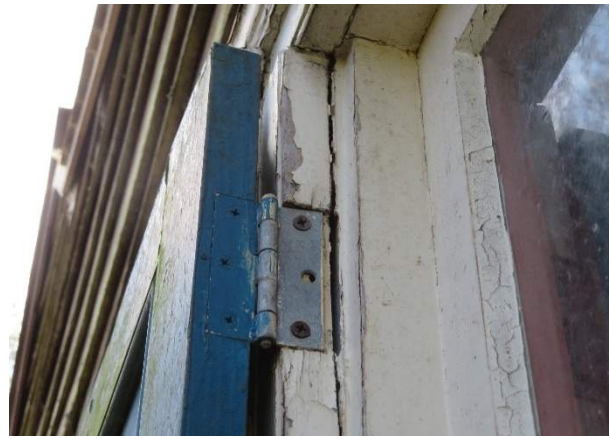
Photo 105. Distress to jamb at replacement hardware for left shutter.

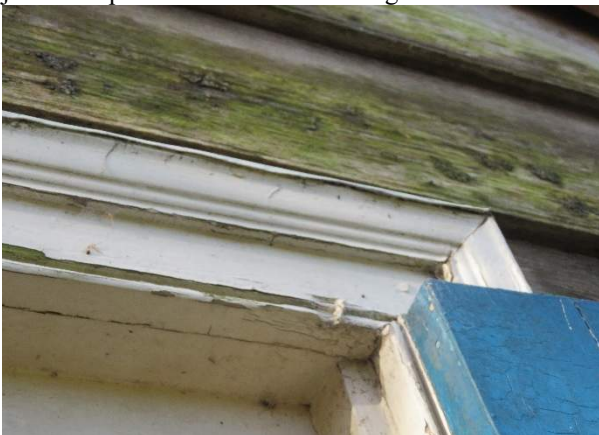
Photo 106. Sheet metal flashing cap at window head.

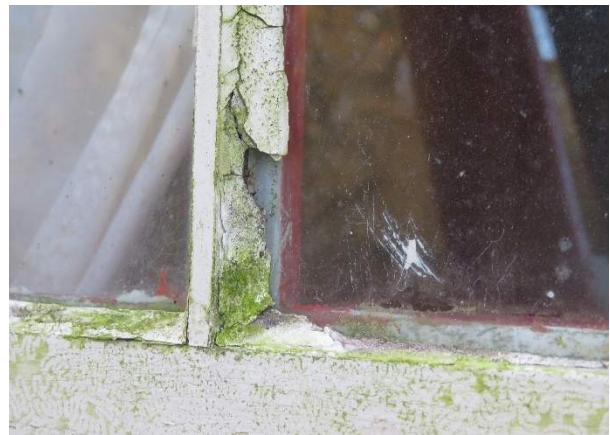
Photo 107. Failed glazing putty.

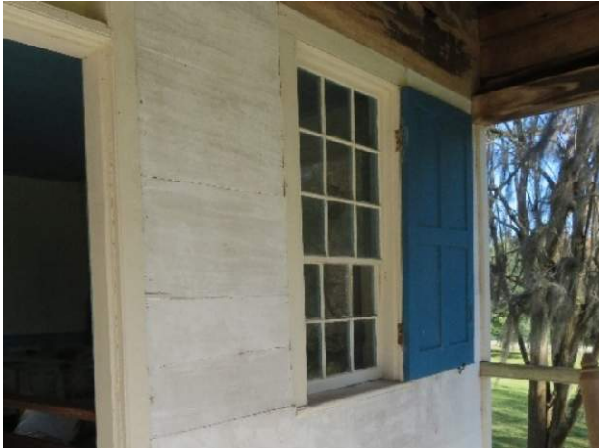
Photo 108. Window W700, overall.

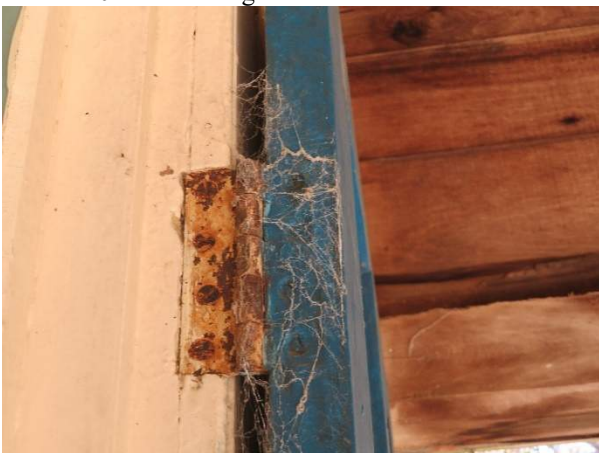
Photo 112. Replacement shutter hardware.

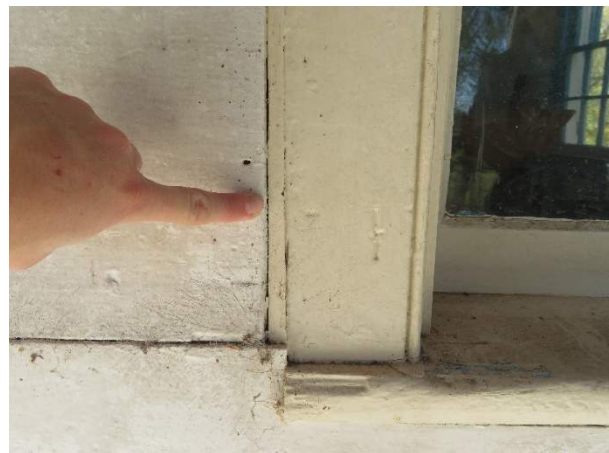
Photo 113. Minor distress to lower left jamb.

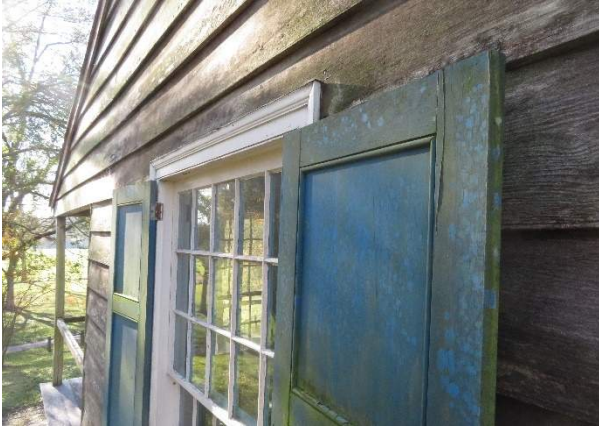
Photo 114. Window W701, top of window looking south.

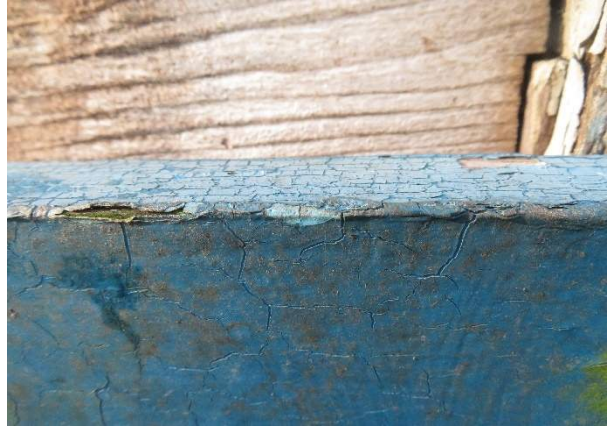
Photo 115. Failure of painted surfaces and minor deterioration of top rail of shutter.

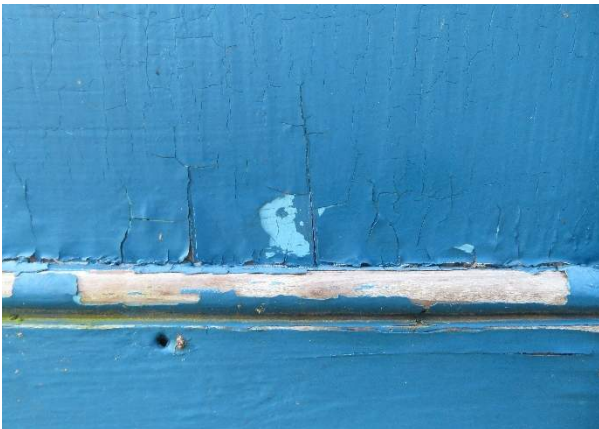
Photo 116. Failure of painted surfaces of shutter, showing multiply layers of blue paint.

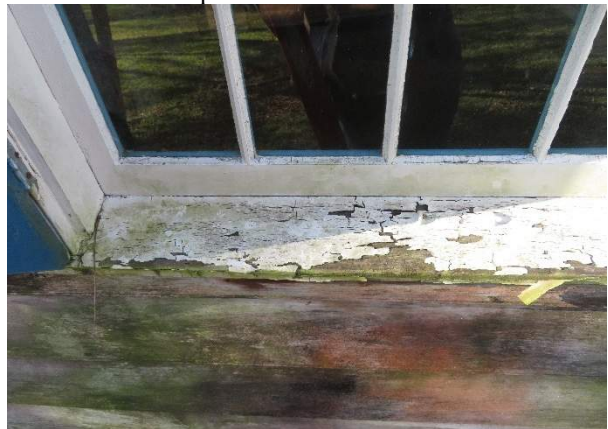
Photo 117. Deterioration of the sill.

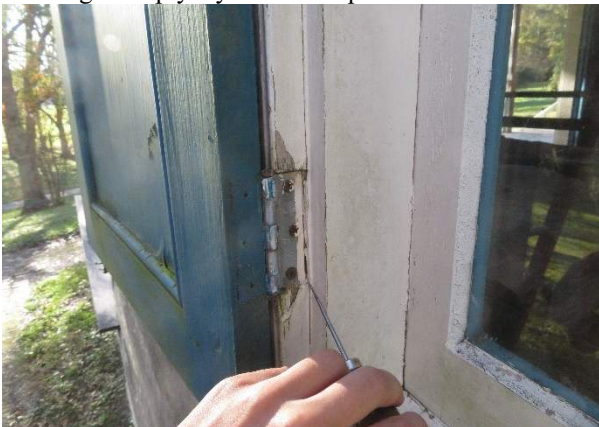
Photo 118. Distress to jamb at replacement hardware.

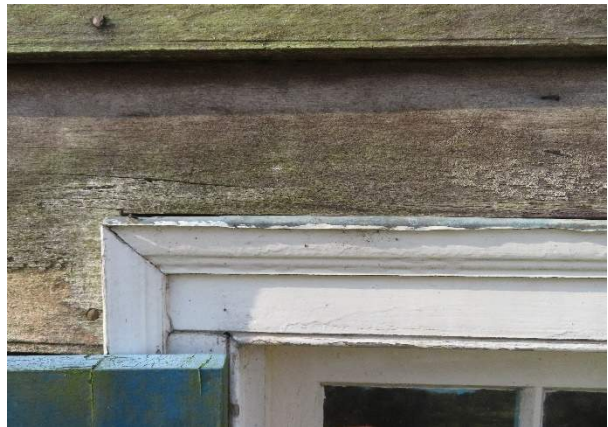
Photo 119. Sheet metal flashing cap at window head.

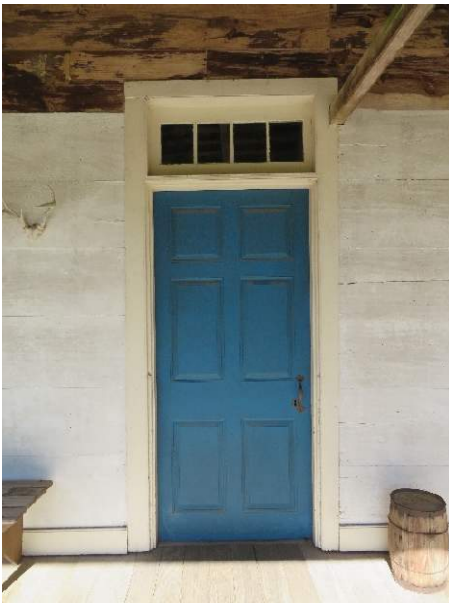
Photo 120. Door D100, overall.

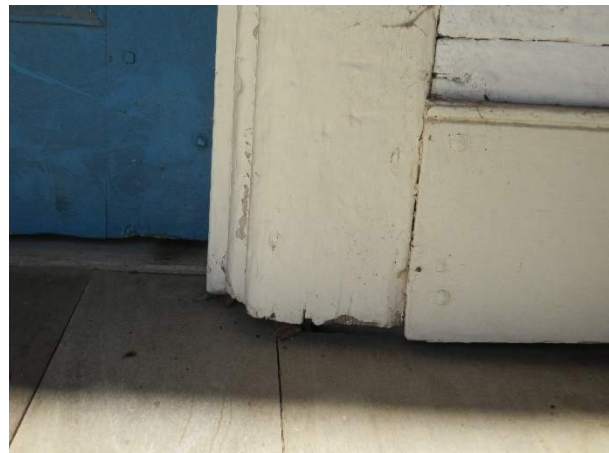
Photo 123. Minor weather-related deterioration of base of jamb trim.

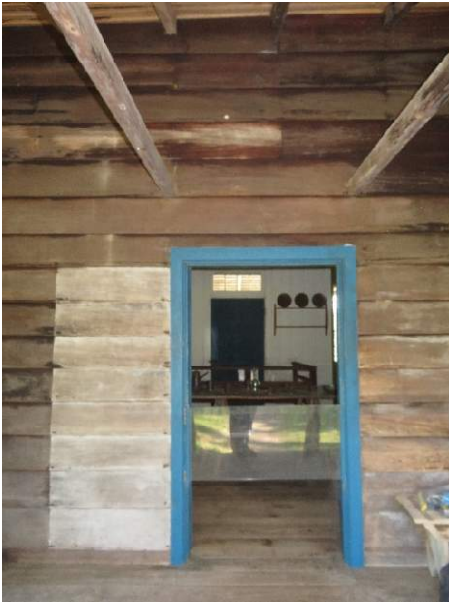
Photo 124. Door D101. overall, looking south.

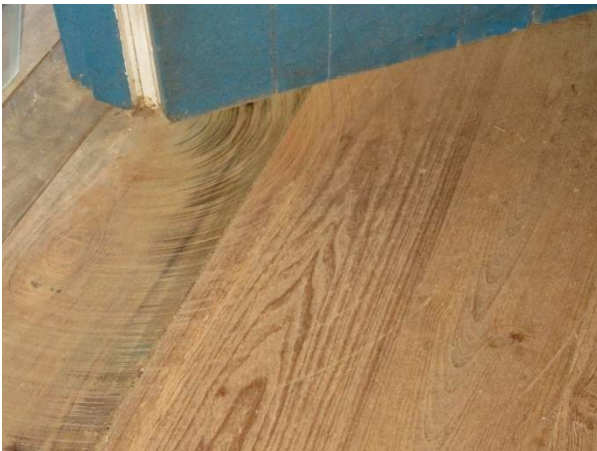
Photo 128. Abrasion to the flooring from door swing.

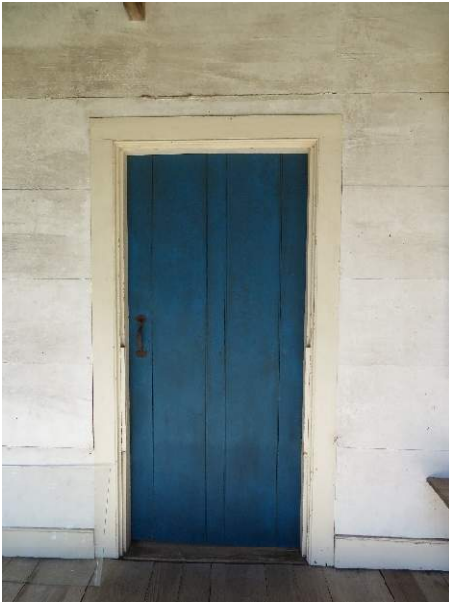
Photo 129. Door D200, overall.

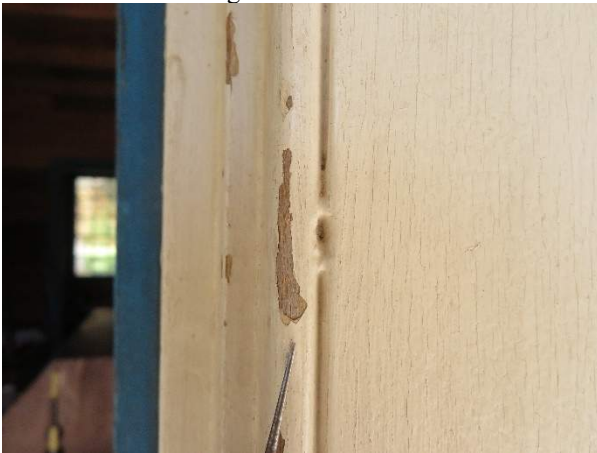
Photo 133. Failure of painted surfaces at door jamb.

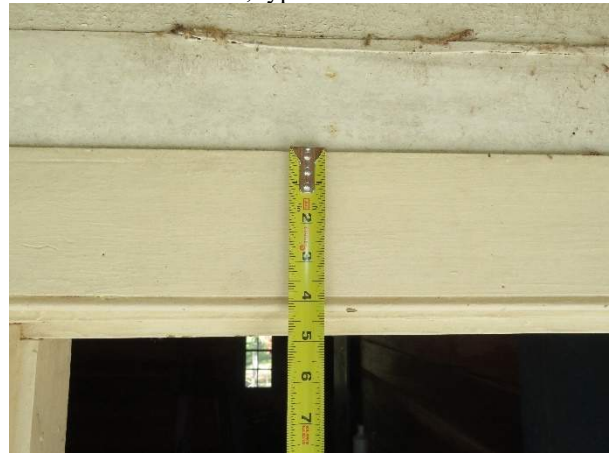
Photo 134. Head trim, typical.

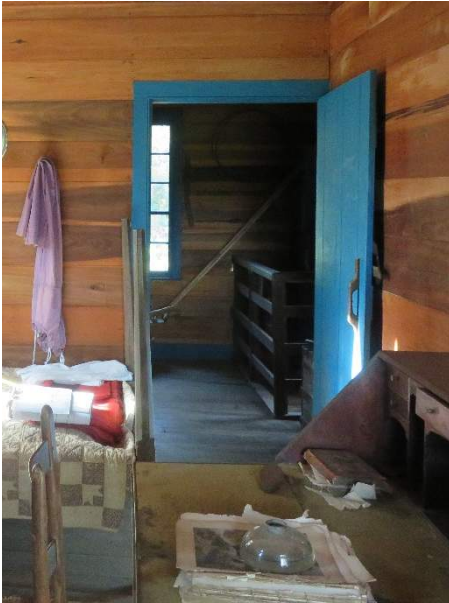
Photo 135. Door D201, overall looking north.

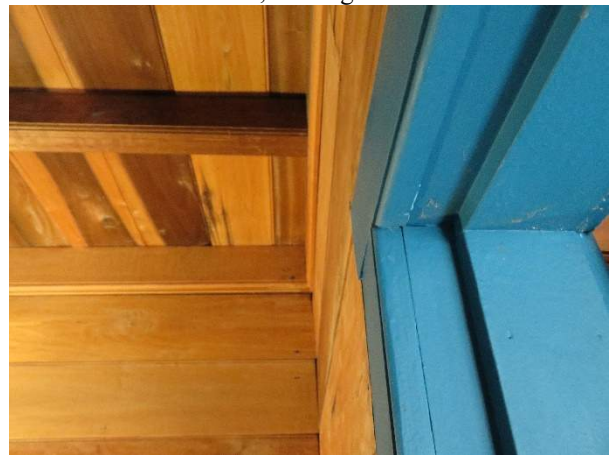
Photo 138. Minor separation of jamb and head trim in Room 2 (102).

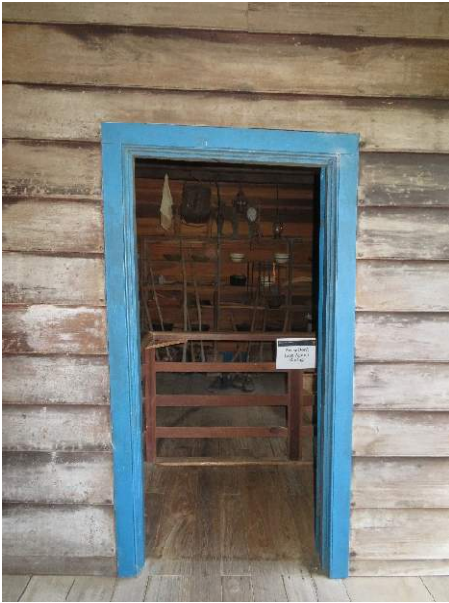
Photo 139. Door D300, overall.

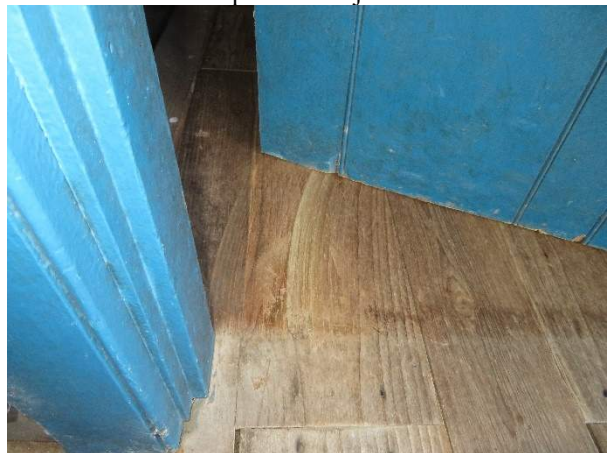
Photo 144. Abrasions to flooring from door swing.

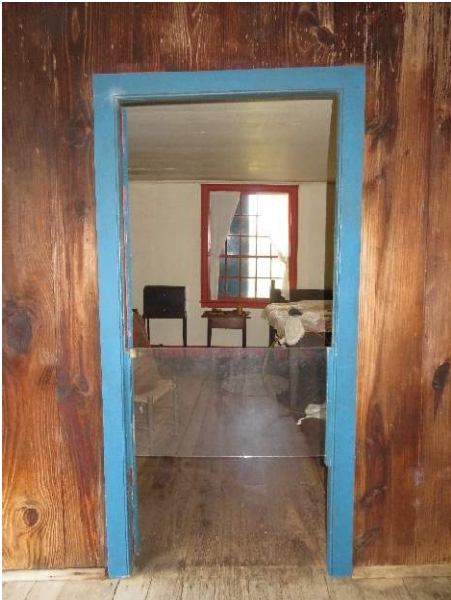
Photo 145. Door D600 with plexiglass pedestrian barrier in place.

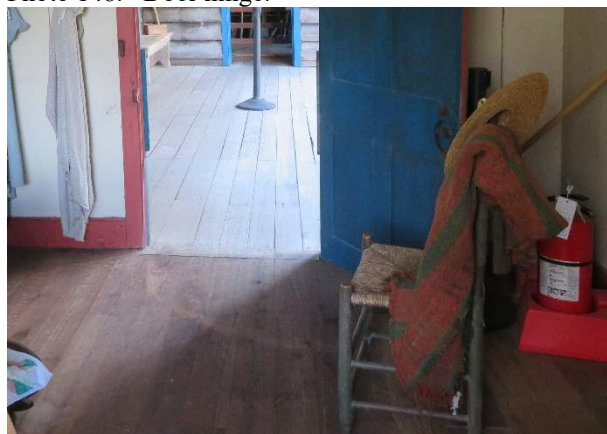
Photo 150. Abrasions to floor boards from door swing.

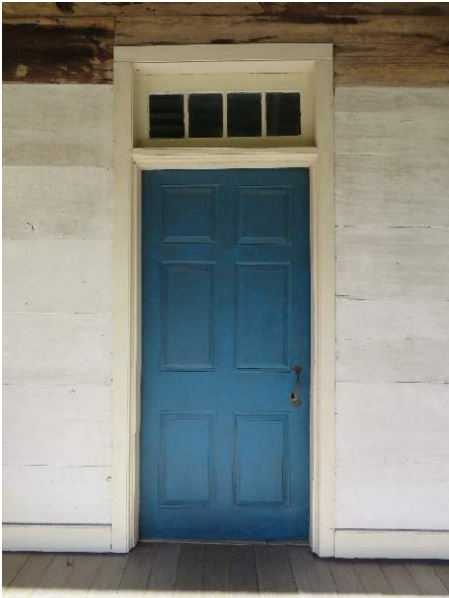
Photo 151. Door D700, overall.

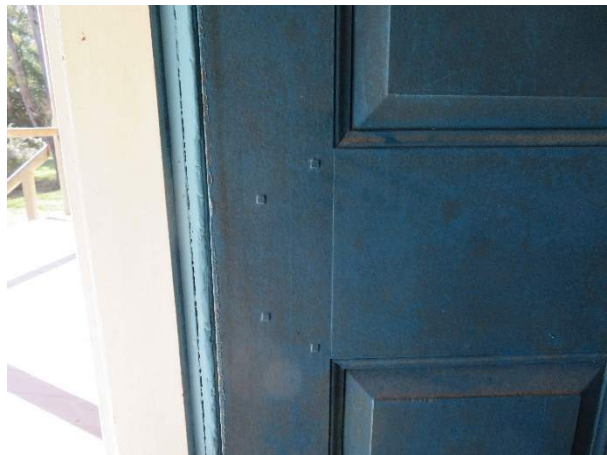
Photo 154. Connection detail of rail and middle stile at door D700.

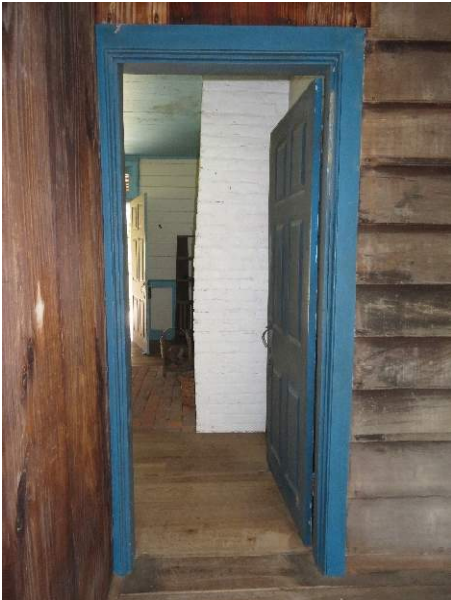
Photo 155. Door D701, looking south.

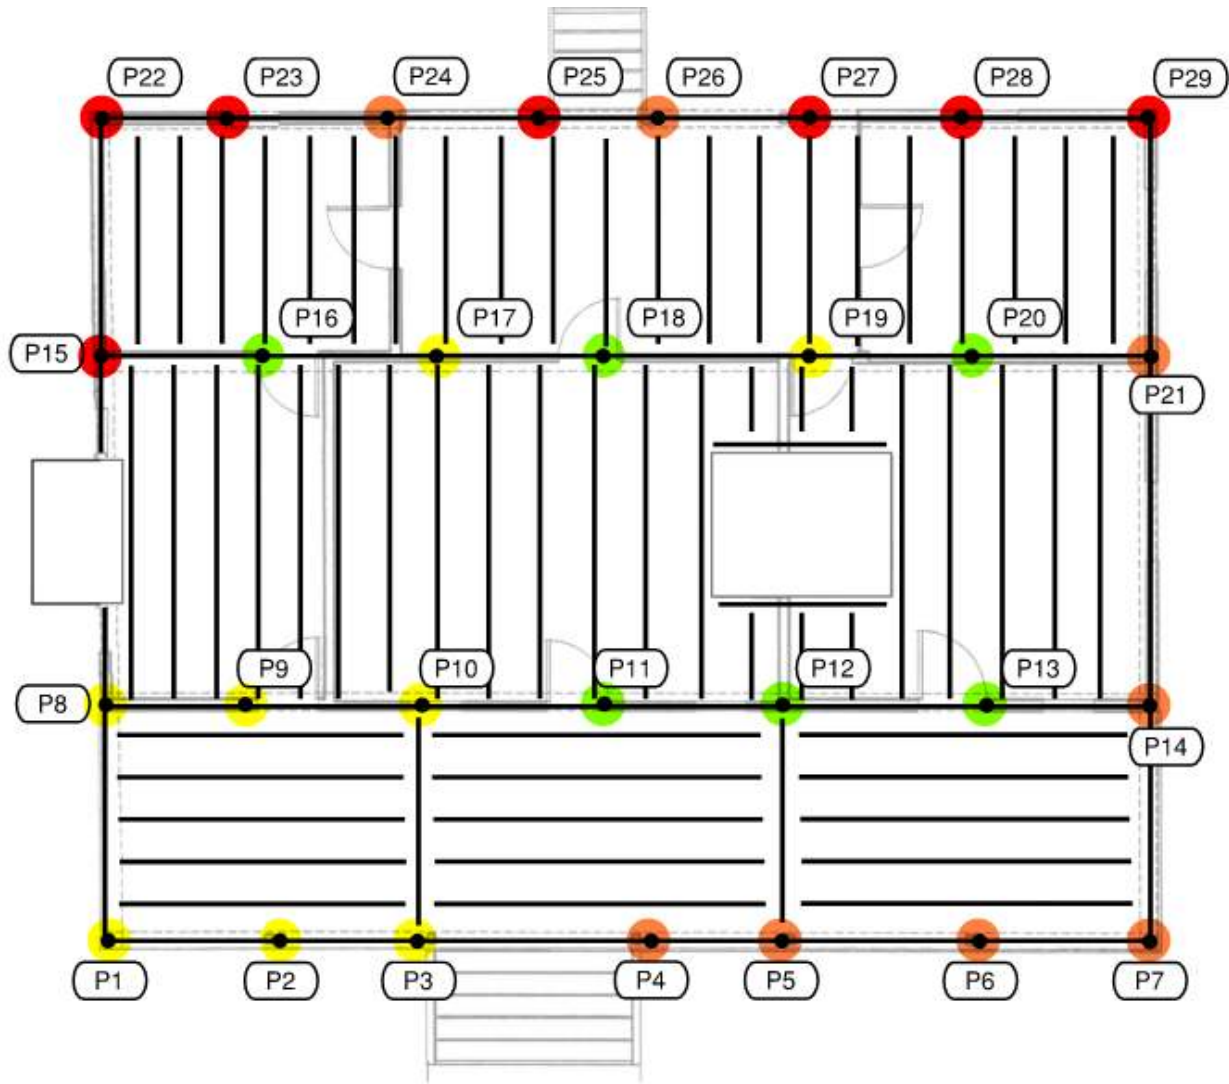
Figure 3. Schematic floor framing plan graphically showing condition ratings for foundation piers: Good (green), Fair (yellow), Poor (orange), and Failed (red).

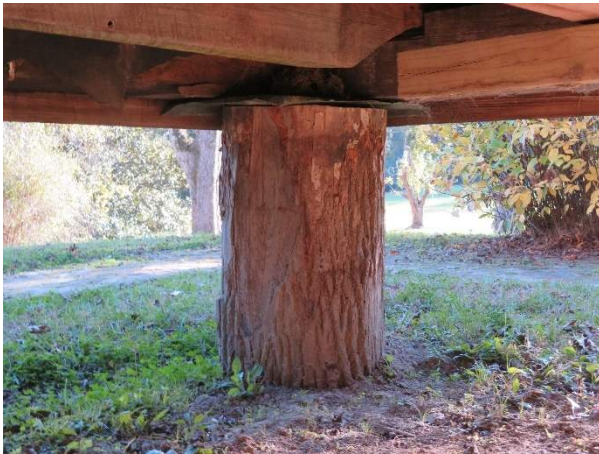
Photo 159. Pier P1, looking southwest.

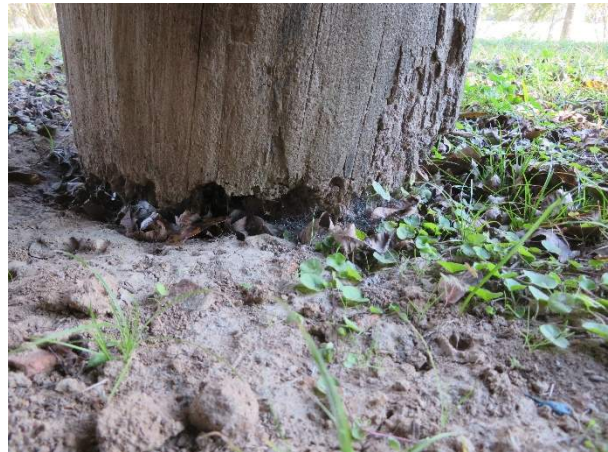
Photo 166. Deterioration at the base of Pier P6.

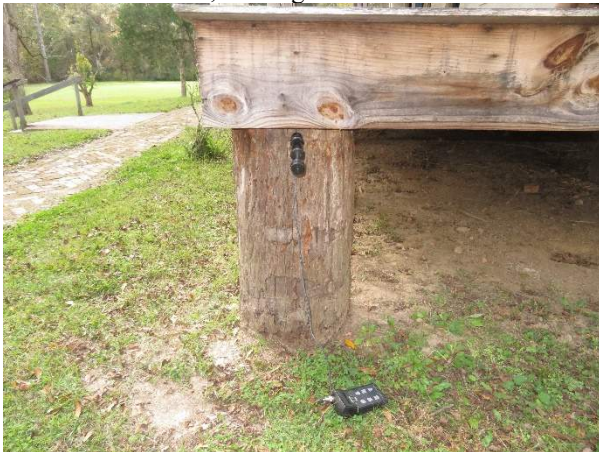
Photo 167. Pier P7, looking west.

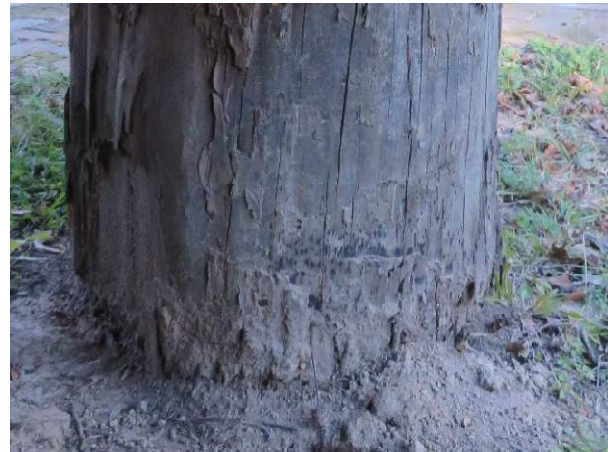
Photo 168. Deterioration at the base of Pier P7.

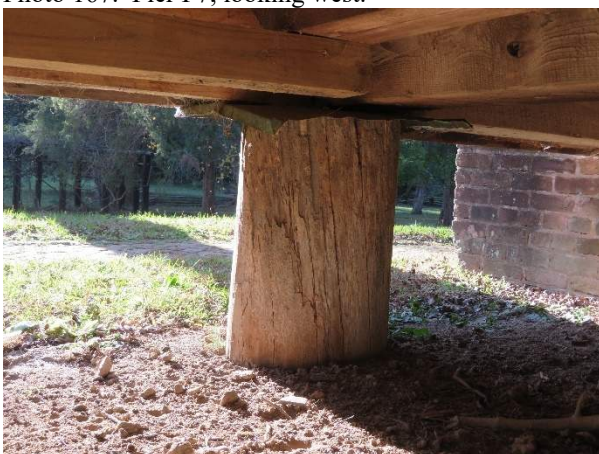
Photo 169. Pier P8, looking west.

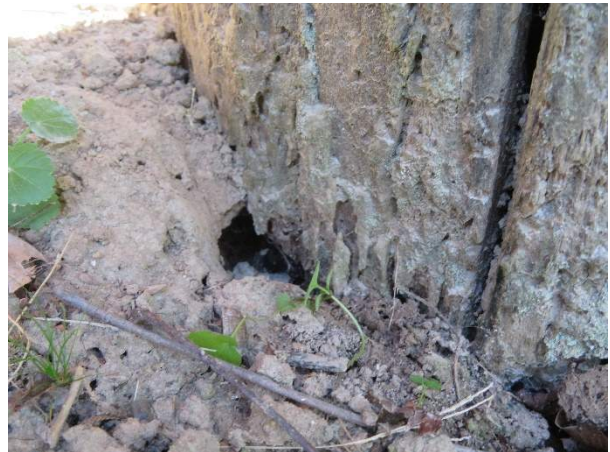
Photo 186. Pier P22 deterioration below grade.

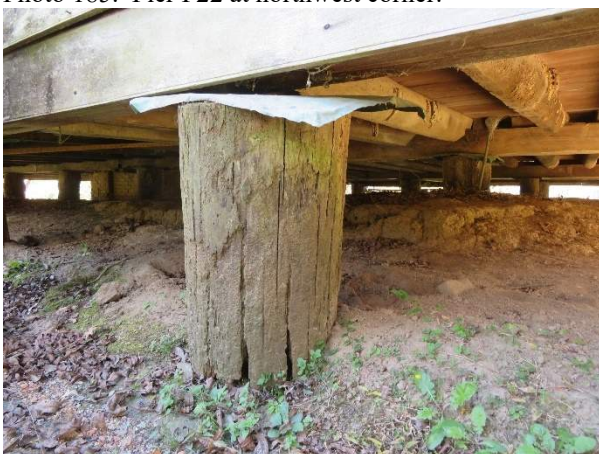
Photo 187. Pier P23 has settled due to deterioration and is no longer supporting the perimeter beam.

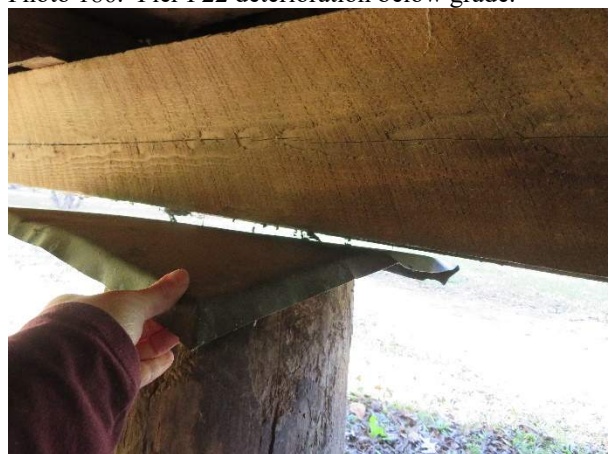
Photo 188. Pier P23 was no longer in contact with the perimeter beam.

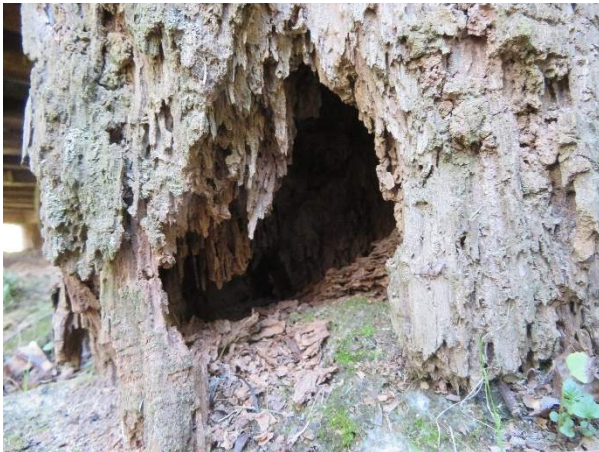
Photo 191. Pier P25 has significant loss of section due to internal and below-grade deterioration.

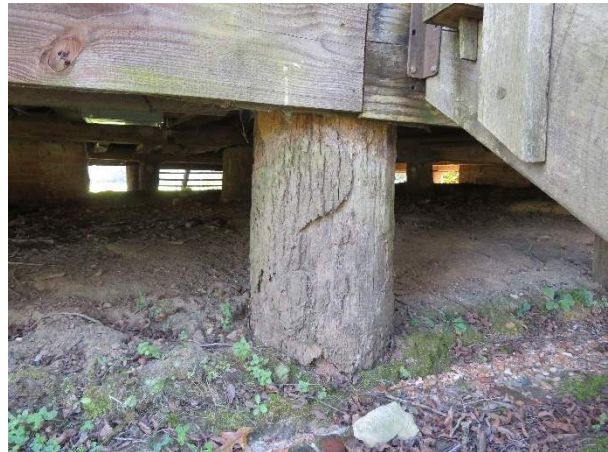
Photo 192. Pier P26.

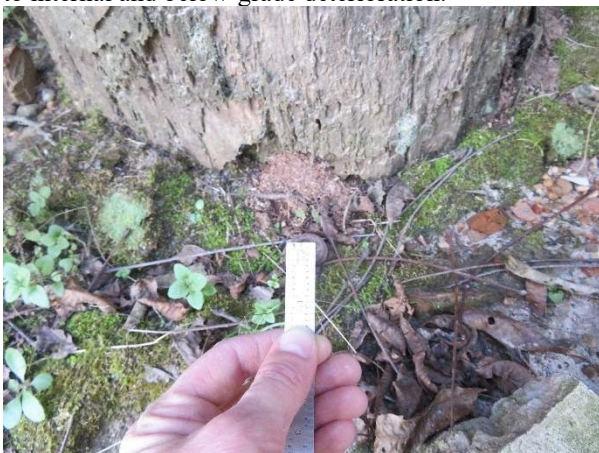
Photo 193. Deterioration at the base of Pier P26 with frass from a wood-boring insect.

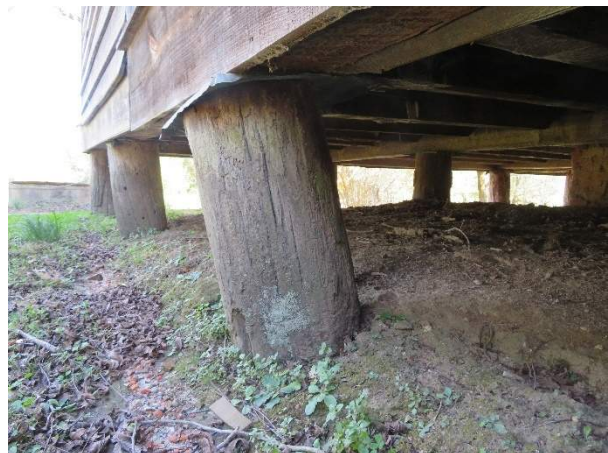
Photo 194. Pier P27 is displaced and has settled due to deterioration and is no longer supporting the perimeter beam.

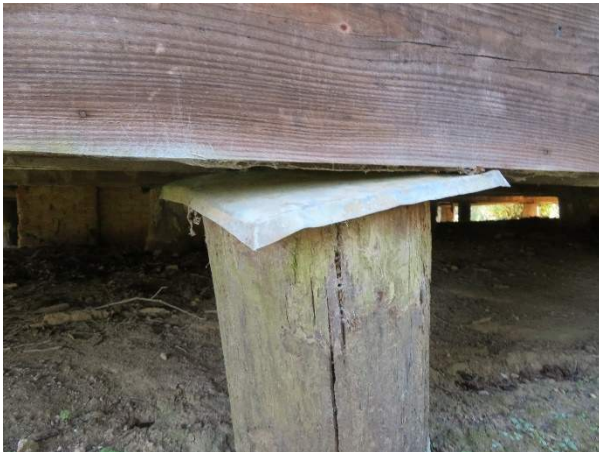
Photo 195. Pier 27 was no longer in contact with the perimeter beam.

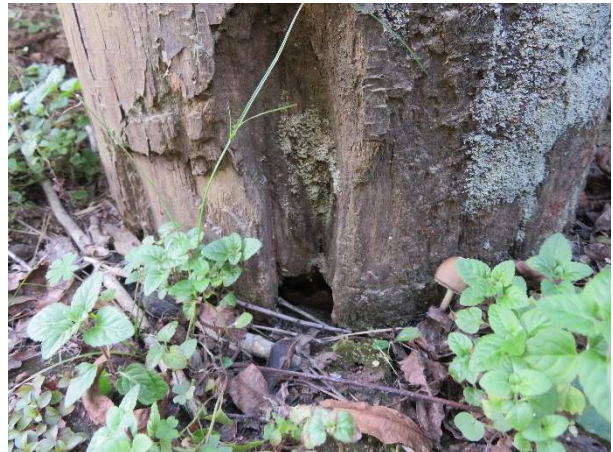
Photo 196. Deterioration of the core of Pier 27.

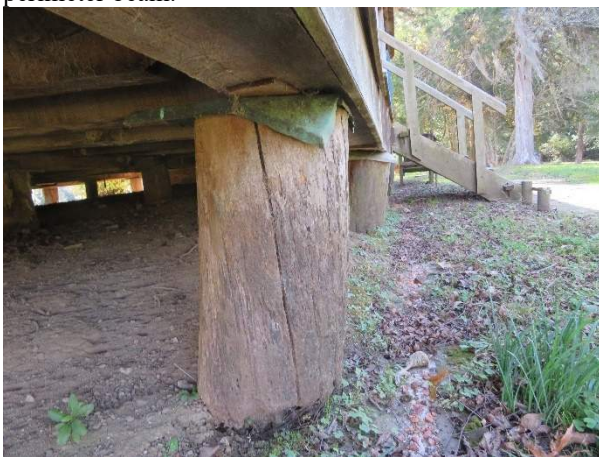
Photo 197. Pier P28, looking west.

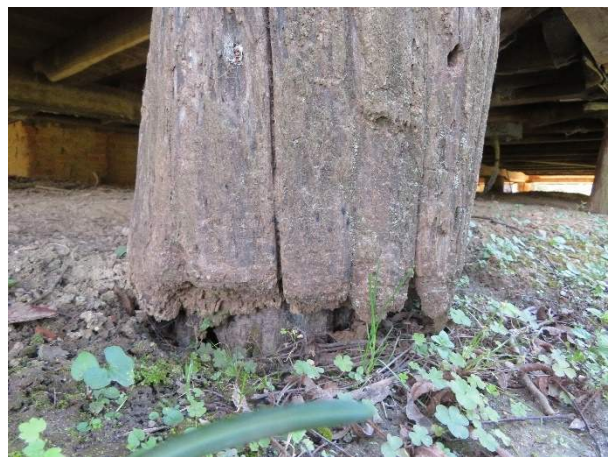
Photo 198. Deterioration and section loss at the base of Pier P28.

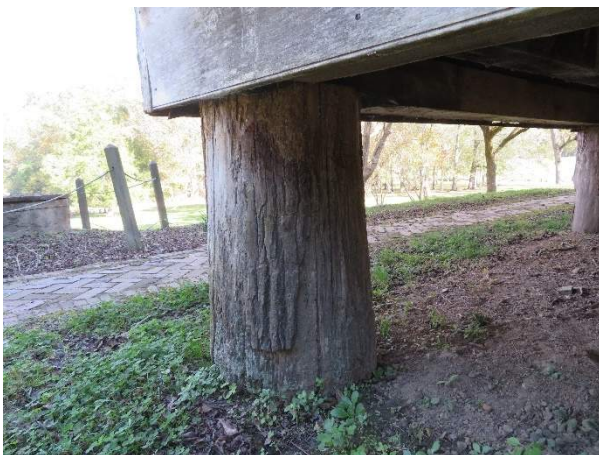
Photo 199. Pier P29 at northeast corner.

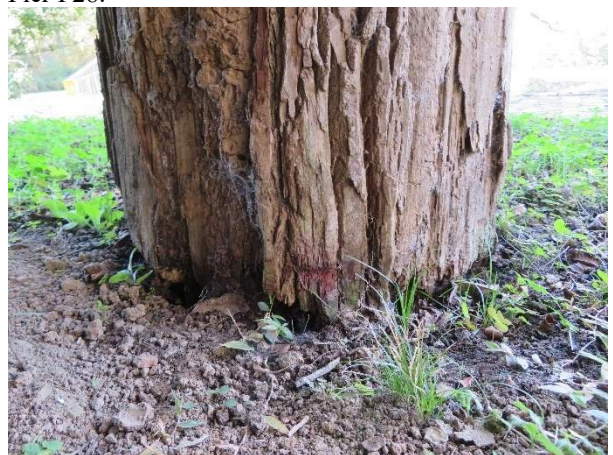
Photo 200. Deterioration and section loss at grade of Pier P29.

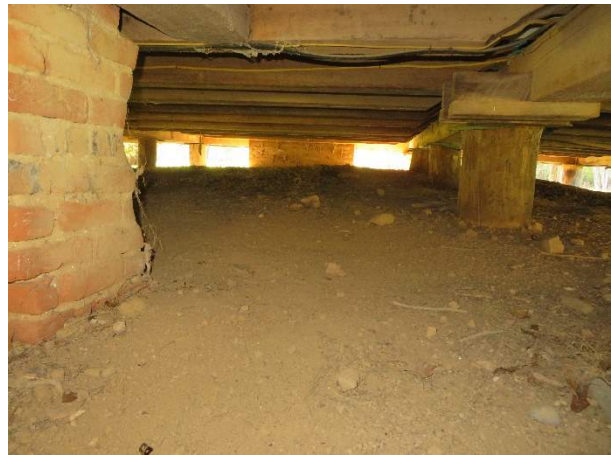
Photo 202. High point of crawlspace under Room 3 (103), looking west.

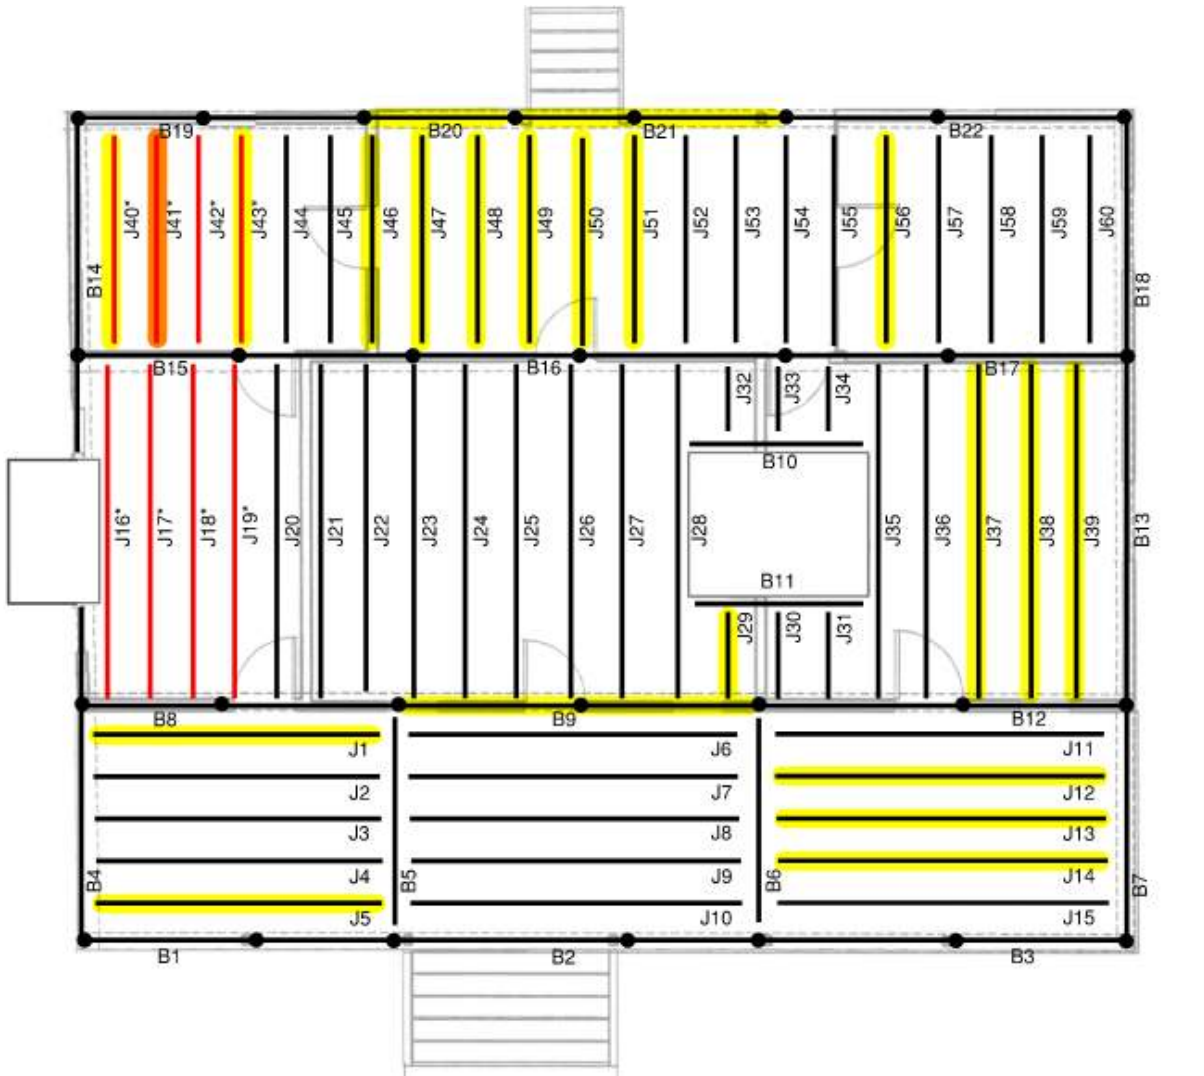
Figure 4. Schematic floor framing plan graphically showing condition ratings for the joists and beams: Good (green - not shown for clarity), Fair (yellow), Poor (orange), and Failed (red - none). Joists which may be repurposed historic members are indicated as red lines and with an asterisk (\*).

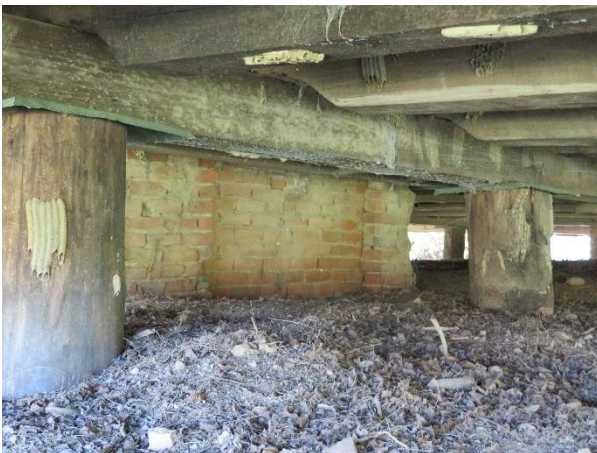
Photo 203. Floor framing system, showing foundation piers, beam, and joists, below Room 6 (106) looking south showing joists running north-south.

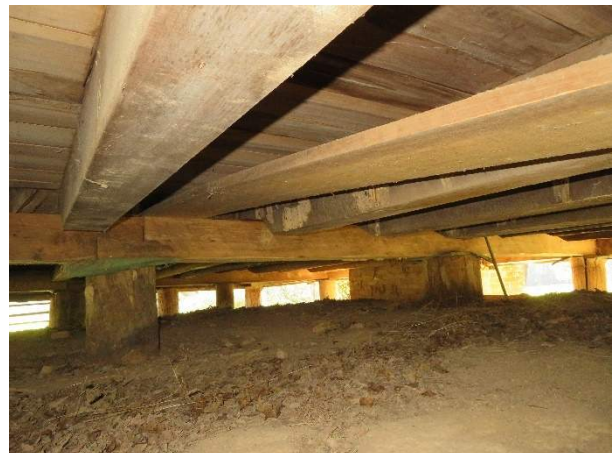
Photo 204. Floor framing system below Room 3 (103), looking southwest showing joists running north-south.

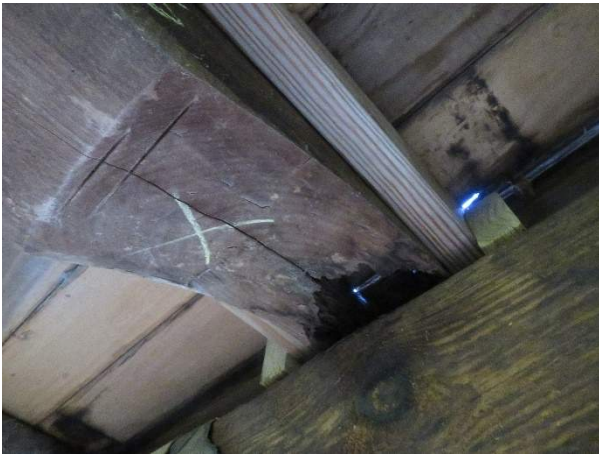
Photo 207. Joist J48, showing deterioration and sister repair at north bearing end. This is typical of several joists at the north.

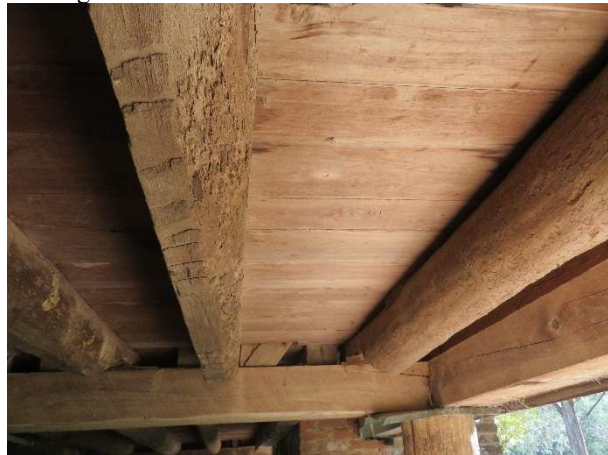
Photo 208. Reused or salvage puncheon Joists J40, J41, and J42 under Room 3 (103), looking south.

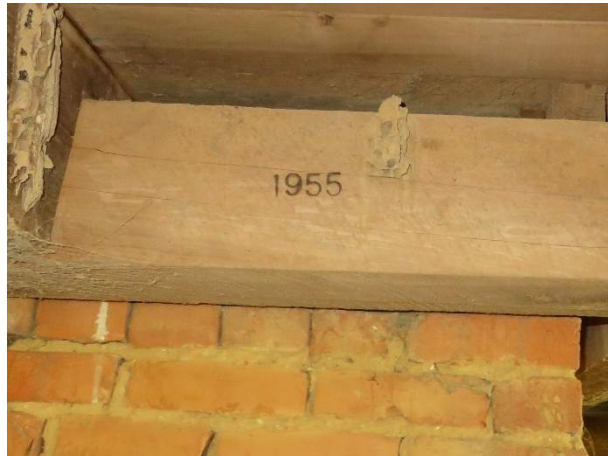
Photo 210. Typical identifying brand on Beam B11, indicating the member was replaced during the 1955 restoration.

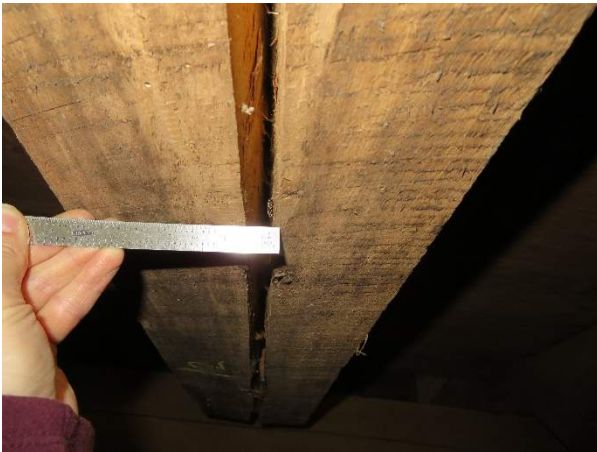
Photo 211. Deep checking of Joist J29.

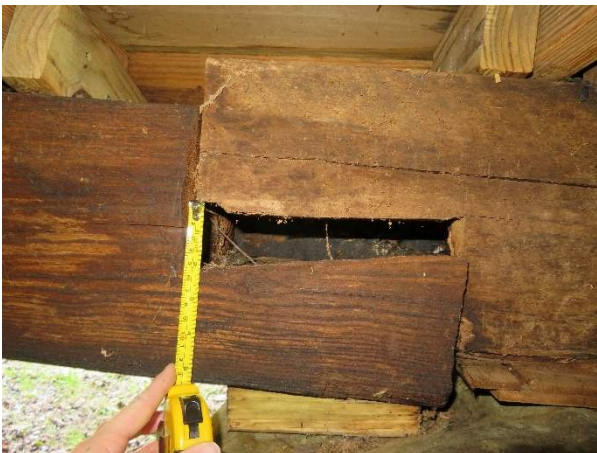
Photo 215. Beam B20 and B21 splice at Pier P25, showing 2-inch displacement due to settlement of the foundation piers at the northeast corner.

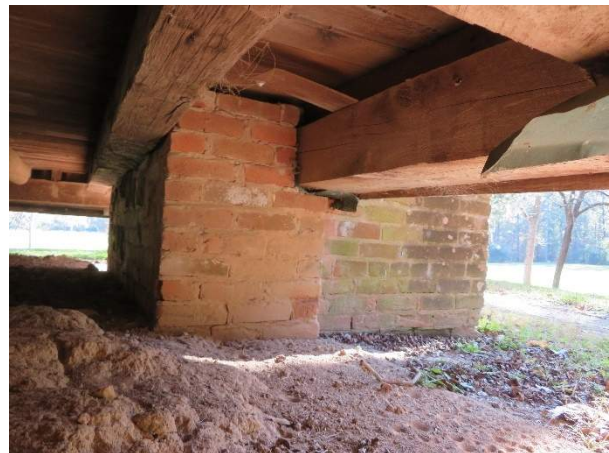
Photo 216. Beam B14 bearing end at west chimney with copper capillary break, looking south.

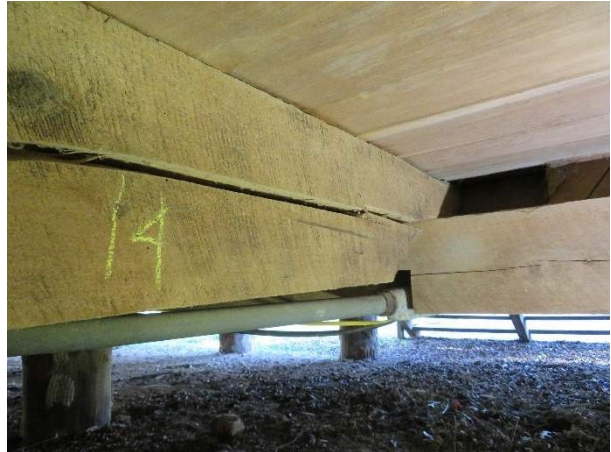
Photo 218. Beam B9 and Joist J24 modified for electrical conduit with distress at notch, looking south.

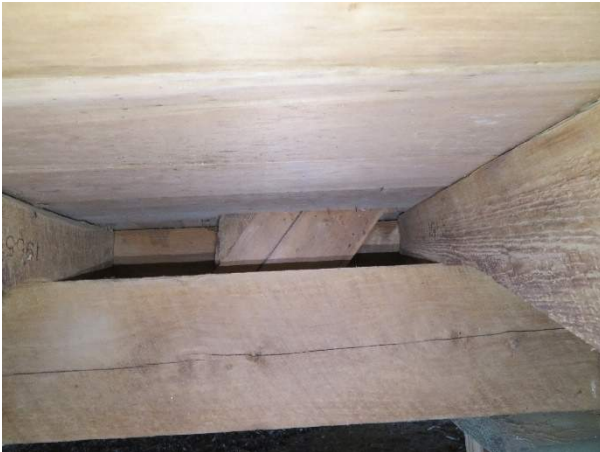
Photo 219. Wall member for the south wall of Room 2 (102), bearing on Beam B8. Note the joists on either end are branded with “1955”.

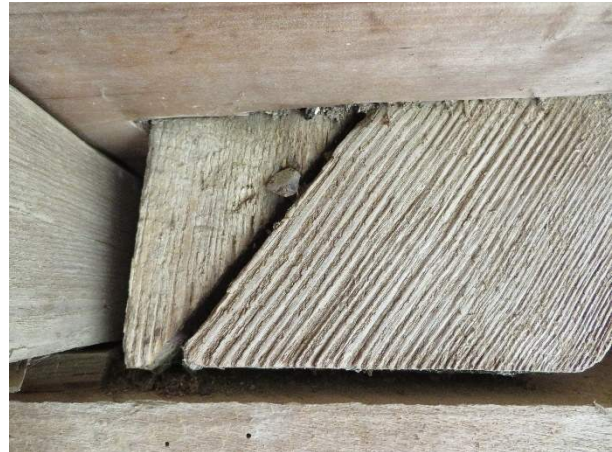
Photo 220. Wall members for north wall of Room 2 (102), near Joist J18 and bearing on Beam B15, with a forged nail.

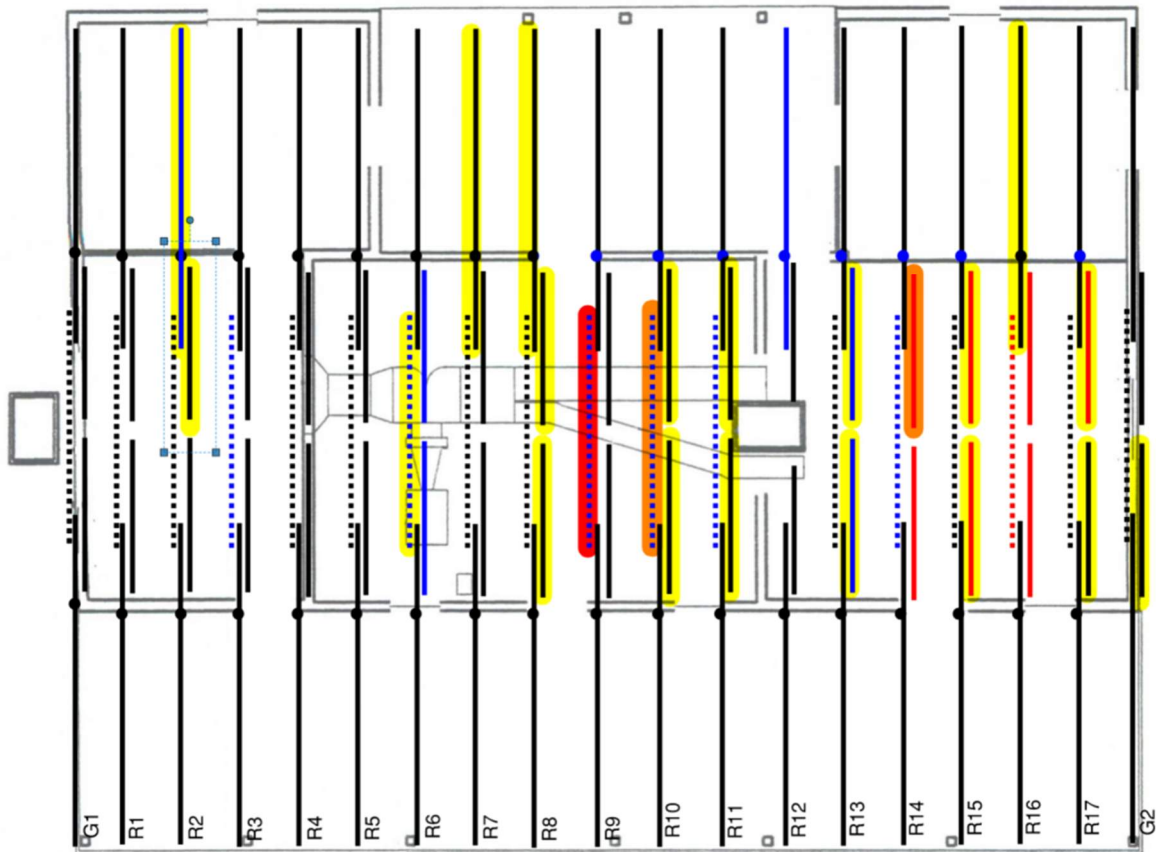
Figure 5. Schematic roof framing plan graphically showing condition ratings for the roof framing members.

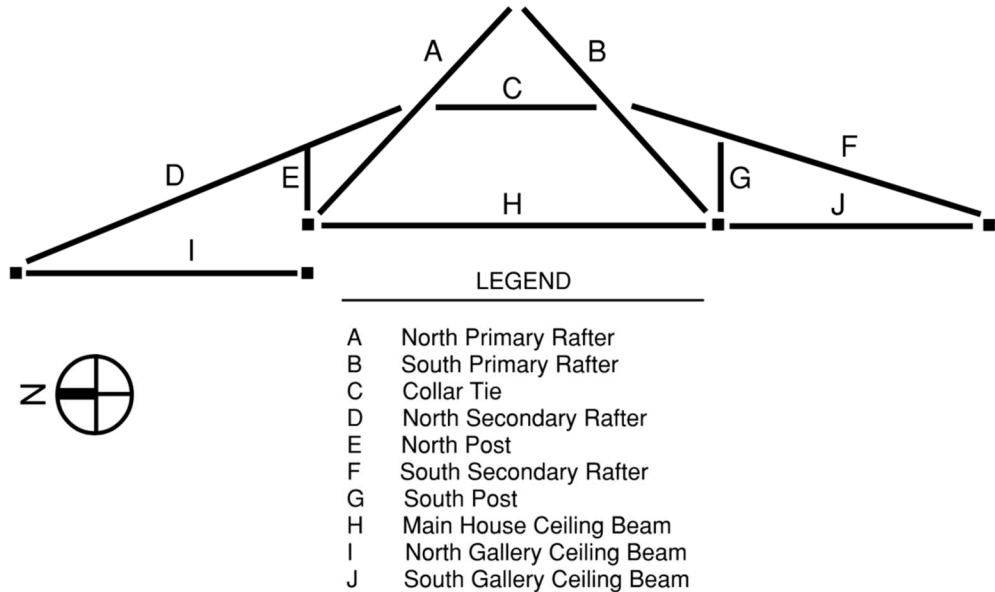
Figure 6. Roof framing diagram, identifying each structural member within a paired rafter bay, for reference in Table 3 narratives below.

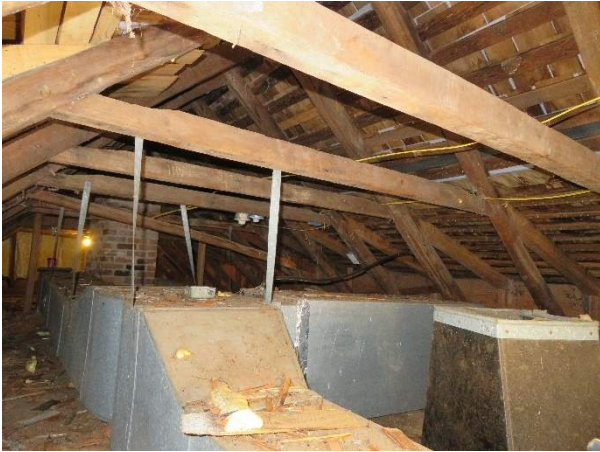
Photo 221. View in attic looking west.

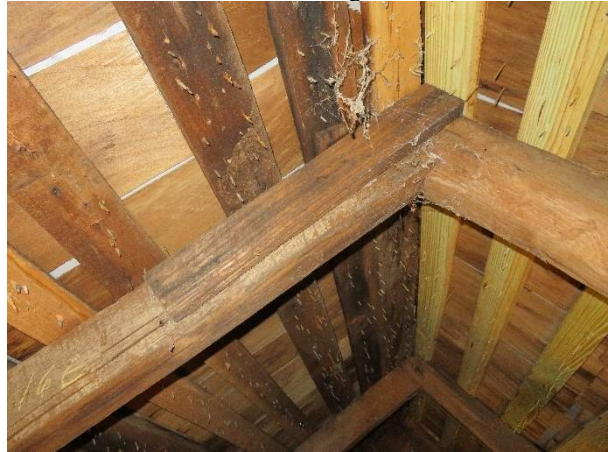
Photo 224. Repair to the scarf joint at the apex of Rafter Bay R2.

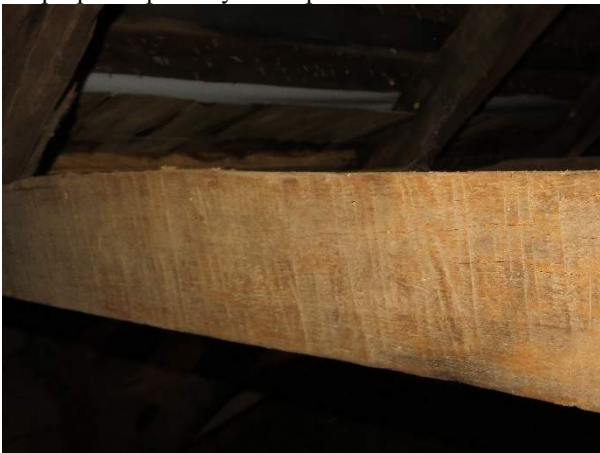
Photo 225. Vertical saw marks on the collar tie for Rafter Bay R7. On the topside of this member, "1955" is branded into the wood.
