National Park Service  
U.S. Department of the Interior

Natchez Trace Parkway  
Tupelo, MS

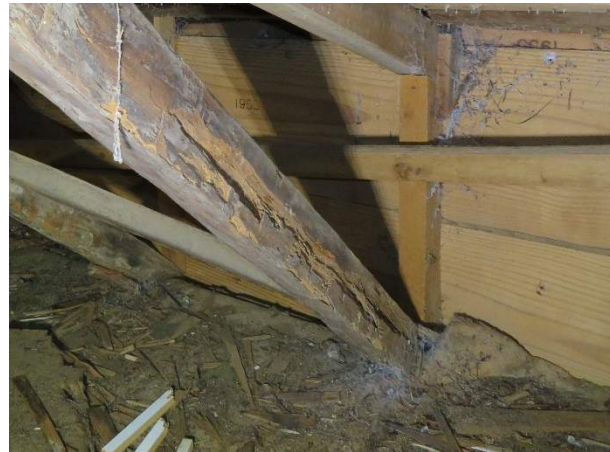
Photo 228. Termite damage at the bearing end of the south primary rafter in Rafter Bay R9.

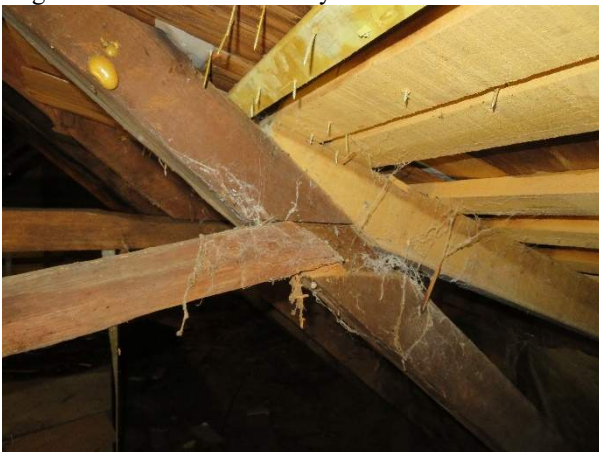
Photo 229. Failed collar tie at the north primary rafter in Rafter Bay R9.

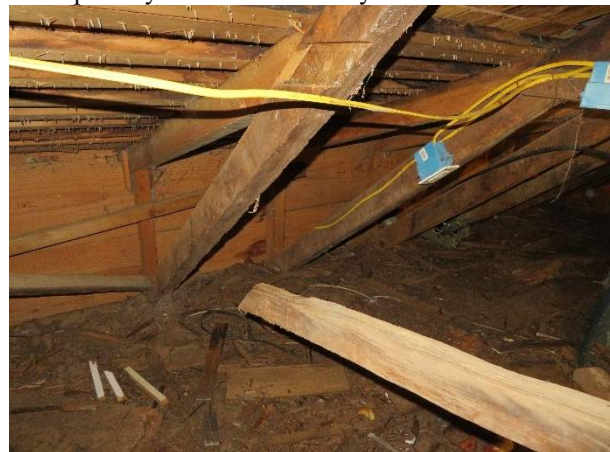
Photo 230. Failed collar tie at the south primary rafter in Rafter Bay R9.

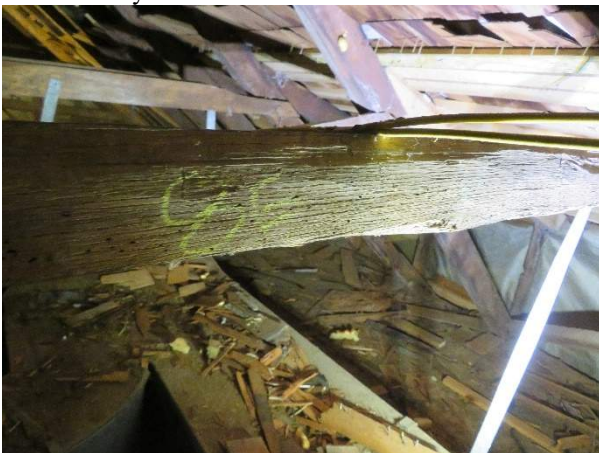
Photo 231. Wood boring insect damage to the collar tie in Rafter Bay R10.

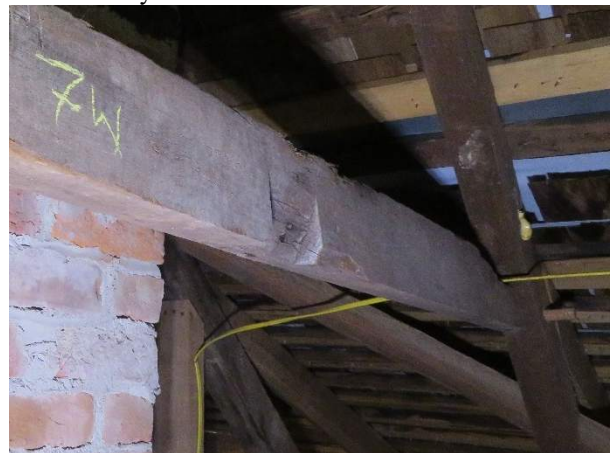
Photo 232. Repurposed timber used as a collar tie in rafter Bay R11.

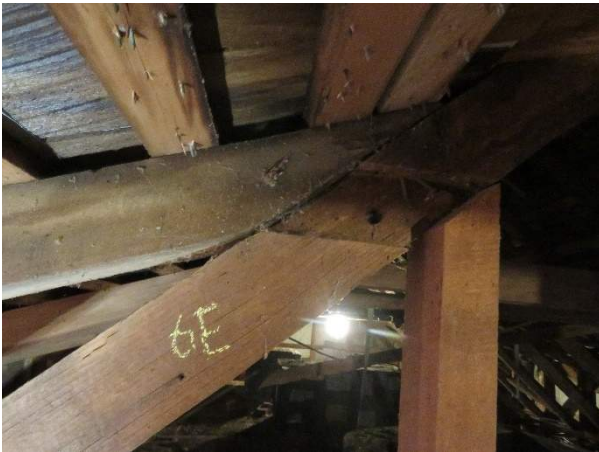
Photo 233. Missing collar tie replaced by a vertical post in Rafter Bay R12.

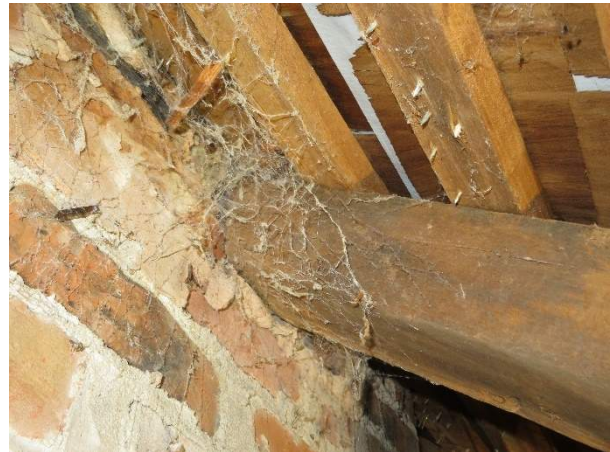
Photo 234. Primary rafter bearing at brick masonry chimney in Rafter Bay R12.

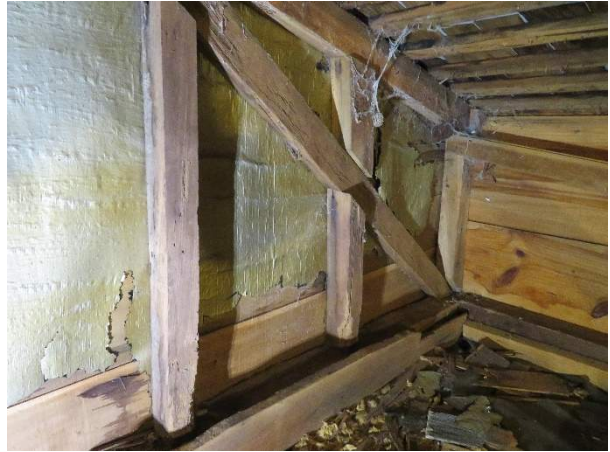
Photo 240. Squirrel damage to framing of east gable end wall.

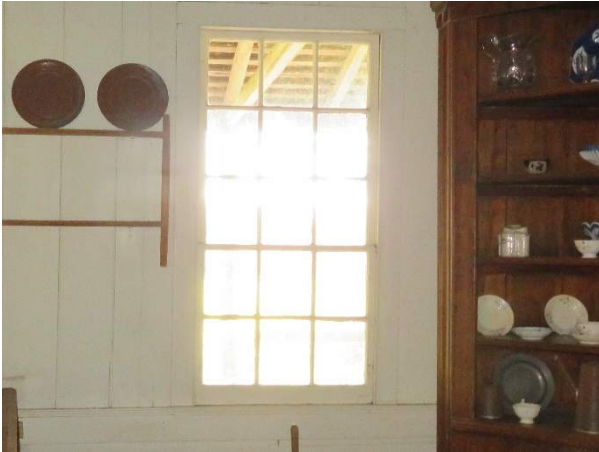
Photo 241. Window W100 from the interior.

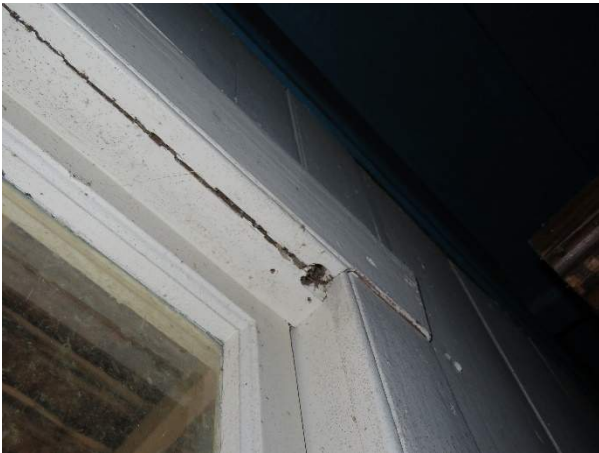
Photo 243. Detail of distress to head trim, showing separation of trim pieces and deterioration of wood.

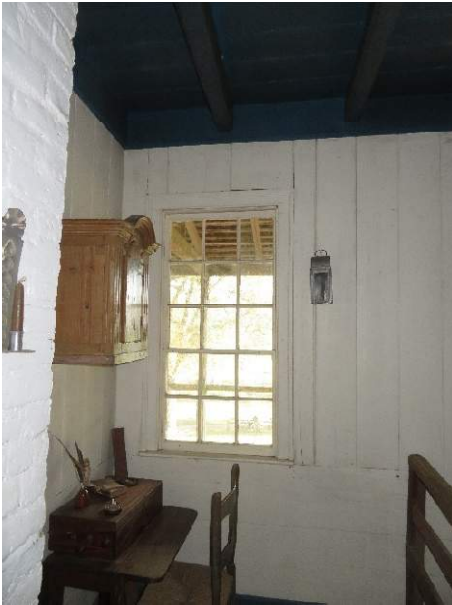
Photo 244. Window W101 from the interior.

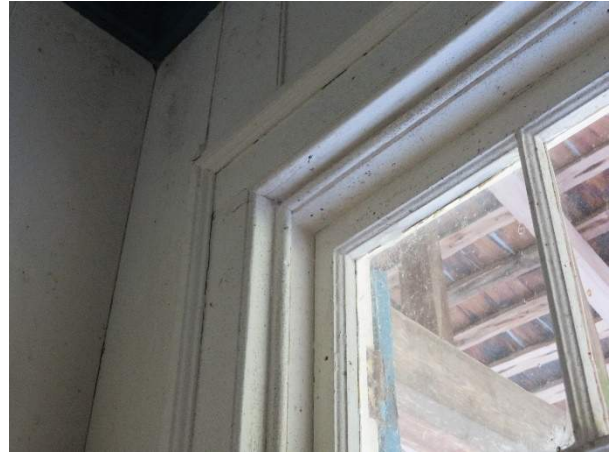
Photo 245. Jamb and head trim were in good condition.

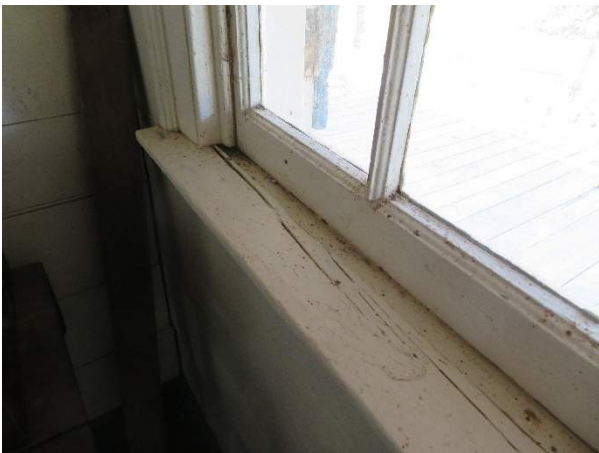
Photo 246. The interior sill had failed due to water damage.

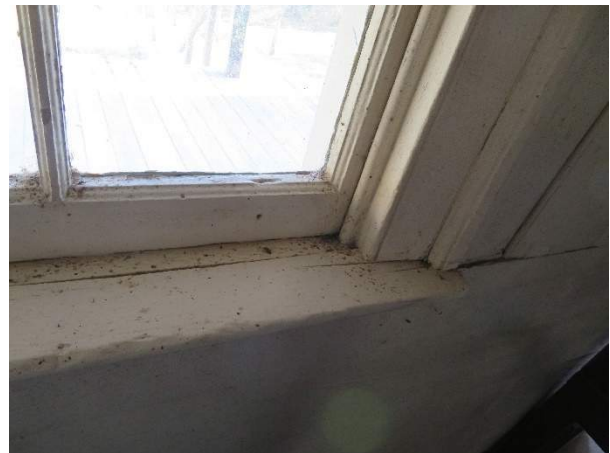
Photo 247. The interior sill had failed due to water damage.

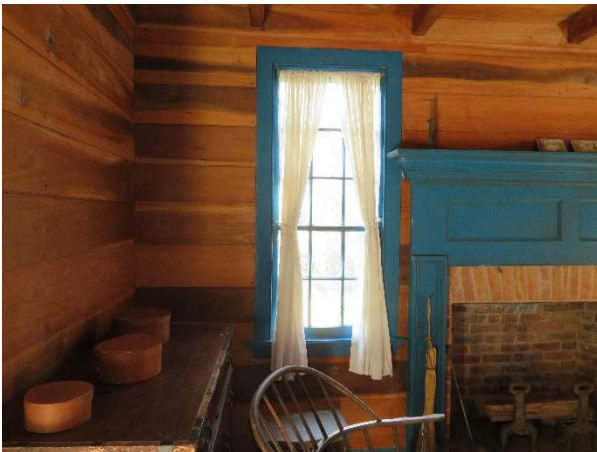
Photo 248. Window W200 from the interior.

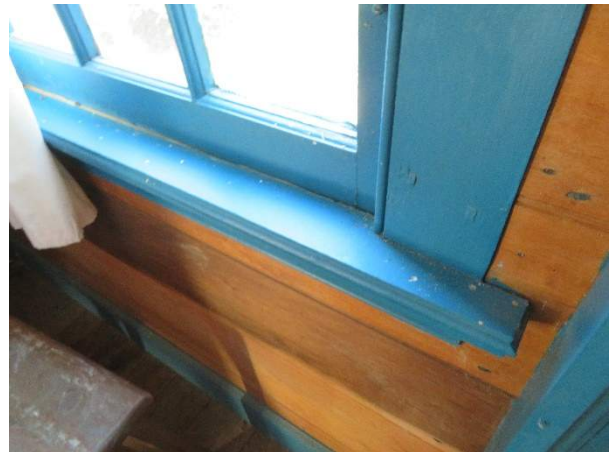
Photo 249. The interior sill of window W200 was in good condition, despite the poor condition of the exterior sill.

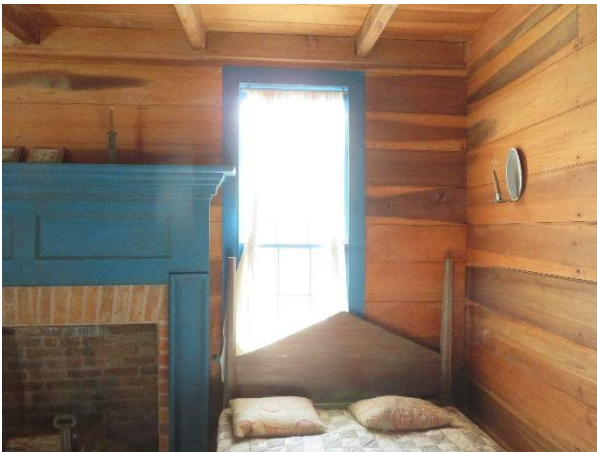
Photo 250. Window W201 from the interior.

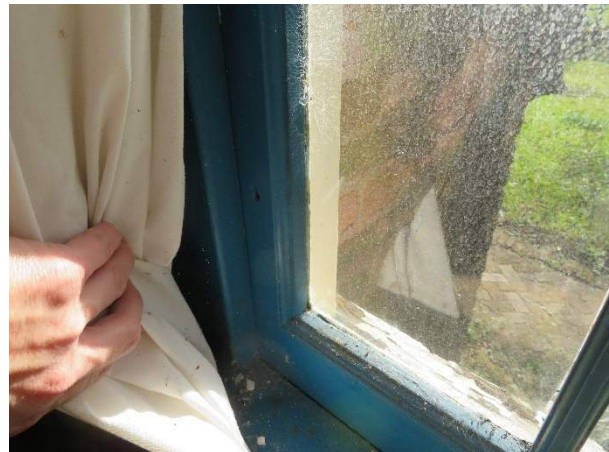
Photo 251. The interior of the lower sash and sill were in good condition, despite the poor condition of the window exterior.

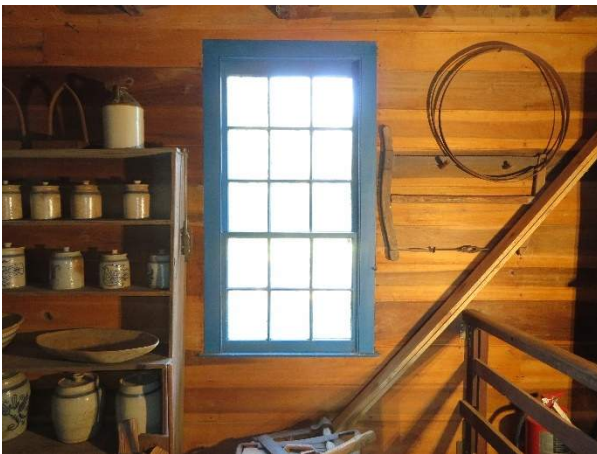
Photo 252. Window W300 from the interior.

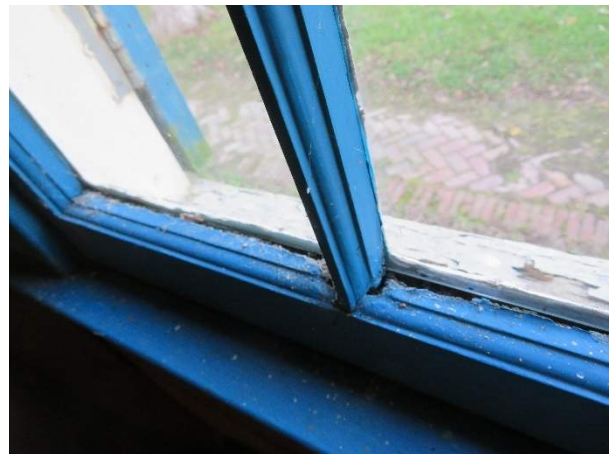
Photo 253. Deterioration of the interior muntin and rail of the lower sash.

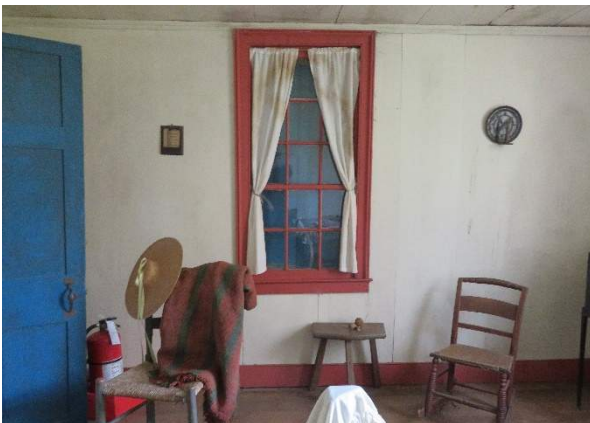
Photo 254. Window W600 from the interior.

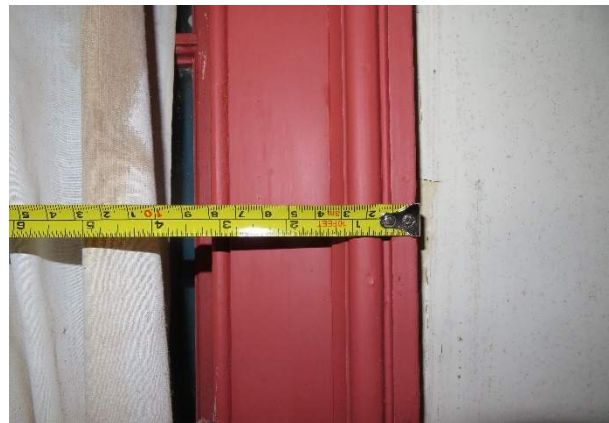
Photo 255. Jamb trim at Window W600 was in good condition.

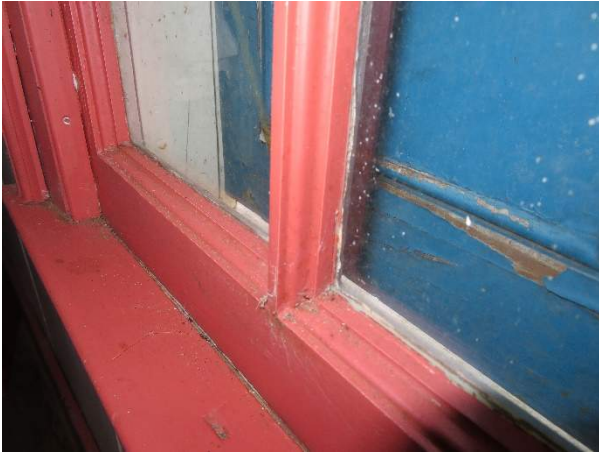
Photo 256. The interior muntins and rails of the lower sash were in good condition.

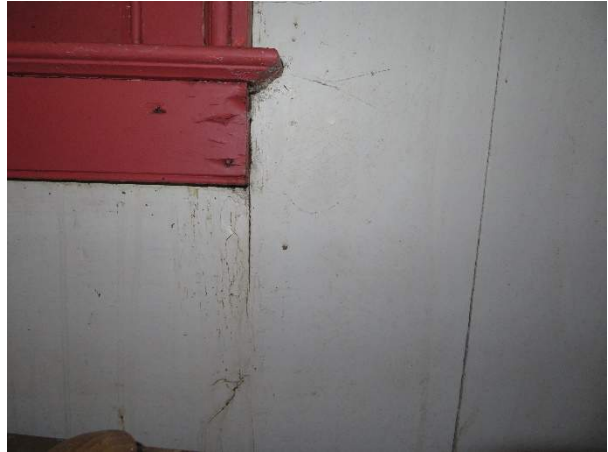
Photo 257. Evidence of water intrusion and water damage at the lower right corner of the window.

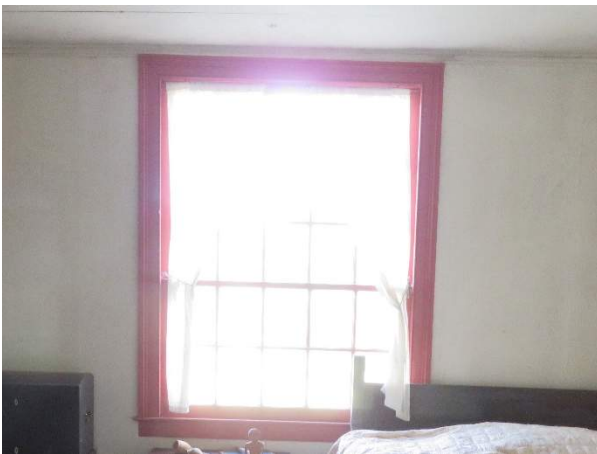
Photo 258. Window W601 from the interior.

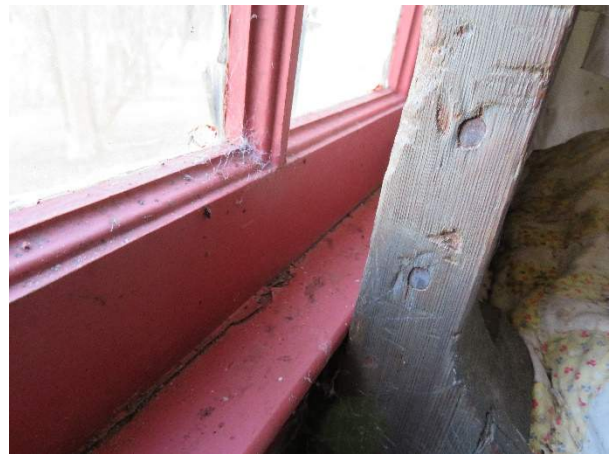
Photo 259. Water damage and wood deterioration at the interior sill.

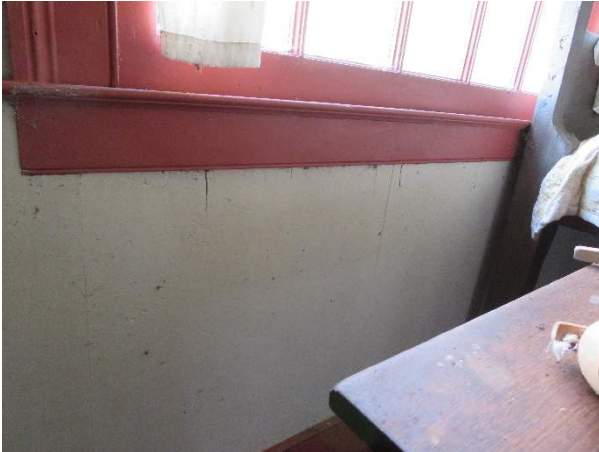
Photo 260. Evidence of water intrusion at the wood panels below the window.

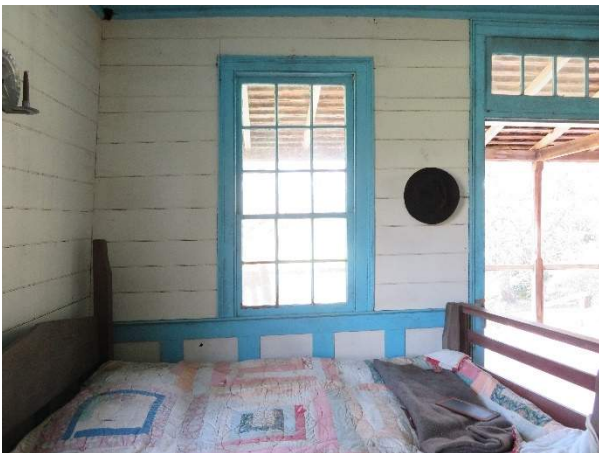
Photo 261. Window W700 from the interior.

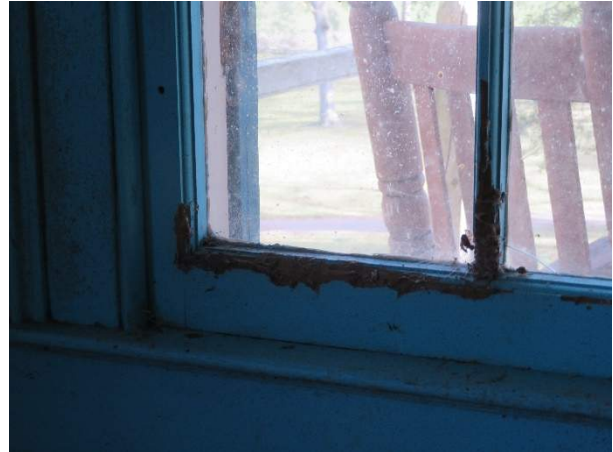
Photo 264. Patch repairs to the interior of the lower sash.

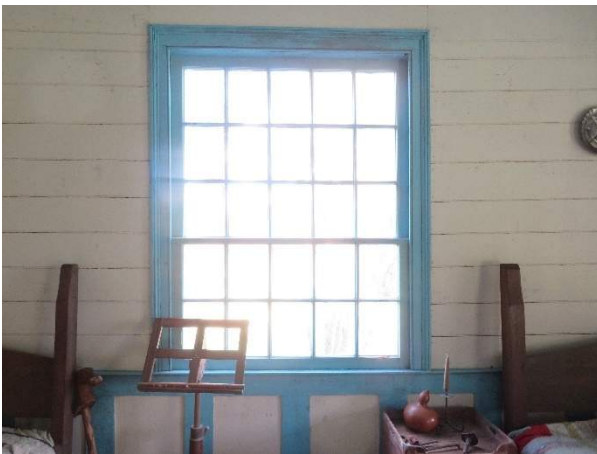
Photo 265. Window 701 from the interior.

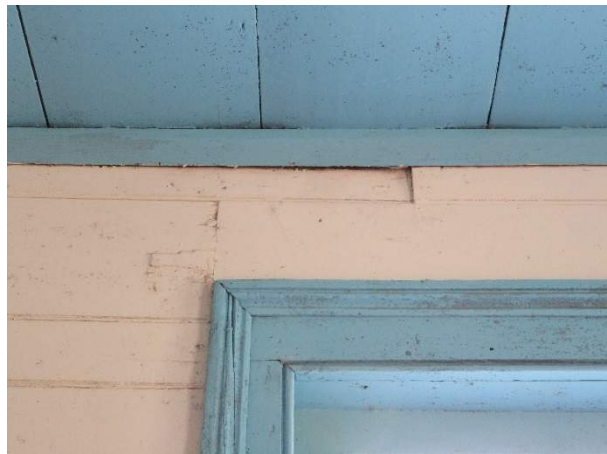
Photo 266. Head and jamb trim were in good condition.

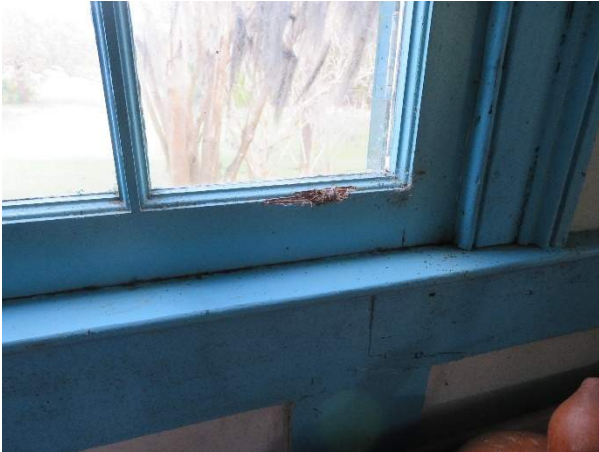
Photo 267. Damage to lower sash, potentially from squirrels.

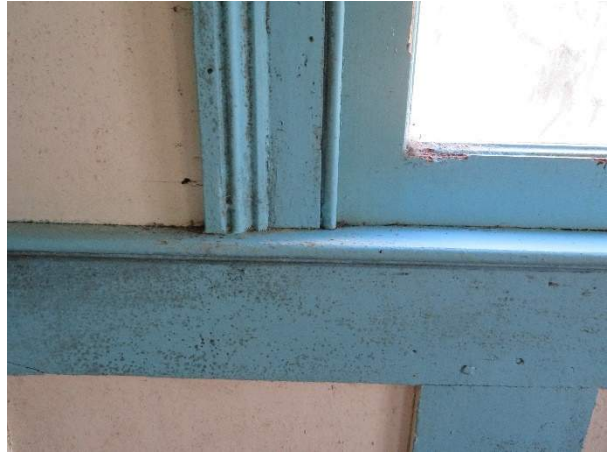
Photo 268. Damage to lower sash, potentially from squirrels. Note the mildew on the painted surfaces.

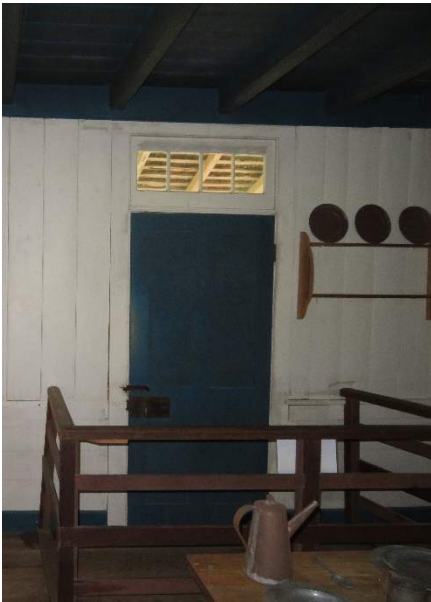
Photo 269. Door D100 from the interior.

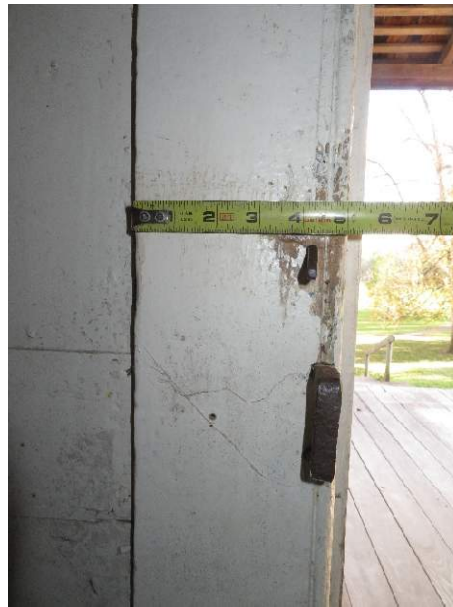
Photo 270. Jamb catch for the lift-latch and rim lock, showing damage to the finishes on the jamb trim.

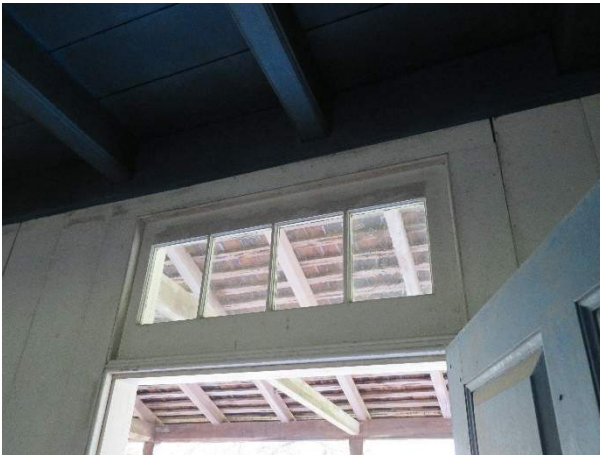
Photo 271. The transom of Door D100.

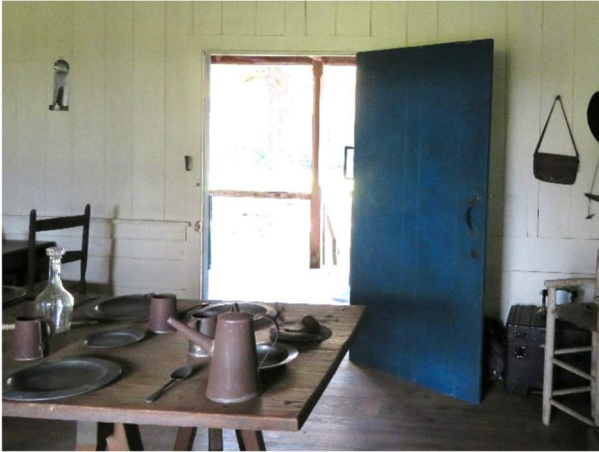
Photo 272. Door D101 from the interior.

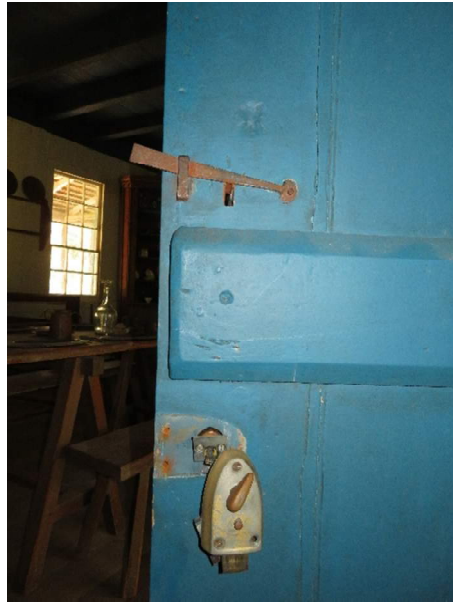
Photo 273. Interior door hardware, showing lift-latch and broken rim lock.

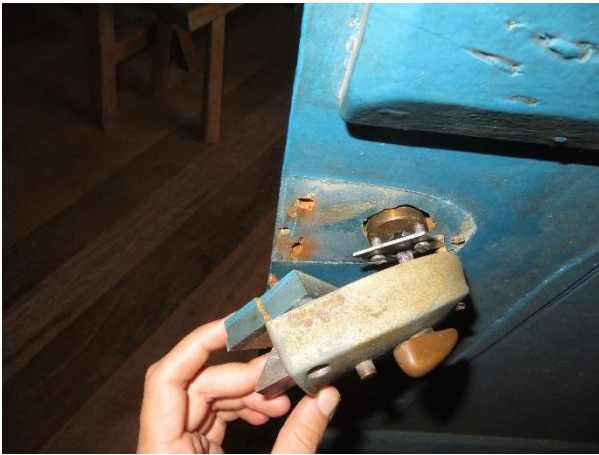
Photo 274. Broken rim lock.

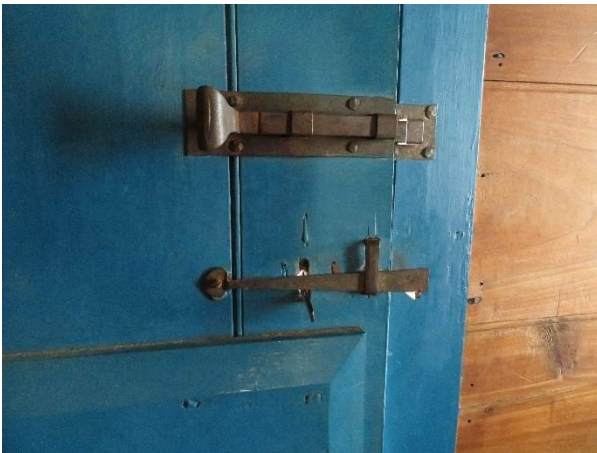
Photo 275. Interior handle and locking mechanisms.

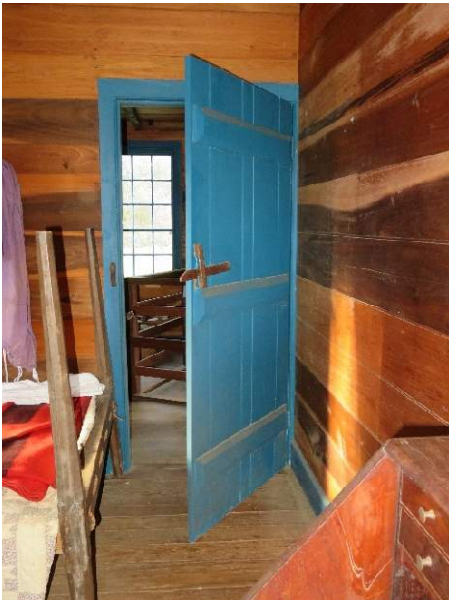
Photo 276. Door D201, from Room 2 (102).

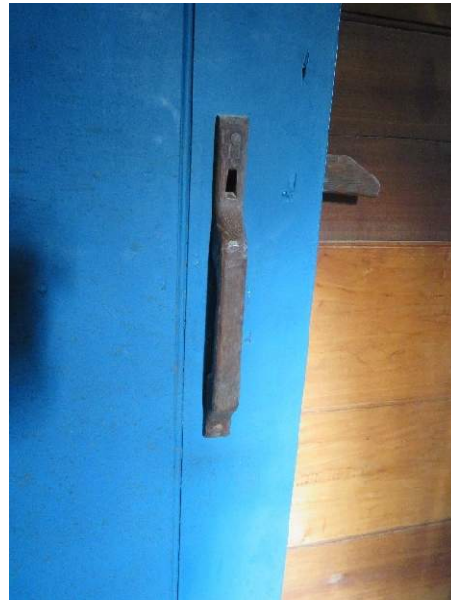
Photo 277. Damaged exterior handle of Door D201.

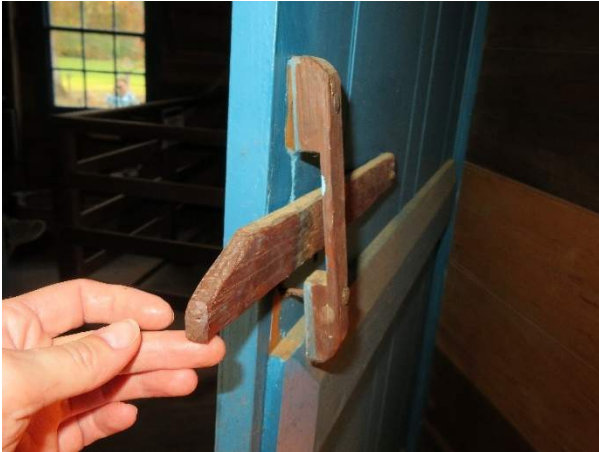
Photo 278. Loose and damaged interior hardware of Door D201.

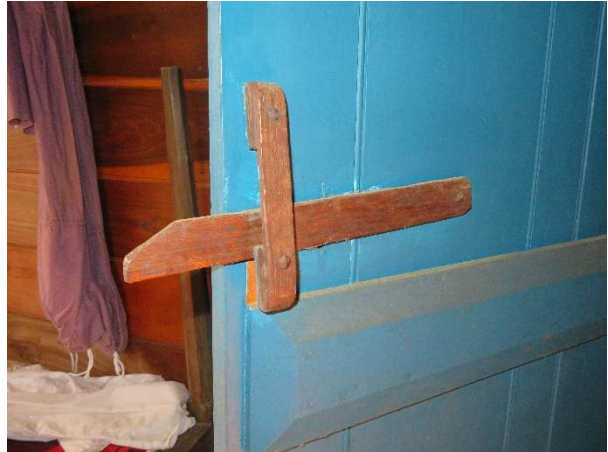
Photo 279. Loose and damaged interior hardware of Door D201.

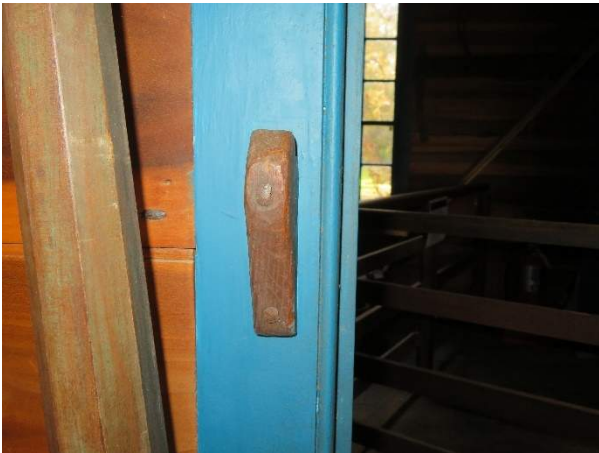
Photo 280. Latch catch on the jamb.

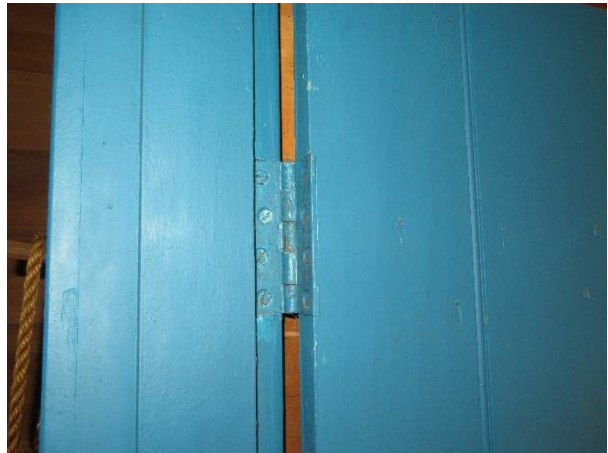
Photo 281. Butt hinges for Door D201.

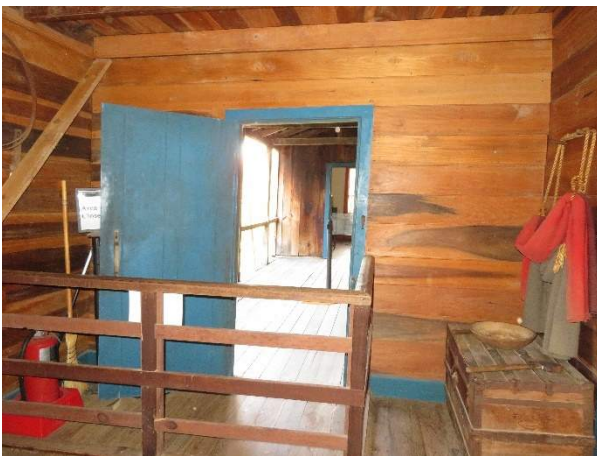
Photo 282. Door D300 from the interior.

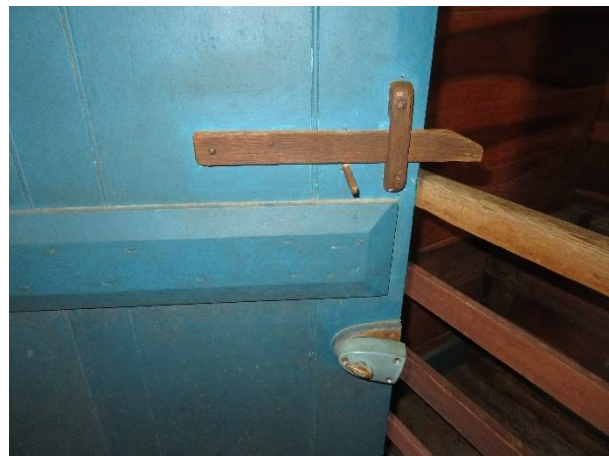
Photo 283. Interior hardware, showing the lift latch and the damaged rim lock.

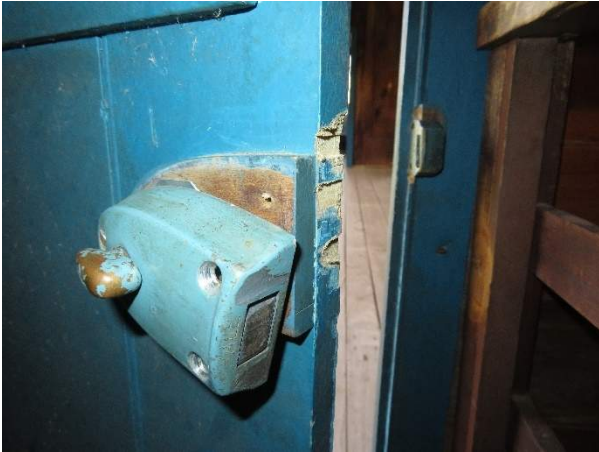
Photo 284. Damaged and partially disengaged rim lock, with damage to the edge of the door where it meets the jamb strike plate.

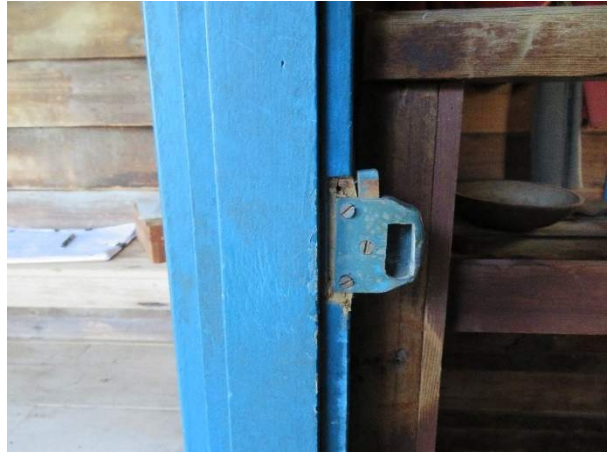
Photo 285. The strike plate at the jamb, showing abandoned screw holes from the strike plate being adjusted. The strike plate is original to the lock.

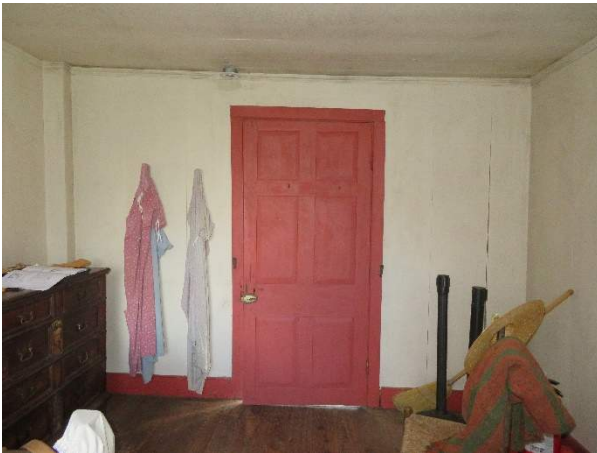
Photo 286. Door D600 from the interior.

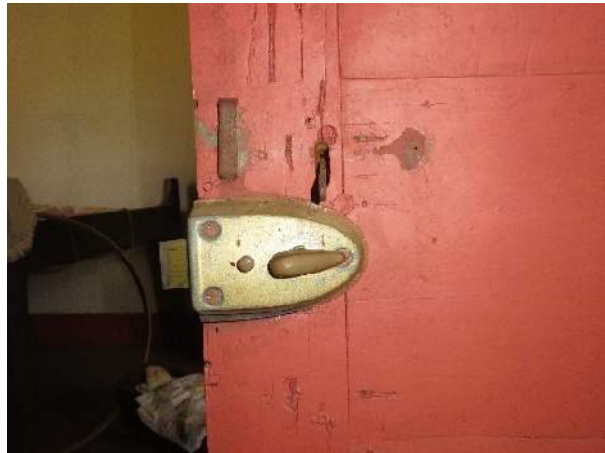
Photo 287. Lacquered metal rim lock, missing interior lift-latch components, and damage to the door stile.

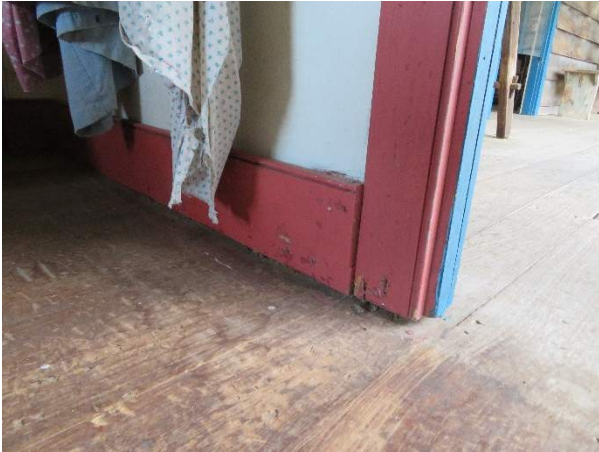
Photo 288. Minor deterioration of the bottom of the jamb trim, where the floor slope creates a gap at the base of the wall.

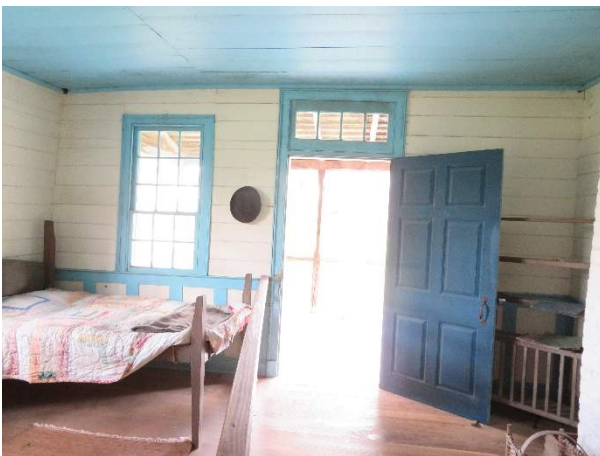
Photo 289. Door D700 from the interior.

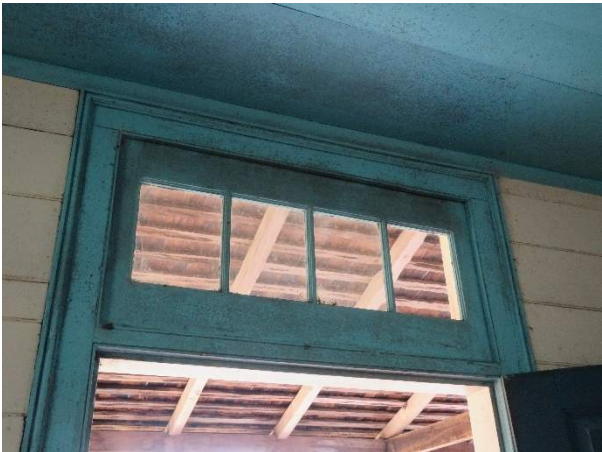
Photo 291. Transom of Door D700.

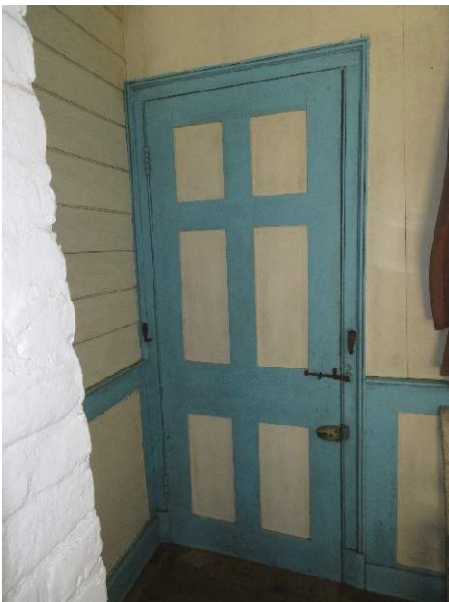
Photo 292. Door D701 from the interior.

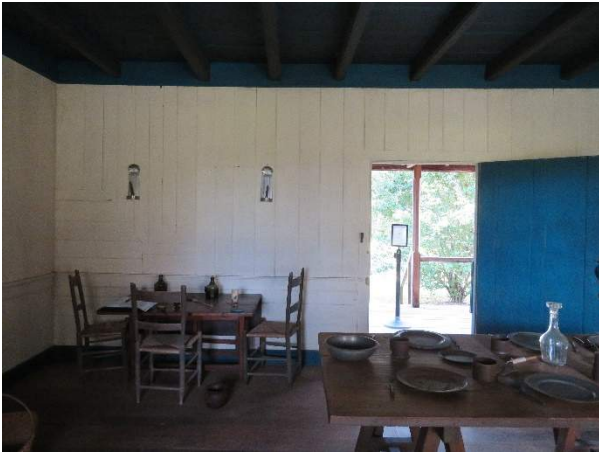
Photo 294. Room 1 (101), looking south towards the primary entry (Door D101).

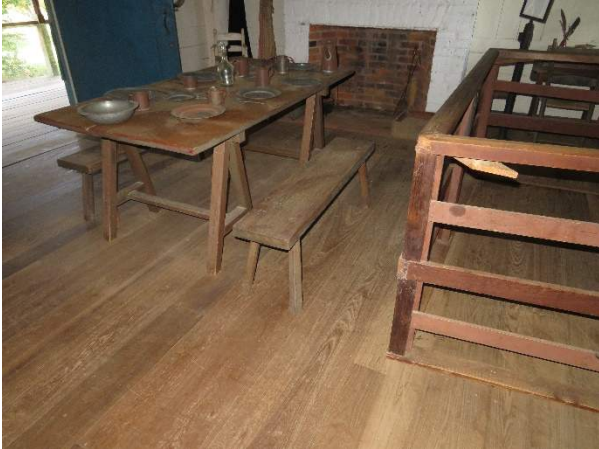
Photo 296. Wear of the flooring around the dining table, looking east.

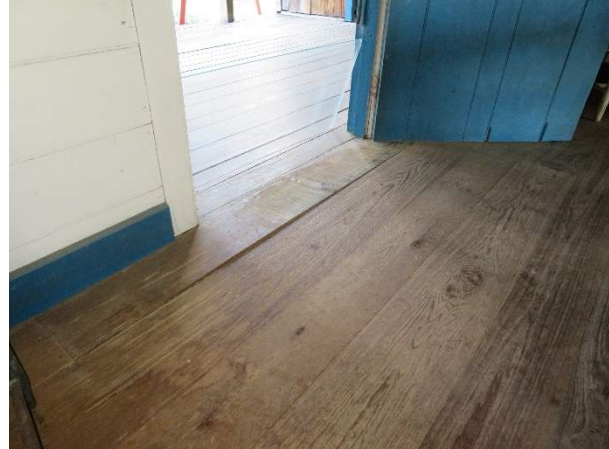
Photo 297. Heaving and abrasion of the floor boards at the threshold of Door D101.

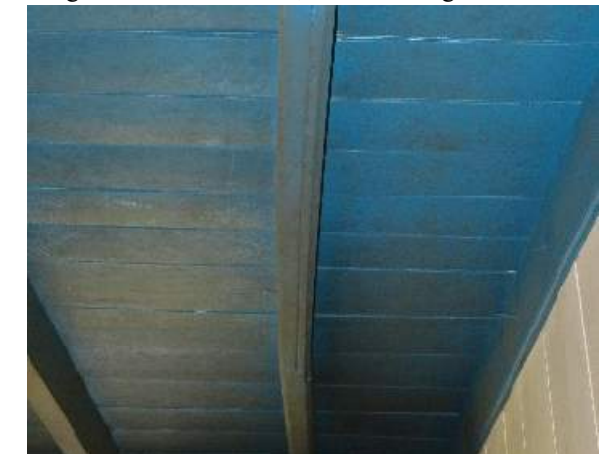
Photo 305. Out of plumb ceiling beam splice, as depicted on the 1940 HABS drawings.

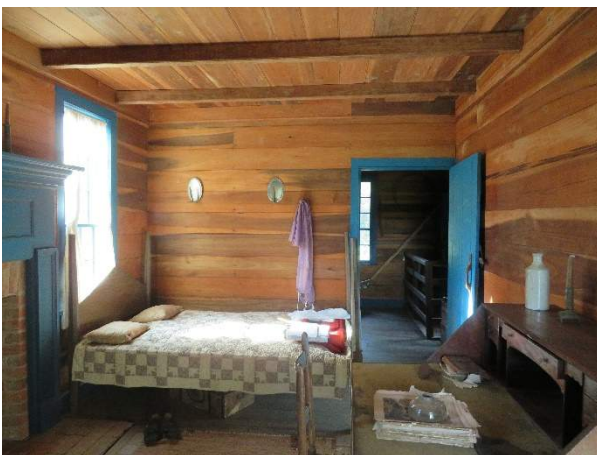
Photo 306. Room 2 (102), looking north.

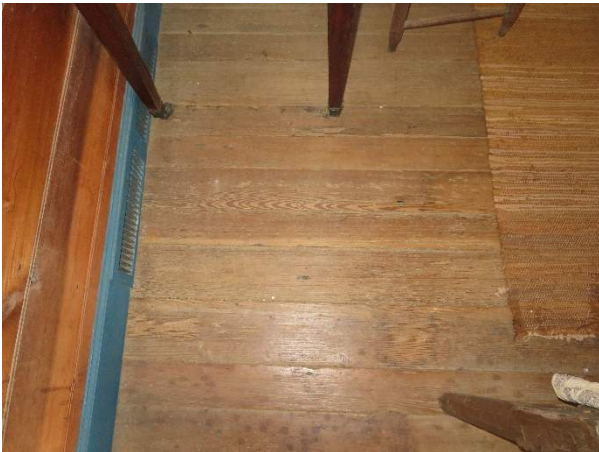
Photo 308. Minor areas of wear to the flooring.

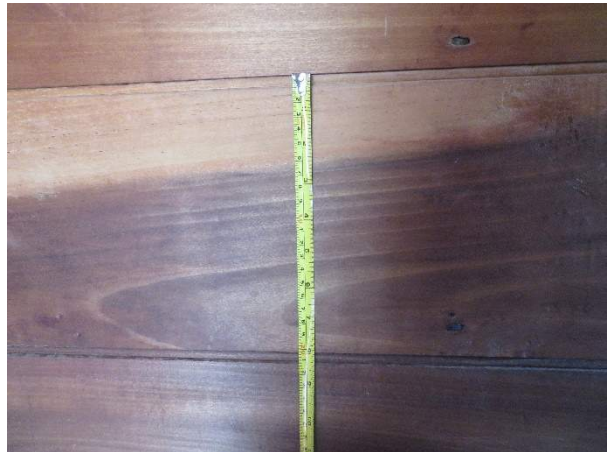
Photo 309. Horizontal wall boards with beaded edge detailing likely date to the 1955 restoration.

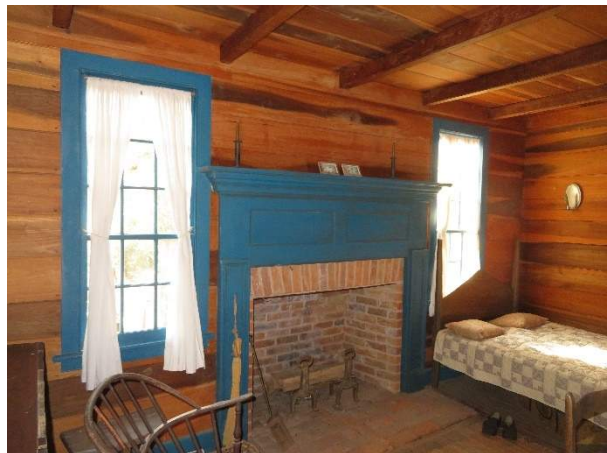
Photo 313. Fireplace mantel on the west wall.

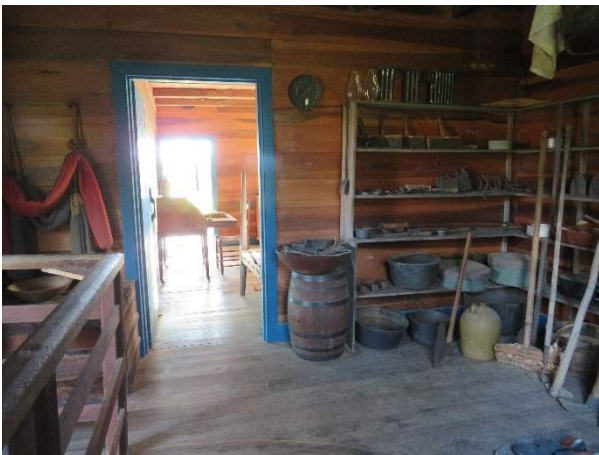
Photo 314. Room 3 (103), looking east.

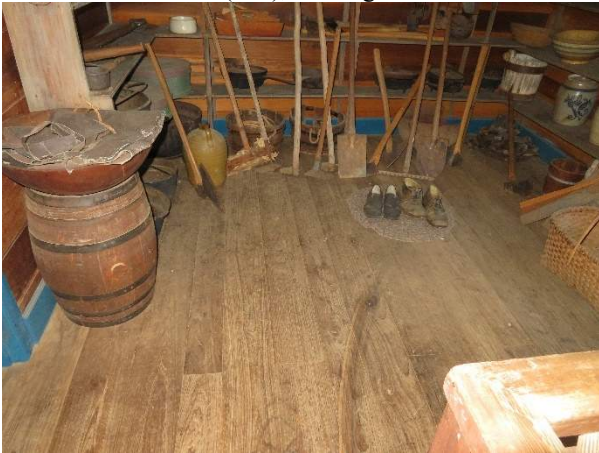
Photo 316. Evidence of minor wear on the flooring.

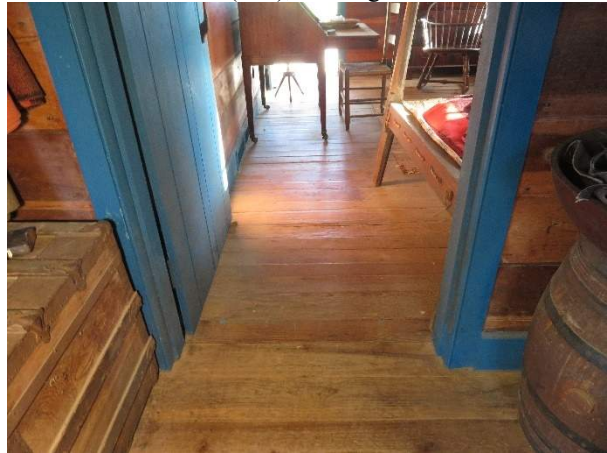
Photo 317. Wear on the flooring at the threshold to Room 2 (102).

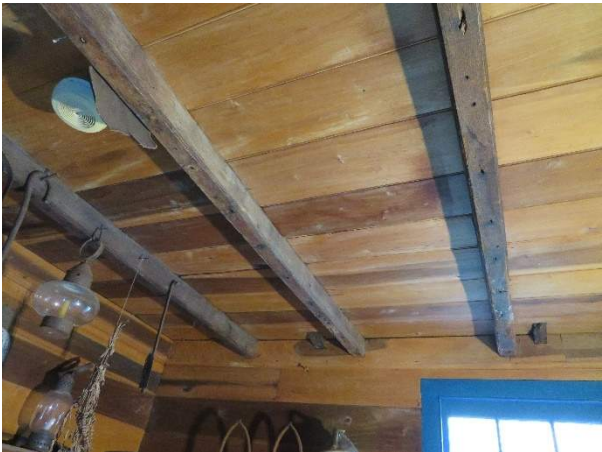
Photo 318. Ceiling planks and exposed beams.

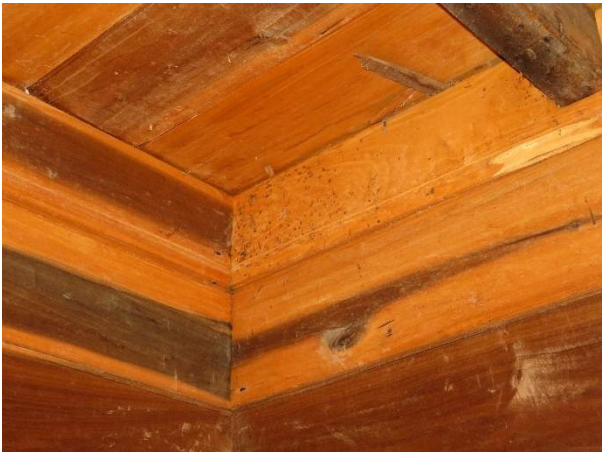
Photo 319. Ceiling moulding.

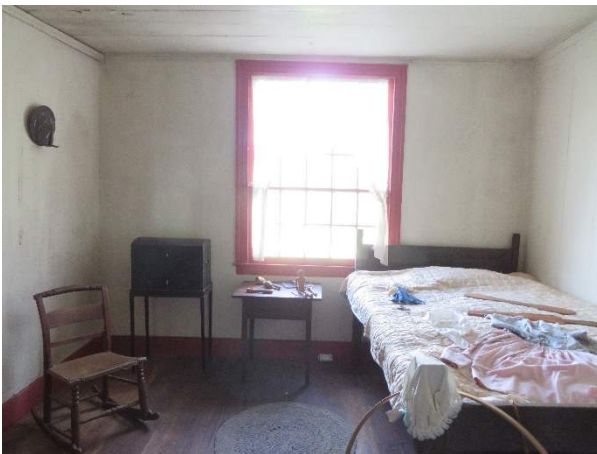
Photo 320. Room 6 (106), looking east.

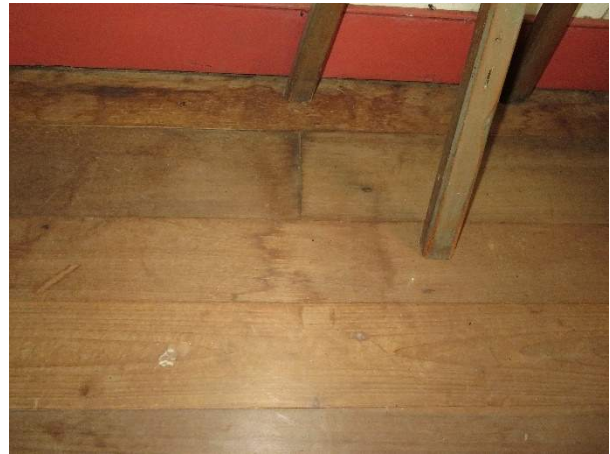
Photo 323. Water stains on the flooring at the north wall under Window W600.

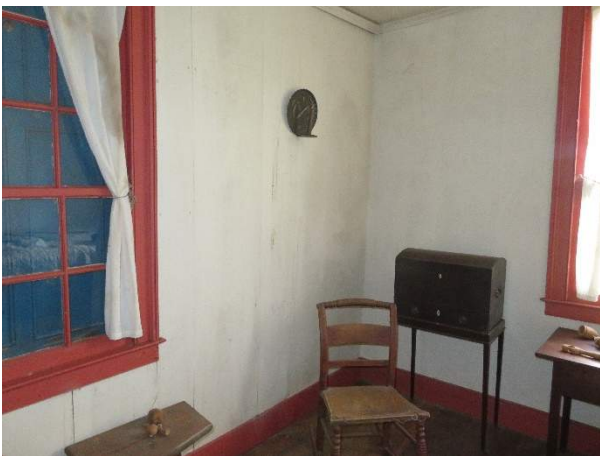
Photo 324. Wall boards in the northeast corner.

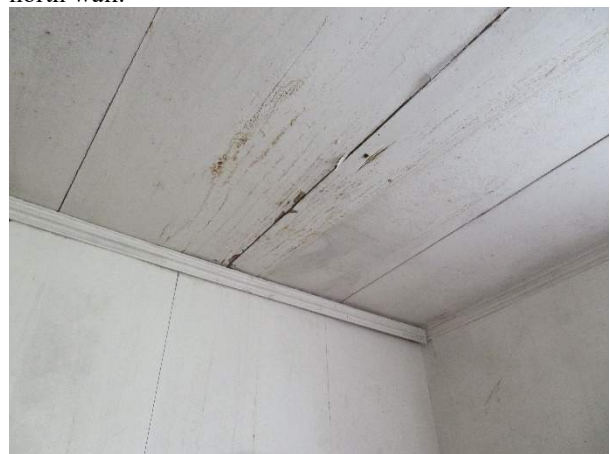
Photo 327. Water damage to the ceiling boards.

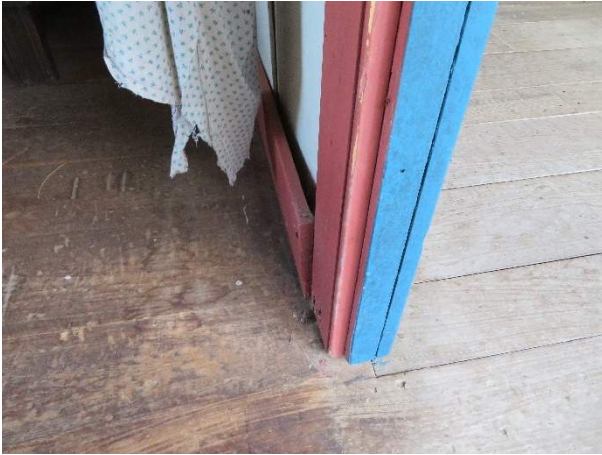
Photo 328. Displaced and loose base board near Door D600.

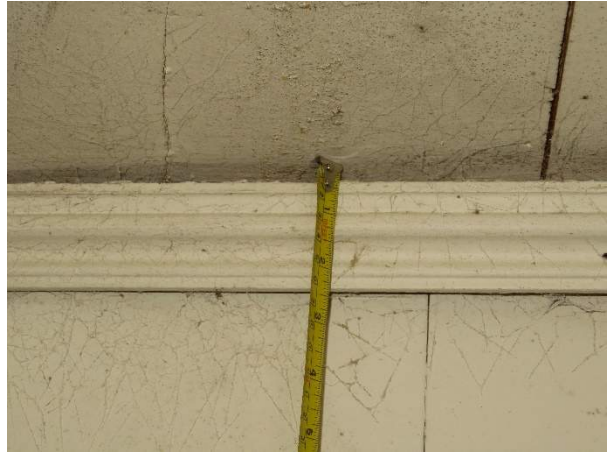
Photo 329. Displaced and loose ceiling moulding.

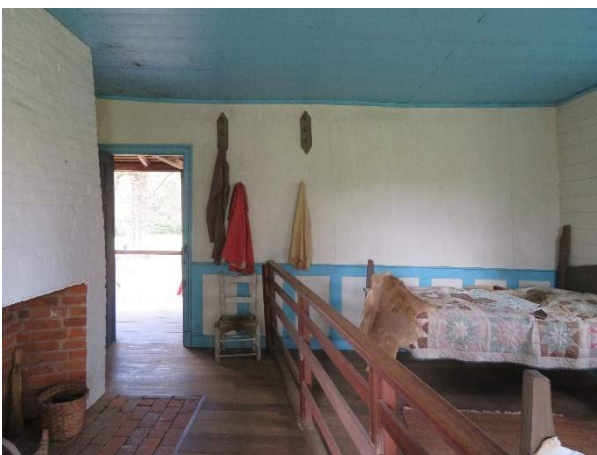
Photo 330. Room 7 (107), looking north.

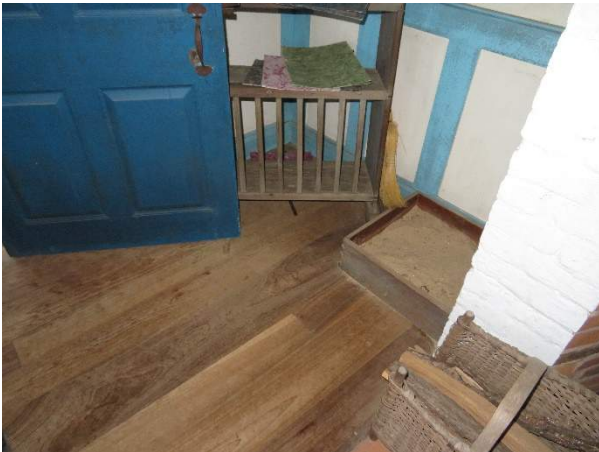
Photo 332. Wear to the flooring around Door D700.

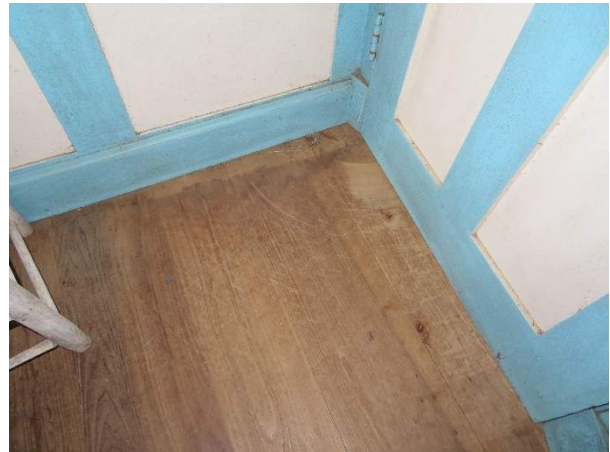
Photo 333. Wear to the flooring from abrasion by Door D701.

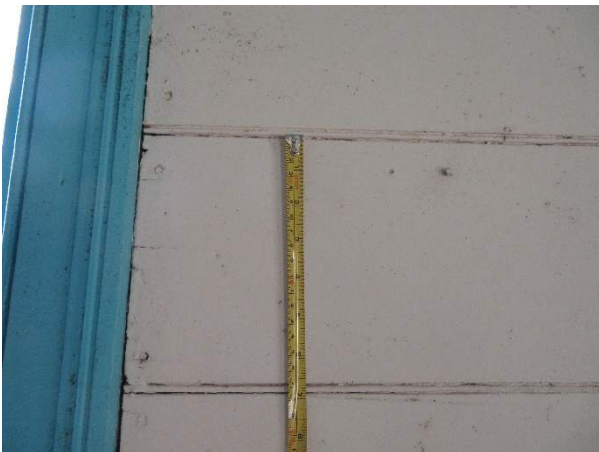
Photo 334. Typical horizontal wall board.

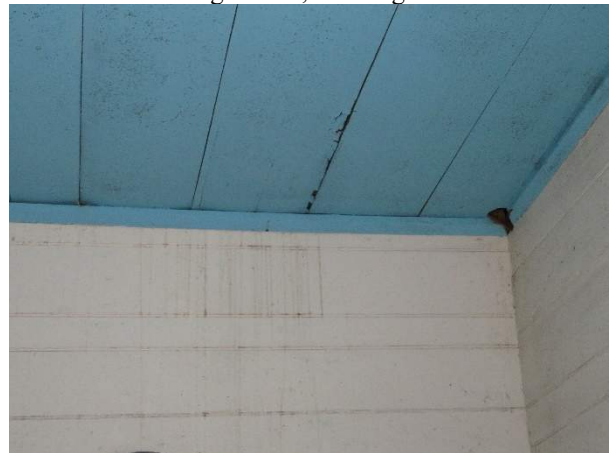
Photo 337. Deterioration of ceiling board and water stains on the wall finishes in the southeast corner.
