National Park Service  
U.S. Department of the Interior

Natchez Trace Parkway  
Tupelo, MS

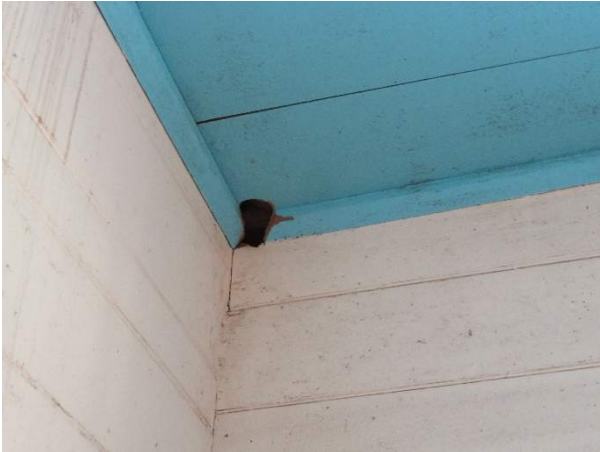
Photo 338. Pest hole in the southeast corner.

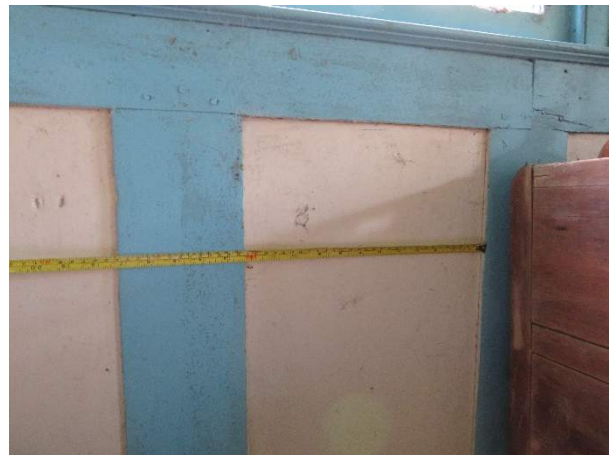
Photo 341. Typical conditions and construction of the rail-and-stile, flat panel wainscot.

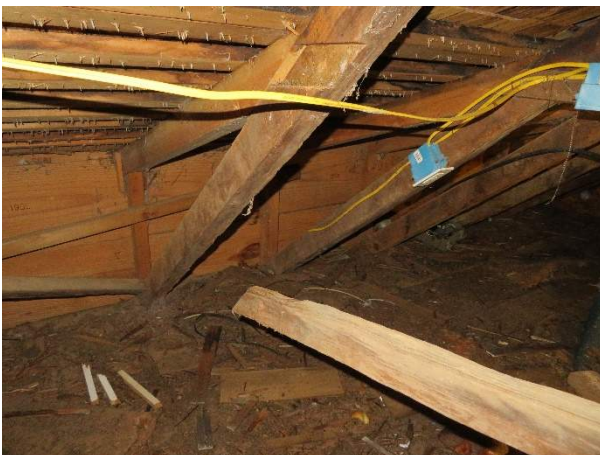
Photo 342. Romex and other unshielded electrical lines in the attic.

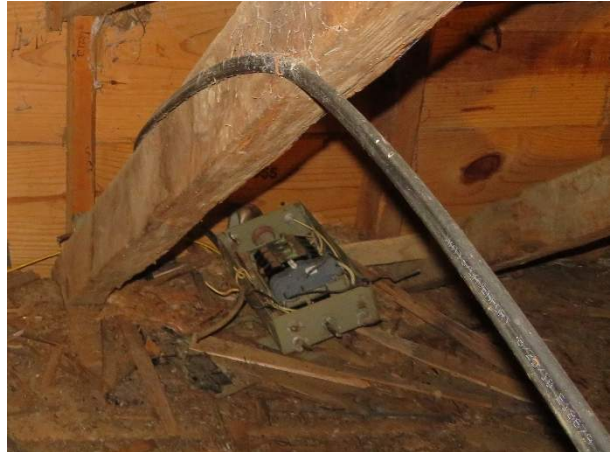
Photo 345. Damaged electrical panel in the attic.

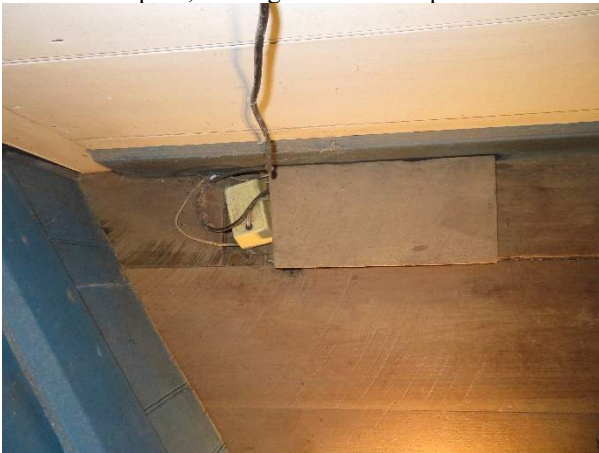
Photo 346. Damaged floor receptacle in Room 1 (101).

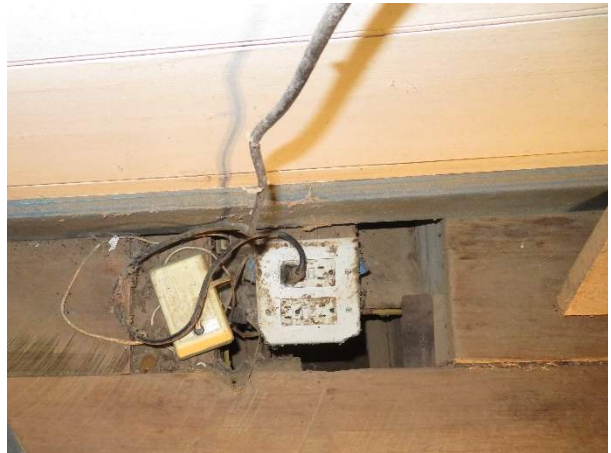
Photo 347. Damaged floor receptacle in Room 1 (101).

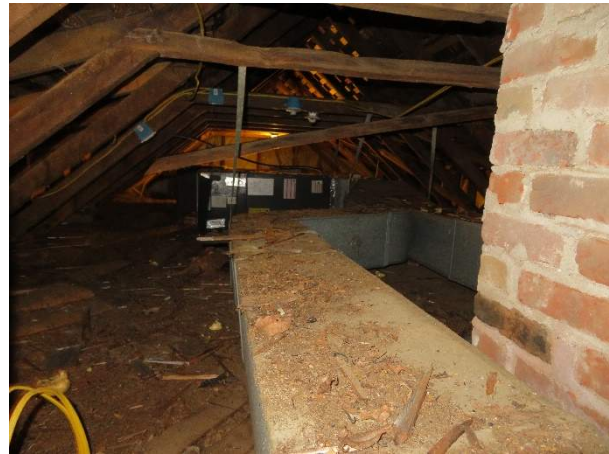
Photo 349. Abandoned HVAC unit in attic.

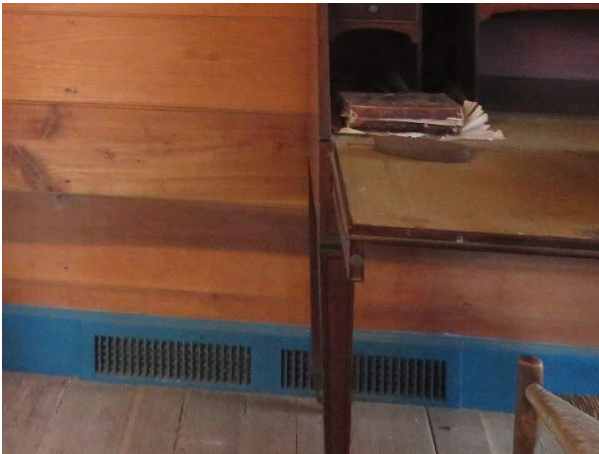
Photo 350. Abandoned registers in the base board of Room 2 (102).

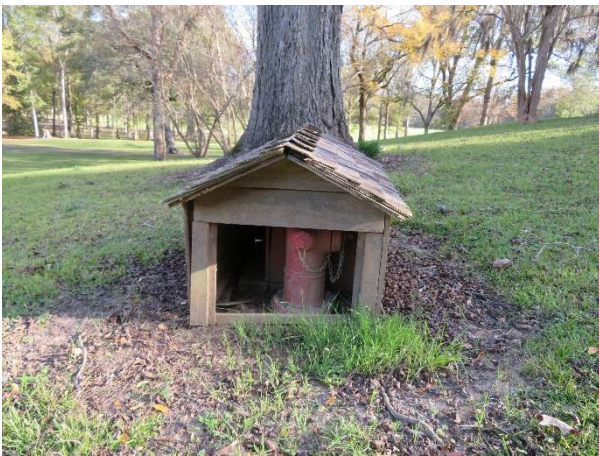
Photo 351. Hydrant, located approximately 50 feet north of the main house.

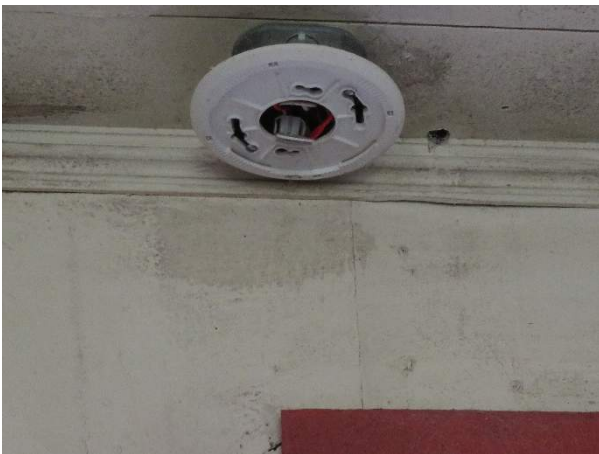
Photo 352. Damaged ceiling-mounted detector in Room 6 (106).

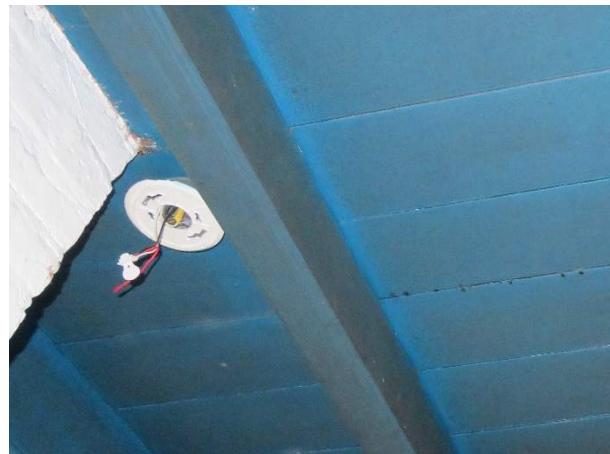
Photo 353. Damaged ceiling-mounted detector in Room 1 (101).

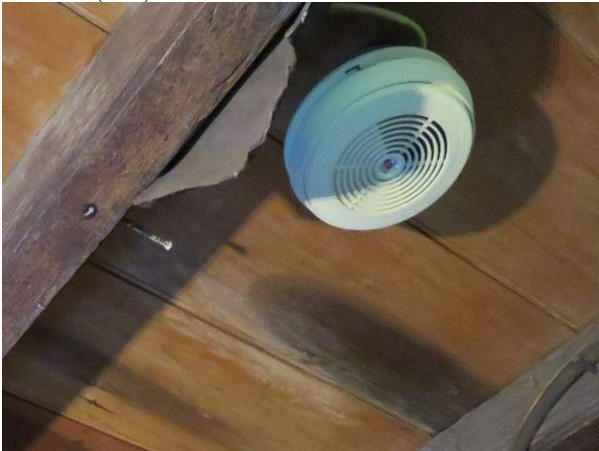
Photo 354. Ceiling-mounted detector in Room 3 (103).

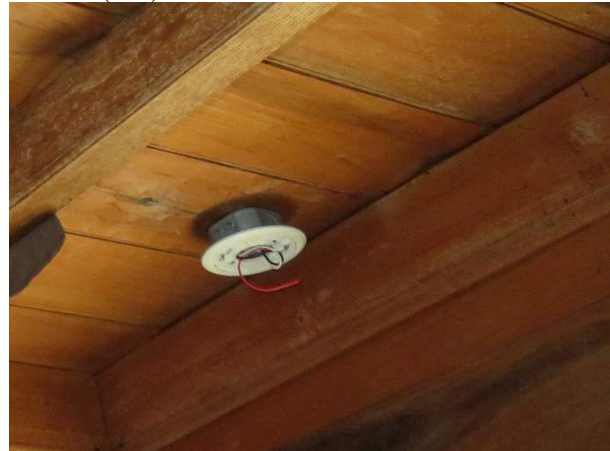
Photo 355. Damaged ceiling-mounted detector in Room 2 (102).

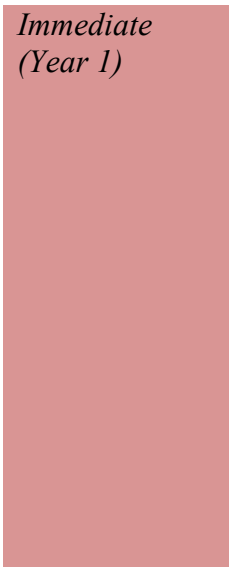
*Immediate  
(Year 1)*

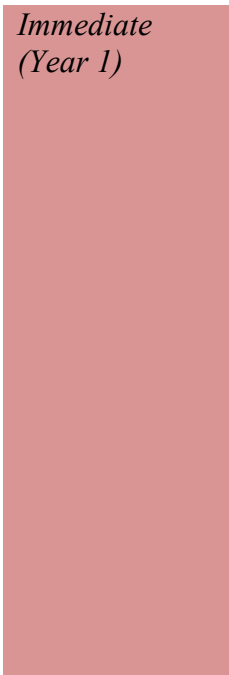
*Immediate  
(Year 1)*

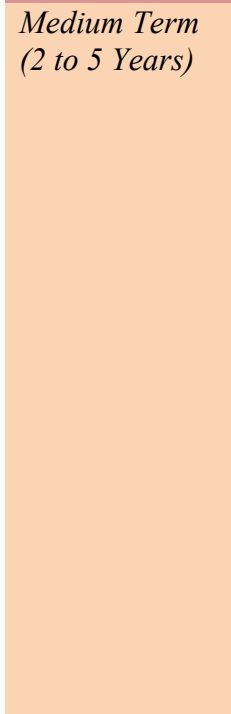
*Medium Term  
(2 to 5 Years)*
