GRIST MILL
Historic Structure Report

San Antonio Missions
National Historical Park
San Antonio, Texas

Mission San José

October 1997

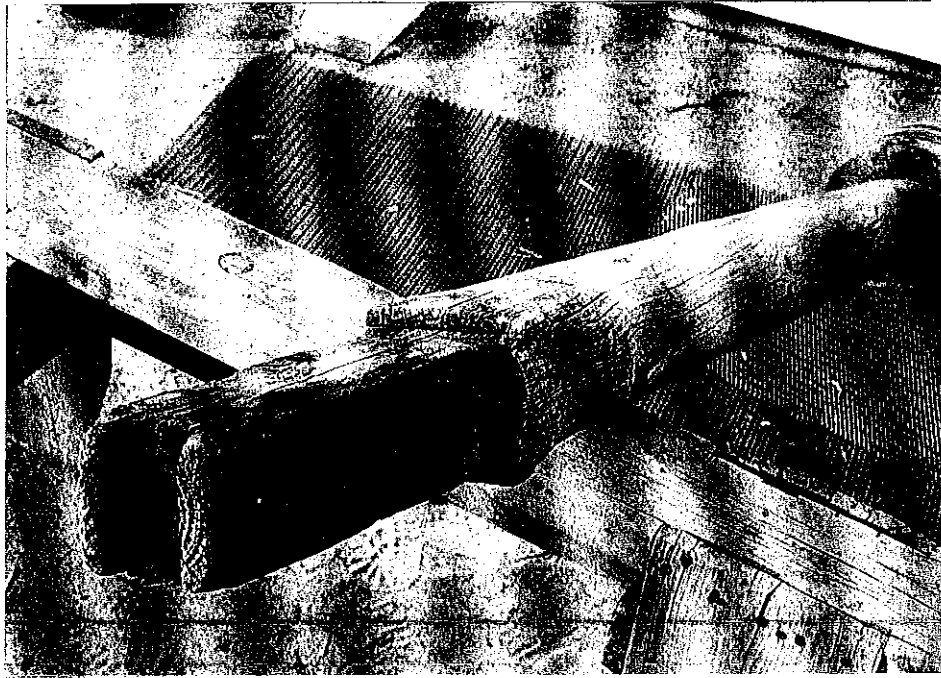
Figure 1-20 Fall 1990. Detail of main shaft removed from Truchas mill during initial investigations. Note the deterioration of the shaft at the bottom at the location of the thrust bearing. El Rancho de las Golondrinas, Santa Fe, New Mexico.

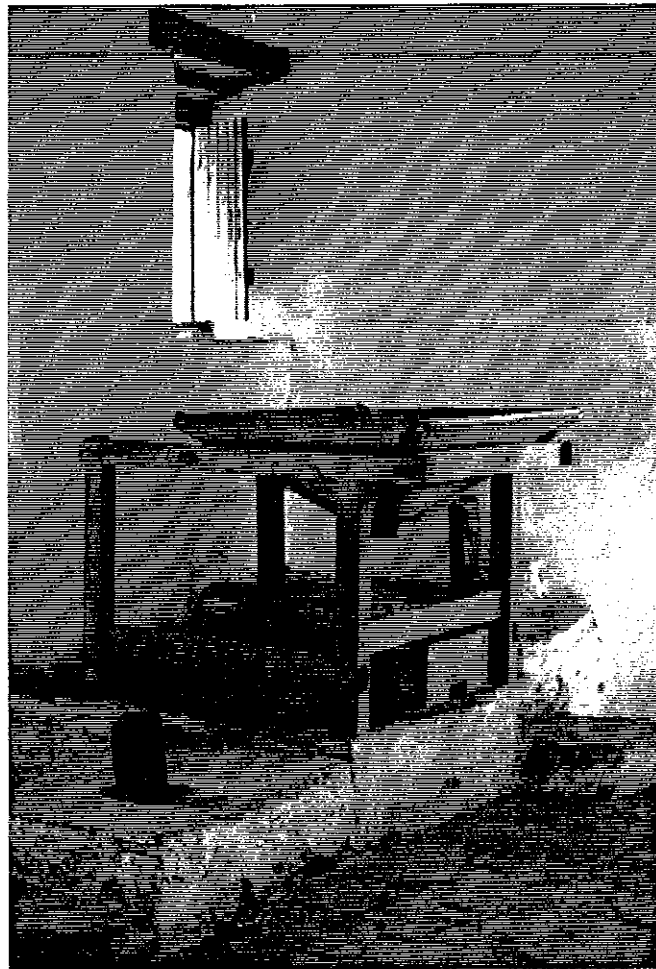
Figure 2-72 ca. 1981. A detail of the milling equipment. Both tram rods are in place, however, many other parts of the milling apparatus are missing (tramming wedges, wedge bushing, wood chutes, operating arms for both tram rods).

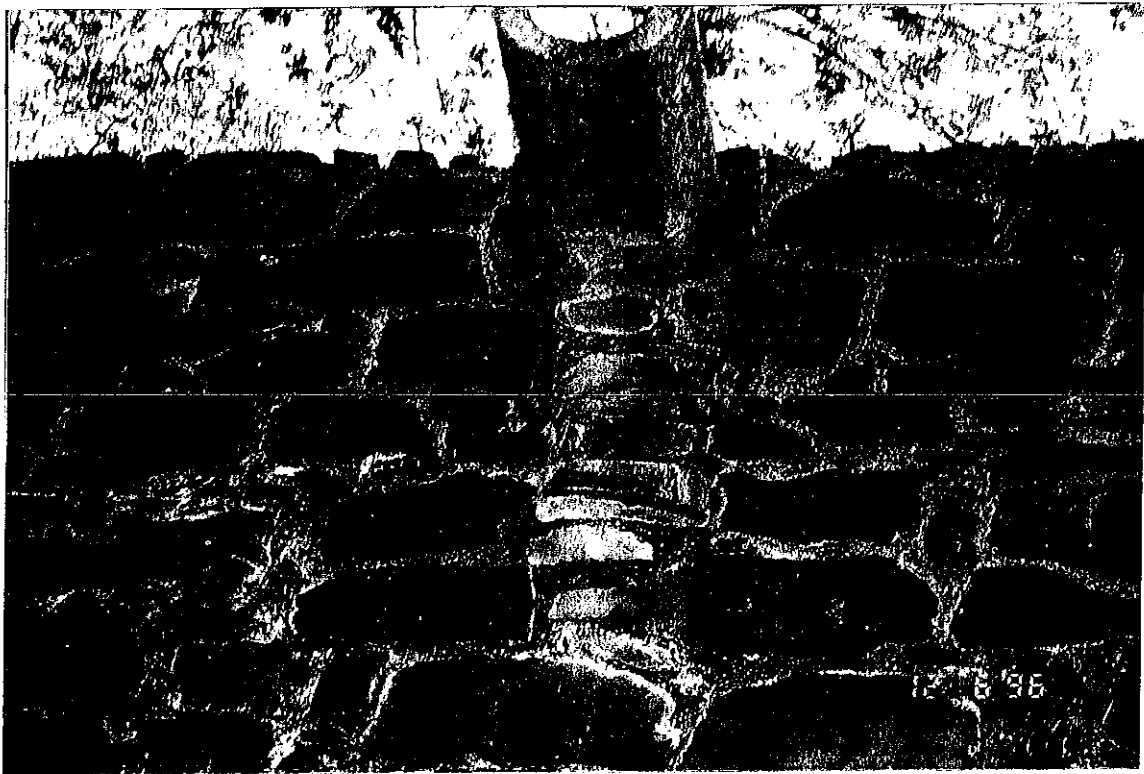
Figure 3-35 December 6, 1996. Detail of single existing concrete drain in the north elevation. The stonework appears to have been changed immediately below this drain (the lighter stone and absence of lichens is most likely due to the drain acting like a small roof over these stones). Note the variation in stone size however: The coursing appears to change radically in this 12-inch by 32-inch section of the wall below the drain. This seems to support the late-1940s rehabilitation discussed in Chapter 2 (pages 2-18 to 19) which stated that, due to deterioration by this center roof drain of masonry walls below, this drain was removed and the drain at the northeast corner of the building enlarged. See also Figure 2-70.

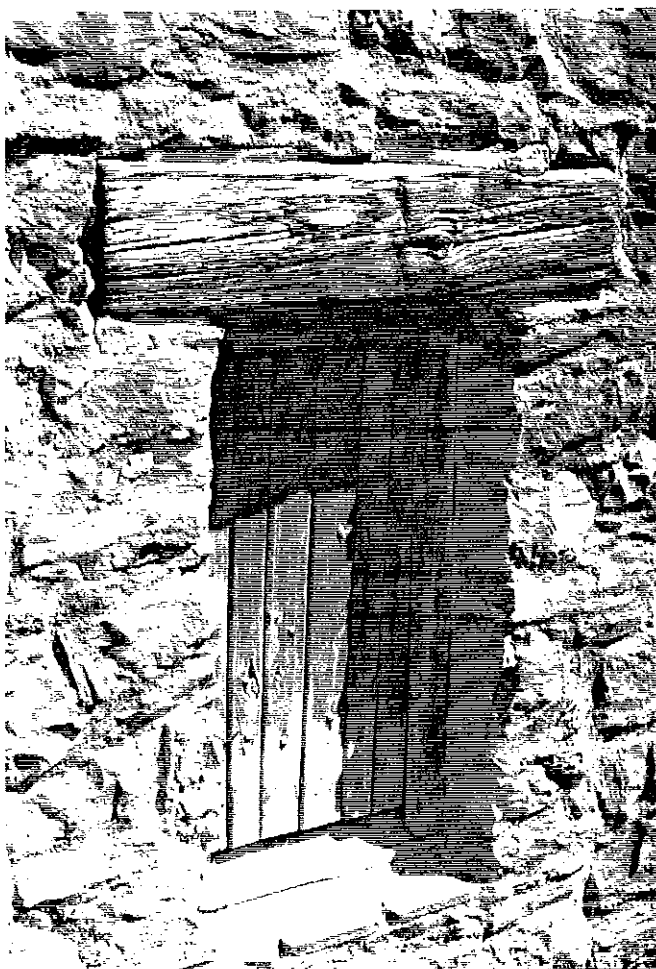
Figure 3-37 June 1996. Detail of the southwest window in the south elevation. The condition of the lintel is fair to good.

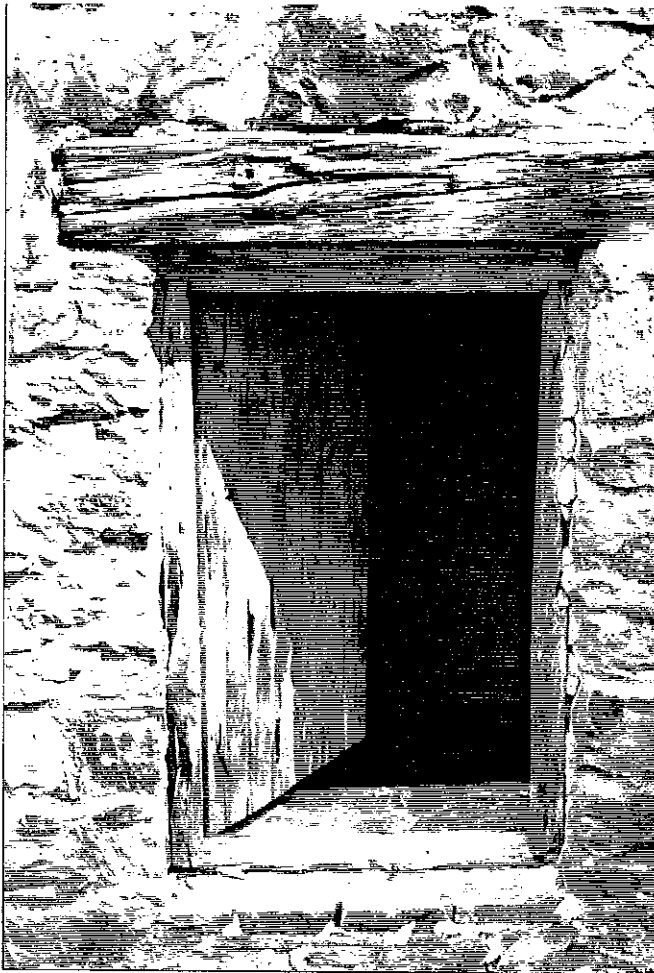
Figure 3-39 June 1996. Detail of the middle window in the south elevation. The condition of the lintel is fair to good, minor pointing is required, primarily above the window lintel.

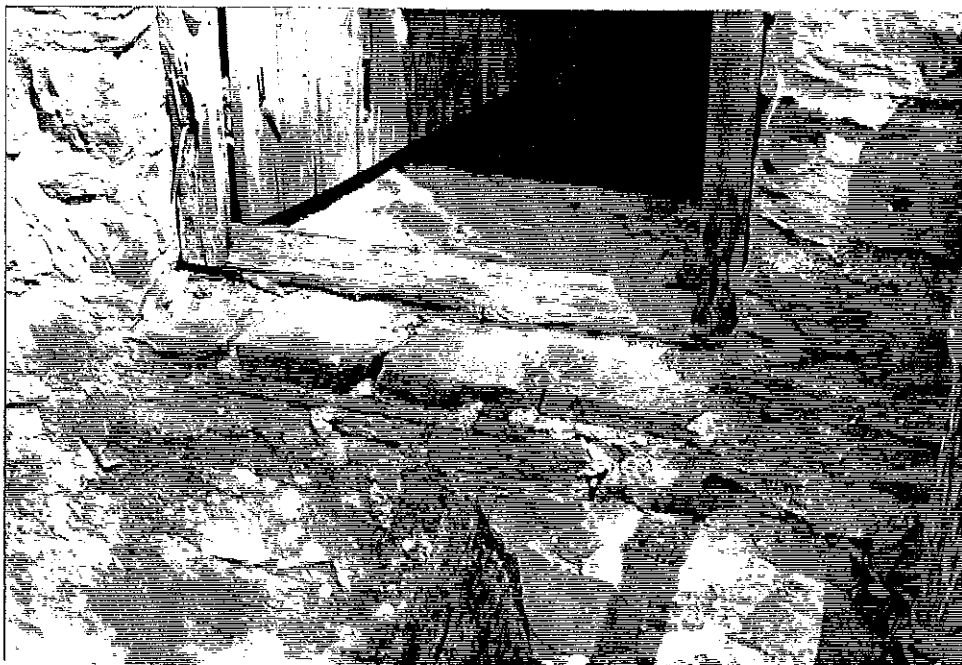
Figure 3-40
June 1996
Detail of the sill of the middle window in the south elevation (typical for all window sills). The condition of the sill is good, minor pointing is required.

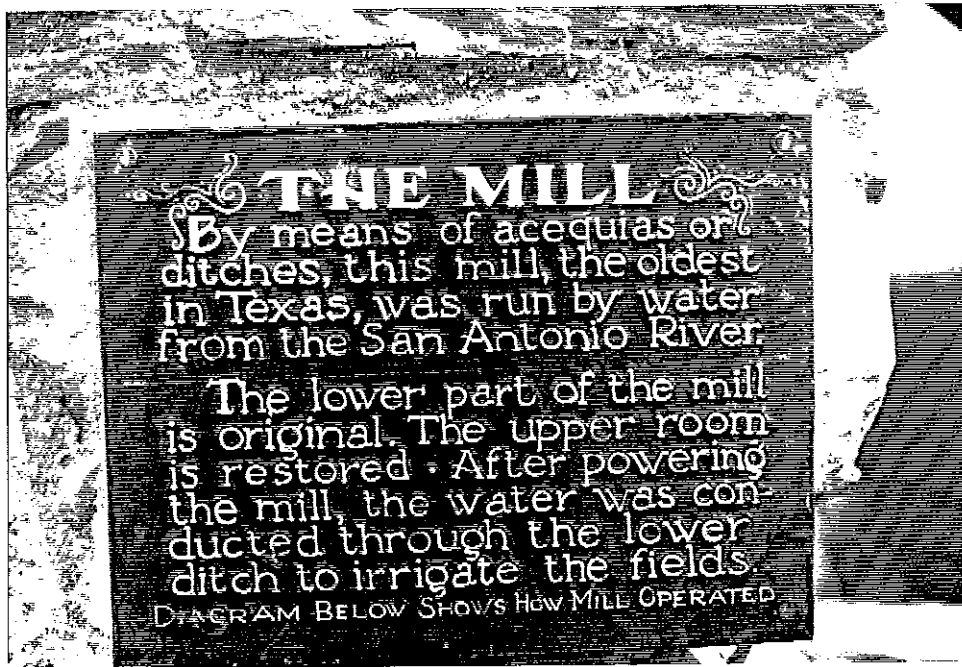
Figure 3-42 June 1996. Enlarged detail of the plaque on the southwest corner of the building (a second plaque which had the "diagram" is missing).

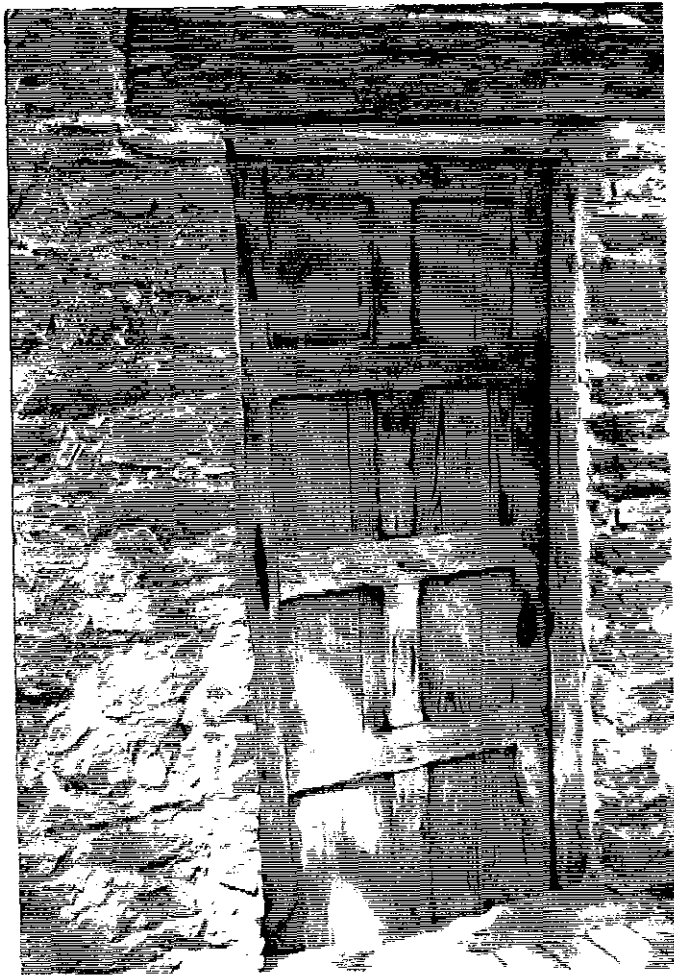
Figure 3-44
June 1996
Detail of the door in the east elevation.
The door is pretty difficult to open and
close. The jamb is loose and the lintel is
in good to fair condition.

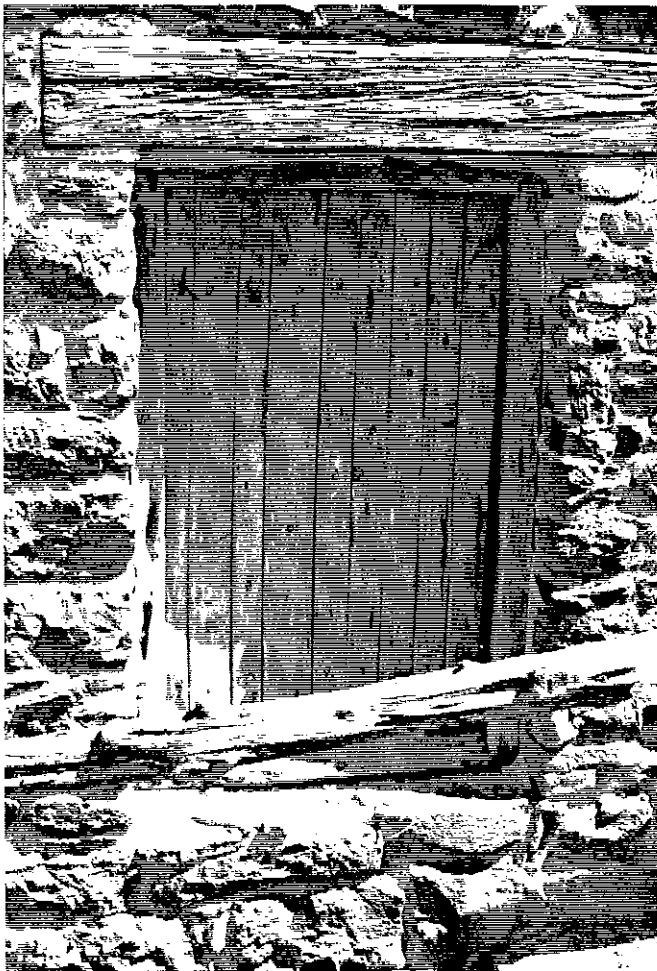
Figure 3-51 June 1996. Detail of the window in the west elevation. Condition of the masonry on the west elevation is excellent again with the exception of some pointing that needs to be done around the window.

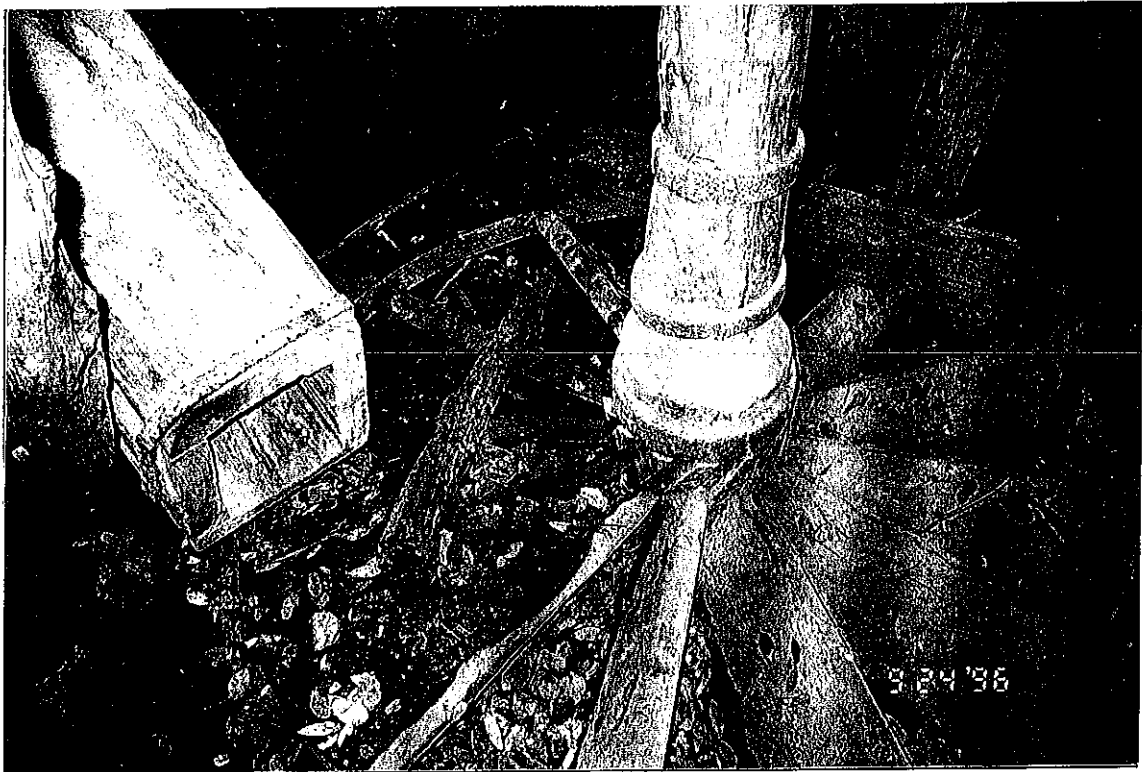
Figure 3-54 November 4, 1996. Detail of the deteriorated water wheel and wooden chute. The support post for the chute is visible at the extreme left of the photograph.
