**THE M'CLINTOCK HOUSE**  
**HISTORIC STRUCTURE REPORT**

**Women's Rights National Historical Park**  
**Waterloo, New York**

Barbara A. Yocum  
Architectural Conservator

1993

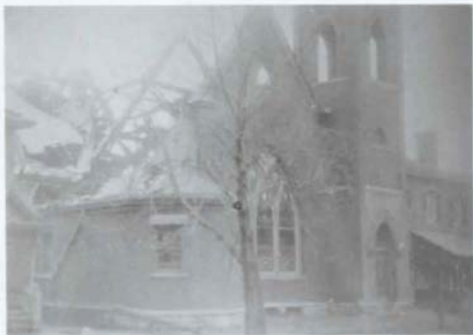
Figure 29. Photograph Showing the Fire-Damaged Baptist Church and Adjacent Parsonage, March 1906.

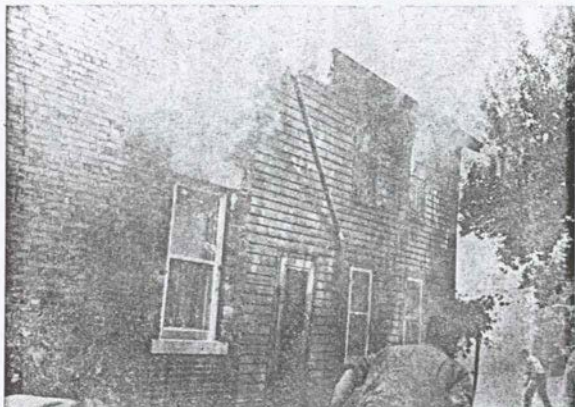
FLAMES THAT DID DAMAGE OF ABOUT \$5000 leap from windows of rear part of Baptist parsonage in East Williams street Sunday afternoon when family of Rev. Carlton F. Carpenter were observing Mrs. Carpenter's birthday. Investigation has not yet revealed the cause of the blaze. Mark, youngest son of the carpenters, was sleeping upstairs at time and was taken from smoke-filled room by his father. Loss was only partially covered by insurance. Members of the family stayed at homes of several church members until house could be made fit for reoccupation.

Figure 36. Photograph Showing the Fire at the Baptist Parsonage, Thursday, June 9, 1955.

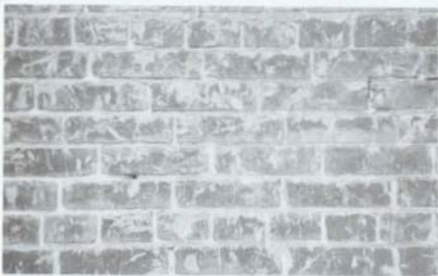
Figure 45. M'Clintock House: Damaged Bricks at Former East-Wall Trellis [1988].

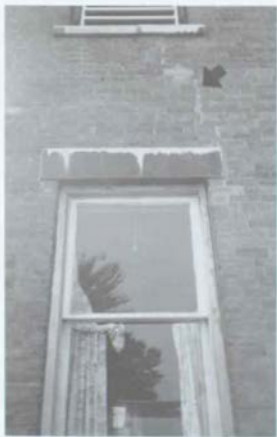
Figure 46. M'Clintock House: Vertical Crack Between Windows in the East Wall [1988].

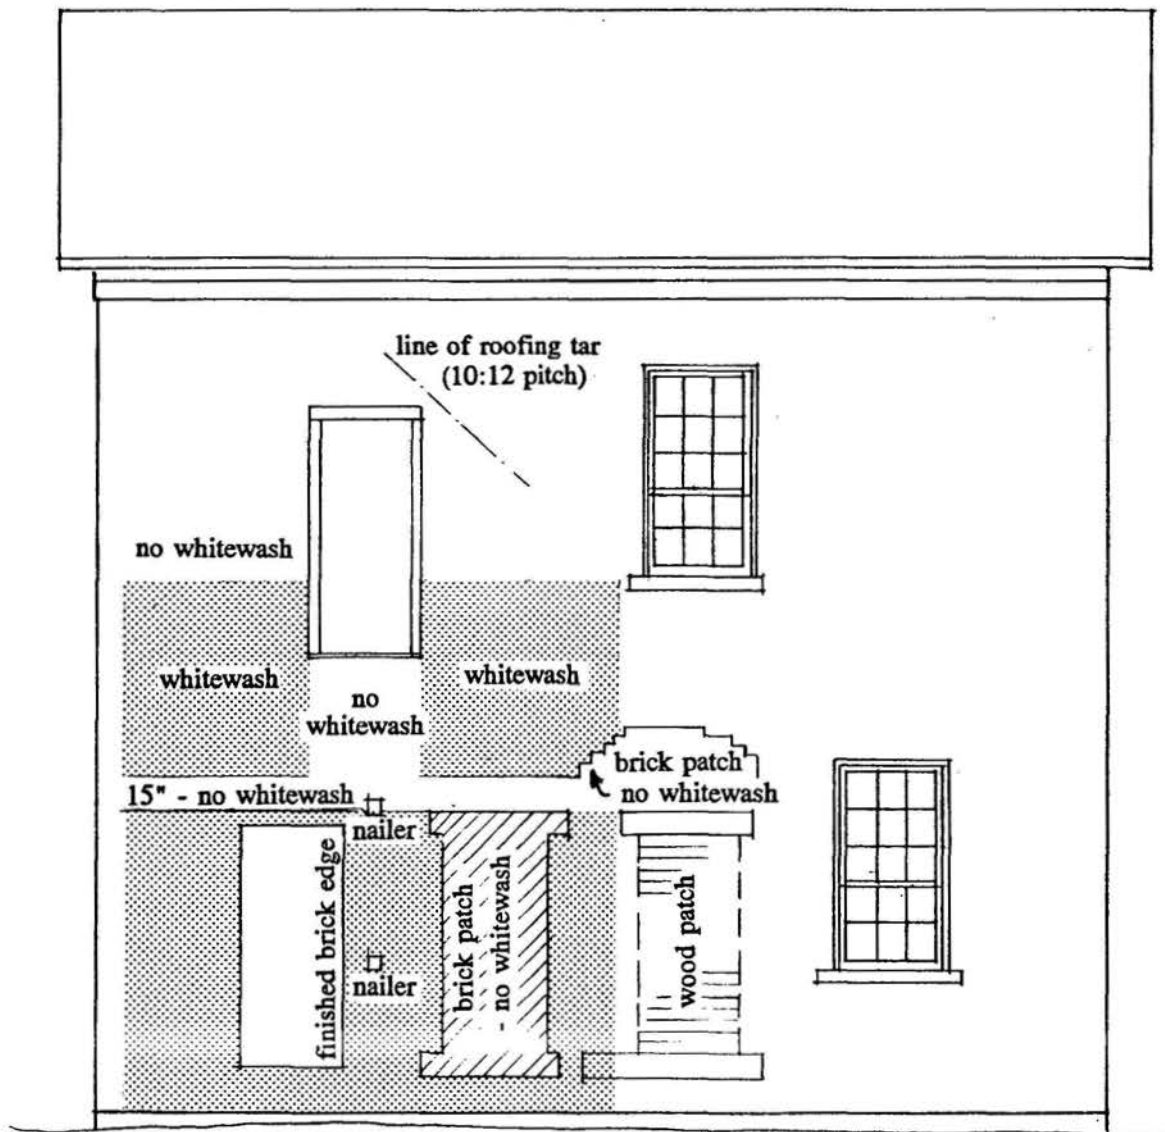
Figure 54. M'Clintock House: Physical Evidence Discovered on South Wall of Main House in May 1990.
