**CONDITION ASSESSMENT REPORT:**  
**BAKER ISLAND LIGHTKEEPER'S QUARTERS,**  
**ACADIA NATIONAL PARK**

**Frank Briscoe**  
**Building Conservation Branch, CRC**  
**North Atlantic Region, National Park Service**  
**U.S. Department of the Interior**  
**Boston, Massachusetts**  
**1990**

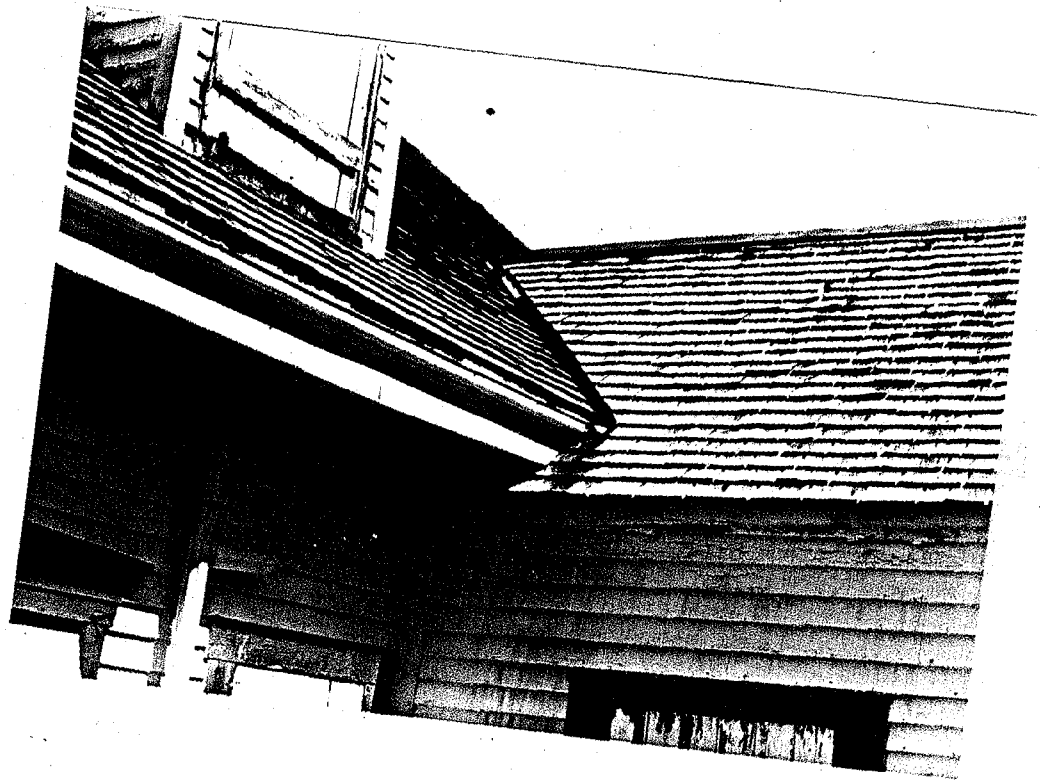
Of these moisture sources, the drainage from the roof is probably the most destructive. This is because roof run-off is generally deposited in a more concentrated way - beneath valleys and failed gutter systems. Some of the problems related to building drainage are visible in the foundation near the intersection of the wing and one and one-half story section on the west side. A valley draining a large area of the roof (Fig. 7.) and a disconnected gutter leader empty run-off along the foundation at this point. Several relatively small cracks and numerous patches in the pointing can be seen along the south facade of the original building in this area (Fig. 8.). Some of the most conspicuous evidence of movement in the foundation is visible along this section of the wing.

Figure 7. Valley on west side of  
building. (BCB)

6. Apply a coating suitable for rusted metal to the flashing of the valleys on the east and west sides.

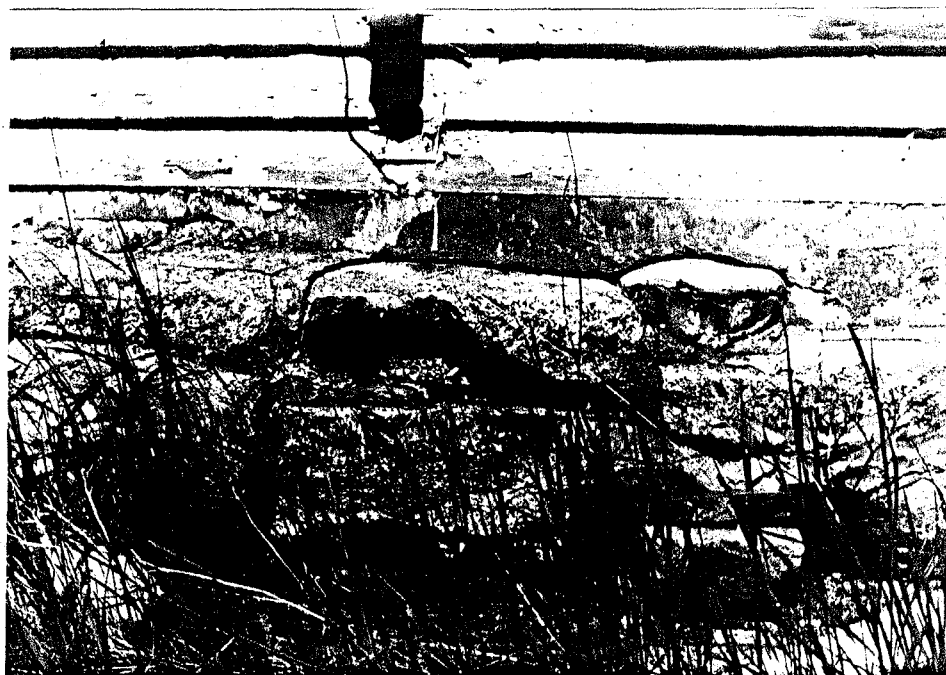
Figure 8. Damage to foundation below  
south gutter leader from roof  
drainage. (BCB)

The wooden gutters of the north and south facades should be made functional, even if these repairs are only temporary. Holes in the gutter troughs can be patched with asphalt building paper embedded in asphalt roofing cement. Particular care should be taken in sealing the joints where the downspouts join the troughs. Leaders should be checked for obstructions. An elbow should be added to lower end of the north leader and this leader extended to carry run-off away from the perimeter of the building (toward the north). If feasible, the leader of the south gutter should be added to and routed around the building to a point where runoff will not further damage this vulnerable corner.

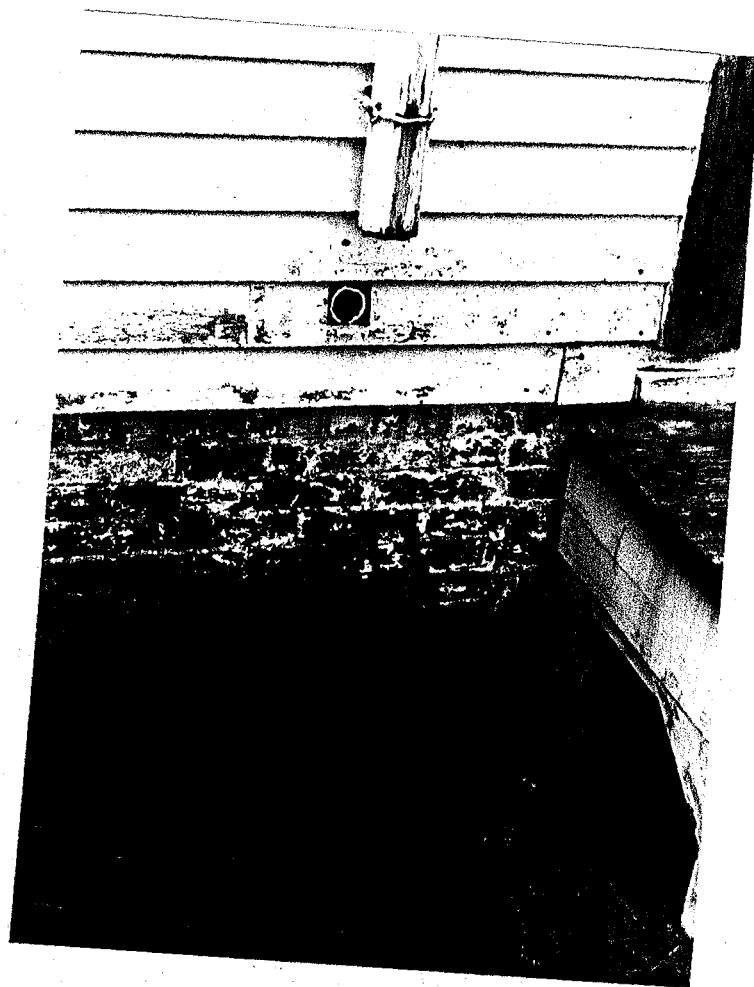
Damage from run-off deposited by the leader of the north roof gutter just east of the front door is also evident, but less of a threat. Some loss of material from the stone foundation and some spalling and loss of pointing from the brick can be seen (Fig. 9.). Areas where the brick skirt is in close proximity to ground level, such as at this point, are prone to the effects of rising damp. This damage is most apparent at the north side of where the hyphen to the lighthouse used to join the original building (Fig. 10.).

Figure 9. Damage to brick skirt  
below north gutter leader.

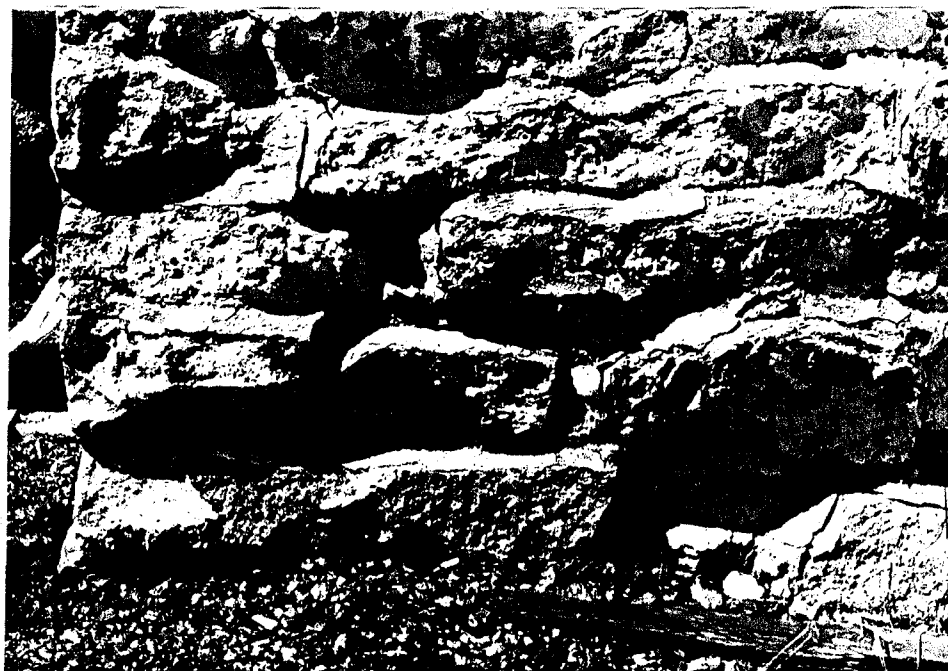
the east facade. The northern half of the building's perimeter is relatively well-drained. Foundation problems from poor site drainage are most visible along the south facade and on the east facade near the southeast corner of the building (Figs. 11., 12.). At the southwest corner foundation settlement has removed all visible means of support from the enclosed entrance here (Fig. 13.).

Figure 11. Cracks in stone  
foundation on east facade near south  
corner. (BCB)

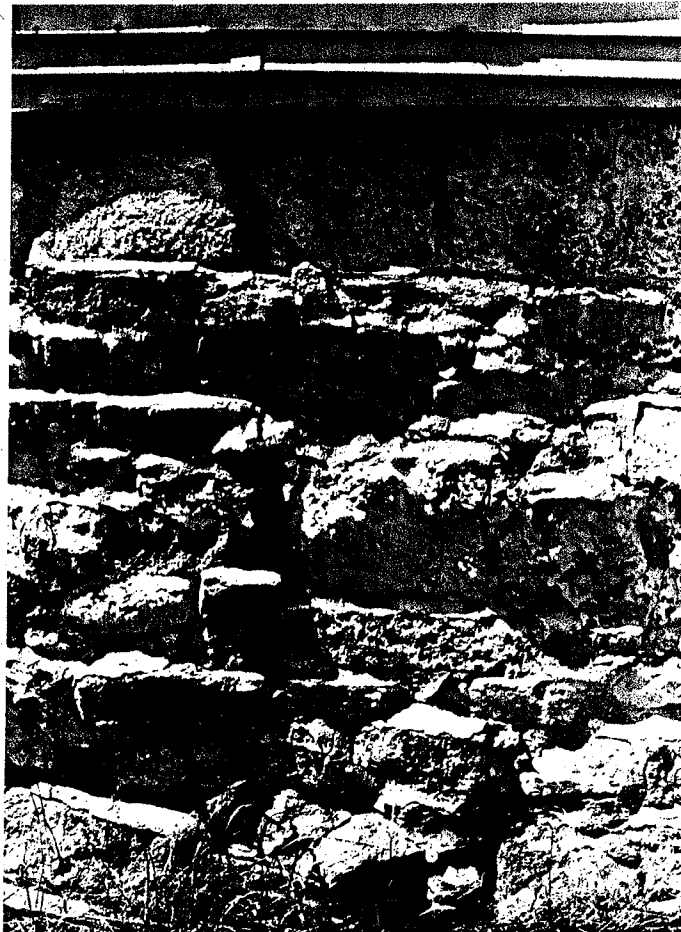
Figure 12. Cracks in foundation on  
east facade near south corner. (BCB)

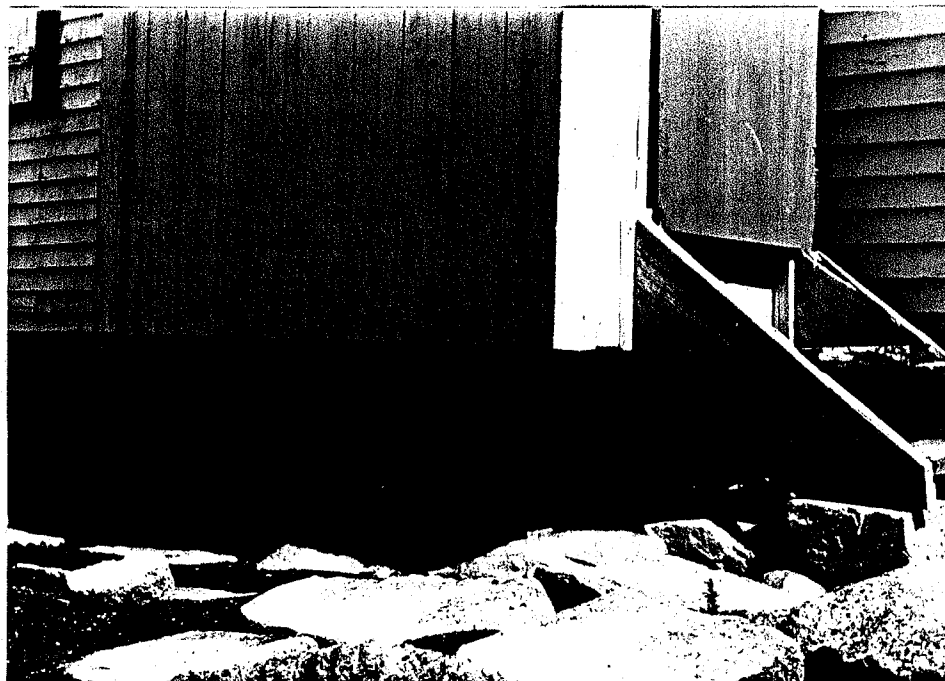
Figure 13. Foundation settlement at southwest corner. (BCB)

Installation of temporary gutters along the east and west eaves of the wing would significantly slow damage to the foundation. Leaders from these gutters should carry precipitation away from locations lacking adequate drainage (especially the southwest corner).

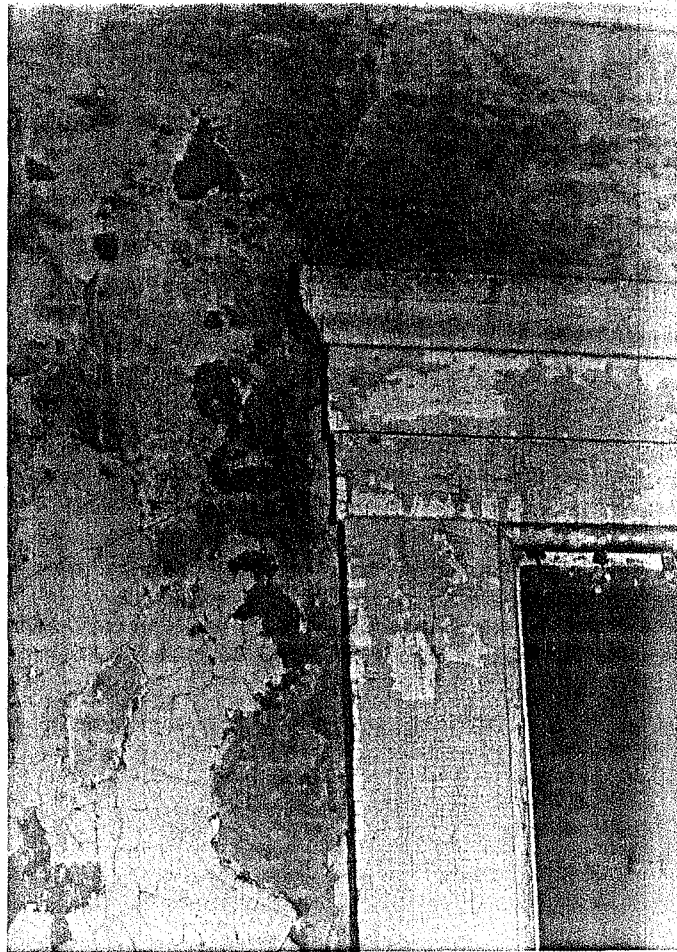
Besides the effects of inadequate ventilation on the basement wall pointing mentioned above, ventilation problems are most apparent in extensive failure of the interior finishes (Fig. 15.). Insufficient ventilation often results in damage to finishes on denser surfaces, such as plaster

Figure 15. Failing interior finishes from excessive moisture levels and insufficient ventilation. (BCB)

walls. In the Lightkeeper's quarters, however, the finishes of virtually all surfaces have failed. To a lesser degree, humidity is beginning to cause failure in the wall plaster itself. Soft spots were found in the plaster in locations near openings in the envelope which serve as migration paths for moisture vapor. Interestingly, these conditions have not resulted in the propagation of molds or decay-causing fungi, which generally thrive under similar circumstances.

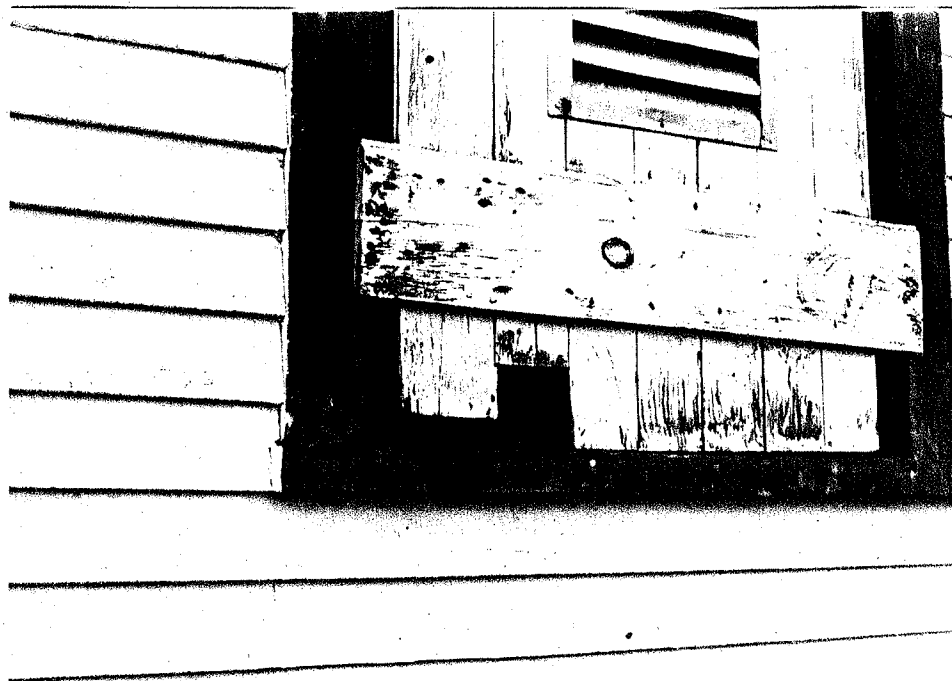
Other problems related to the building envelope include openings or loss of fabric allowing pests to enter the structure and making the building vulnerable to vandalism. The most serious threat by building pests is from birds. Several bird nests were found between window sash and window coverings (Figs. 16., 17.) (believed to be starlings) and in corners of the first floor interior; and between the floor joists over the south basement (swallows). Besides the debris of their nests, birds introduce dirt into structures which can encourage infestations by beetles, particularly wood-boring Longhorn beetles.[2] The excrement of birds is both acid and alkaline and causes decay in a variety of materials. It is also difficult to satisfactorily remove.

Figure 16. Openings in the window covers allow birds to nest in building. (BCB)

The existing window coverings discourage unauthorized entry to the building and provide important ventilation. However, for better security, more effective ventilation, and to protect the interior from building pests without damaging historic fabric, these coverings should be replaced with alternative enclosures described below.

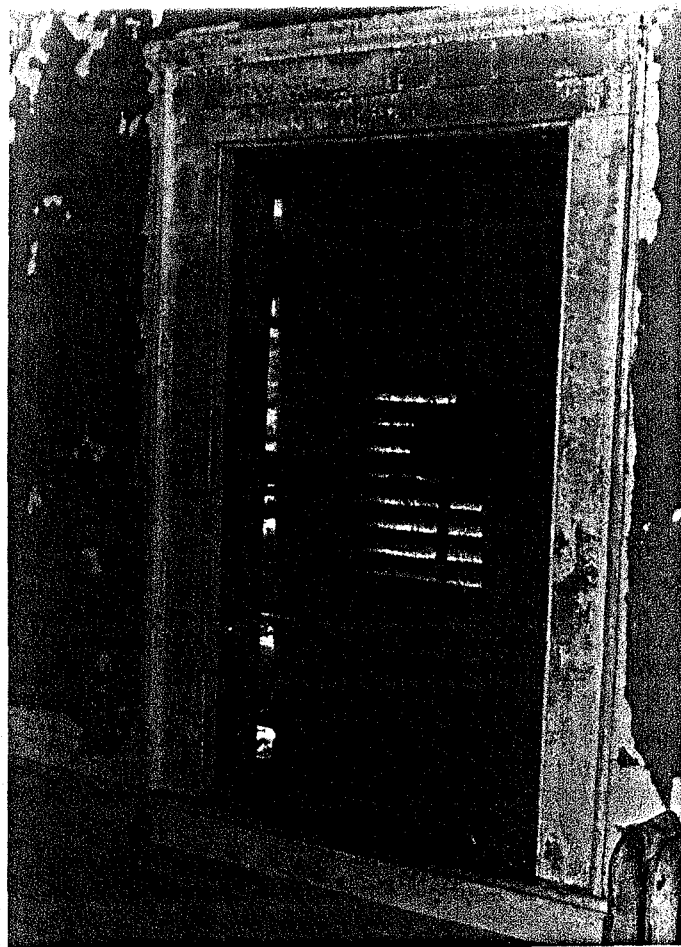
Figure 17. Bird nests in the west window of north facade. (BCB)

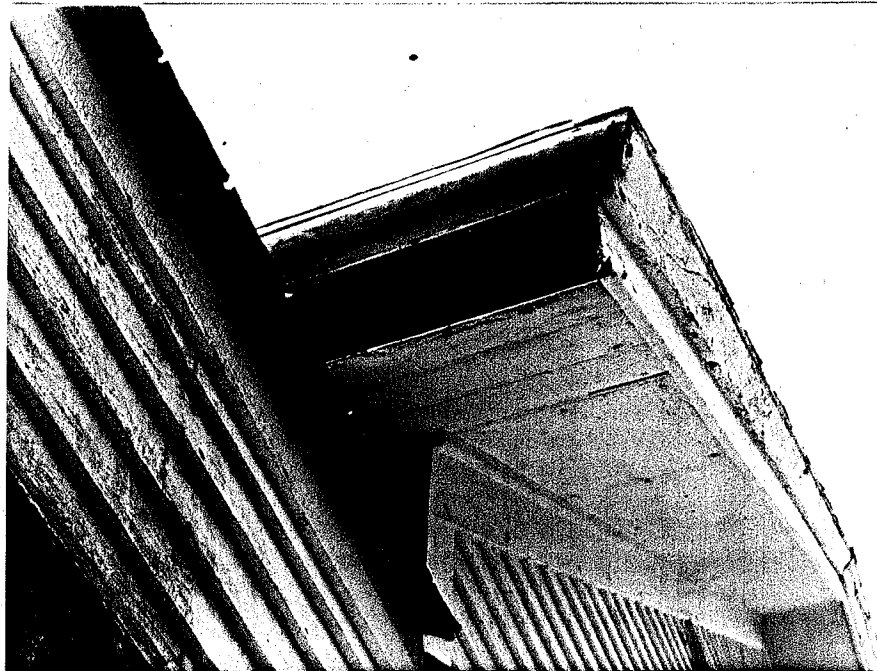
Surprisingly little decay was found in exterior wooden elements. Most of the decay is in areas where roof drainage is concentrated, such as in the wooden gutter troughs, eaves and below the valleys of the east and west facades. On the east side a fascia member is lost from the south side of cornice (Fig. 18.). Minor decay is visible in the cornice molding at this corner of the roof and at the corresponding corner on the west side. Decay is also apparent where the leader comes through the eaves on the west side (Fig. 19.) and in about two and a half feet of the lower eaves member of the north facade at the west corner.

Figure 18. Missing fascia member from  
eave below east valley. (BCB)

All repairs of wall cladding and eaves elements necessary to prevent access by birds should be made. Screen should be applied over the holes where the leaders once entered the

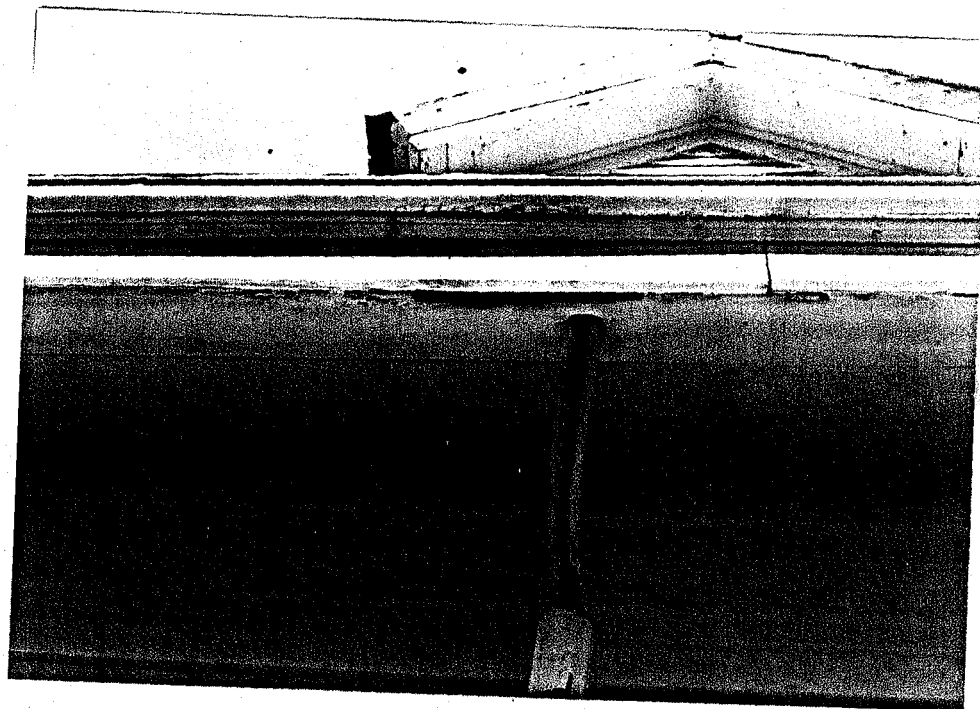
Figure 19. Decay in eaves below  
south gutter. (BCB)

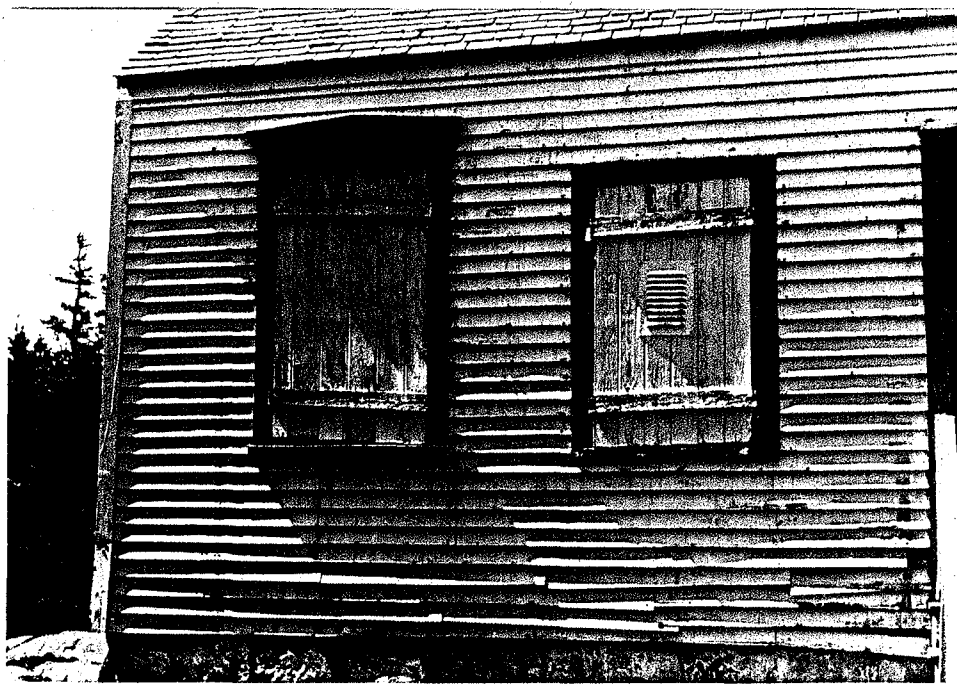
Clapboard is damaged or missing in several areas of the exterior walls. About ten feet of clapboard is loose in the lower four courses on the east facade south of the door (Fig. 20.). Small pieces of clapboard are missing at the north end of west facade (Figs. 21., 22.) and on the south facade of the wing at cornice level.

Figure 20. Loose clapboard on east facade of wing. (BCB)

When feasible, loose and missing clapboard should be re-affixed.

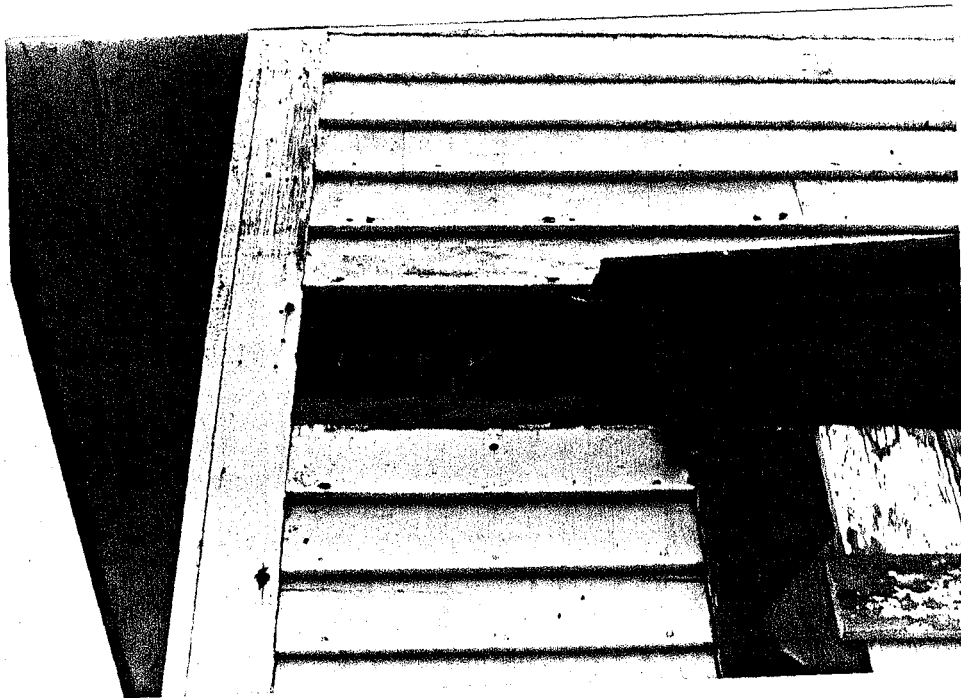
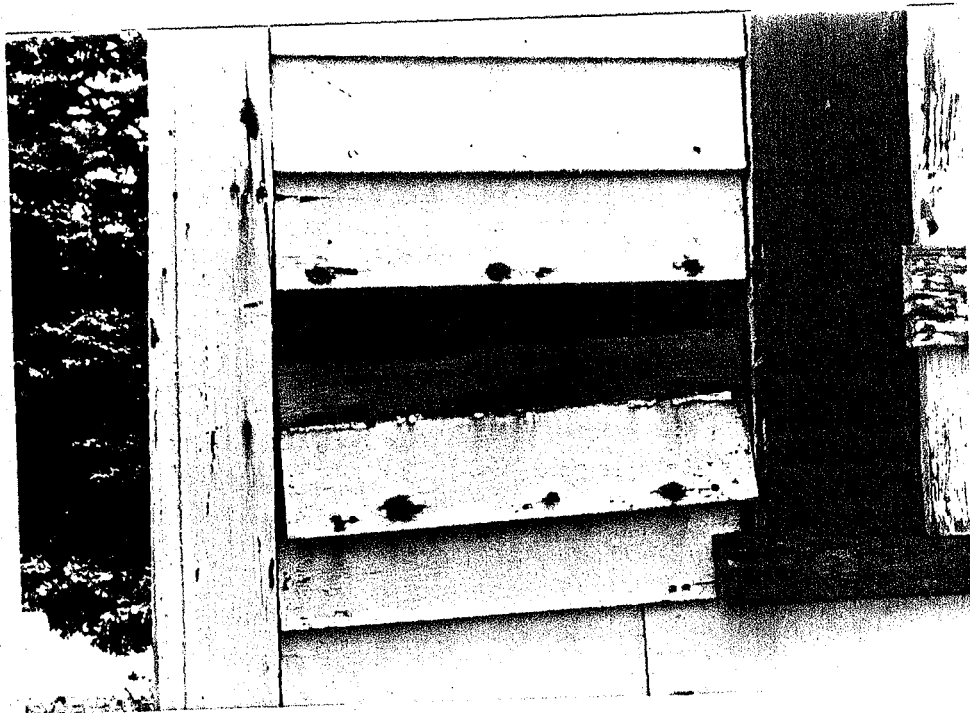
Figures 21., 22. Clapboard missing  
from north window of west facade.  
(BCB)

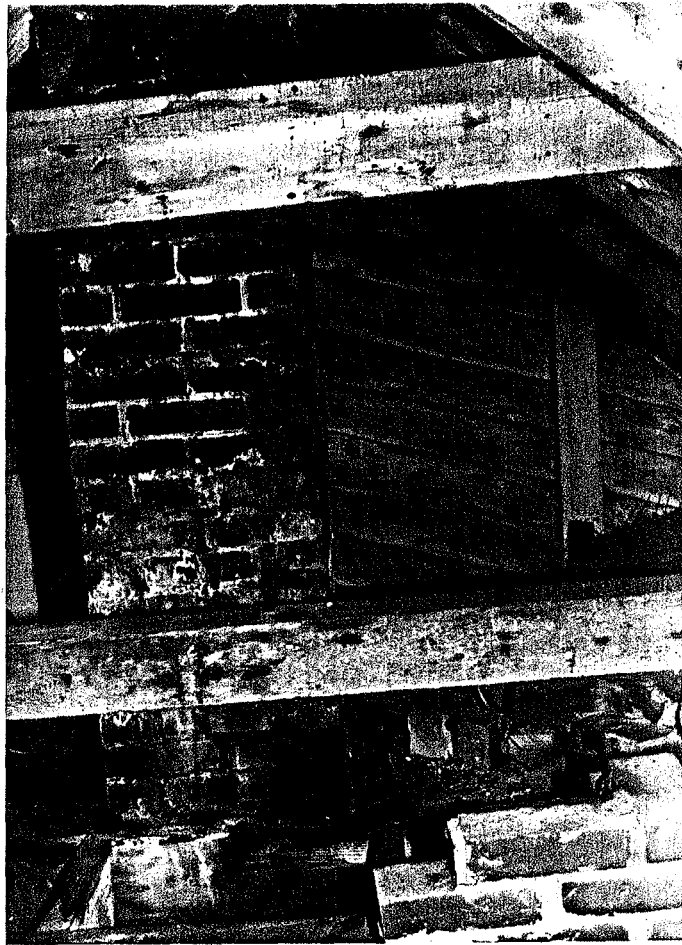
Rain and snow also penetrate the building envelope through the uncapped chimneys. Efflorescence is visible on the south chimney in the attic (Fig. 23.) and on the north

Figure 23. Efflorescence on the south chimney visible from the attic. (BCB)

chimney in the attic of the original structure. This is caused by the deposit of soluble salts as moisture migrates through porous masonry. The resulting crystals can grow and damage the masonry units. Excessive moisture migration through the chimney walls is probably also responsible for the failing pointing of both chimneys.

Chimney caps are highly recommended for both chimneys. These will reduce the amount of moisture on the interior surfaces of these features and greatly slow their deterioration. The caps must allow ventilation of the chimneys. (Removing some of the debris from the stove pipes would probably improve air circulation and further reduce condensation.) The material of choice for the caps would be sheet metal, but wooden caps would be serviceable.

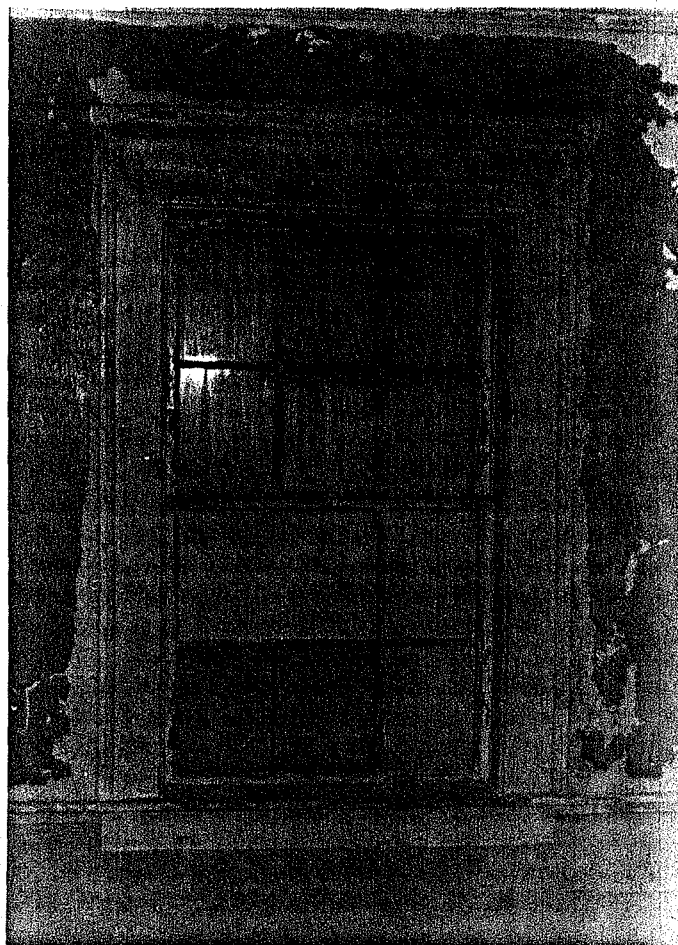
Historic fabric of the building is in generally good condition, with a few exceptions. The historic front door has been extensively battered with a hammer along the upper left exterior side. Several window units have broken sash or muntins (Fig. 27.), and a few muntin elements were found on the floor of the building. Exterior window trim and sills show some damage from the present method of nailing the window coverings into these features (Figs. 28., 29.).

Figure 27. Several windows have broken or missing muntins. (BCB)

Some elements of the historic fabric were found loose, scattered about the interior. These include the surviving basement window sash (in north basement and outside near bulkhead) and pieces of the sash of other windows (such as the muntins). Measures should be taken to insure that these are not discarded or further damaged. If possible, pieces should be tagged with the location they were found and stored in building where they will remain dry.

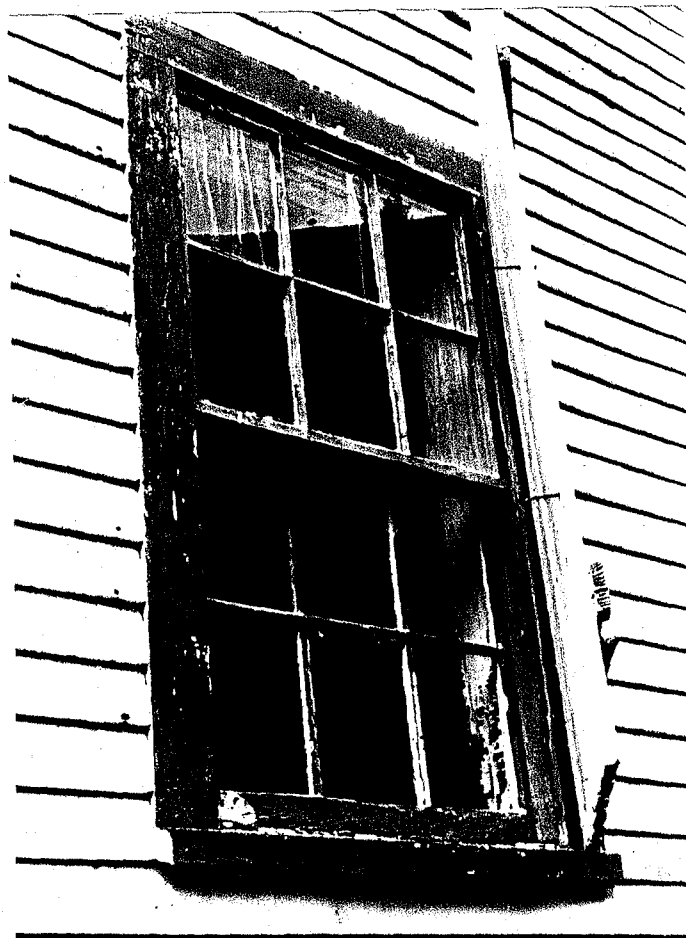
Figure 28. Present method of  
securing window coverings results in  
damage to historic trim. (BCB)

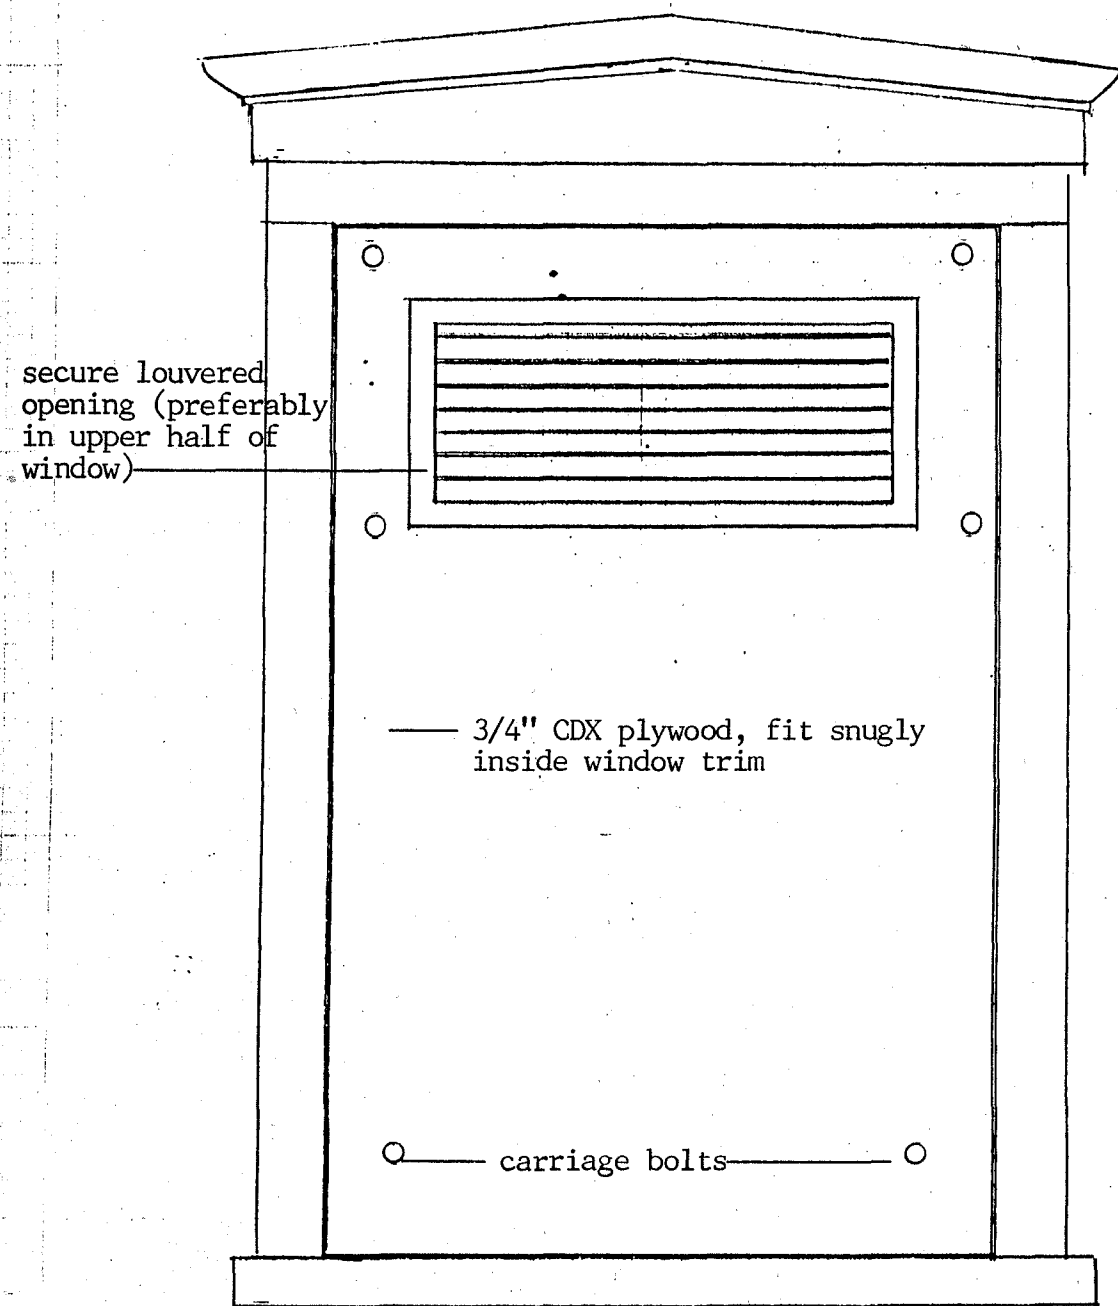
Figure 30. Elevation showing recommended window covering for first story. (Second story can have larger louver.) (BCB)

The enclosures we recommend are similar to those the park used in some of the window openings at the Gilley house. The upper sash is lowered half-way, the lower sash is raised half-way, a piece of 3/4" exterior grade plywood is cut to fit snugly over the outside of exterior window stop (inside the trim) and bolted with carriage bolts to "strong-backs" (usually 2 by 4s) set flat overlapping the interior window opening (Figs. 30., 31.).

The plywood should contain a large louvered ventilating screen. Ventilating covers for all of the basement windows are highly recommended. Since upper story windows are less vulnerable to unauthorized entry, and since these are critical to effective ventilation, the louvered screens of these windows should be as large as possible. The plywood coverings must fit tightly in the window and door frames. Sparrows can get through openings less than

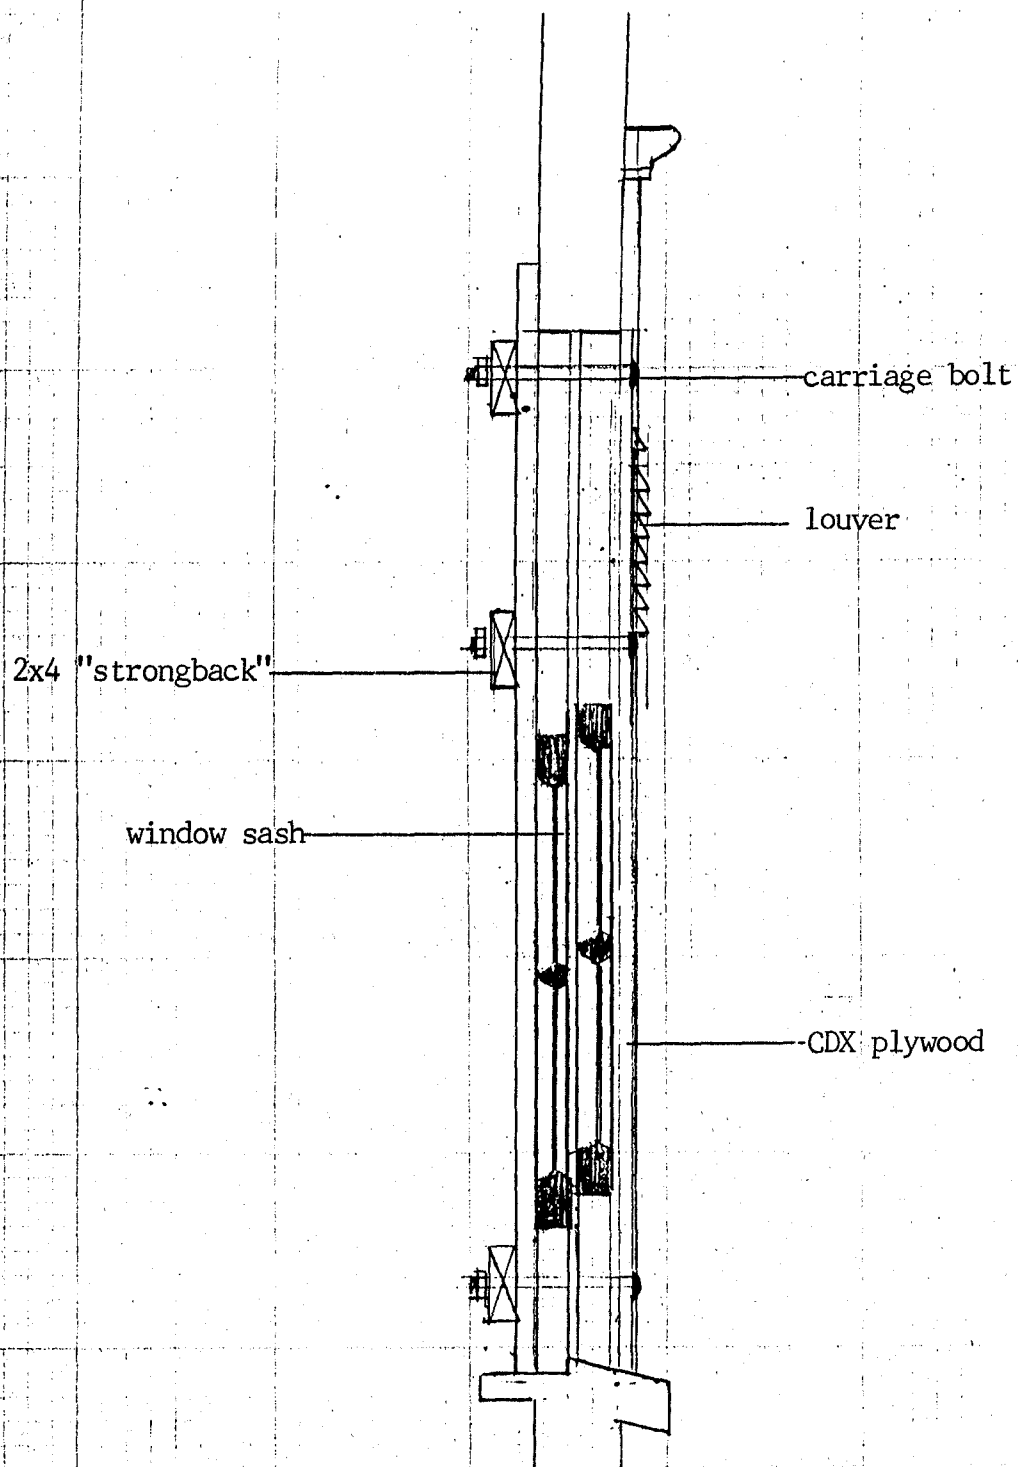
Figure 31. Section of recommended window covering. (BCB)
