Apostle Islands National Lakeshore
Wisconsin

Devils Island Light Station

Cultural Landscapes Inventory

July 2014

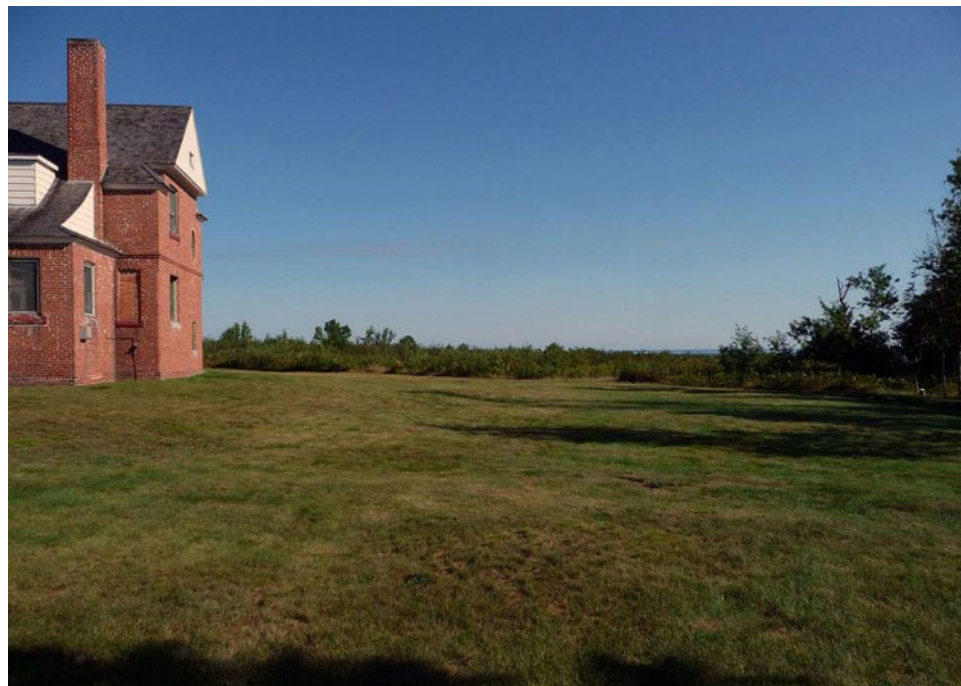
Shadow depression marking the nonextant Assistant Keepers Quarters and associated barn.
(Anderson Hallas Architects/NPS 2009)

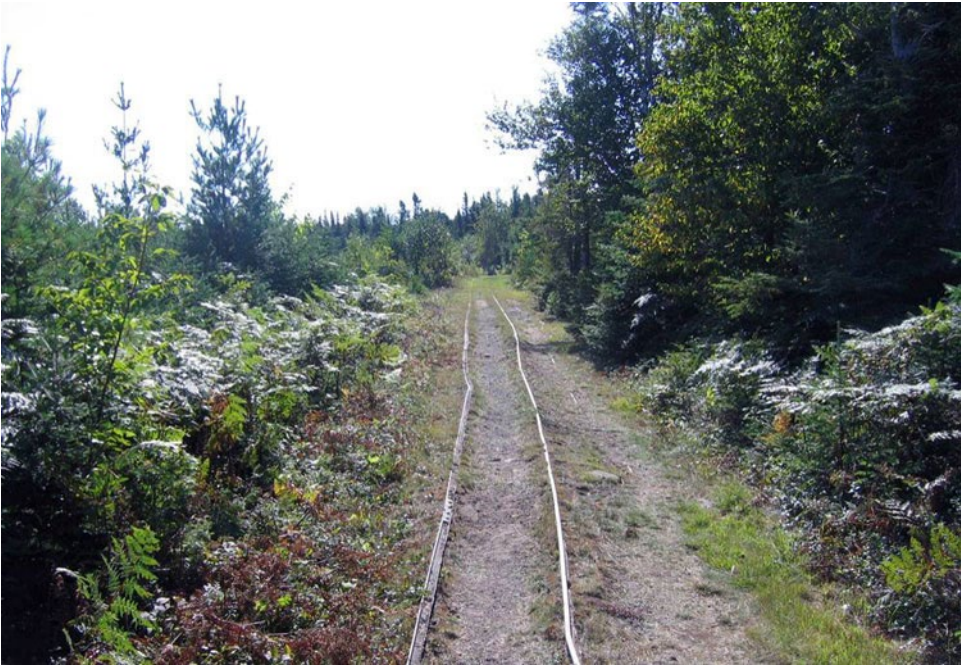
The primary transit of materials on site historically was accomplished using the tram tracks that cross the light station grounds from the north to south linking the Fog Signal building with the Keepers Quarters and Tramway Engine Building. The tracks are in fair to poor condition and are not fully functional.

Tram tracks between the Fog Signal Building and the Keepers Quarters.
(Anderson Hallas Architects/NPS 2009)

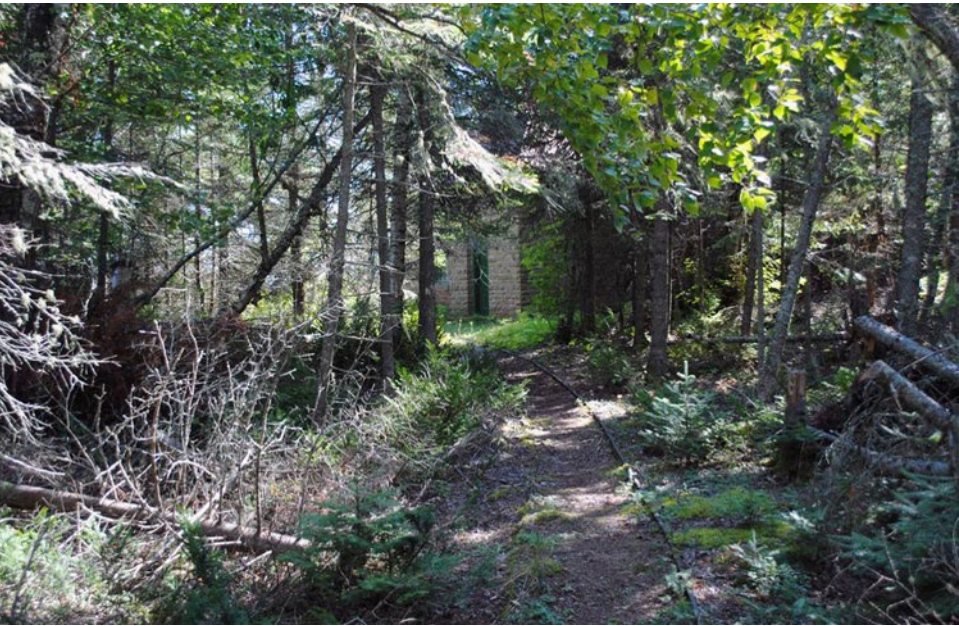
Tram tracks at the Tramway Engine Building, showing the extent of forest encroachment.
(Anderson Hallas Architects/NPS 2009)

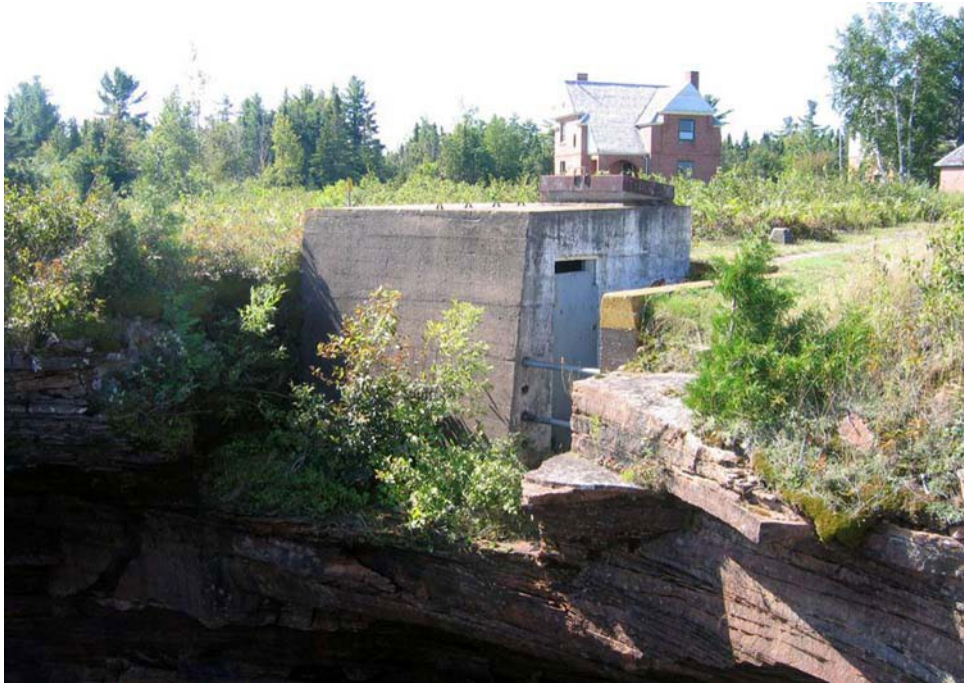
The Pump House (LCS 017087) is directly located east of the Keepers Quarters, and is perched on and built into the edge of the shoreline cliff. It is a board formed, cast-in-place, concrete structure, approximately 10’ x 10’ in size, with a concrete stairway leading down to an access door on its west facade. The stairway is in good condition but lacks handrails.

Pump House at cliff edge. (Anderson Hallas Architects/NPS 2009)
