VOLUME III OF VI: OUTER ISLAND CLR/HSR

**CULTURAL LANDSCAPE REPORT, HISTORIC STRUCTURE REPORT
AND
ENVIRONMENTAL ASSESSMENT**

LIGHT STATIONS OF MICHIGAN ISLAND, OUTER ISLAND, DEVILS ISLAND,
LONG ISLAND AND SAND ISLAND

prepared by
Anderson Hallas Architects, PC
Golden, Colorado

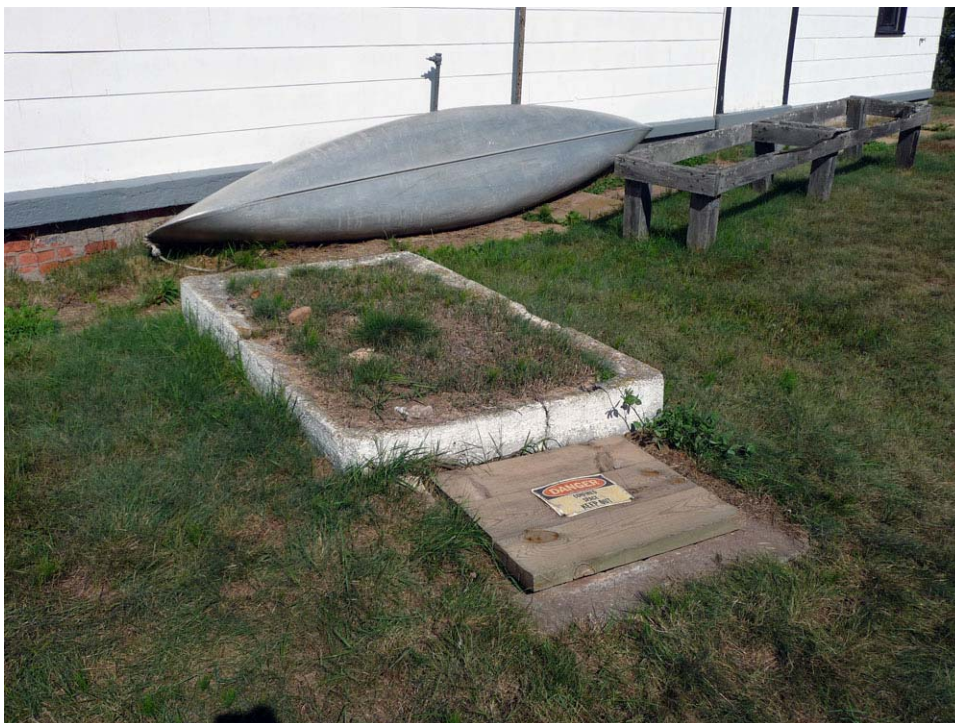
Site Image OI-50: Fog signal cistern foundation, 2009 (Source: MBD P1010929.JPG)

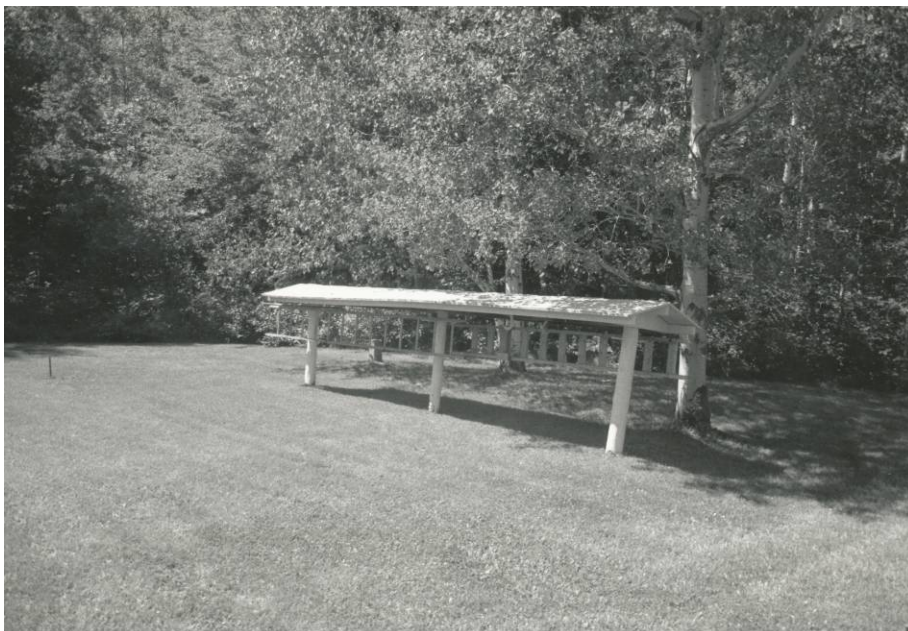
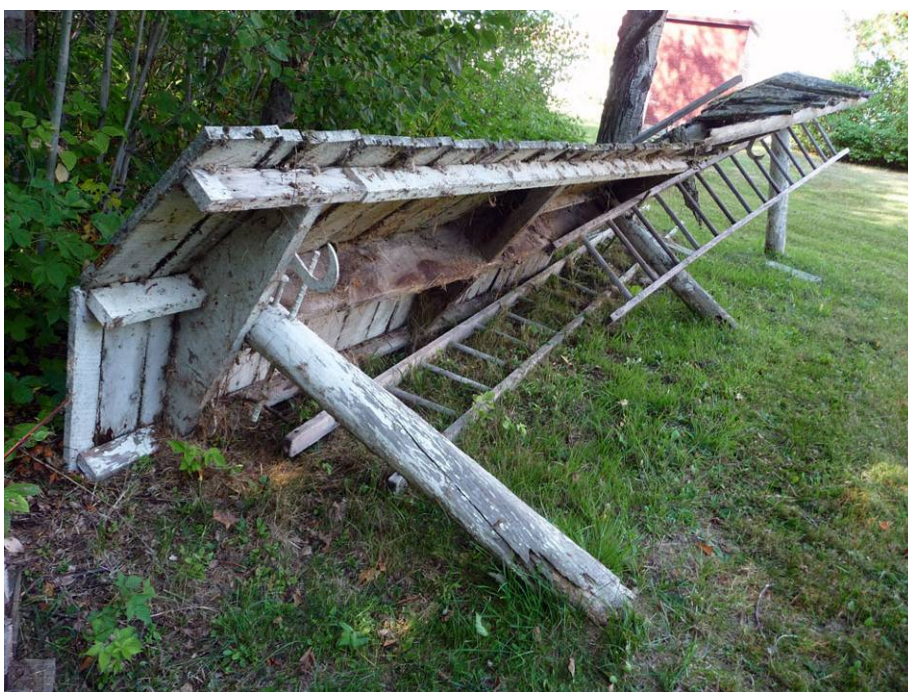
Site Image OI-51: Collapsed ladder stand (c. 1939), above: c. 1980 (Source: NPS APIS Archives); below: c. 2009 (Source: MBD P1010984.JPG)

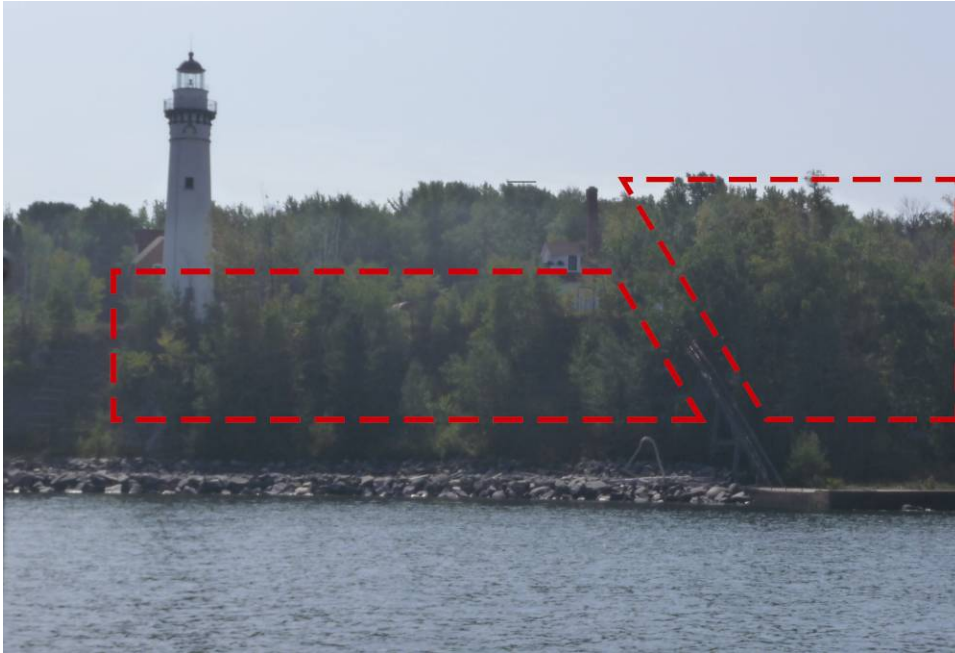
Site Image OI-79: Area of selective clearing for the restoration of views to the light station from Lake Superior, 2010 (Source: MBD P1010831_annotated.JPG)

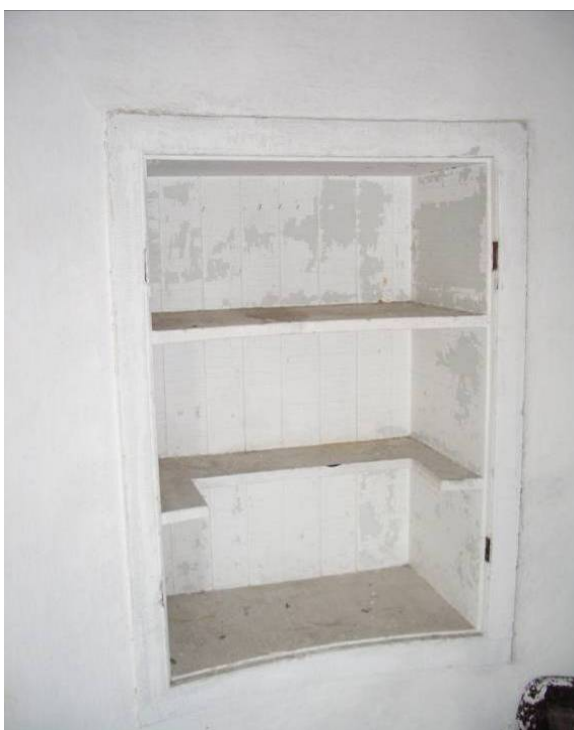
OI-T-07: Tower wood cabinet with missing door (Source: AH IMGP3230)

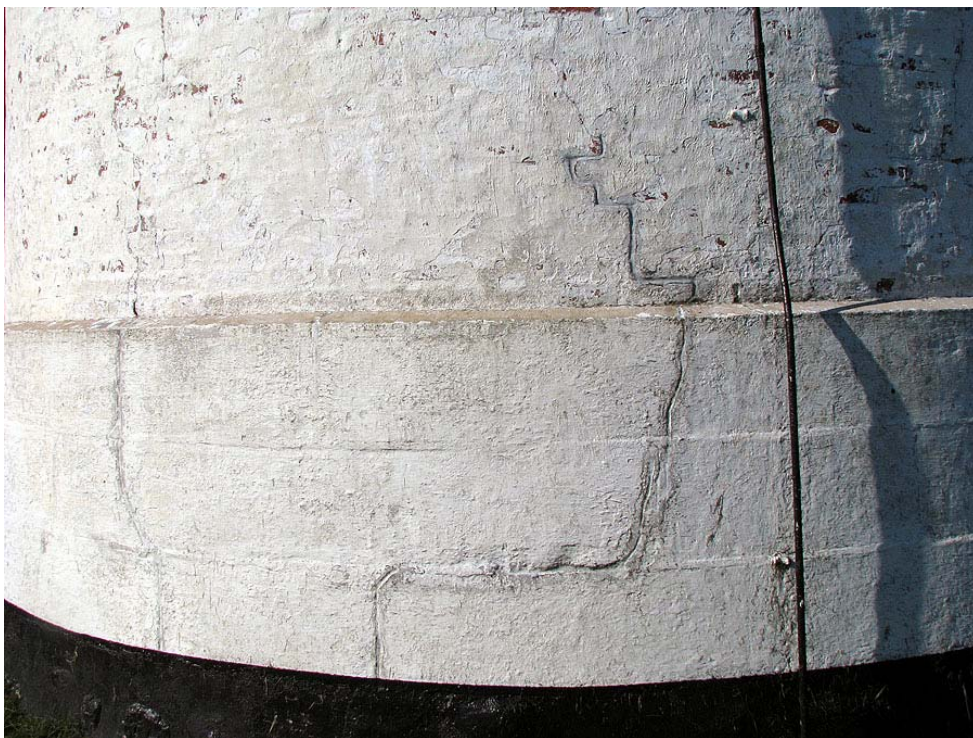
OI-T-16: Foundation and wall cracks (Source: Martin/Martin)

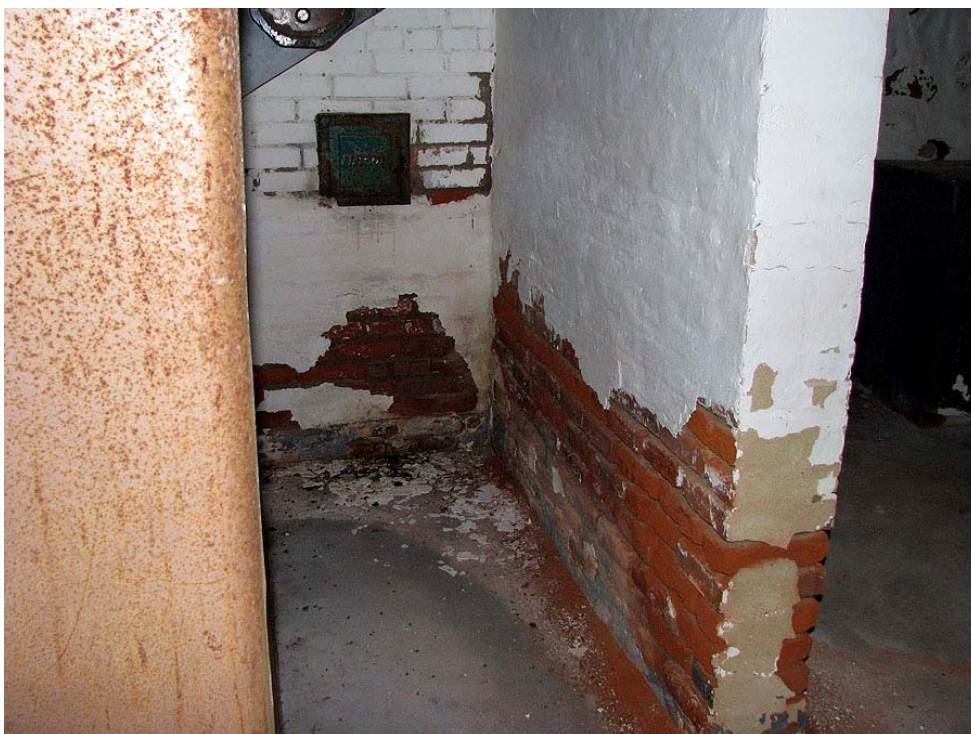
OI-KQ-33: Deteriorated masonry wall in basement (Source: Martin/Martin)
