CULTURAL LANDSCAPE REPORT • HISTORIC STRUCTURE REPORT

VOLUME IV OF VI: DEVILS ISLAND CLR/HSR

**CULTURAL LANDSCAPE REPORT, HISTORIC STRUCTURE REPORT
AND
ENVIRONMENTAL ASSESSMENT**

prepared by
Anderson Hallas Architects, PC
Golden, Colorado

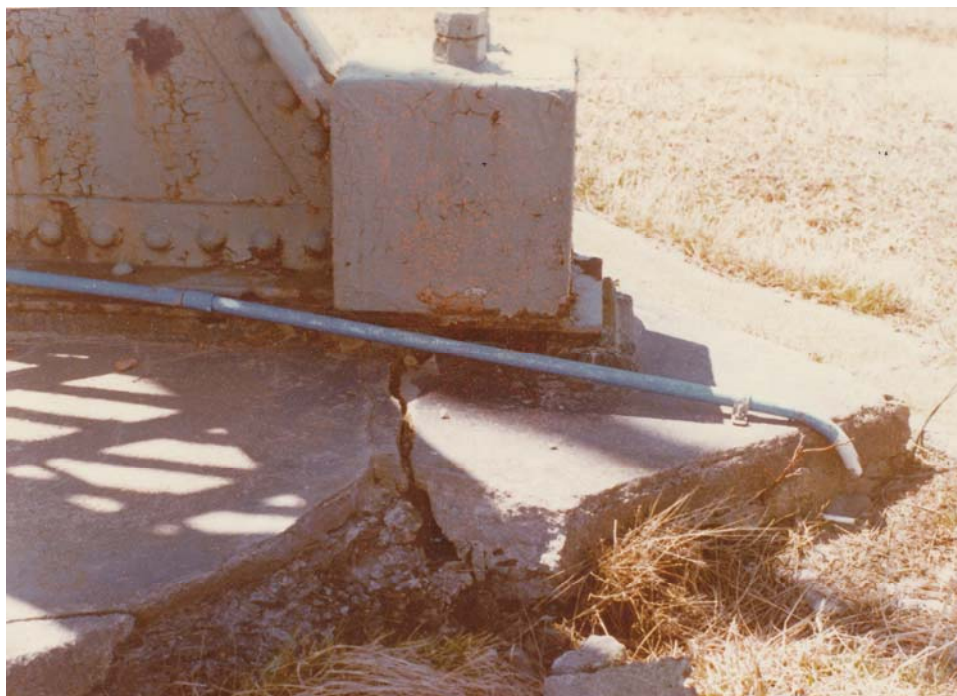
Historic Image DI-23: Devils Island Tower Foundation before repair work, 1978 (Source: NPS APIS Archives)

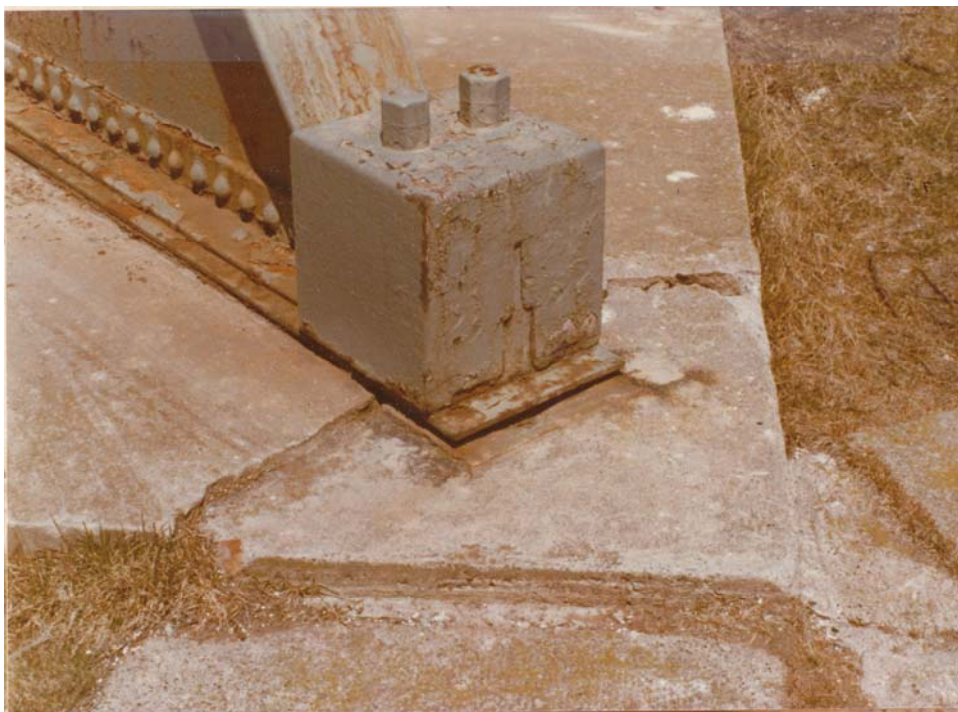
Historic Image DI-24: Devils Island Tower Foundation before repair work, 1978 (Source: NPS APIS Archives)

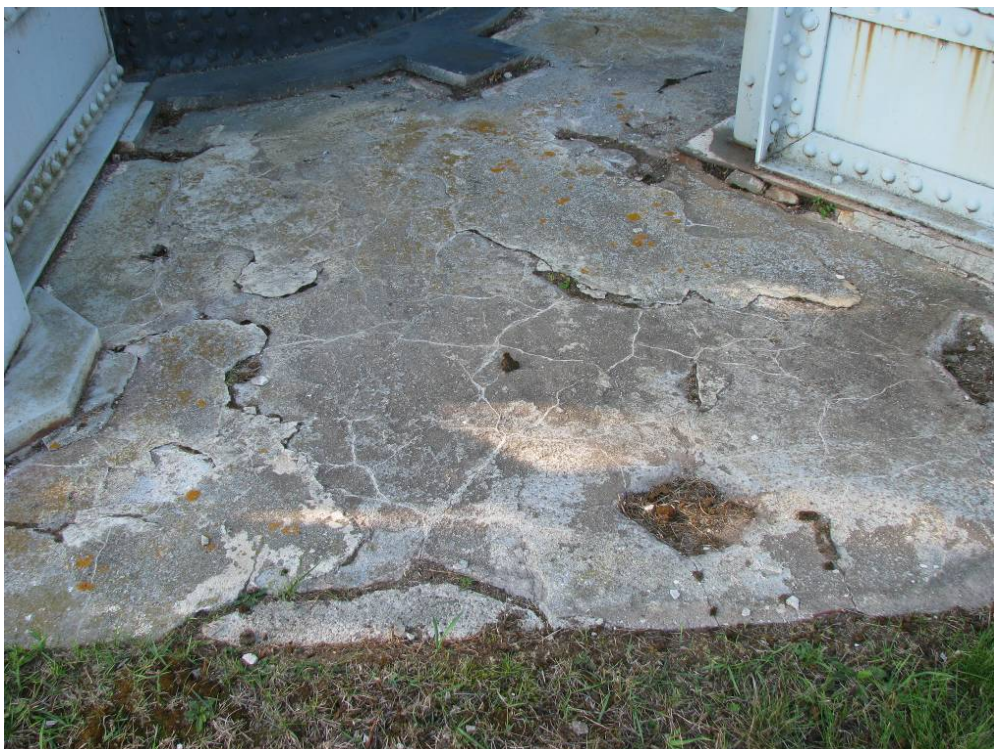
DI-LS-17: Severe cracking of mat foundation (Source: Martin/Martin)

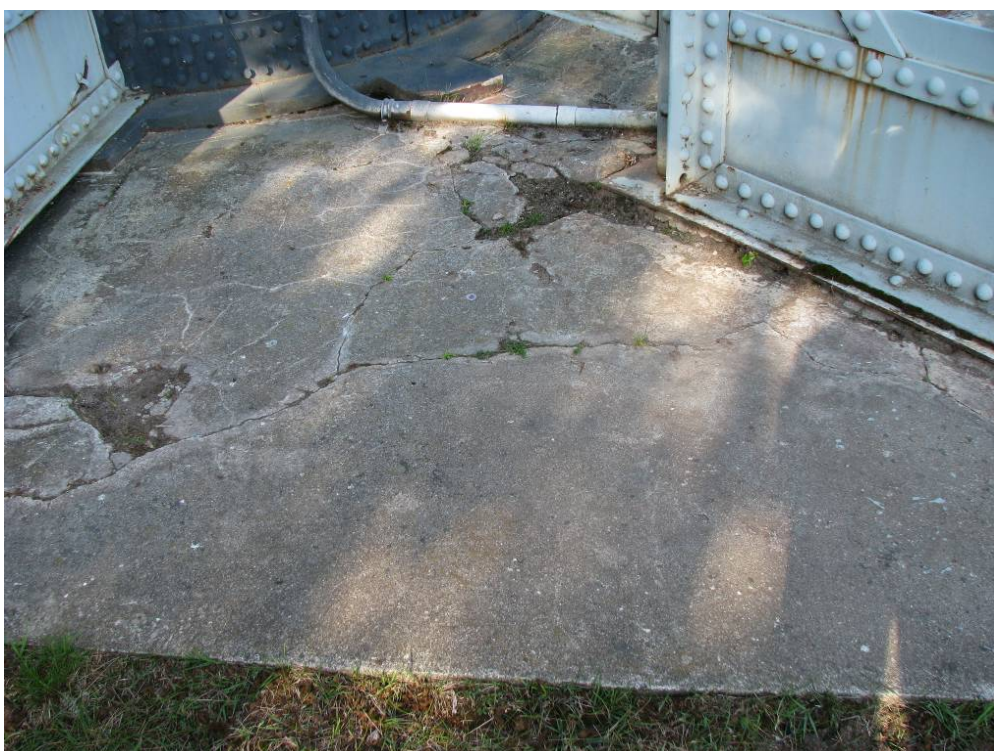
DI-LS-18: Cracking of mat foundation (Source: Martin/Martin)

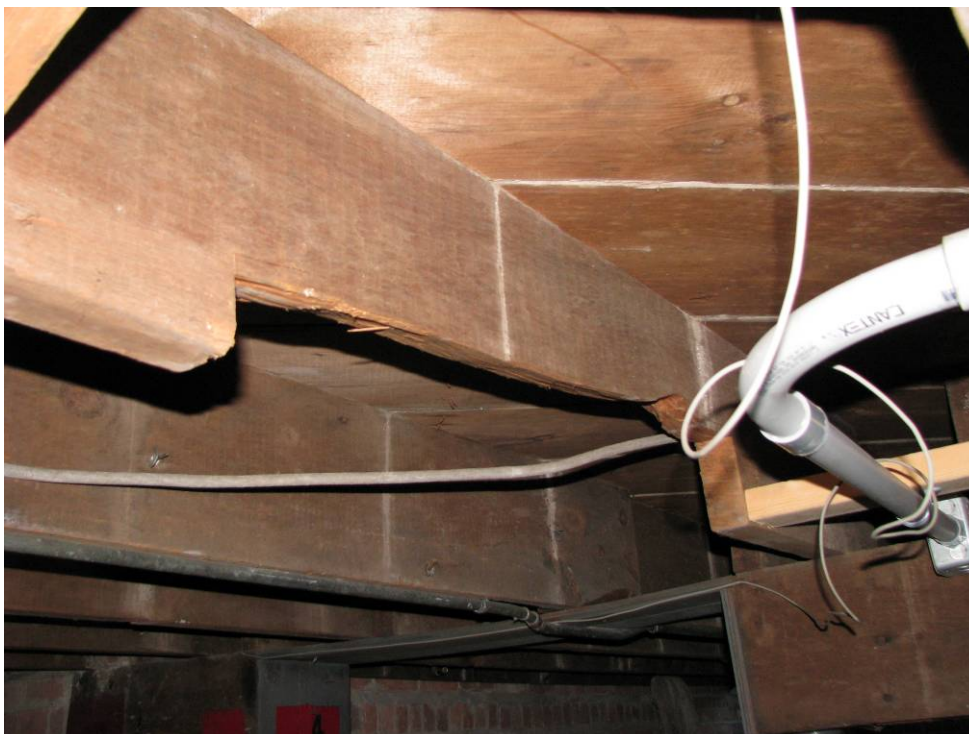
DI-KQ-35: Damaged floor joist (Source: Martin/Martin)

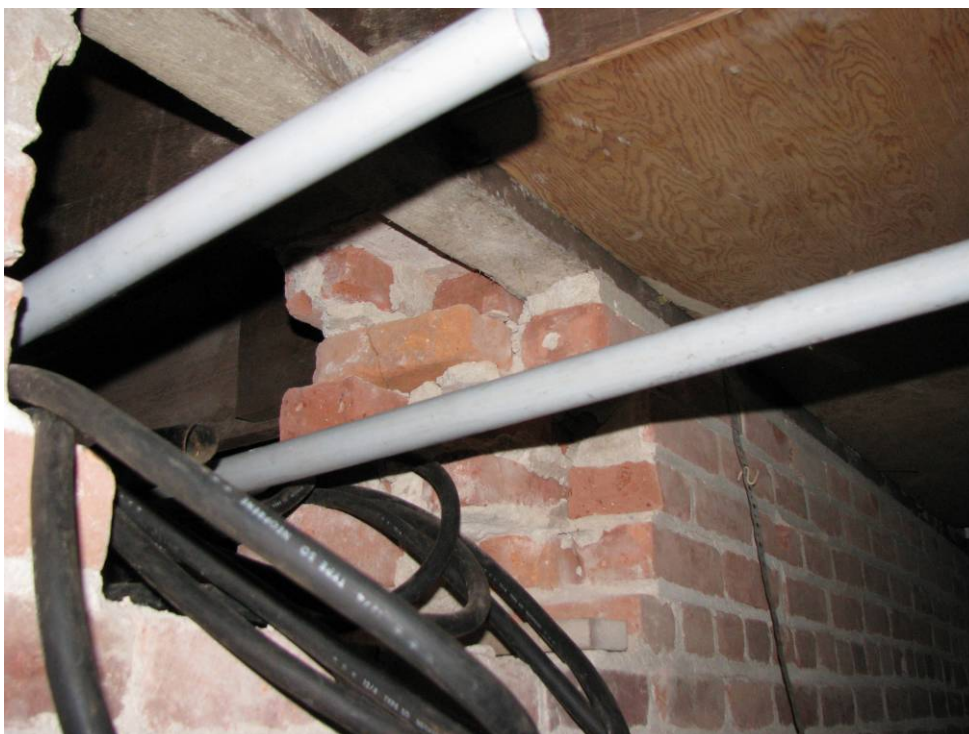
DI-KQ-36: No joist support at cistern (Source: Martin/Martin)

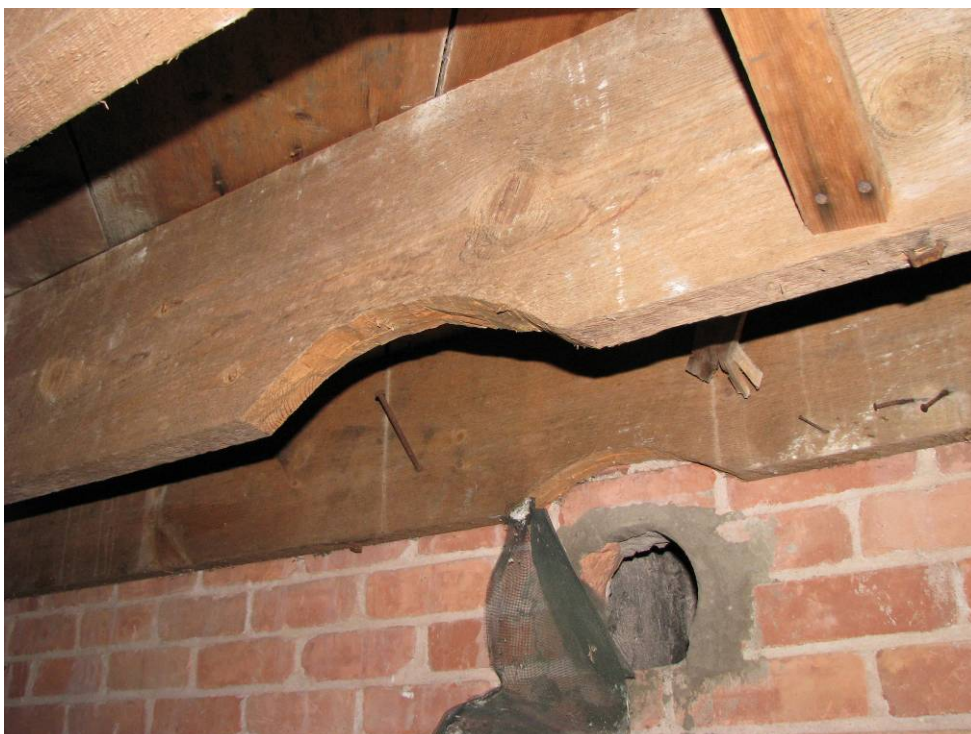
DI-AKQ-32: Damaged floor joist (Source: Martin/Martin)

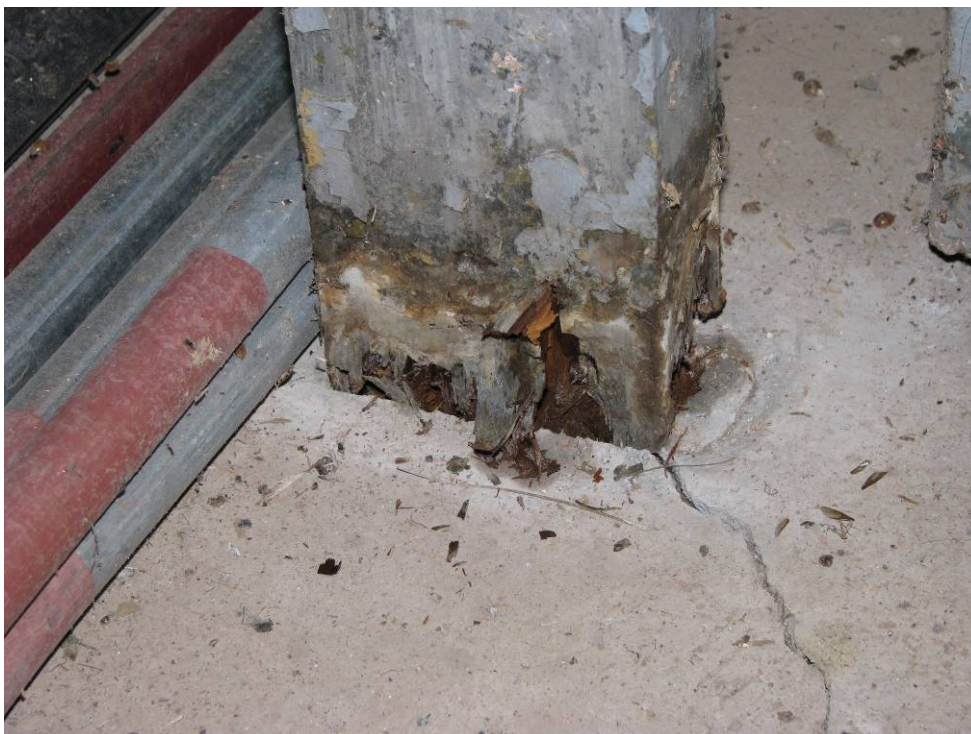
DI-AKQ-33: Deterioration at base of post at basement (Source: Martin/Martin)

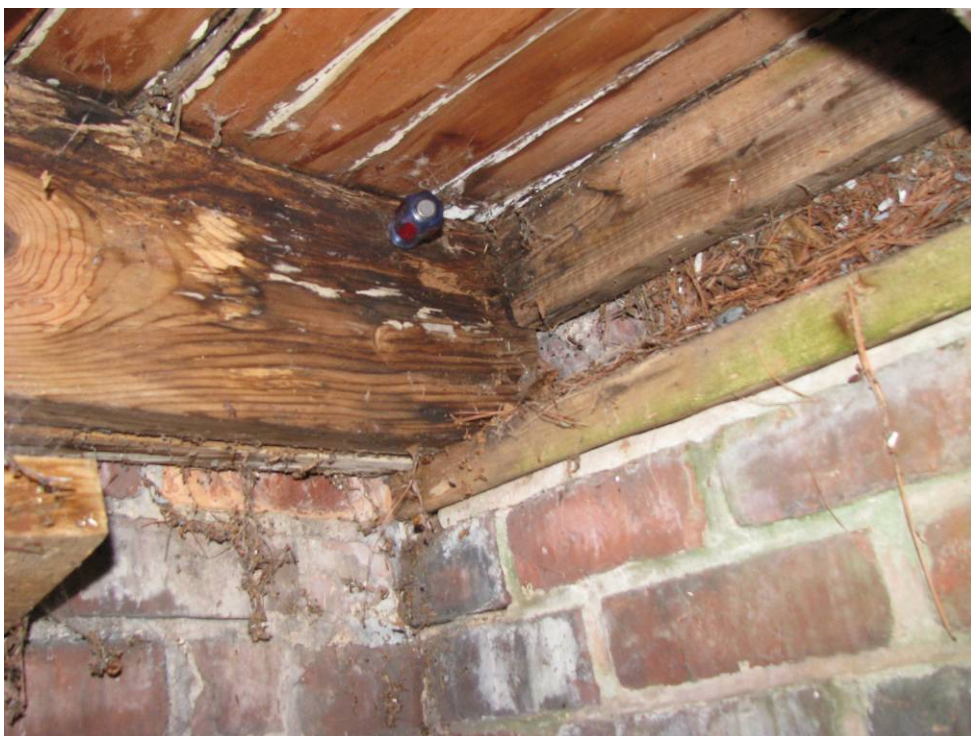
DI-AKQ-34: Deterioration at front porch (Source: Martin/Martin)

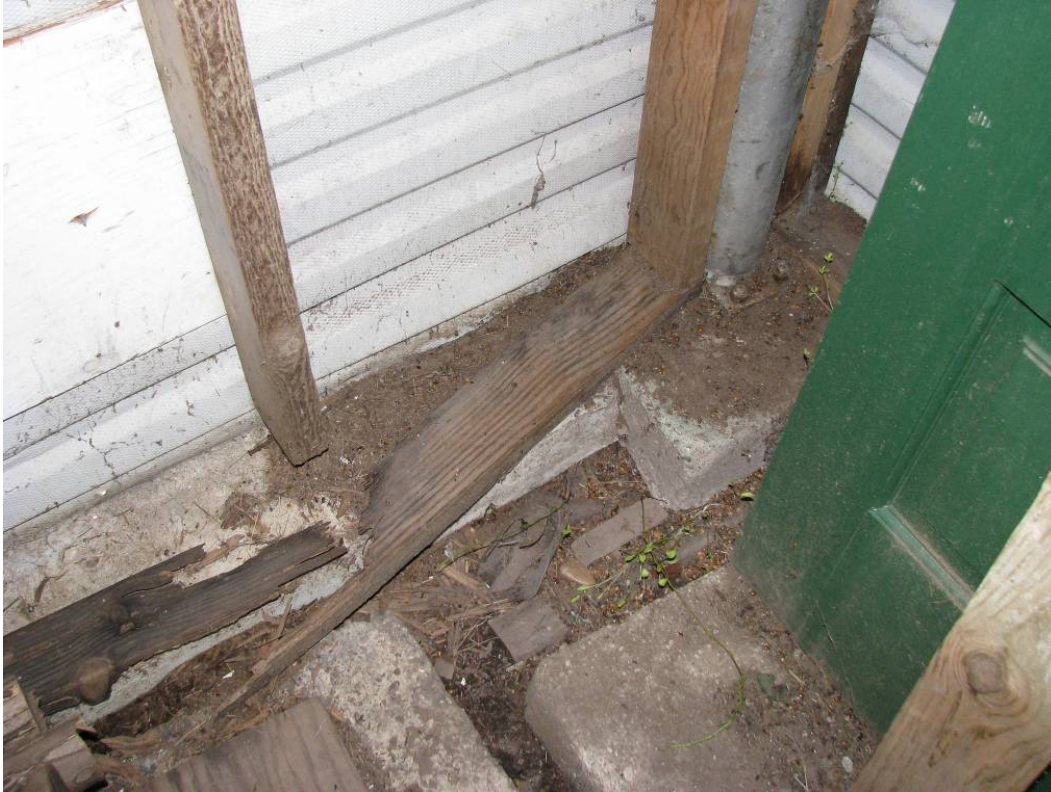
DI-FSB-24: Deteriorated sill plate (Source: Martin/Martin)
