VOLUME V OF VI: LONG ISLAND CLR/HSR

**APOSTLE ISLANDS NATIONAL LAKESHORE
LIGHT STATIONS OF MICHIGAN ISLAND, OUTER ISLAND, DEVILS ISLAND,
LONG ISLAND AND SAND ISLAND**

**CULTURAL LANDSCAPE REPORT, HISTORIC STRUCTURE REPORT
AND
ENVIRONMENTAL ASSESSMENT**

prepared by
Anderson Hallas Architects, PC
Golden, Colorado

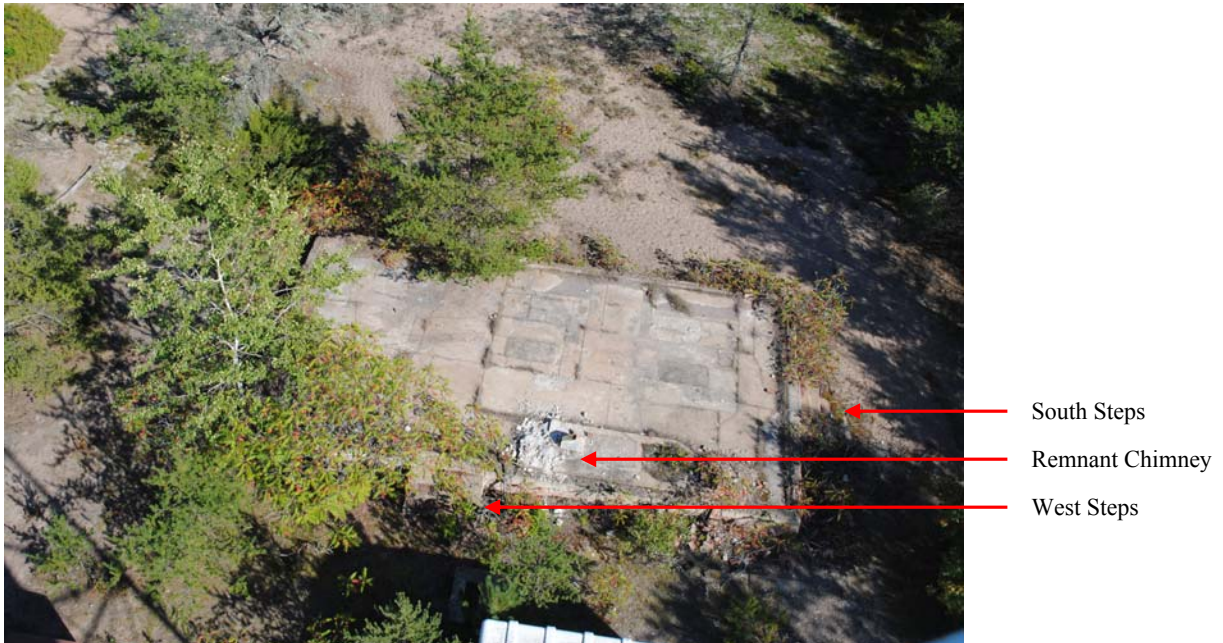
Site Image LI-43: Fog Signal Building foundation as viewed from LaPointe Light Tower, 2009 (Source: MBD DSC_0152.JPG)

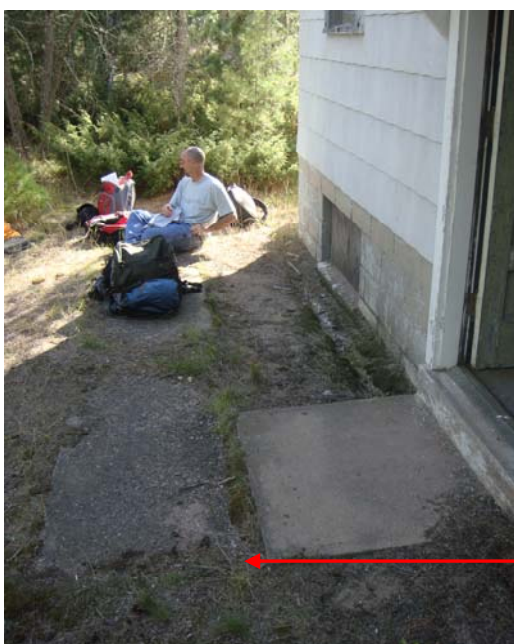
Area of Damaged Concrete

Site Image LI-52: Concrete walk east of Triplex, 2009 (Source: MBD DSC01343.JPG)

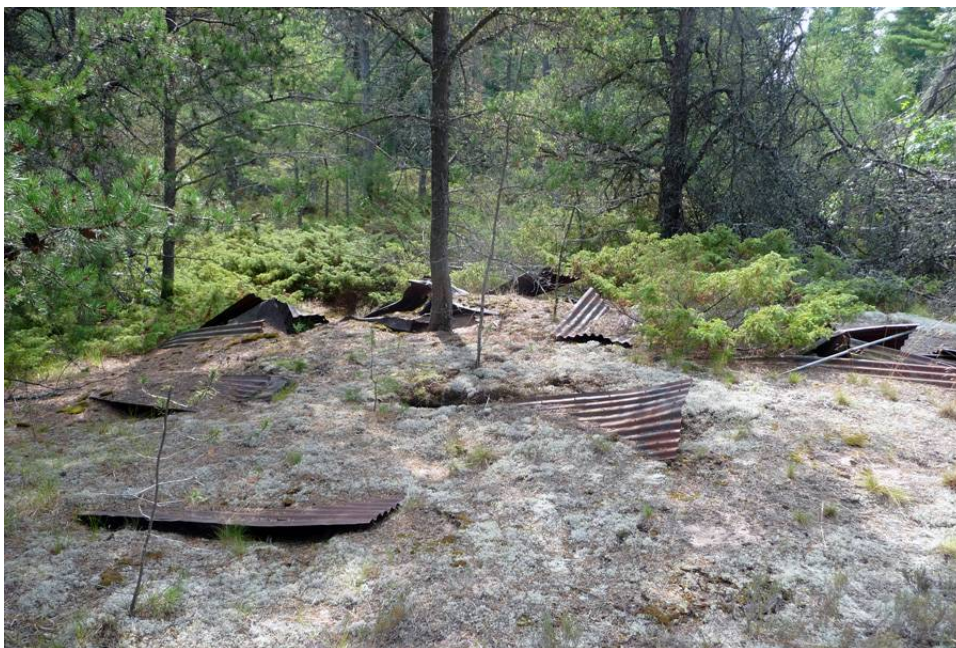
Site Image LI-58: Rubble pile west of Fog Signal Building foundation, 2009 (Source: MBD P1020347.JPG)

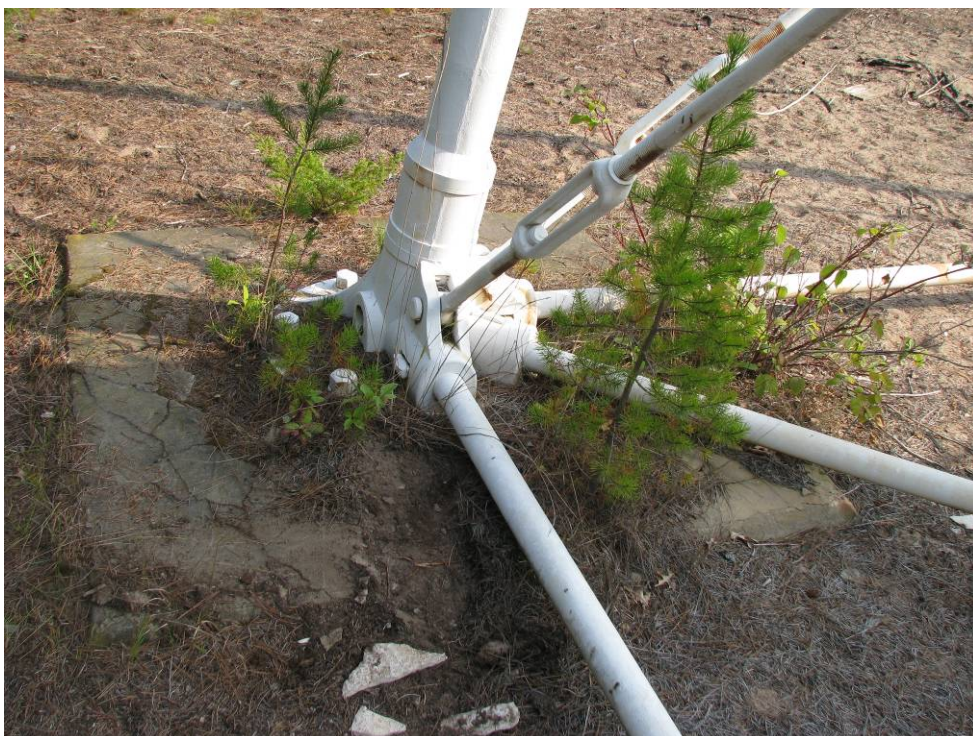
LI-LT-20: Deteriorated footing (Source: Martin/Martin)

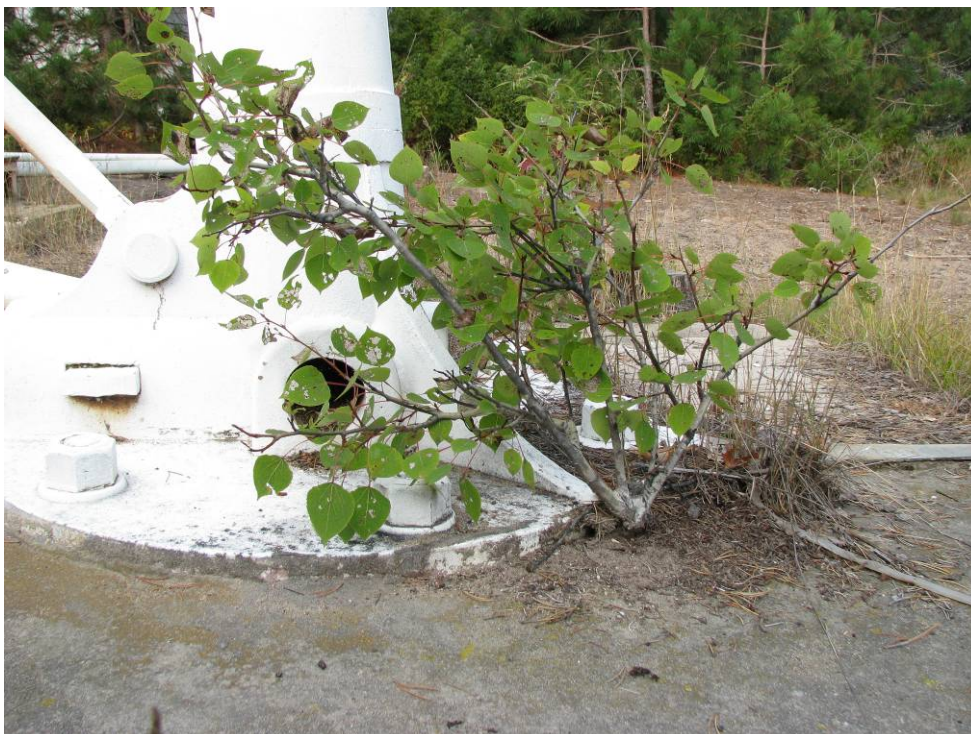
LI-LT-21: Deteriorated footing (Source: Martin/Martin)

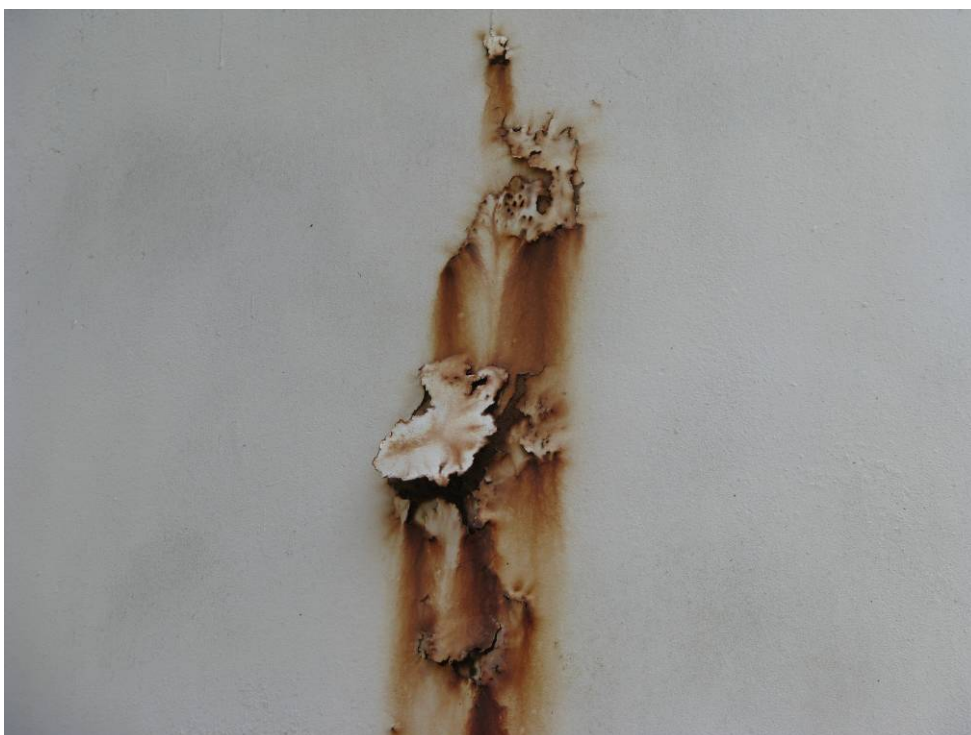
LI-LT-22: Surface delamination (Source: Martin/Martin)

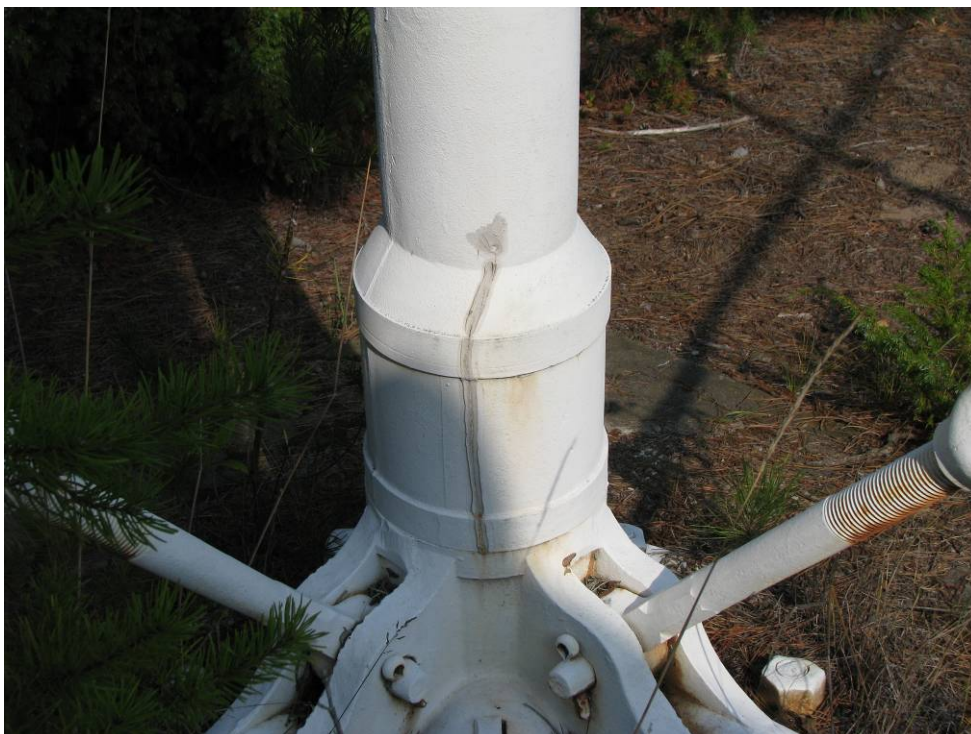
LI-LT-25: Cracked brace (Source: Martin/Martin)

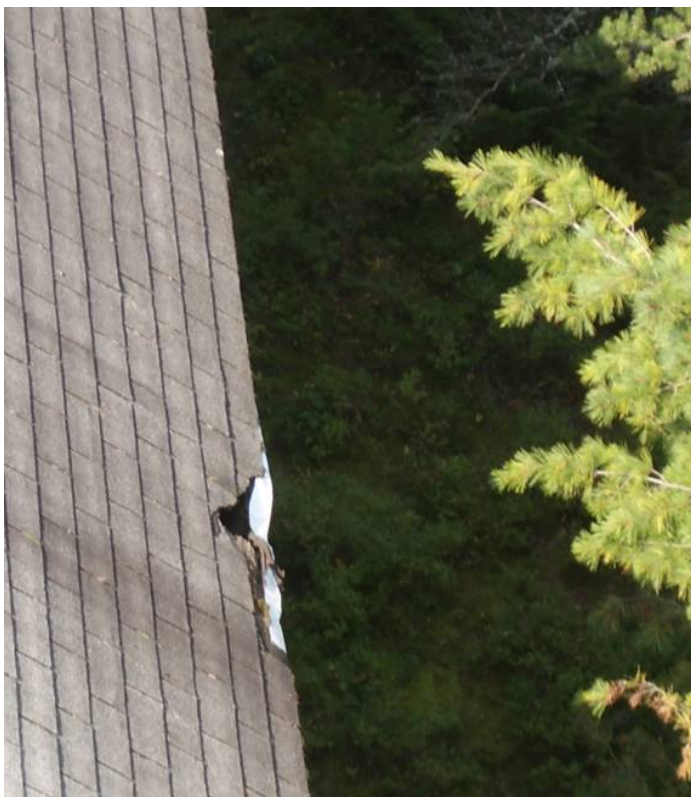
LI-TX-07: Roof damage at southeastern portion (Source: AH IMGP2987)

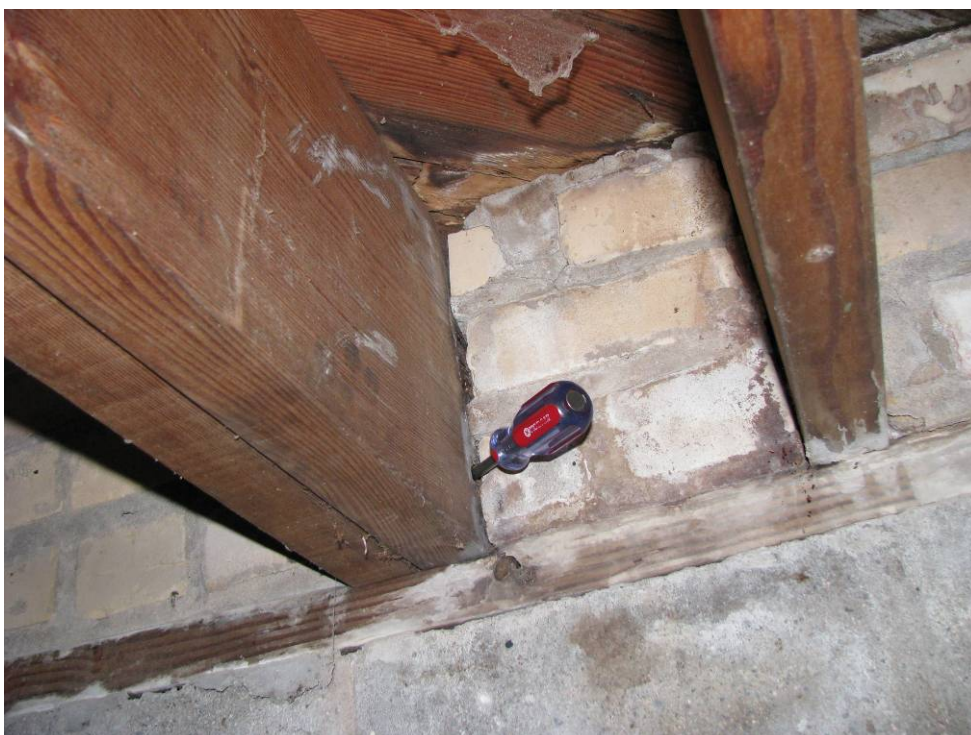
LI-TX-44: Deteriorated floor joist (Source: Martin/Martin)

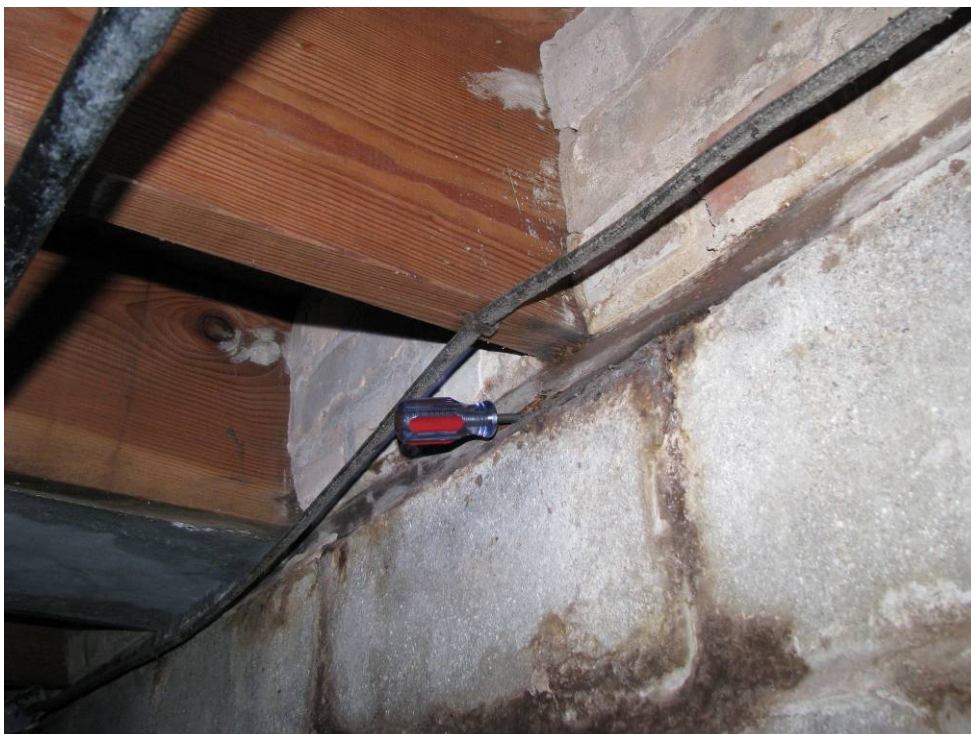
LI-TX-45: Deteriorated sill plate (Source: Martin/Martin)
