VOLUME VI OF VI: SAND ISLAND CLR/HSR

APOSTLE ISLANDS NATIONAL LAKESHORE
LIGHT STATIONS OF MICHIGAN ISLAND, OUTER ISLAND, DEVILS ISLAND,
LONG ISLAND AND SAND ISLAND

JULY 2011

**CULTURAL LANDSCAPE REPORT, HISTORIC STRUCTURE REPORT
AND
ENVIRONMENTAL ASSESSMENT**

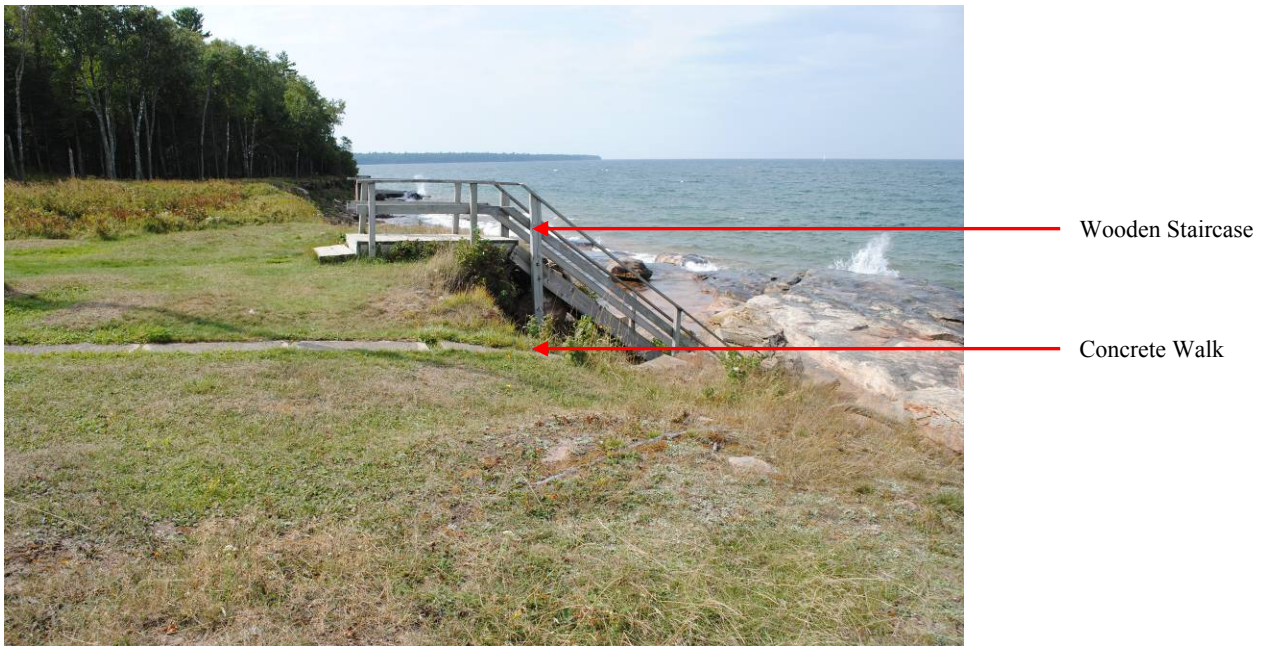
Site Image SI-38: Wooden staircase at north landing offset from historic concrete walk, 2009 (Source: MBD DSC_0263.JPG)

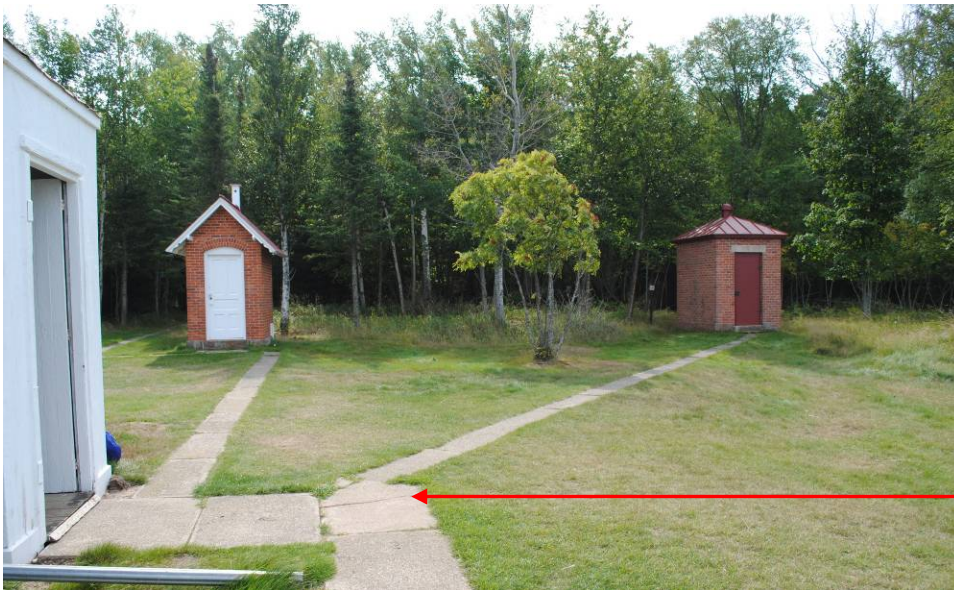
Site Image SI-43: Typical concrete walk of precast slabs, and center, area of replacement concrete, 2009 (Source: MBD DSC_0288.JPG)

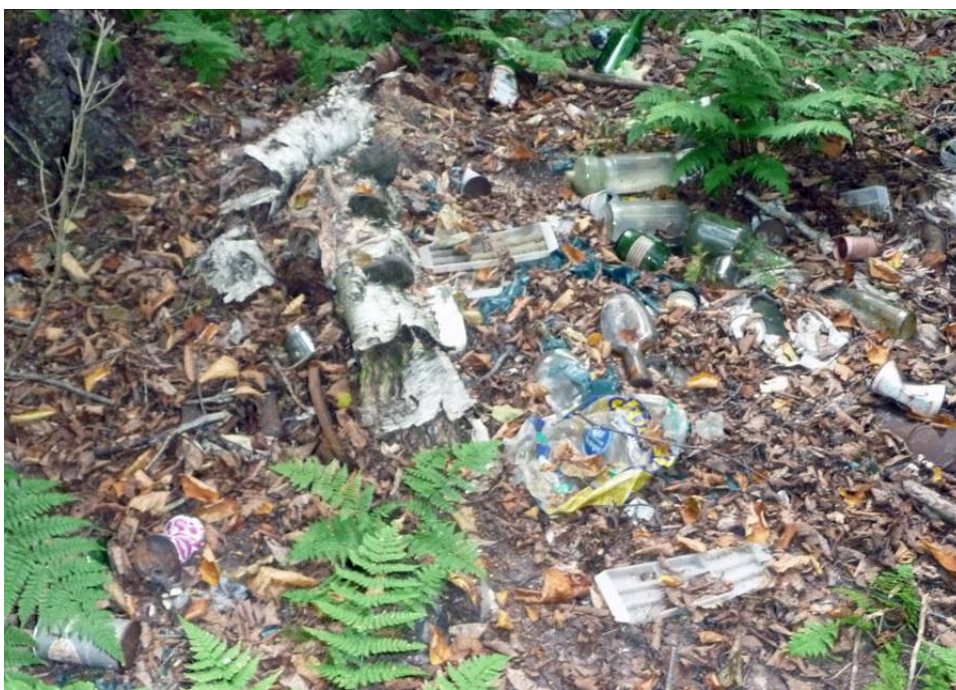
Site Image SI-45: Dump site No. 1, 2009 (Source: MBD P1020382.JPG)

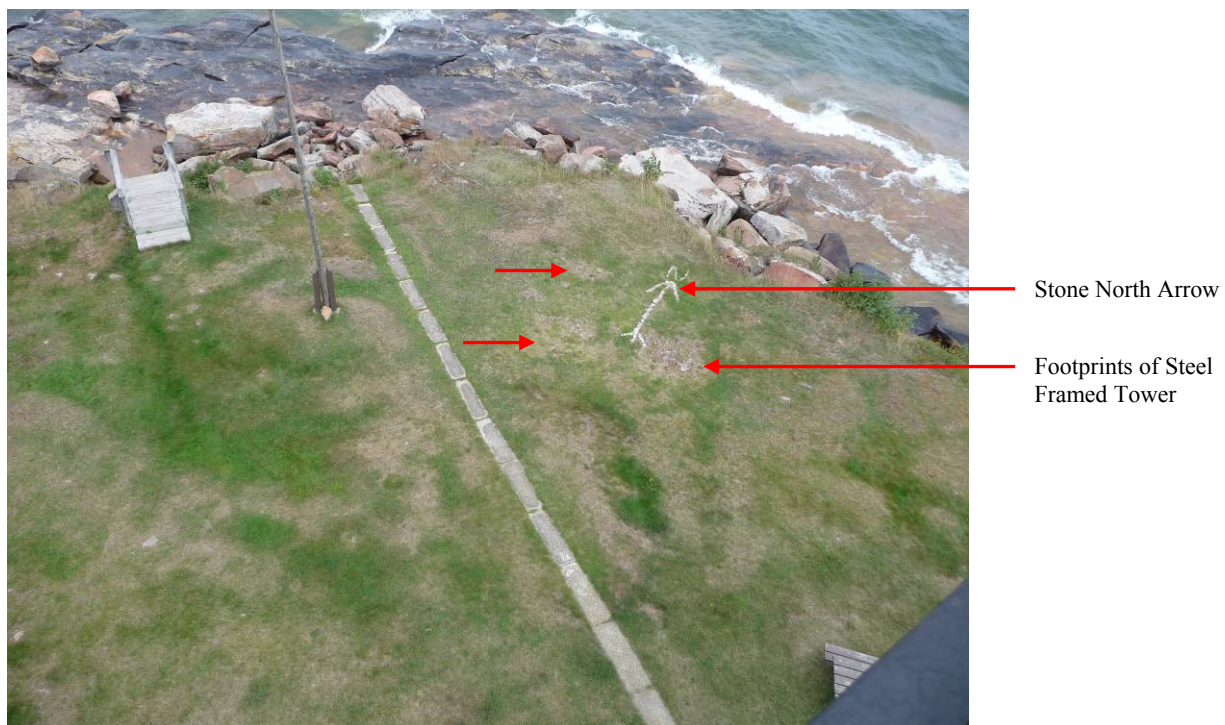
Site Image SI-56: Footprints of steel framed tower (indicated by arrows above) and stone north arrow, 2009 (Source: MBD P1020412.JPG)

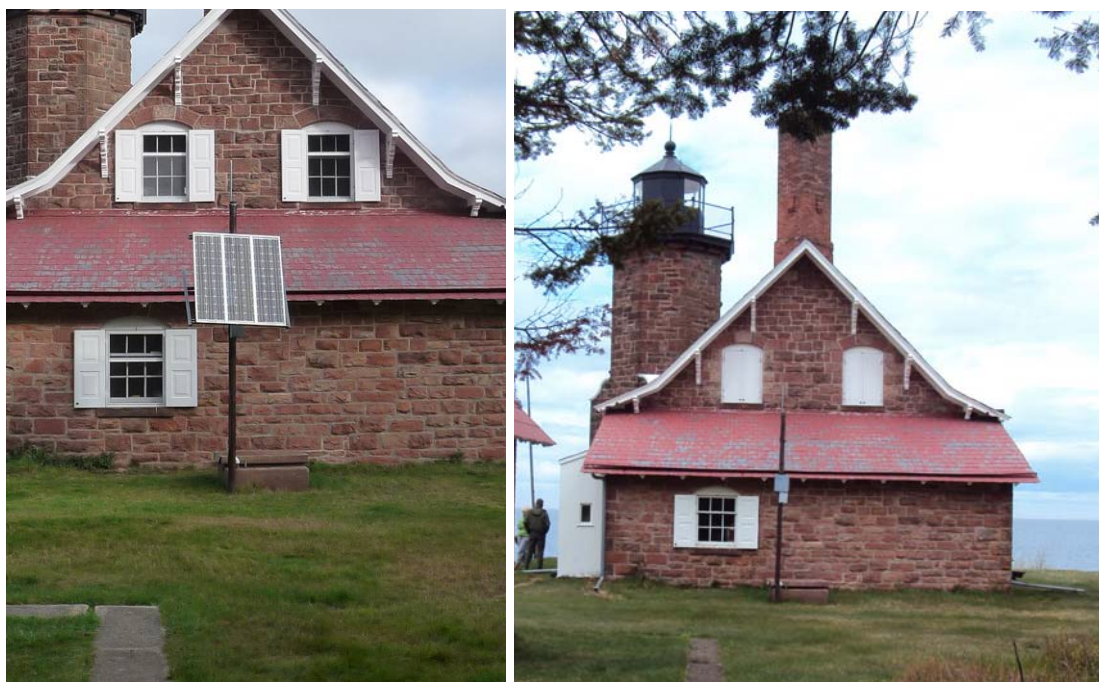
Site Image SI-57: Solar panel and battery unit before and after recent damage: left, 2009 (Source: MBD P1020383.JPG); right, 2011 (Source: MBD DSC00849.JPG)
