Reference: Apostle Islands National Lakeshore, Package No. 150,
Little Sand Bay, Historic Structure Report, Hokenson
Fish Dock Buildings

HISTORIC STRUCTURE REPORT

ARCHITECTURAL DATA SECTION

HOKENSON FISH DOCK BUILDINGS

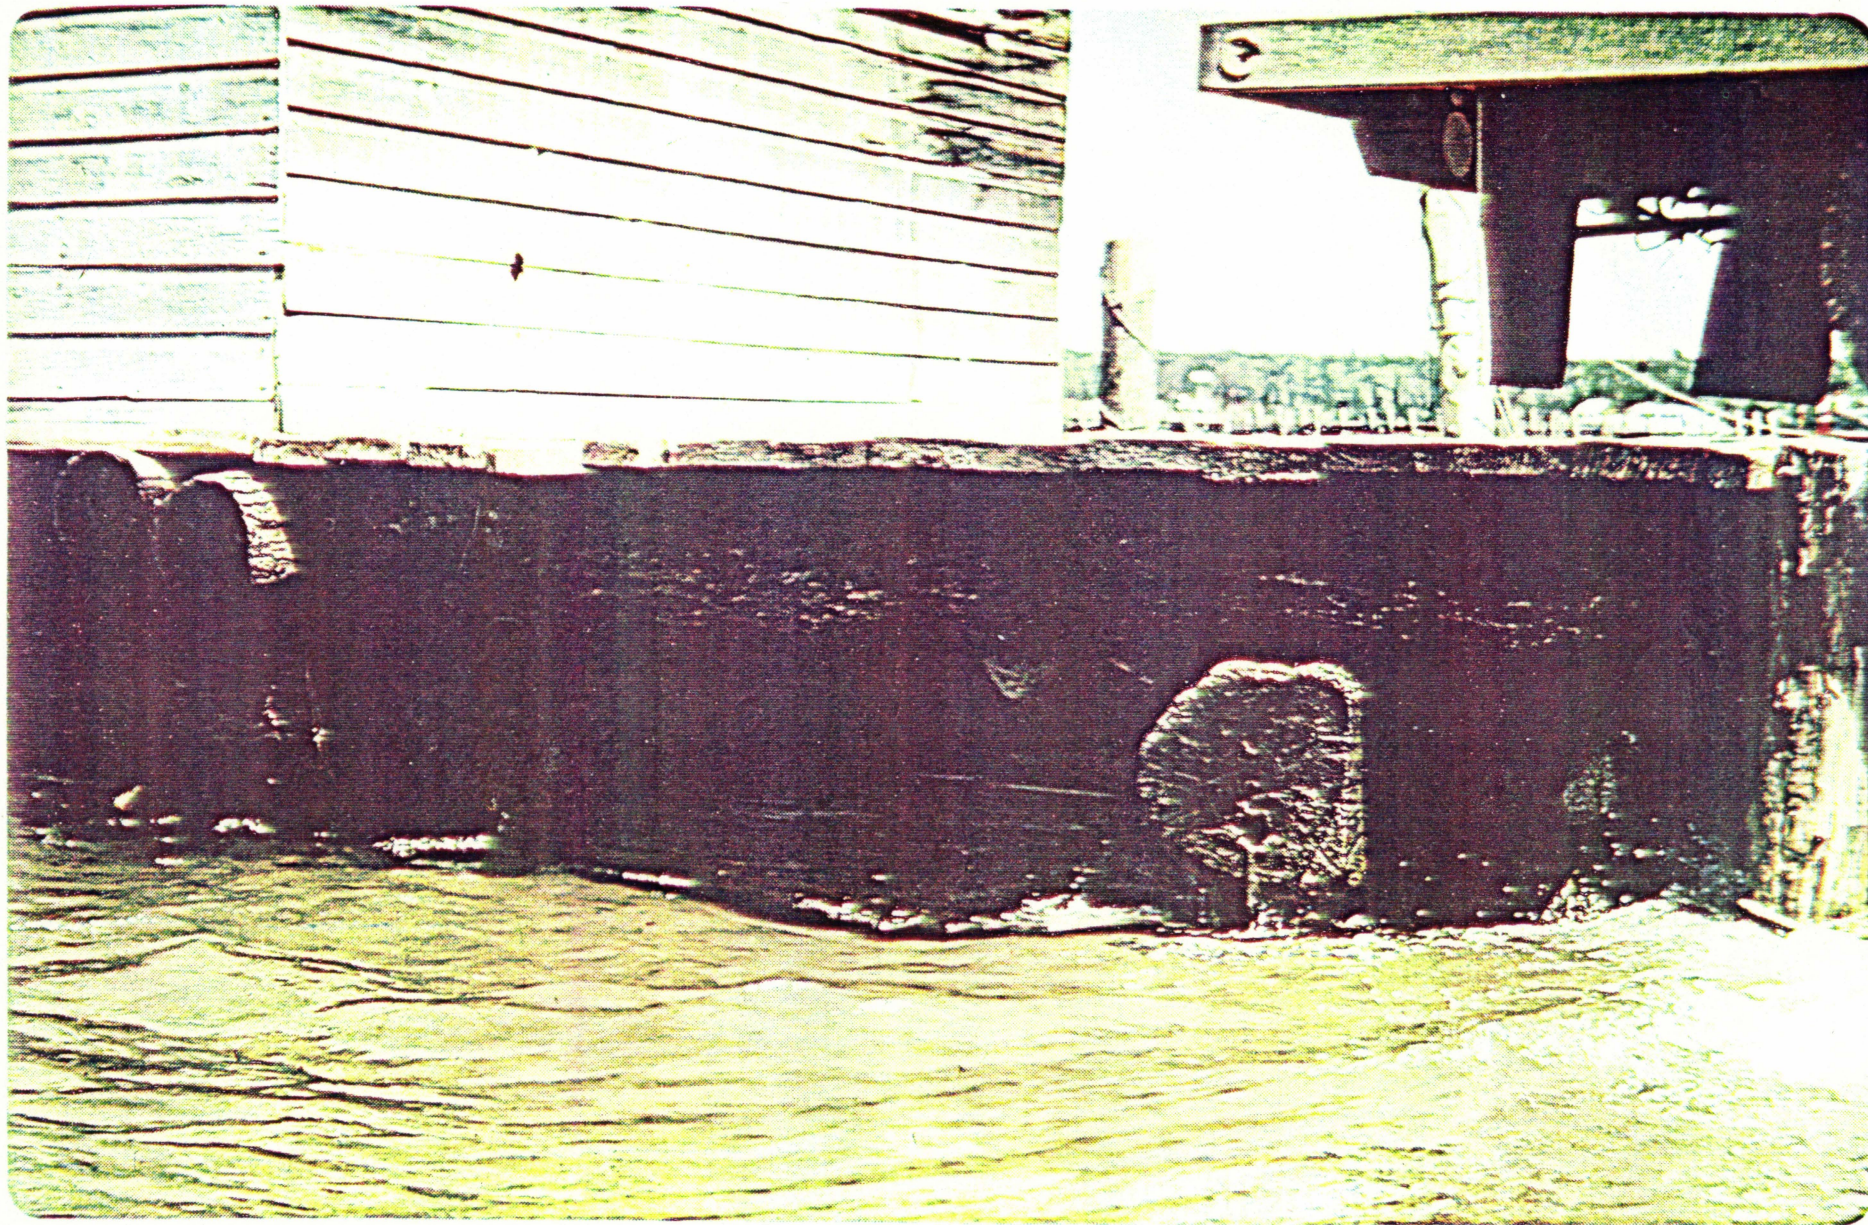
Existing Dock Pilings and Cribbing

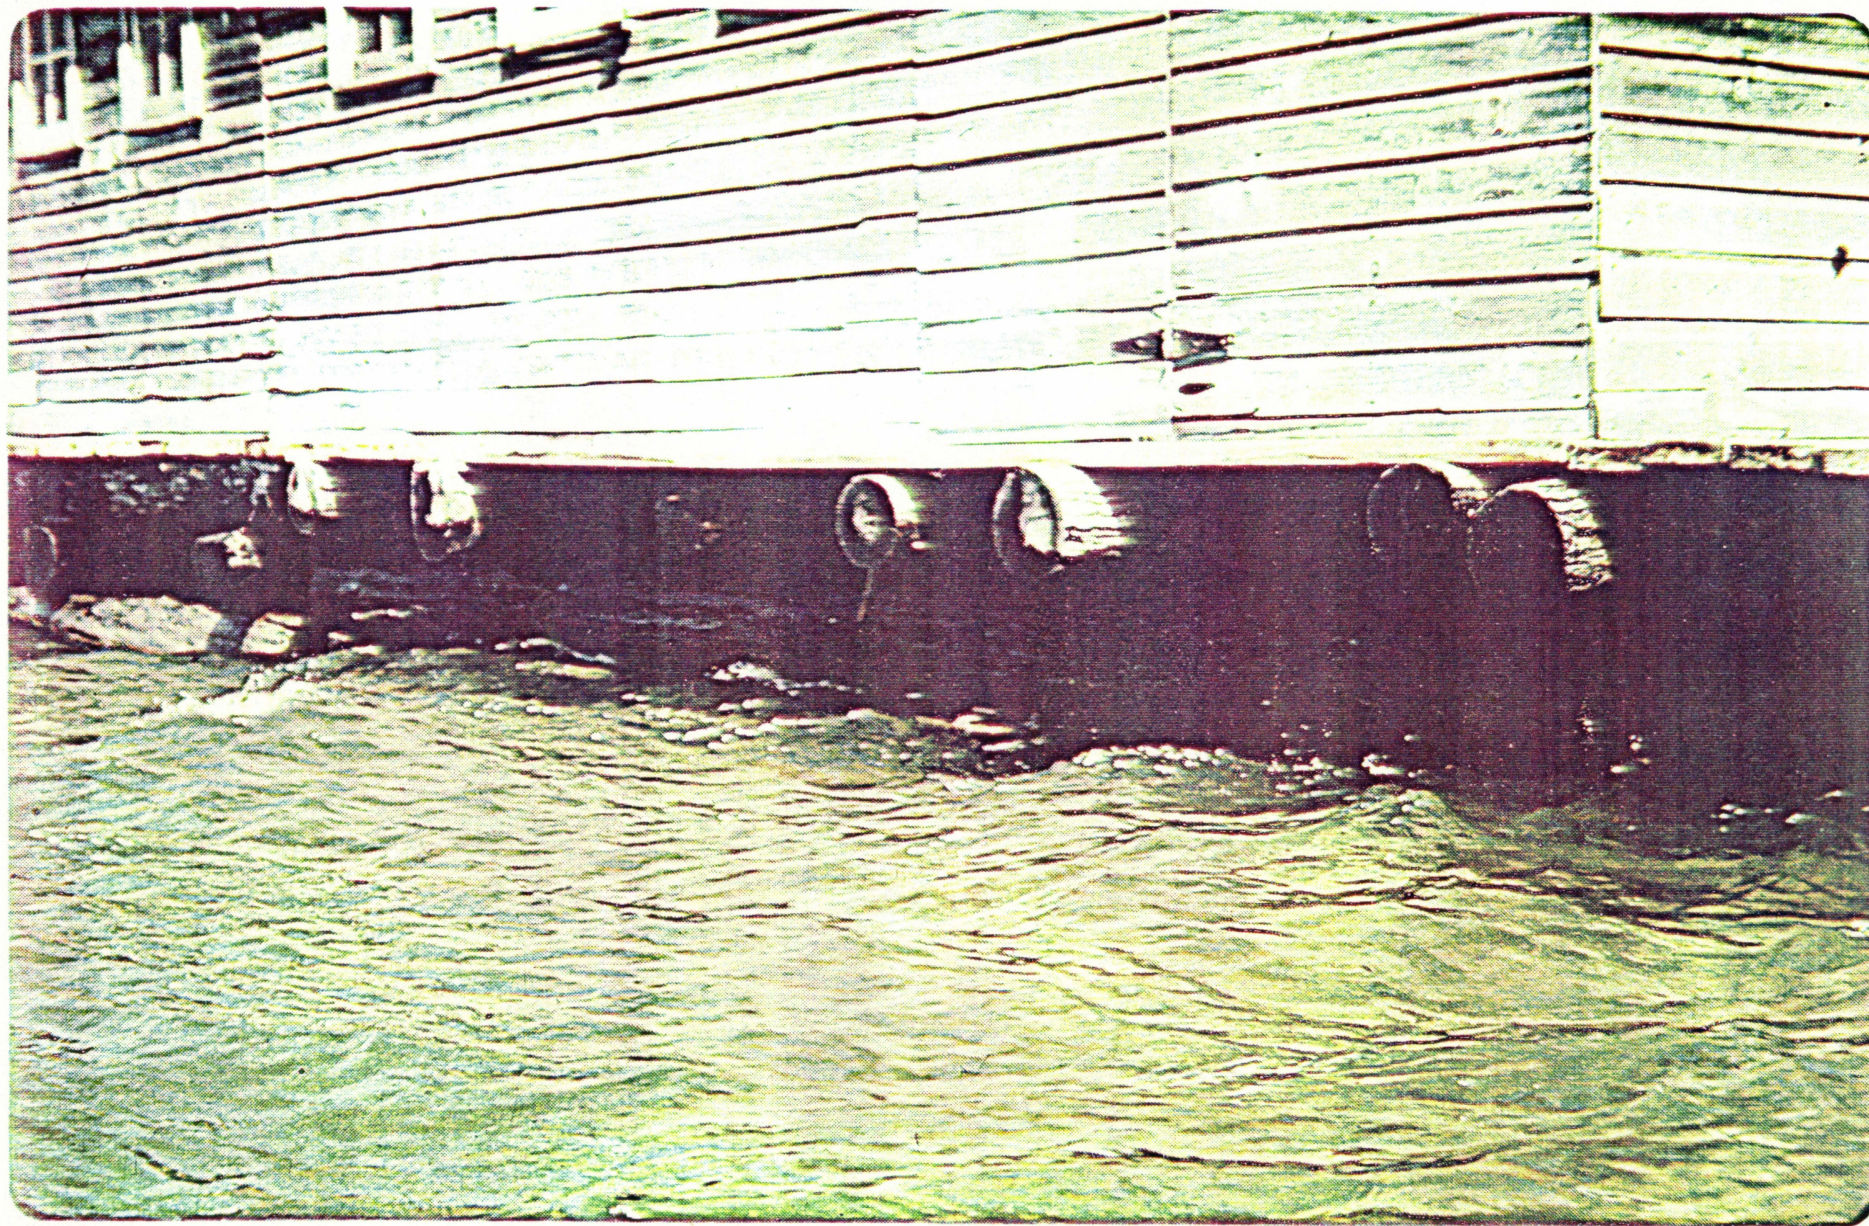
Existing Pilings and Cribbing - West Side

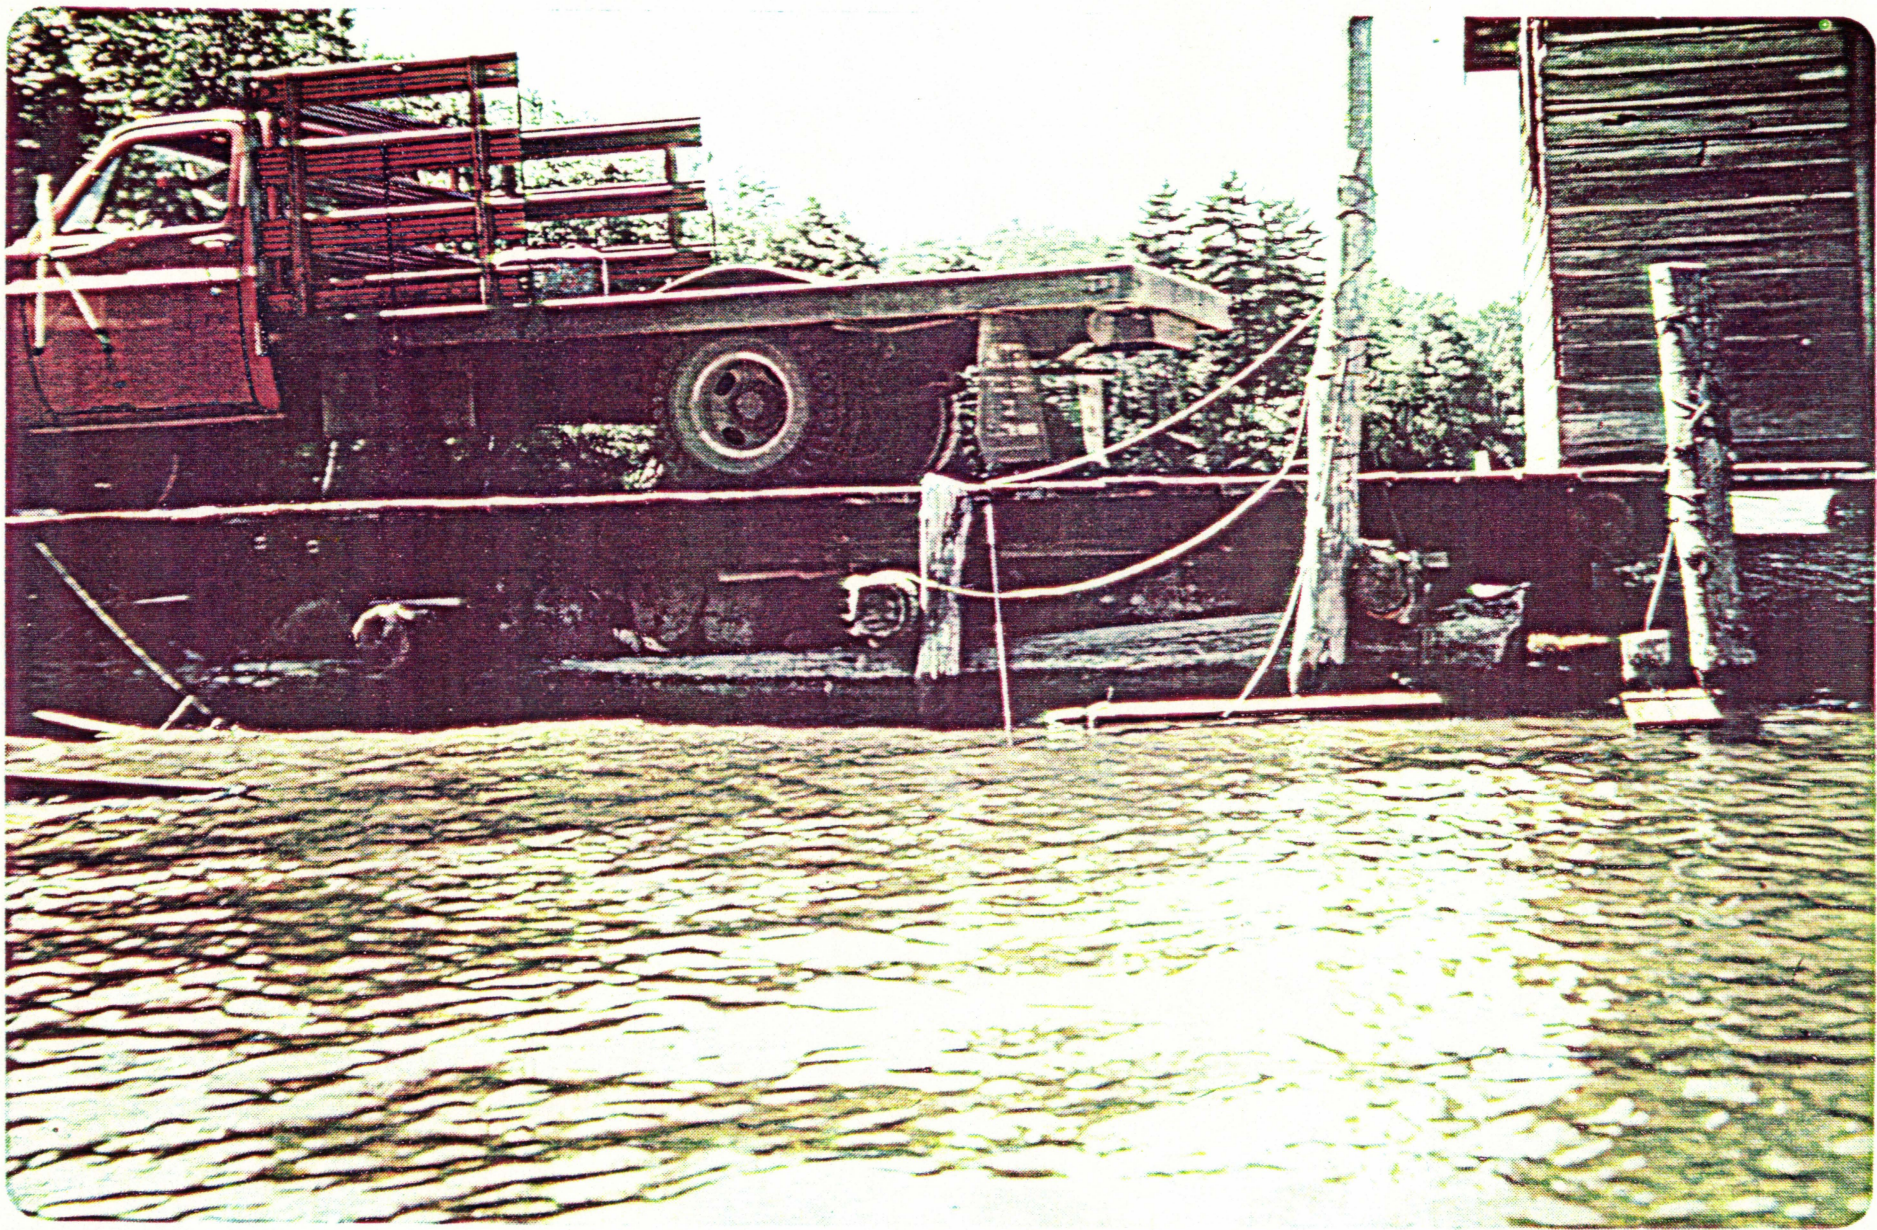
Existing Pilings and Cribbing

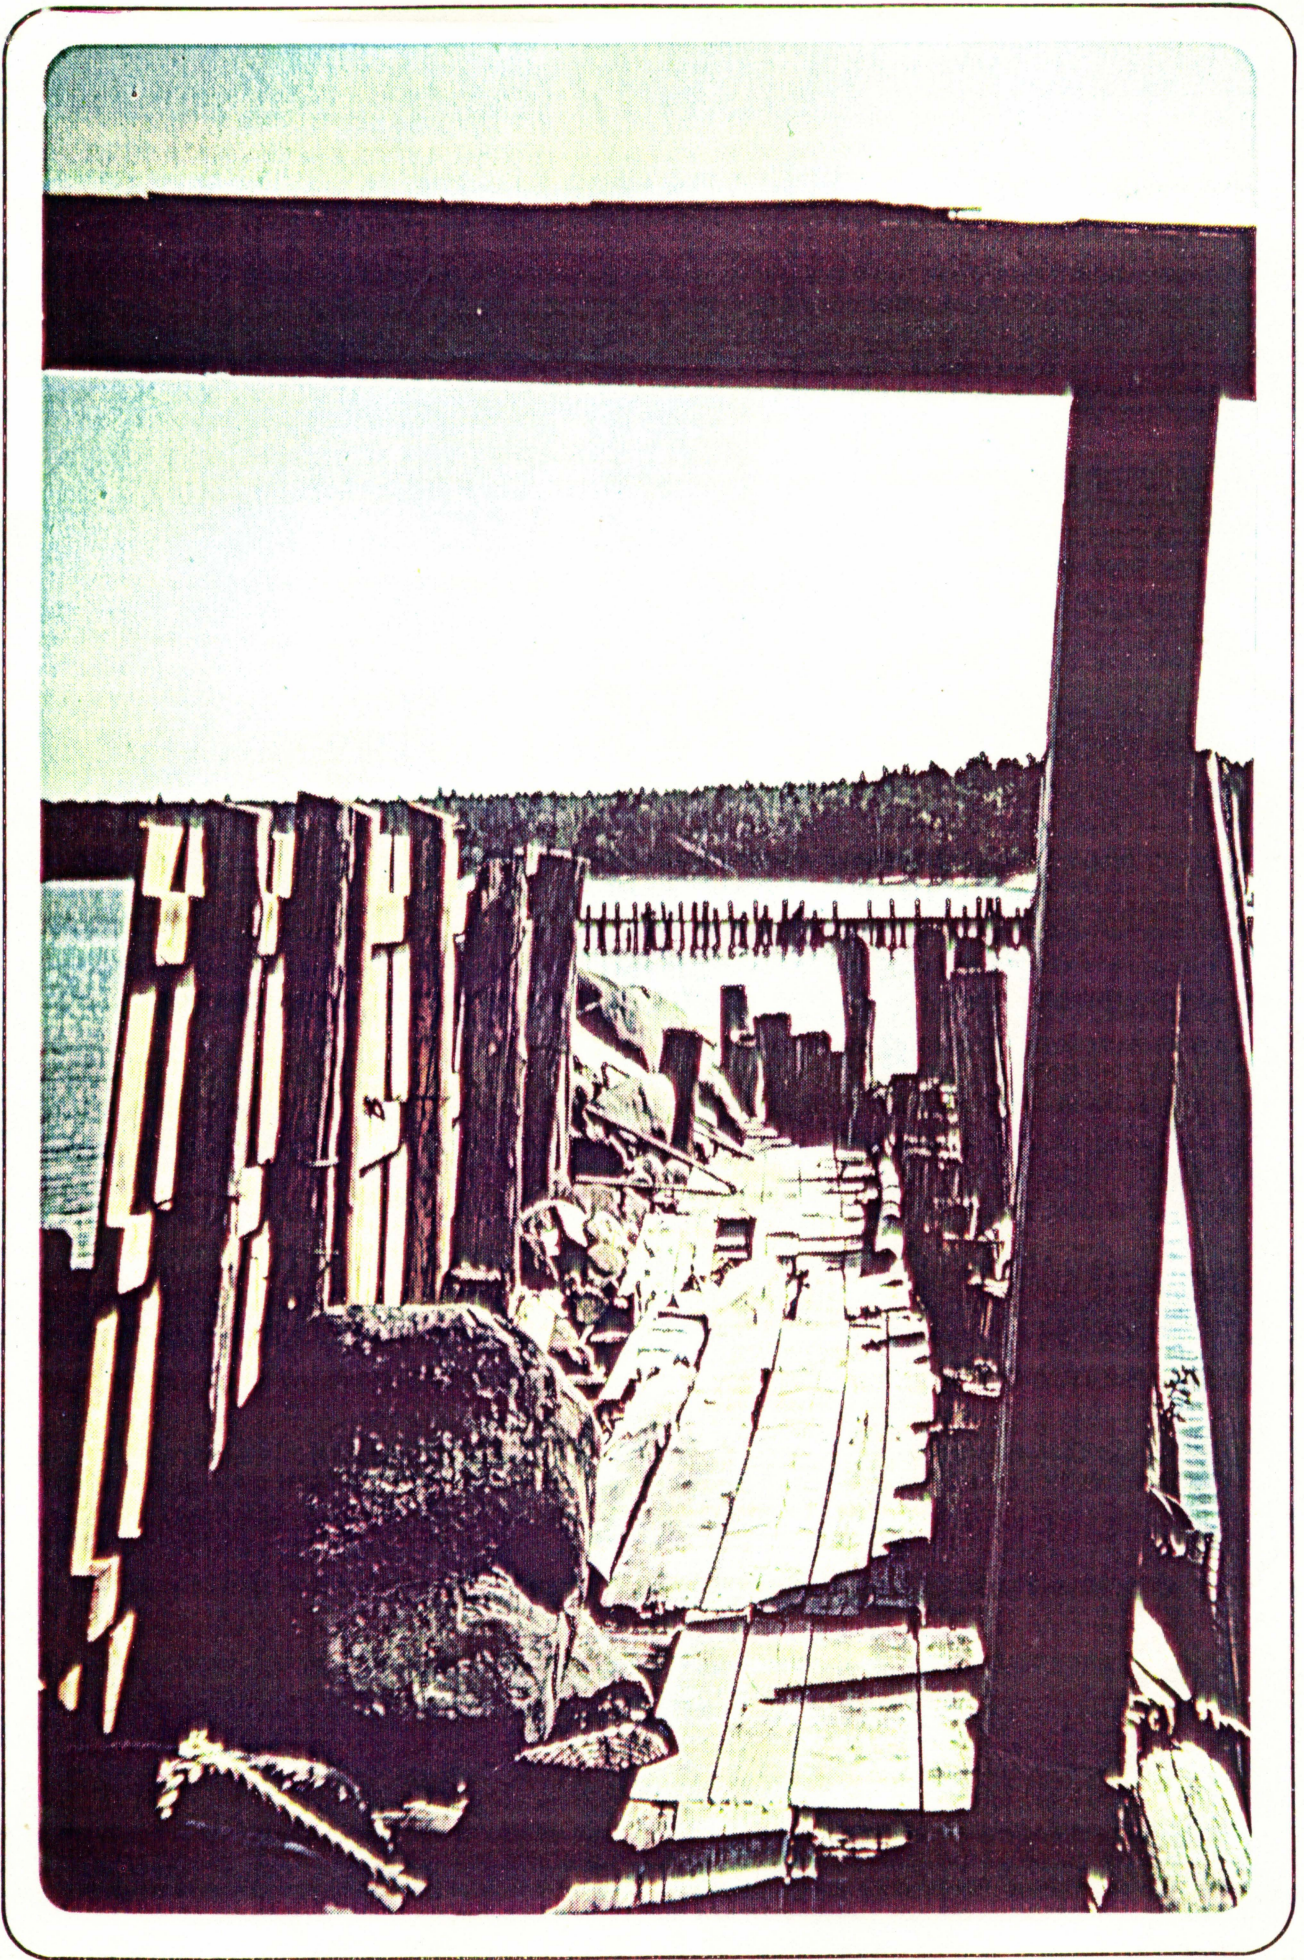
New decking and some new and some reinforcement structural piles and cribs have been installed over the past few years, up to the bend in the "L." From that point on though, the decking is in extremely deteriorated condition due to weathering and water damage. The piles and cribs also are severely worn. The fence on the dock, installed after the dock was built, to protect against ice and wind, was knocked down recently during a storm, and is in the process of being replaced.

Existing Conditions - Leg of Dock

Replace all old decking with like pieces of hemlock.

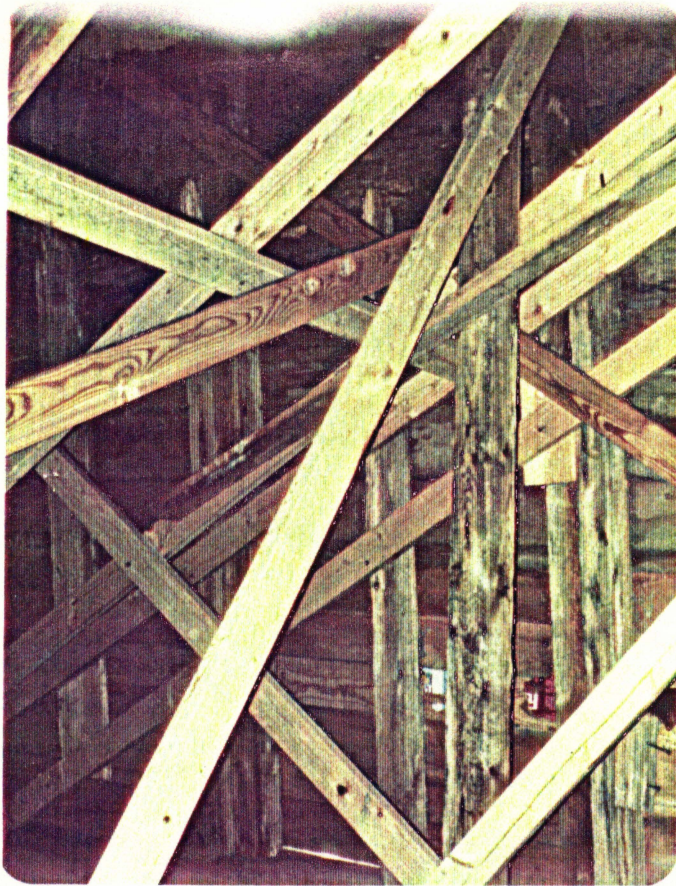
added pressure has caused the structure to be racked to the north and east. For this reason, many new braces have been added to the interior in order to attempt to temporarily stabilize the structure (see photographs 25 and 26).

#25 Existing Temporary Bracing

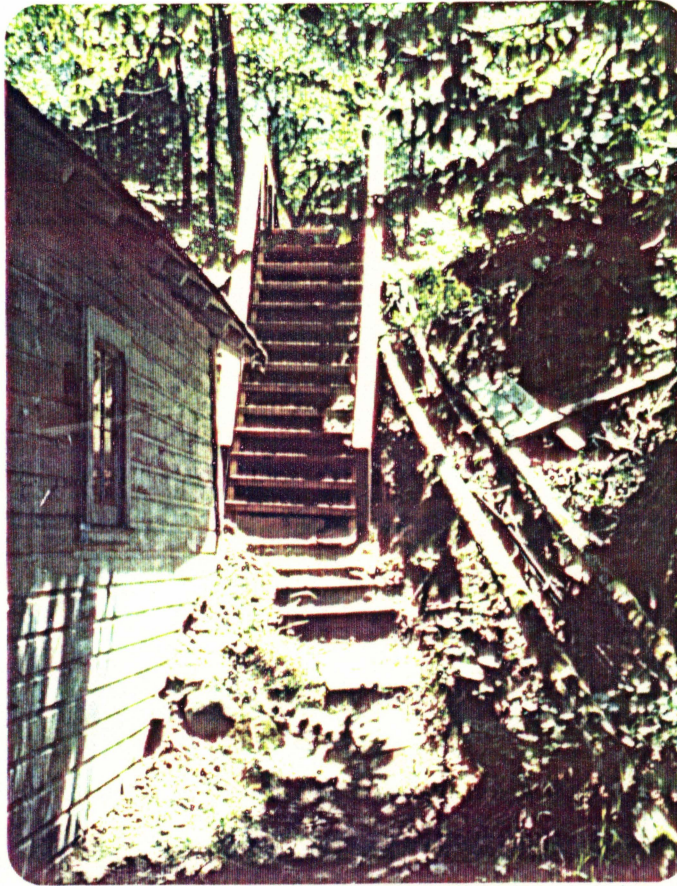
From the southwestern corner of this structure rises a stairway which climbs the bluff to the Twine Shed. This stairway (see photo 30) is new, installed August 1978, which replaced an older interior stairway which had rotted (see photo 31). The older stairway had been put in place about 15 years before, and had come from a church in Bayfield. Running along side this stairway are two narrow rails which were used to slide the packing boxes down the hill to the ice house from the bluff area where they were stored. These boxes, large wooden crates, were stored on the hill in order to minimize water damage to them in case the lake rose and to keep them sand-free. The boxes were sent down as needed. The rails are presently rusting and in poor condition. (See photographs 30 - 32).

Existing stairway to Twine Shed

Remove new stairway to lakeshore and replace with stairs of a shallower angle with proper rise/run ratios (per building code).

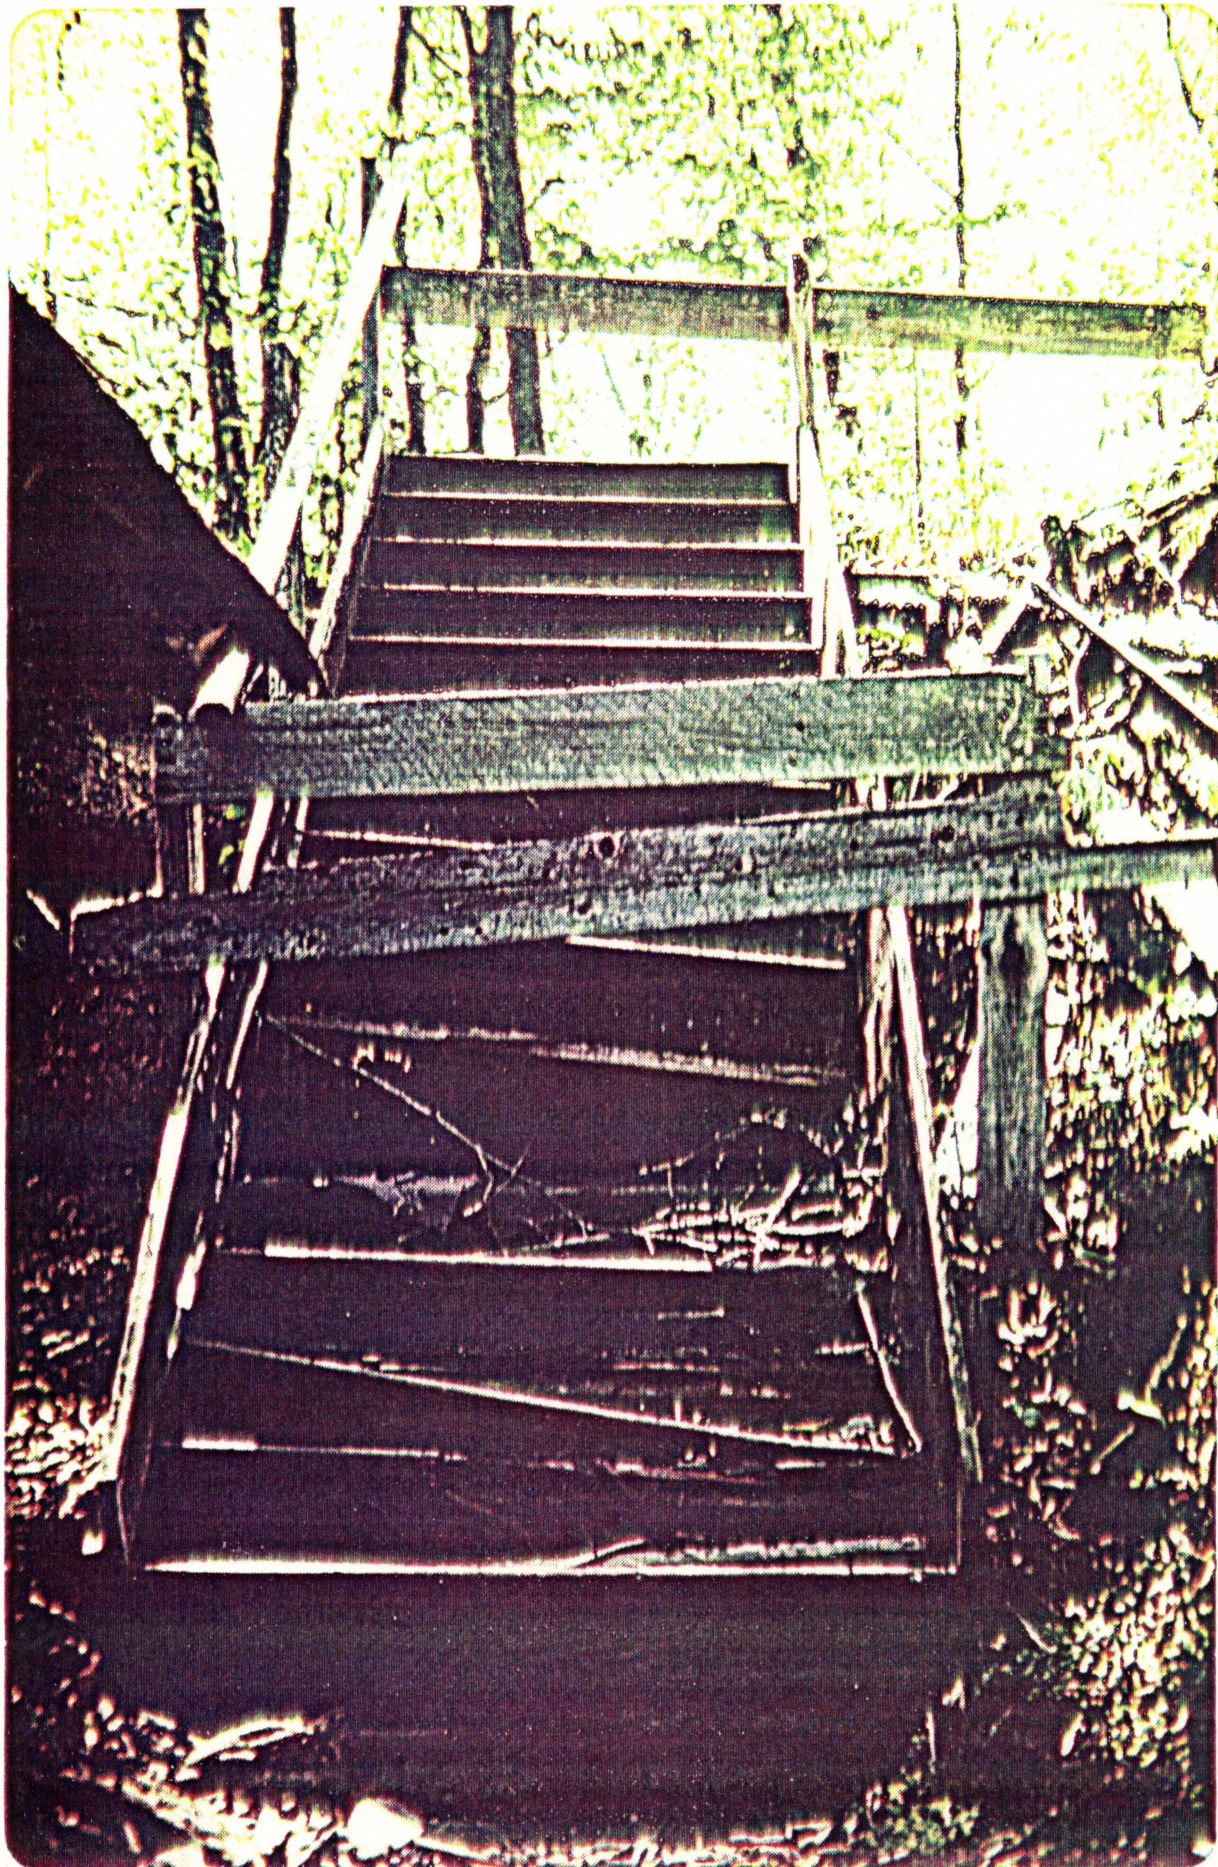
Previous rotted stairway.

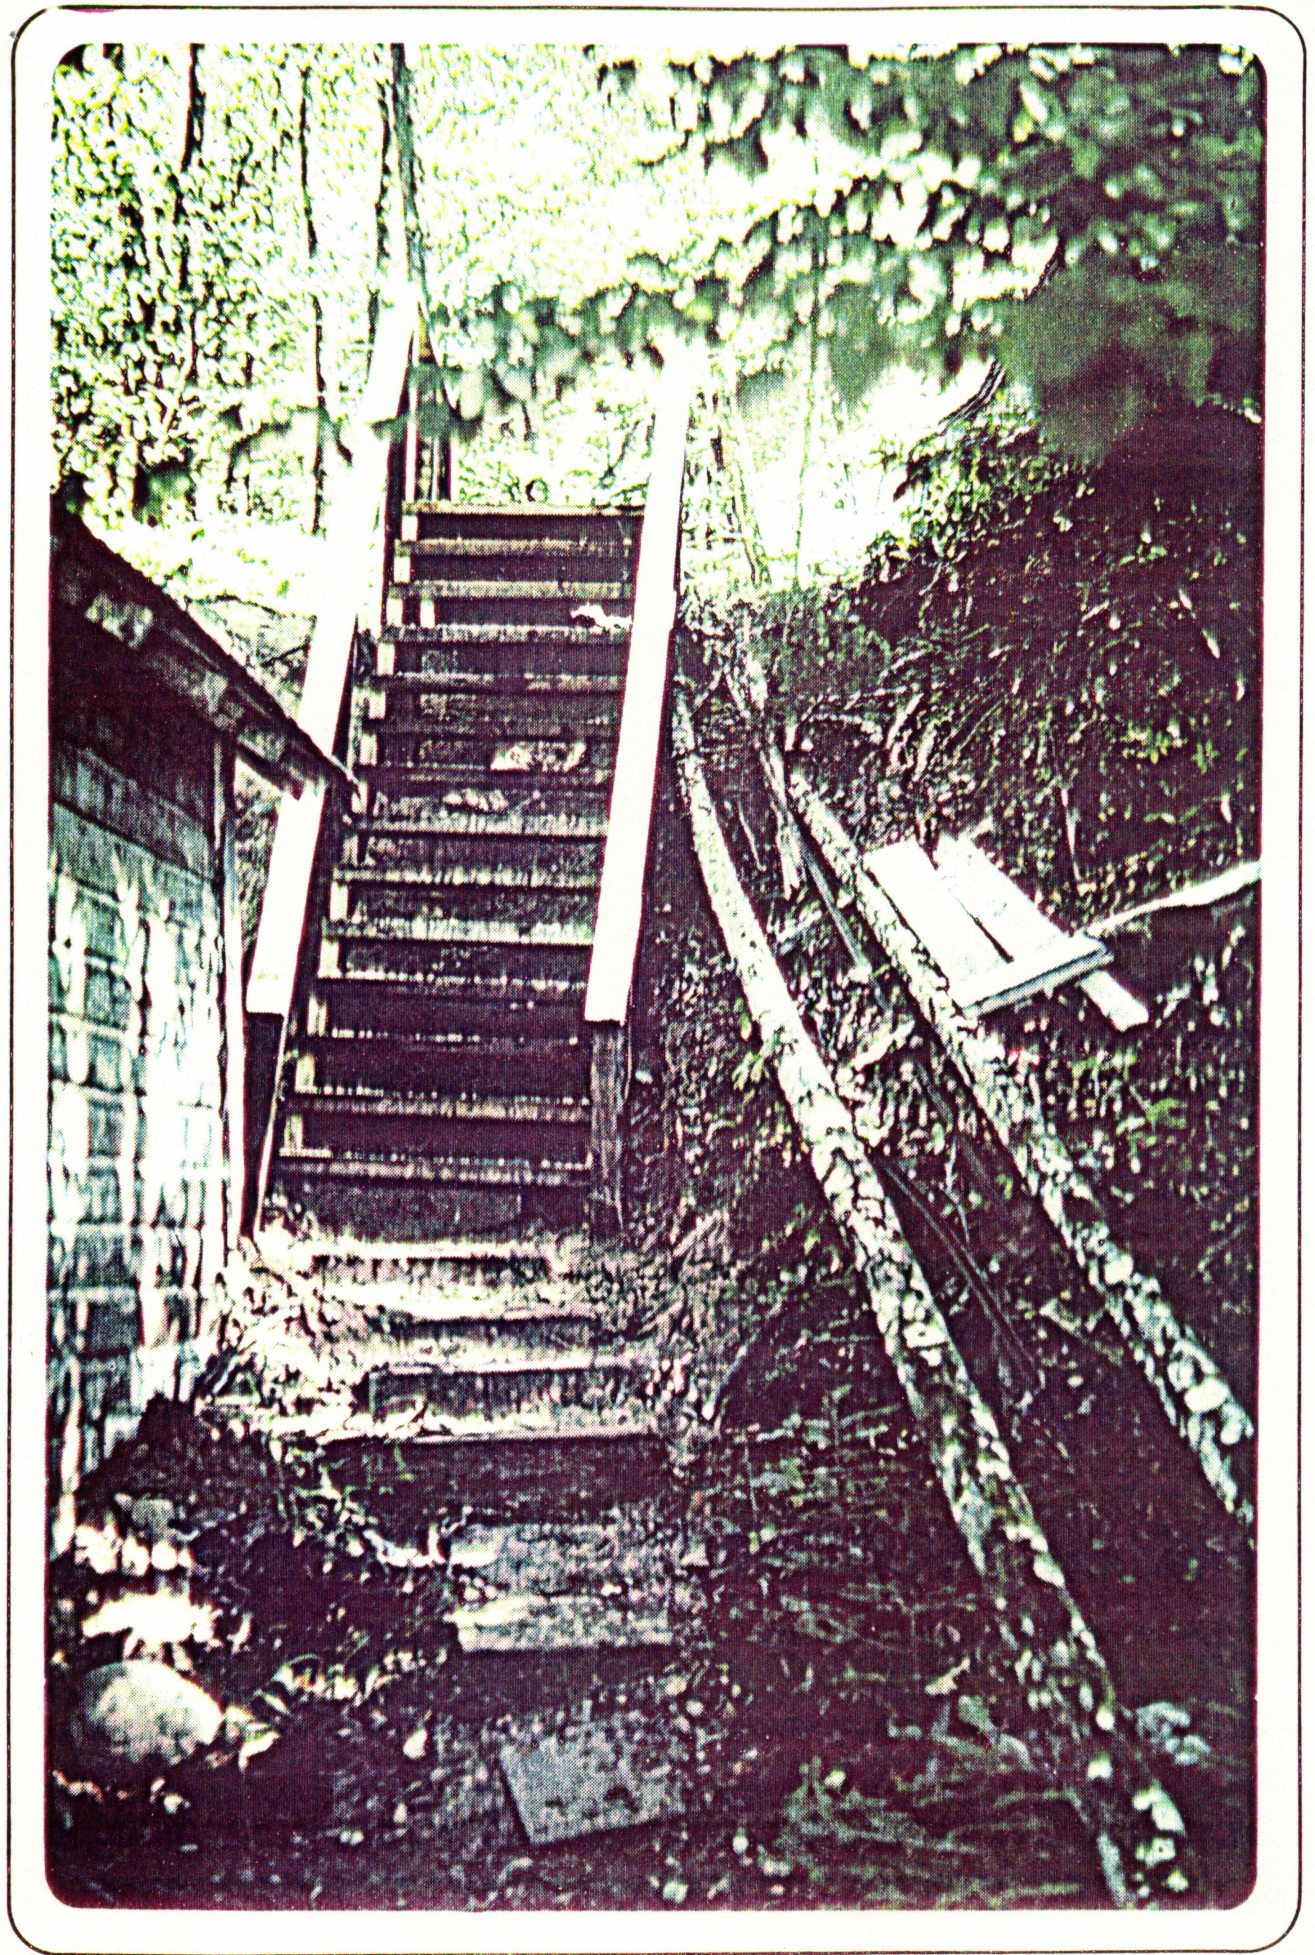
Existing stair to Twine Shed and box rails

Treat rails to protect them from further deterioration and weathering.

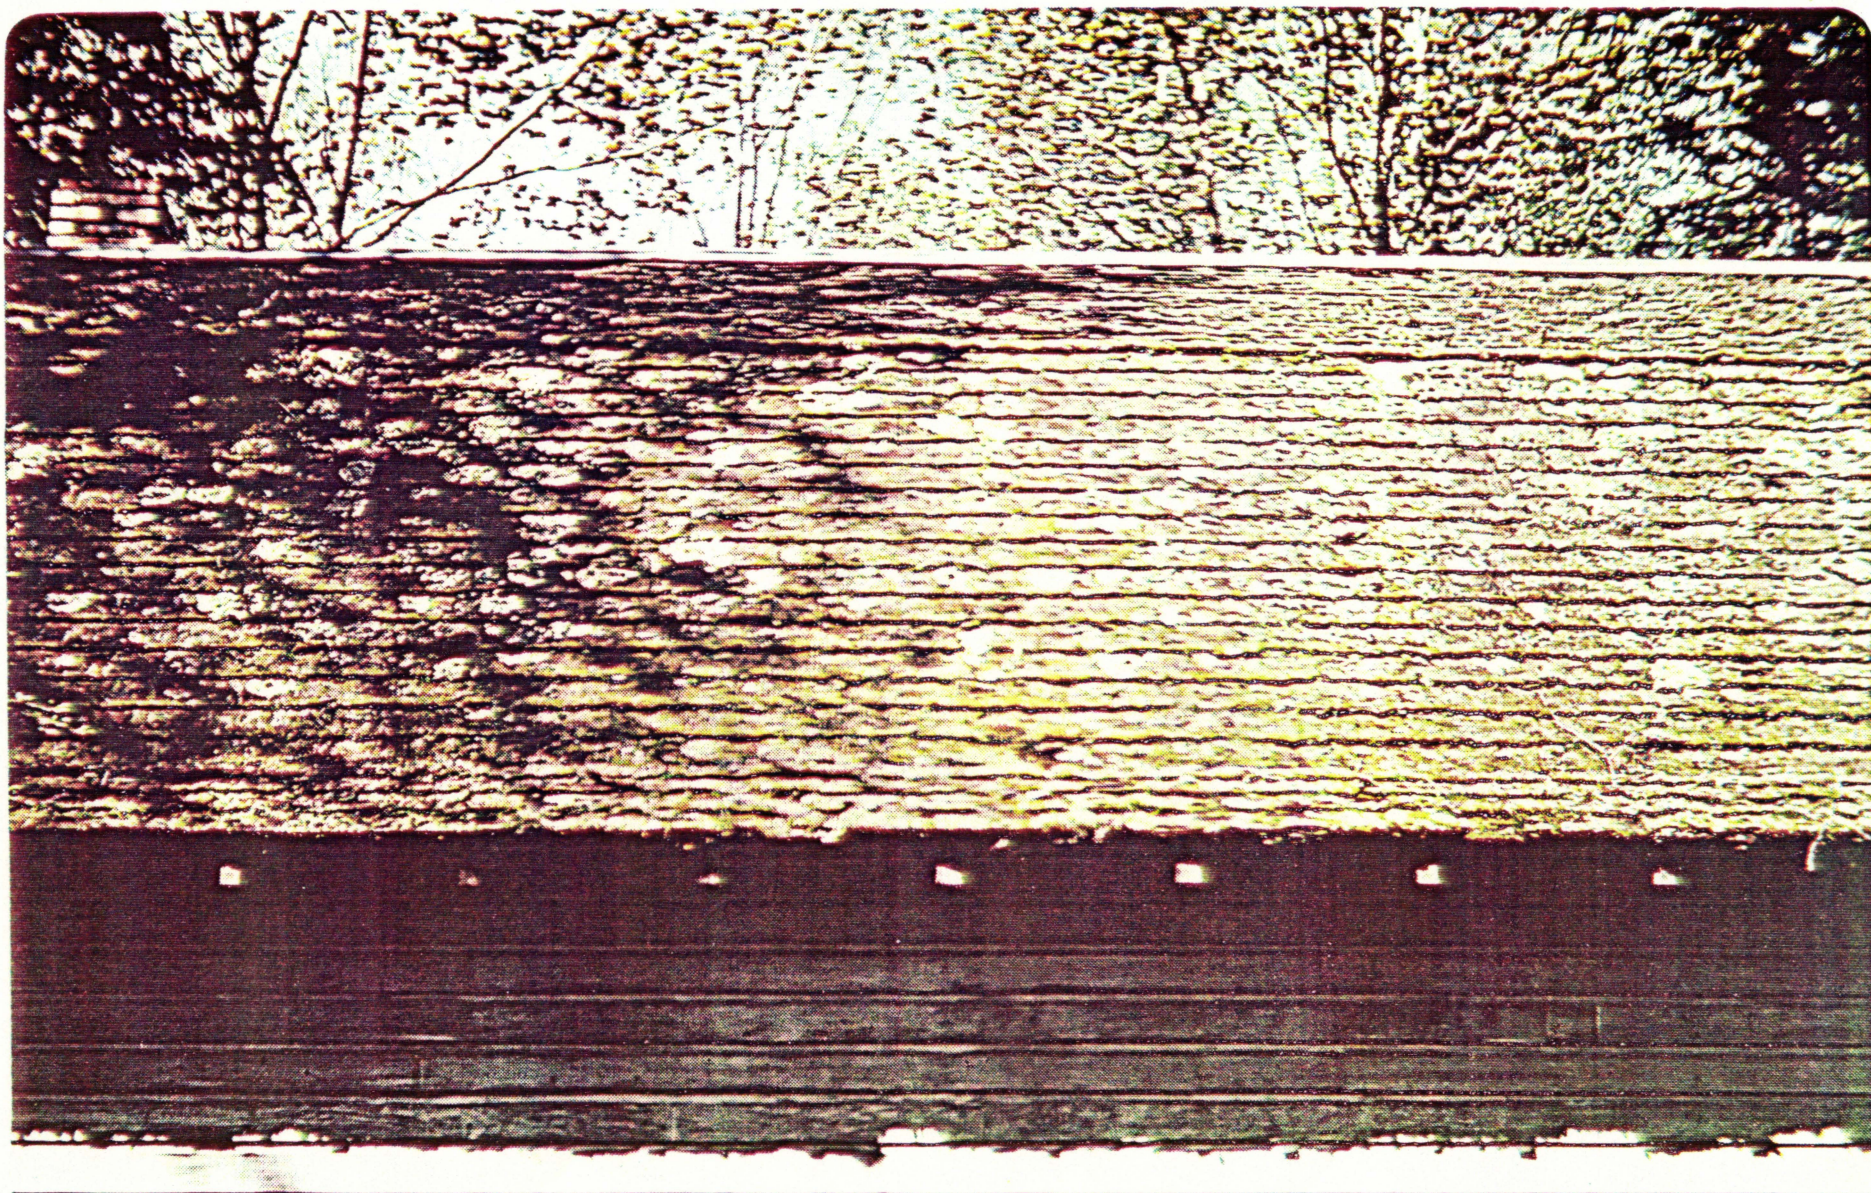
Twine Shed - Roof condition

Replace roof with like kind.

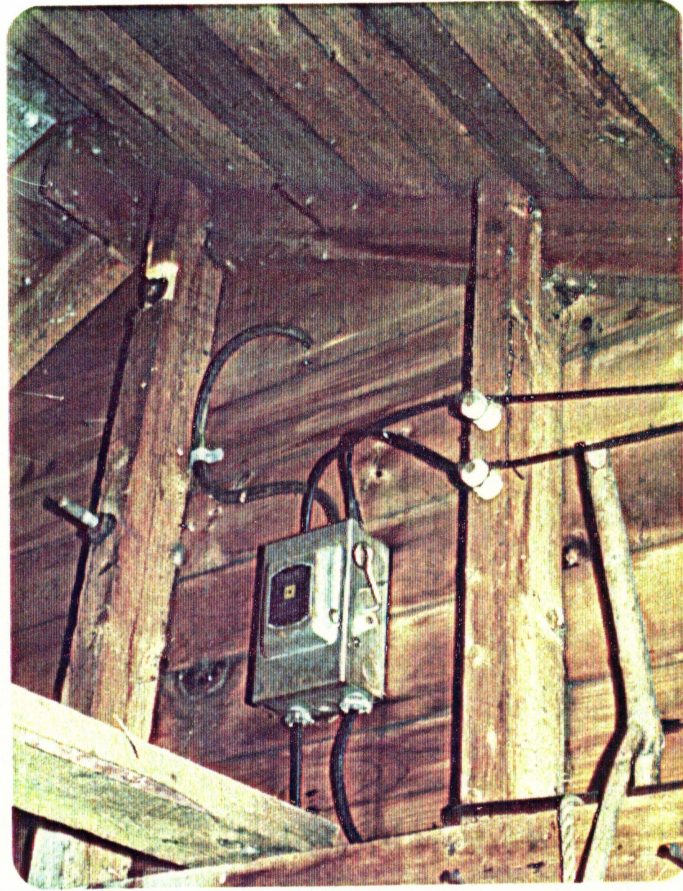
Existing Electrical Condition (Typical) #40

Electrical: Rewire design and outlet placement and recommendations for the buildings are dependent upon the interior design which will not be complete until some date in the future; therefore, recommendations on electrical and wiring design should be made at that time. Existing lines should be checked and live power deadened where safety could be a factor until a decision on use and design

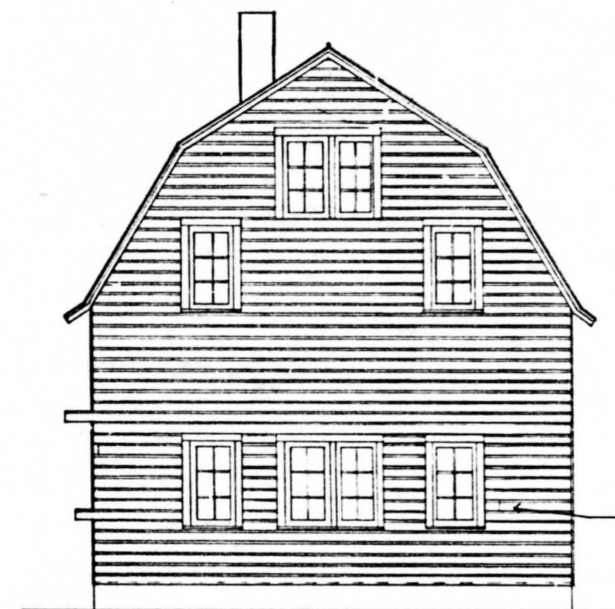
SOUTH ELEVATION
DRAWN AT 1/4" = 1'-0"

BOARD NEEDS REPAIRING

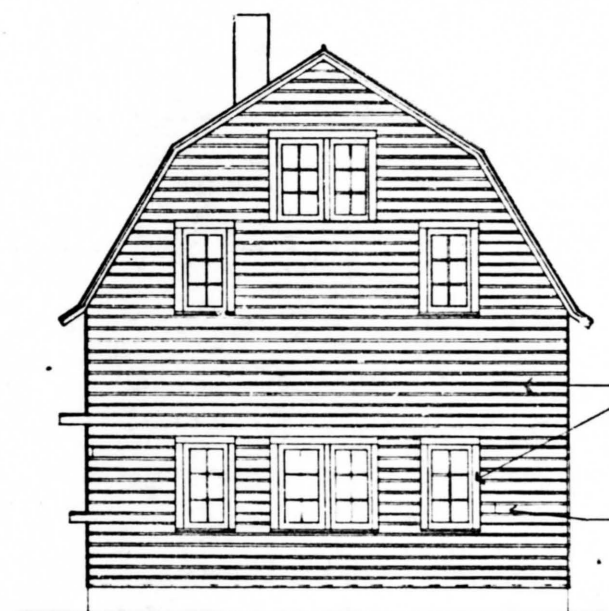
SOUTH ELEVATION

BOARD NEEDS REPAIRING

REPAINT BUILDING W/ OIL
BASE PAINT
PAINT TRIM W/ OIL BASE PAINT (TYP)
