HISTORIC STRUCTURE REPORT

Raspberry Island Lighthouse

(Historic Structure 08-103A)

Apostle Islands National Lakeshore
Wisconsin

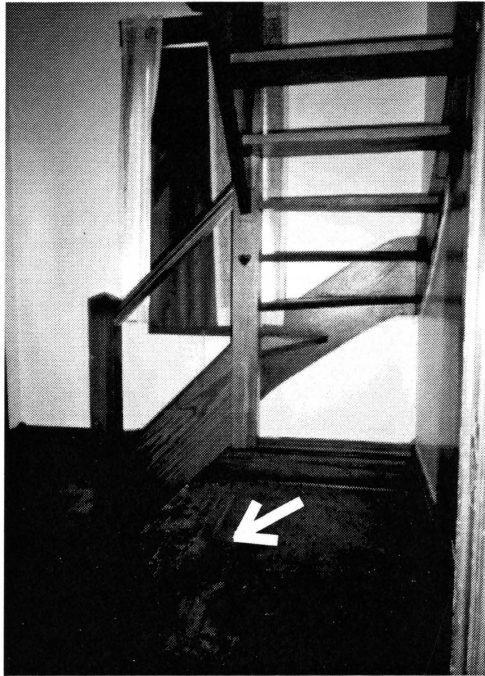
Illustration 16

Interior of the tower at the first floor level looking west, 1995. The arrow indicates the area of dark circular ghosting and broken floor boards at the center of the room, an indication of the former location of the weight shaft.

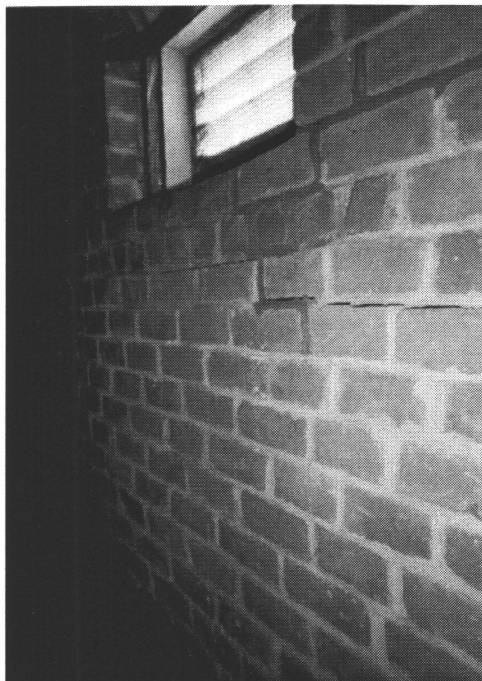
Illustration 4

1995 photo of the east basement wall at the south half of the basement. Note the header brick course below the window opening, and the inward bulging of the wall surface.

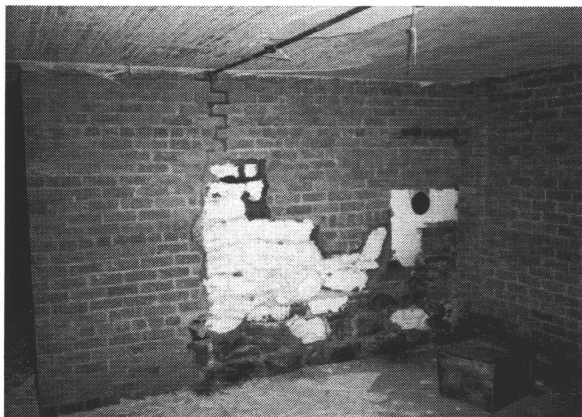
Illustration 5

Photo looking south at the north face of the crawl space wall, 1995. Note the lateral expansion between the rough stone and brick wall surfaces.

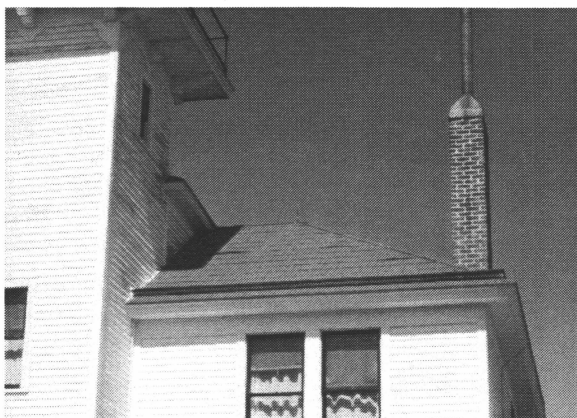
Illustration 15

Detail view of the roof above the one-story south end of the lighthouse, 1995. Note the shingles that are pulling loose.

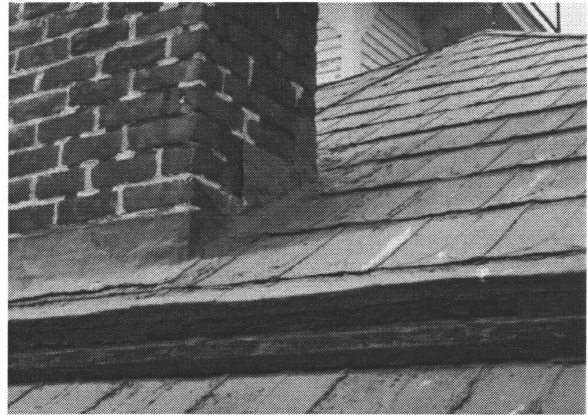
Illustration 16

Detail of the south chimney, 1995. Note the deteriorated wood along the bottom side of the built-in wood gutter and the failed flashing, both at the gutter, and stepped along the chimney face. The incompatible color and joint size of the tuckpointing is also evident.

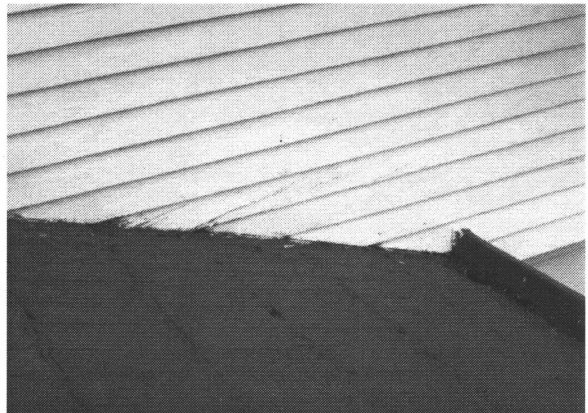
Illustration 17

Detail at the south end of the lighthouse of the one-story roof meeting the two-story wall, 1995. Note the deteriorated clapboard siding at the intersection of the two surfaces, most likely caused by a combination of snow build-up, and the lack of proper flashing.

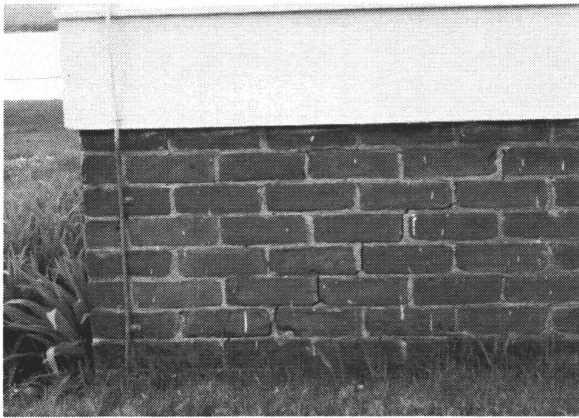
Illustration 19

Photo of the stepped cracking along the mortar joints at the corner of the east elevation, 1995.

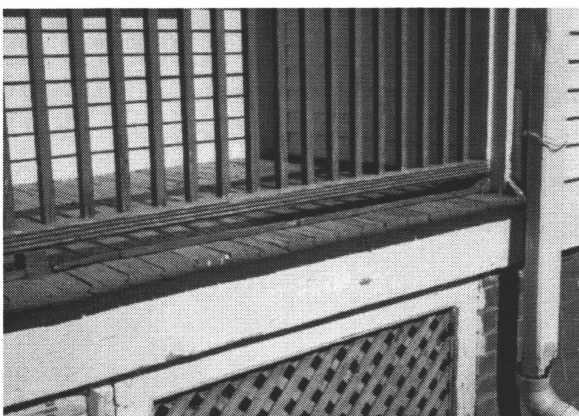
Illustration 21

View of the tongue and groove floor boards of the north porch deck, 1995. Many are pulling apart, and several of the "tongues" have split in two.

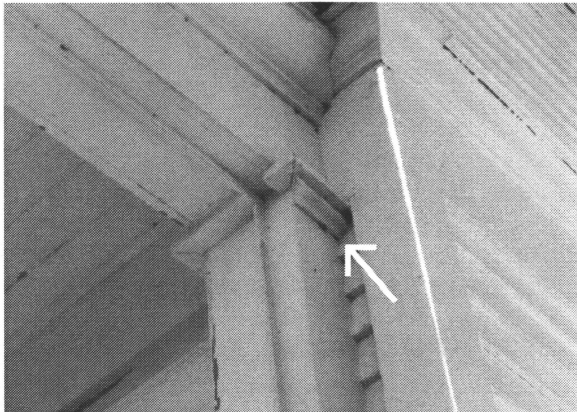
Illustration 23

View of the column at the south porch against the wall, 1995. Note the cut in the cap and the attached wood frame used for the installation of the wood screen. The small trim molding just below the cap is the only remaining piece of the original trim (also see illustration 62).

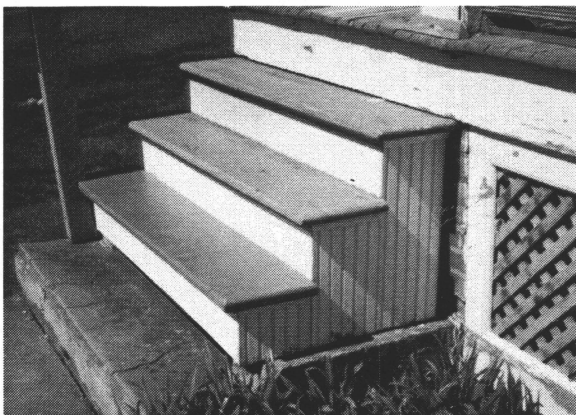
Illustration 26

Current condition of the steps leading up to the north porch, 1995. Note the virtually identical amount of settlement as that seen in the 1920s photo of the south end (Illustration 25a). Also note the non-historic beaded skirt boards.

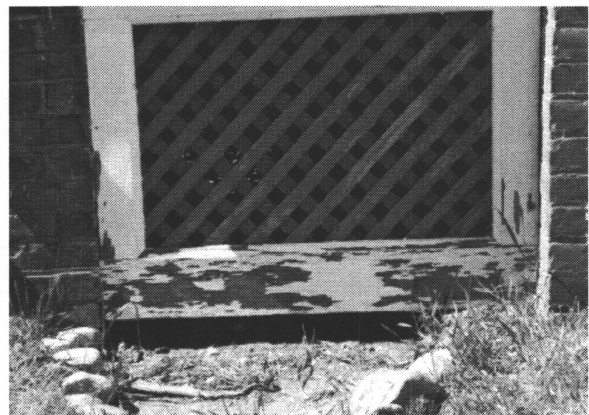
Illustration 28

Photo showing the dry rot and paint failure at the porch skirt along the west elevation, 1995.

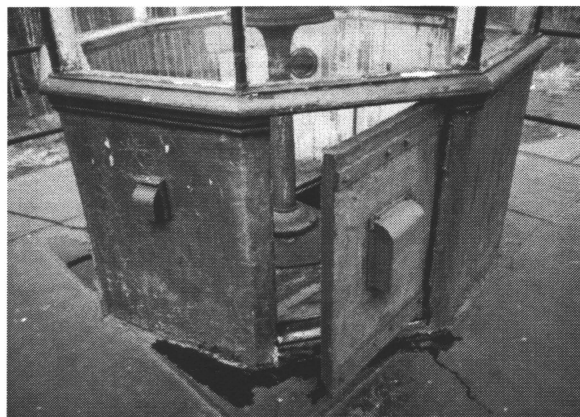
Illustration 29

View of the lantern base showing the paint build-up over the canvas covering the entire base, 1995. Also note the relatively small slope which allows water to sit following periods of rain.

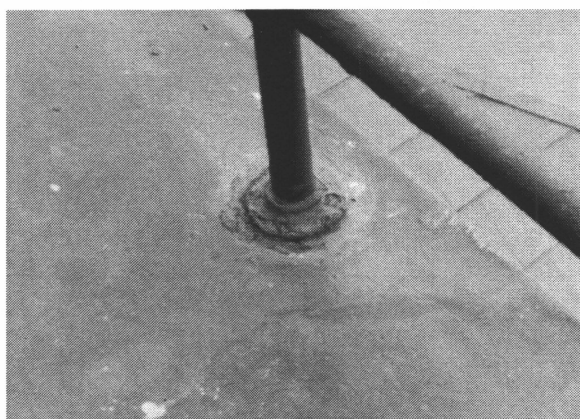
Illustration 31

Detail of the galvanized guardrail post meeting the copper sheet metal over the decking, 1995. Also shown is the corrosive reaction of the two metals.

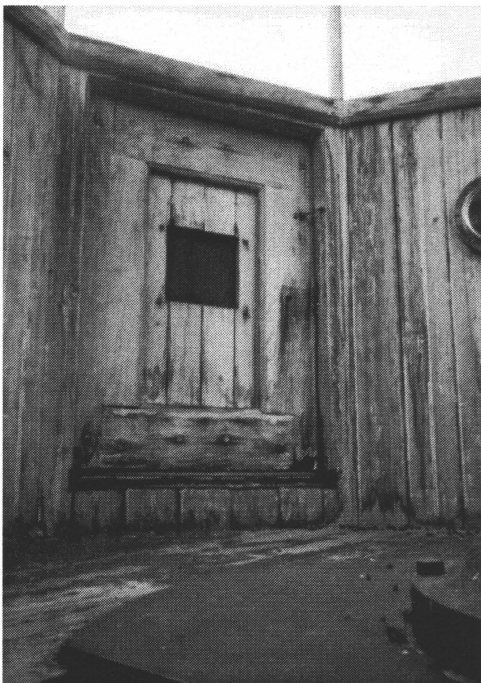
Illustration 32

Interior view of the lantern's exterior door and wainscot, 1995. Note the deteriorated wood.

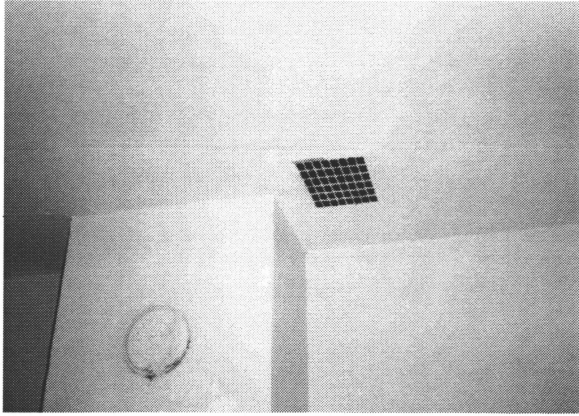
Illustration 36

View of the chimney and north wall of Room 102 (Kitchen), 1995. Note the evidence of water infiltration at the chimney including: the spalling plaster, peeling paint, and rust around the metal stovepipe hole cover. Also note the metal grille at the opening, cut in 1931 by Keeper Wilkes to allow warm air upstairs.

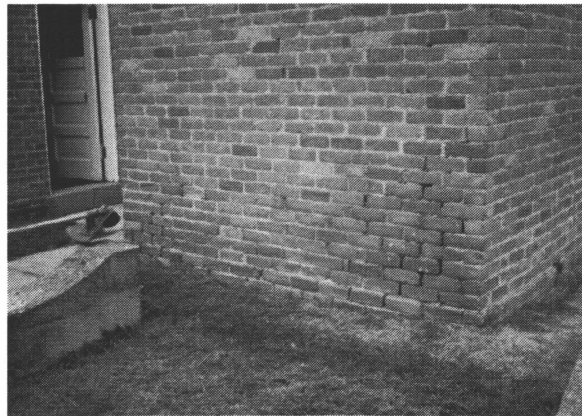
Illustration 37

Detail of the deteriorated mortar joints at the south elevation of the brick oil house. (1995)

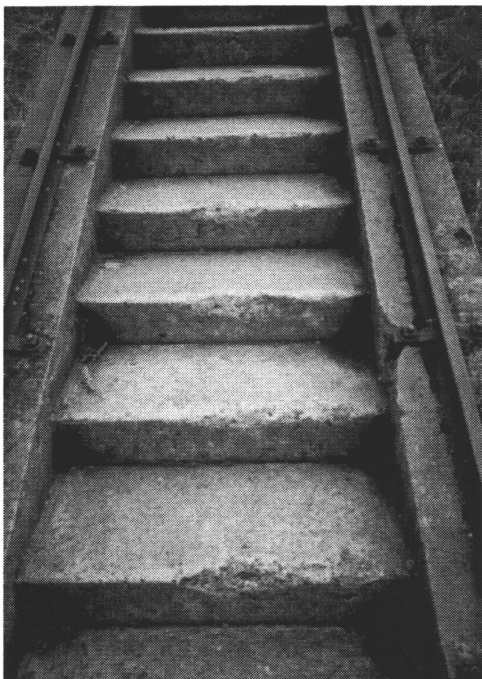
Illustration 38

Detail of the concrete tramway, displaying worn nosing and settlement cracks. (1995)
