SAND ISLAND WEST BAY CLUB STRUCTURES
APOSTLE ISLANDS NATIONAL LAKESHORE
Historic Structures Report

PMIS #191296
July 5th, 2023

Historic Structures Report

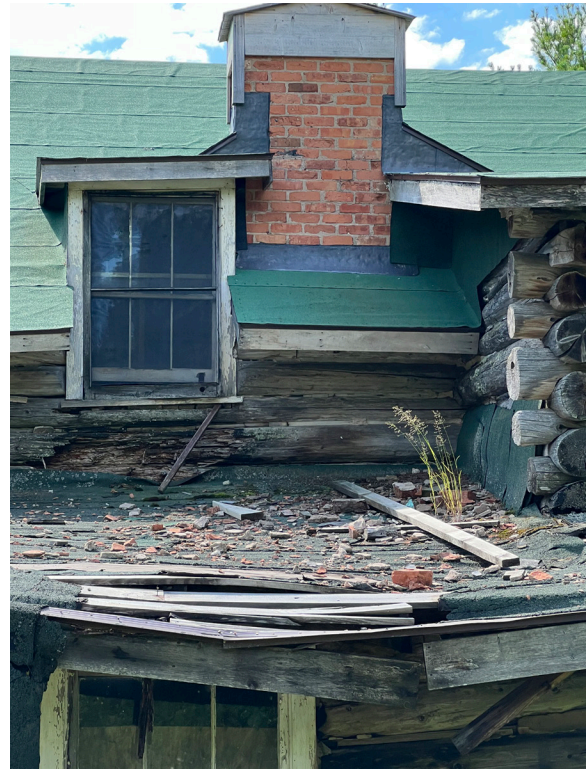
Debris scattered across the Kitchen (102) roof consisting of brick and wood scraps have fallen from the chimney above. Bio-growth and grass was observed growing on the Kitchen roof. As noted above, no sidewall flashing was observed where this

Figure 1-76. Debris covers the Kitchen roof and areas of the roofing are missing and torn. (AH, 08/01/2022)

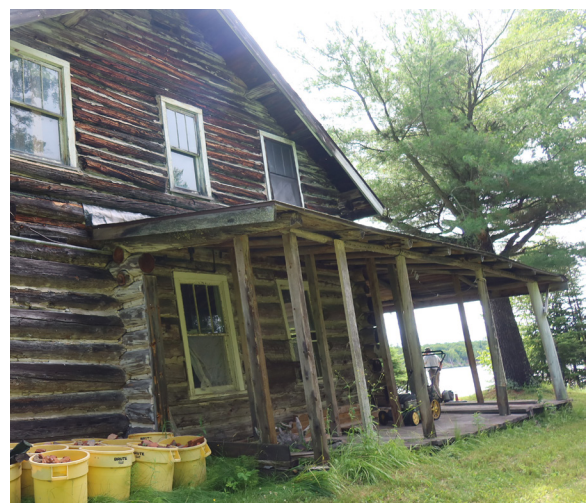
Figure 1-77. Missing fascia on the west porch eave, showing exposed square-cut log ends. (AH, 08/01/2022)

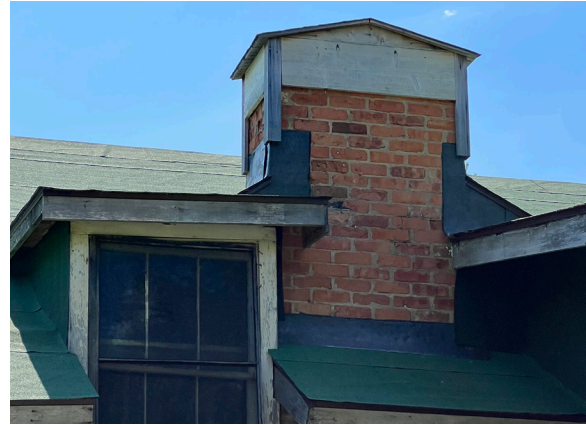
The chimney is in poor condition. The new cap appears to have halted water intrusion in

Figure 1-84. The brick chimney was partially disassembled and capped in 2019. (AH, 08/01/2022)

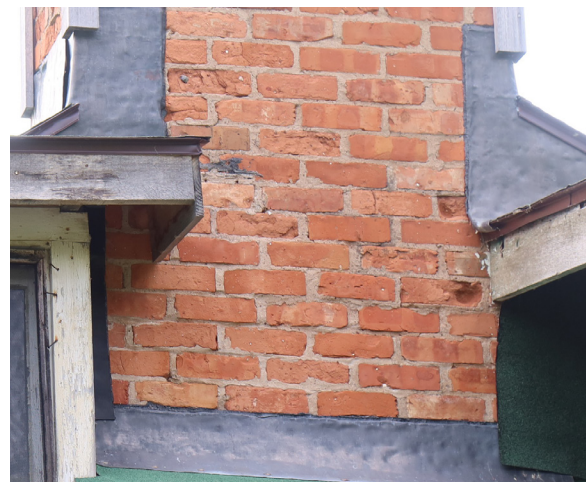
- **Mortar Analysis:** Mortar visible at the chimney exterior appears to be incompatible with the adjacent brick, leading to spalling and deterioration of the brick. Interior and exterior samples of the chimney mortar should be analyzed to determine a compatible replacement composition.

Figure 1-85. Spalled brick on the north face of the chimney. (AH, 08/01/2022)

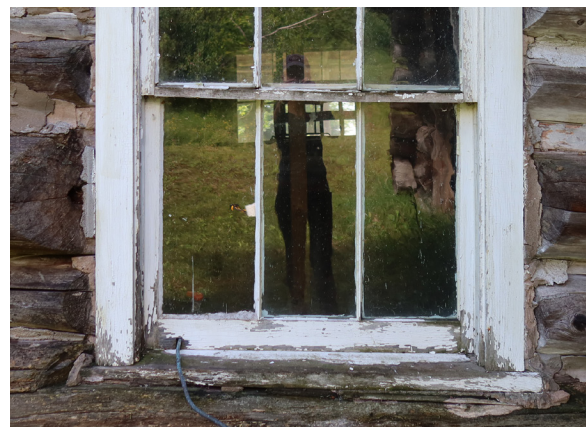
Figure 1-88. Deteriorated sill at of east window on the north wall. (AH, 08/01/2022)

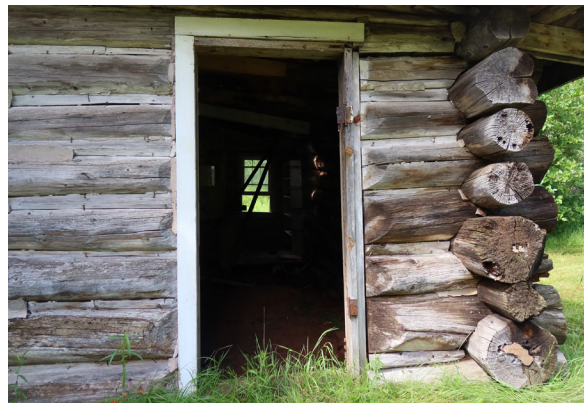
Figure 1-90. Exterior door trim to Kitchen (102). Note the missing trim on right side of opening. (AH, 08/01/2022)

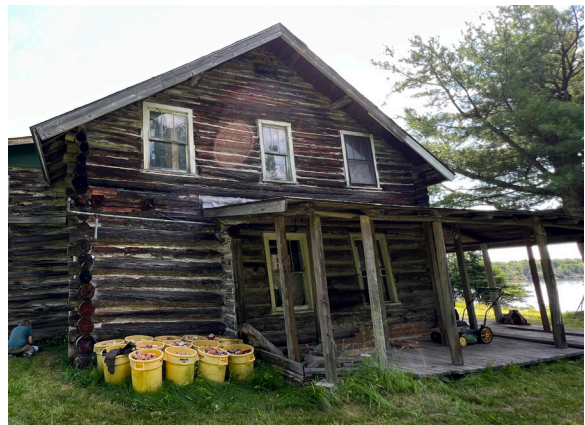
Figure 1-91. Fascia boards at west wall. Note missing board on porch eave. (AH, 08/01/2022)

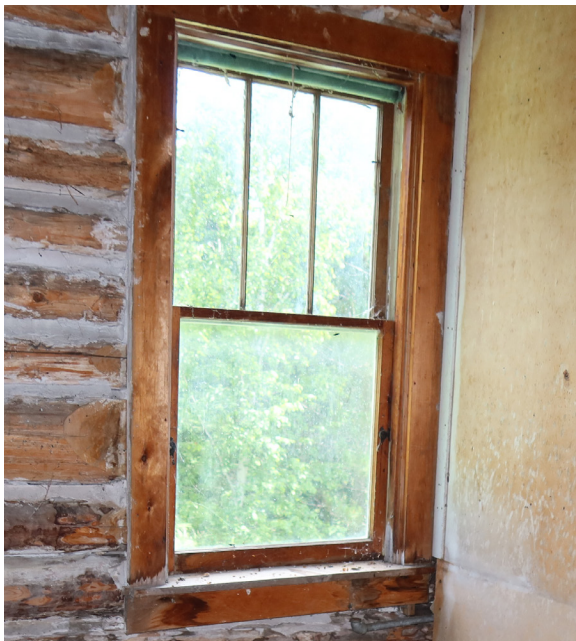
Figure 1-104. Interior of Type B window, viewed from Bedroom (204). Note water staining at the window sill. (AH, 08/01/2022)

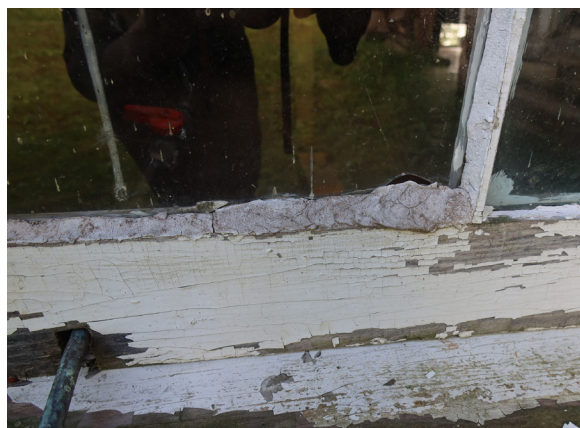
Figure 1-107. Type A window at the north wall of Living Room (101). Broken glazing with rough putty patch. (AH, 08/01/2022)

- Living Room (101) east window on the north wall: Glazing in one of the bottom lites is broken and has been roughly patched with putty. A 1-inch diameter hole has been drilled in the base of the bottom sash to accommodate a gas line.
- Kitchen (102) east wall: A notch has been cut in the base of the bottom sash to accommodate a since-removed gas line.
- Kitchen (102) north wall: The sill and bottom sash are missing. This window is boarded from the interior with a sheet of plywood.

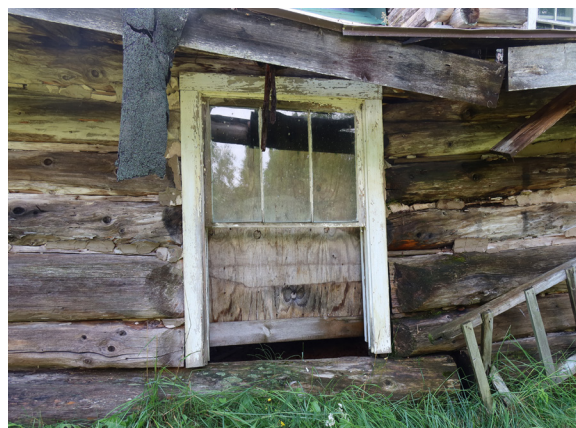
Figure 1-109. Exterior of Type A window at Kitchen (102) north wall. Note the missing sill and bottom sash (AH, 08/01/2022)

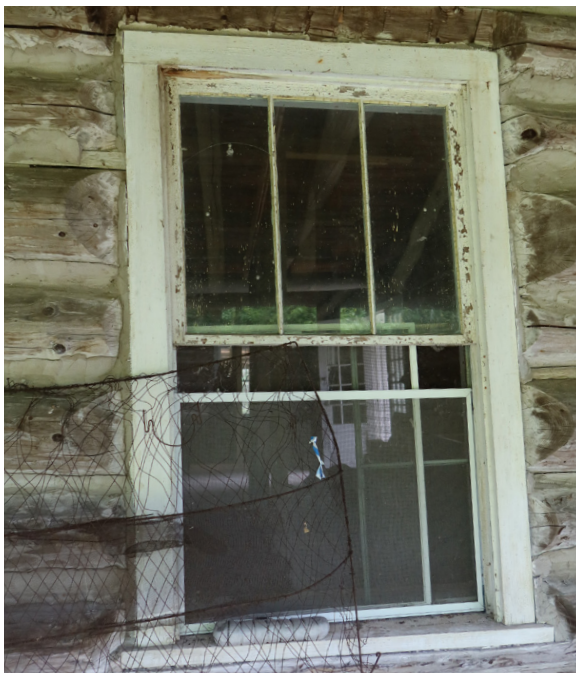
Figure 1-111. Type B window at Living Room (101) west wall, viewed from exterior. Note the missing bottom sash and cracked lite at top left. (AH, 08/01/2022)

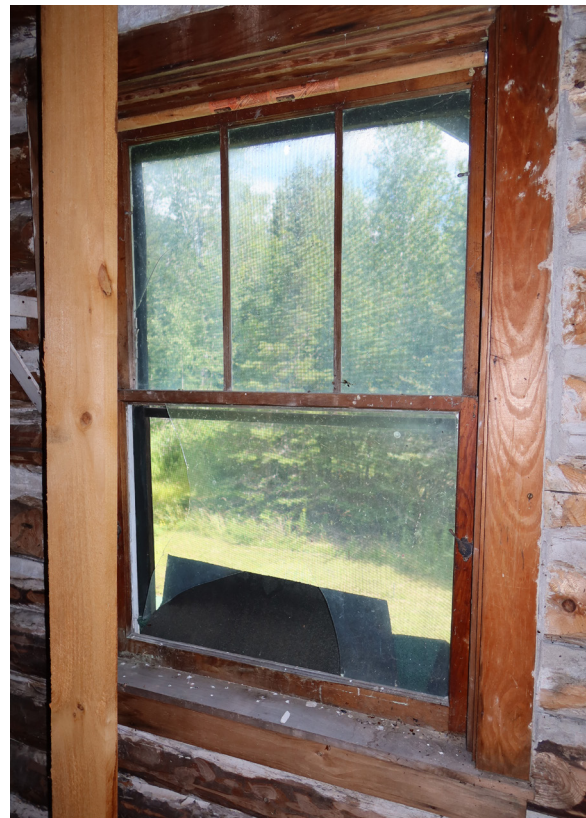
Figure 1-115. Interior of east Type B window in Bedroom (205). Note broken glazing in bottom sash. (AH, 08/01/2022)

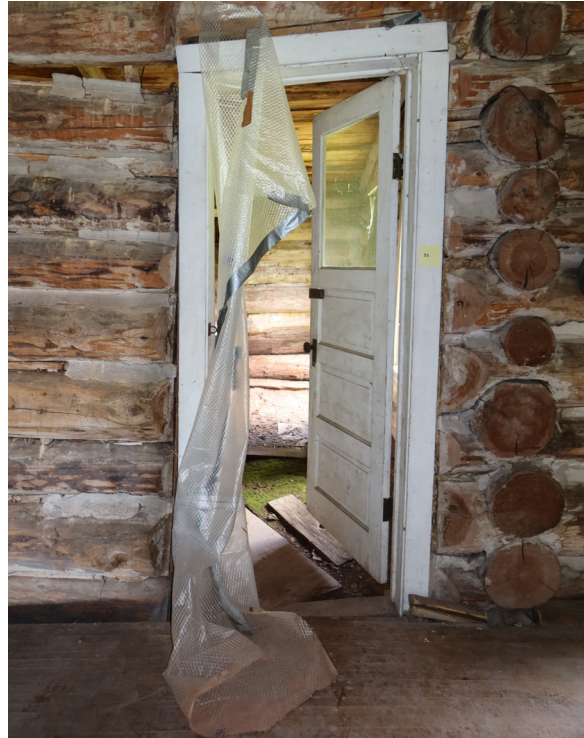
Figure 1-131. Type C door, viewed from Living Room (101). Note the distortion of the framed opening and the plastic sheet taped over the interior of the door. (AH, 08/01/2022)

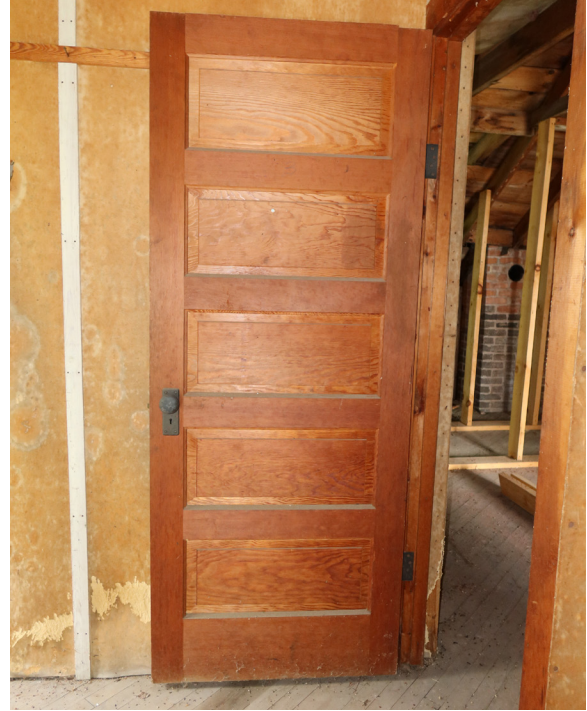
- Hall (201) to Bedroom (203): This door is in poor condition. The door is lightly water-stained, most severely near the base of the door, and does not close. Due to structural settlement, the door binds against the floor when pulled closed.
- Hall (201) to Bedroom (204): This door is in fair condition and is lightly water-stained. Temporary structural shoring through the framed opening prevents operation.
- Hall (201) to Bedroom (205): This door is in fair condition and is lightly water-stained. Operation is difficult.

Figure 1-133. Type D door from Hall (201) to Bedroom (203). (AH, 08/01/2022)

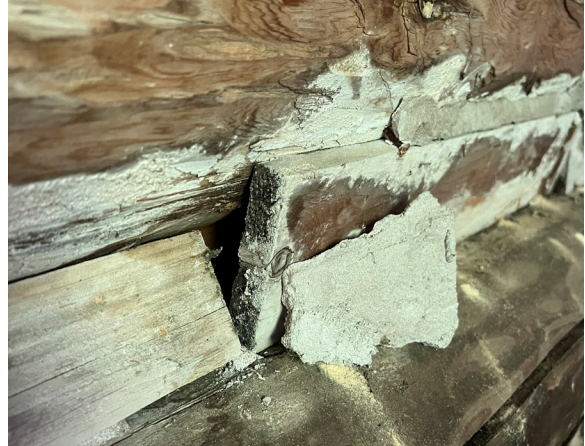
Figure 1-150. Partially missing and loose daubing on the log walls. (AH, 08/01/2022)

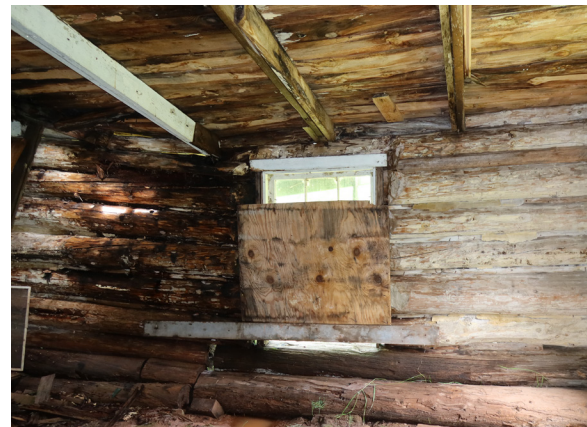
Figure 1-155. Deterioration of the north wall of Kitchen (102) is significant. (AH, 08/01/2022)

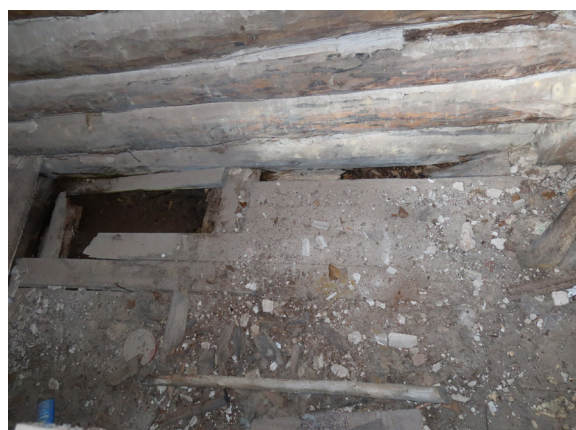
Figure 1-159. Flooring beneath the stairs is concealed with debris. (AH, 08/01/2022)

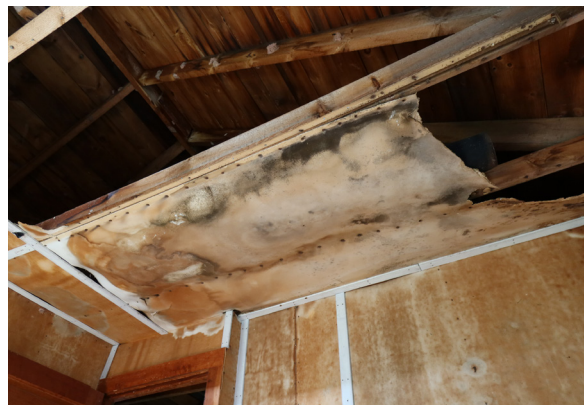
Figure 1-171. Remaining fiberboard ceiling finishes are warped and water damaged. (AH, 08/01/2022)

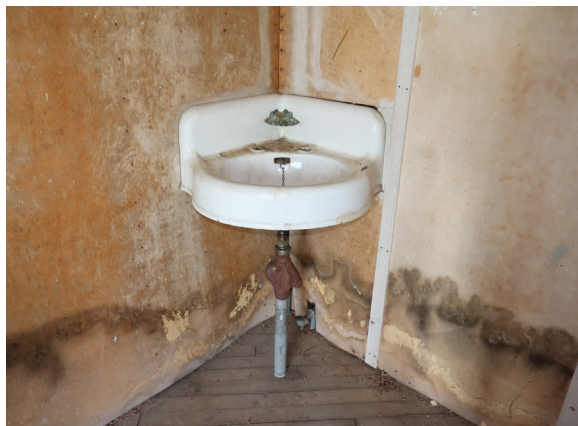
Figure 1-169. Cast-iron sink in corner of Bedroom (204). Note darkened and water-stained adjacent wall finishes. (AH, 08/01/2022)

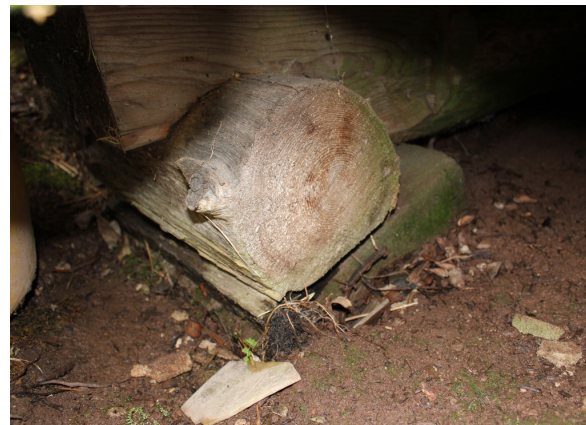
Figure 1-175. Floor joist supported on stack of lumber (CBB, 08/01/2022)

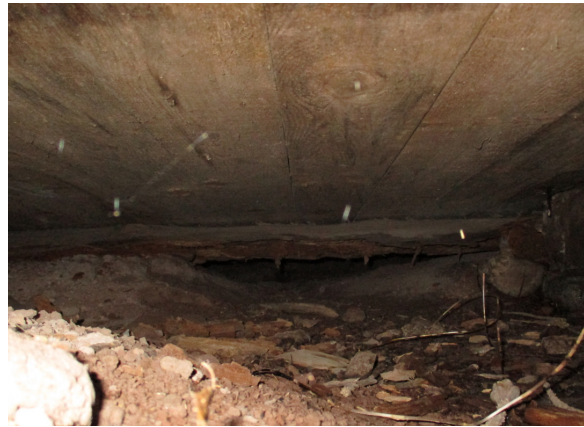
Figure 1-179. Deteriorating floor joist visible from the crawlspace (CBB, 08/01/2022)

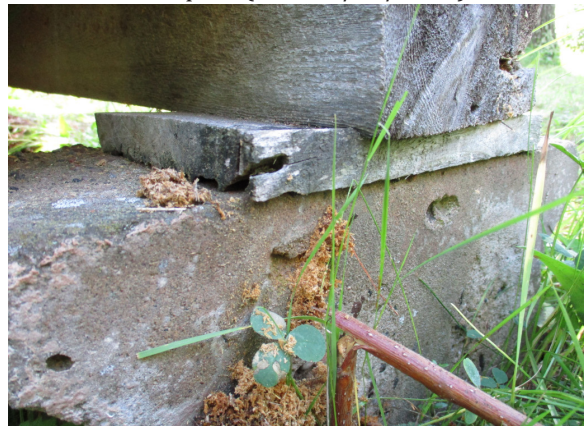
Figure 1-180. Active carpenter ant activity at the southwest corner of the lumber supporting the porch (CBB, 08/01/2022)

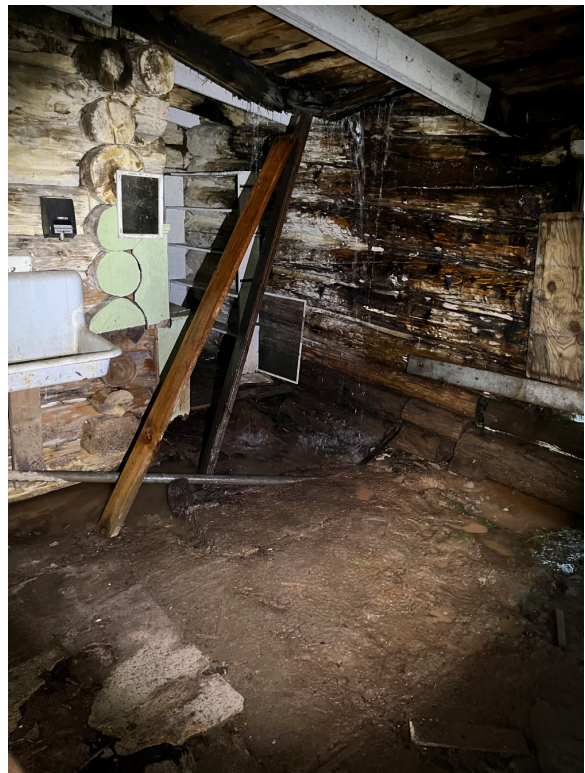
Significant log deterioration and failure of the roof structure were observed at the kitchen, as documented in the Structural existing conditions assessment. As detailed in the appended treatment workshop minutes, it was determined by the Park and stakeholders

Figure 1-187. Deteriorating roof framing in the Kitchen (102) (CBB, 08/01/2022)

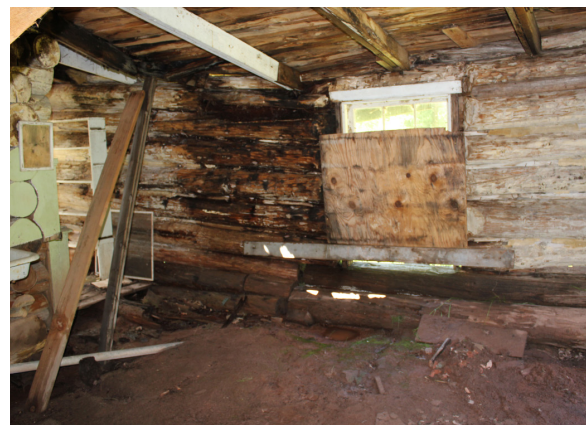
Figure 1-189. Deteriorating wall framing in the Kitchen (102) (CBB, 08/01/2022)

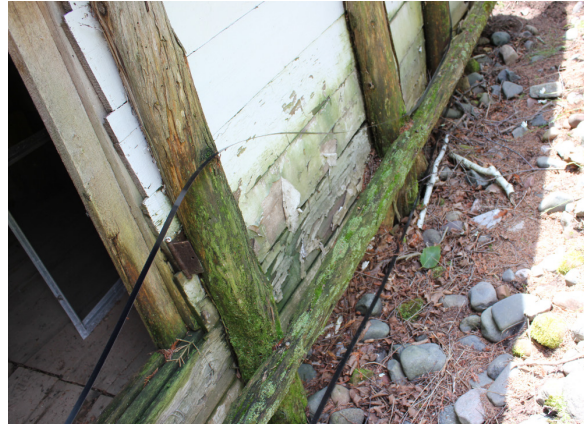
Figure 1-228. Biological growth and wood rot at north façade (CBB, 08/05/2022)

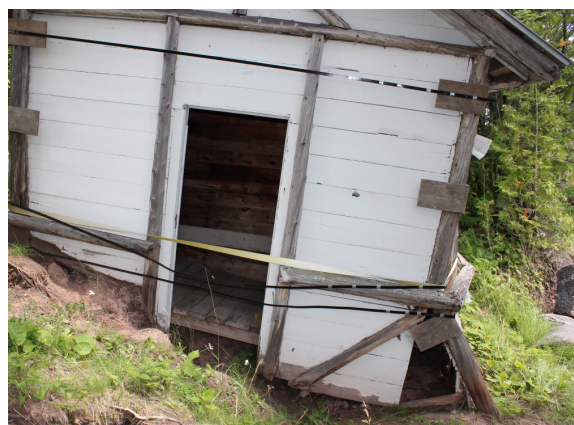
Figure 1-232. Broken southwest post that is kicked out below the girt (CBB, 08/05/2022)

Documentation and removal of the Icehouse is recommended. Stabilization or rehabilitation efforts would further destabilize the eroding hillside and jeopardize the site.

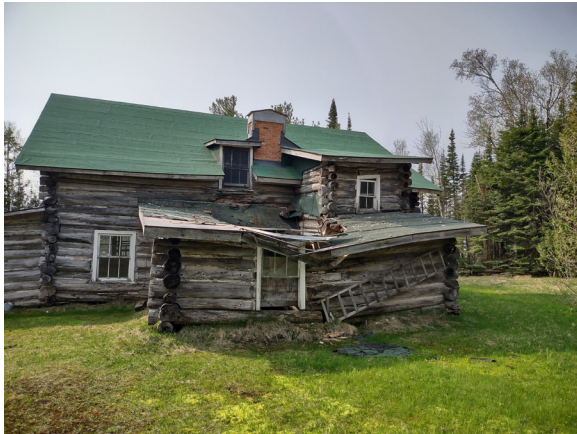
Figure 3-1. Lodge viewed from north. Kitchen Wing is at image center with significant roof collapse. (APIS, 05/23/2023)

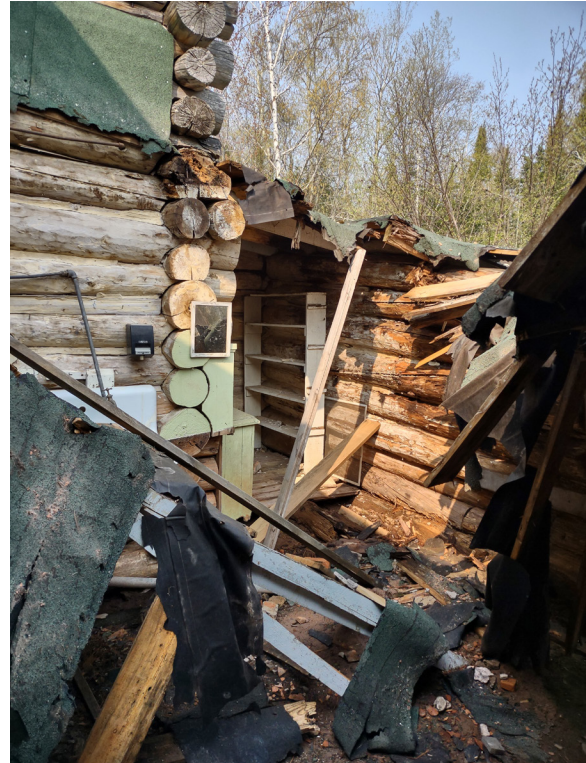
Figure 3-3. Interior view of collapsed Kitchen roof. View facing northwest in the Kitchen. (APIS, 05/23/2023)
