*HISTORIC STRUCTURE REPORT*  
**HISTORIC CEMETERY COMFORT STATION  
(BUILDING #313)**

Kevin Wohlgemuth, Senior Associate, Building Conservation Associates, Inc. (BCA)  
Dorothy Krotzer, Director, BCA  
Michele Boyd, Director of Preservation Services, BCA  
Kate Whitney-Schubb, Staff Conservator, BCA

The following 100% Draft of the Historic Structure Report for the Historic Comfort Station (Building #313) at Arlington National Cemetery represents a synthesis of all research and analysis performed for this project.

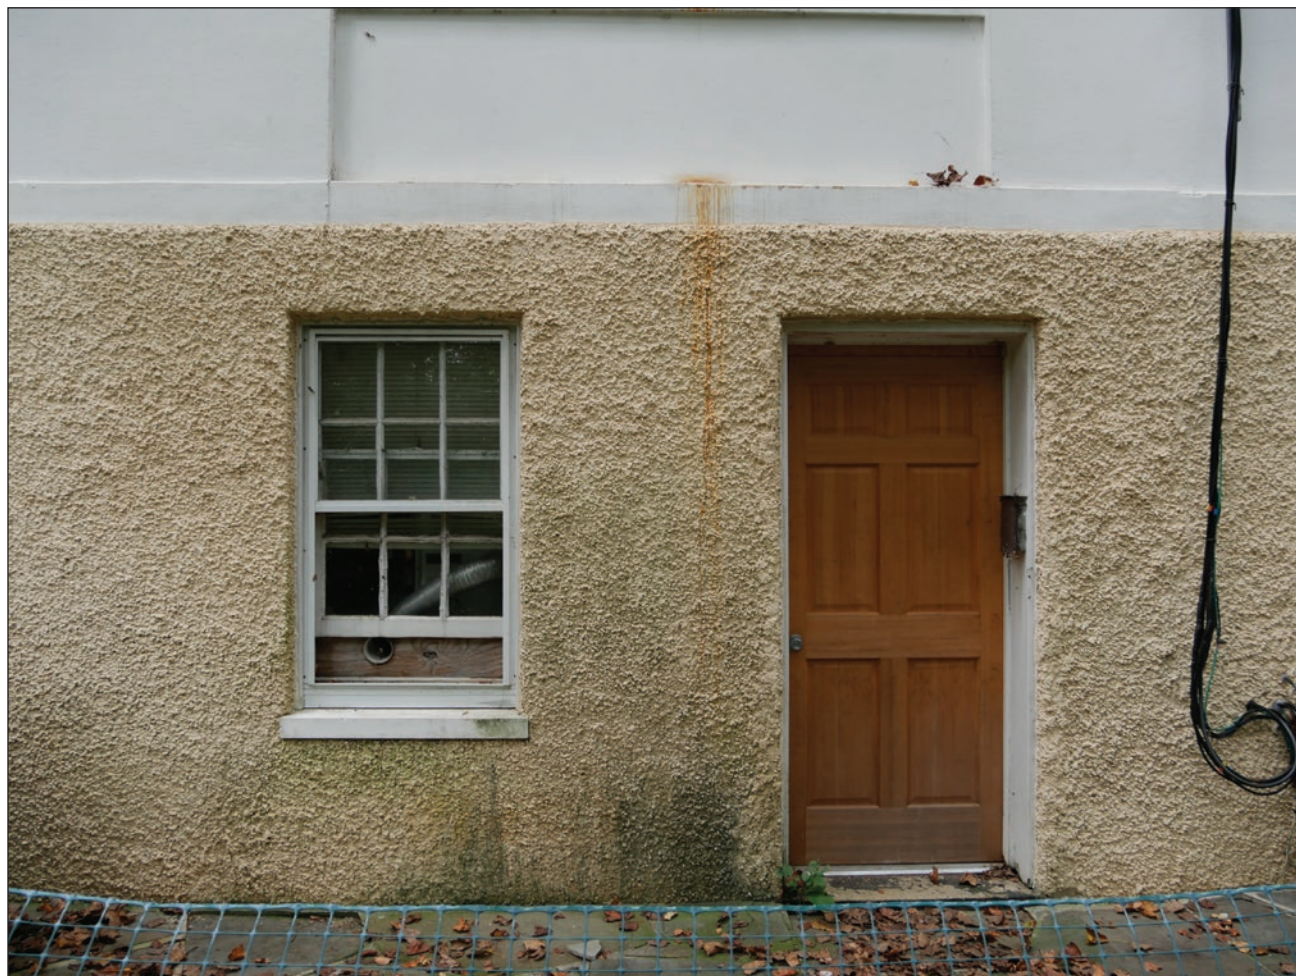
**Figure 205.** General soiling, biological growth, and rust staining on the pebble dash stucco at the east elevation. Building Conservation Associates, 2025.

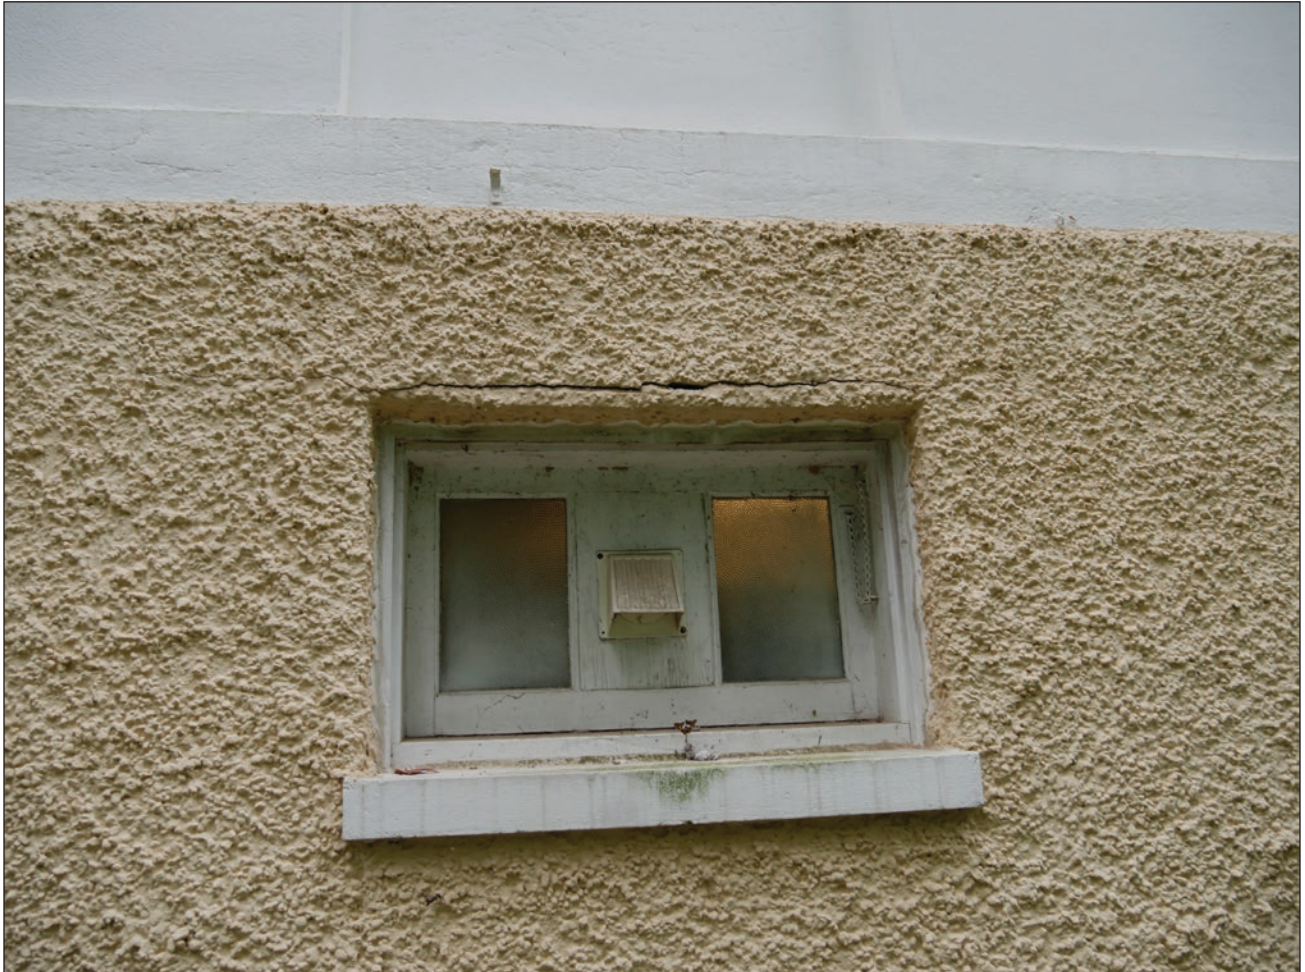
**Figure 206.** Horizontal crack in the pebble dash stucco at the lintel above a basement window on the north elevation. Also note the modification of the hopper window to accommodate a vent. Building Conservation Associates, 2025.

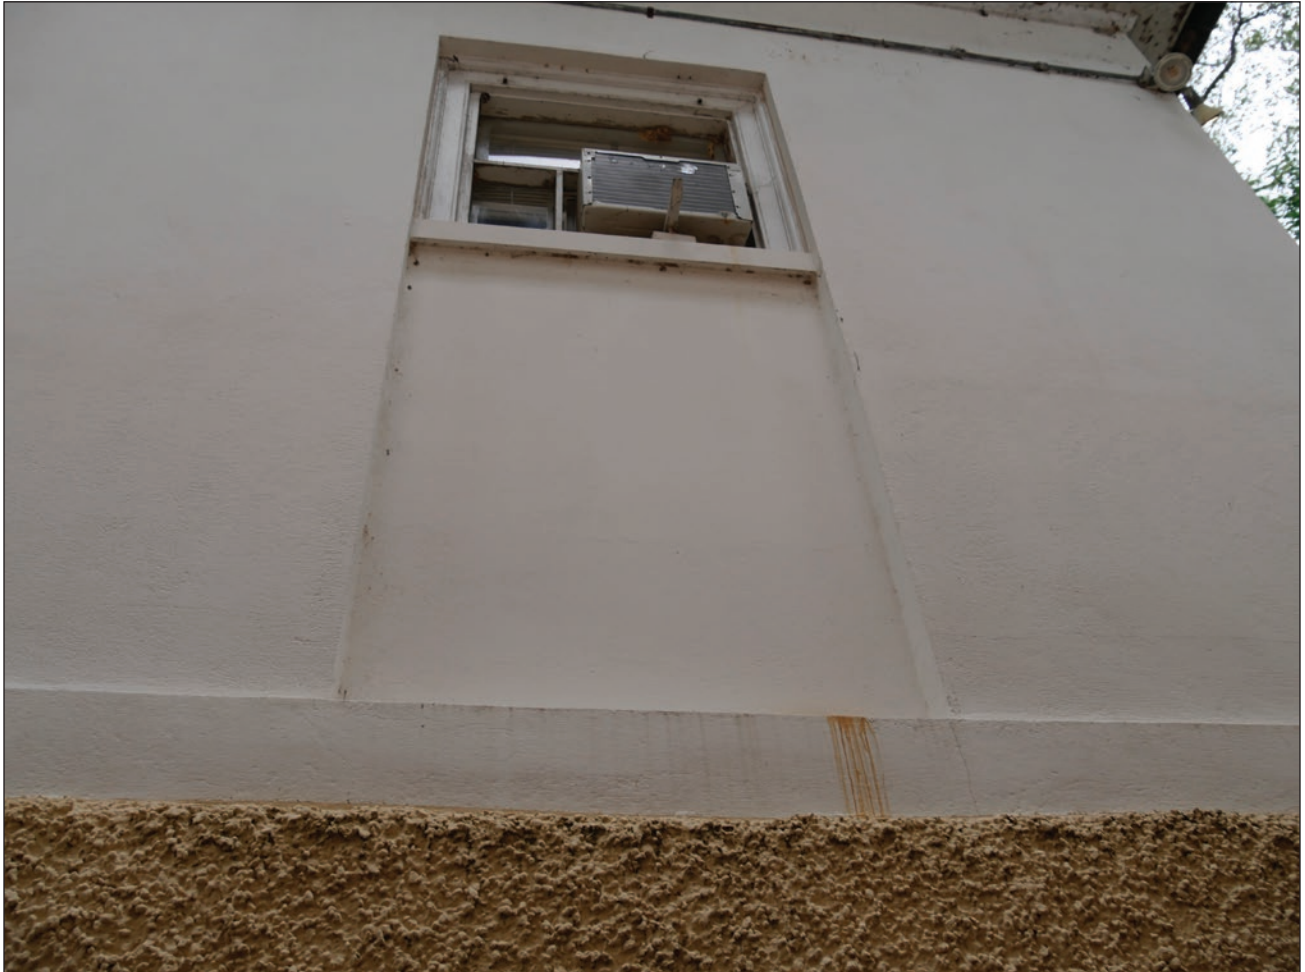
**Figure 210.** Rust staining on the flat stucco beneath a window A/C unit on the east elevation. Building Conservation Associates, 2025.

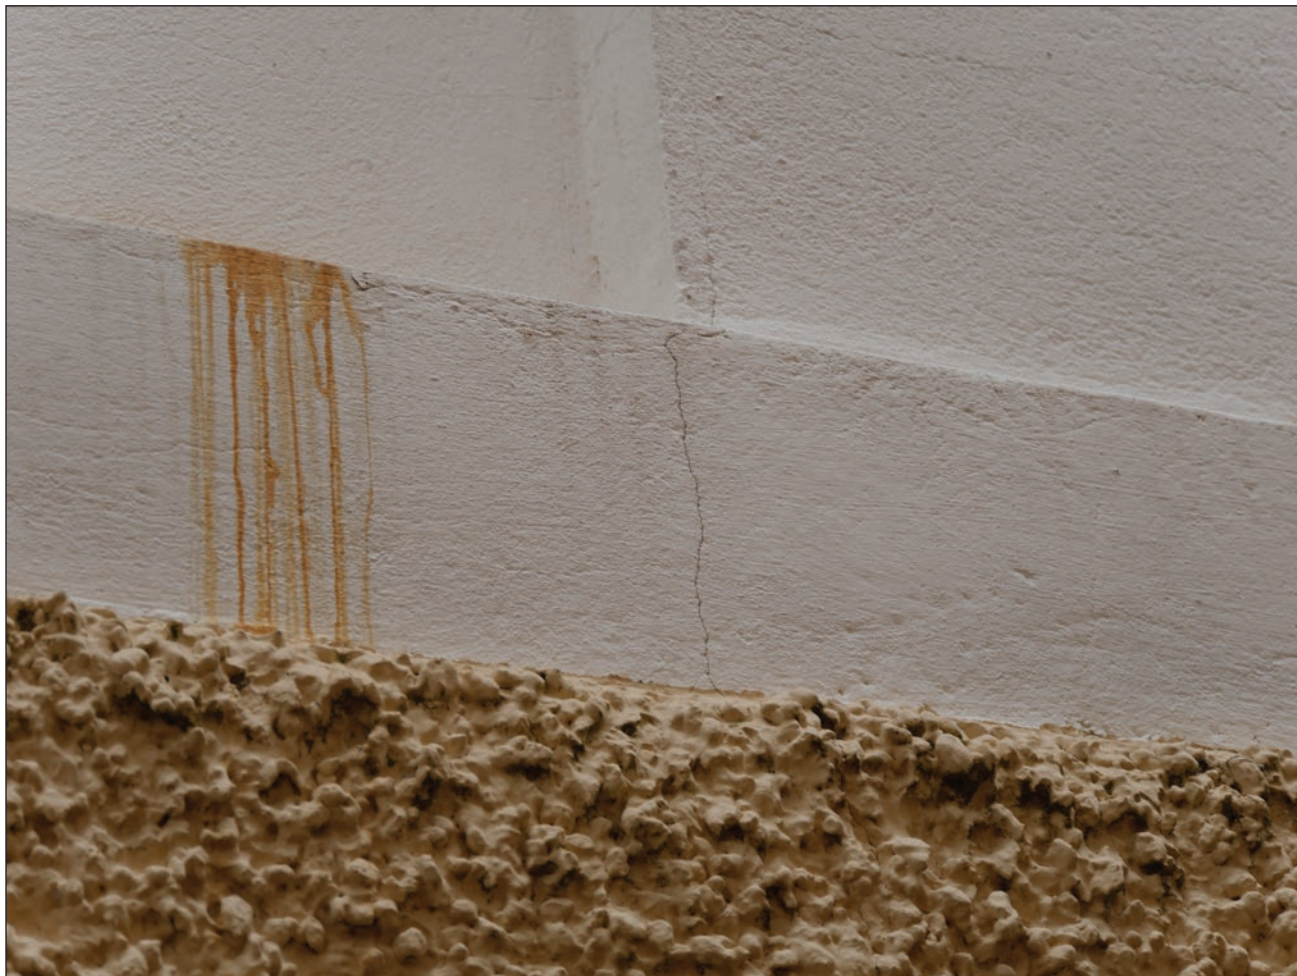
**Figure 211.** Rust staining at the flat stucco on the south elevation. Also note the narrow crack. Building Conservation Associates, 2025.

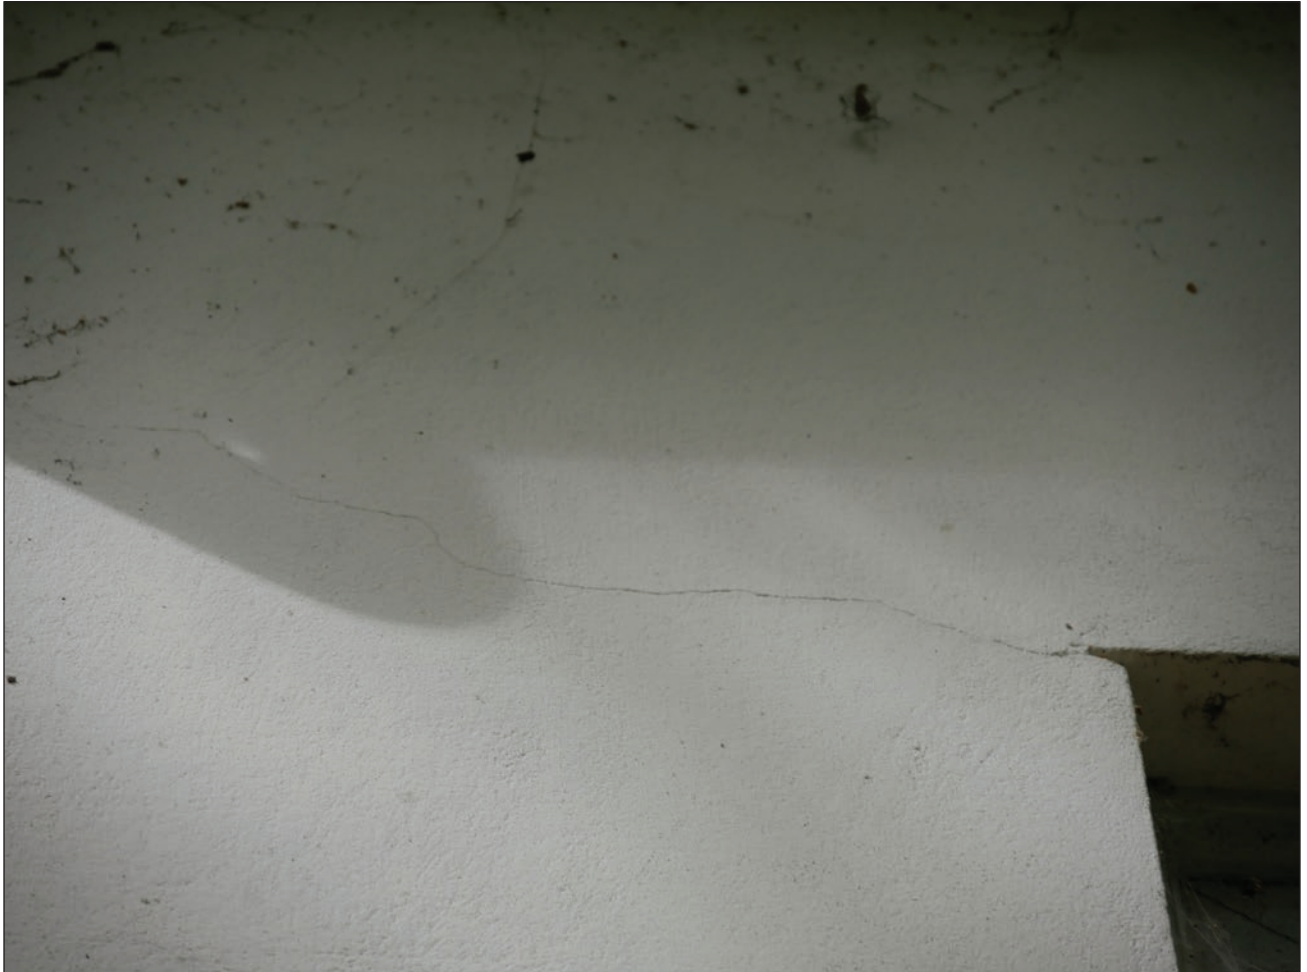
**Figure 212.** Narrow crack in the flat stucco on the east elevation. Building Conservation Associates, 2025.

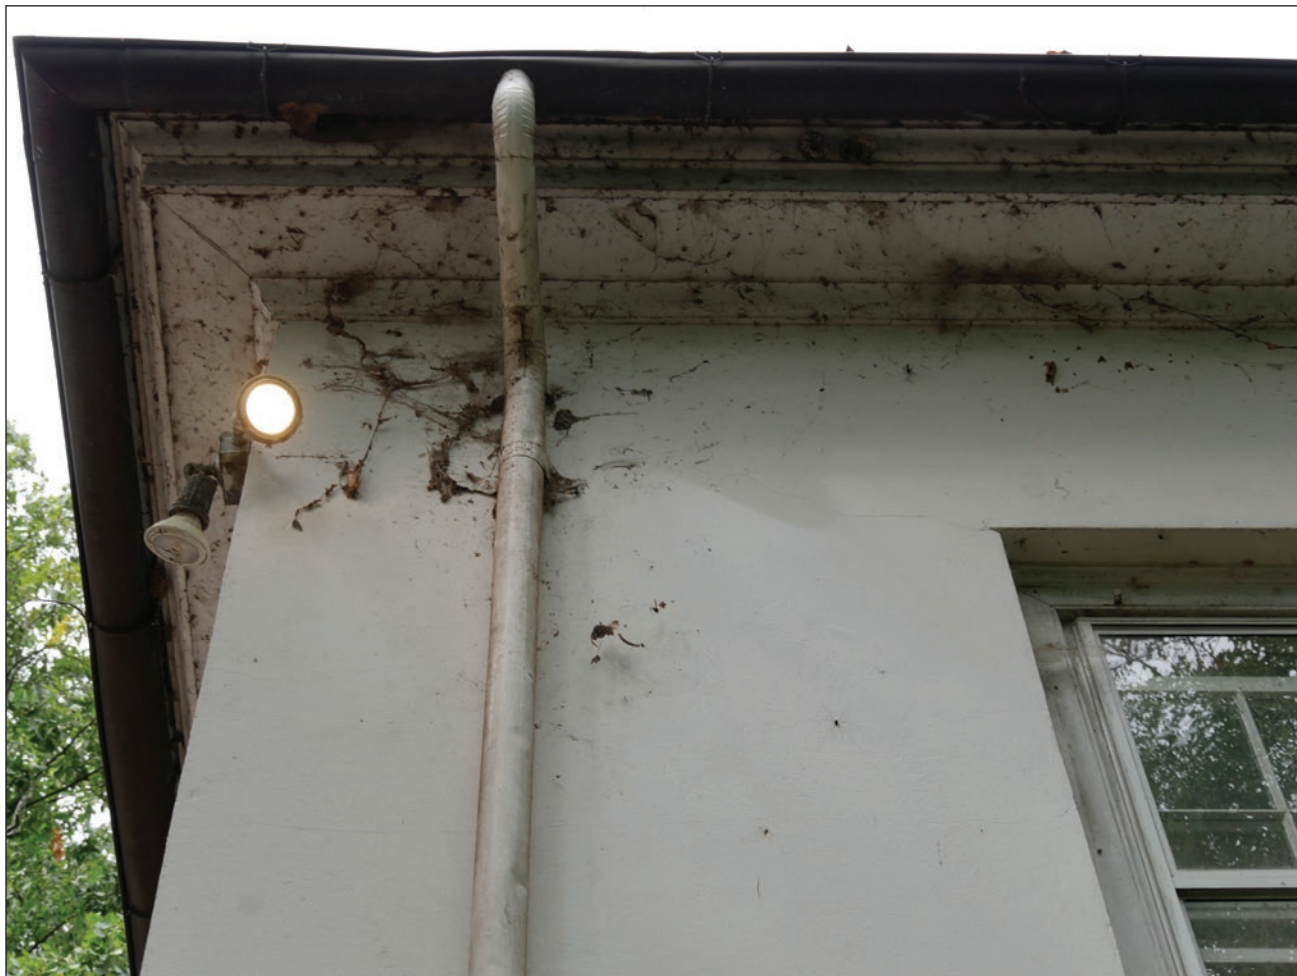
**Figure 213.** Insect activity at the cornice of the southeast corner. Building Conservation Associates, 2025.

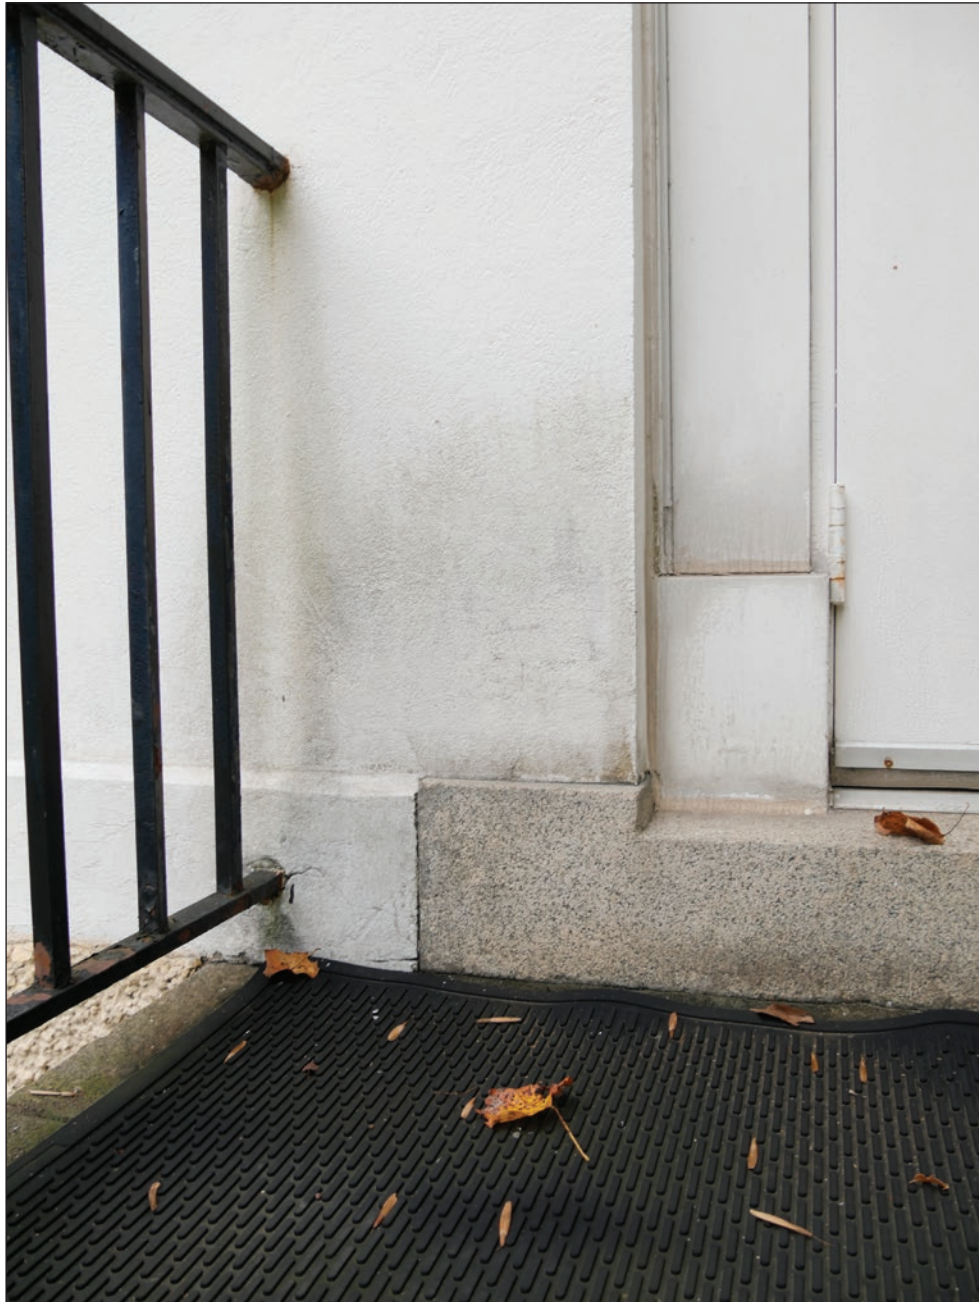
**Figure 214.** Cracking and rust staining at the railing penetration in the flat stucco on the west elevation. Building Conservation Associates, 2025.

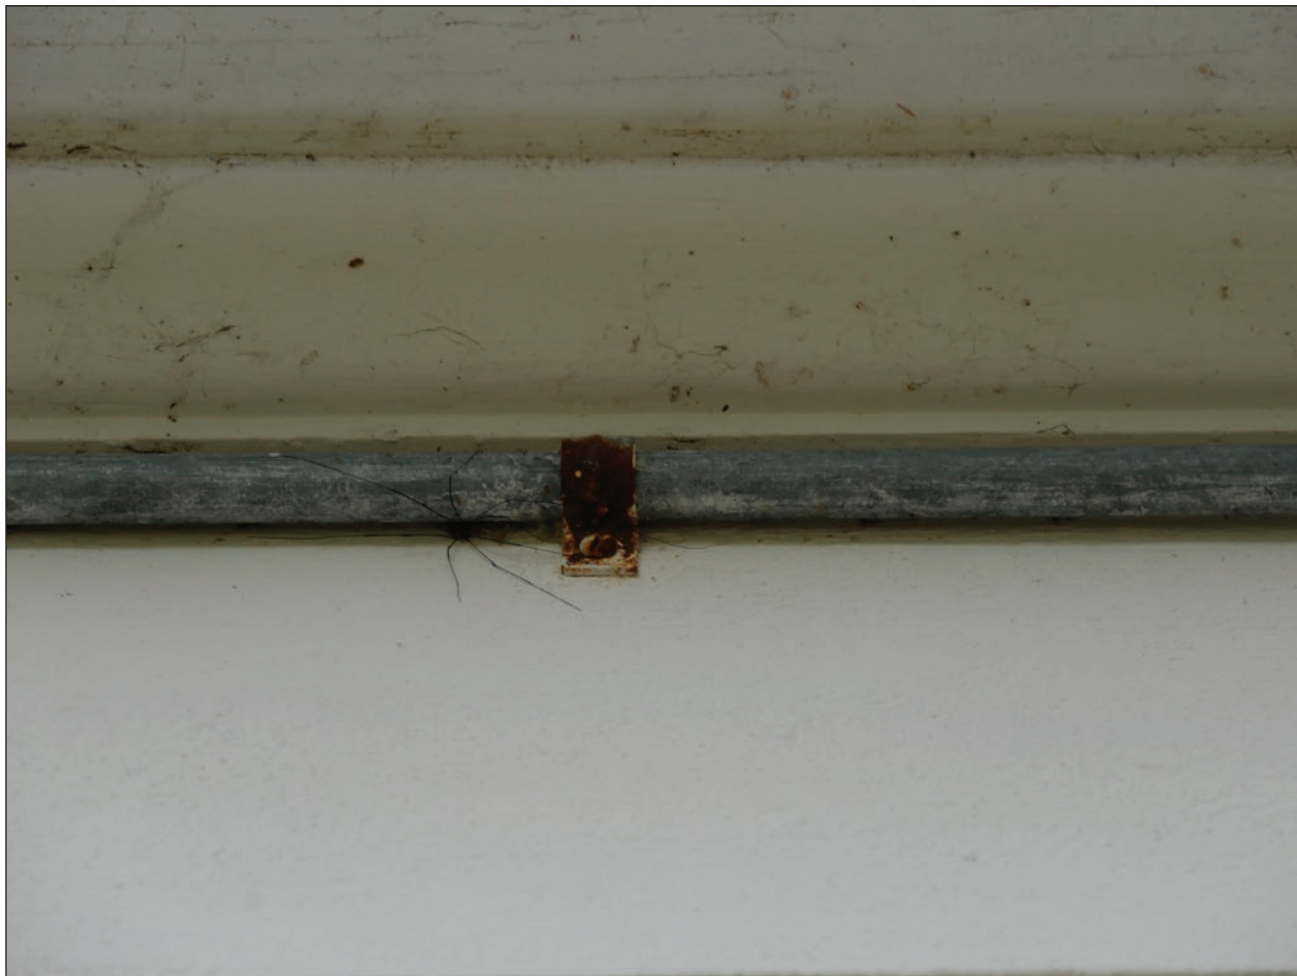
**Figure 215.** Rusted conduit bracket at the west elevation. Building Conservation Associates, 2025.

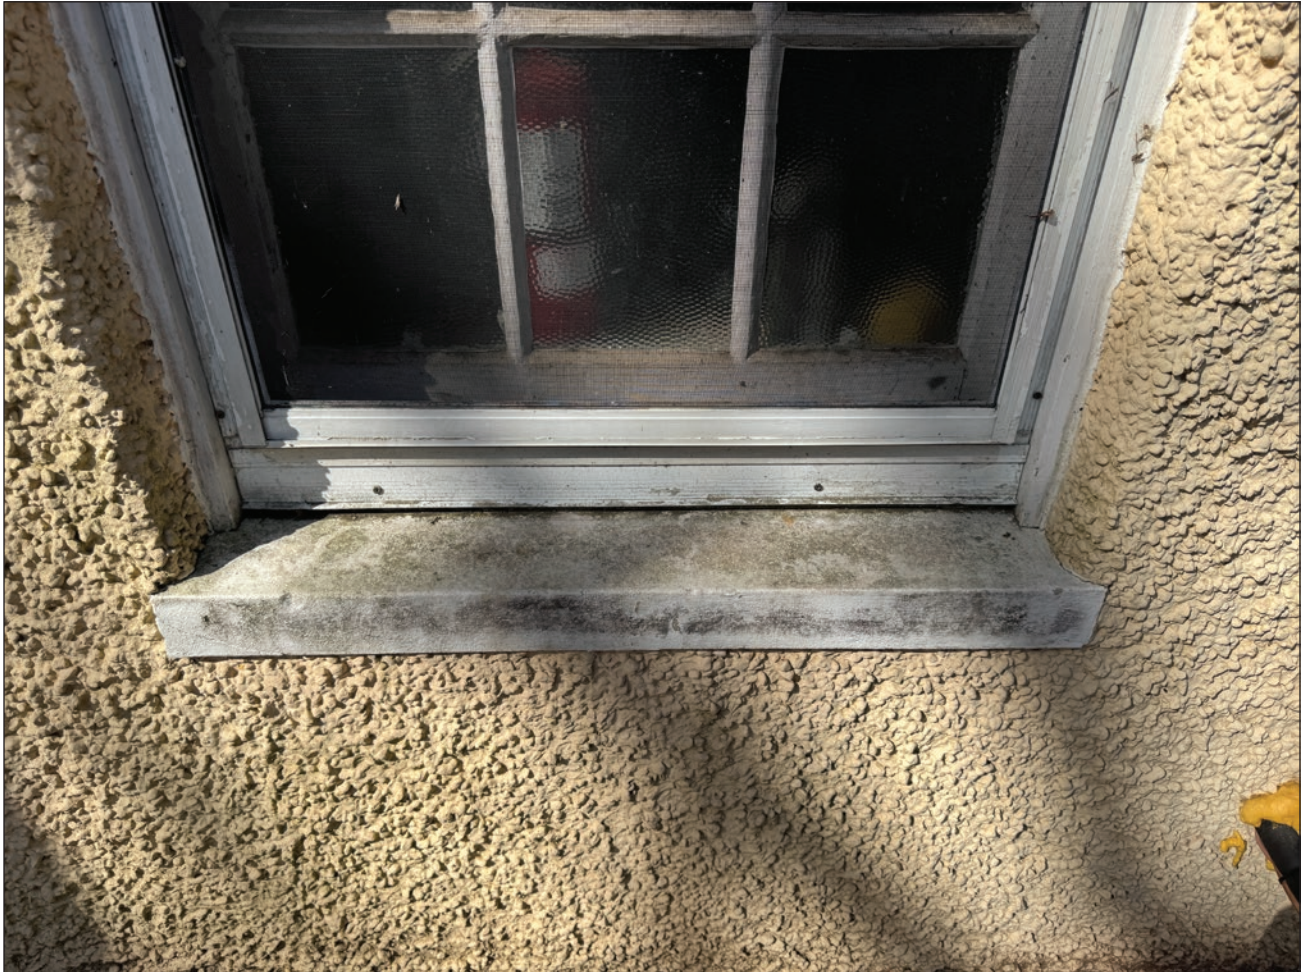
**Figure 216.** Biological growth and soiling at a window sill on the east elevation. Building Conservation Associates, 2025.

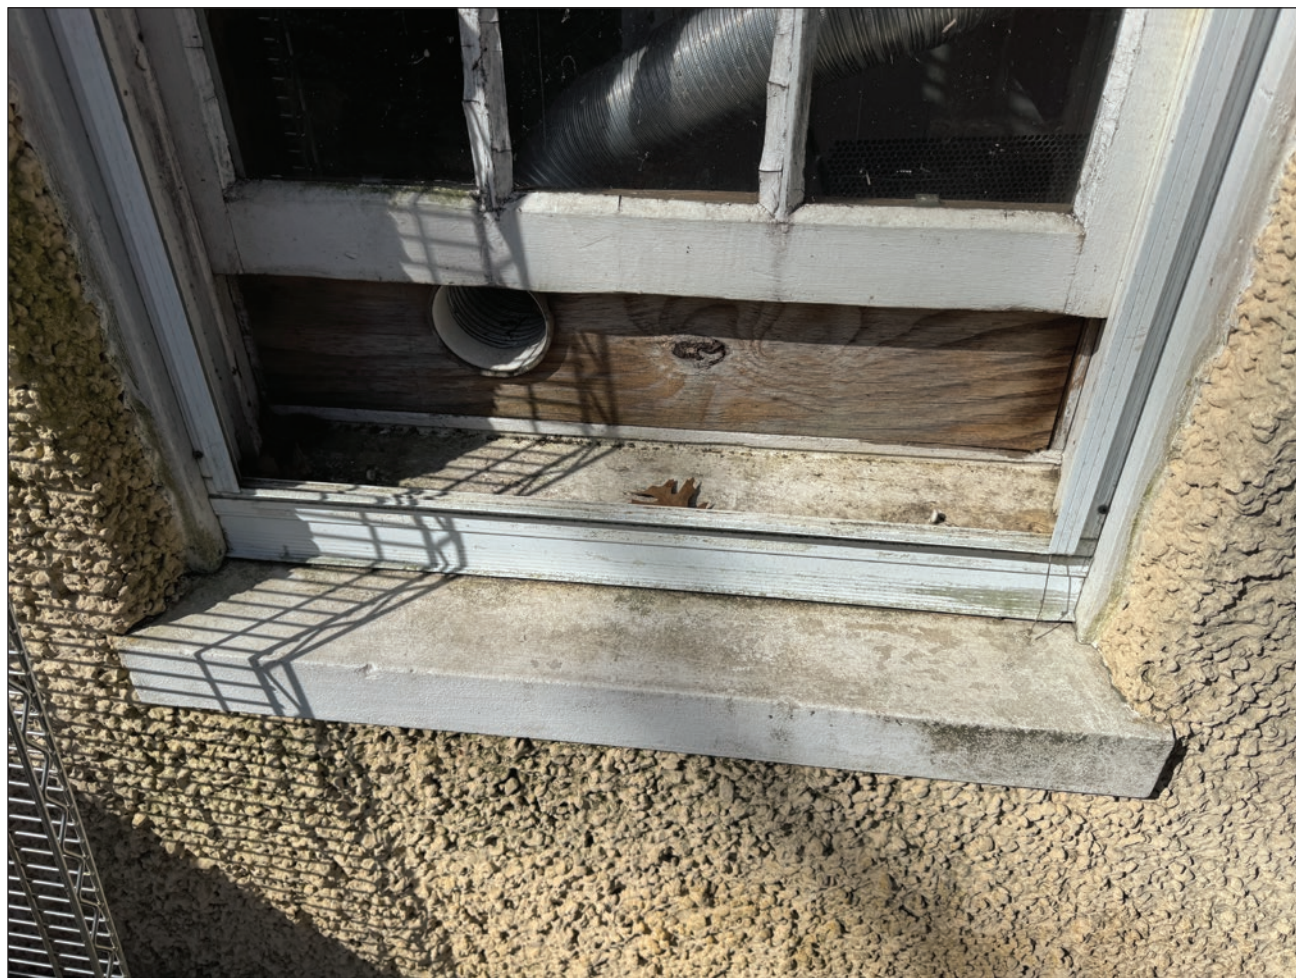
**Figure 217.** Failing sealant and paint at a sash window on the east elevation. Building Conservation Associates, 2025.

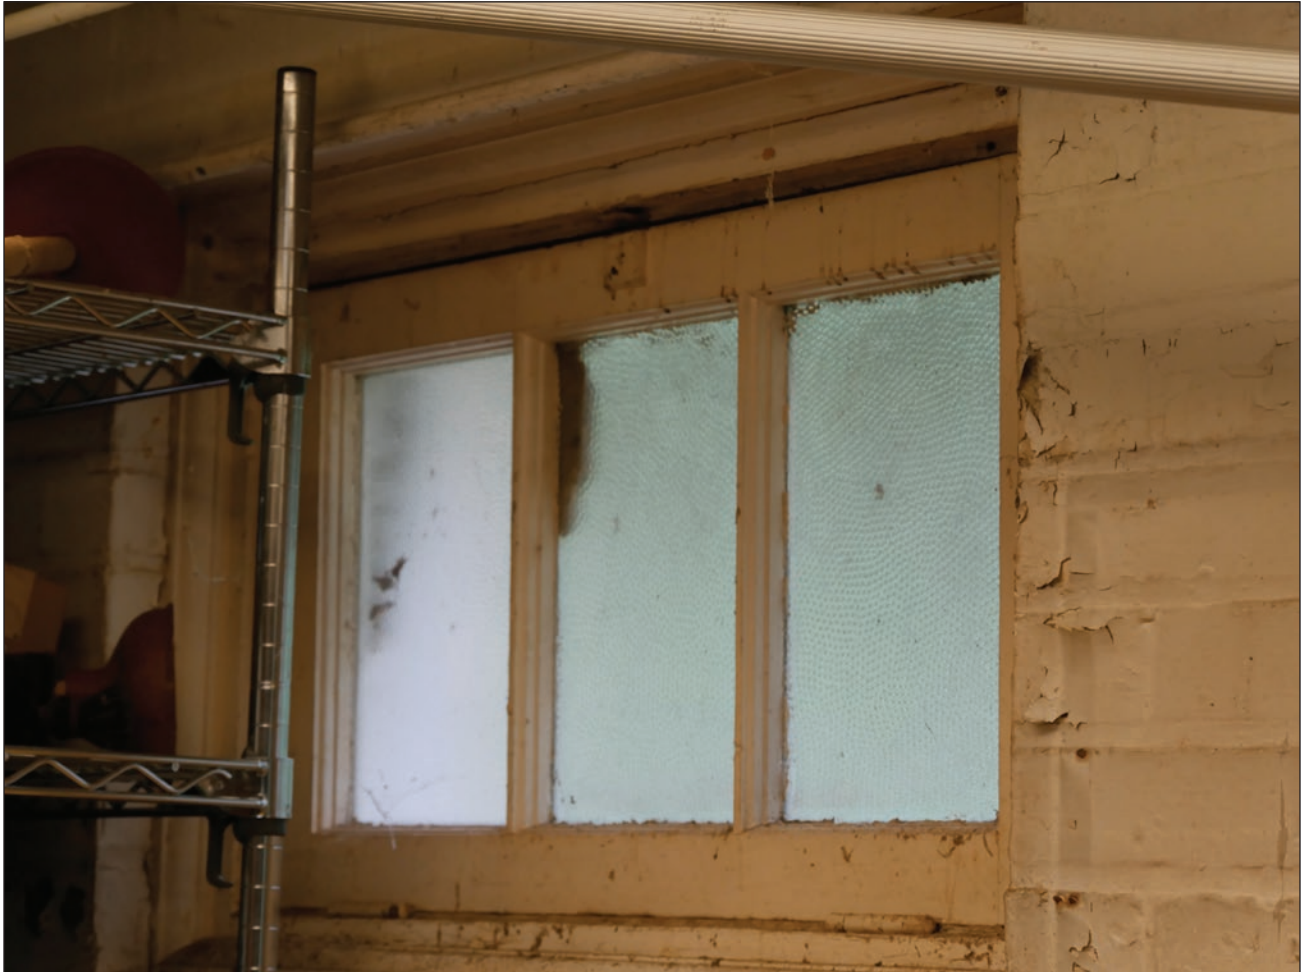
**Figure 218.** Basement hopper window with general soiling, a replacement glass pane, and missing hardware. Building Conservation Associates, 2025.

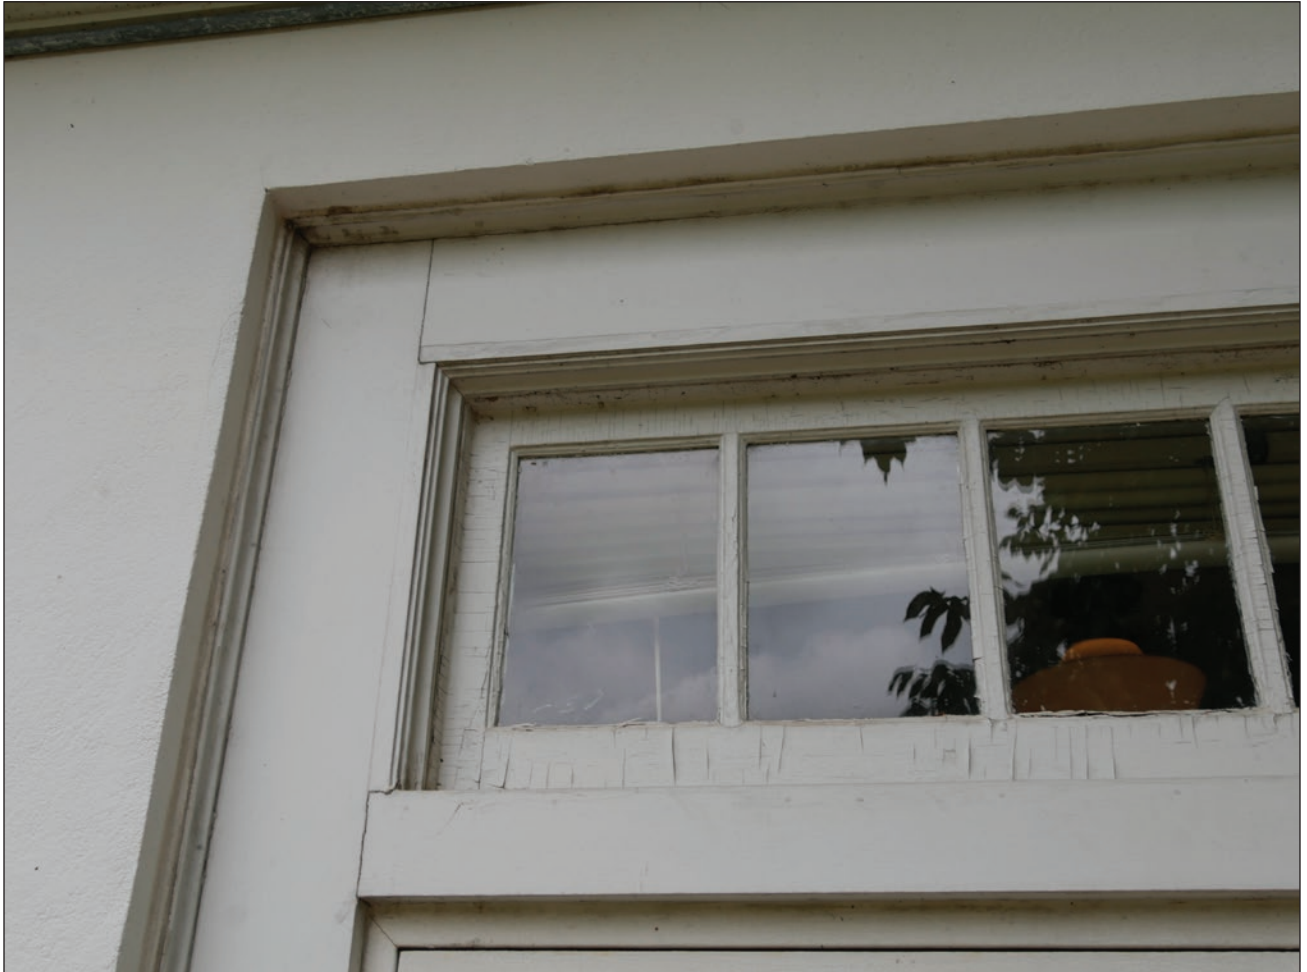
**Figure 222.** Failing paint at the west transom window. Building Conservation Associates, 2025.

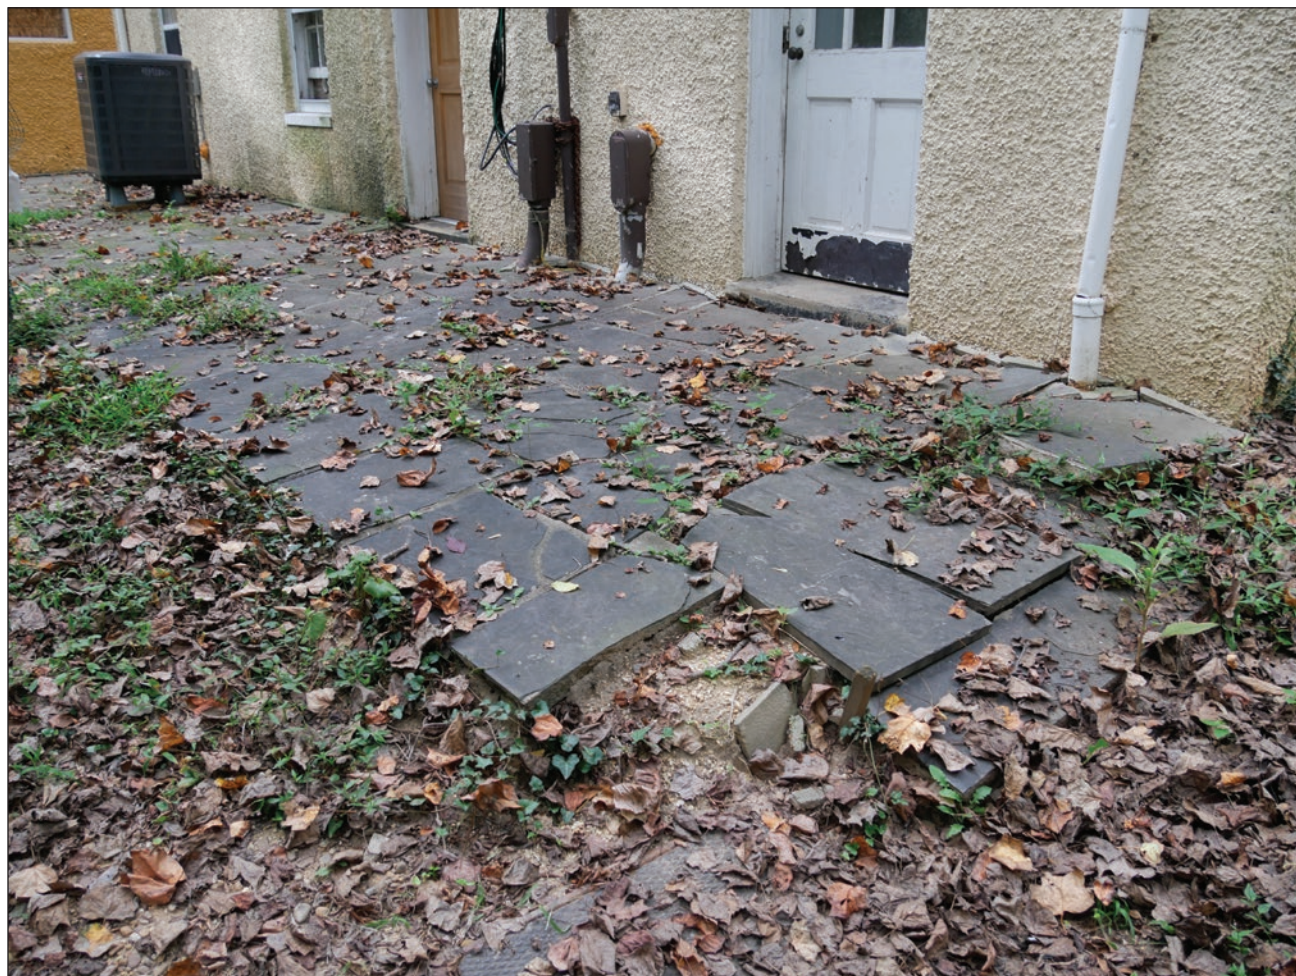
**Figure 223.** Displaced flagstones at the east patio. Building Conservation Associates, 2025.

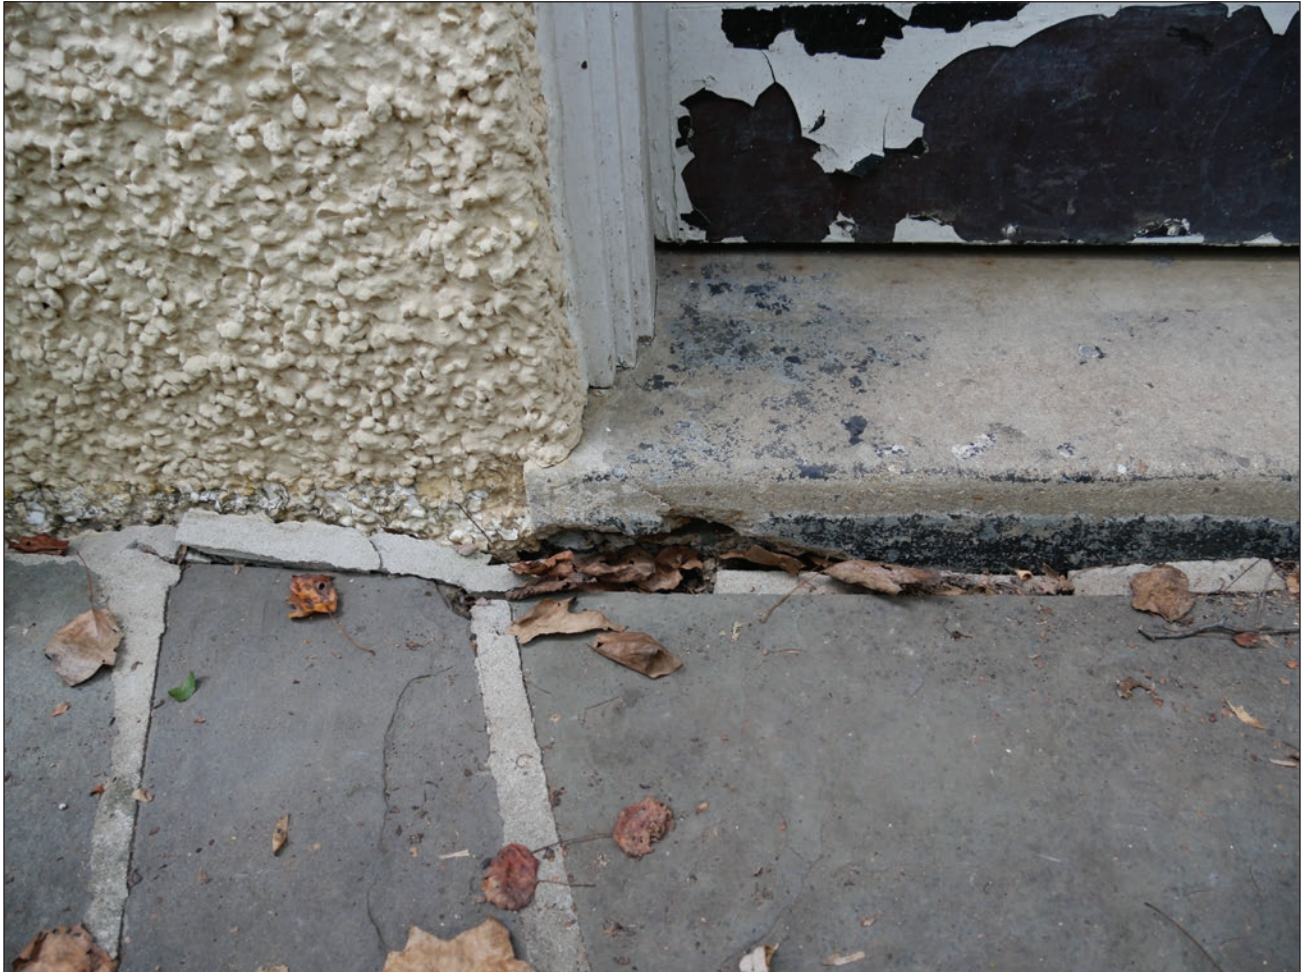
**Figure 224.** Displaced flagstones and damaged mortar at the east patio. Building Conservation Associates, 2025.

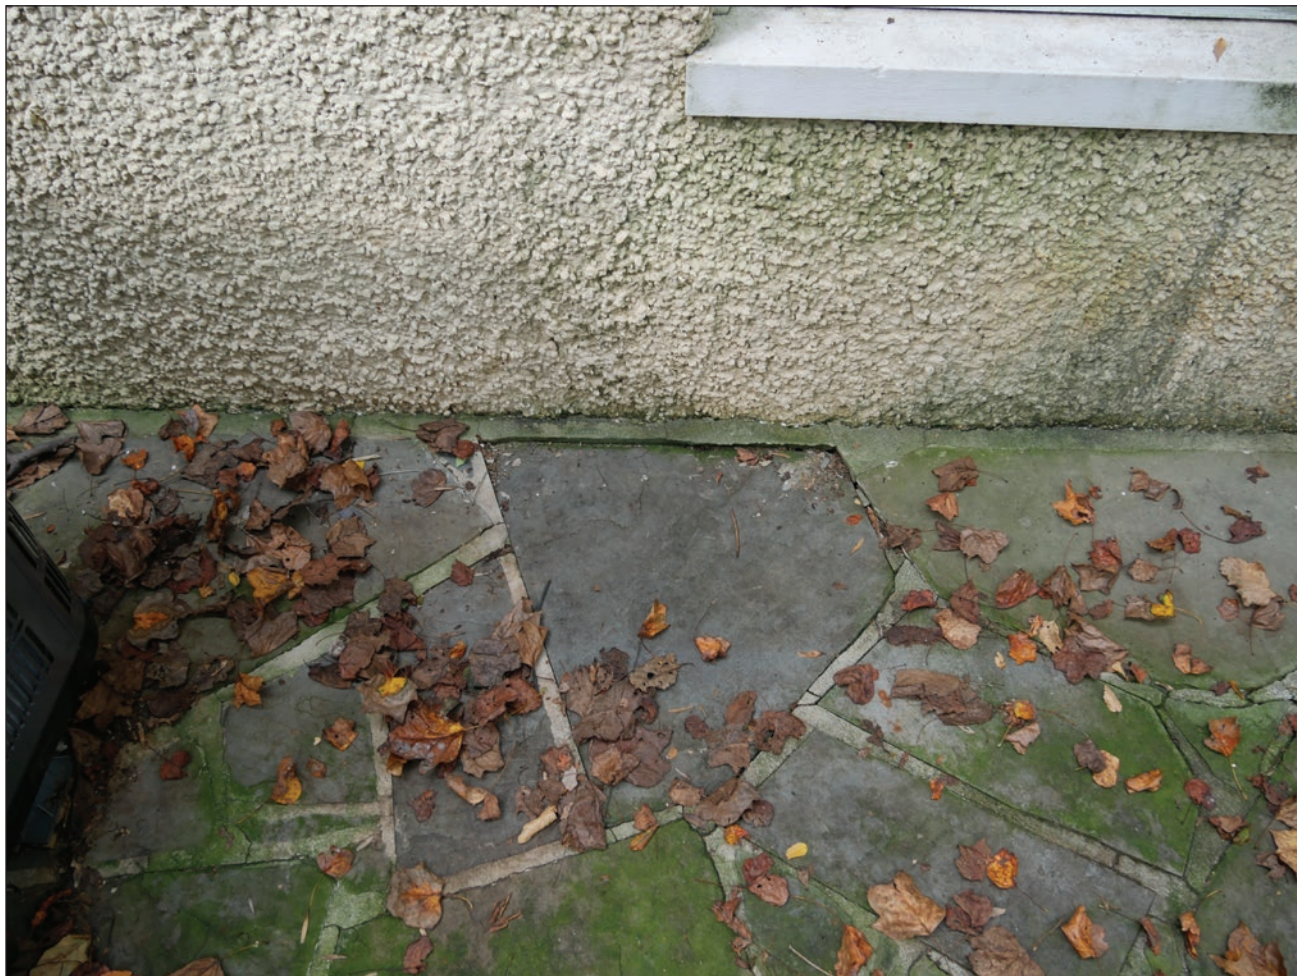
**Figure 225.** Stains from biological growth at the east patio. Building Conservation Associates, 2025.

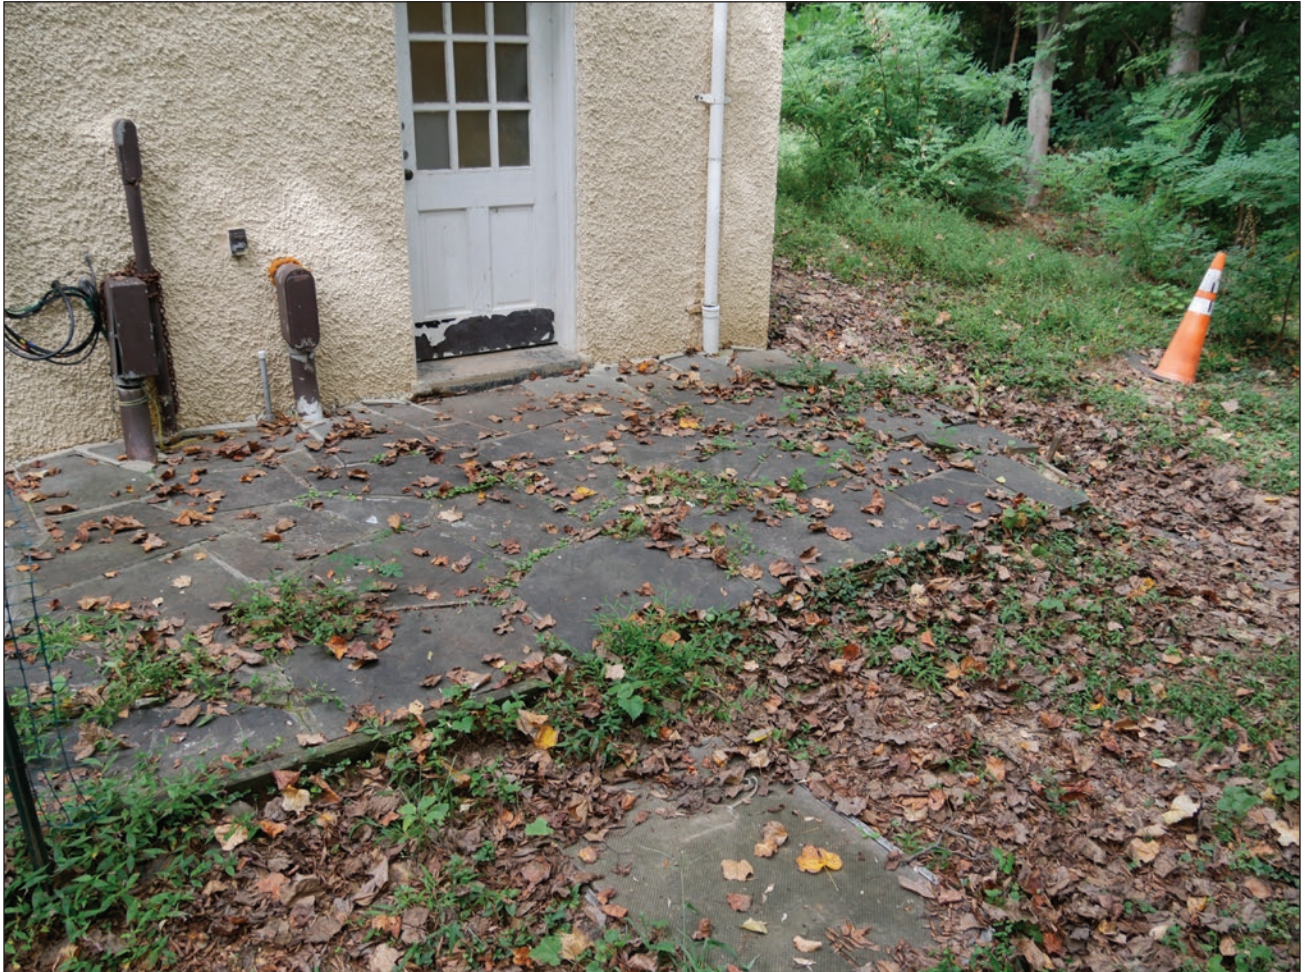
**Figure 226.** Missing wood edging at east patio. Building Conservation Associates, 2025.

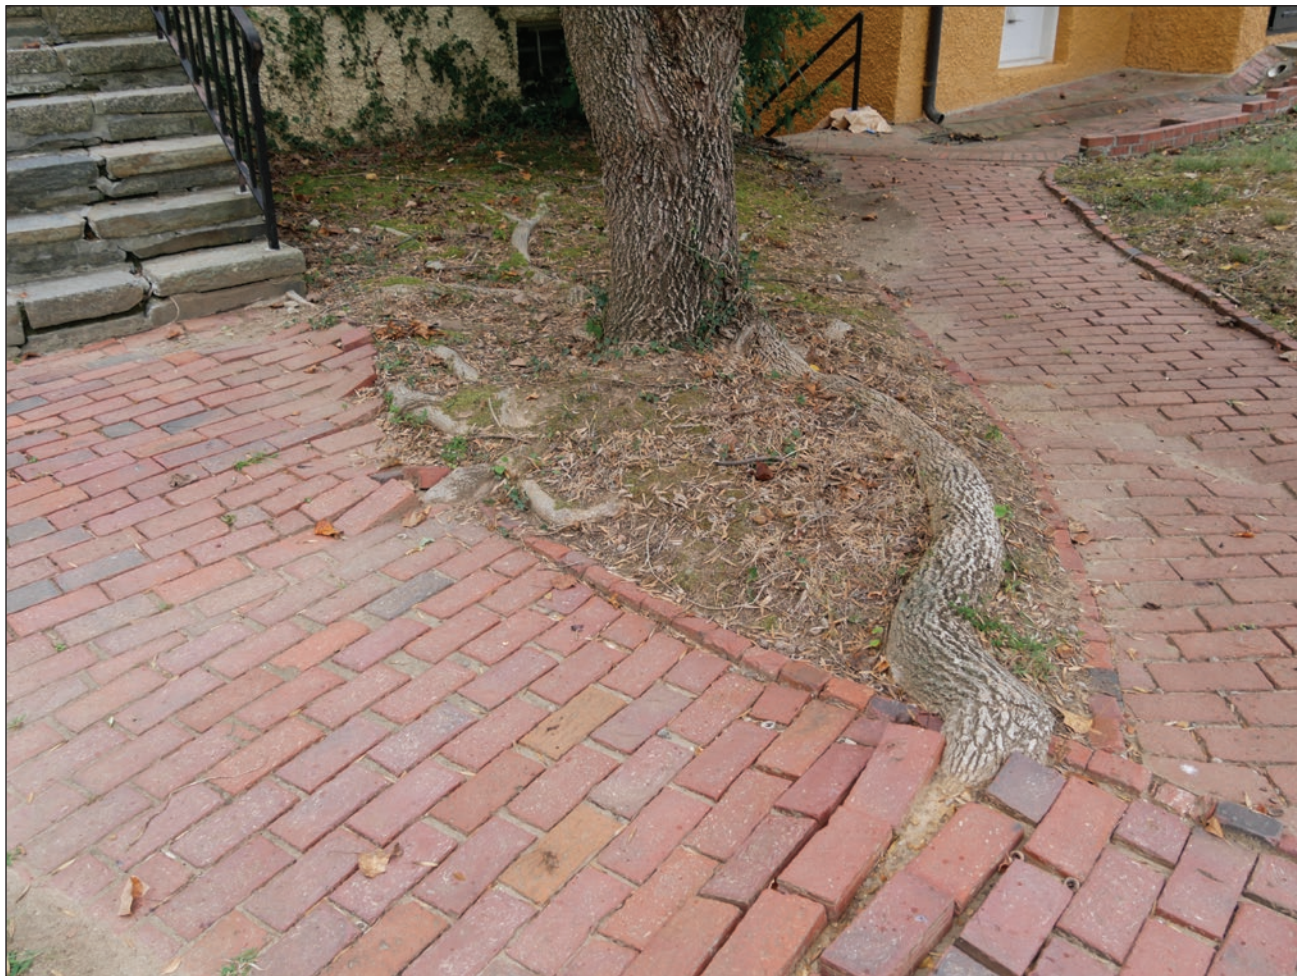
**Figure 227.** Displaced brick, lost edging, and mortar loss at brick path. Building Conservation Associates, 2025.
