*HISTORIC STRUCTURE REPORT*  
**HISTORIC CEMETERY COMFORT STATION  
(BUILDING #313)**

Kevin Wohlgemuth, Senior Associate, Building Conservation Associates, Inc. (BCA)  
Dorothy Krotzer, Director, BCA  
Michele Boyd, Director of Preservation Services, BCA  
Kate Whitney-Schubb, Staff Conservator, BCA

The following 100% Draft of the Historic Structure Report for the Historic Comfort Station (Building #313) at Arlington National Cemetery represents a synthesis of all research and analysis performed for this project.

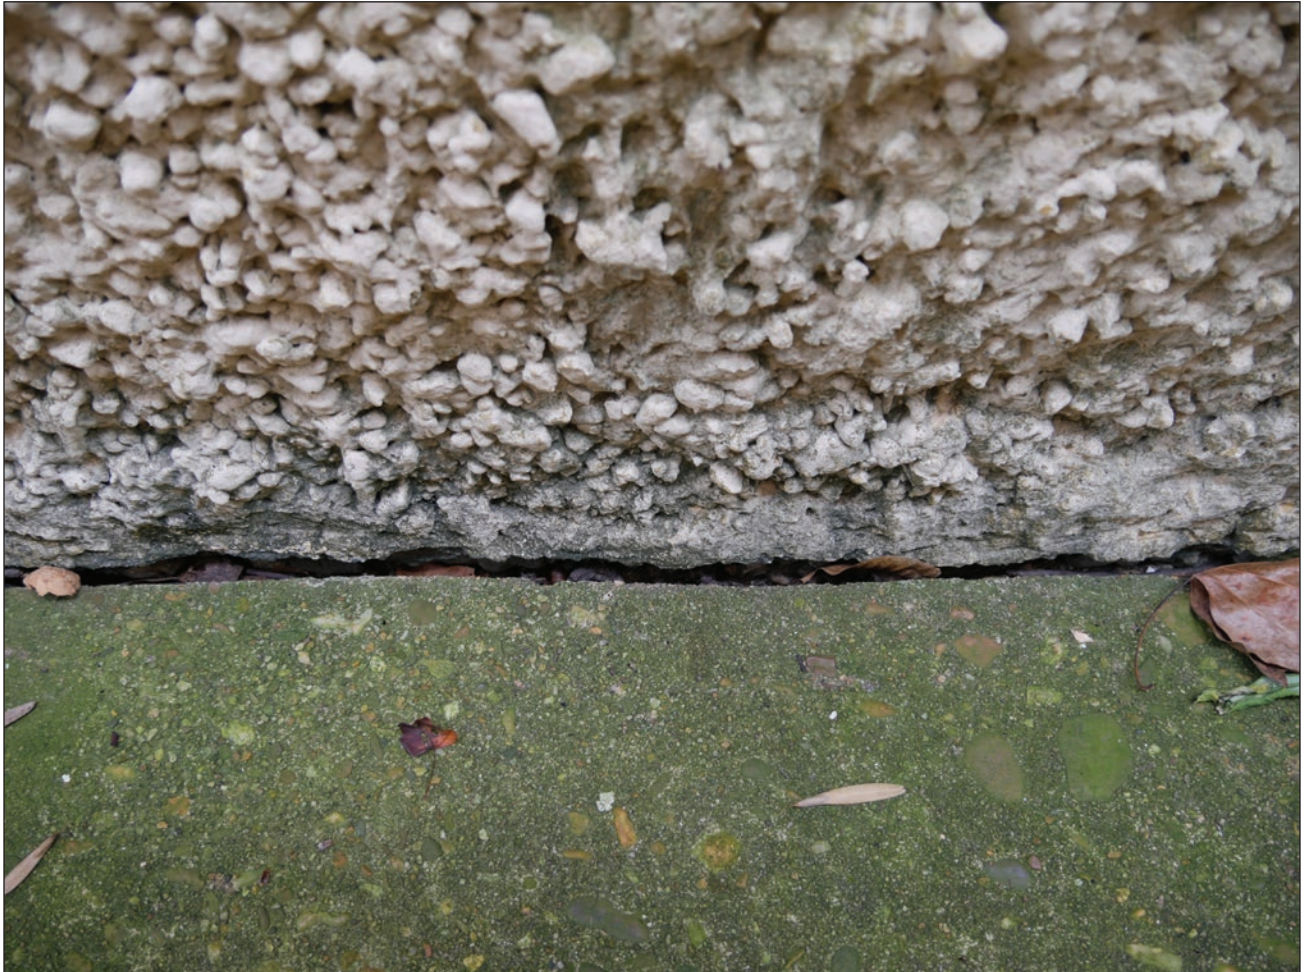
**Figure 228.** Sealant loss and stains from biological growth at concrete walkway on the south side of the building. Building Conservation Associates, 2025.

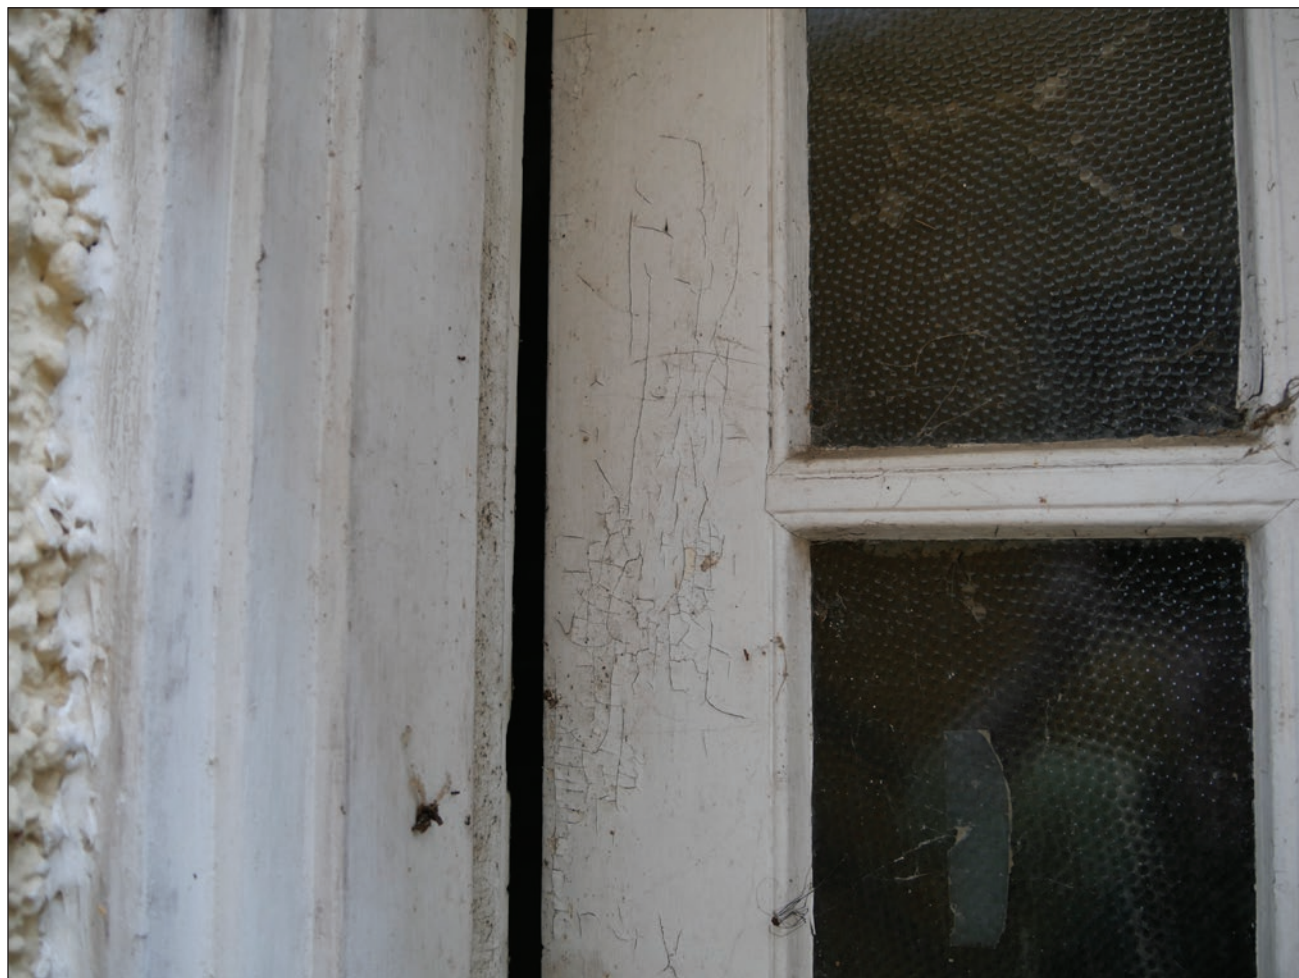
**Figure 229.** Paint flaking at southwest basement door. Building Conservation Associates, 2025.

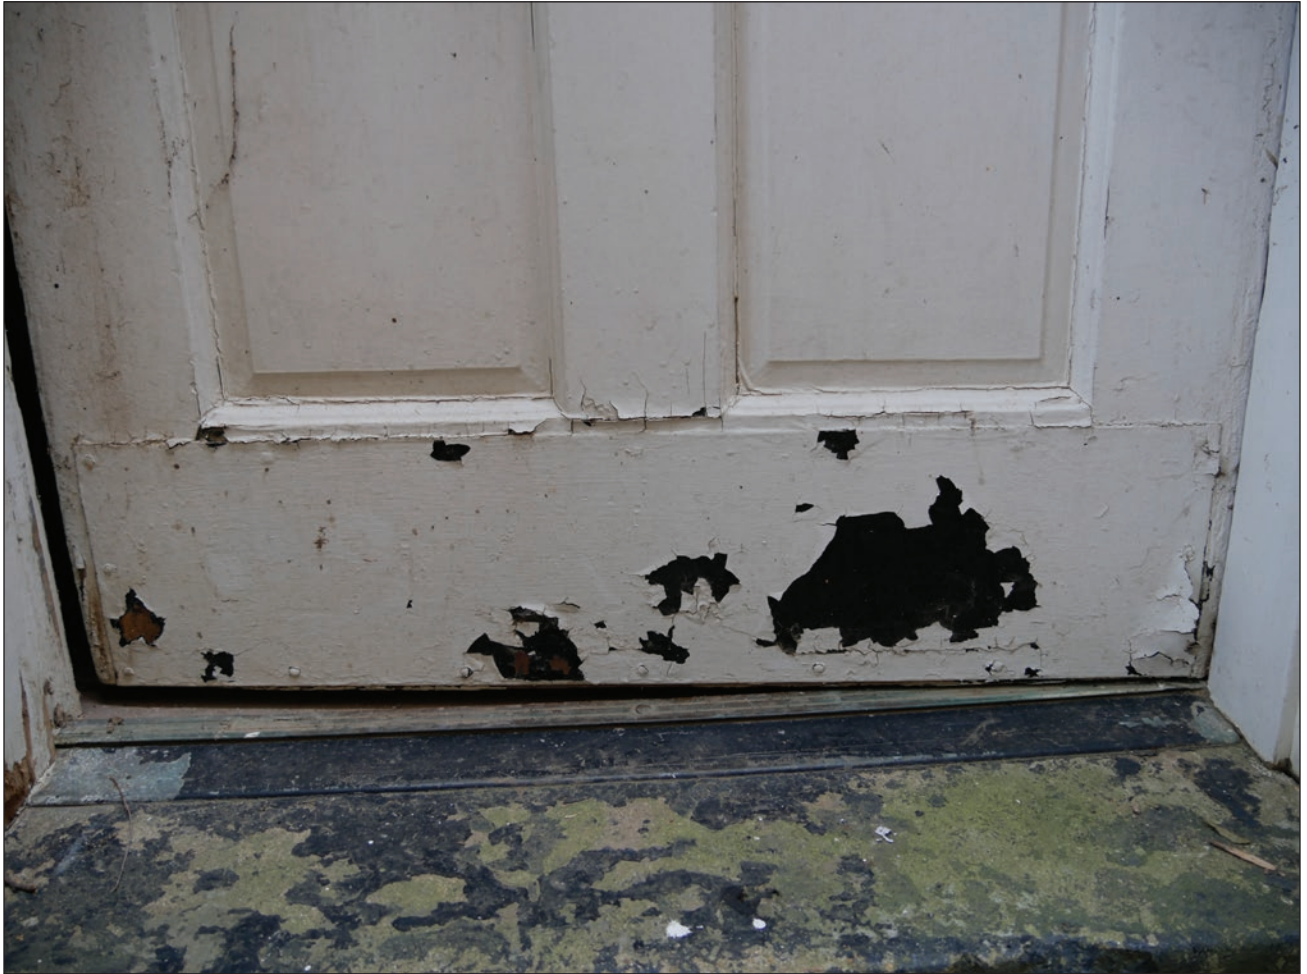
**Figure 230.** Paint loss and stains from biological growth at southwest basement door and threshold. Building Conservation Associates, 2025.

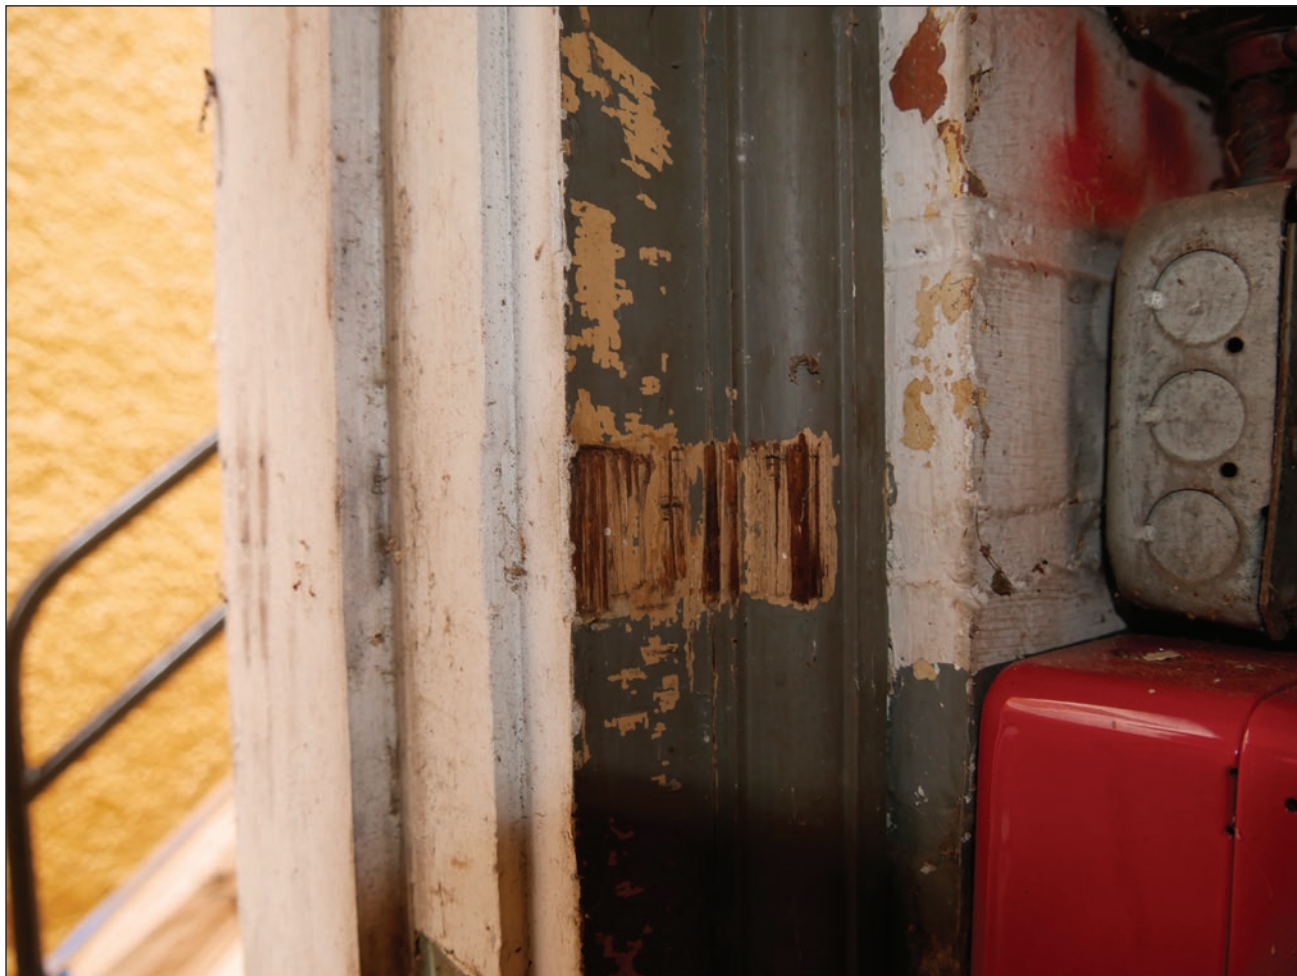
**Figure 231.** Wood damage and paint loss at interior of southwest basement door. Building Conservation Associates, 2025.

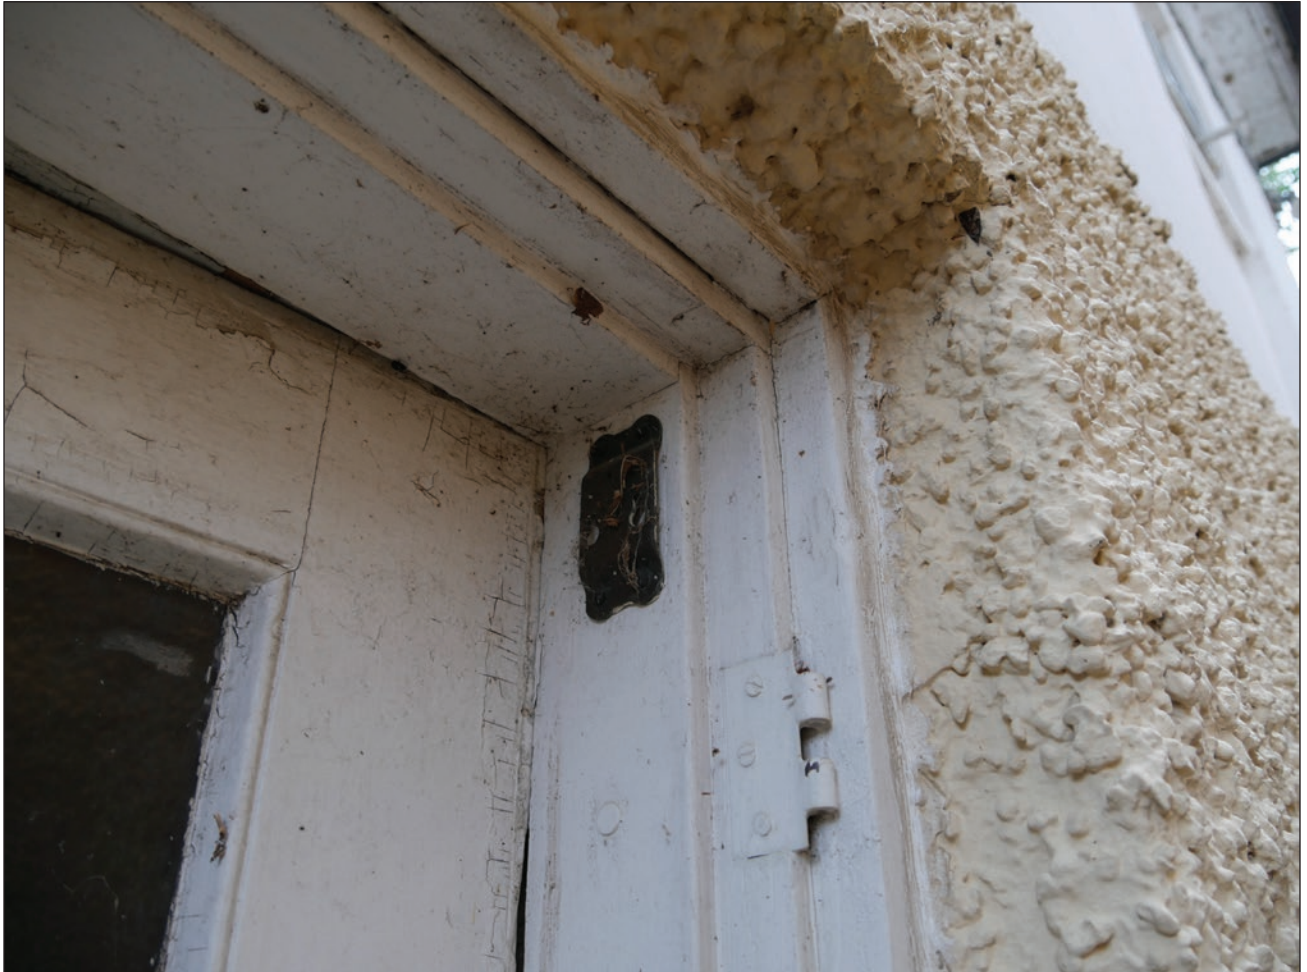
**Figure 232.** Abandoned historic and non-historic hardware at southwest basement door. Building Conservation Associates, 2025.

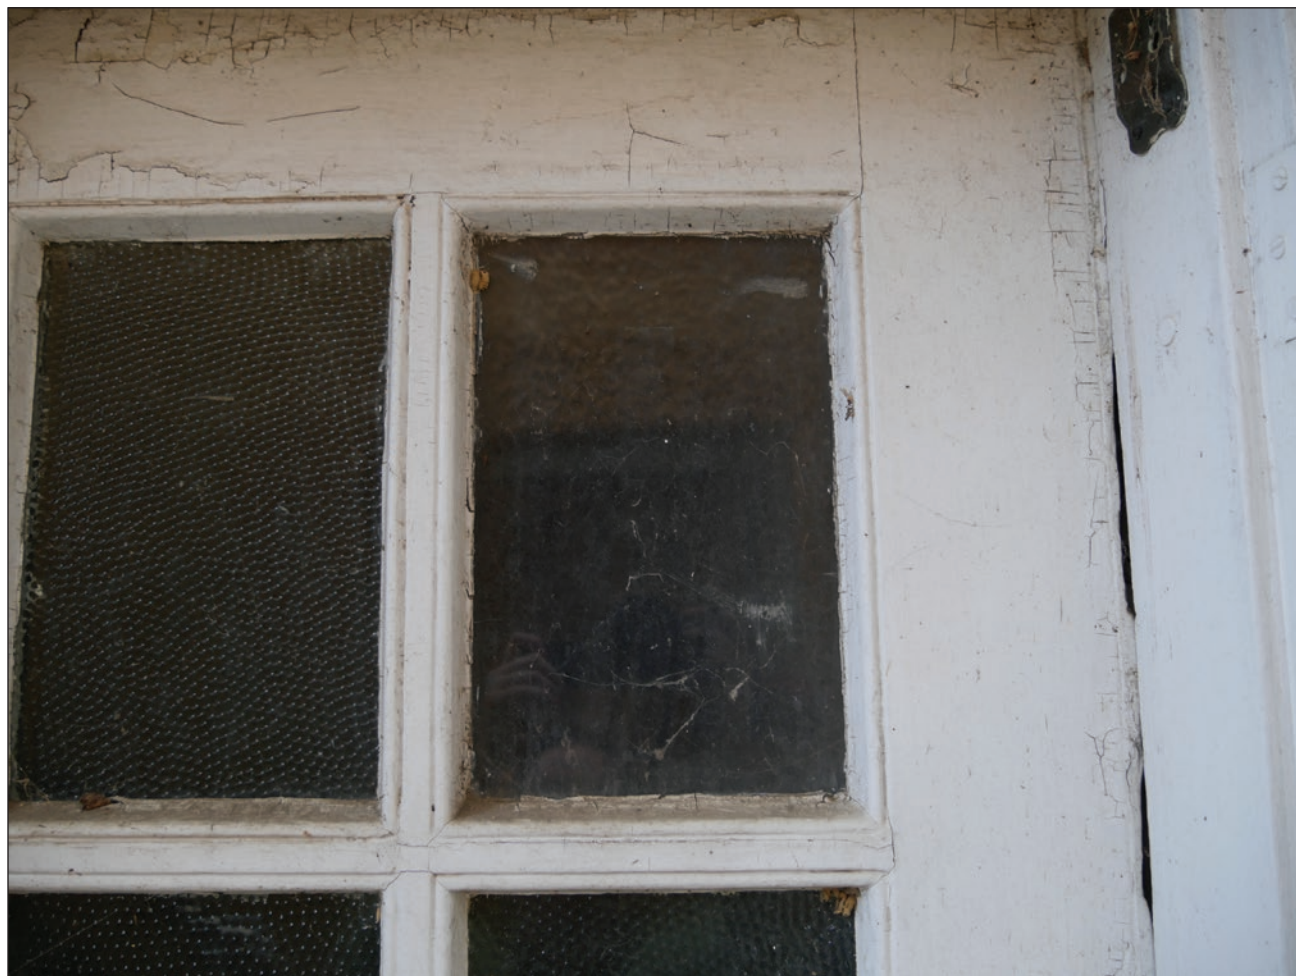
**Figure 233.** Replacement glass pane at southwest basement door. Building Conservation Associates, 2025.

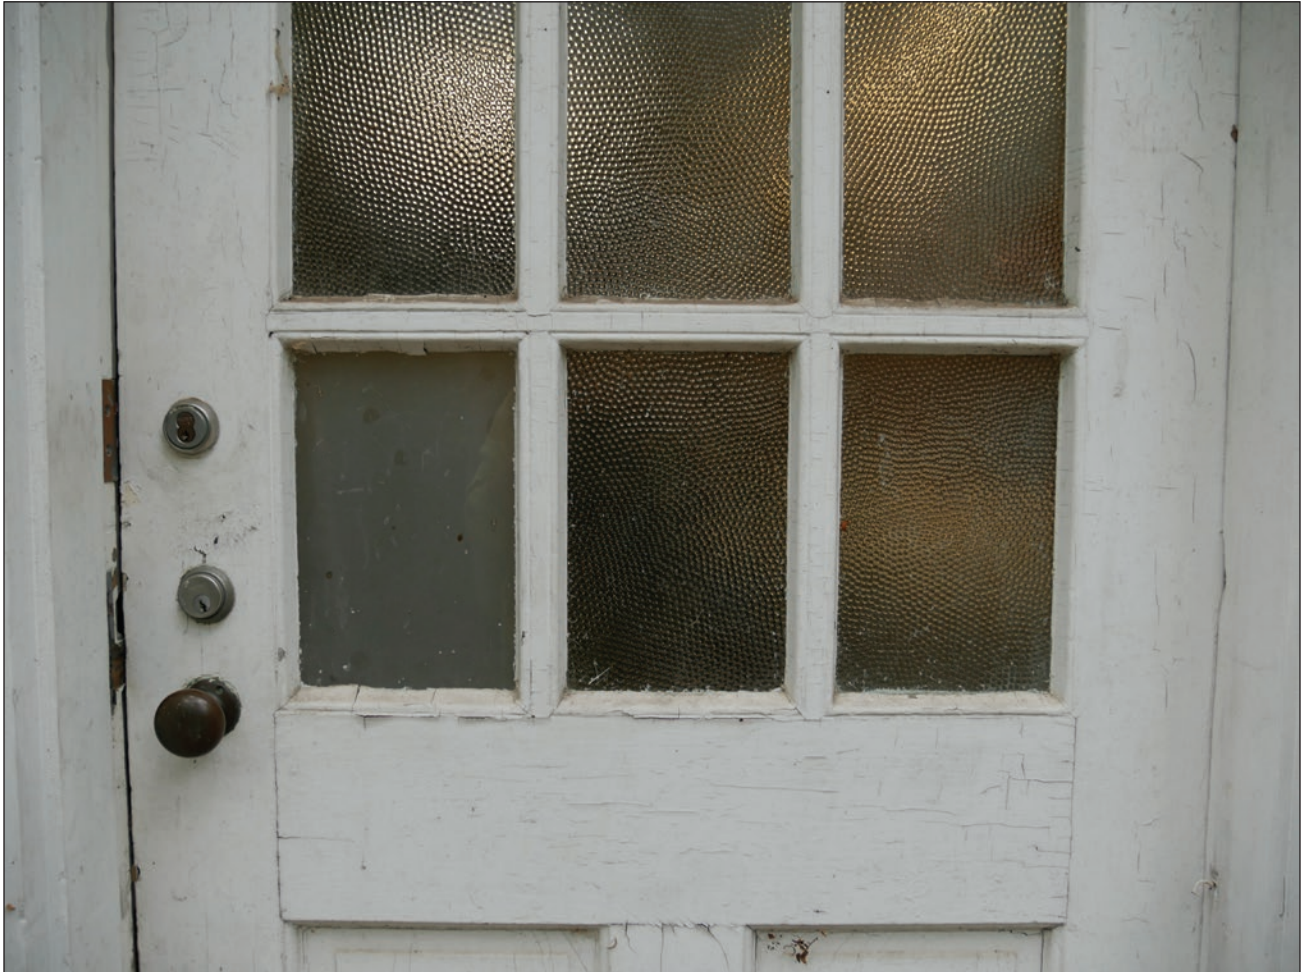
**Figure 234.** Replacement glass pane, non-historic hardware, and paint failure at northeast basement door. Building Conservation Associates, 2025.

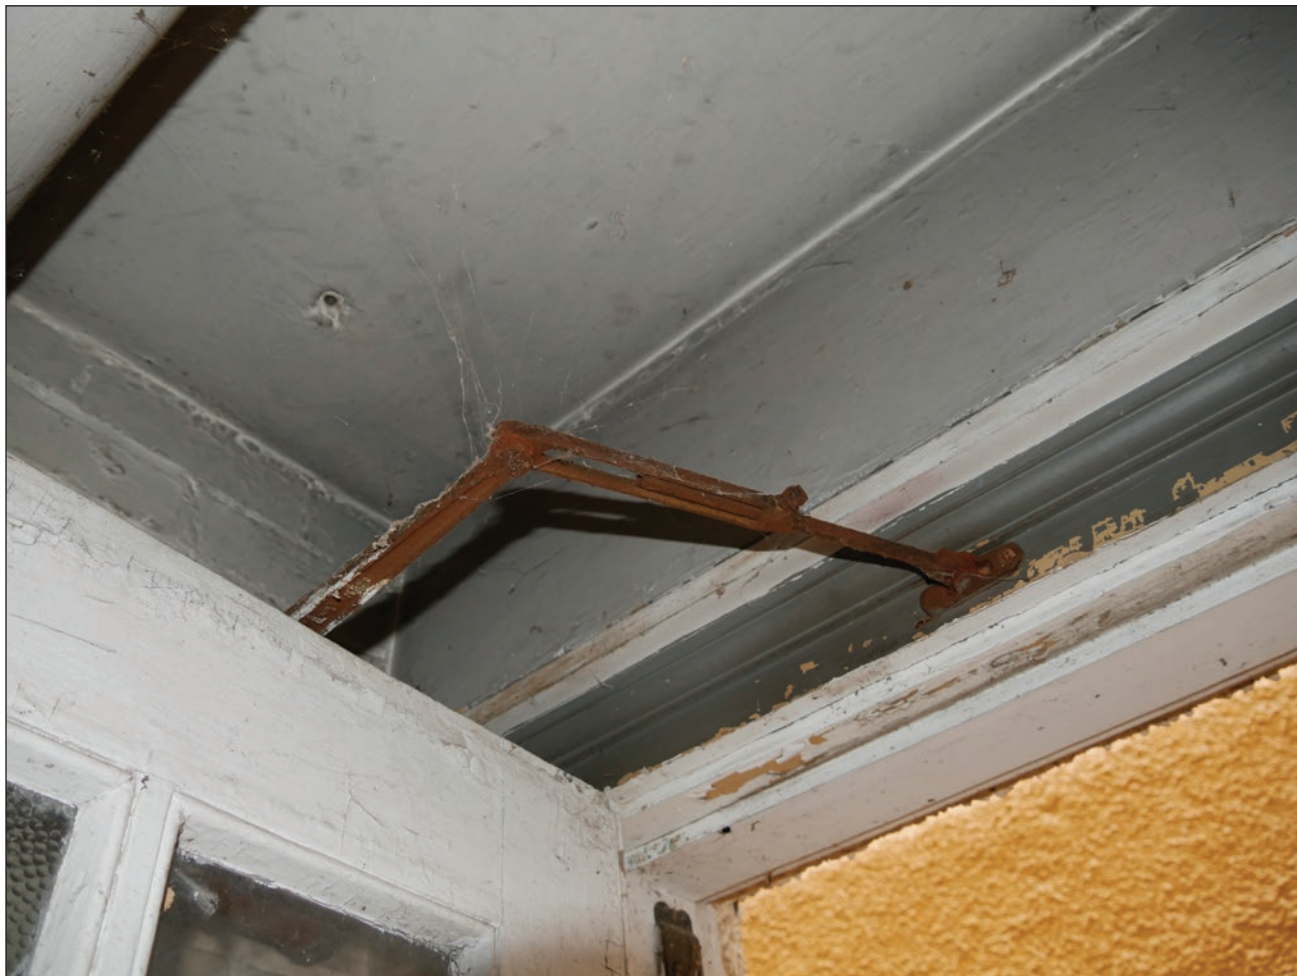
**Figure 235.** Rusted hardware at southwest basement door. Building Conservation Associates, 2025.

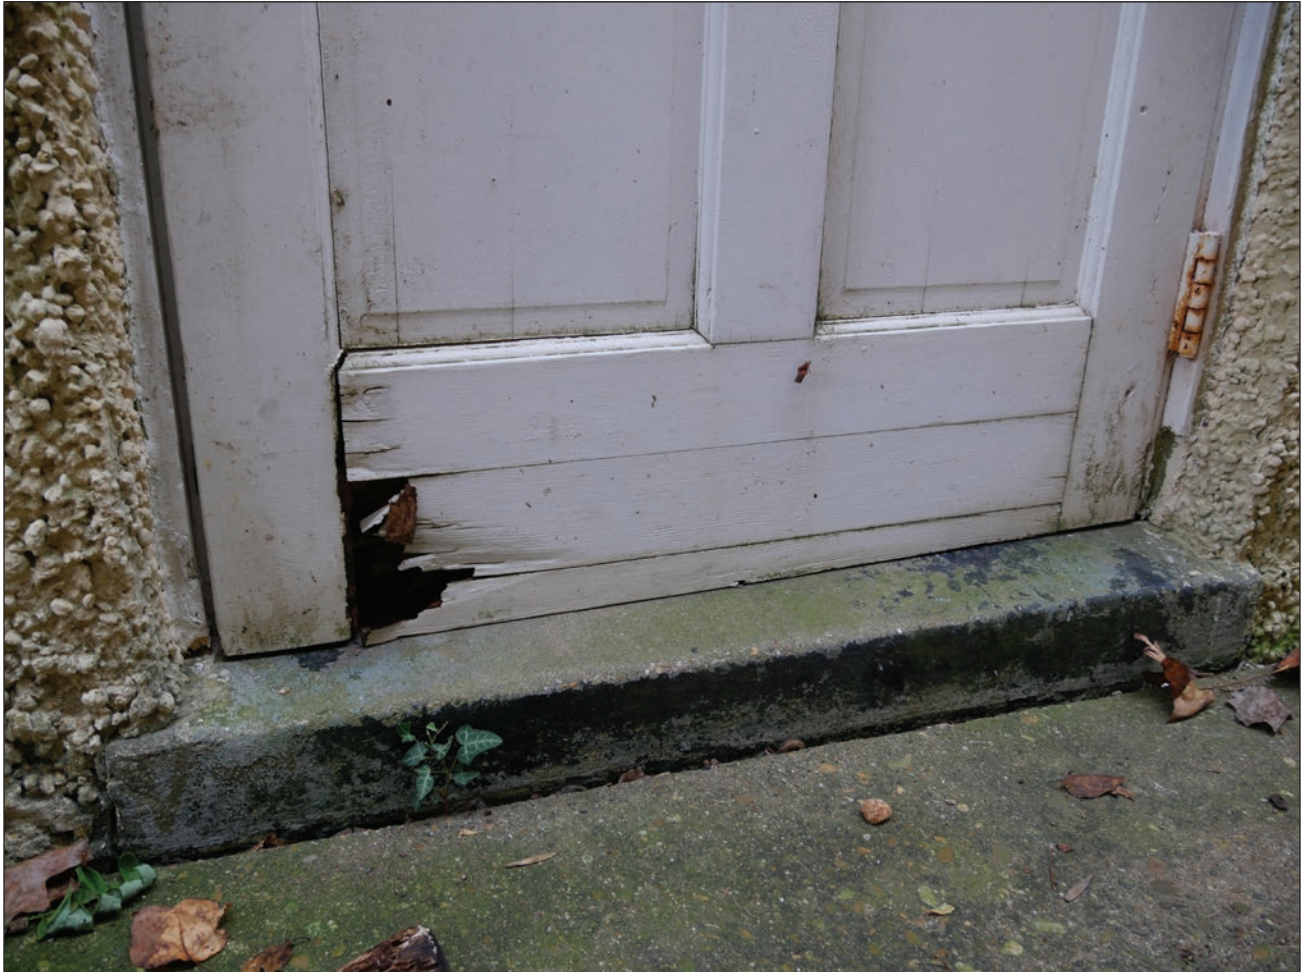
**Figure 236.** Damaged wood rail at southeast basement door. Building Conservation Associates, 2025.

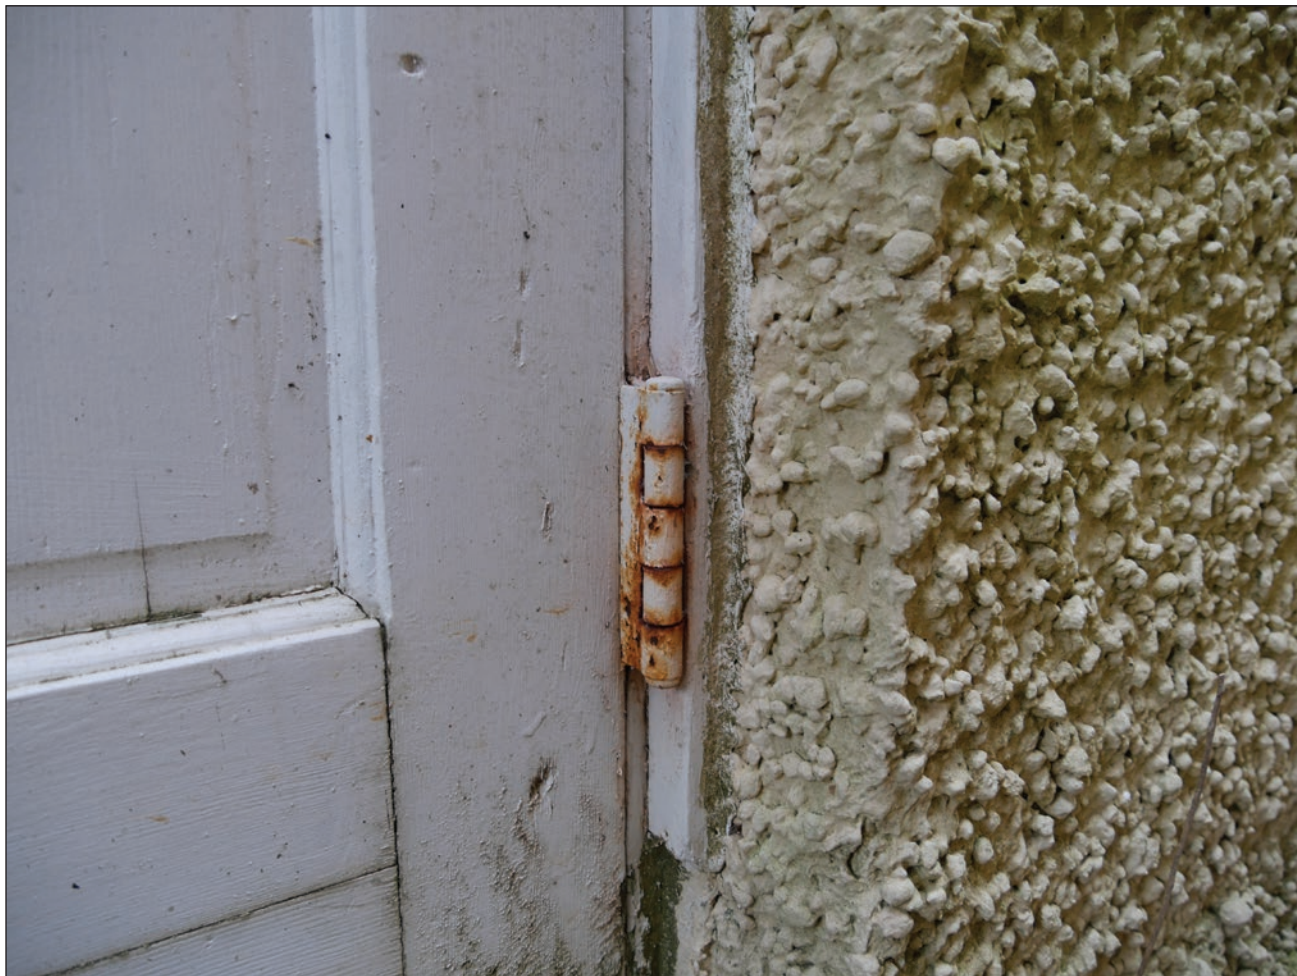
**Figure 237.** Rusting hinge at southeast basement door. Building Conservation Associates, 2025.

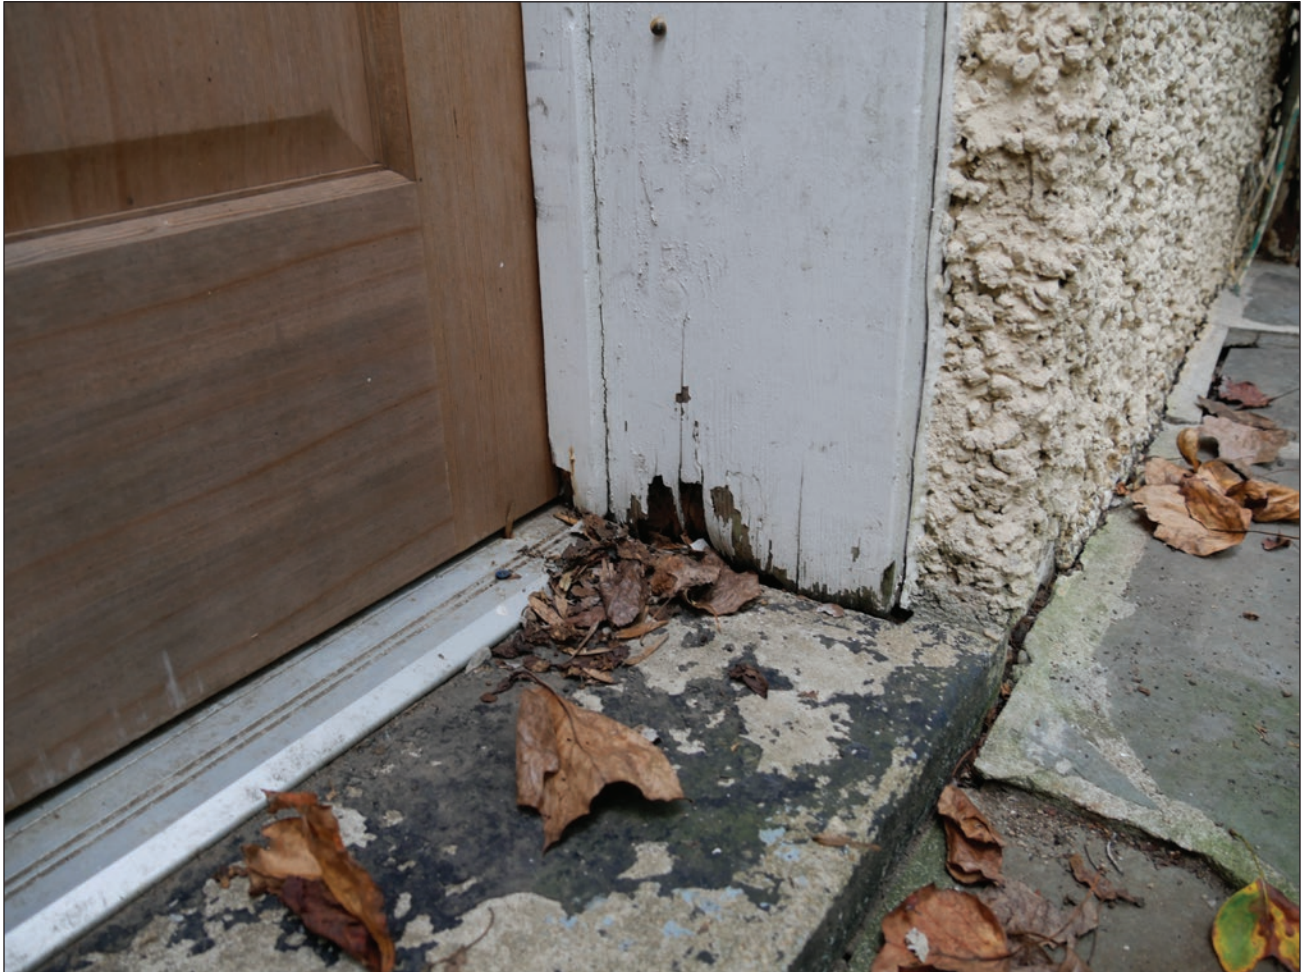
**Figure 238.** Wood loss at east basement door surround. Building Conservation Associates, 2025.

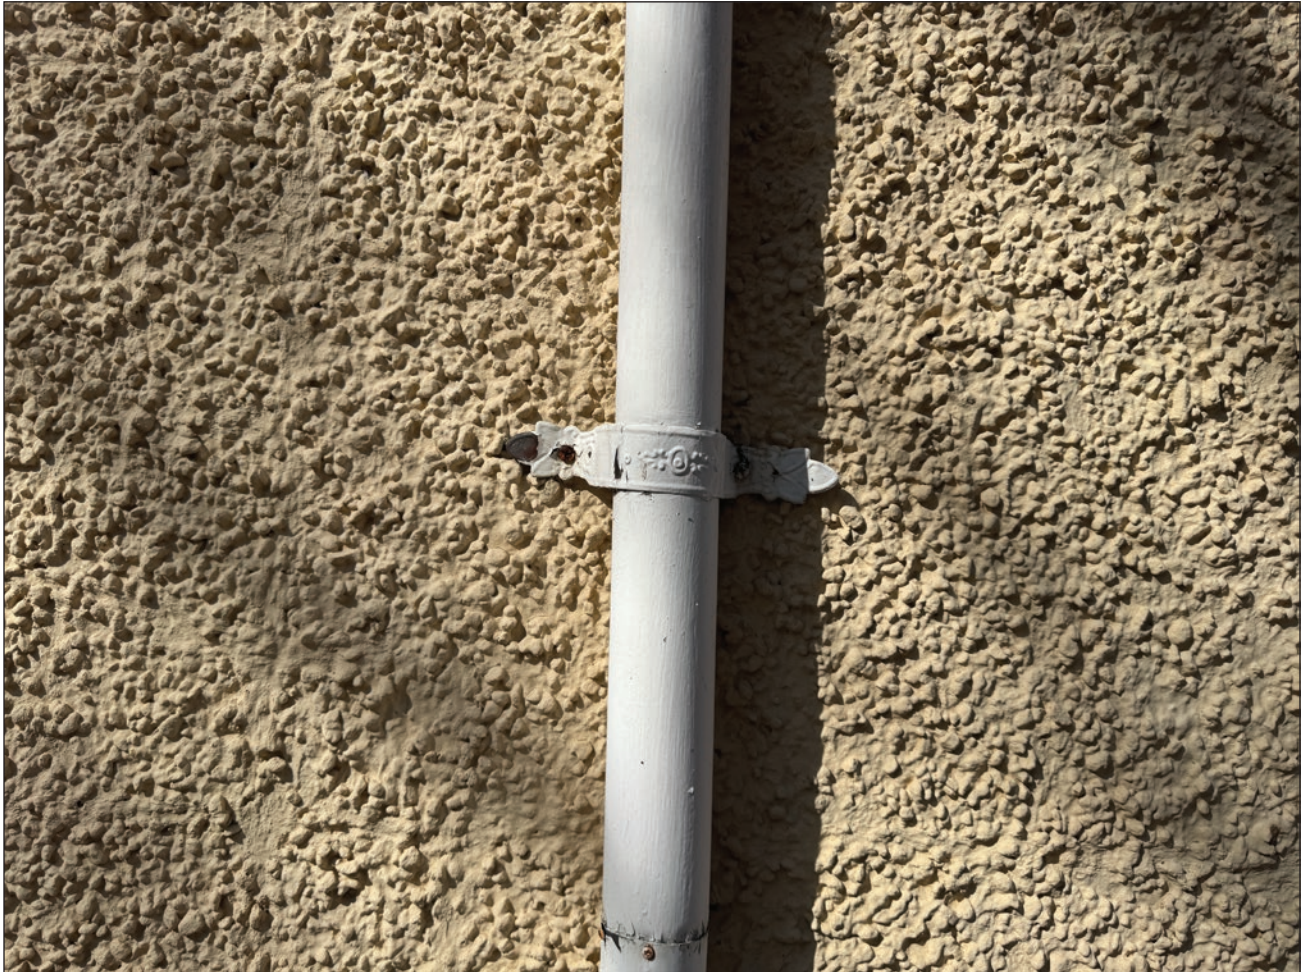
**Figure 240.** Rusting downspout band at east elevation. Building Conservation Associates, 2025.

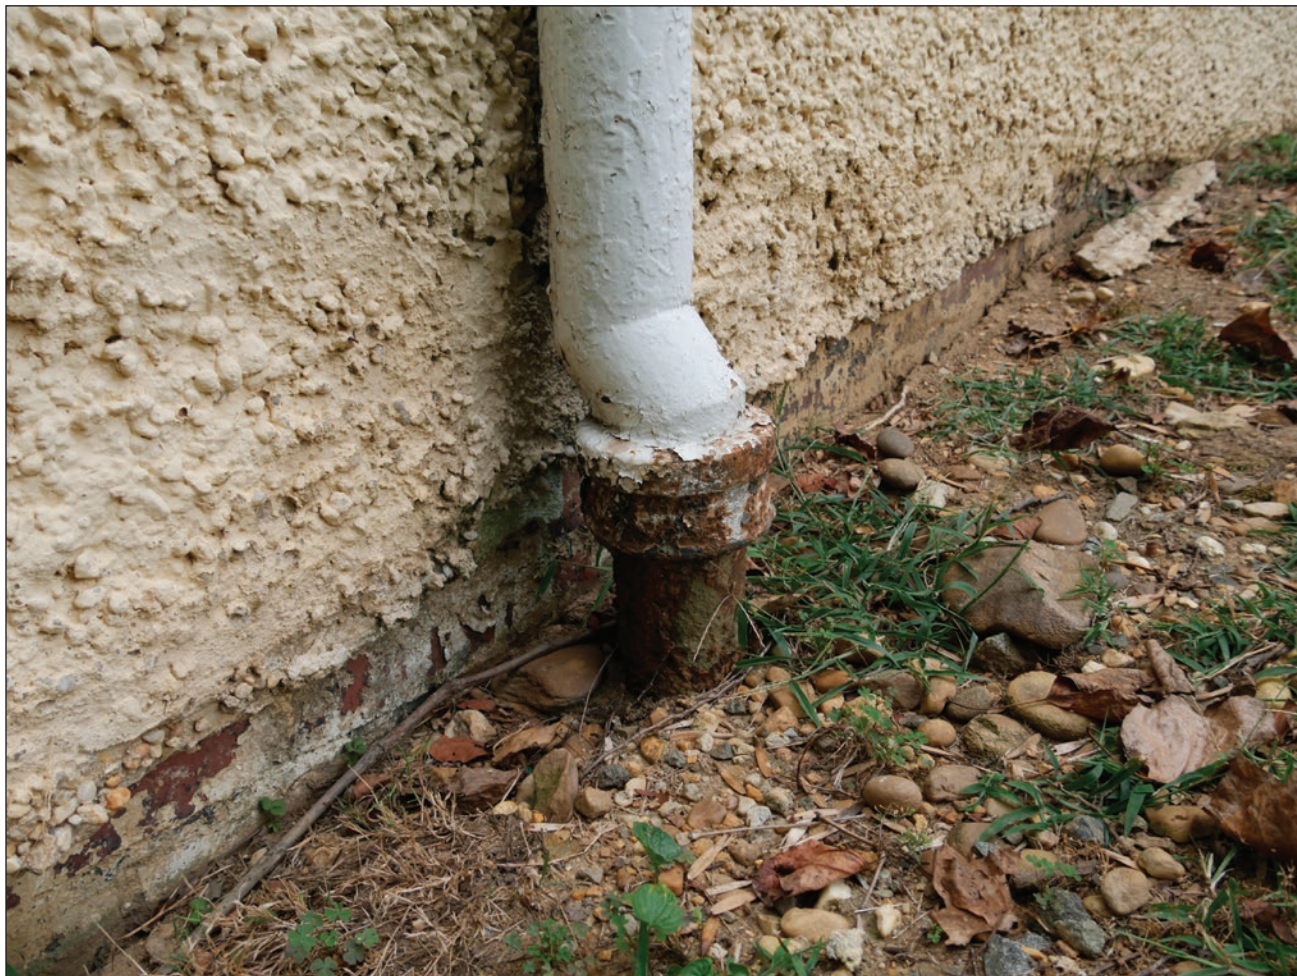
**Figure 241.** Rusting cast-iron shoe at northeast corner. Building Conservation Associates, 2025.

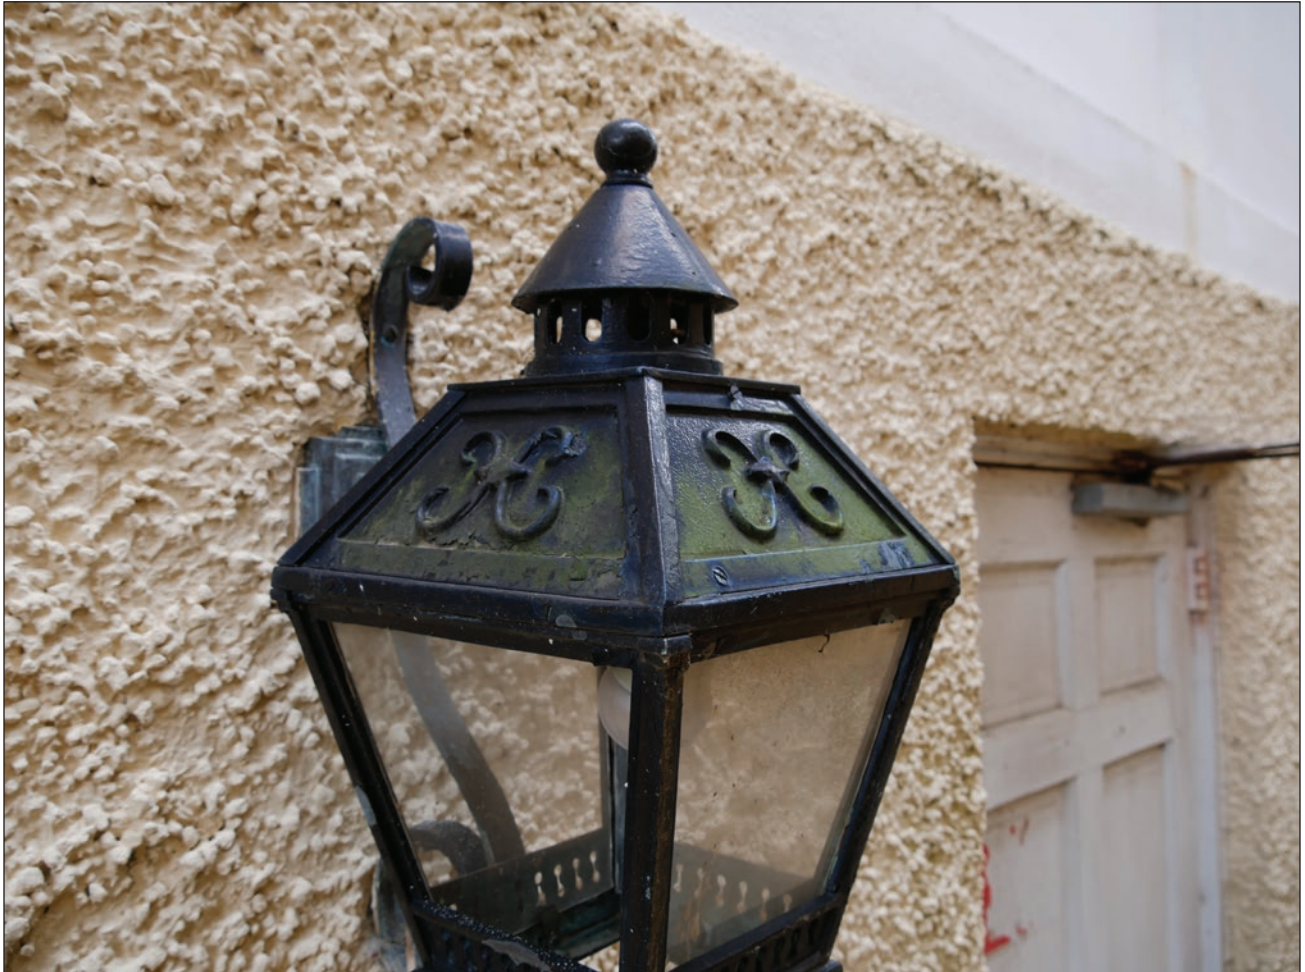
**Figure 242.** Biological growth on iron lantern sconce at south elevation. Building Conservation Associates, 2025.

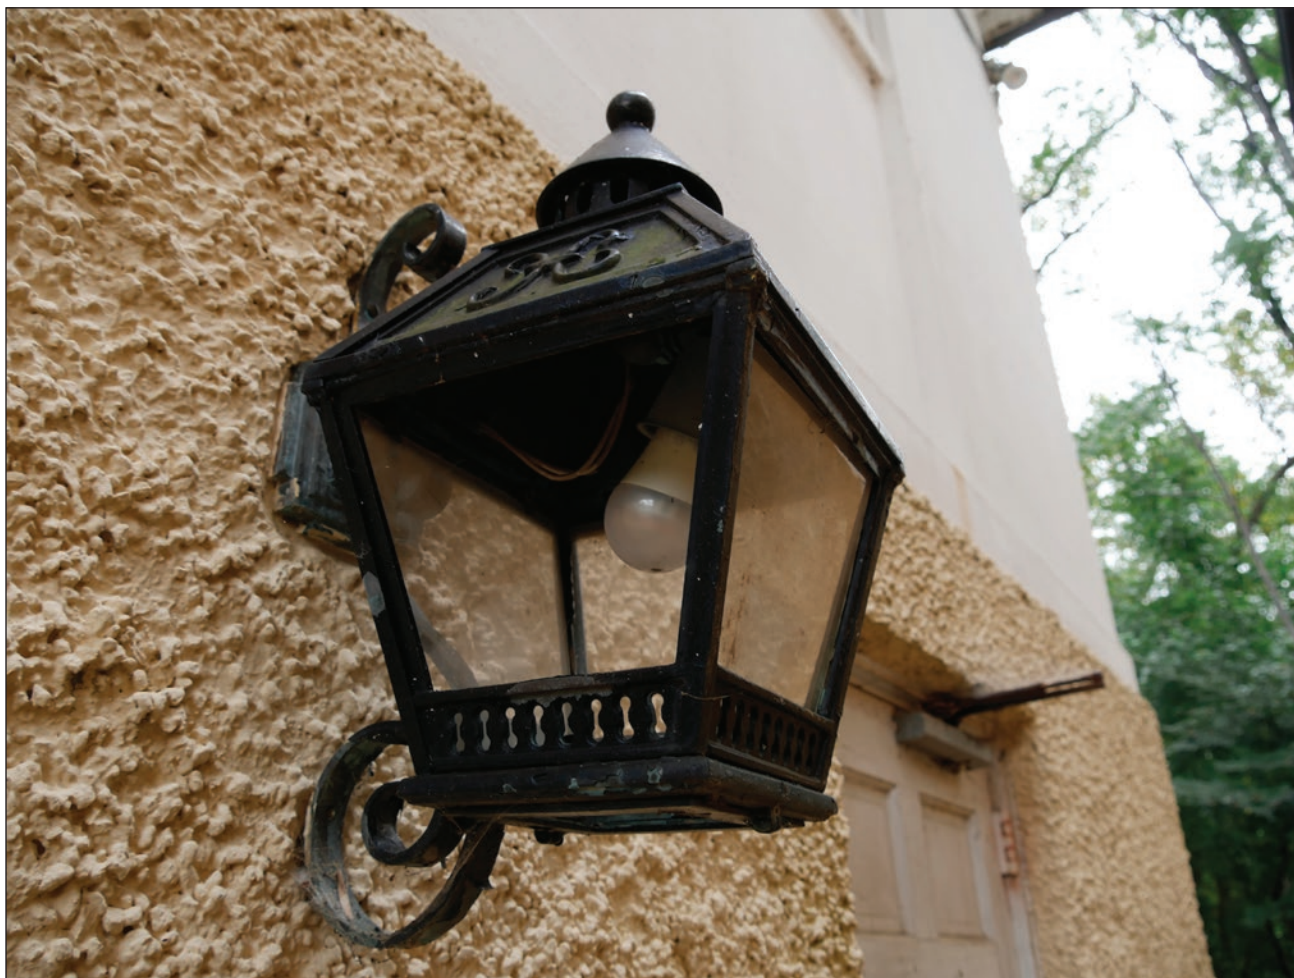
**Figure 243.** Missing glass pane at lantern sconce at south elevation. Building Conservation Associates, 2025.

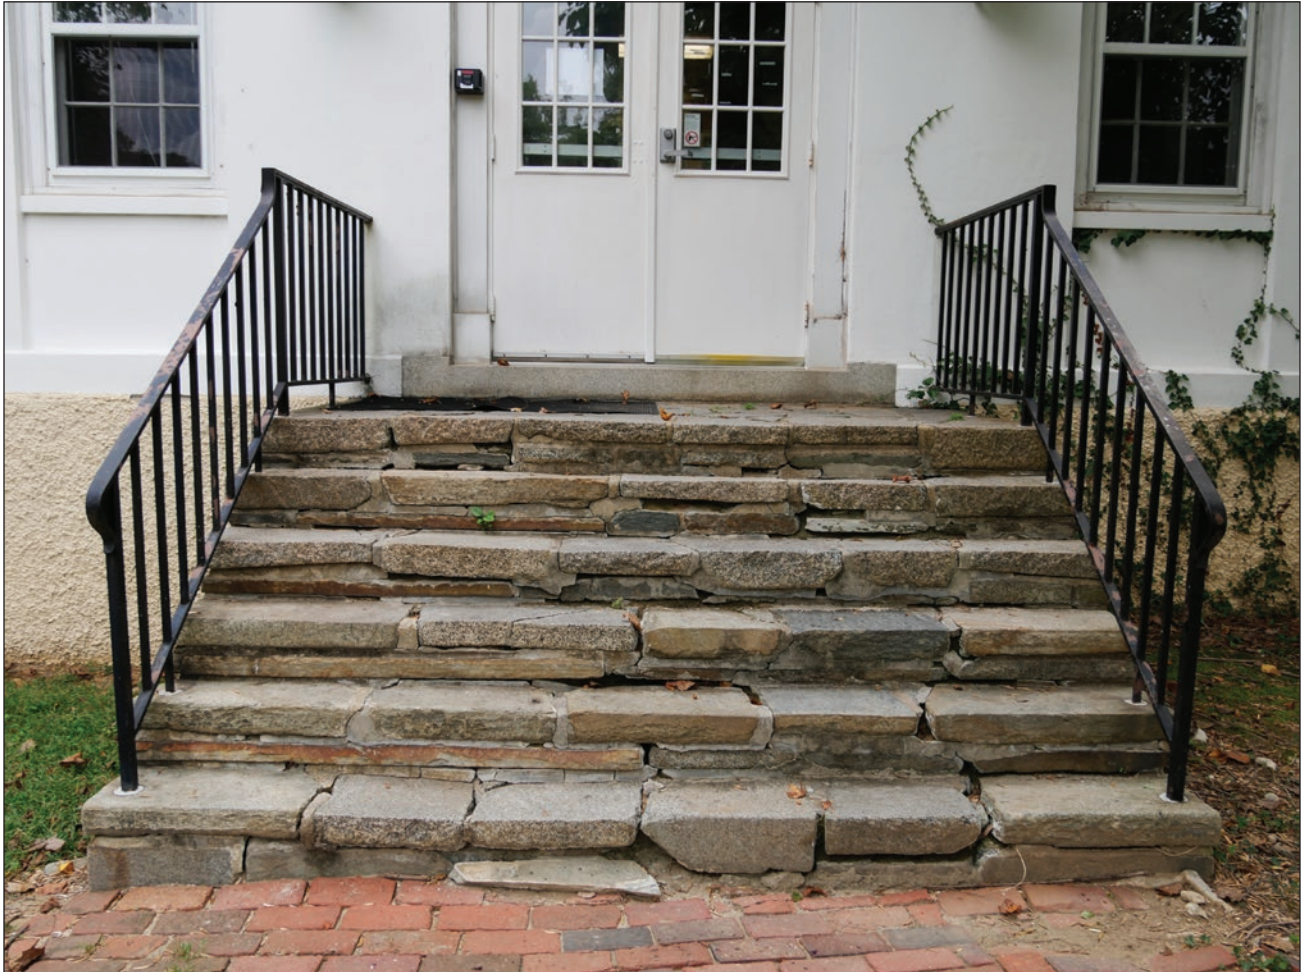
**Figure 244.** Displaced stones and mortar loss at main entry steps. Building Conservation Associates, 2025.

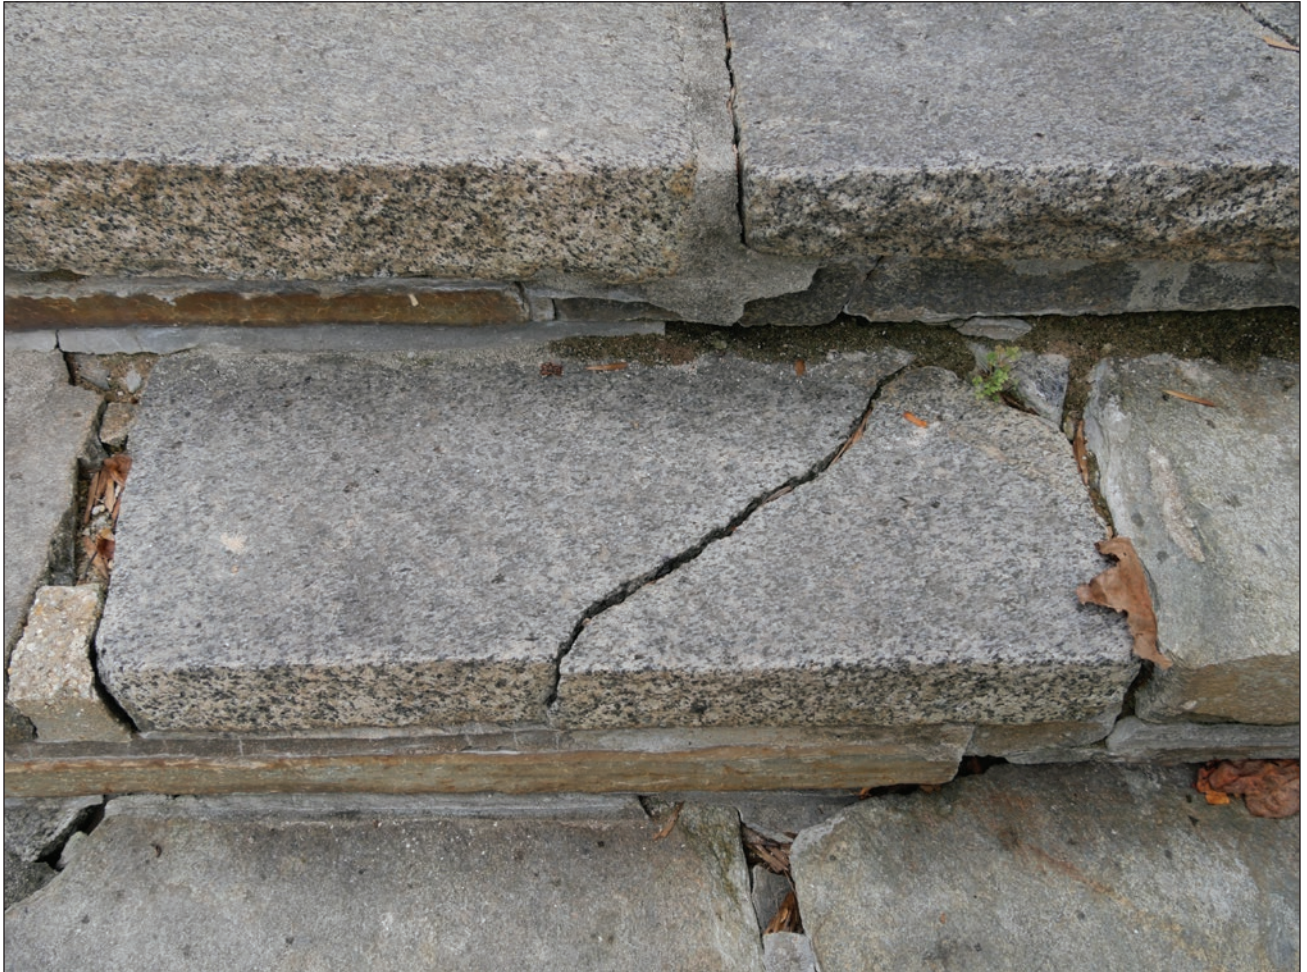
**Figure 246.** Cracked stone unit at main entry steps. Building Conservation Associates, 2025.
