*HISTORIC STRUCTURE REPORT*  
**HISTORIC CEMETERY COMFORT STATION  
(BUILDING #313)**

Kevin Wohlgemuth, Senior Associate, Building Conservation Associates, Inc. (BCA)  
Dorothy Krotzer, Director, BCA  
Michele Boyd, Director of Preservation Services, BCA  
Kate Whitney-Schubb, Staff Conservator, BCA

The following 100% Draft of the Historic Structure Report for the Historic Comfort Station (Building #313) at Arlington National Cemetery represents a synthesis of all research and analysis performed for this project.

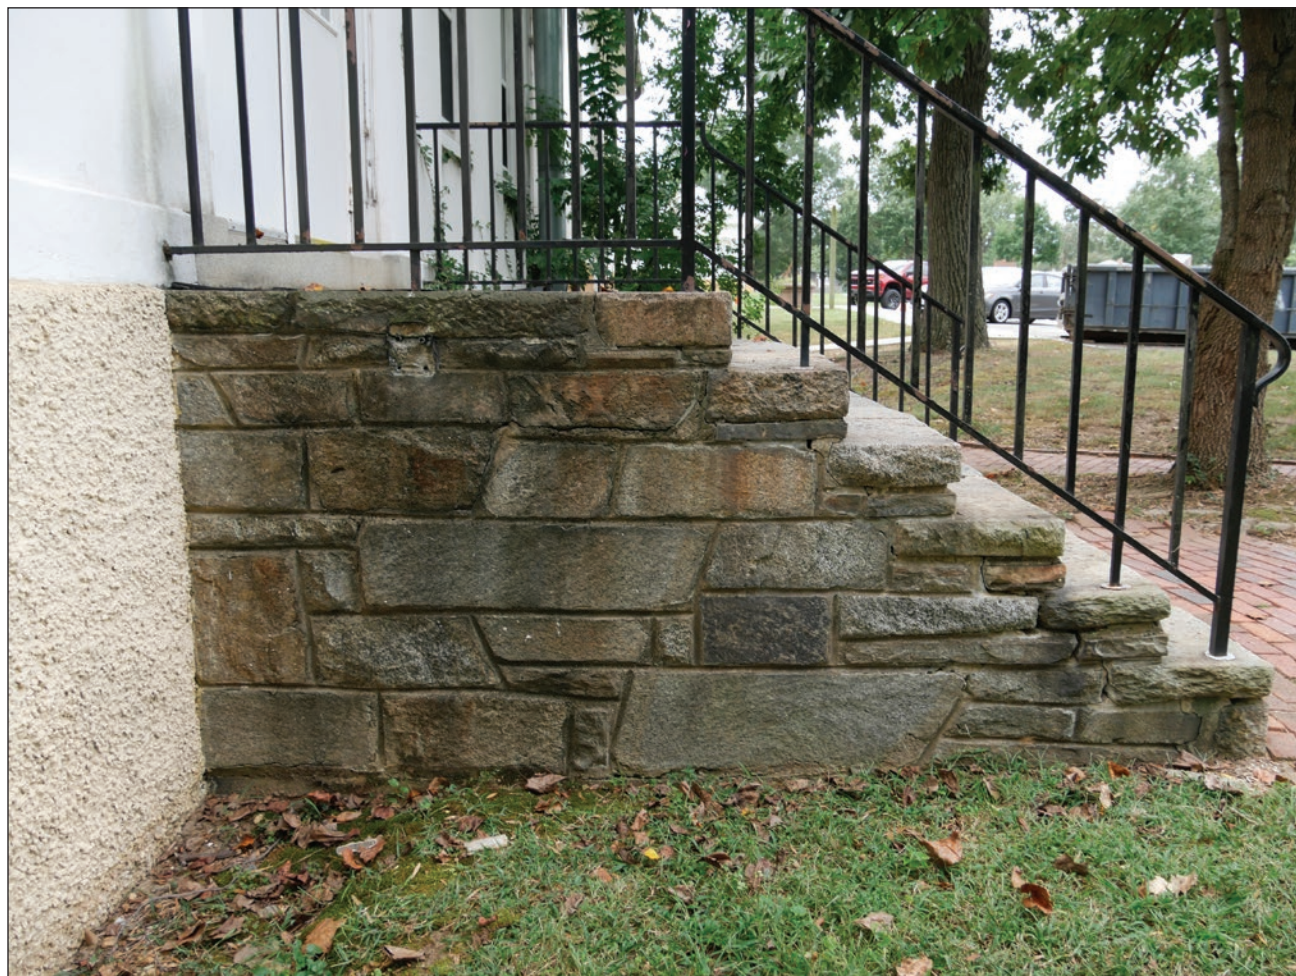
**Figure 247.** Heavy soiling at north side of main entry steps. Building Conservation Associates, 2025.

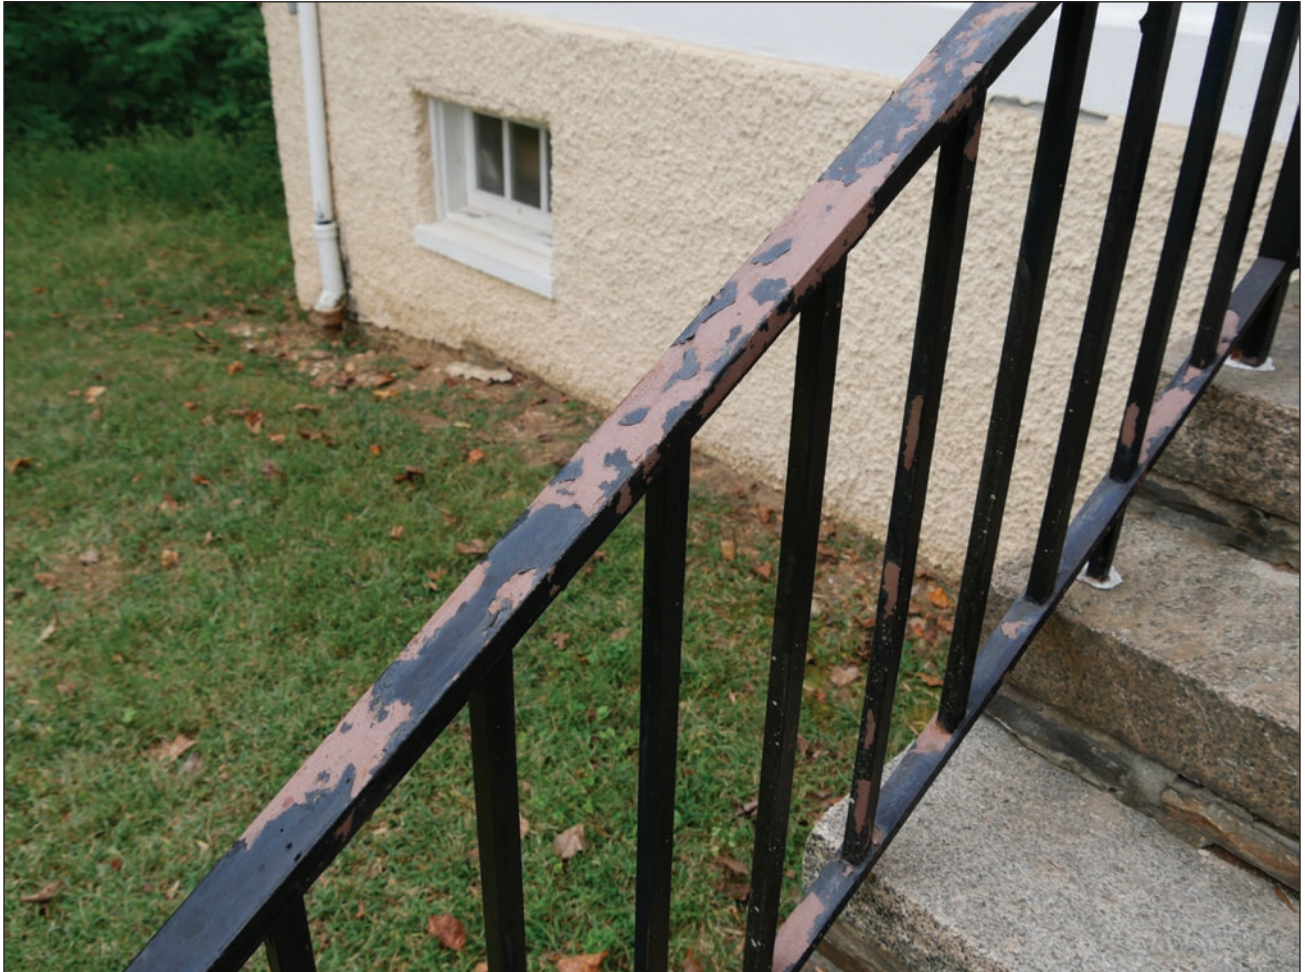
The painted wrought-iron railing exhibits paint loss and rusting (Figure 248).

**Figure 248.** Paint loss and rust at wrought-iron handrail at main entry steps. Building Conservation Associates, 2025.

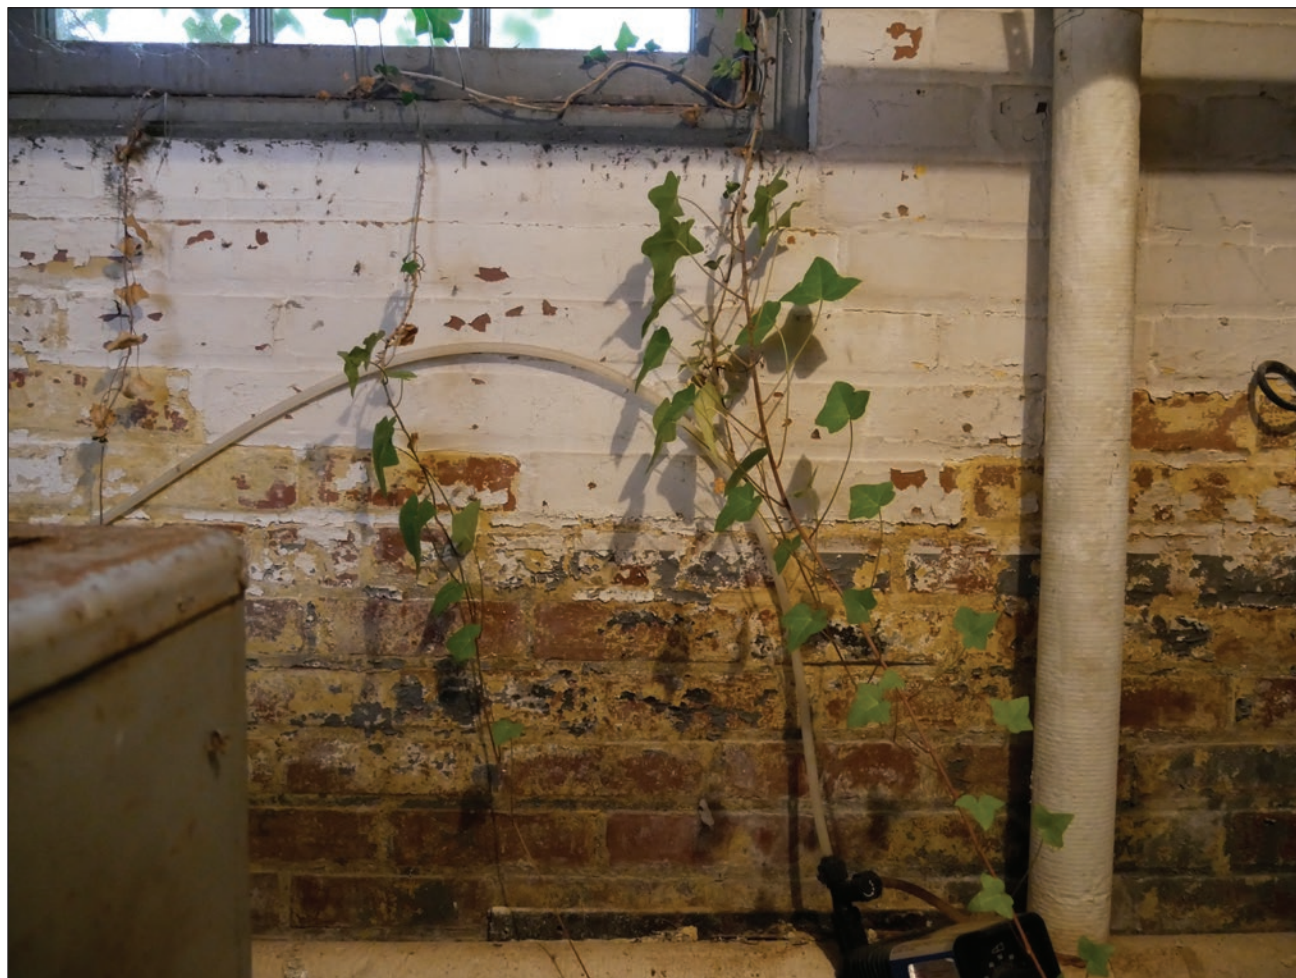
**Figure 249.** Water damage, mold, paint loss, and biological growth at southwest basement room. Building Conservation Associates, 2025.

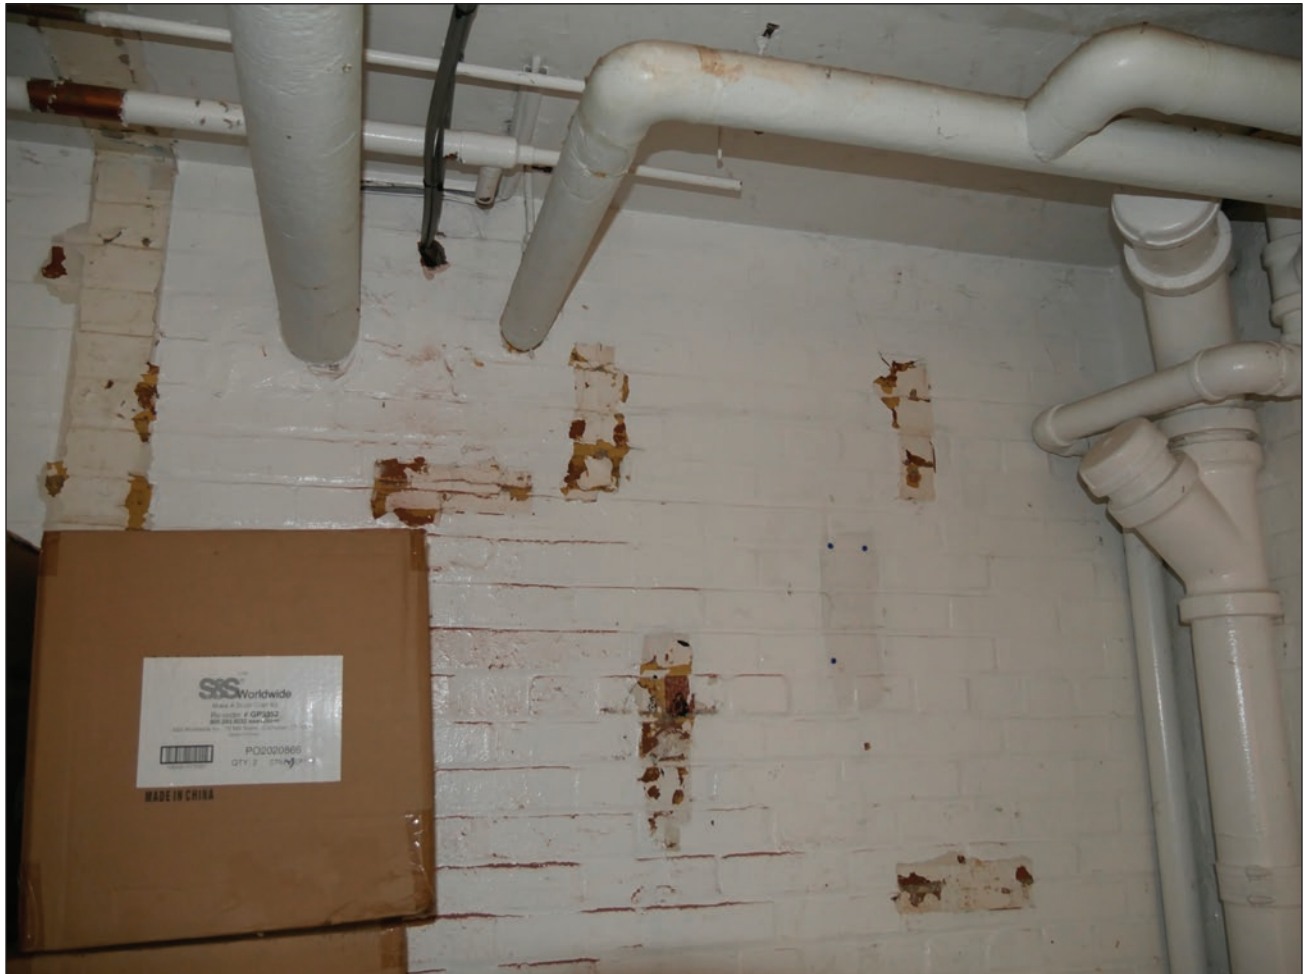
**Figure 250.** Paint loss at southeast basement room. Building Conservation Associates, 2025.

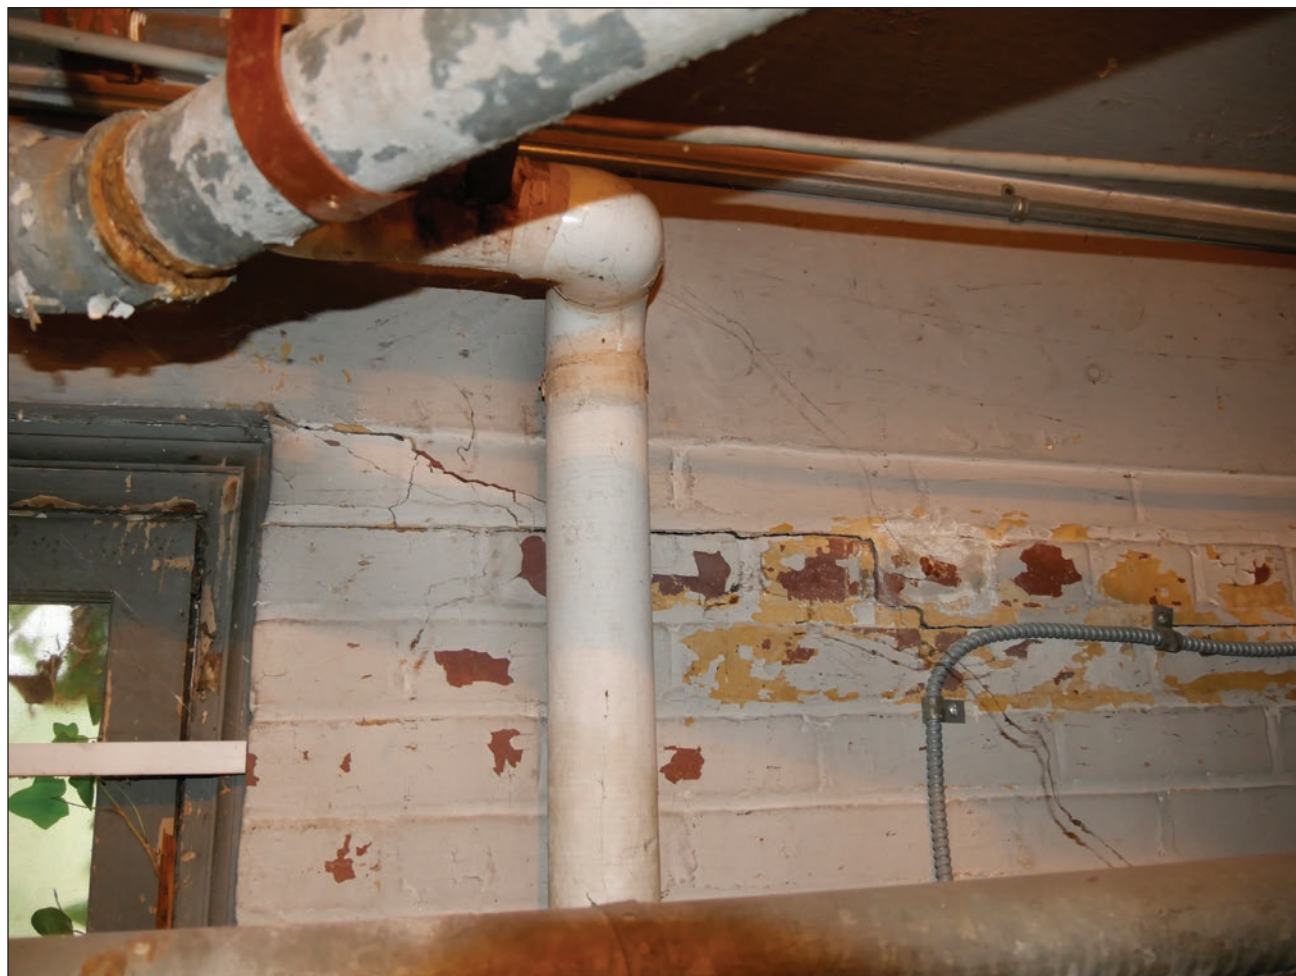
**Figure 251.** Brick cracking at southwest basement room. Building Conservation Associates, 2025.

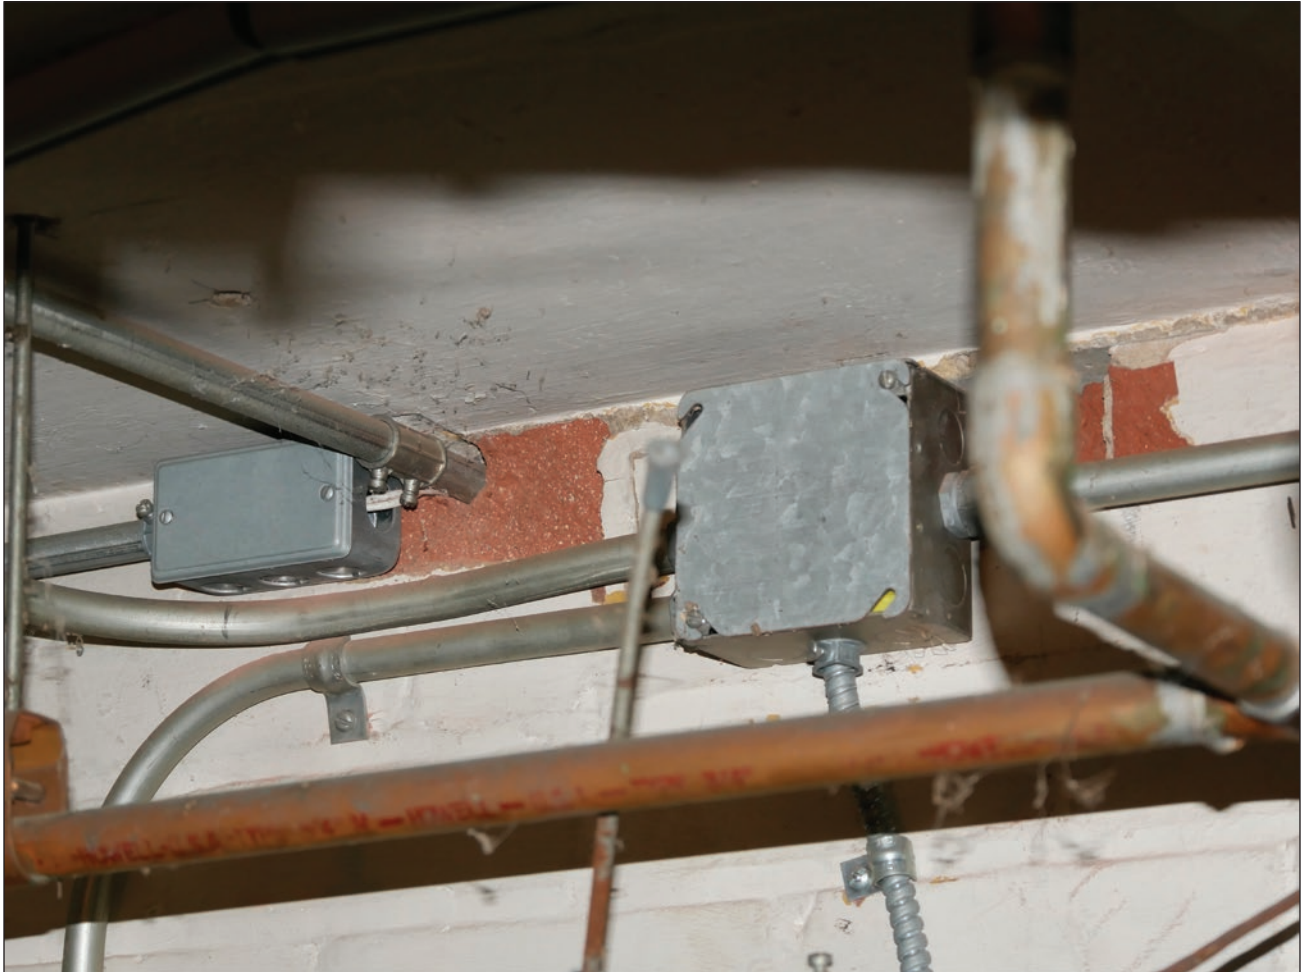
**Figure 252.** Brick spall at penetrations in basement. Building Conservation Associates, 2025.

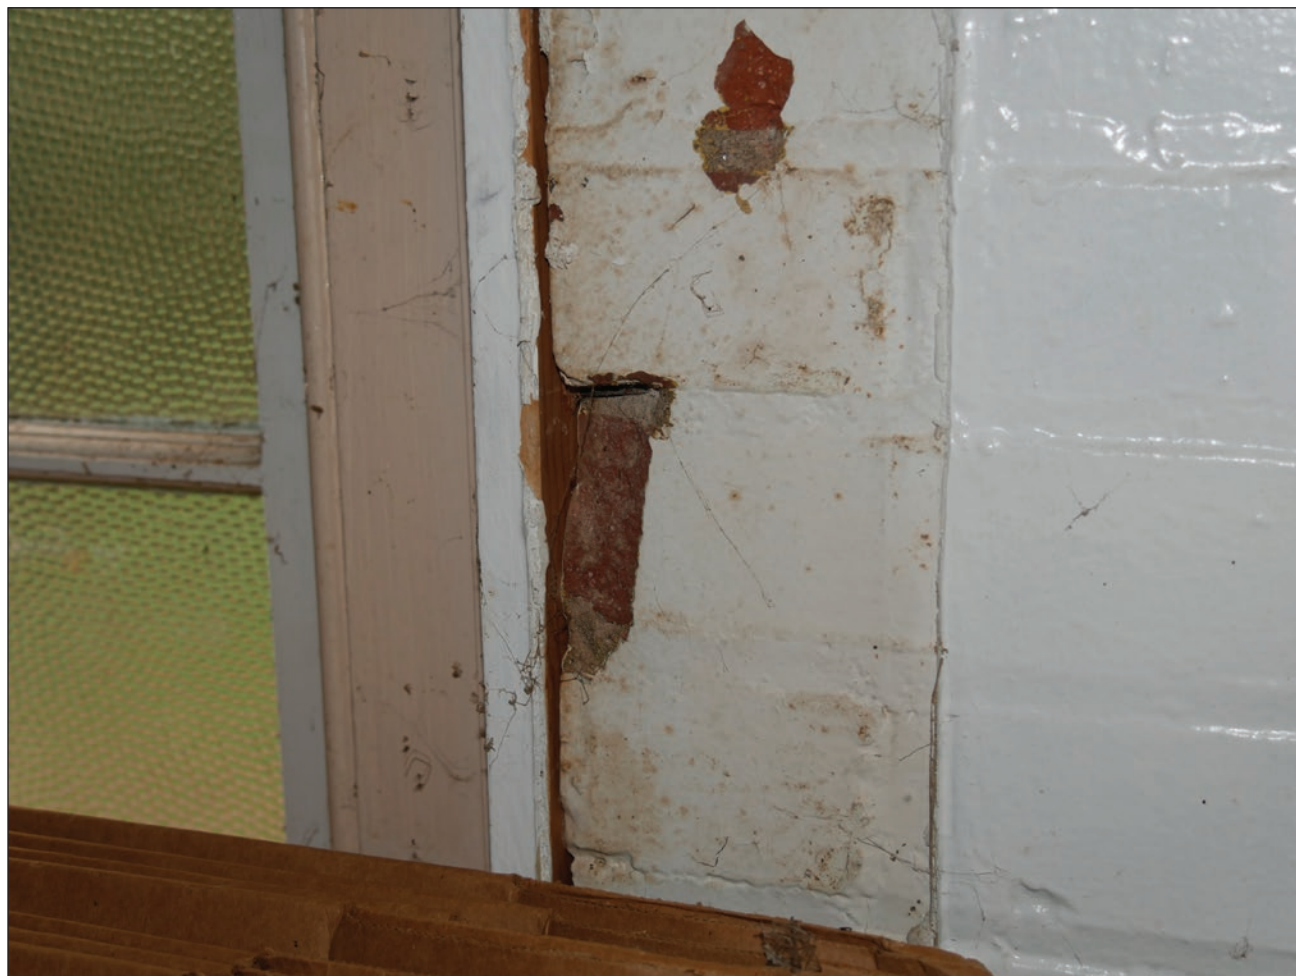
**Figure 253.** Brick spall at southeast basement room. Building Conservation Associates, 2025.

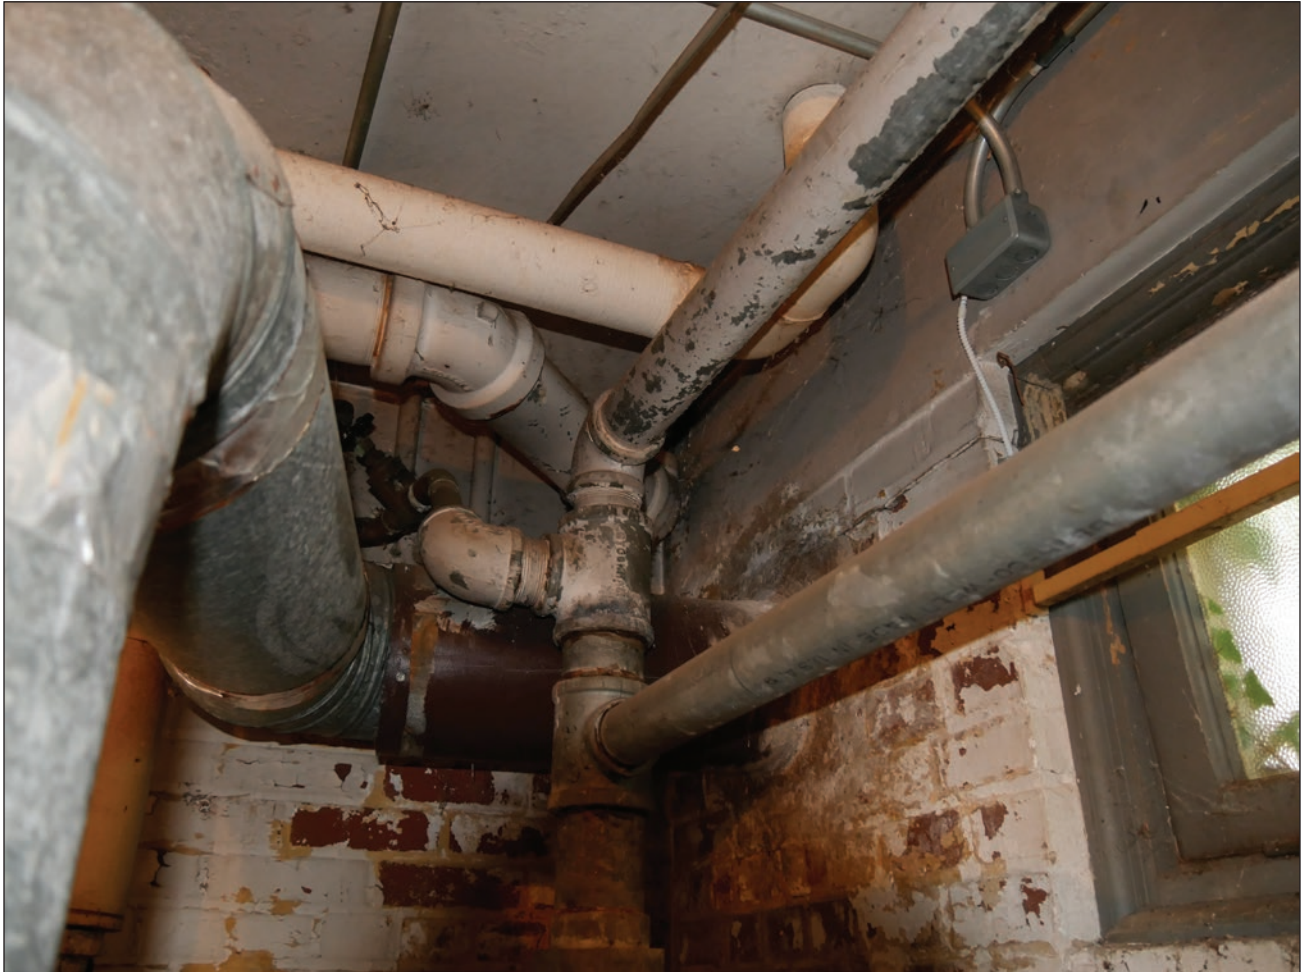
**Figure 254.** Cement patching at brick wall penetration in southwest basement room. Building Conservation Associates, 2025.

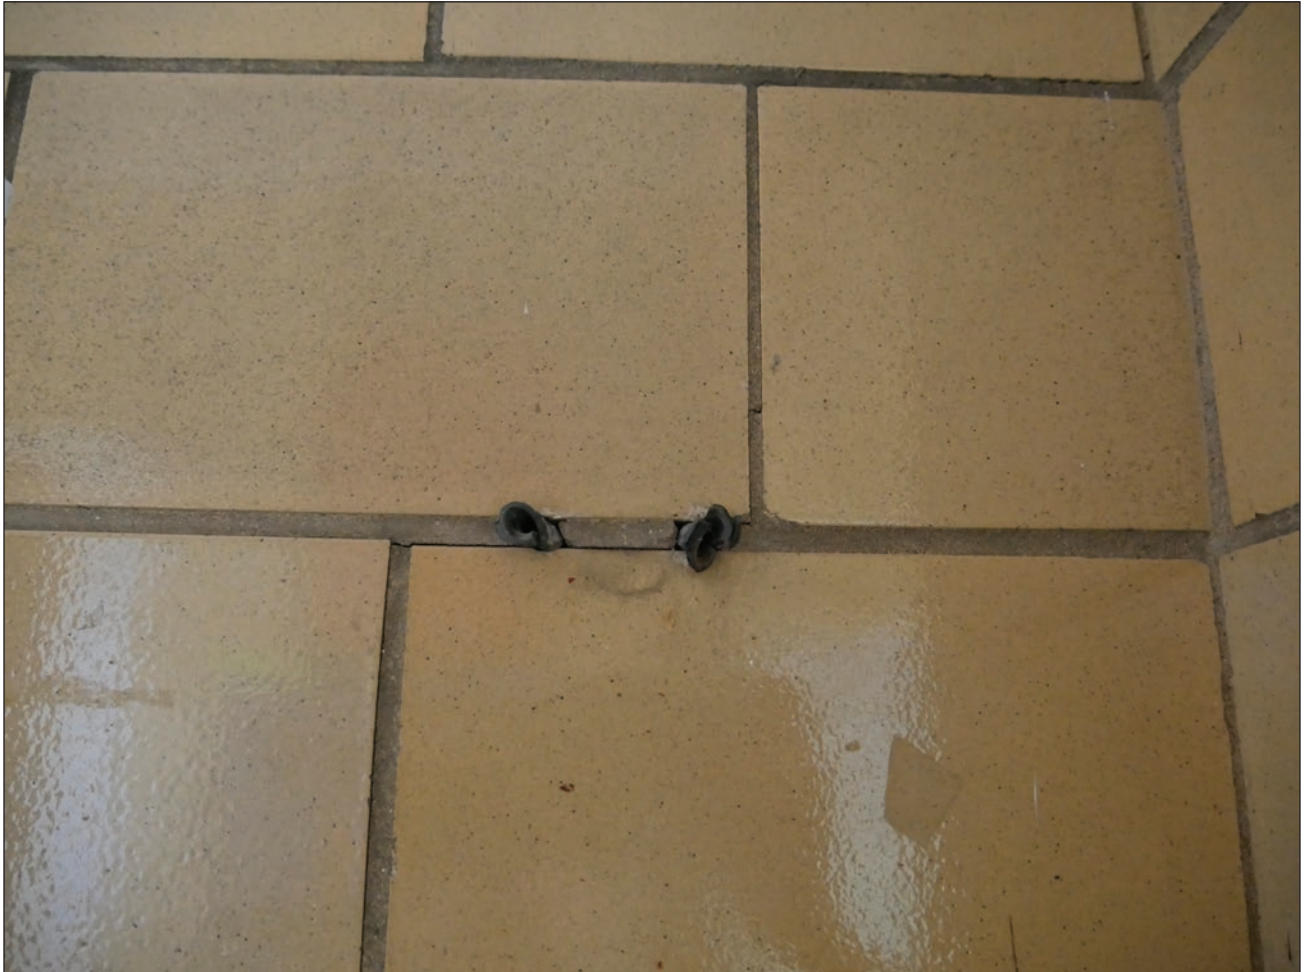
**Figure 260.** Abandoned anchors in vestibule glazed tile wall. Building Conservation Associates, 2025.

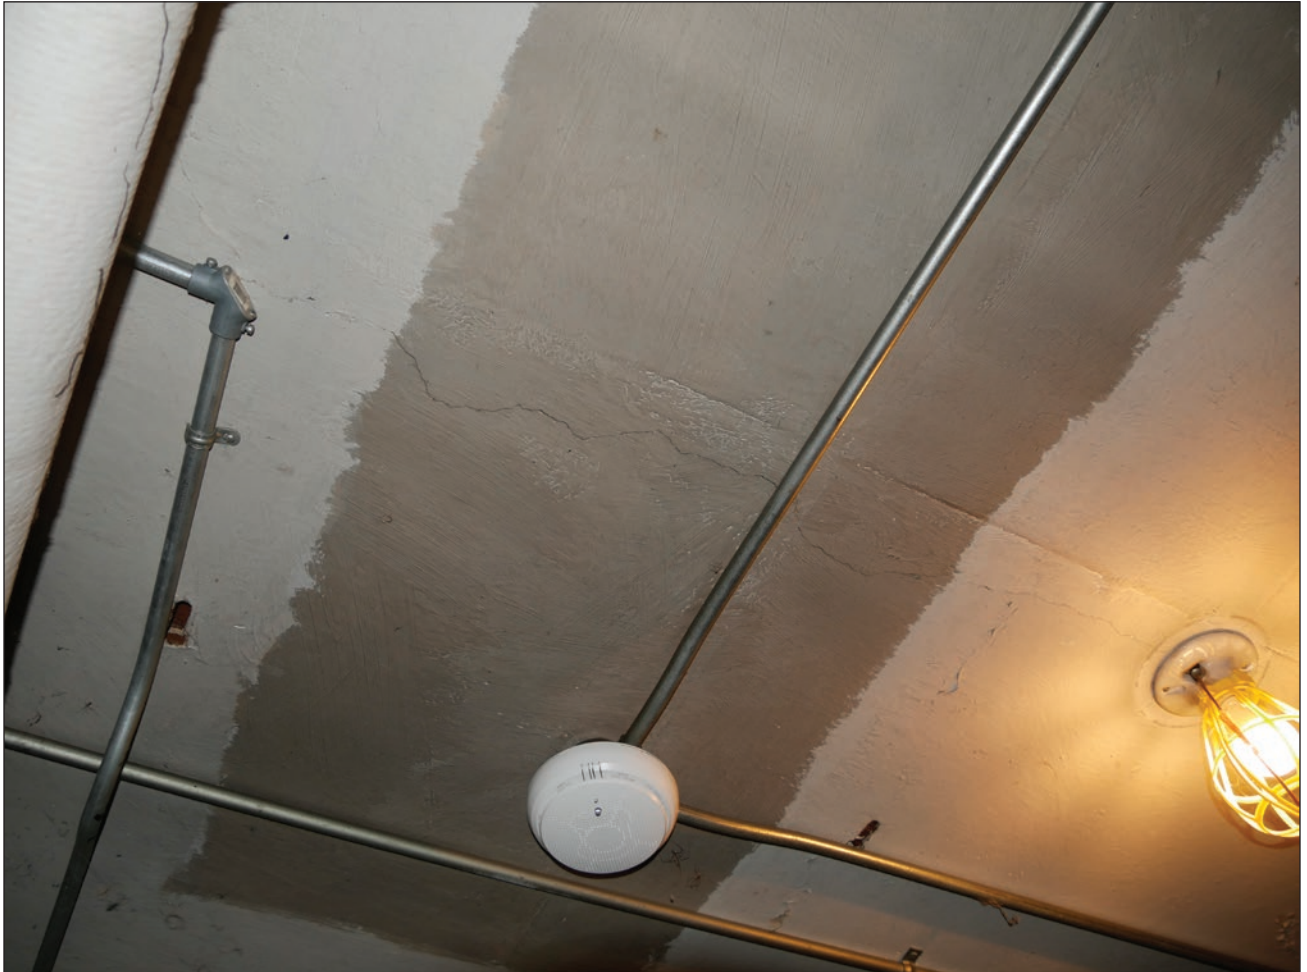
**Figure 264.** Cracks and penetrations in plaster ceiling in basement. Building Conservation Associates, 2025.

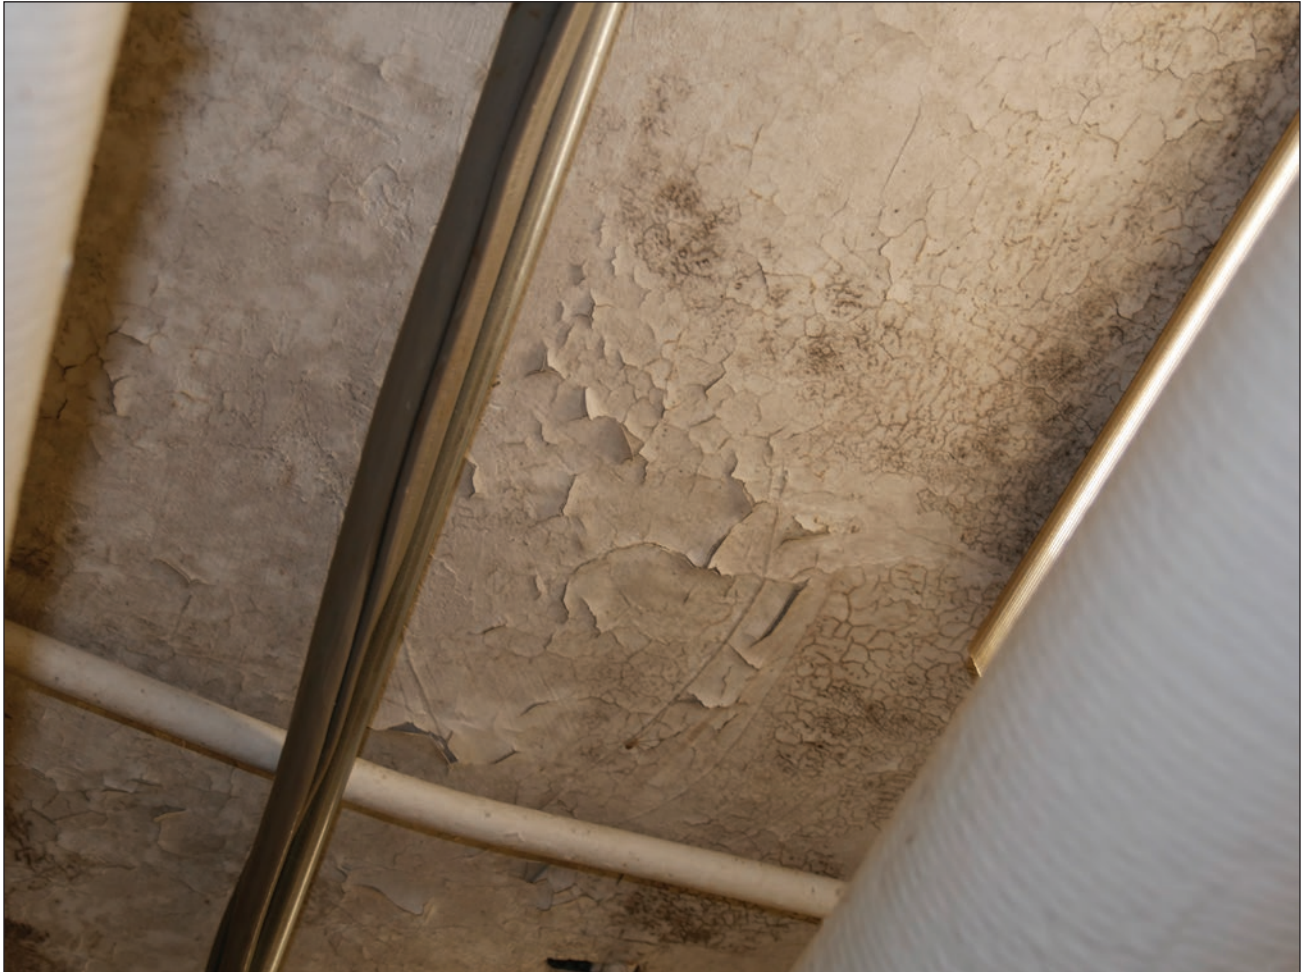
**Figure 266.** Flaking paint and mold at plaster ceiling in basement. Building Conservation Associates, 2025.

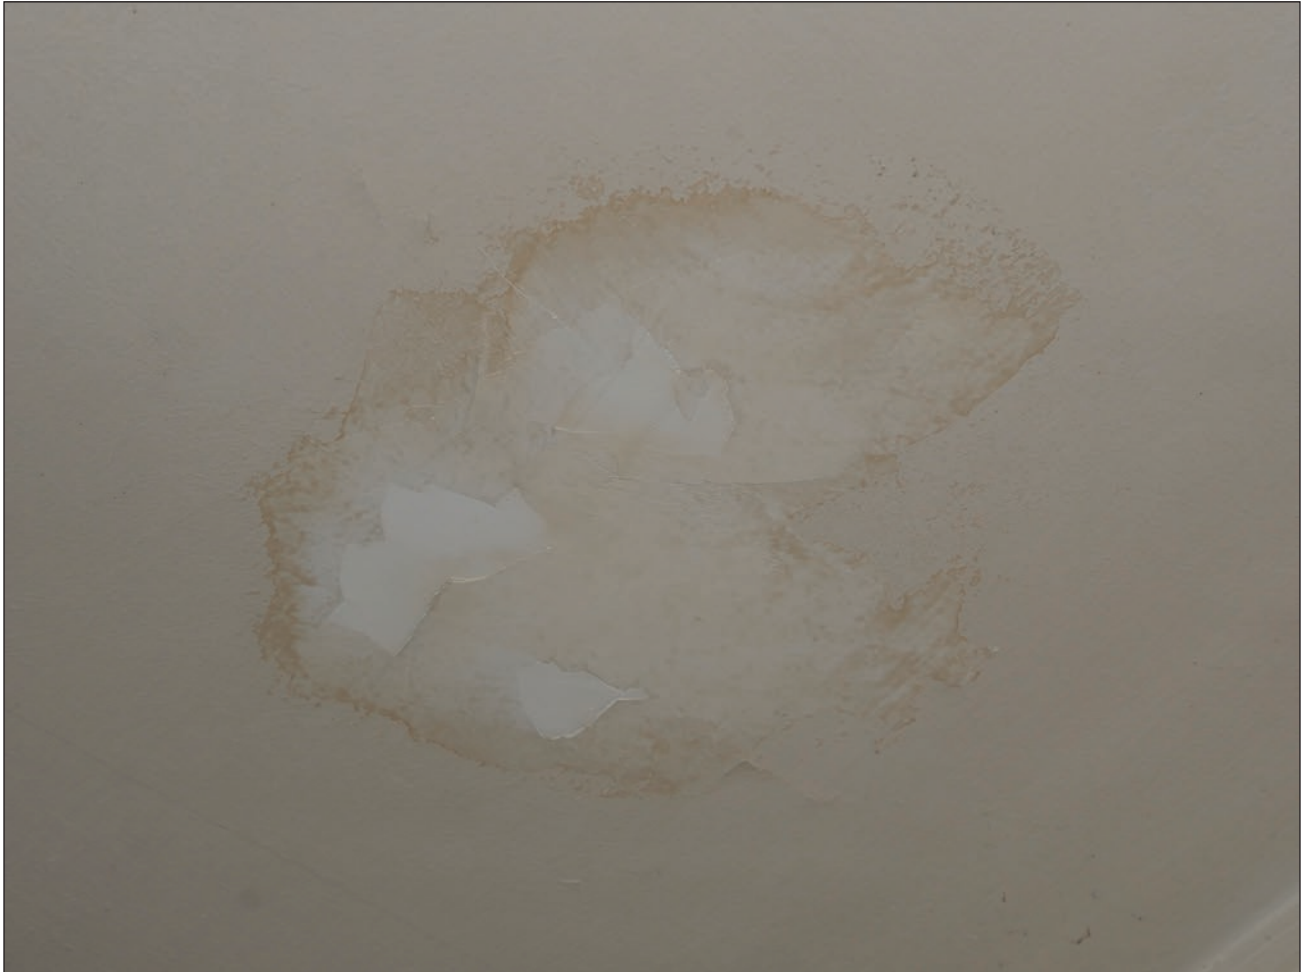
**Figure 268.** Detail of water damage and paint loss at vestibule ceiling. Building Conservation Associates, 2025.

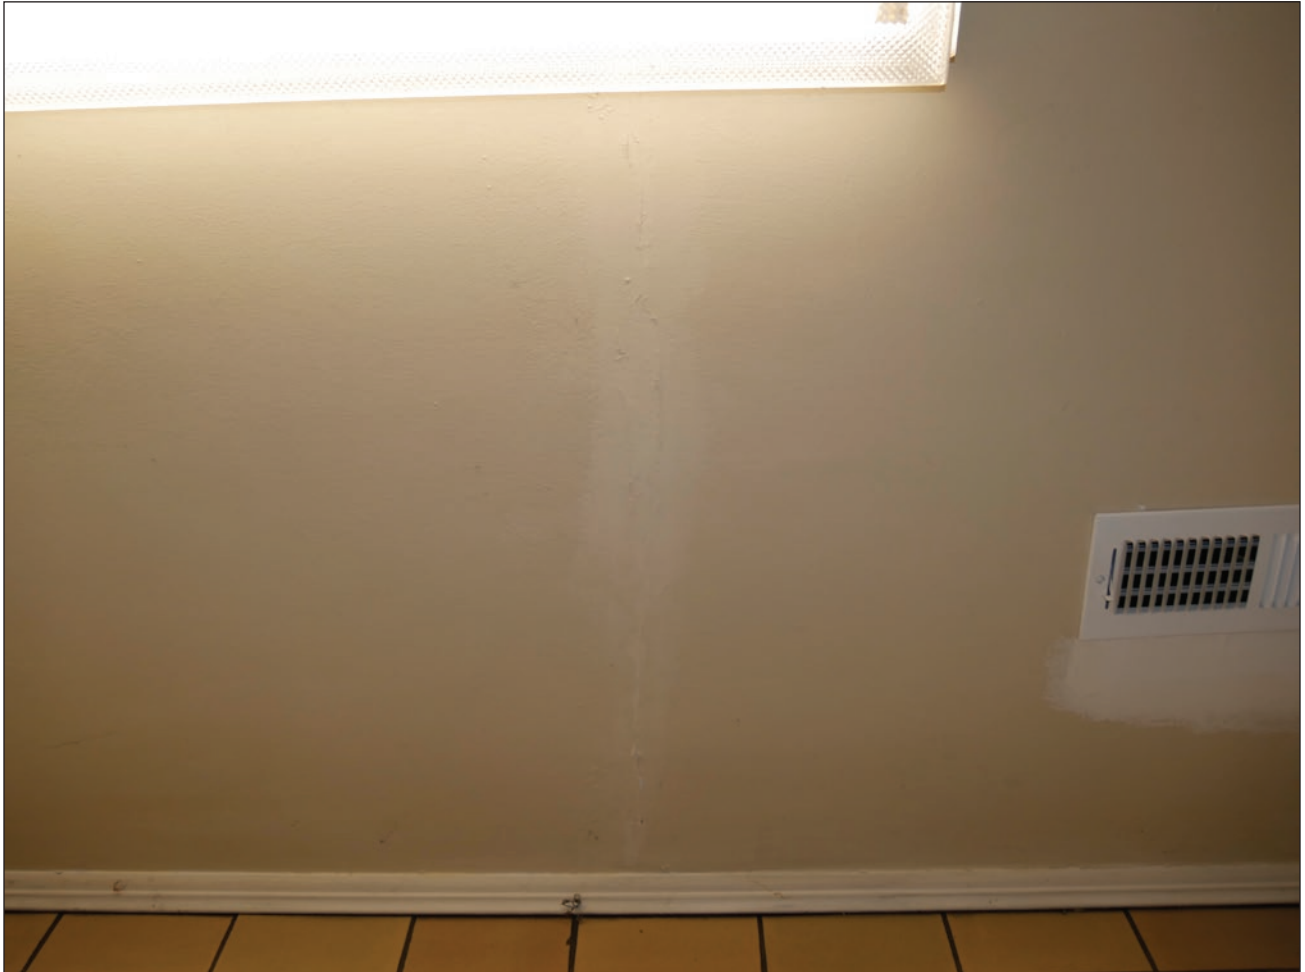
**Figure 270.** Crack in plaster ceiling in first floor east room. Building Conservation Associates, 2025.

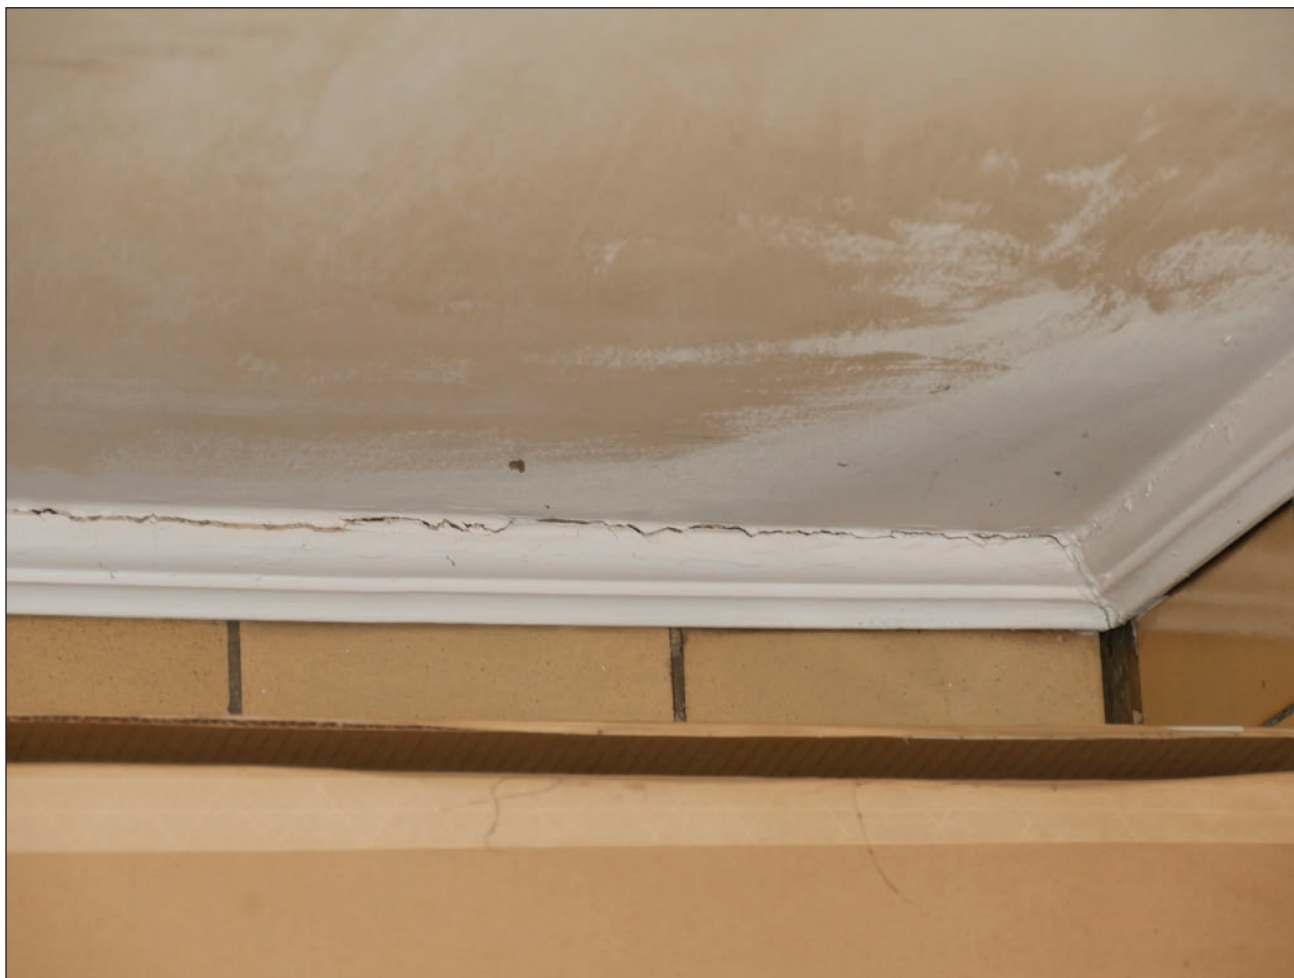
**Figure 271.** Crack at seam between plaster ceiling and wood trim in first floor east room. Building Conservation Associates, 2025.

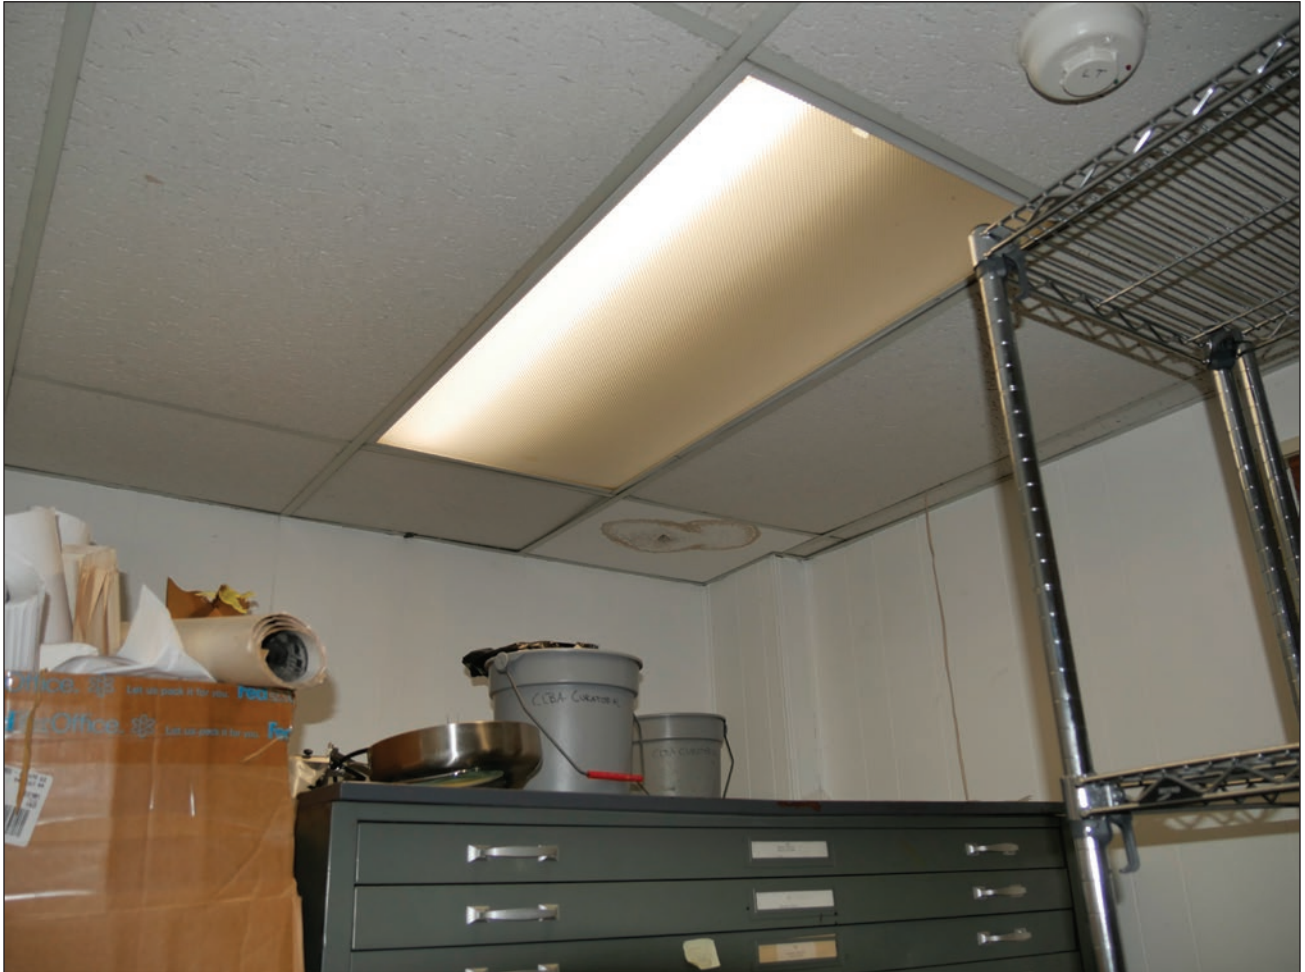
**Figure 272.** Water damage at suspended ACT in first floor southeast room. Building Conservation Associates, 2025.
