CUSTIS-LEE MANSION STRUCTURE STUDY

Prepared by  
A. W. Franzen, Architect  
April 1971

OFFICE OF HISTORY & HISTORIC ARCHITECTURE, ESC

UNITED STATES DEPARTMENT OF THE INTERIOR  
NATIONAL PARK SERVICE  
WASHINGTON, D. C.

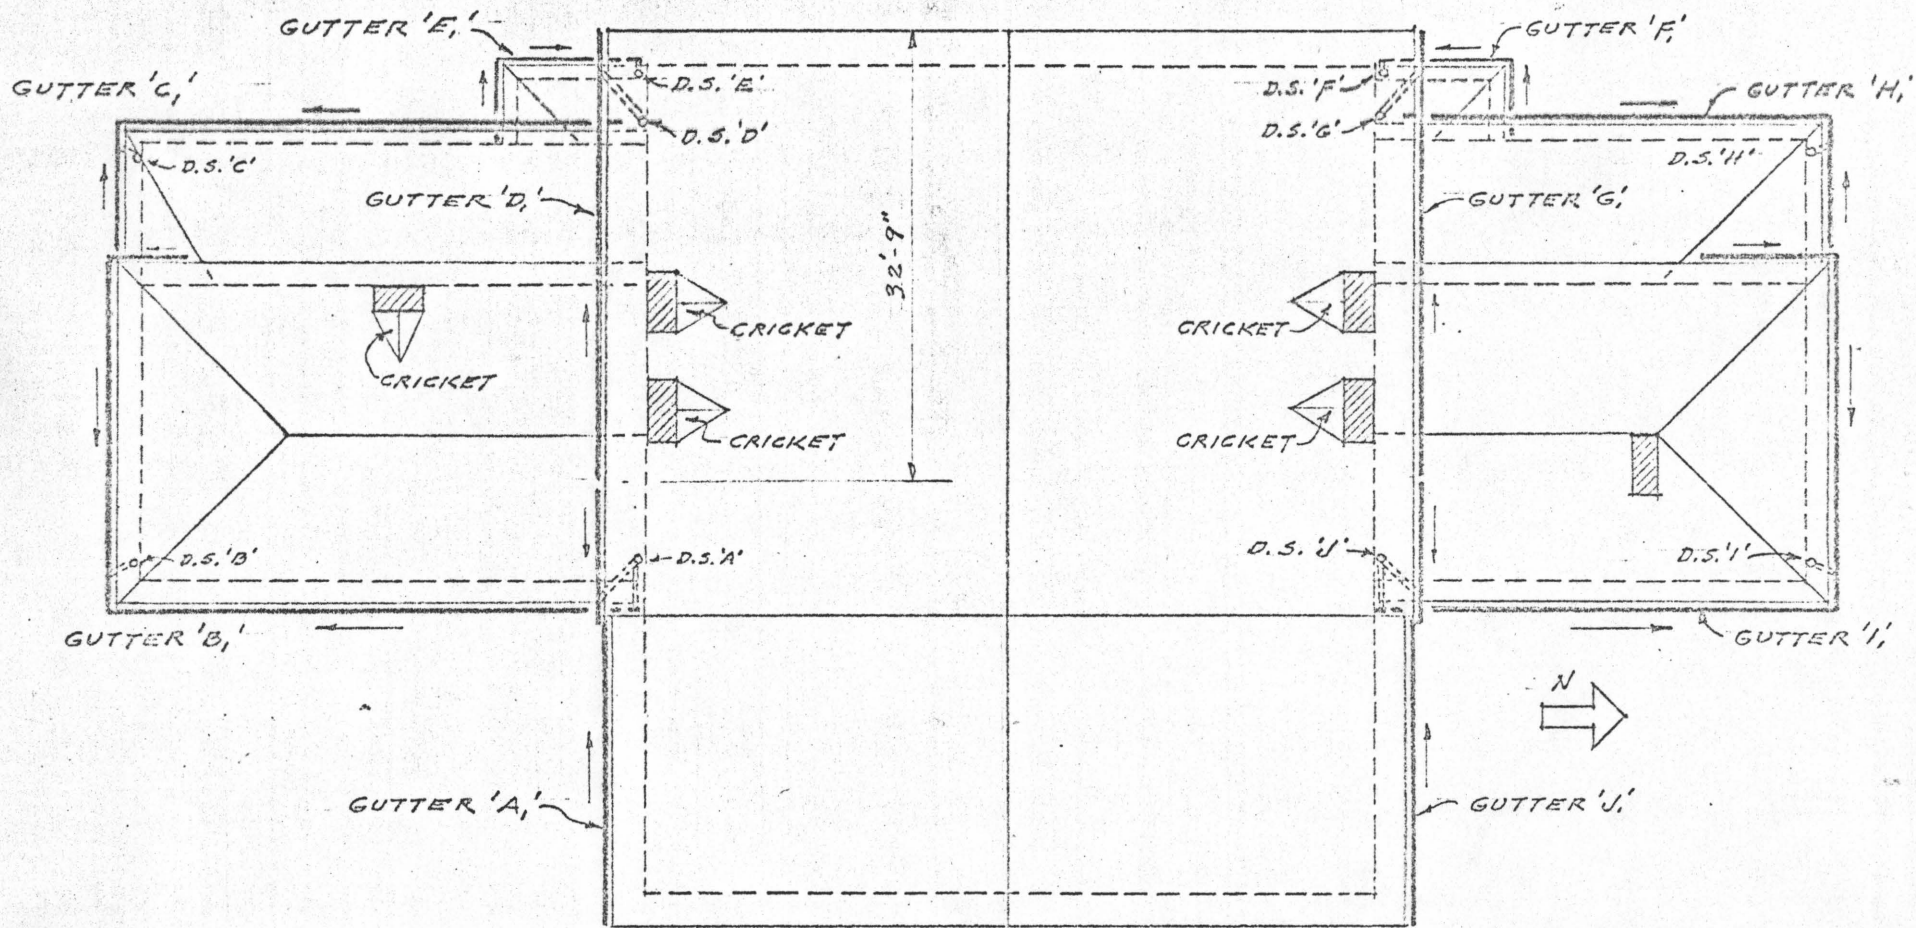
ROOF PLAN  
SCALE  $\frac{1}{16}" = 1'-0"$

Observations by maintenance and interpretive personnel, over a period of time, indicated that the gutters and downspouts were inadequate for the roof areas they serve. This has permitted excessive amounts of water to soak into the exterior walls, particularly on the eastern facade of the structure.

Appended are elevations and a roof plan showing the proposed gutter and downspout arrangement, a schedule of gutter and downspout sizes, and a sketch of the proposed gutter outlets to the downspouts.

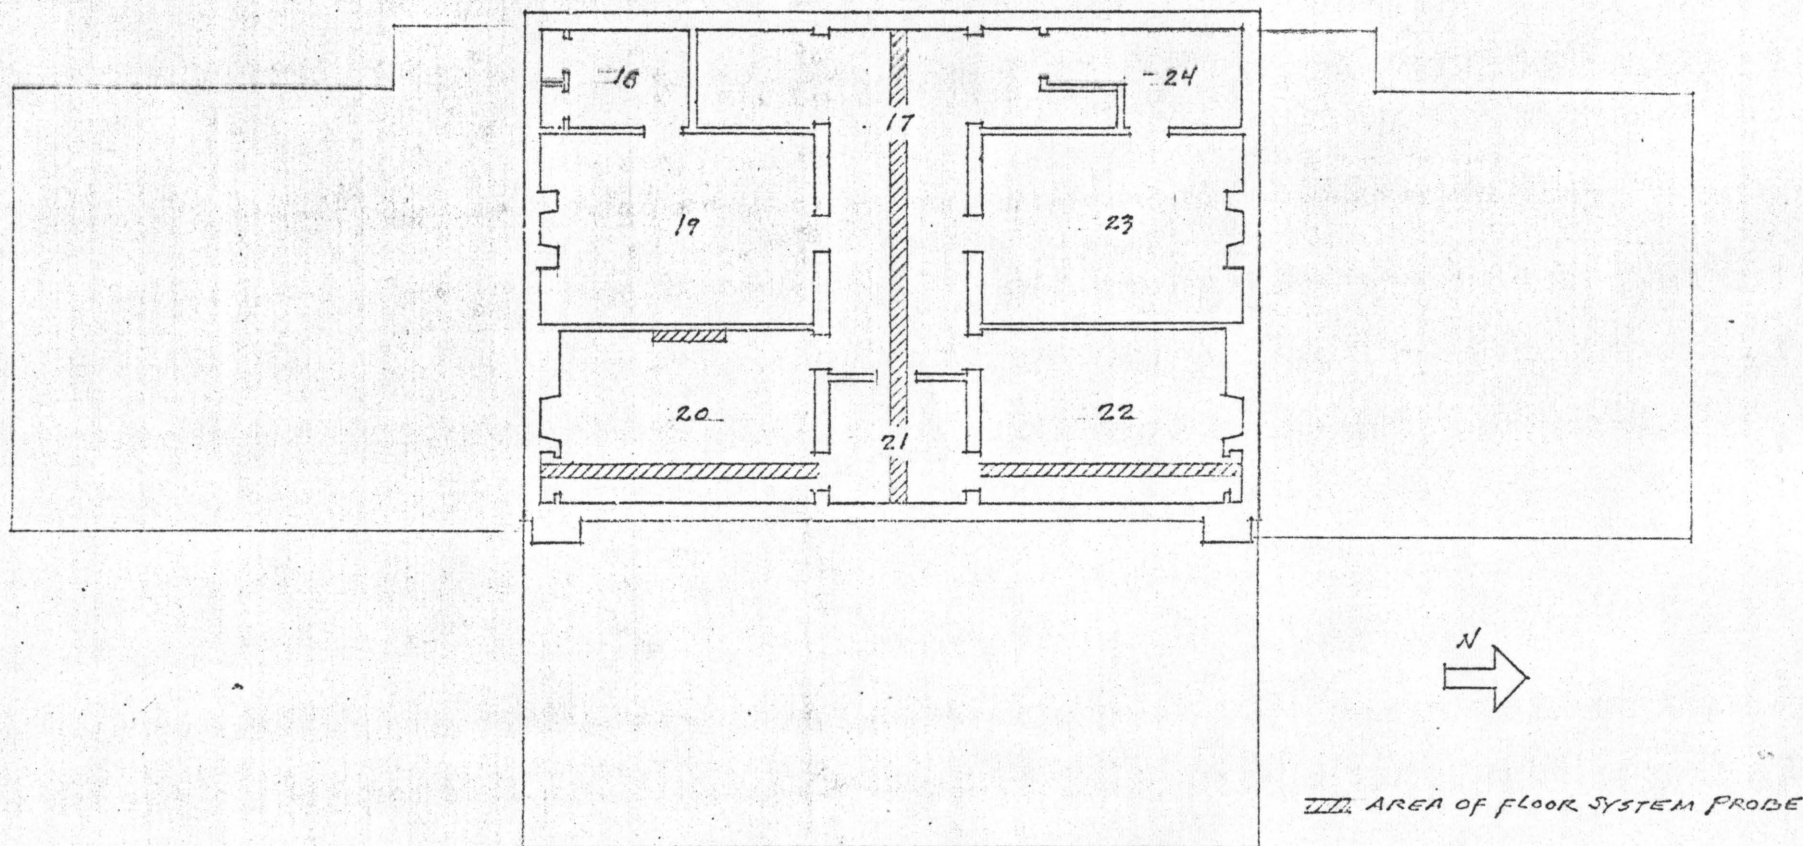
SECOND FLOOR PLAN  
SCALE  $\frac{1}{16}" = 1'-0"$

However a limited number of floor boards at the second floor level were lifted to determine the sizes, spacing and species of the underlying floor joists. A floor plan is appended to indicate the areas inspected. Mr. Harry Martin supervised the probe and recorded the findings.

At the points inspected it was found that the joists were yellow heart pine with eleven to sixteen annular rings per inch. The joists measured 3" to 3 $\frac{1}{4}$ " in width and 9-5/8" to 10-1/8" in depth. Their average spacing measured sixteen inches on center.

Of the portions that could be seen it appeared that they were in excellent condition.

Calculations based on this data showed that the joists are more than capable of sustaining a live load of 100 lbs per square foot (an accepted loading for the use the Mansion is subjected to.
