## HISTORIC STRUCTURE REPORT

# Mabry Mill

*This is a report done to examine the historic structure at the complex of Mabry Mill. The structure is located at milepost 176.2, on the Blue Ridge Parkway in Floyd County, Virginia.*

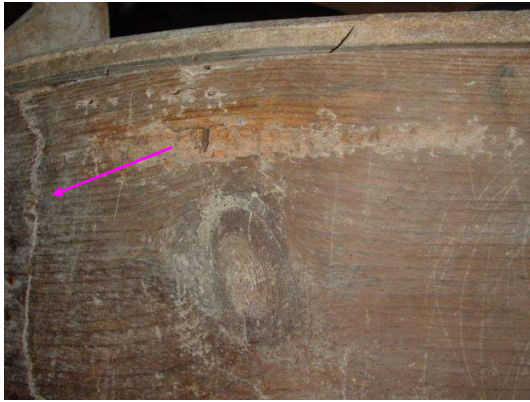
Cracks in buckwheat stone cover.

- Sheet metal on cornmeal hopper needs to be removed. Cornmeal hopper needs to be repaired in kind.
- The cover for the cornmeal hopper is damaged and needs to be repaired in kind. The sheet metal used as a mending material needs to be removed because it takes away from the character of the original structure.
- The grist mill sits next to the cornmeal hopper.
- The stones on the mill should be regularly and professionally sharpened and balanced. According to the miller the last time the stones were sharpened was 12 years ago in 1993.

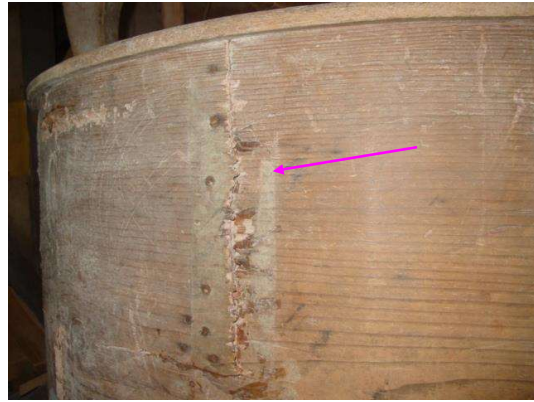
Cracks in buckwheat stone cover.

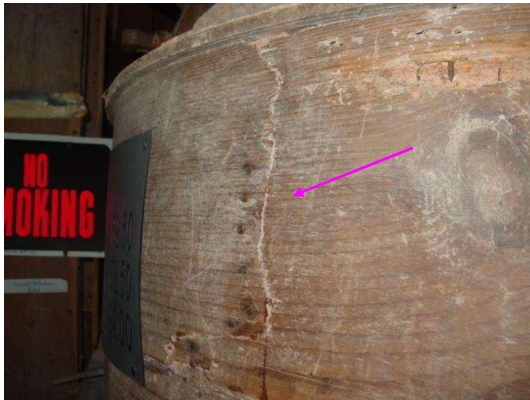
Cracks in buckwheat stone cover.

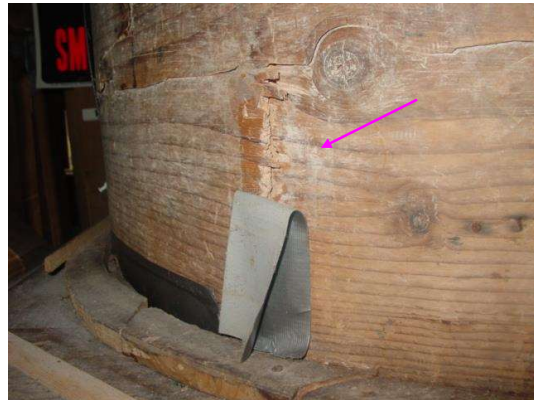
Cracks in buckwheat stone cover are under the duct tape.

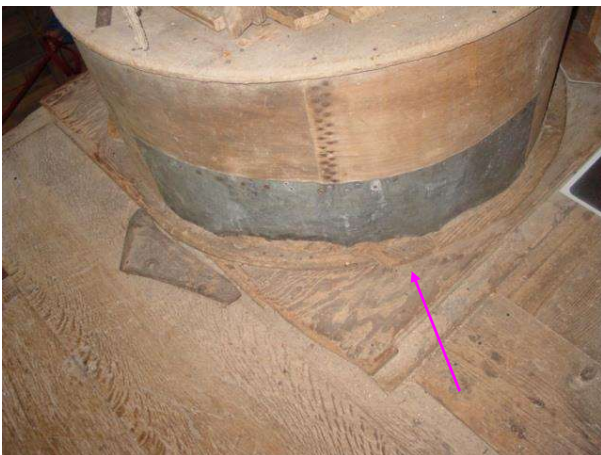
Sheet metal on Buckwheat stone cover used to keep it from cracking.

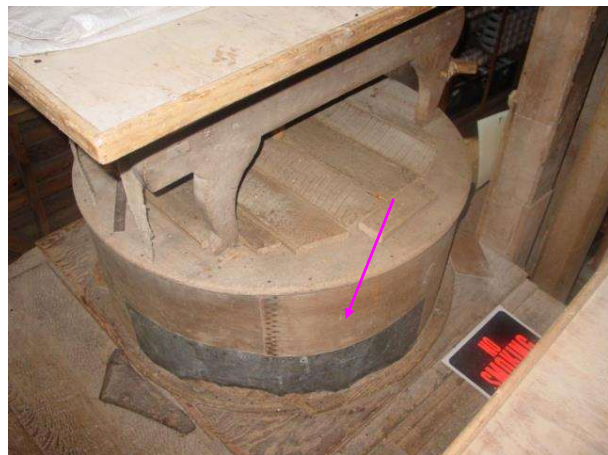
Sheet metal on buckwheat stone cover used to keep it from cracking

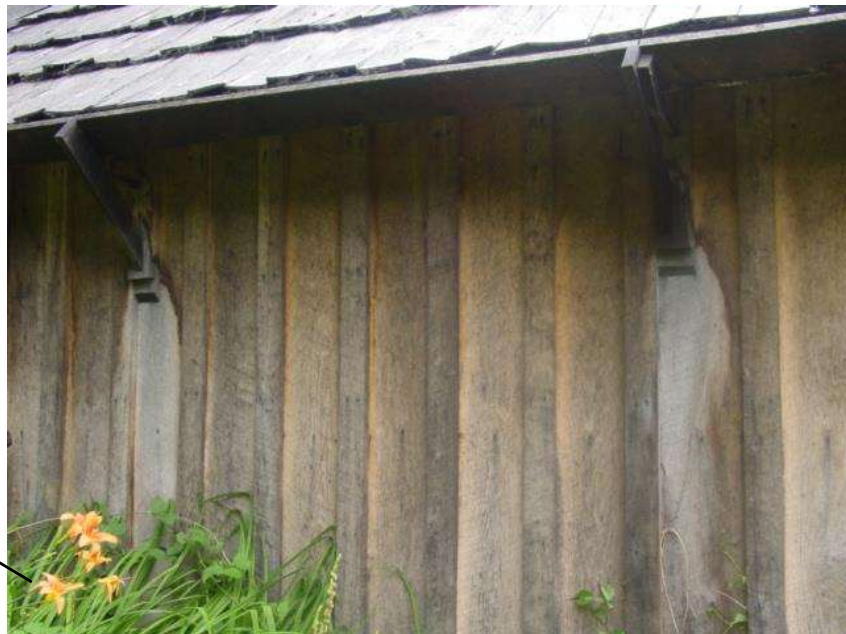
Overgrown  
vegetation  
touching  
west  
elevation.

*Markings underneath the gutter brackets on the west elevation of the carpenter shop.*

- There is water damage on the west elevation. This water damage created by the down spout from the gutters. The gutters need to be cleaned on a regular basis. Check the down spout and seal any leaks. These leaks can be damaging to the structure.
- There is a guard railing located on the west elevation near the pond. On this railing there is a piece of paper tied to the rail stating the necessary caution to the poison oak that surrounds that area. Either remove the poisonous vegetation or create a more permanent, appropriate sign cautioning visitors of the surrounding danger.
- There are markings under the gutter brackets on the woodworking shop area of the west elevation. Evaluate in order to see why there are markings under these brackets (supports).

- There is vegetation touching part of the vertical boards creating moisture damage. Some of this vegetation is poison ivy. Either remove, or move the vegetation so that it is not directly touching the building.
- Gutters need to be cleaned out every 2-3 months to prevent water damage. Check the downspouts regularly for leakage.

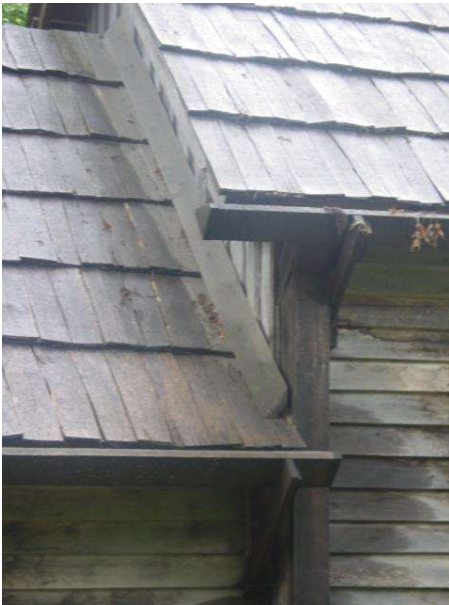
Connection of sawmill and gristmill on west elevation. Connection of gutters and down spout, that leads to leak problems if not cleaned.

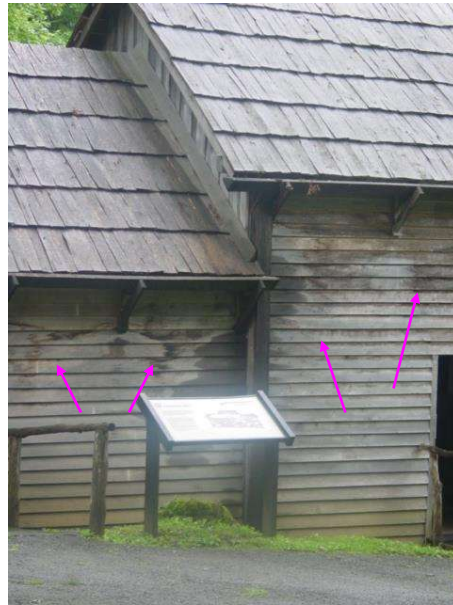
Connection of sawmill and gristmill on west elevation. Connection of gutters and down spout, that leads to leak problems if not cleaned. Roof shakes also visible.

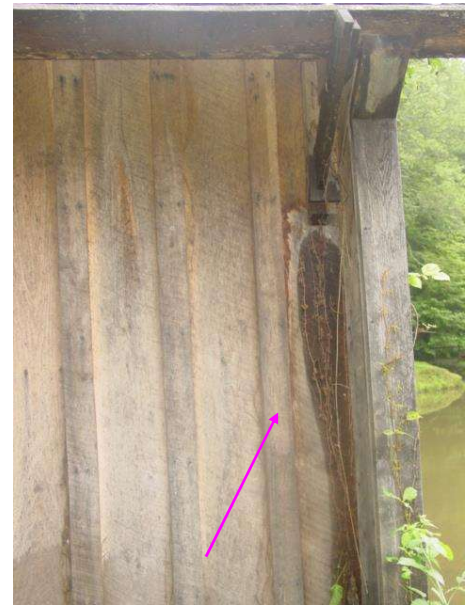
Corner on woodworking shop on west elevation [nearest to the north] vines are attached to the building and buildup will cause moisture.

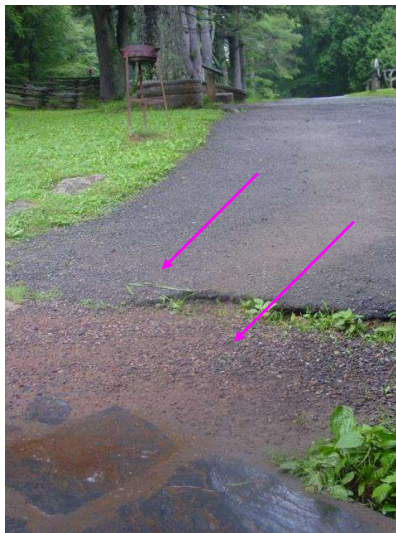
Viewing erosion on handicap walkway standing inside of woodworking shop looking to the west of the complex. Note: the uneven connection with the asphalt and ground. This should be fixed.

- On the west elevation there is some erosion nearest the furthest northern entrance. The land slopes at a downward angle causing water and erosion to interfere with the handicap accessible walkway. This water goes underneath the building to an open area under the gristmill and causes moisture problems. This problem starts all the way from an opening in a gate on the top of the hill near the road (Blue Ridge Parkway). We suggest that the slope should be regarded and should slope away from the building. Consult with a historical landscape architect regarding the implementation of the idea. No water penetration or erosion should be allowed to continue being a threat to this handicap accessible area.

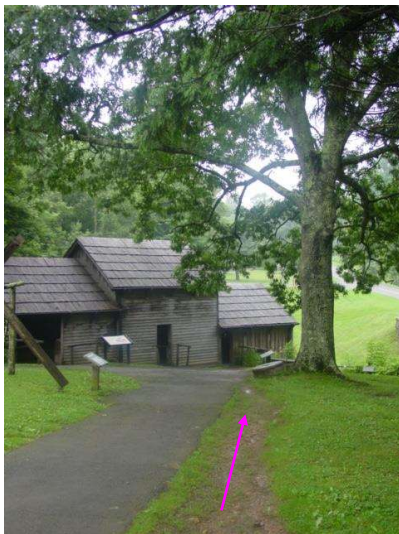
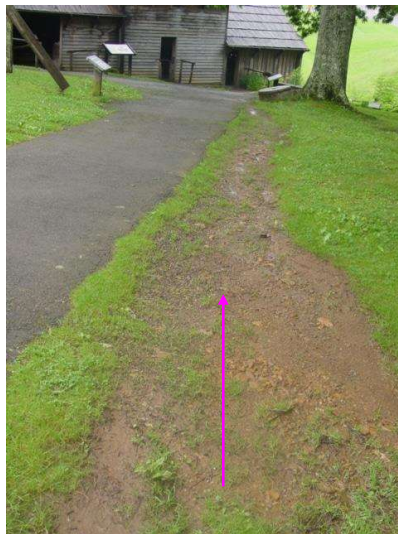
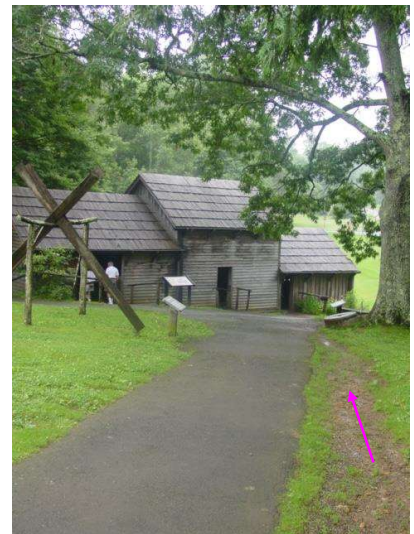
*Erosion on the west elevation side near the carpenter shop entrance*

*This is a diagram showing the path of the water that leads to erosion on the west elevation looking towards the woodworking shop entrance of Mabry Mill.*

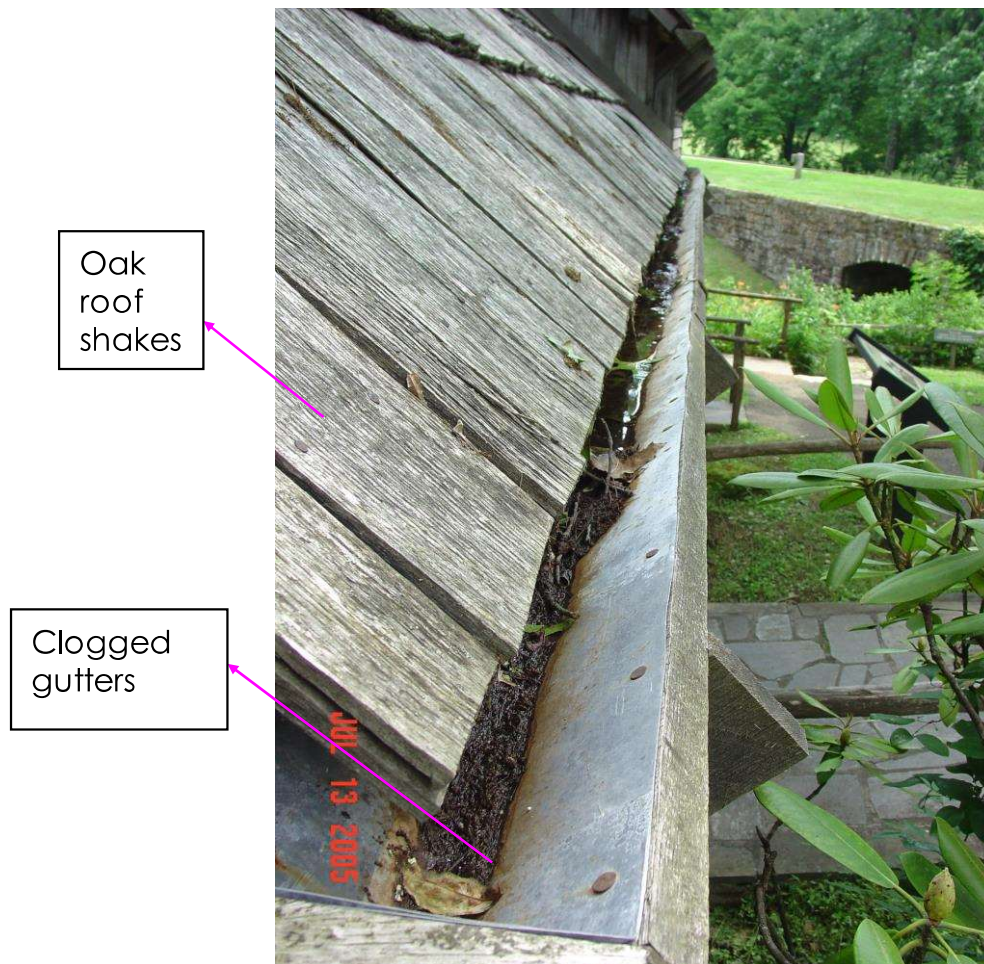
*Clogged gutters on the west elevation of the building.*

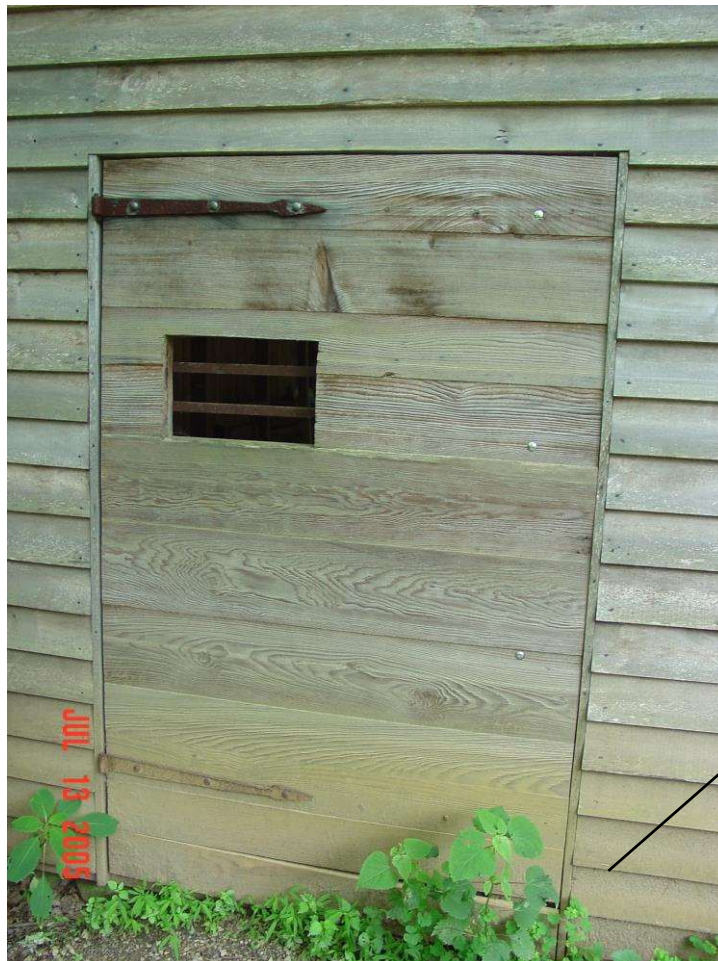
- There is overgrown vegetation on the north elevation of the mill near the door creating moisture damage. This vegetation needs to be removed without damaging the original materials of the structure.

Overgrown  
vegetation.

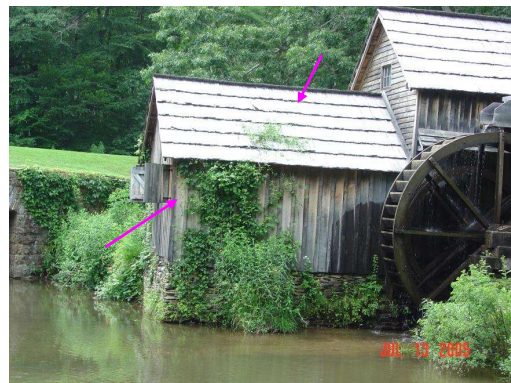
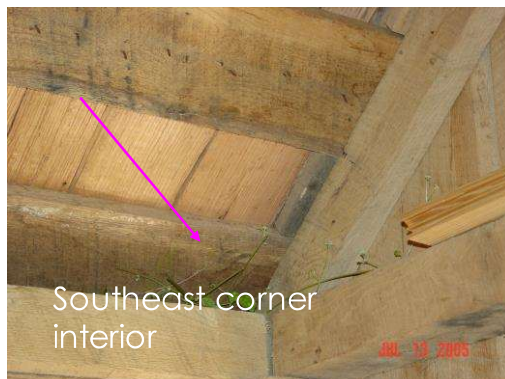
- There are no gutters on the east elevation of the building.
- There is vegetation on the east elevation that is creating water damage. This vegetation needs to be removed. It is damaging to the structure and takes away from the integrity and character of the structure.

*This is a diagram that shows how the vegetation on the east elevation roof of the woodworking shop invades the interior of the structure.*

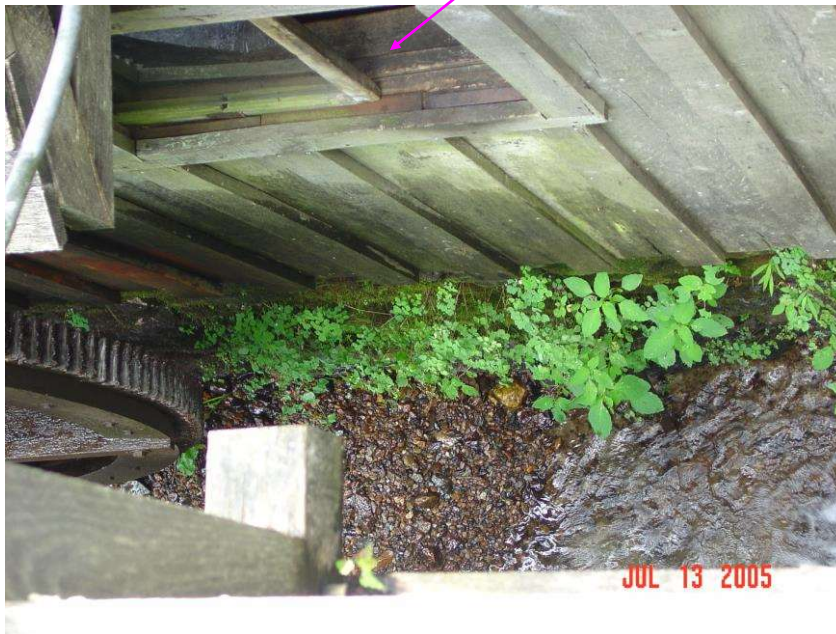
Overgrown vegetation on the east elevation near the water wheel axle; note moisture on east elevation from splashing due to the water wheel.

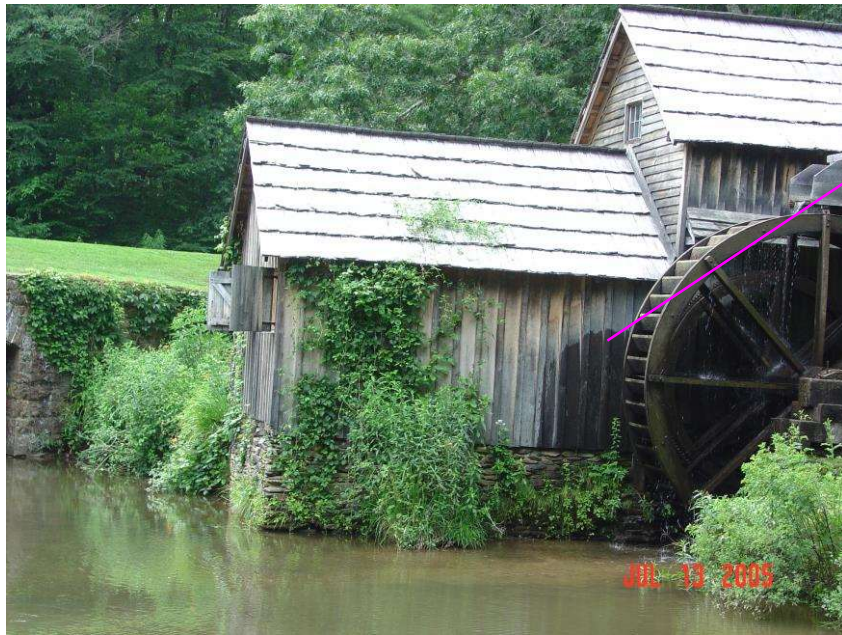
Note the water damage from splashing of the water wheel.

*Overgrown vegetation on the east and south elevations.*

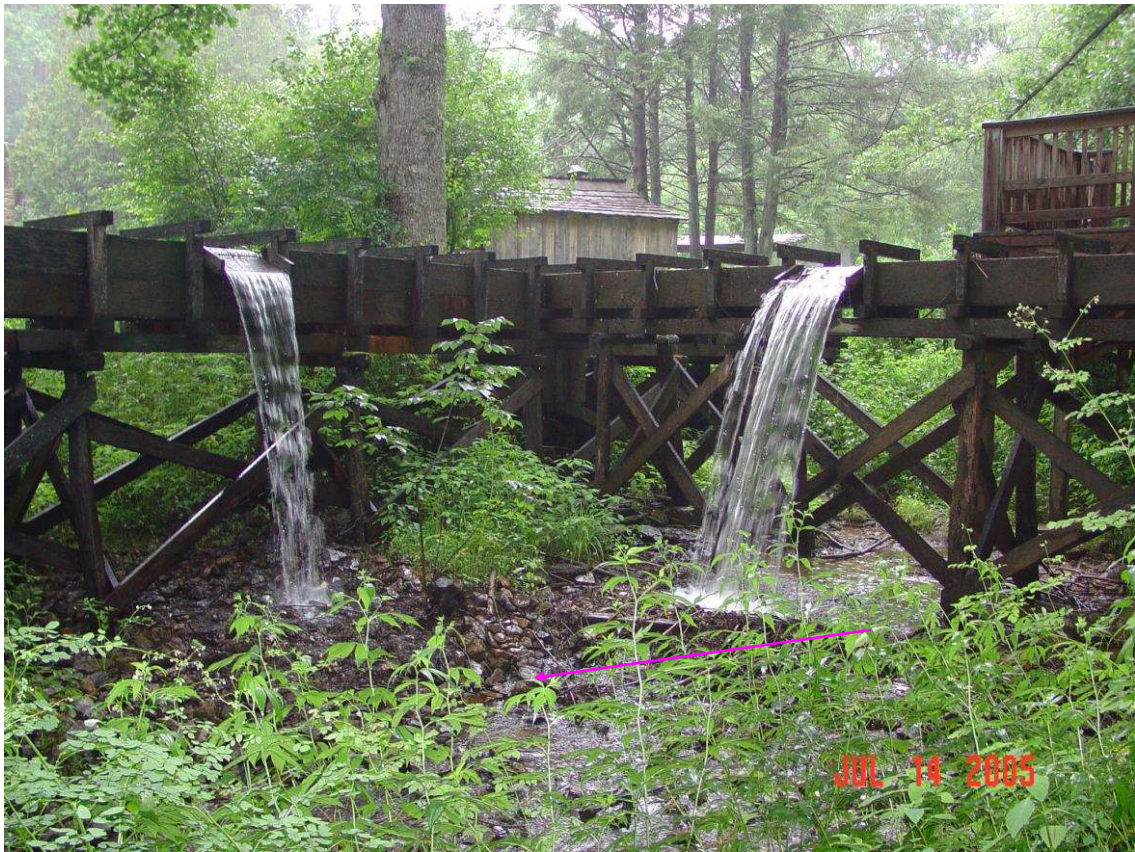
*This is the overflow section of the flume and race. This overflow water creates a stream underneath the flume, which causes moisture damage and erosion near the east elevation of the building.*

- Over flow sections in flumes create moisture that is damaging to the east elevation. It is suggested that the path of water underneath the flumes be redirected away from the structure and angled toward the pond. This action will decrease the likelihood of water damage to the mill's east elevation and create a much less harmful channel of water flowing directly into the mill pond.

- The flume overflow stream leading to the pond causes considerable and preventable water damages to the mill's east elevation. The park should periodically monitor this stream-caused damage to the east exterior foundation and exterior walls. Due to the proven damage caused by this stream, the water source should be redirected and angled towards the pond and away from the mill structure and flume piers.

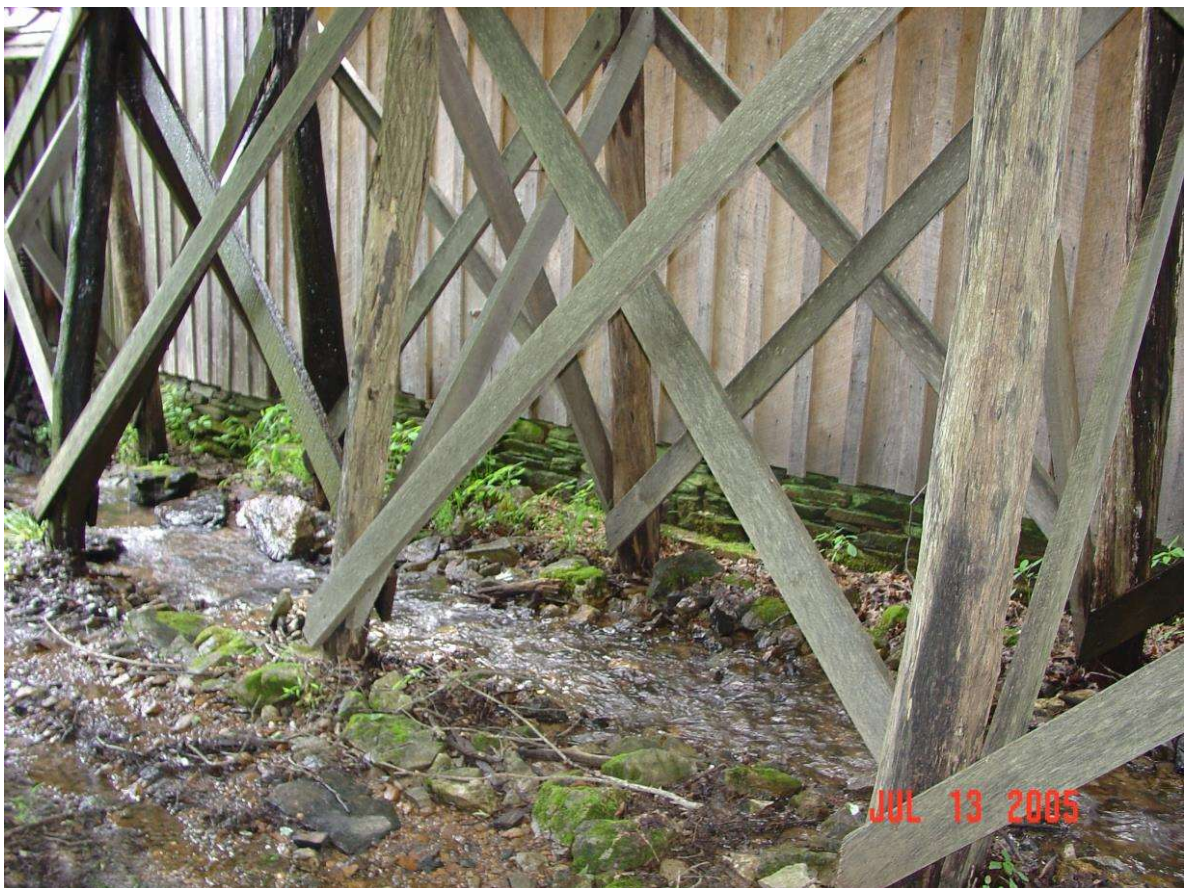
*Water stream under the flume.*

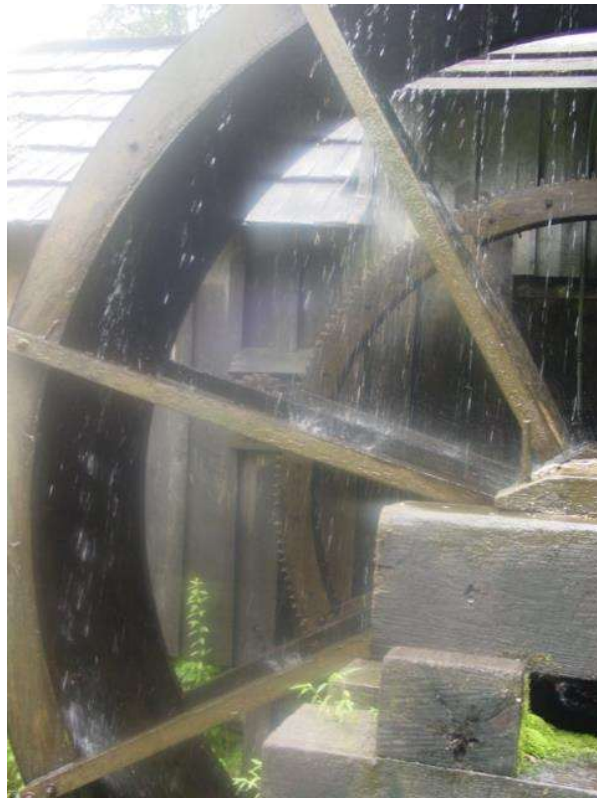
*Wet water wheel: water wheel leaks, buckets inside of wheel need to be sealed; seek professional evaluation of the wheel leaks; water splashes on east elevation.*

Moist east elevation gets splashed from water wheel and flume leaks.

- When the wheel is stopped the least amount of water should leak from the flume. There are also holes in the buckets of the water wheel. The flume should not leak water when the mill is off [shut down]. The door in the flume that keeps the water off when the wheel is off should work properly. Consult with a professional for correction of the problem.
- The wheel needs remain uniformly wet when not in use in order to stay balanced. See professional do determine the actions to be taken with the water wheel.
- Running the wheel only part time is not proper for the balance of the wheel. There is also an effect when the wheel is icy in the winter. The wheel needs to stay evenly wet at all times [unless the entire wheel is completely dried. Consult with mill professionals to find ways to keep the waterwheel evenly wet.

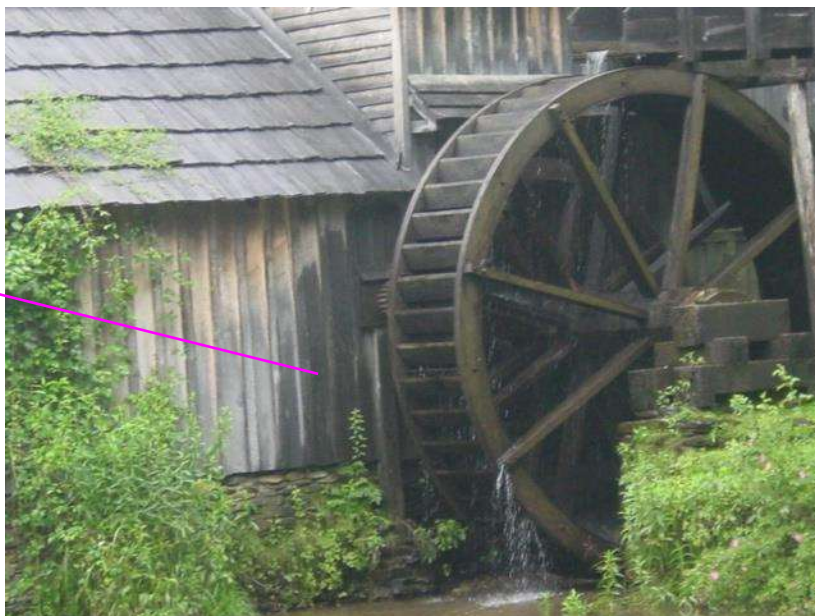
*Viewing east elevation; note the wet façade and leaking water wheel and flume; seek professional evaluation of wheel; consider using an appropriate clear sealant for the east façade wood.*

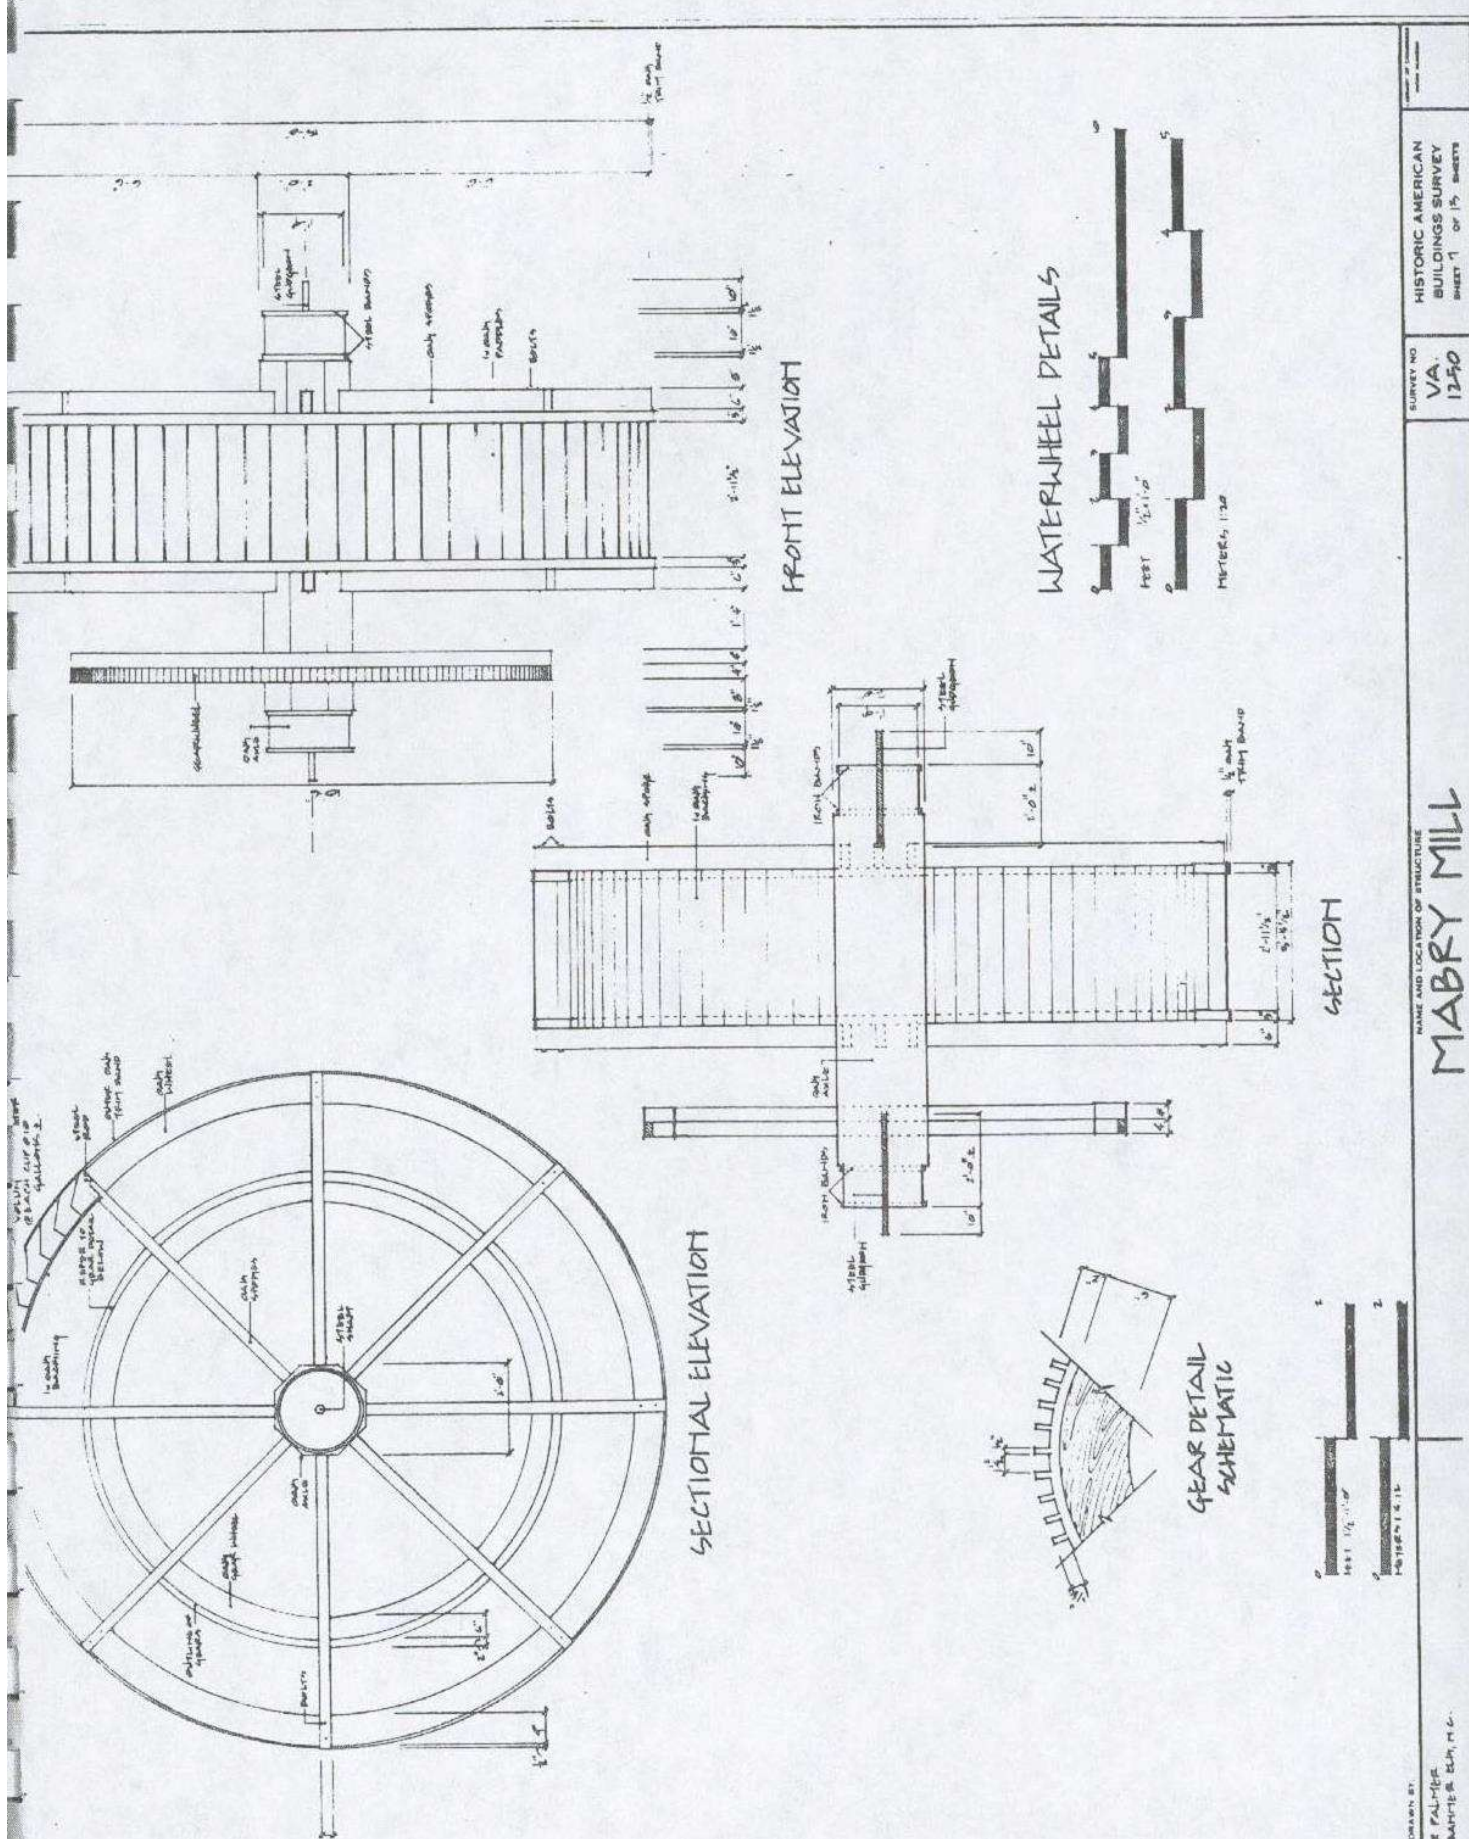
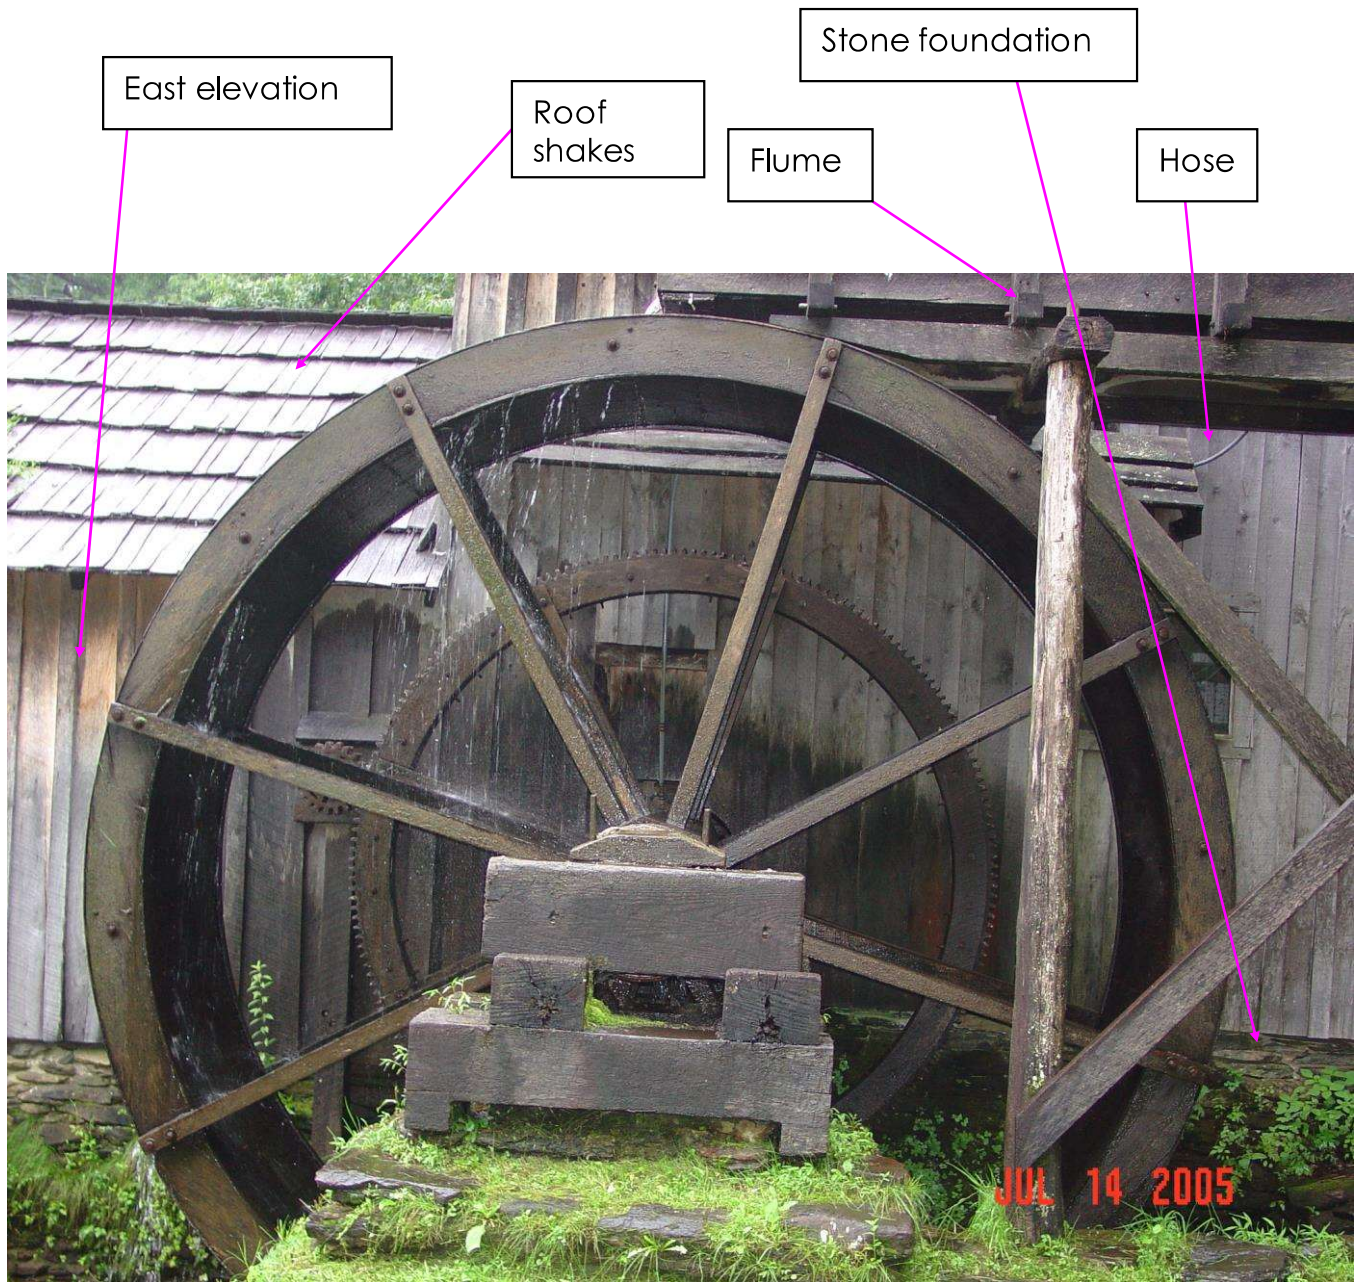
Water wheel and flume on the east elevation: Note that the water wetting the wheel is only wetting half of the wheel and is also splashing the east elevation. The entire wheel must stay evenly wet in order to stay balanced. Consider seeking professional evaluation in order to determine an accurate solution for this problem.

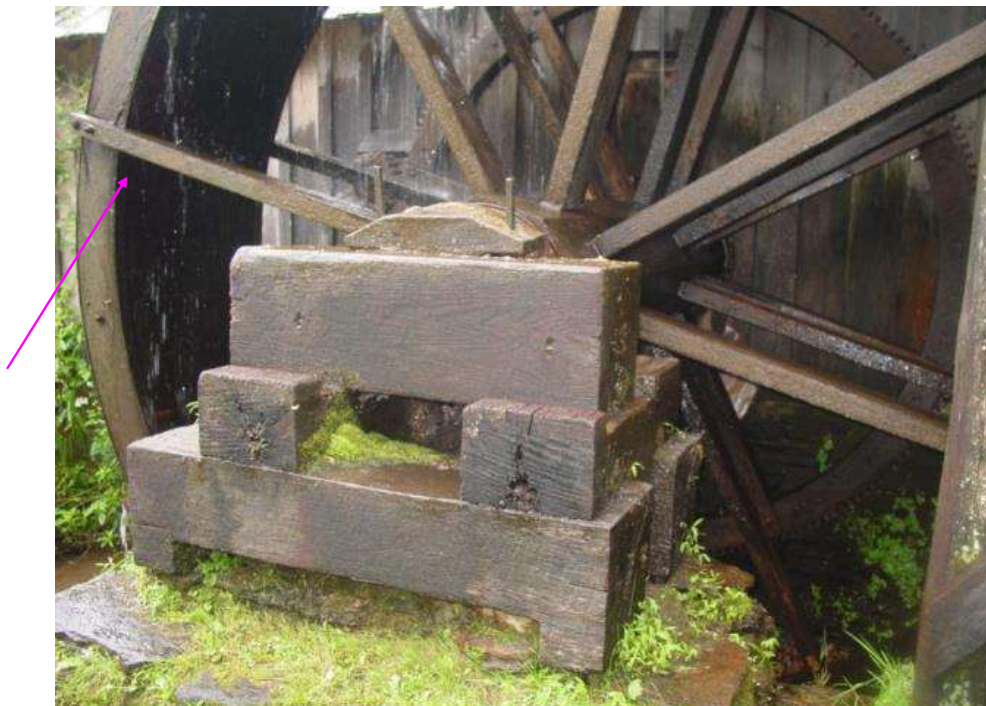
*This photo shows that the wheel buckets are leaking.*

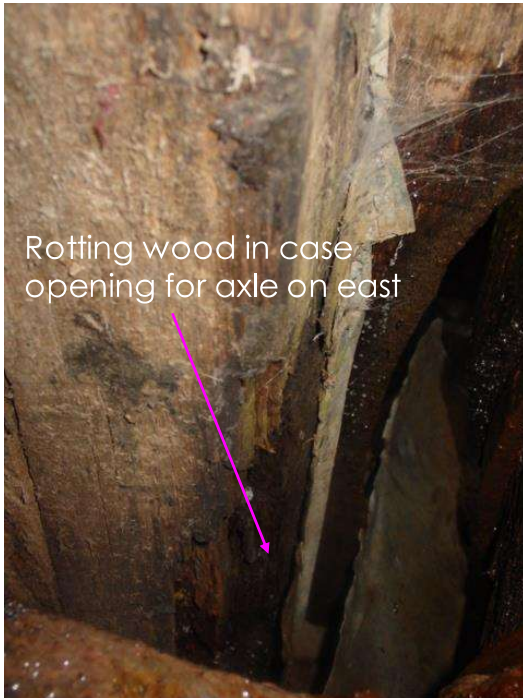
Water damage on case opening creates wood rot and needs to be replaced.

- The east wall is the same through out the whole interior of the mill.
- There is rotting wood on the interior of the opening for the water wheel connection [the axle] due to the water that splashes from the wheel. These pieces of wood should be repaired or replaced if necessary, in kind.
- The window [sash] on the east wall is attached by metal angle supports and needs to be repaired in kind.

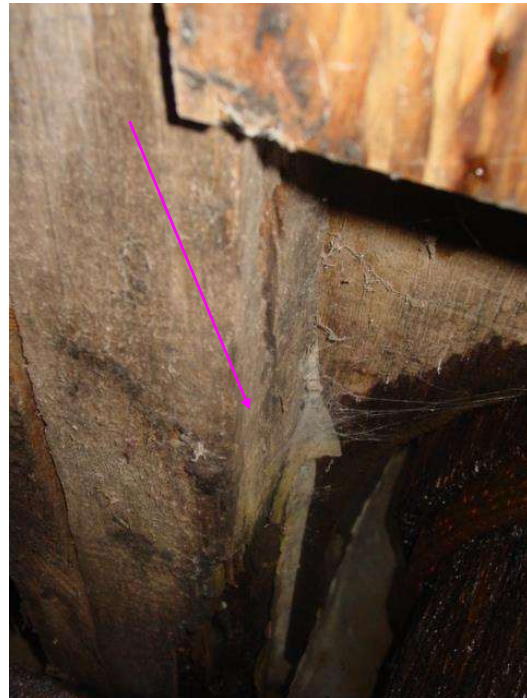
Water damage from splashes from water wheel through the case opening for the axle.

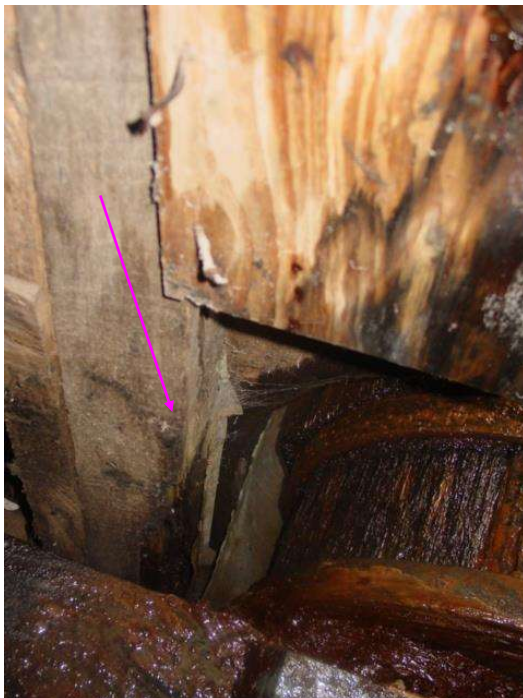
Water damage from splashes from water wheel through the case opening for the axle.

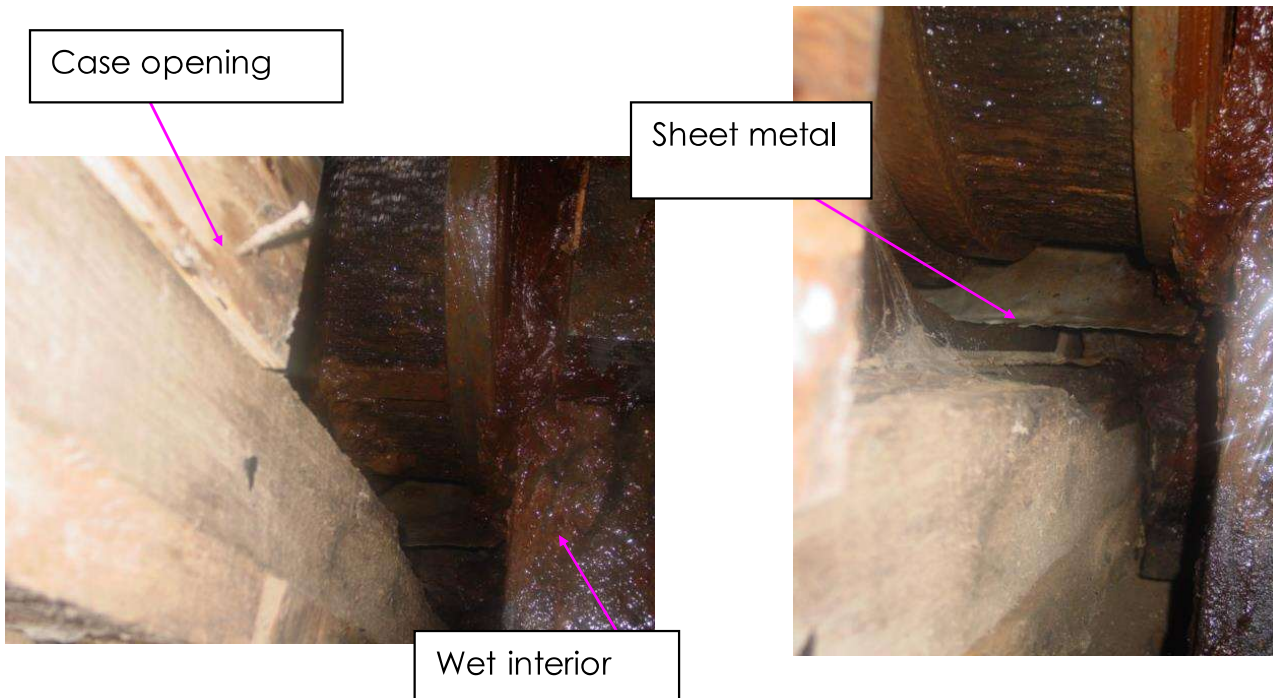
*Sheet metal is placed to keep out moisture. Consider evaluation and recommendations for improvement by a professional; view is from the top of the axle and the case opening.*

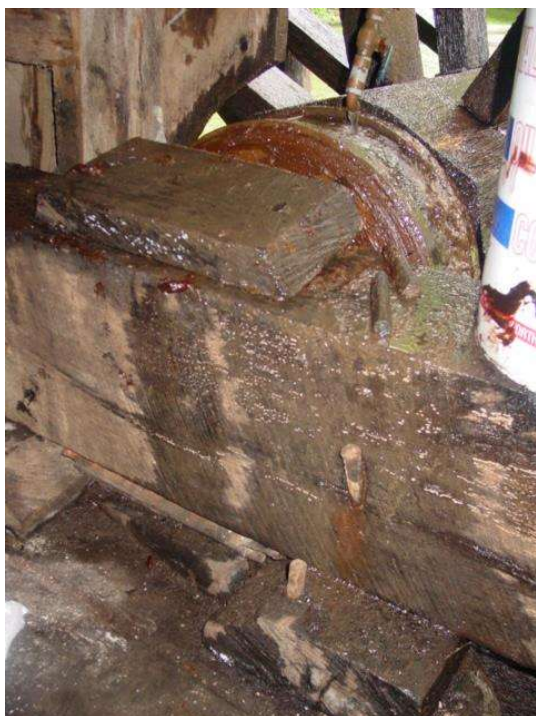
Viewing the wet axle, case opening and interior on the east wall of the interior.

- There is water damage on the east interior wall which could be caused by water splashing from the wheel or from overgrown vegetation. The east wall should be protected using in-kind fabric materials from this water damage caused by the flume and water wheel.

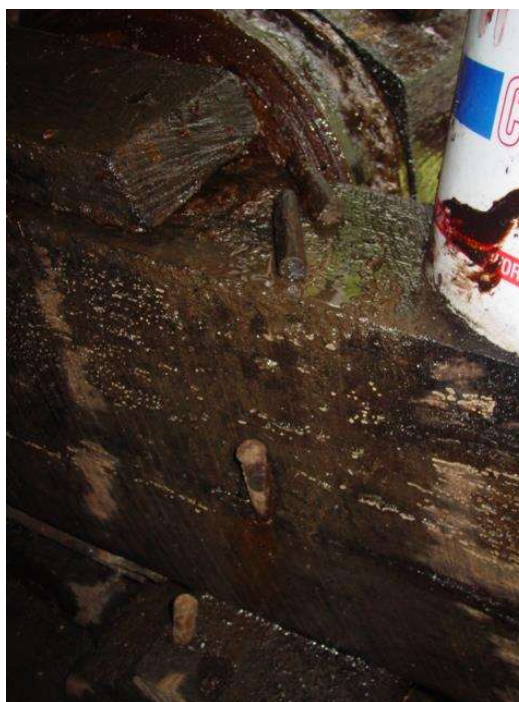
Viewing water damage on case opening of water wheel axle.

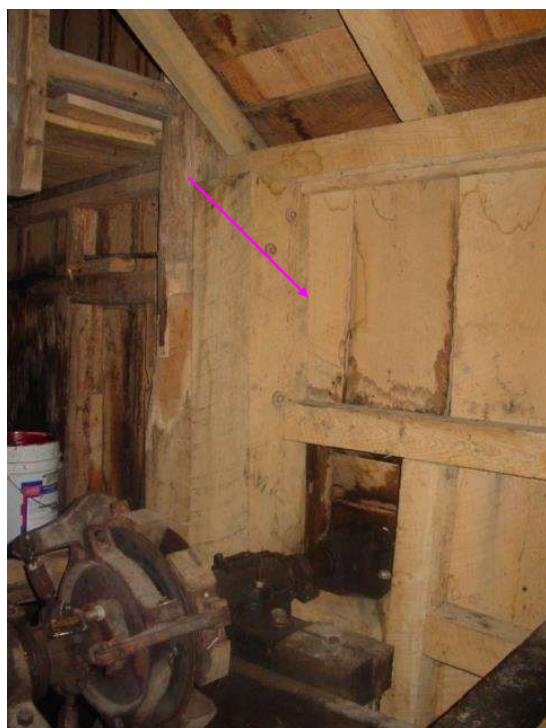
Showing water stains on the east wall of the interior in the mill section of the building, above case opening for the clutch of the mill.

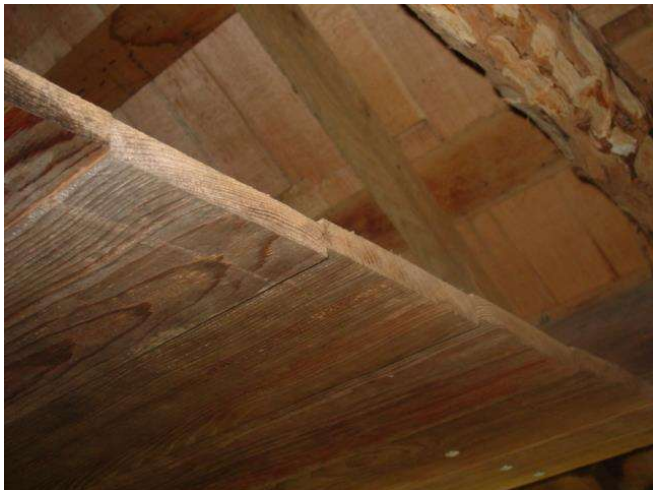
*Faux clapboard to blend door with the façade of the west sawmill section elevation; this is a photo of the raised door [from the side]; note the clapboard like finish.*

Minor wood rot

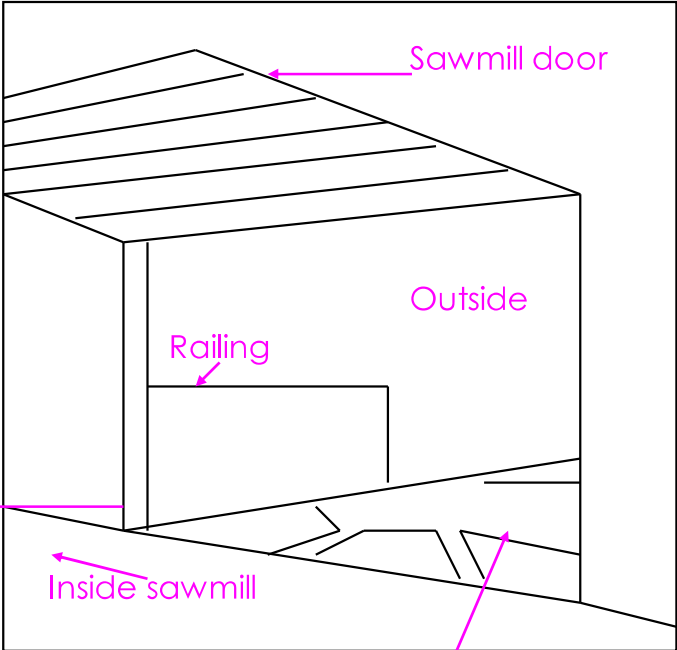
*Viewing the sawmill entrance door, standing in the far north east corner of the sawmill section looking southwest through the door [located on the west façade].*

Minor wood rot at the base of the door on the left lower corner  
[standing on inside of the building looking out towards the west.]

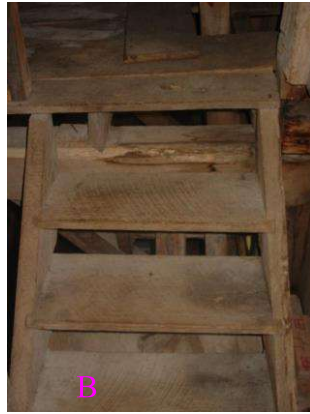
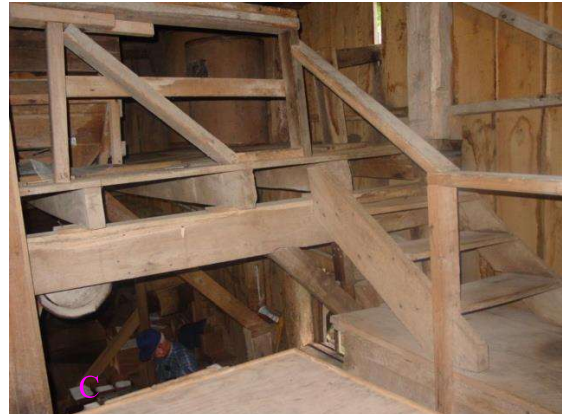
A: Stairs from the ground level to mid level of loft. B: Stairs from the mid level to the upper landing of the loft. C: Stairs from the upper landing to upper level of the loft in the mill section of the structure.

Water damage on east elevation

- These stairs are original. The "employee's only" sign should be removed from the original structure.

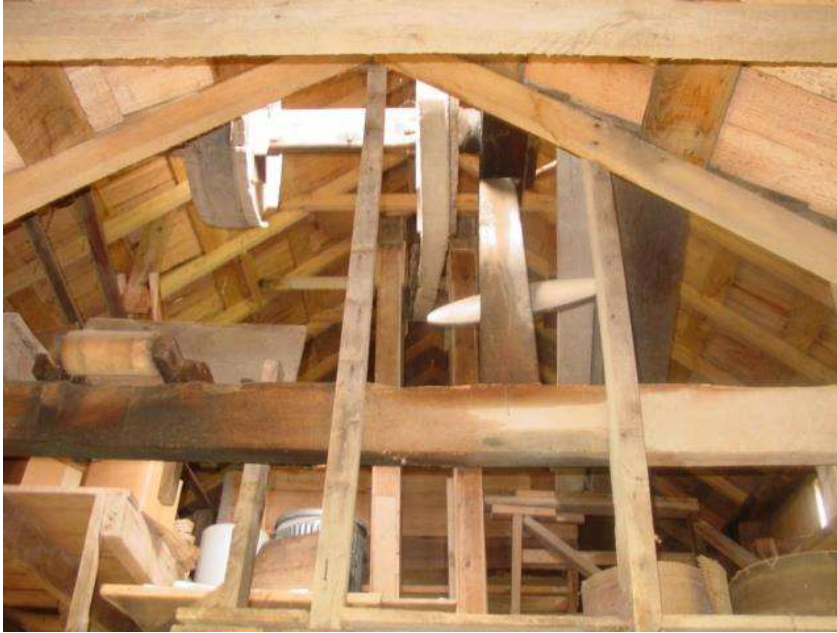
*This is one of the most important aspects of the mill. Because it is attached to the ceiling in the upper loft, check for leaks that may occur through the connections.*

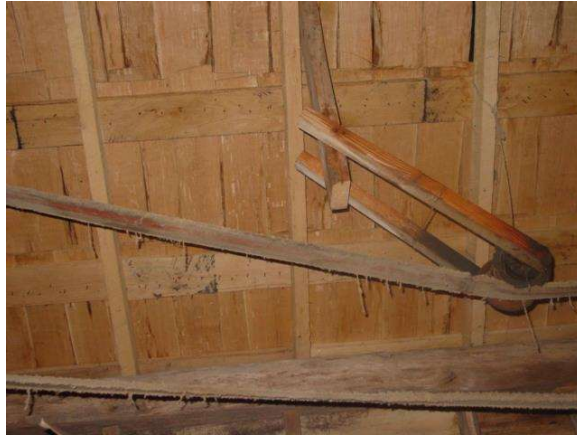
*Ceiling and attached pulley in the upper loft of the mill; check for leaks especially where the pulleys are attached to the ceiling. Pulleys are not original to Mabry's 2 milling efforts: cornmeal and chop animal feed. Pulleys shown in photos were installed in the late 1940s by concessionaires to allow the bolting processes required in order to produce buckwheat flour sold thereafter to visitors*
