## HISTORIC STRUCTURE REPORT

# Mabry Mill

*This is a report done to examine the historic structure at the complex of Mabry Mill. The structure is located at milepost 176.2, on the Blue Ridge Parkway in Floyd County, Virginia.*

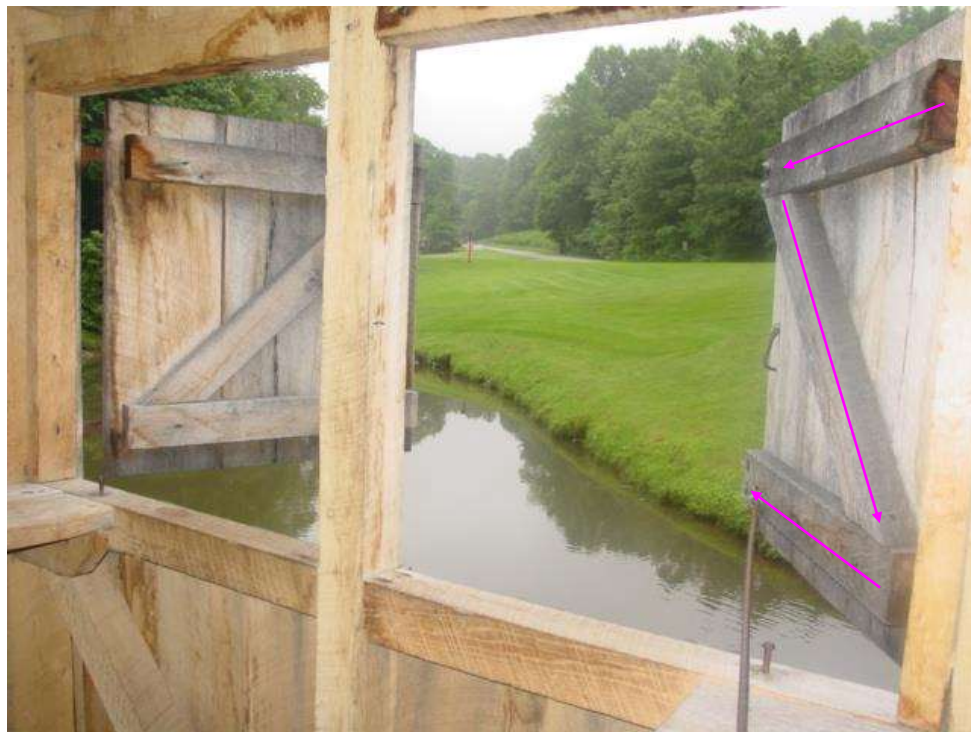
*Open windows on the south interior wall of the woodworking shop. These windows are NOT original to Mabry's structure; they were installed by NPS in 1942.*

There is water damage on the south wall. This damage is caused by overgrown vegetation and leaks through the wall. The vegetation needs to be removed and leaks sealed in kind. Consider applying a protective sealer in kind to prevent moisture absorption from the pond.

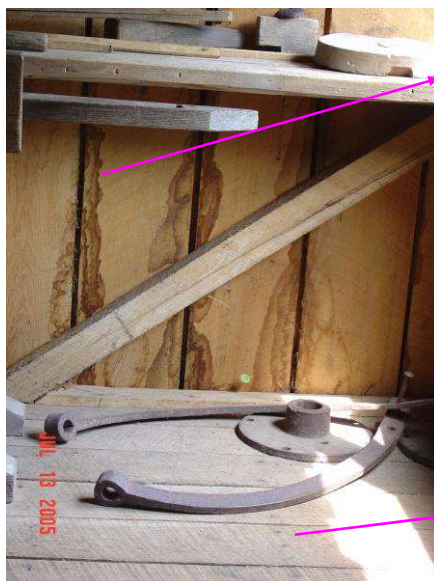
East wall [in  
woodworking shop]  
water damage

- There is vegetation intruding from the outside into the east interior wall. This vegetation must be removed in order to protect the wood from moisture damage.

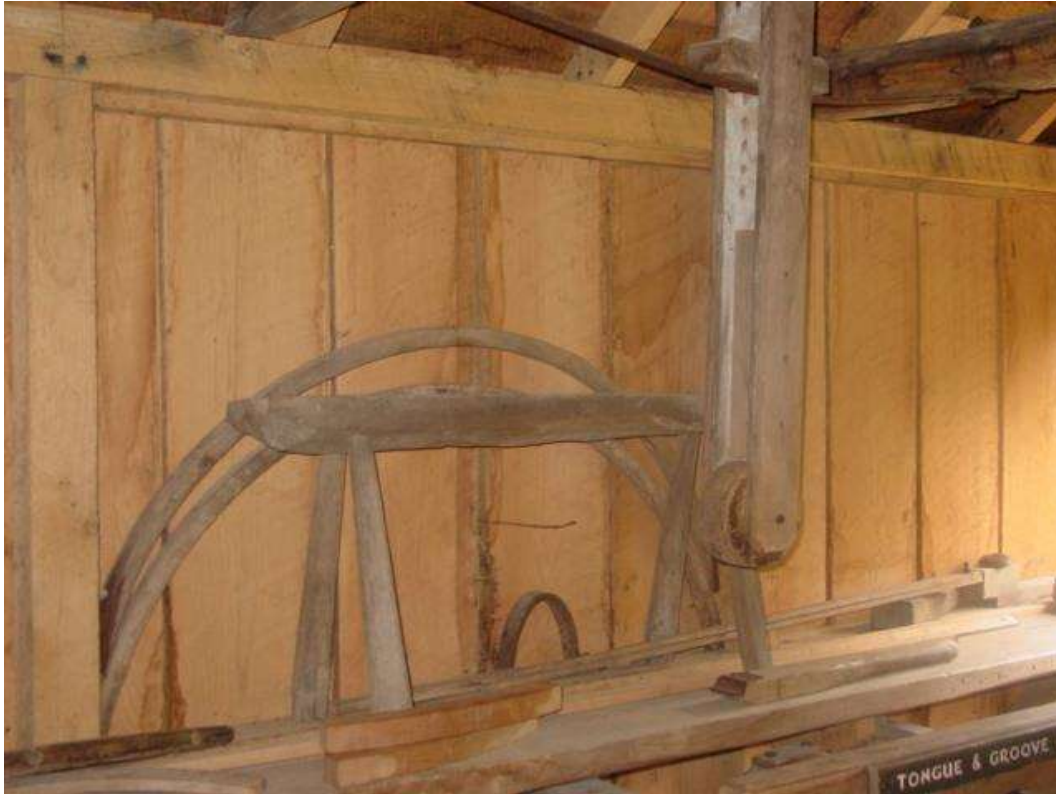
*This is the east wall in the woodworking shop showing various post that serve as the structure; this wall is in jeopardy of water damage due to splashing of the water wheel on its exterior. Also shown is the tongue and groove machine.*
