# Historic Structure Report

**The Blackwell School Alliance Board**

**UTSA** College of Architecture,  
Construction and Planning

Date : 04.24.19

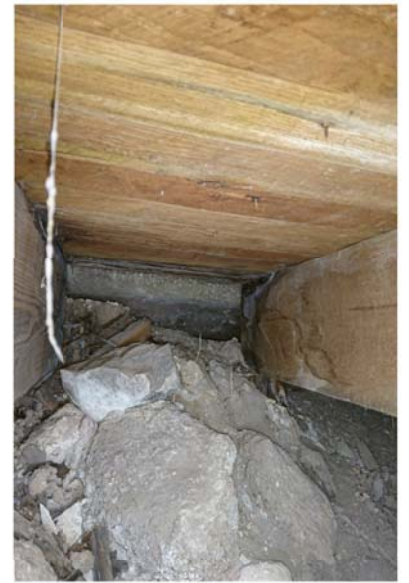
**4** A concrete slab has been poured on top of the demolished rubble foundation at restrooms.

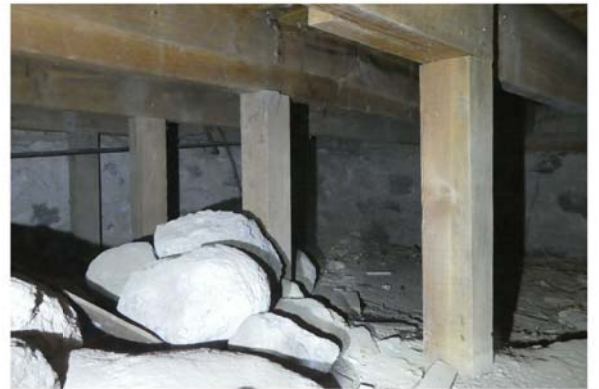
**5** Secondary supports placed under the floor joists where the floor has been modified.

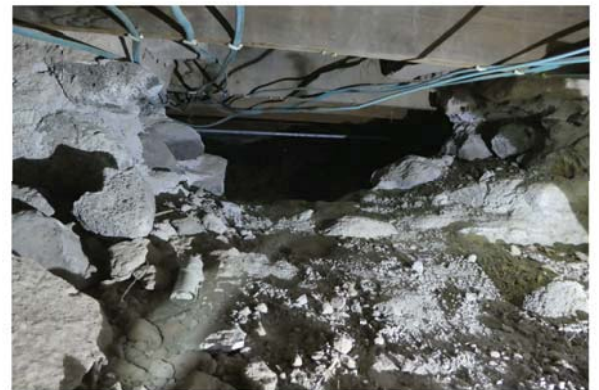
**6** Portion of the foundation wall has been removed for access between the classroom and vestibule area.

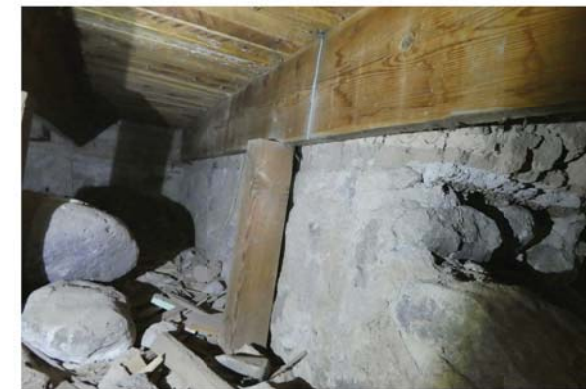
**6** Secondary support has been placed under the floor joist which is positioned adjacent to the rubble foundation wall.

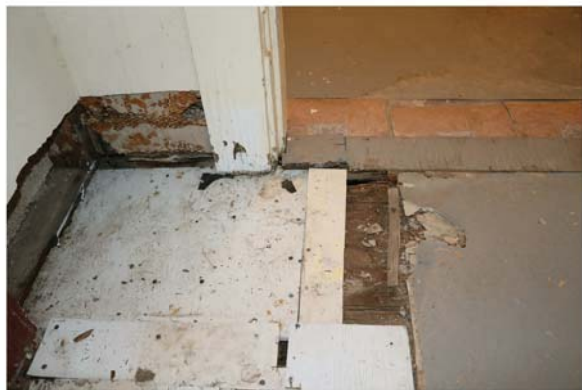
**2** Numerous layers of plywood have been installed where excessive water damage has occurred.

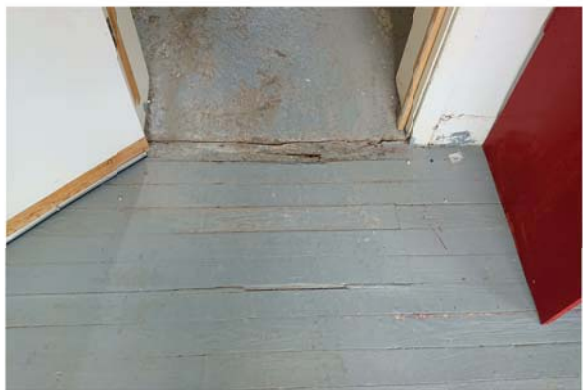
**3** A roof leak in the connecting hallway has caused deterioration and rotted wood where the concrete ramp connection slopes toward the band hall.

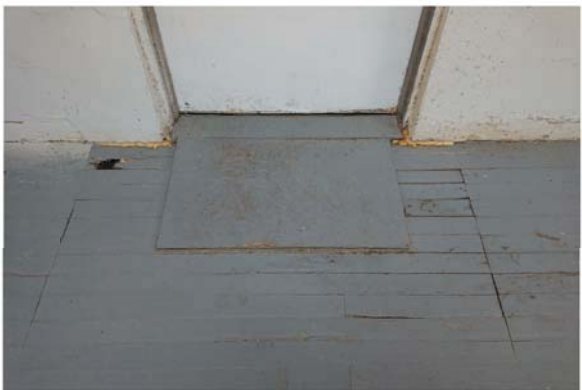
**4** Plywood partially covers deteriorated floor boards which appear to have been previously replaced.

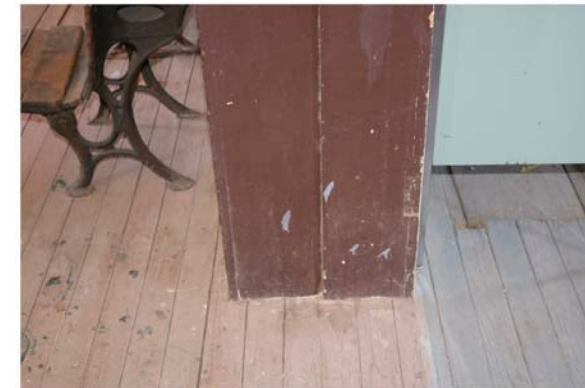
**3** crawl space access panels have been cut on both sides of the center adobe wall.

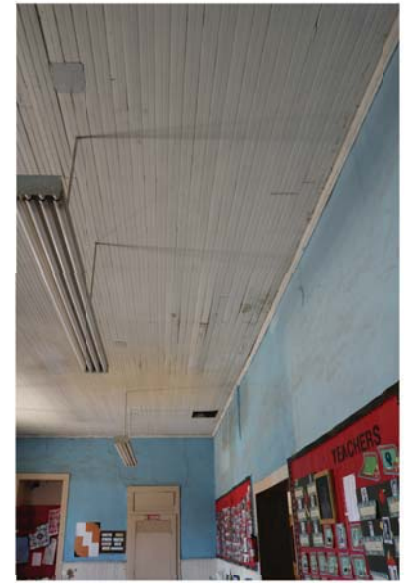
**5** The beaded board tongue-and-groove ceiling boards are deteriorated, sagging, and appear to have detached from the structure. There is an attic access hatch near the center wall.

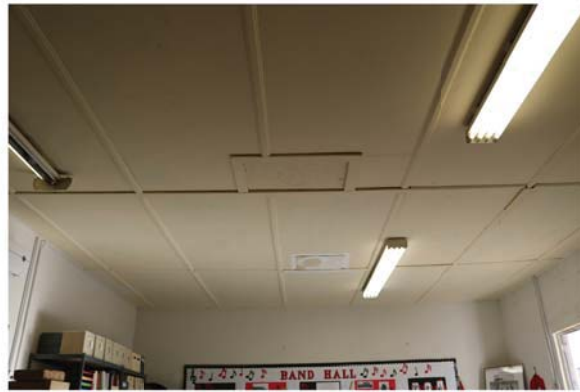
**6** Ghosts of previous room dividers appear at ceiling.

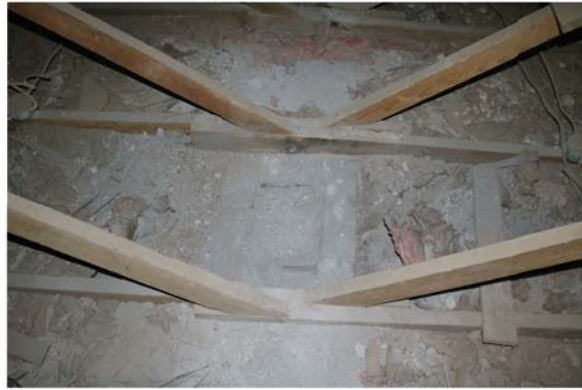
**1** Embedded into the top of the adobe wall is the remains of an old brick chimney that has been removed.

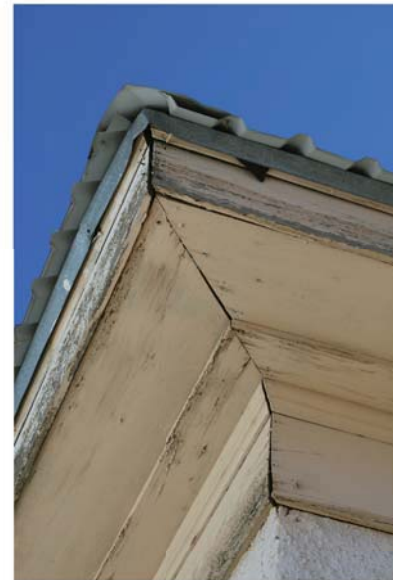
**3** Weathered fascia and soffit hole at roof line allows pest intrusion.

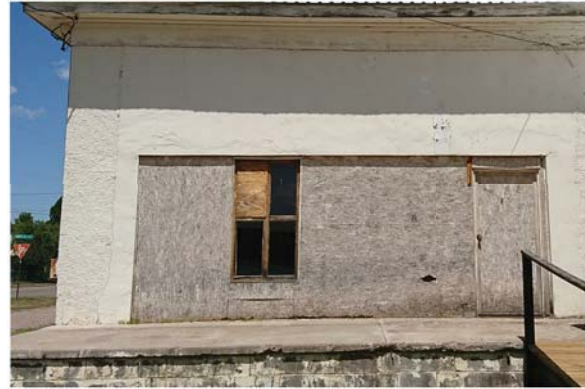
**2** Infill wall at loading dock shows many modifications.

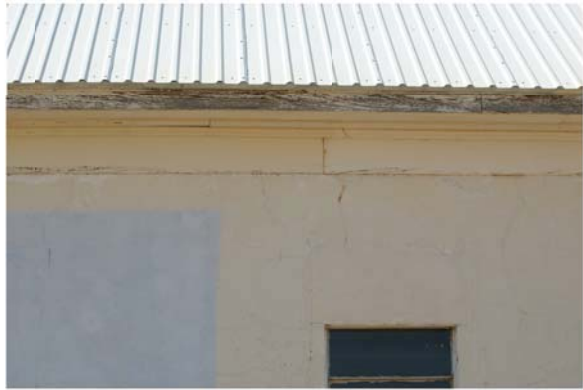
**3** Deteriorated wood, plaster cracks on surface and at modified windows.

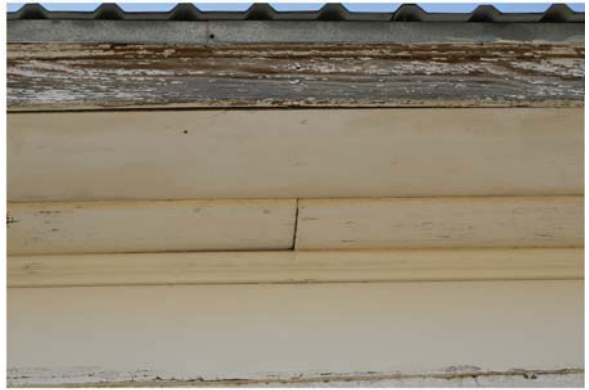
**4** Deteriorated wood at fascia, soffit, trim board and molding.

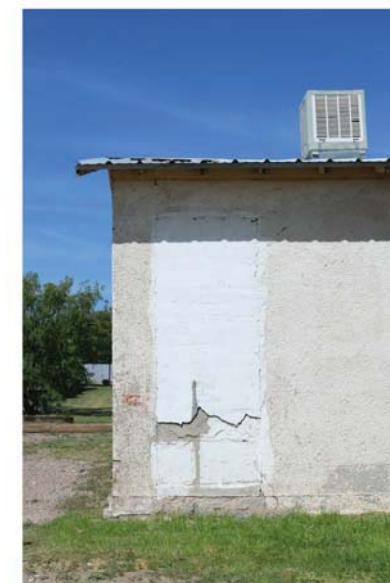
**4** Cracked Stucco reveals location of previously in-filled doorway.

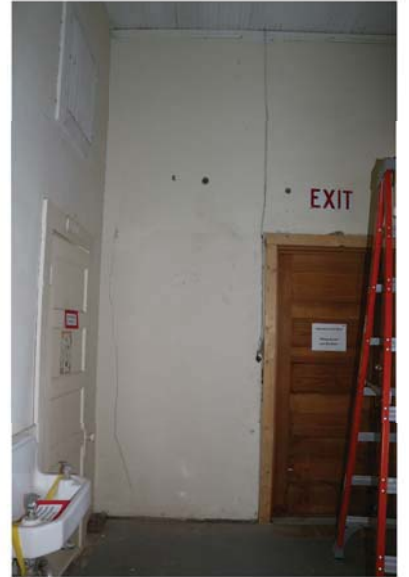
**4** Vertical crack runs full height of wall and corresponds with location of previous reconstruction of adobe wall. Surface boring was conducted at two locations to locate and verify concrete lintel. Stucco on expanded metal lath and plaster was verified.

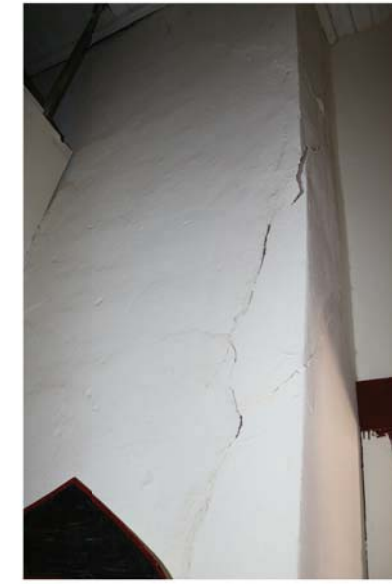
**6-A** This corner was created when the adobe wall was removed for the construction of the stud wall. Plaster was badly cracked and loose. Plaster was not installed on metal lath on this wall.

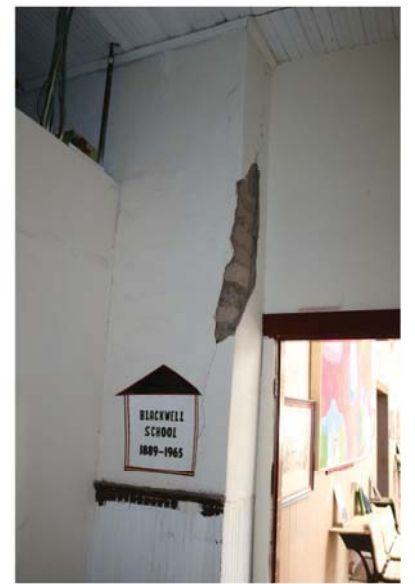
**6-B** Loose plaster was determined to be a safety concern and was taken down.

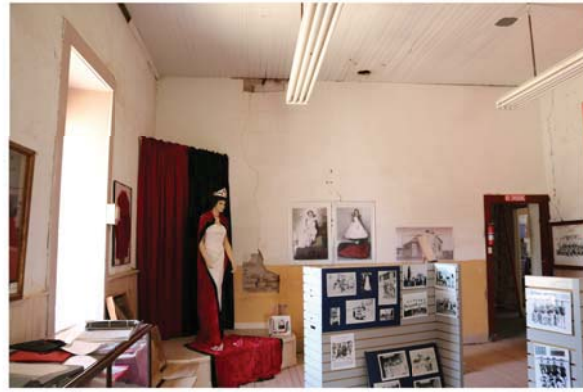
**1** Overall view looking east in museum room shows the vertical crack where two structural systems intersect.

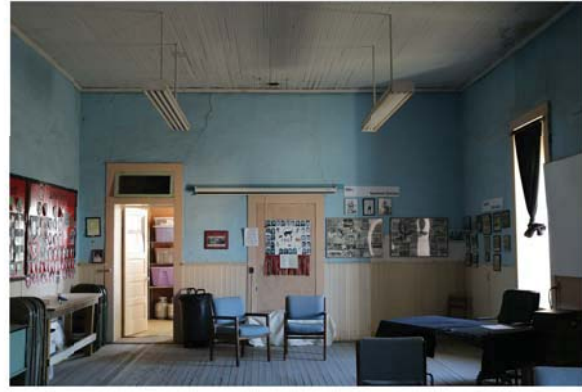
**2** overall view looking east in blue room. Door to the right may not be original.

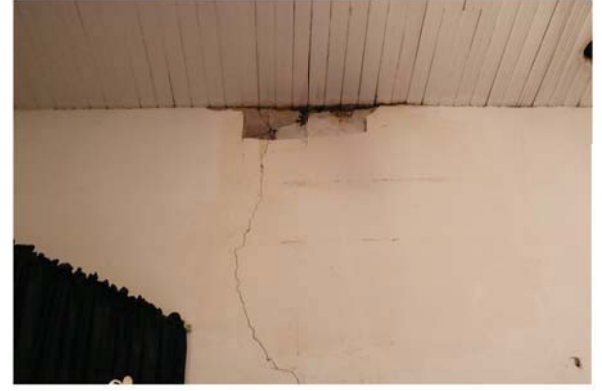
**4** Metal lath and cement plaster have failed to tie the stud wall to the adobe where original wall was removed. Wood trim at ceiling no longer exists along this wall.

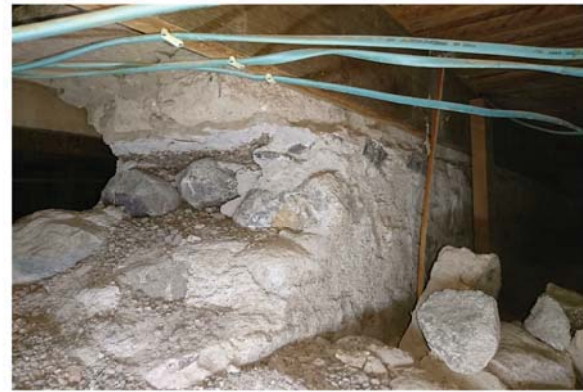
**5** Portion of the foundation wall has been removed for access between the classroom and vestibule area.

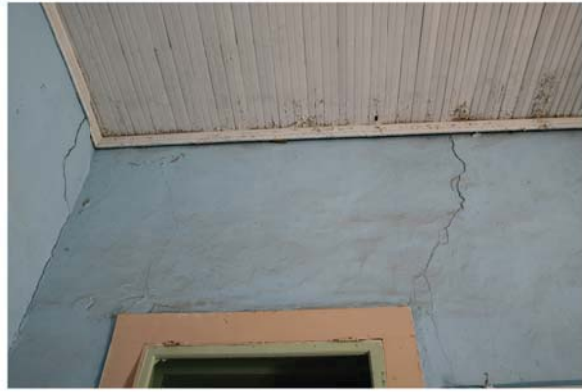
**6** Numerous cracks and patched plaster above the door indicates movement has taken place in this wall. The direction of the crack at the upper right corner of the door indicates the center wall may have moved north after the removal of the original wall at the boys restroom.

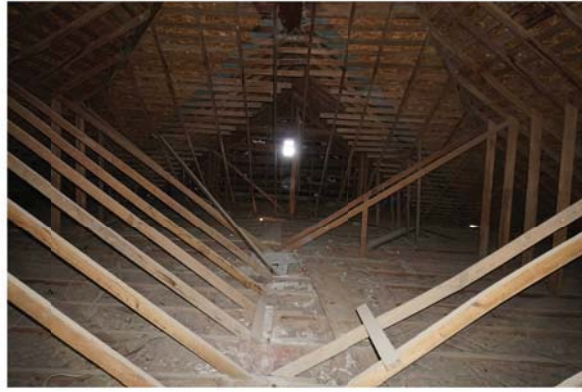
**7** Framing members in attic are missing. This area corresponds with the bow seen in the roof from the exterior.

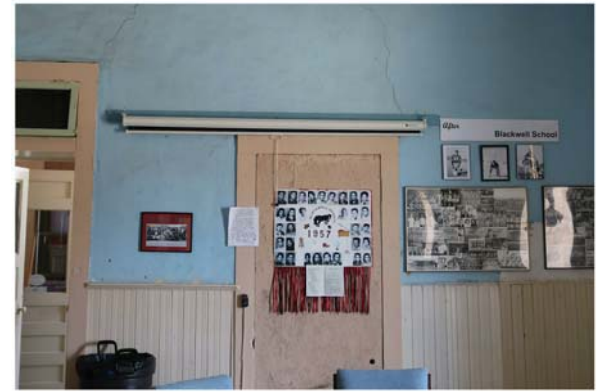
**8** The wainscot cap remains intact to the left side of blocked doorway but has been crudely removed to the right side of the door.

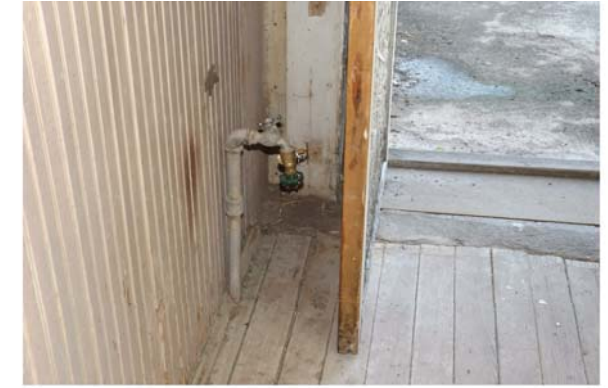
**4** Hose bib inside building is assumed to be part of trade school period. Wood has rotted due to the unusual location of the faucet.

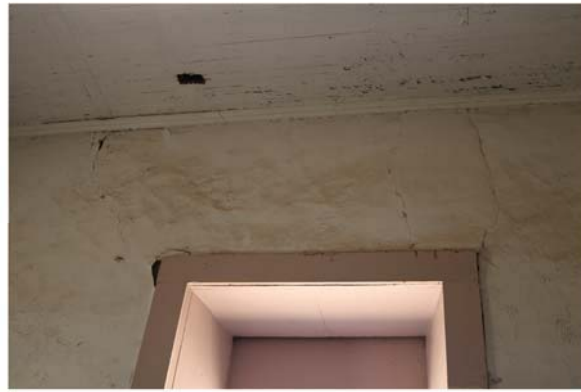
**1** Wall above window shows signs of moisture and numerous plaster repairs. An opening has been cut in the ceiling and there is a ghost of a previously installed cross wall on the ceiling.

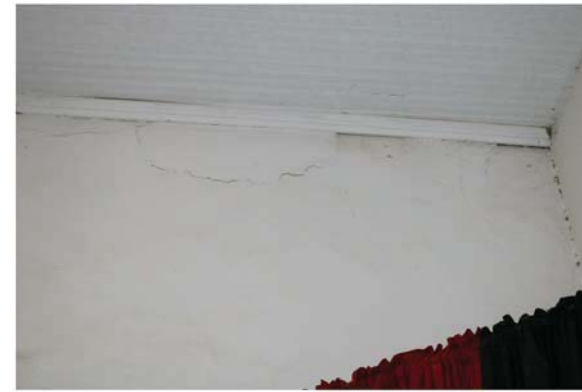
**3** Cracks appear where repairs with different material content are placed adjacent to each other; There is no bond.

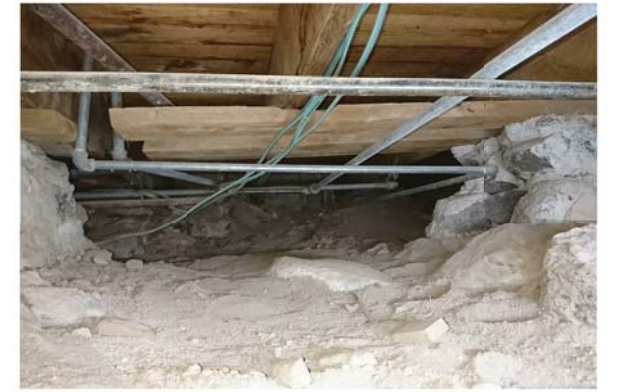
**4** Rubble foundation wall has been knocked away for plumbing access. Wood joists are not fully supported.

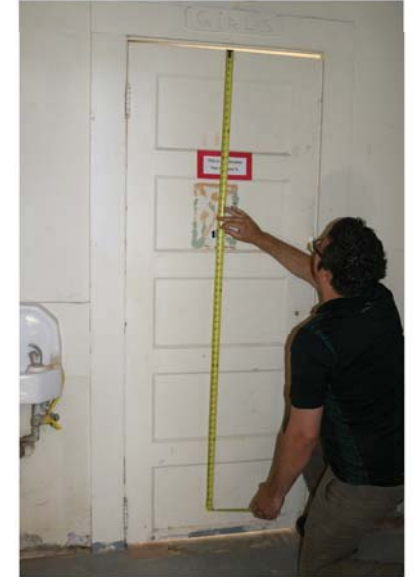
**6** the five-panel wood door has been cut along the bottom rail.

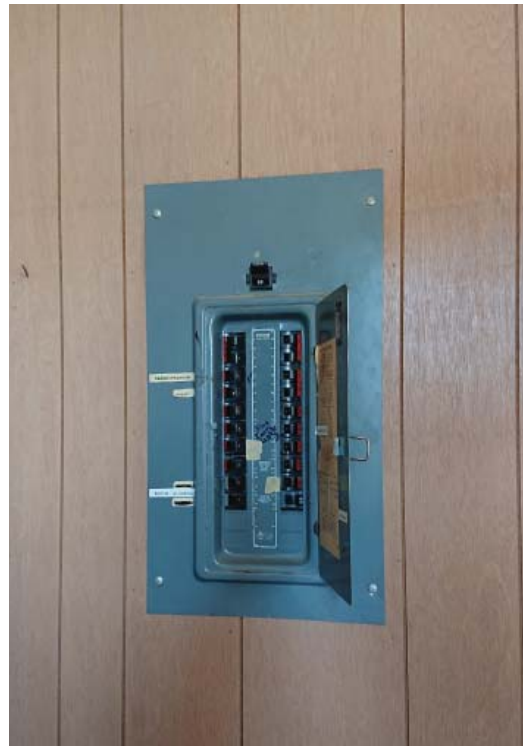
**Relocate electrical panel.**

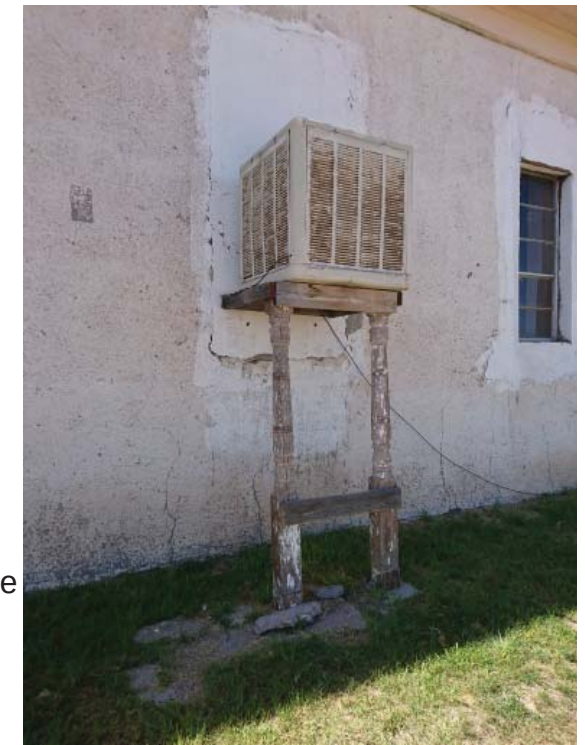
**Remove existing swamp cooler, restore window opening.**

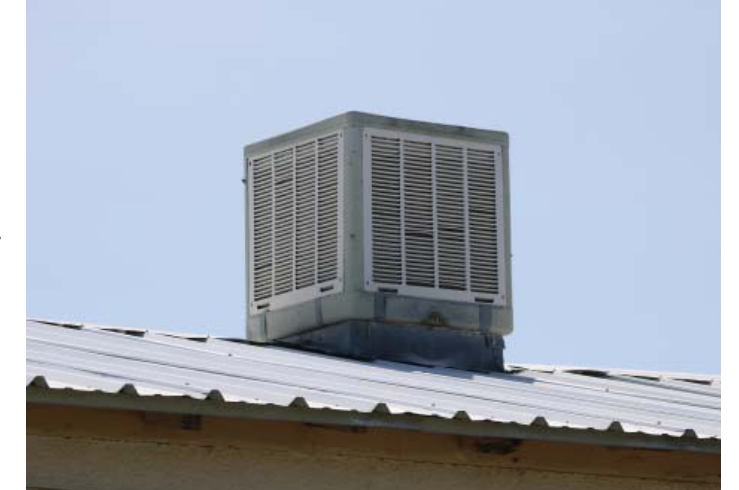
**Remove rooftop swamp cooler.**
