# Ocracoke Light Station Cultural Landscape Report

# Ocracoke Light Station

## Cultural Landscape Report

January 2016

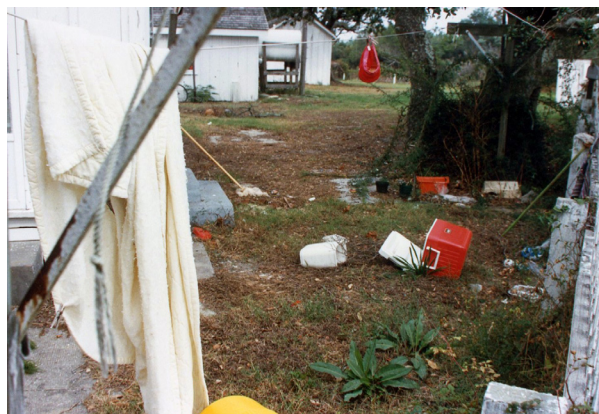
FIGURE 2-26. Condition of the site, 1986. (NPS/CAHA Collection)

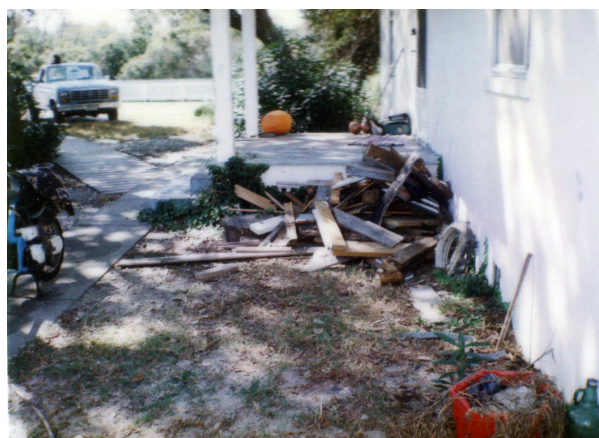
FIGURE 2-27. Condition of the site, ca. 1986. (NPS/CAHA Collection)

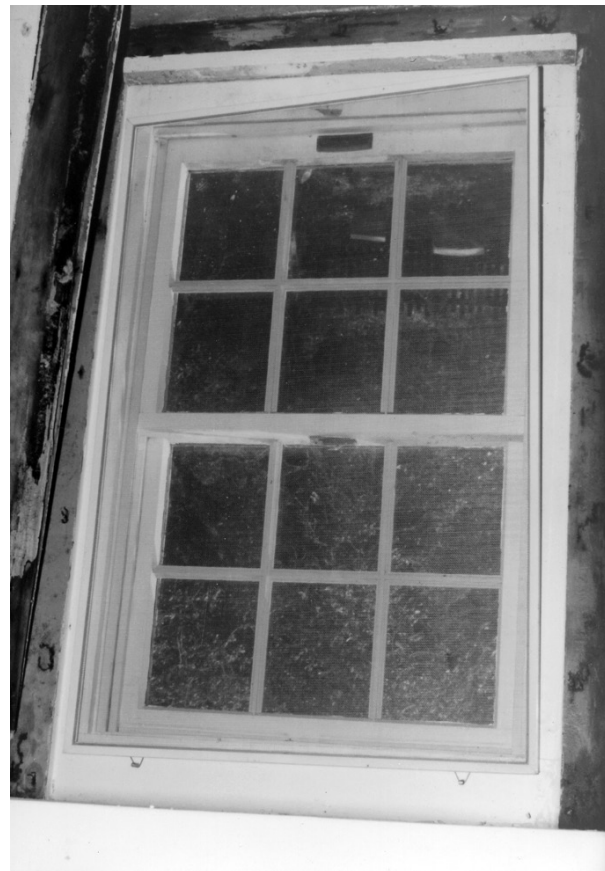
A major breach of preservation philosophy occurred in 1989 when a contractor removed the historic lighthouse windows and replaced them with vinyl-clad thermal sash windows and replaced the historic door with a non-historic metal door. Although the USCG agreed to replace the vinyl-clad windows with repaired/reconstructed windows and to have a new board-and-batten door constructed, questions exist as to the condition of these windows and the quality of wood chosen for the repaired/reconstructed window sash.

FIGURE 2–30. Non-historic replacement window, 1990. (NPS/SER-CRPS Collection)

A crew from the Williamsport Preservation Training Center replaced the non-historic windows with historically accurate wood windows using as much of the surviving fabric as possible. They also removed the non-historic metal door installed by the contractor and constructed a new board-and-batten door as specified by drawings supplied by the North Carolina Department of Cultural Resources. Following this incident, the USCG repeated its suggestion that the NPS consider taking ownership of the Ocracoke Lighthouse while the USCG would maintain the optic.<sup>50</sup>

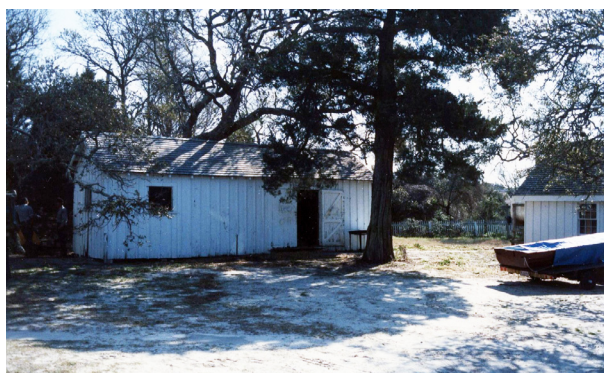
FIGURE 2-66. Sandy conditions of the site with carpenter shop in the background, 1987. (NPS/CAHA Collection)

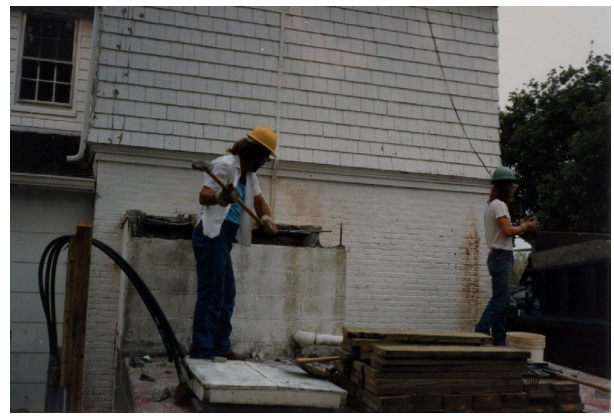
FIGURE 2-93. Cistern repair, 1987. (NPS/CAHA Collection)

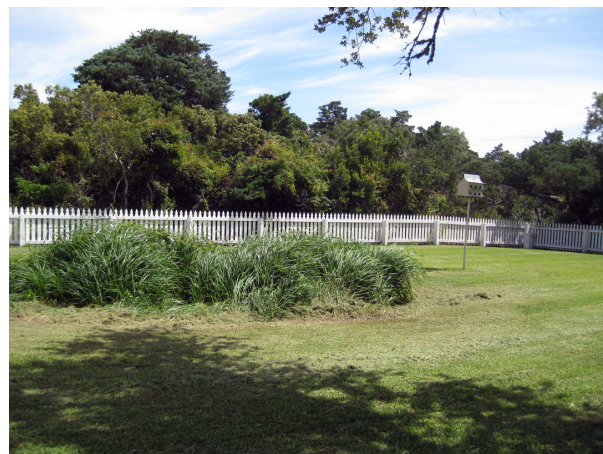
FIGURE 3-13. Unmown grass on drain field, 2013. (NPS/SER-CRPS Collection)
