**The Bowman-Hite Property  
Warren County, Virginia**

**Bowman-Hite Farmhouse  
Historic Structures Report**

**Final Submission**

*October 2013*

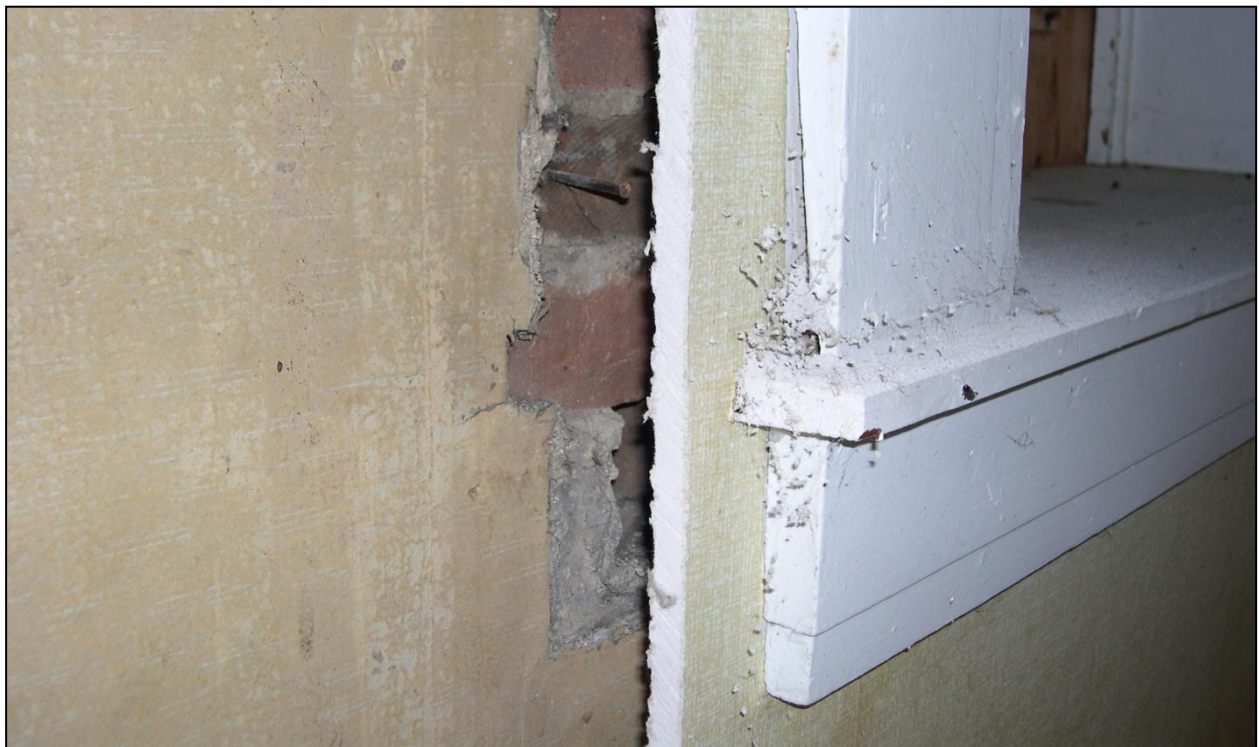
Figure 46: When the interior walls at the Bowman-Hite house were furred out for installation of the HVAC ductwork, the window and door casings were simply reapplied to the new surface, as noted by the ghost marks left behind in the original plaster work. (Photograph by Michael Spencer, 2011)

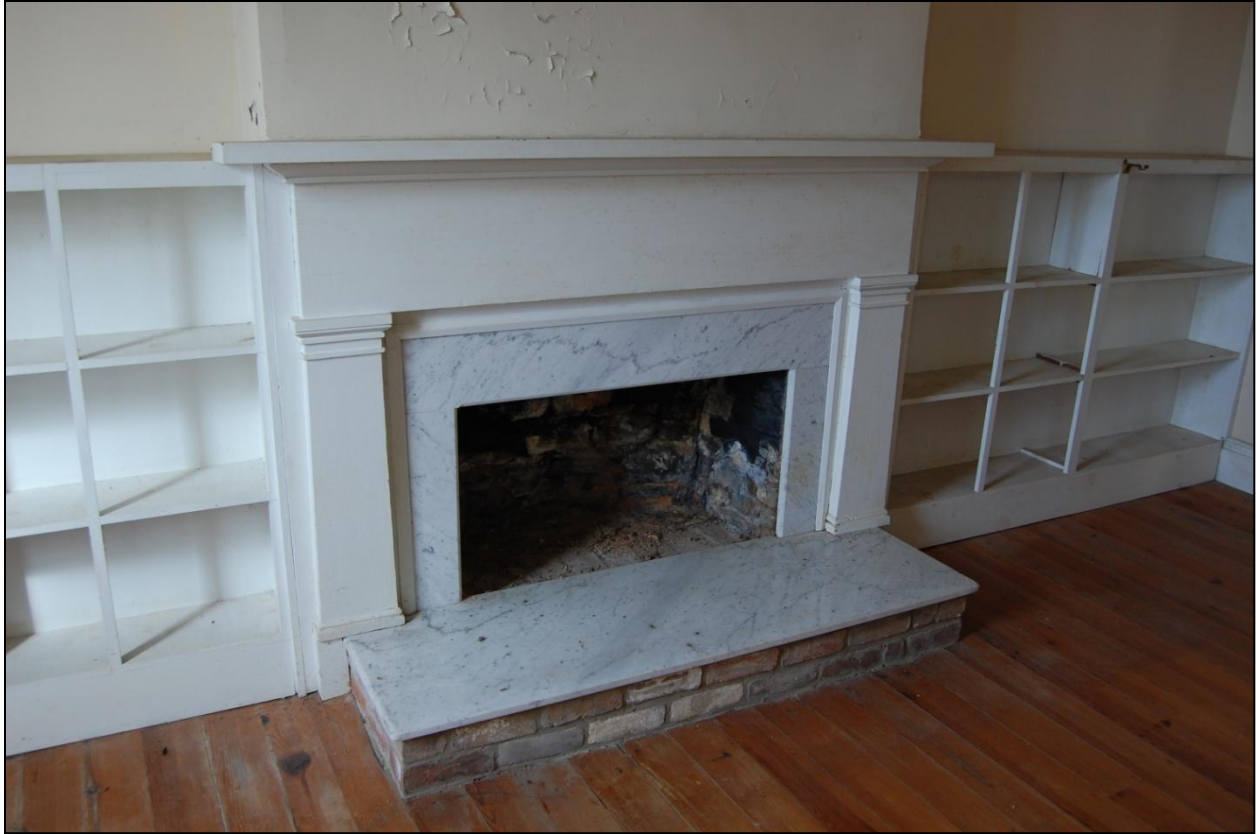
Figure 95: The mantle (above) shows the added raised hearth and marble veneers. Through sensitive restoration the raised hearth may be removed to reveal the original floor level brick hearth.

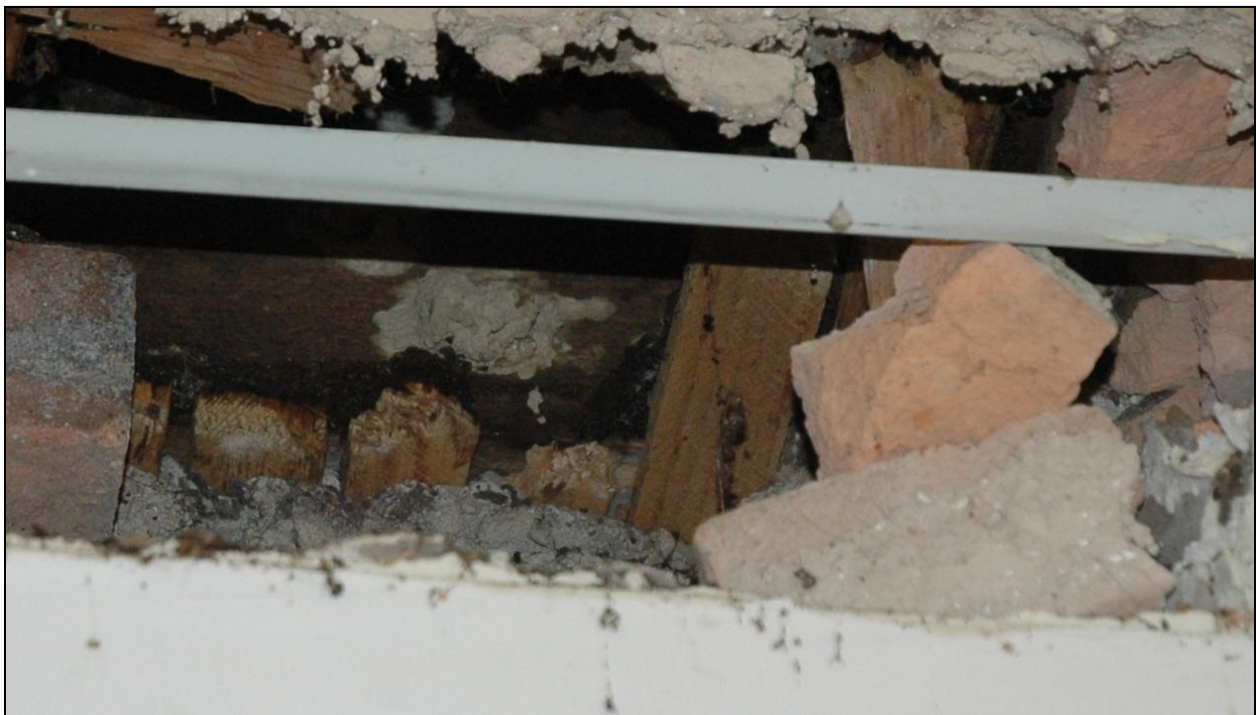
Figure 100: This portion of the second floor ceiling, between the stairwell and west bedroom, shows the lath to be circular-sawn, indicating extensive ceiling repairs in the bedroom. Such repairs may have coincided with the replacement of nailers in the attic.

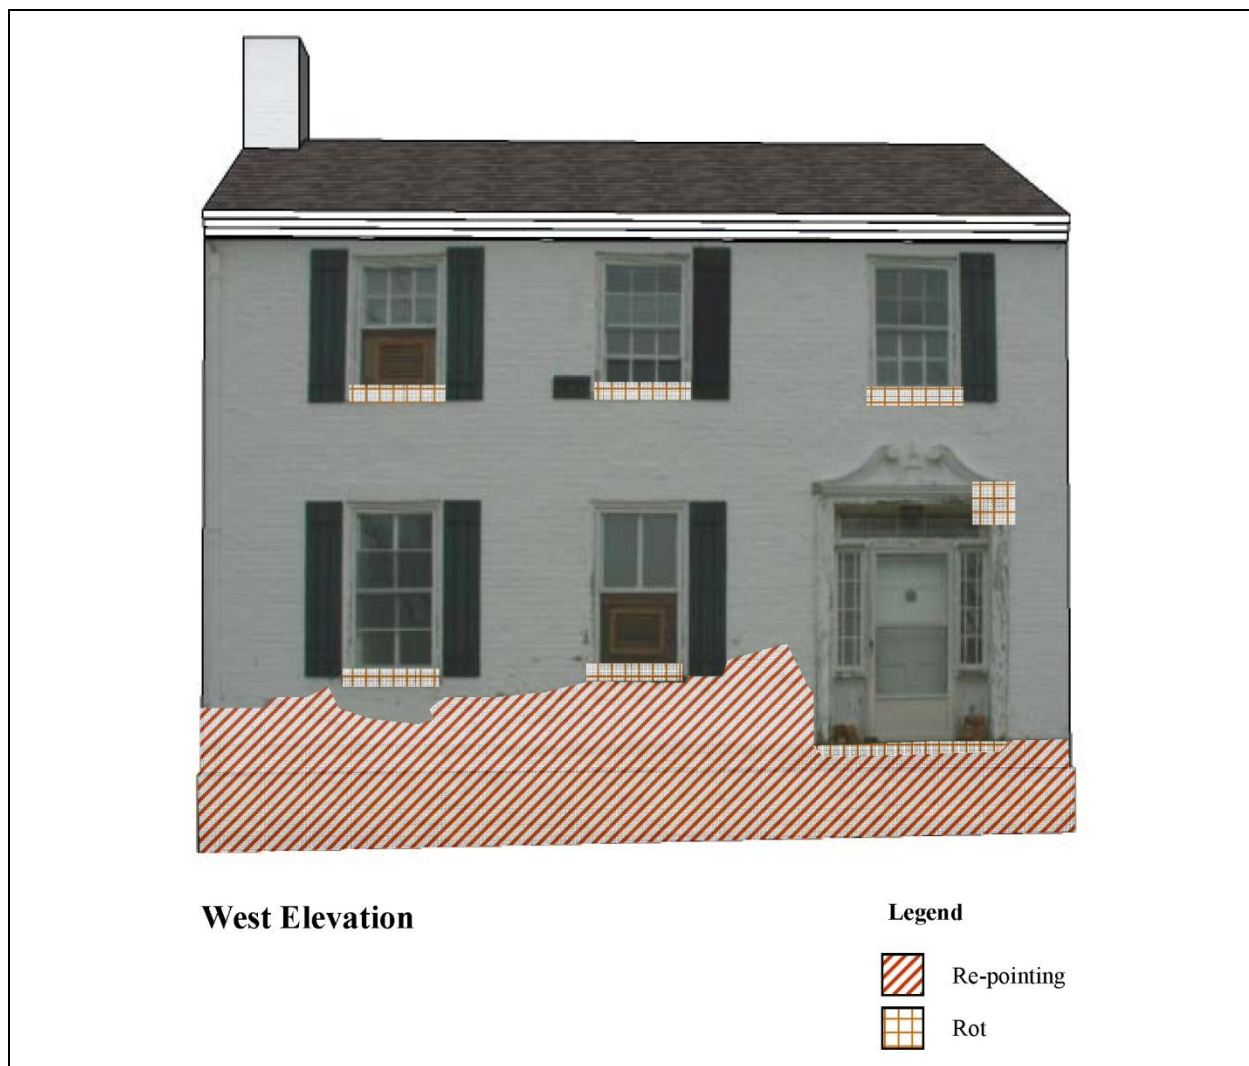
Figure 103: The image above shows the west elevation of the Bowman-Hite farmhouse. Noted by the red hatching are the areas where insensitive, Portland cement, repairs have been made as well as areas in need of re-pointing. The orange square hatching denotes areas where severe rot has occurred.

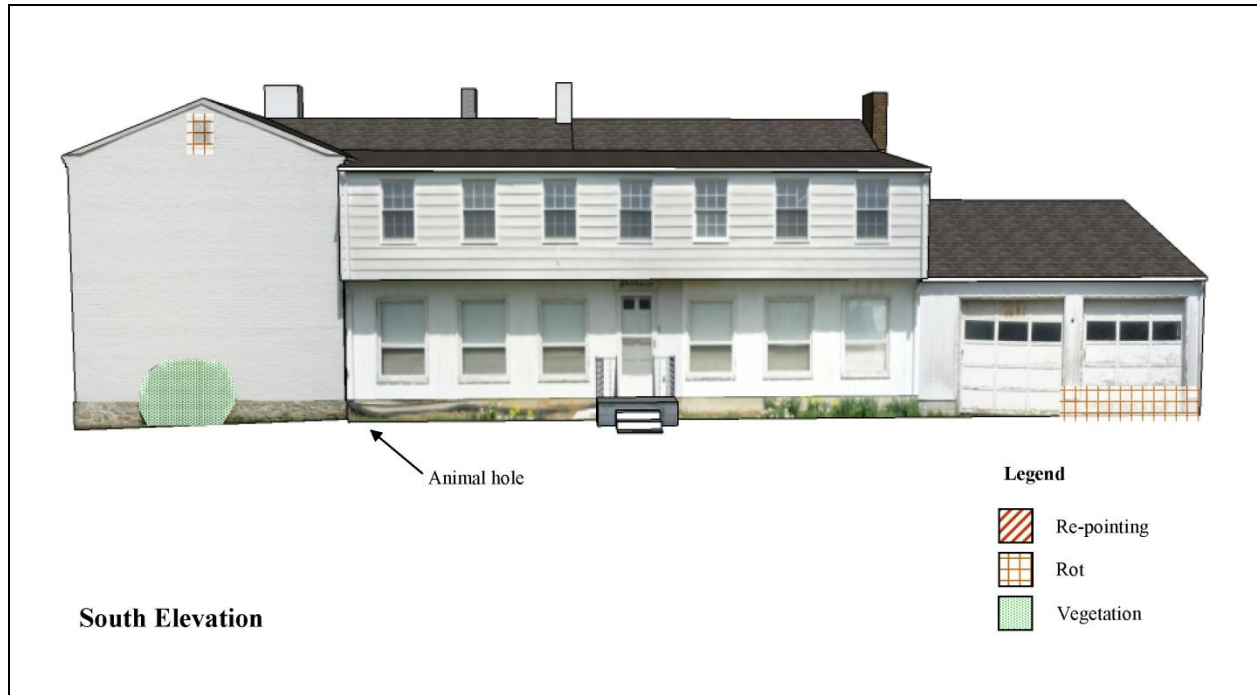
Figure 105: The south elevation pictured above has a variety of issues indicated by the colored hatching including the need for re-pointing, vegetation removal and rot concerns.

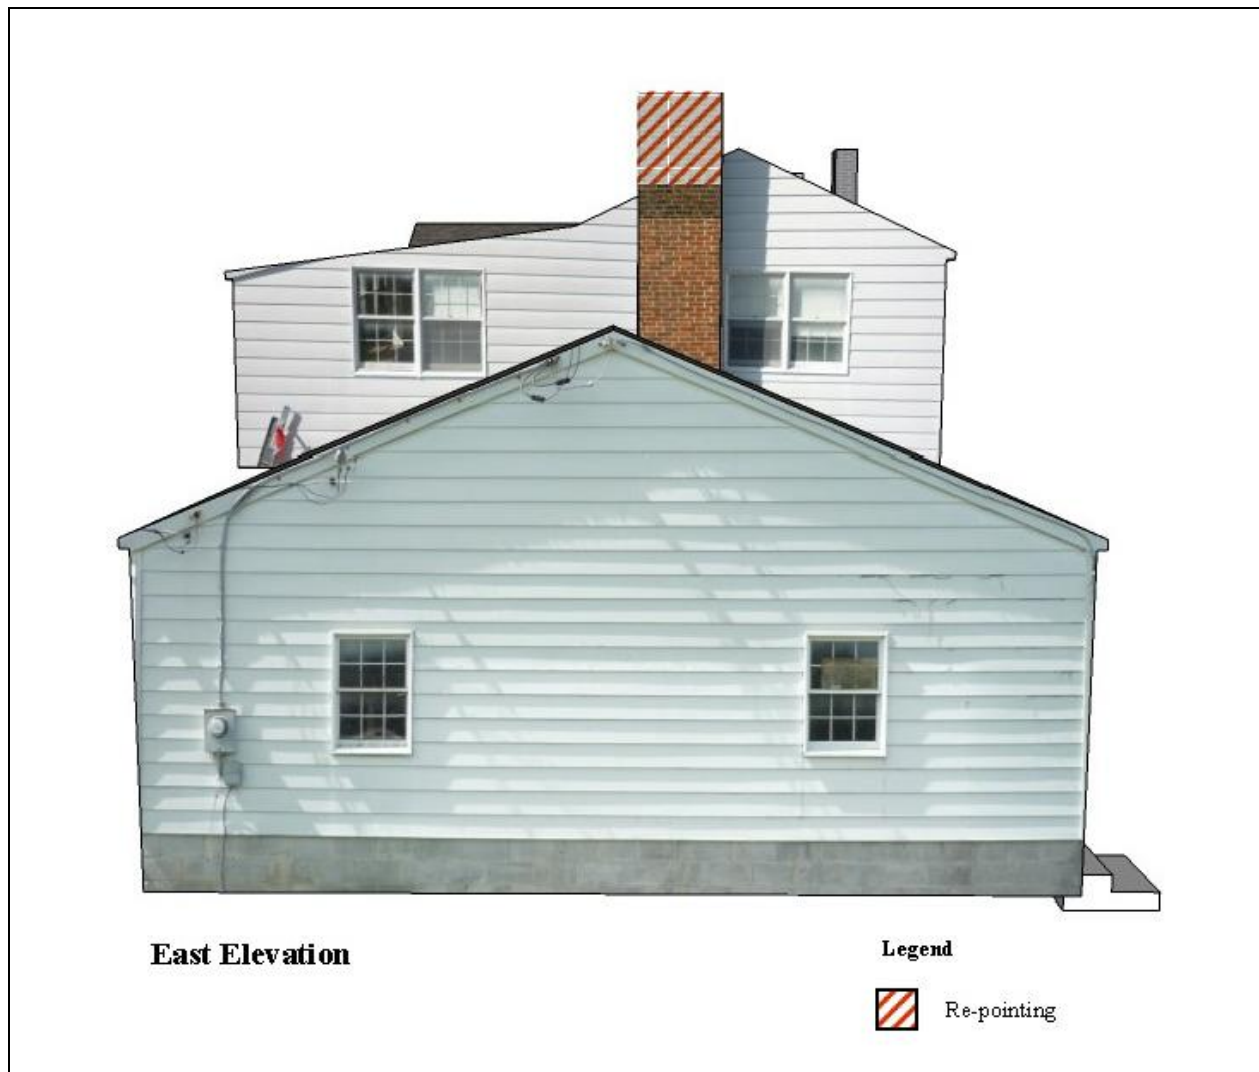
Figure 107: The top image shows the east elevation with the ca. 1876-1880s chimney. Noted at the top of the chimney is the need for re-pointing work. The left image clearly shows the change in brick type between the 1876-1880s portion of the chimney and the newer, ca. 1971 portion.

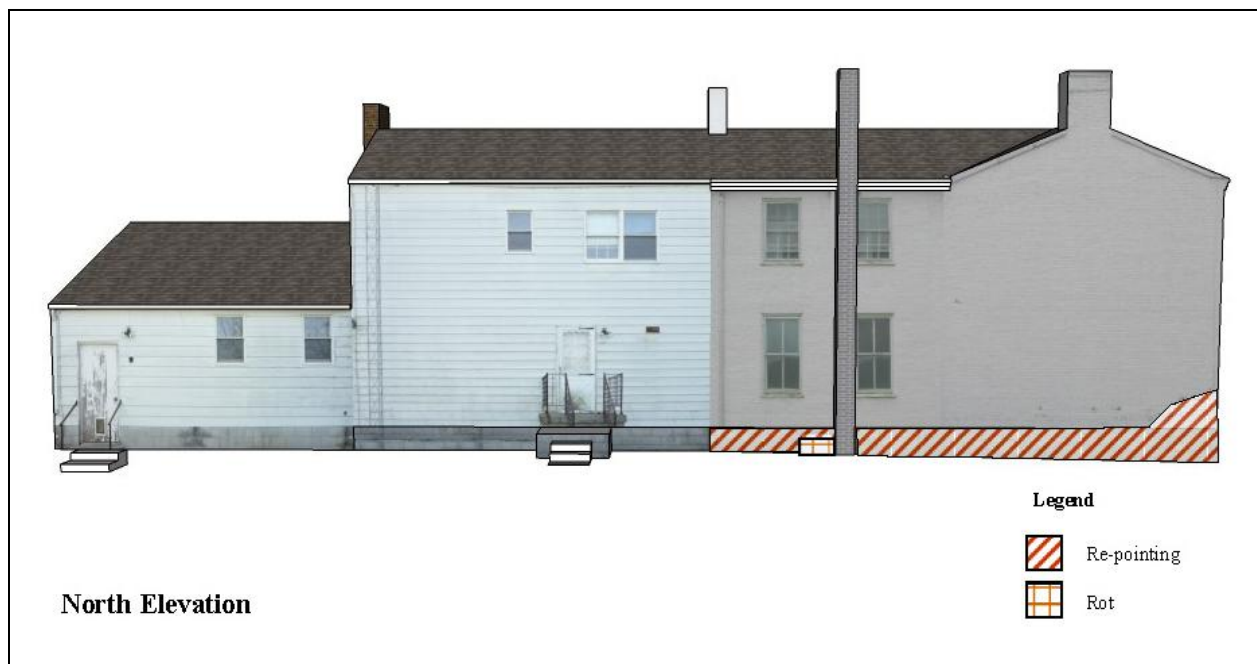
Figure 108: The image above shows the north elevation with the area noted by the red hatching exhibiting mortar loss. The Crack #4 has formed where the rot is denoted near the cellar window (below). Today, 2012, the cinderblock vent stack shown in the above images has been taken down.

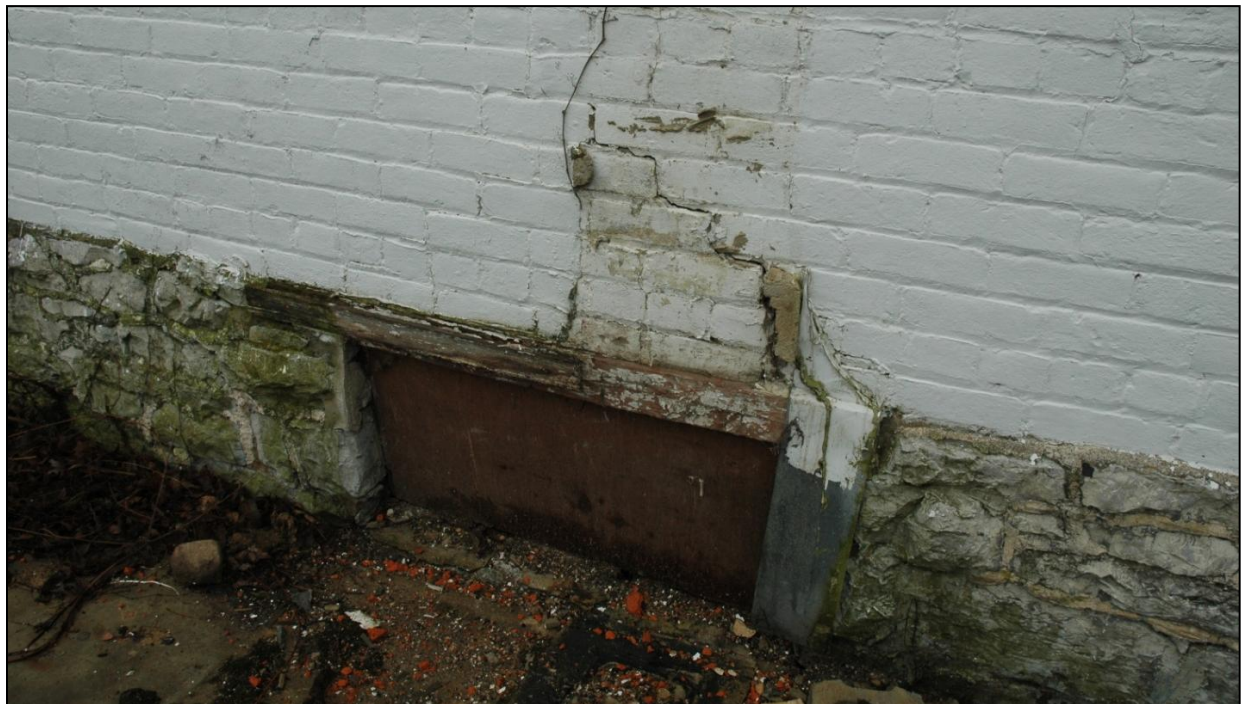
Figure 109: The image above shows the step crack, crack #4, above the wood lintel of the basement/cellar window. These cracks are typical of failing lintels.

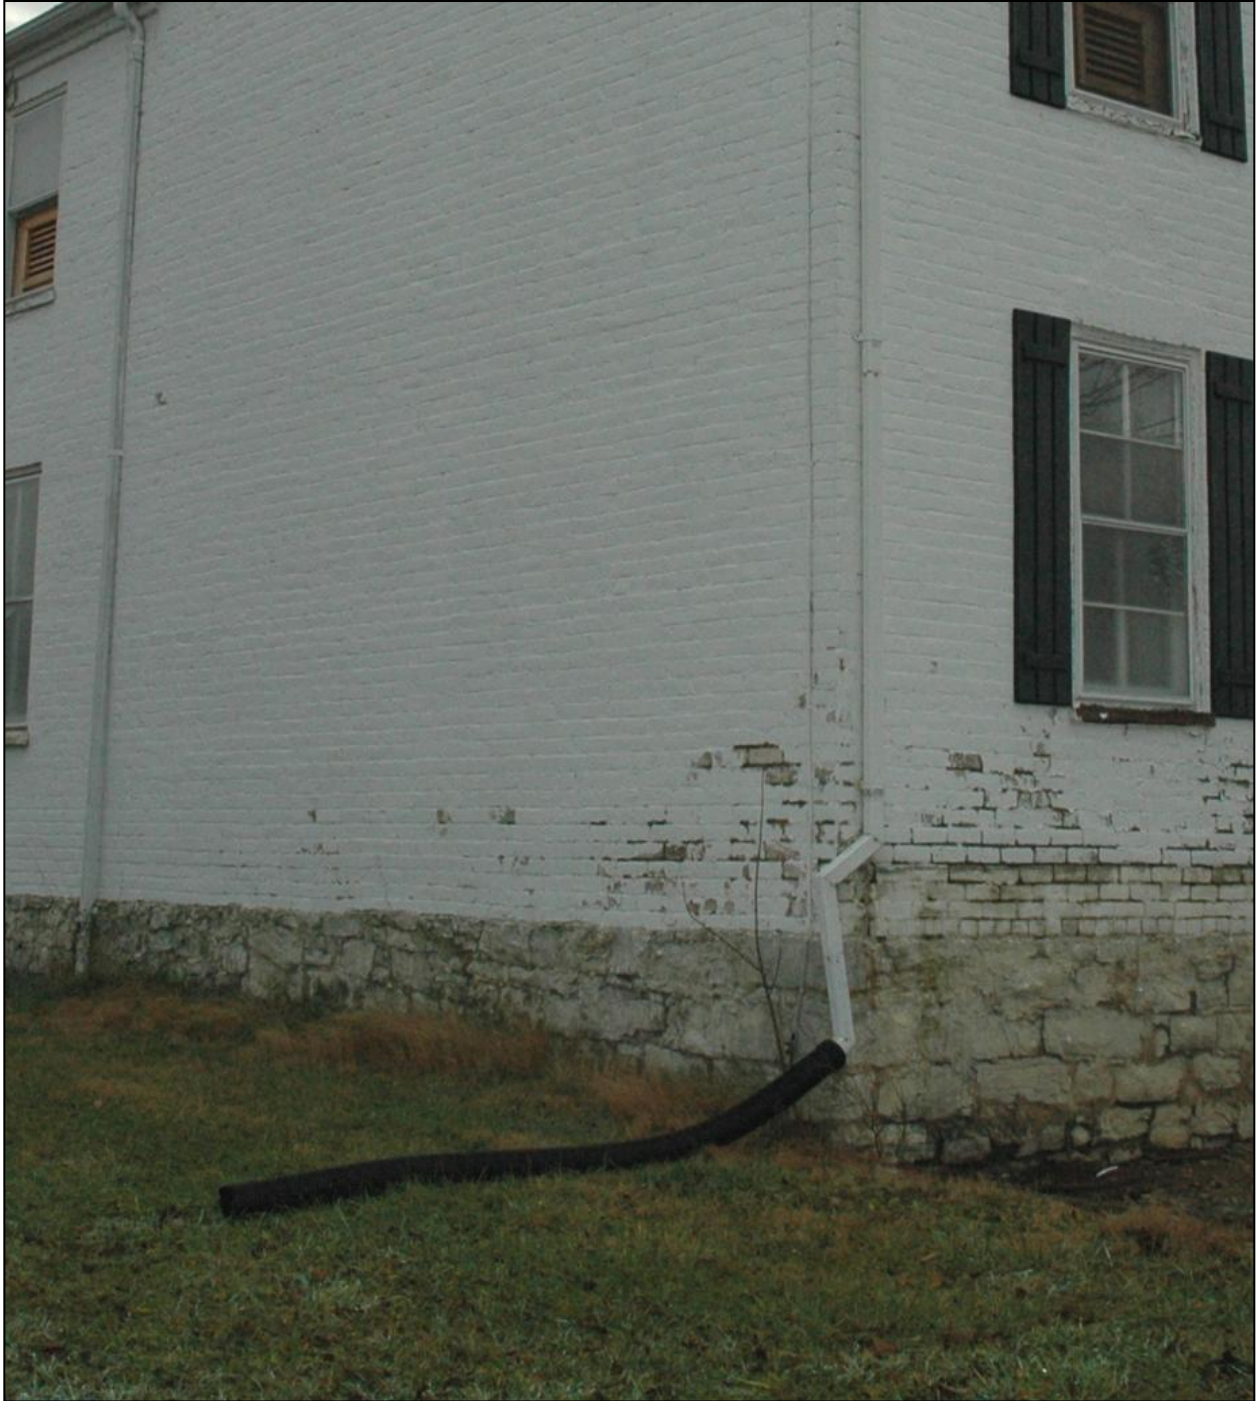
Figure 110: The image shows the northwest corner of the Bowman-Hite house. Note the mortar and paint deterioration close to the downspout, as well as where the cinderblock porch that was along the west elevation but has since been removed. (Spencer, 2012)

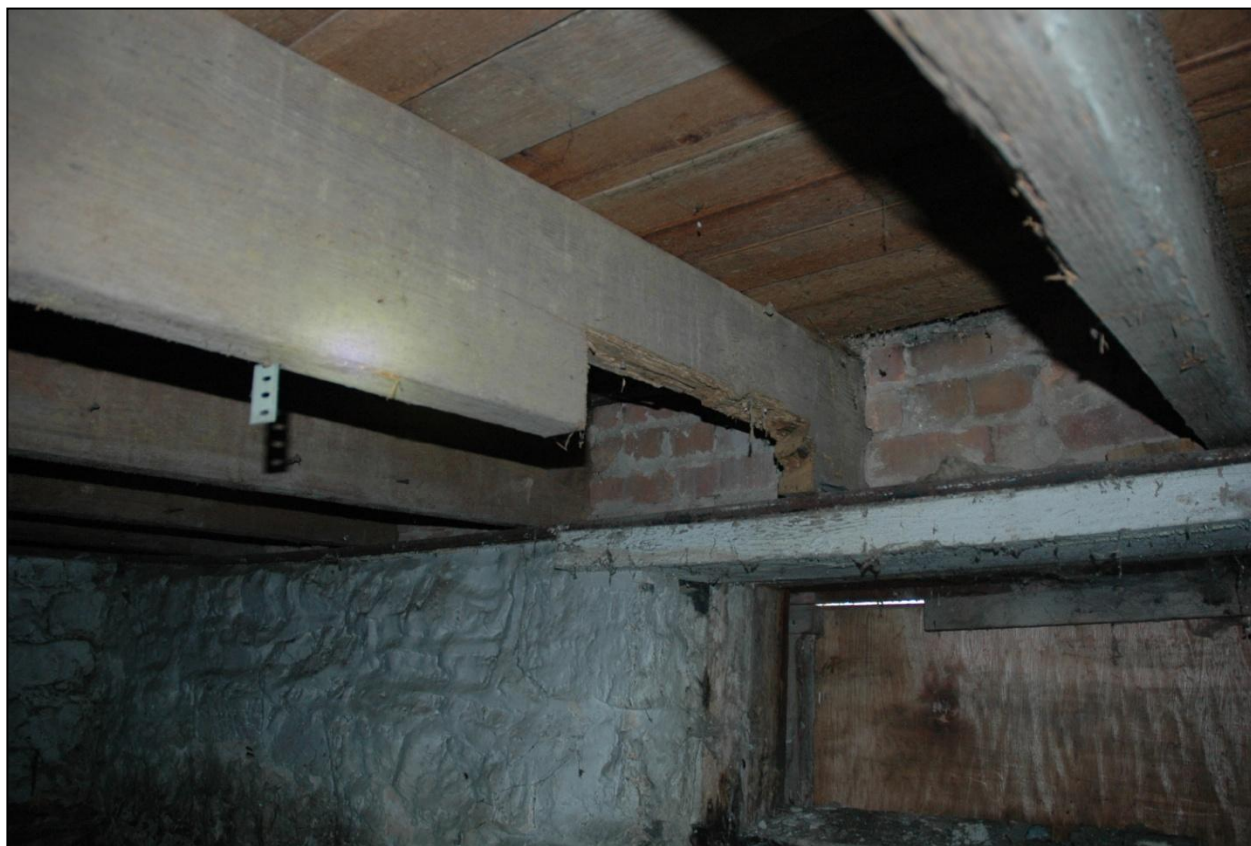
Figure 112: Floor joists in the cellar are for the most part in good condition however, HVAC interventions in some cases cut into the joists diminishing their load bearing capacity as seen above. The wood lintel above the north wall window can also be seen to the right and appears to be bowing slightly.

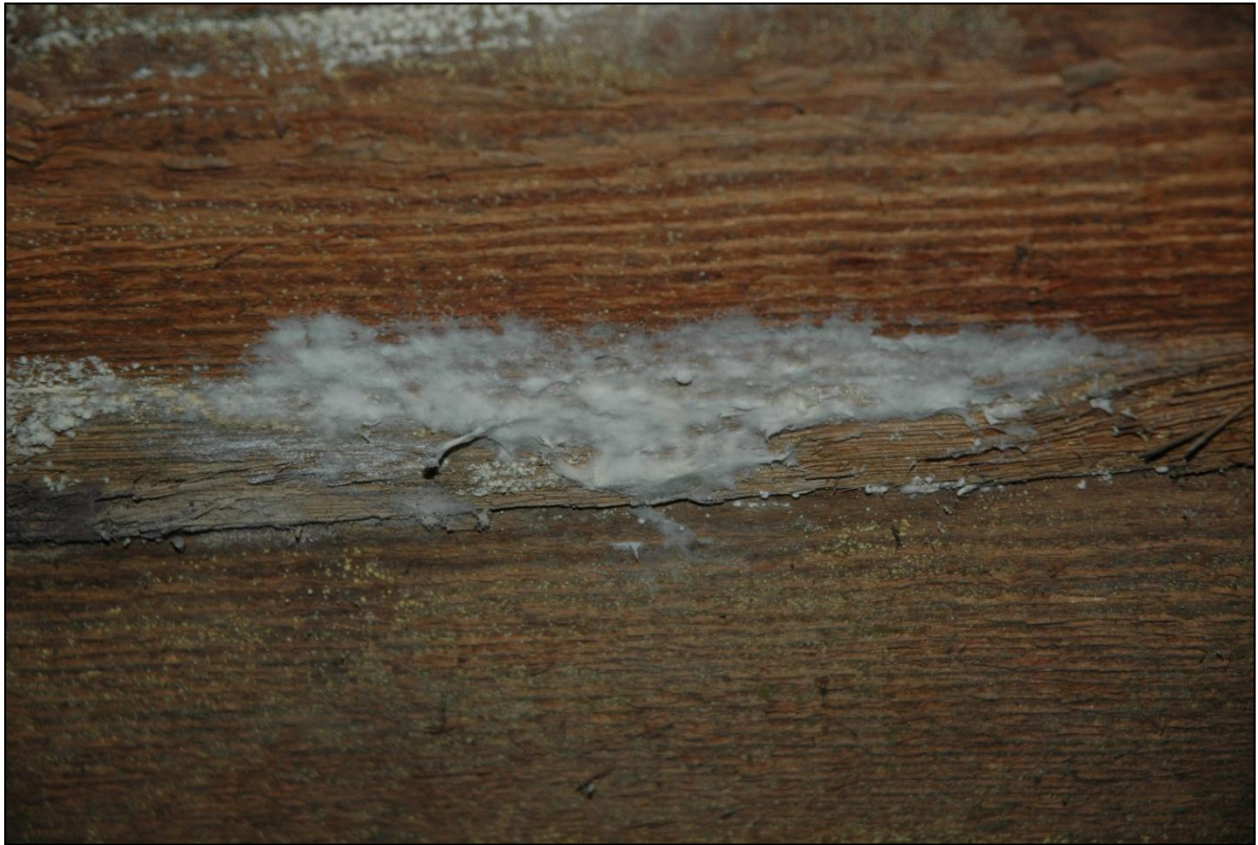
Figure 113: This image of the underside of a floorboard shows the presence of white rot in the cellar. This mold thrives in moist conditions.

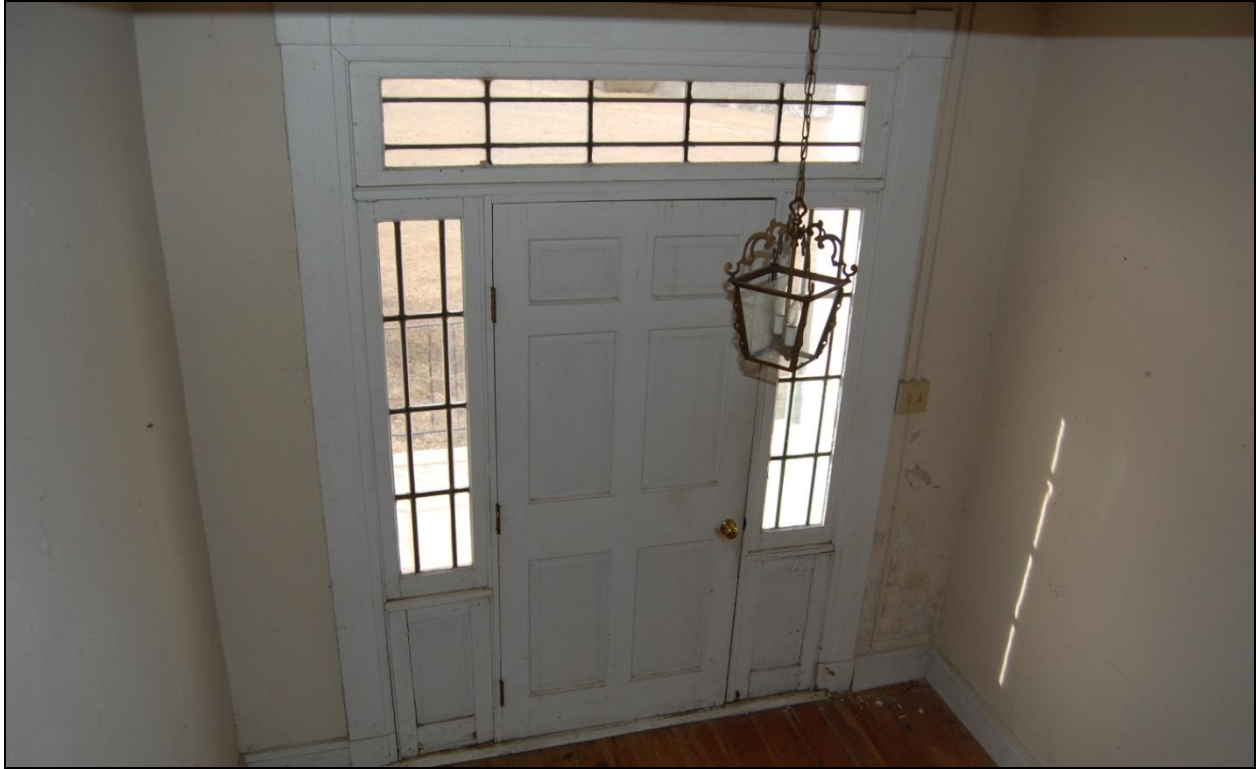
Figure 115: Plaster deterioration can be seen in the bottom right of the image corresponding to exterior mortar failure. Discoloration of the plaster is another sign of the moisture infiltration.

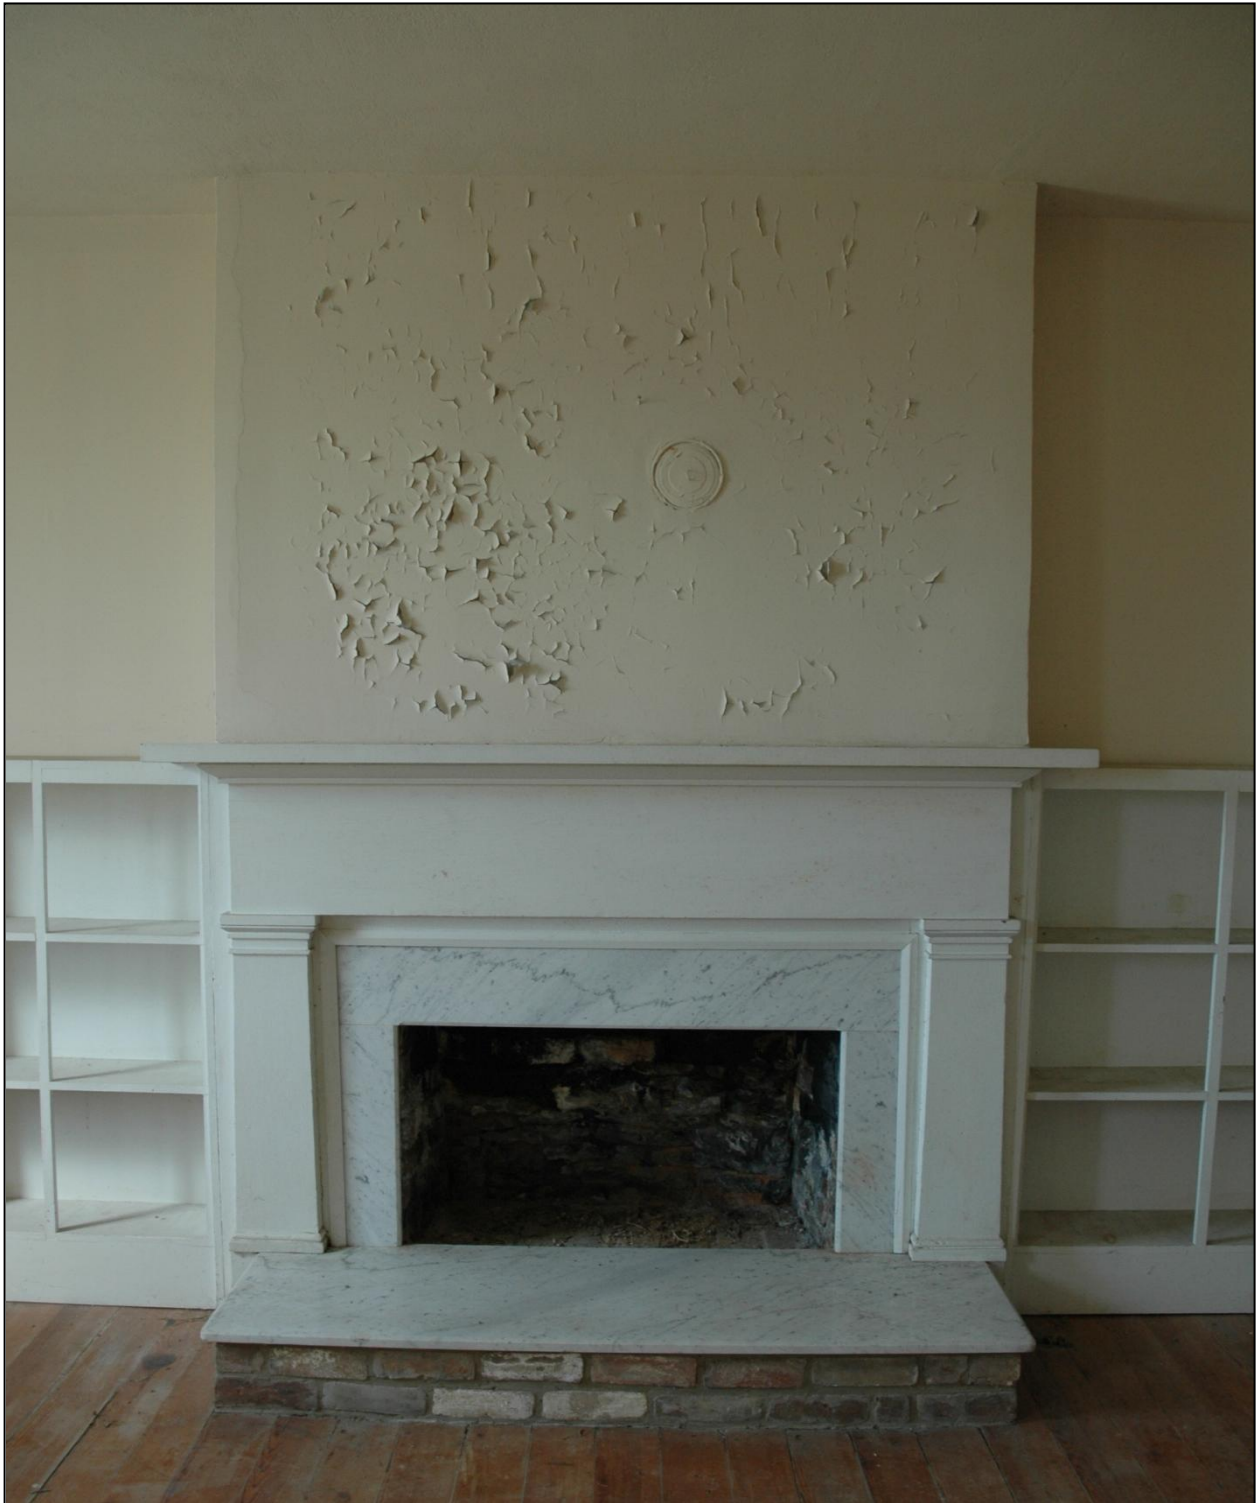
Figure 117: Peeling paint can be clearly seen above the first floor parlor's mantle. While general temperature fluctuations are a culprit, the chimney flue likely maintains a temperature variation when compared with the interior rooms. This variation is likely exacerbating the situation.

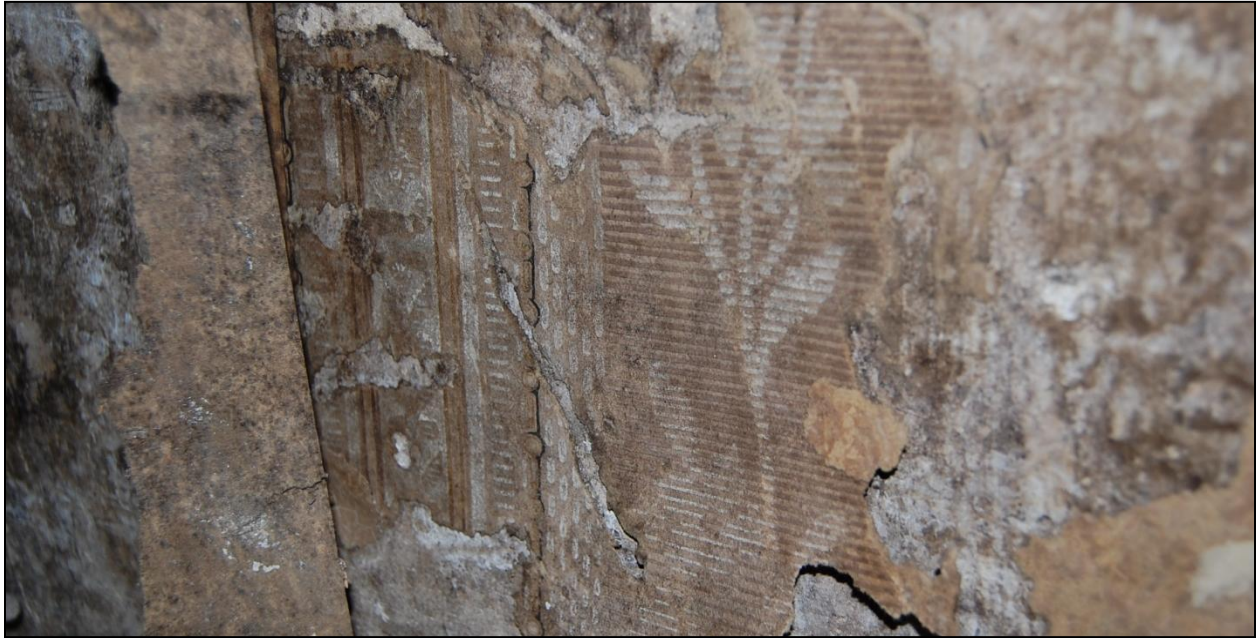
Figure 118: Wall paper was found in the dining room when the furred drywall was removed. The paper appears to be similar to patterns found during the 1850s. The paper also exhibits some signs of mold indicating possible moisture retention within the furred wall cavities.

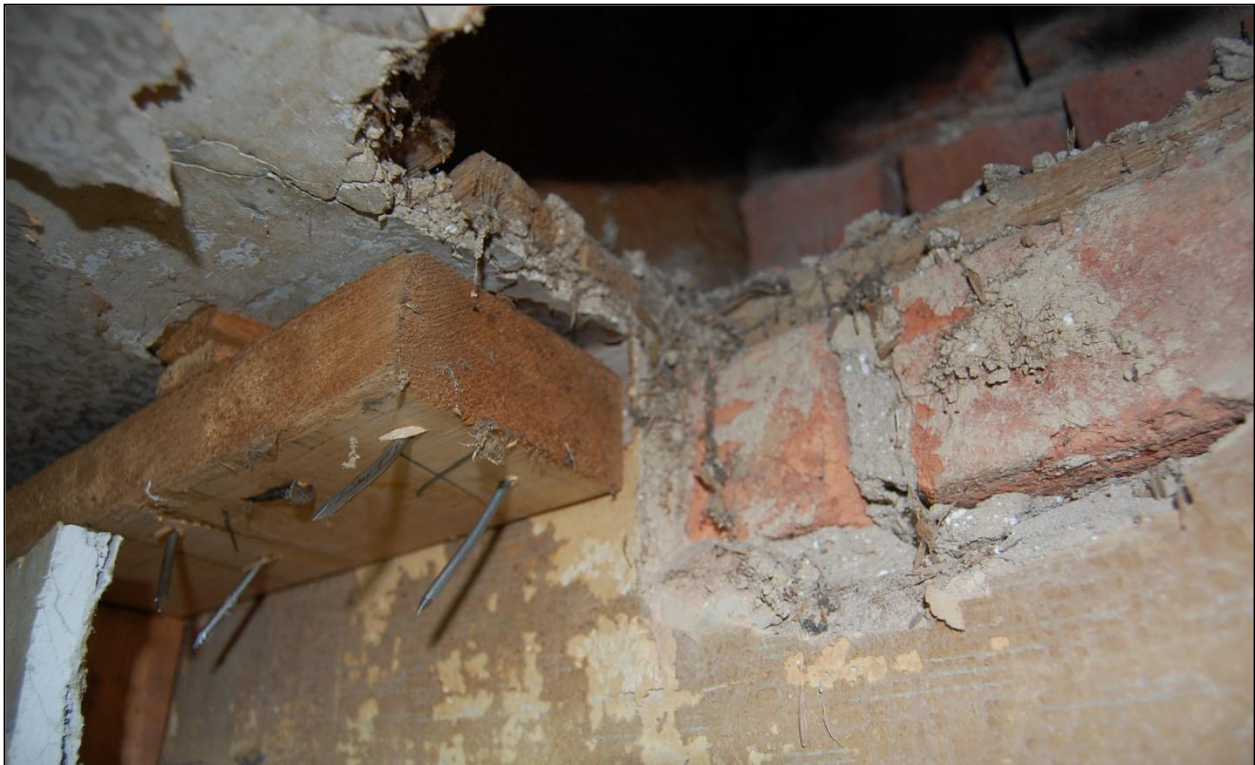
Figure 119: Removed for ductwork, the hole in the plaster ceiling now allows for the examination of interior brick as well as where the wood floor joists intersect with the brick wall.

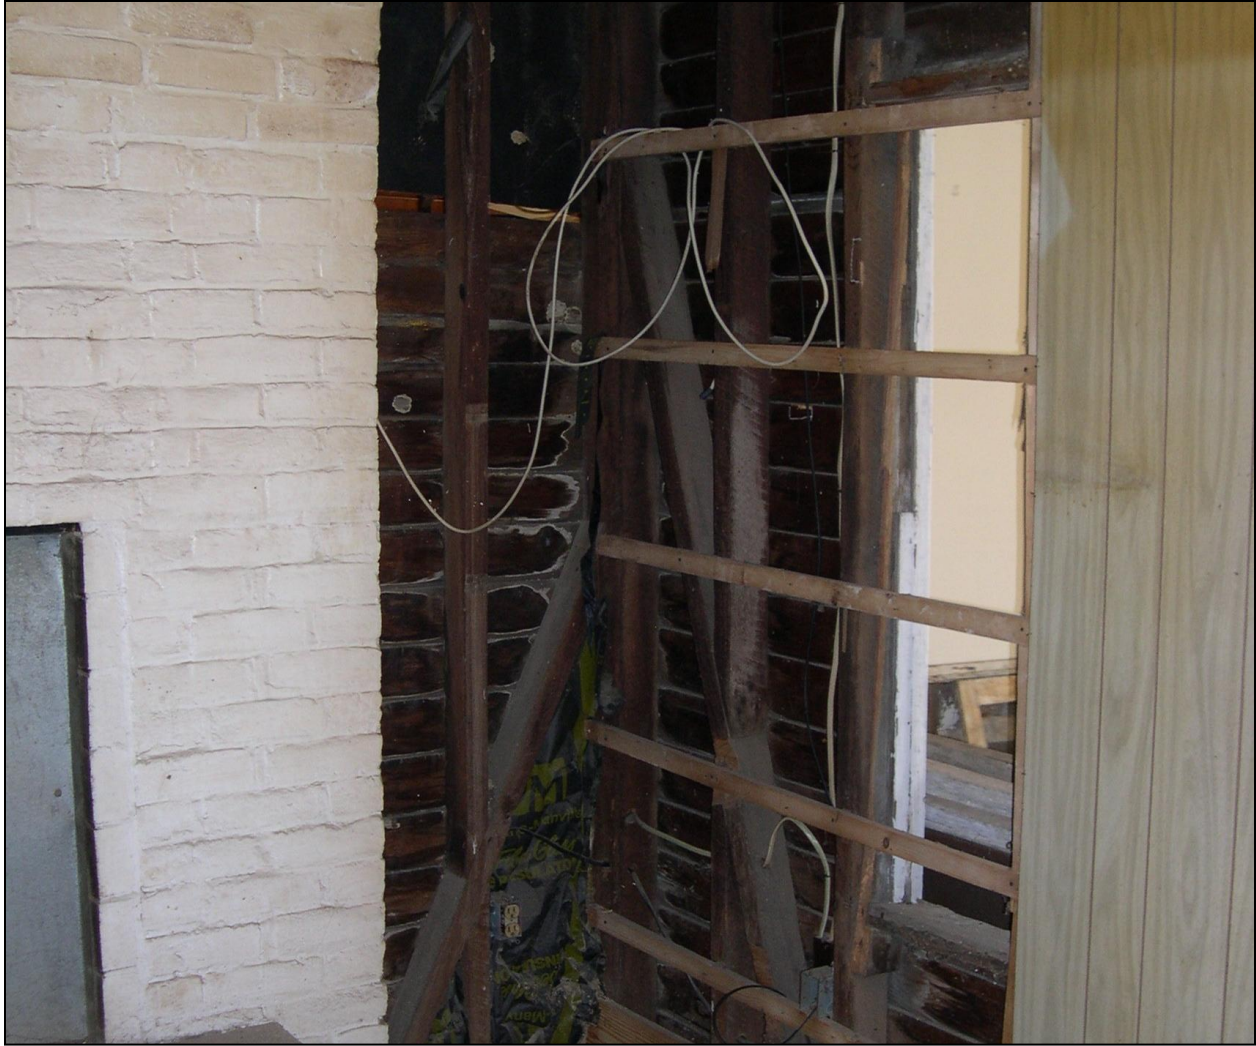
Figure 122: Exposed balloon framing can be seen in the southeast corner of the 1870s wood frame addition. No insulation appears to have ever been installed. Note the larger corner post and the staggered downbracing.

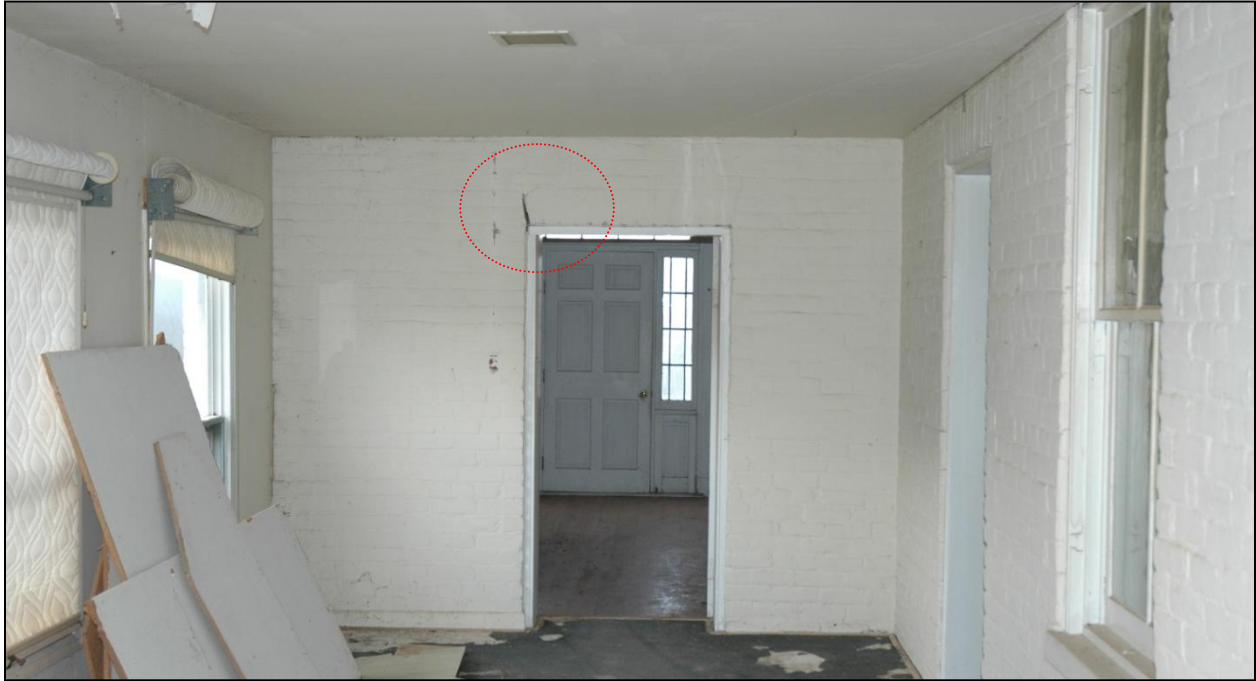
Figure 124: Circled in red is crack #3 at the base of the splayed jack arch. Through the doorway is the front entry hall to the 1850s brick structure. On the right is the brick ells south elevation with doorway and window visible.

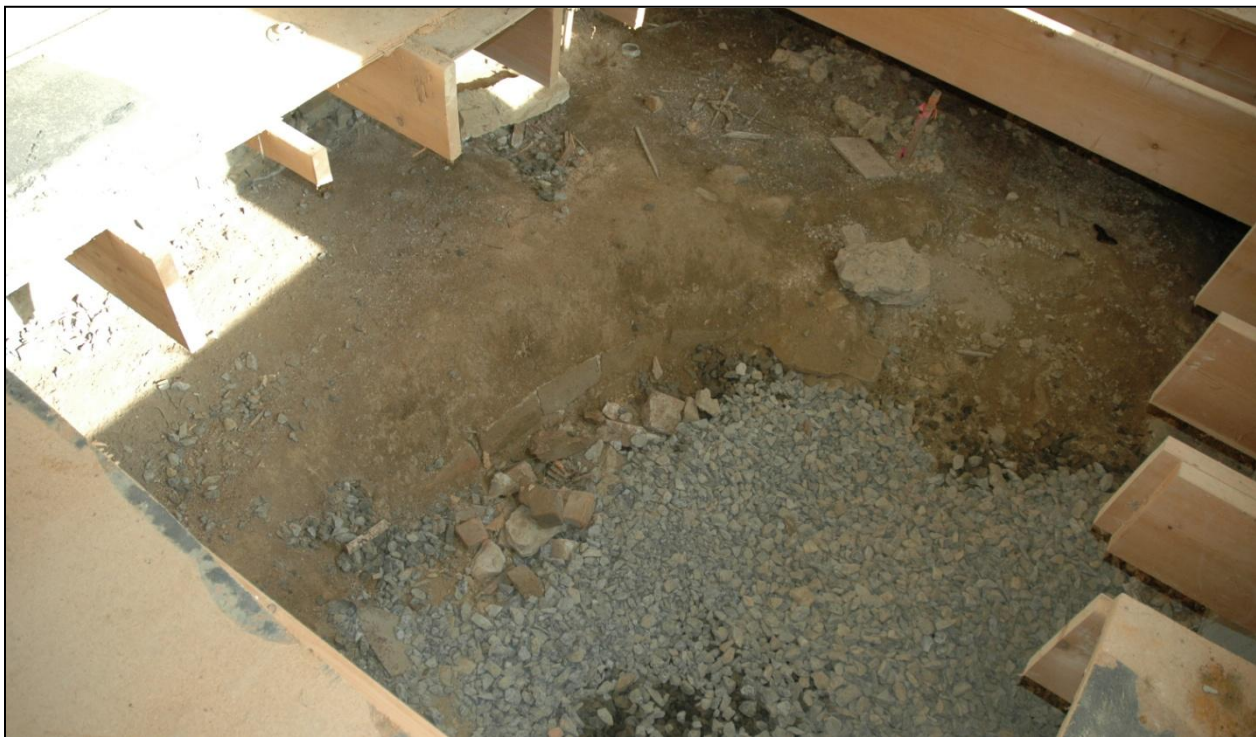
Figure 125: The location of the gravel denotes where the brick lined cistern was backfilled after an archeological excavation. The cut floor joists are a result of the excavation on the east end of the room.

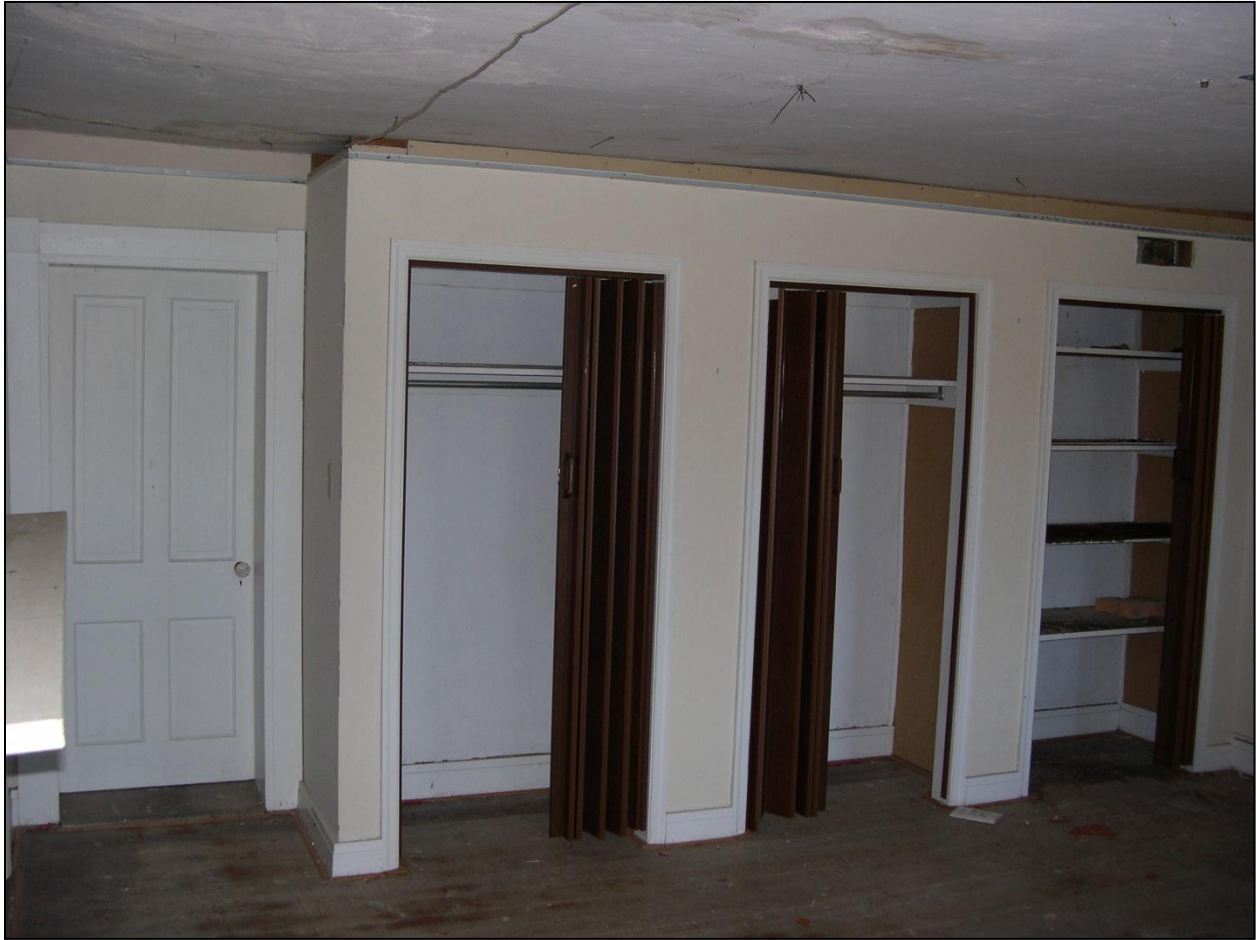
Figure 129: Installed during the Whitham period of occupation, the modern closets conceal some of the damage done by ductwork installation.
