**The Bowman-Hite Property  
Warren County, Virginia**

**Bowman-Hite Farmhouse  
Historic Structures Report**

**Final Submission**

*October 2013*

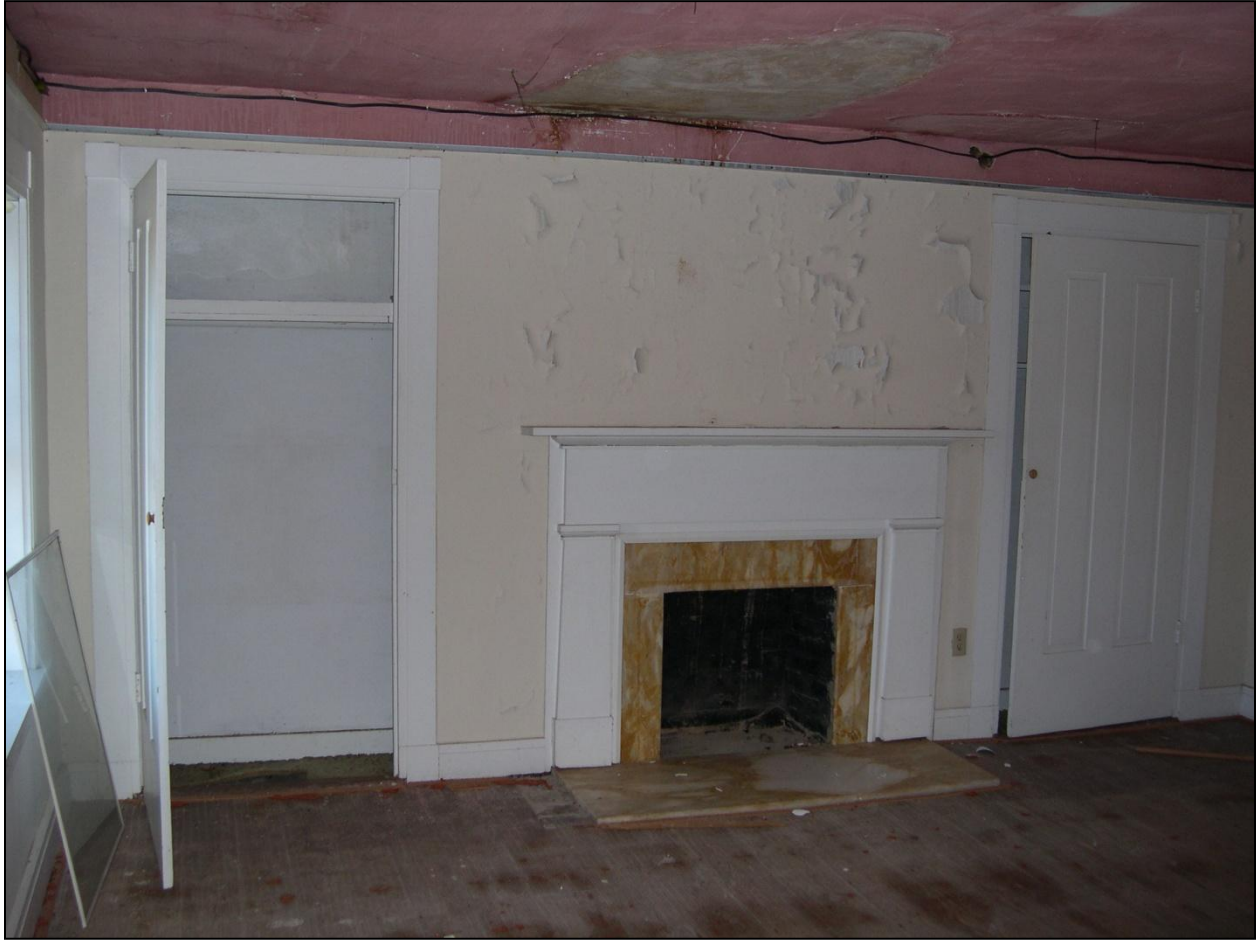
Figure 131: A view of the east wall of the room showing the peeling paint above the fireplace. Water damage and more modern ceiling repairs can be seen at the top of the image.
