**The Bowman-Hite Property
Warren County, Virginia**

**Bowman-Hite Farmhouse
Historic Structures Report
Part II**

Final Submission

June 2015

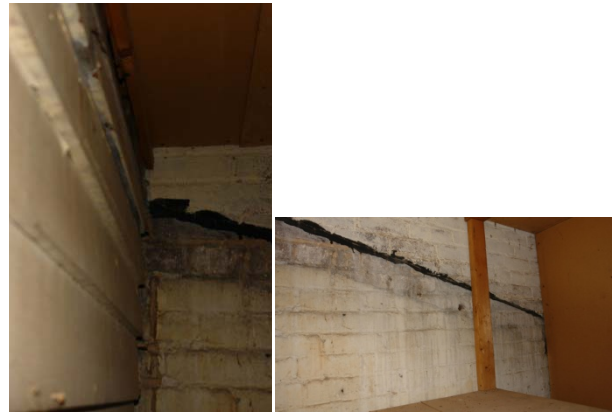
Figure 36: West view through former window opening of the north wall of Room 104 - Kitchen. (Photography by QEA, 2015)
Note the clapboard siding on the backside of the north wall (left) and the ghost of the porch roof on the west brick wall (right).

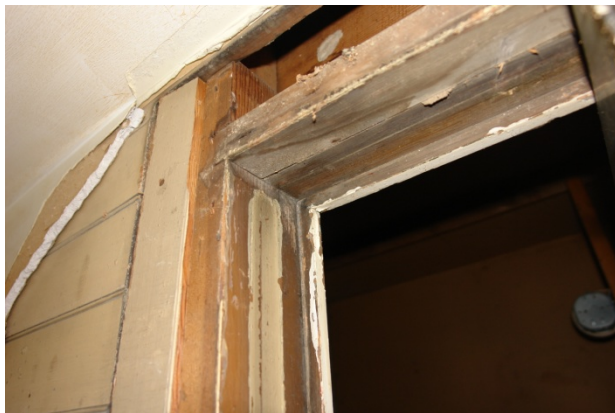
Figure 37: Detail of north wall. (Photography by QEA, 2015)
Note the former window opening and the beadboard.

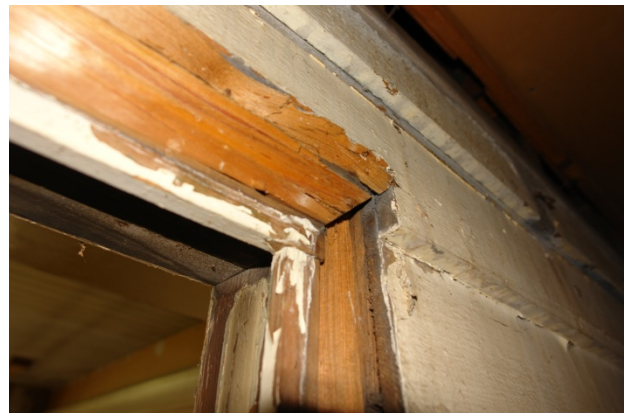
Figure 38: Detail of backside of north wall facing the stairs to the basement. (Photography by QEA, 2015)
Note the former window opening and the clapboard siding.

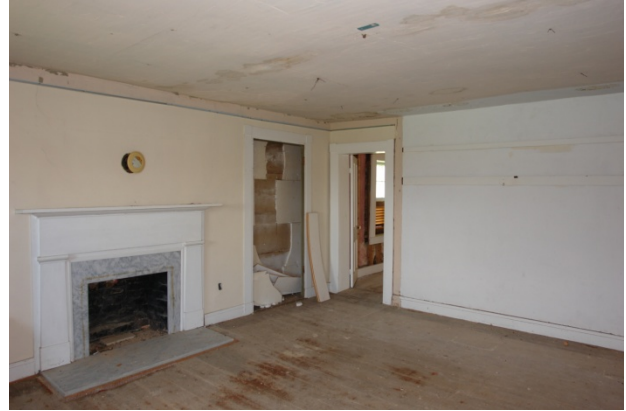
Figure 52: Northeast view of 202 - West Bedroom.
(Photography by QEA, 2015) The modern closets on the east wall have been removed.

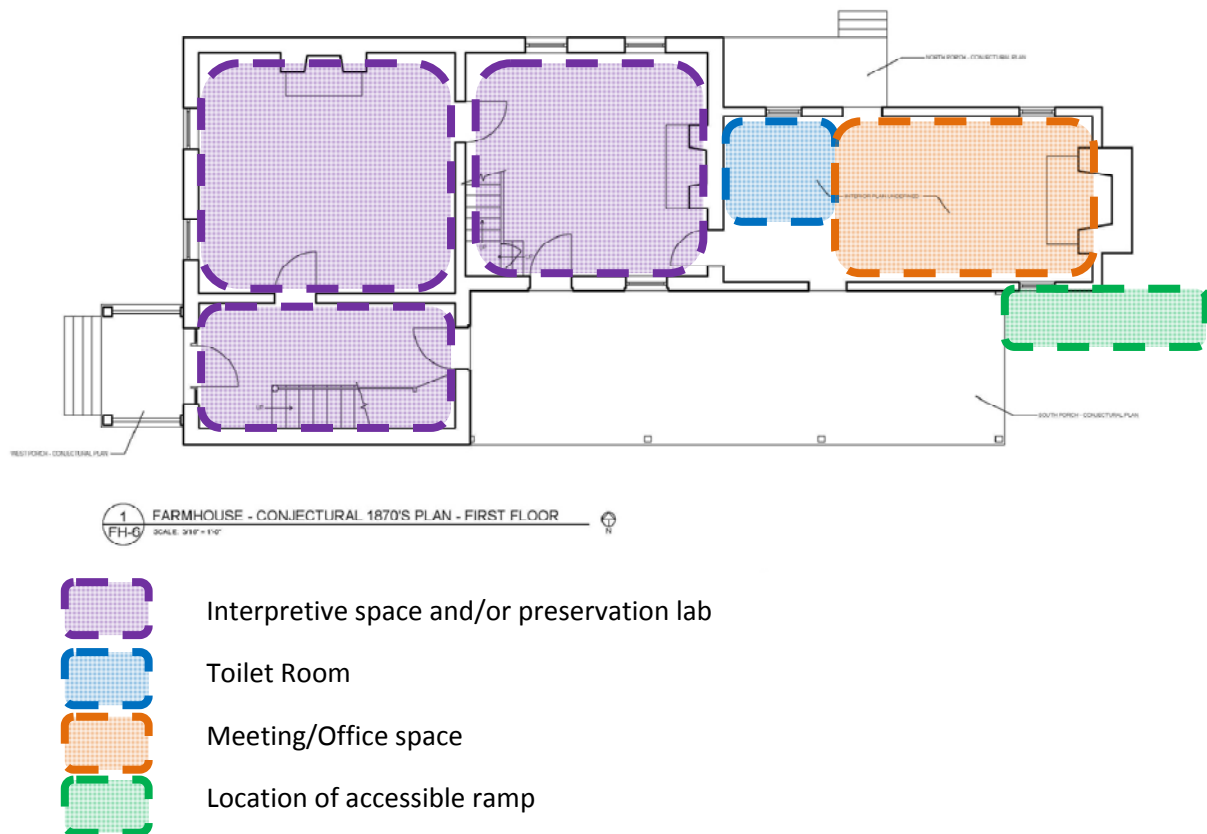
Figure 80: Space utilization plan for the first floor. Note the re-introduction of the front porch, side porch, and back porch as well as the Pirkey rear frame addition.

- Provide an accessible pathway and entrance into the building on the south side.
- Provide a unisex toilet room, with adjacent utility sink and mechanical closet on the first floor. This could be staff use or for public use as a comfort station.
- Examine the existing wooden stairway and upgrade where possible to assure safe utilization.³⁰
- Consider sustainable design strategies and apply selectively to this project to improve the performance and reduce future utility costs (i.e. ground source heat pump, solar power).
- Add thermal insulation to the roof/attic assembly and to the perimeter walls to meet energy conservation standards.
- Assure all window assemblies are in good condition to reduce air infiltration in the summer and winter and then to also provide fresh air ventilation during the mild months.
- Consider providing water and vapor barriers to structural envelope.
