# Historic Structure Assessment Report

Carderock Pavilion  
East Comfort Station  
West Comfort Station

Potomac, Maryland

Chesapeake & Ohio Canal National Historical Park

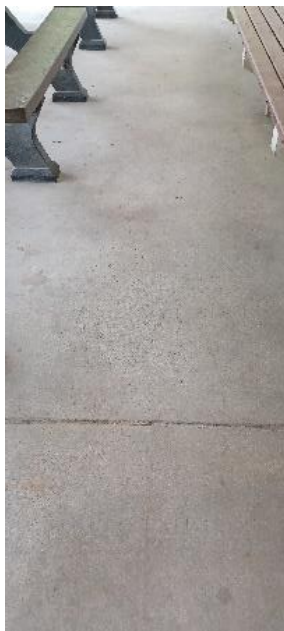
The Pavilion has a concrete slab foundation. It is in good condition.

Pavilion slab foundation/floor.

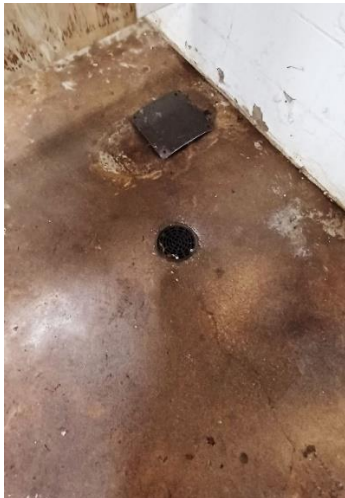
Both the East and West Comfort Stations are built upon concrete slabs. Although both Comfort Station slab floors are very dirty and in need of cleaning, their condition overall is good.

East Comfort Station (Men's room) foundation slab on grade.

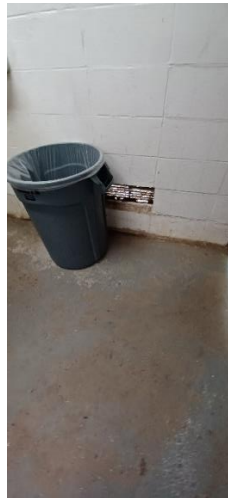
West Comfort Station (Men's room) slab foundation on grade.

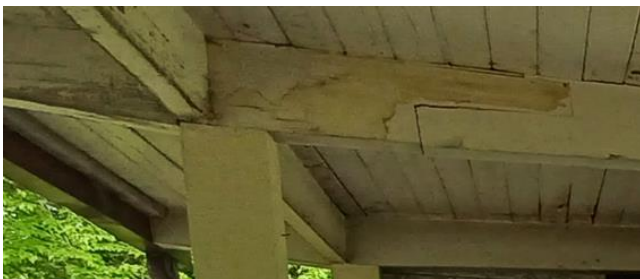
Pavilion, smaller area, failing scarf joint. Beam failure due to water ingress.

The interior ceiling and beam paint is in poor condition which is allowing water to penetrate, damaging the tongue-and-groove wood ceiling and some of the beams (see section B1022 for beam condition assessment).

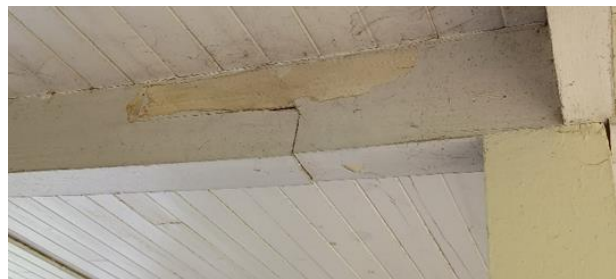
Pavilion, large picnic area, failing scarf joint.

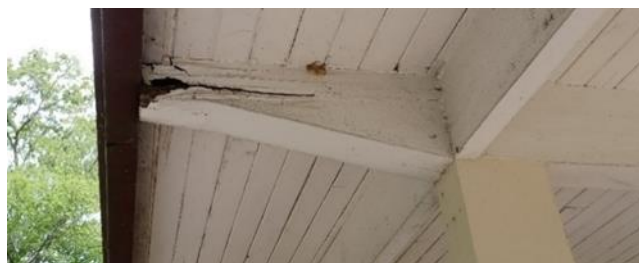
Deteriorated large rafter tail and tongue-and-groove wood ceiling paneling in need of repair and paint.

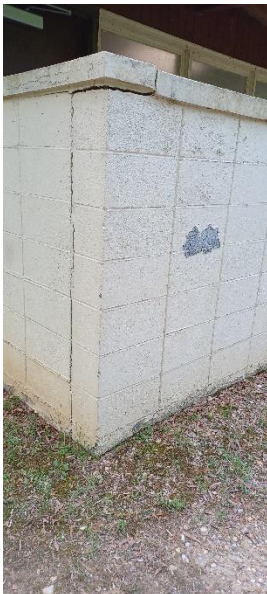
The East Comfort Station has stacked concrete block construction (CMU). There is rising damp on all of its walls caused by its lack of installed drainage gutters and downspouts. The walls are in minor need of paint. The CMU privacy wall and decorative ledge at the Women's Room is cracked with the potential for the wall and ledge to collapse.

East Comfort Station – Southwest oblique. Damaged Privacy wall.

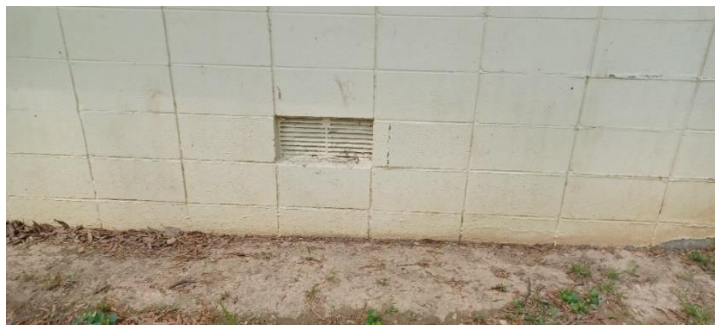
East Comfort Station – west wall.

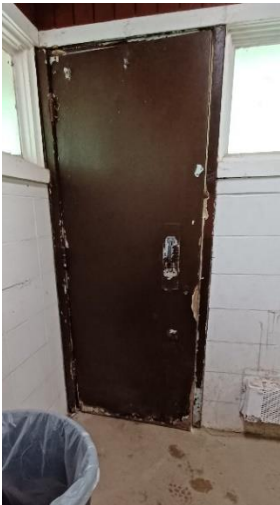
Both Comfort Stations have wood doors that are in fair condition. They all have sections where the outer layer of wood has delaminated and flaked off. All of the doors have, in particular, delaminated at the bottom of the door, allowing for water to penetrate the remainder of the door. They are all in need of paint. The Men's Room door on the West Comfort Station has been unevenly cut short.

East Comfort Station, Men's Room door, Interior.

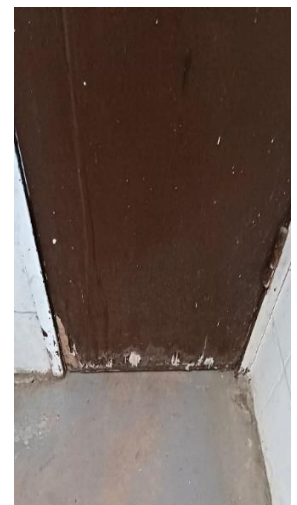
West Comfort Station, Women's Room Door, interior.

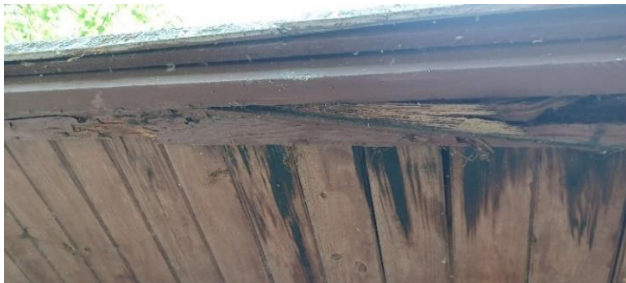
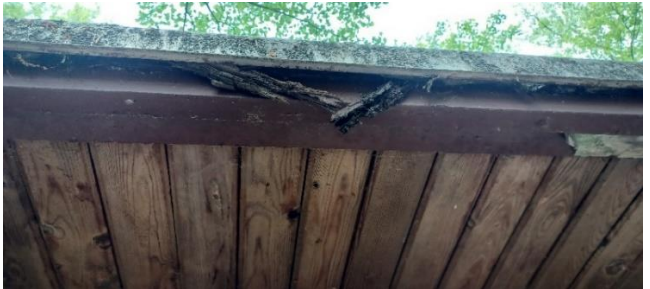
| Category | Element | Sub-Element | Individual Element | Location | Condition Assessment | Category |
|---|---|---|---|---|---|---|
| <p>The roof and flashing were inaccessible on the East Comfort Station. There are no gutters or downspouts, which is likely the cause for the deteriorating trim and soffit. Water from the roof flows to the lowest point, which in this case is metal flashing. Water then moves to the wood soffit on the underside of the flashing, causing severe deterioration.</p> | | | | | | |
| <div> </div> <p>East Comfort Station wood soffit deterioration.</p> | | | | | | |

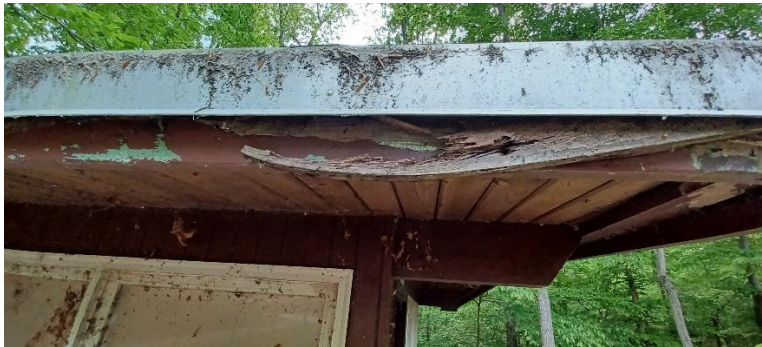
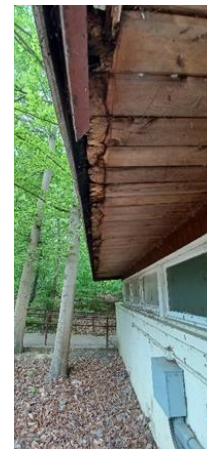
West Comfort station wood soffit deterioration.

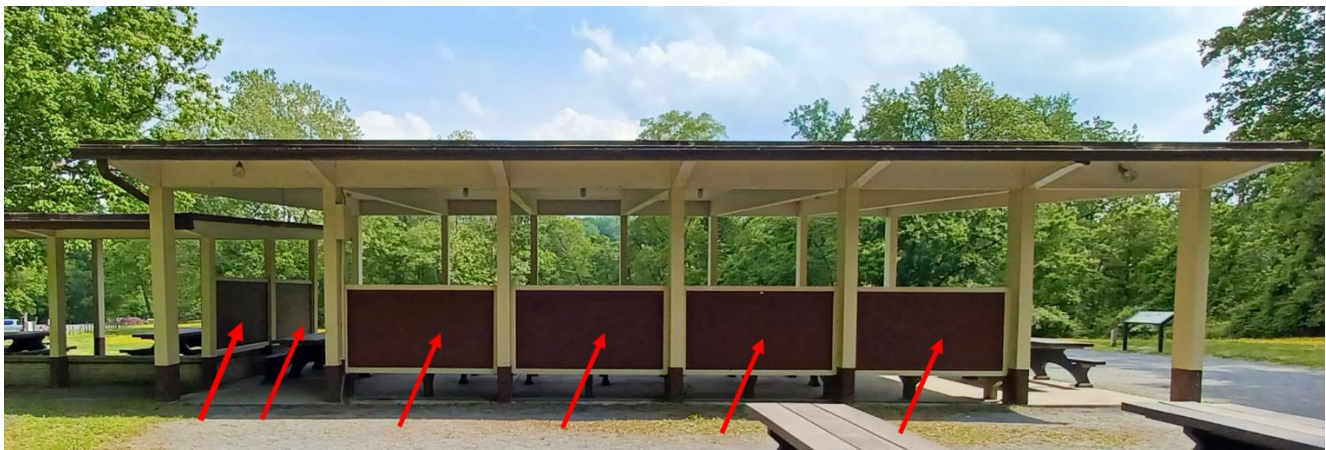
The Pavilion was not constructed to be enclosed by walls. Instead wood screening panels were used on the north and east sides of the Pavilion. The wood panels are in good condition but are in need of paint.

Carderock Pavilion, wood screening on north and east walls.

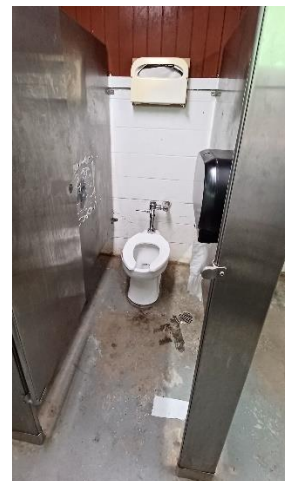
The West Comfort Station men's room has metal lined walls and doors that defines the toilet stalls. Vandalism has damaged one of the walls. It is recommended that the hole in the wall be patched with similar material.

West Comfort Station, men's room stall walls.

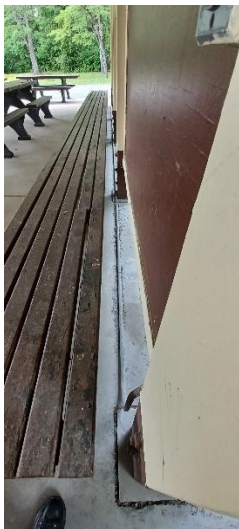
The Pavilion has an open-air construction, and only the inside and outside of the few wood panels and posts are painted. The paint on the columns supporting the roof is in good condition. The wooden screening panels are in need of paint.

Bench and wood panels. Note: cracking paint on wood panel.

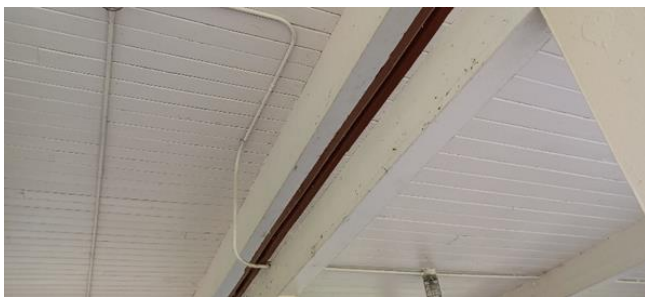
Central beams in larger picnic area. Note deteriorating paint on beams.

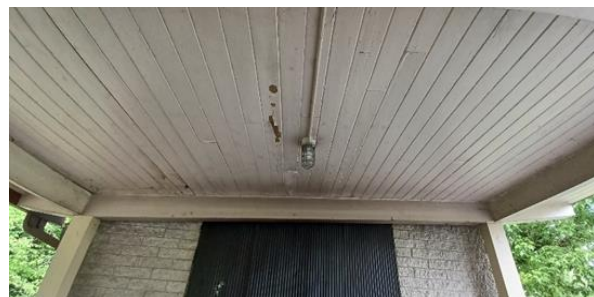
Smaller area in the Pavilion. Paint deterioration on the ceiling.

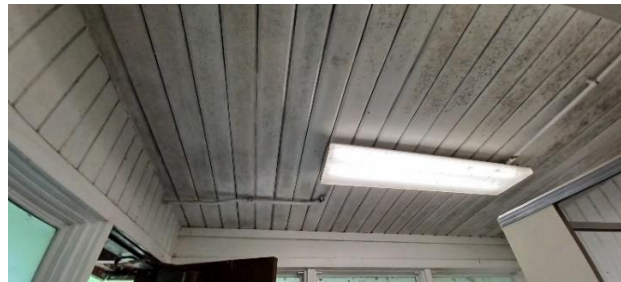
| Category | Element | Sub-Element | Individual Element | Location | Condition Assessment | Category |
|---|---|---|---|---|---|---|
| The interior of all bathrooms in the East & West Comfort Stations have stain and paint in good condition. The West women’s room paint needs cleaning or repainting. | | | | | | |

West Comfort Station, women’s room, paint needs cleaning or repainting.
