AMBLER HOUSE RUIN,

JAMESTOWN ISLAND.

By: Thor Borresen  
October 4, 1939

Memorandum for Superintendent Cox:

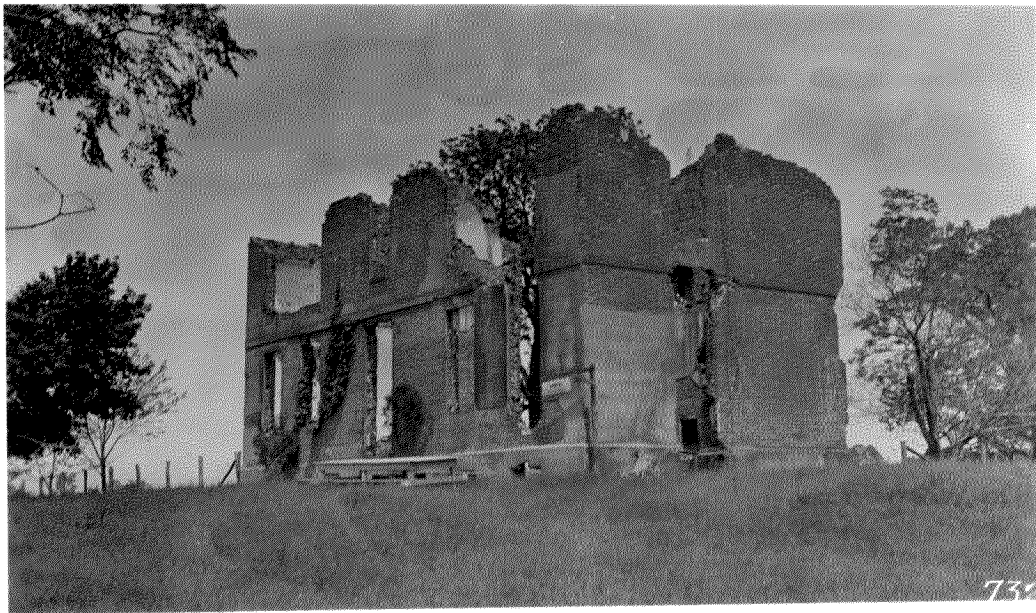
Photograph #1 - Ambler House, Jamestown Island -  
The south (front) wall, and the east wall. This is the  
oldest photograph of the Ambler House in our files.

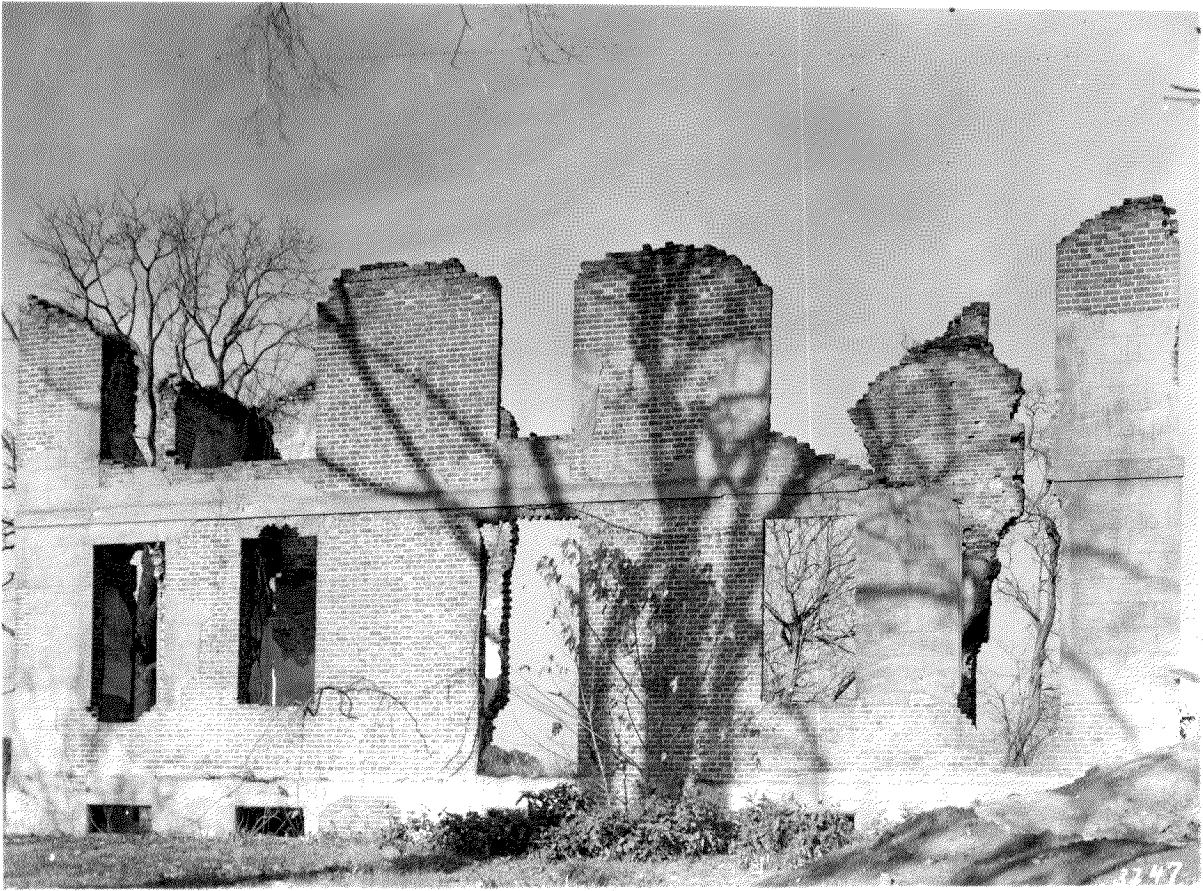
Photograph #3 - Ambler House, Jamestown Island -  
South, or front, elevation of building.

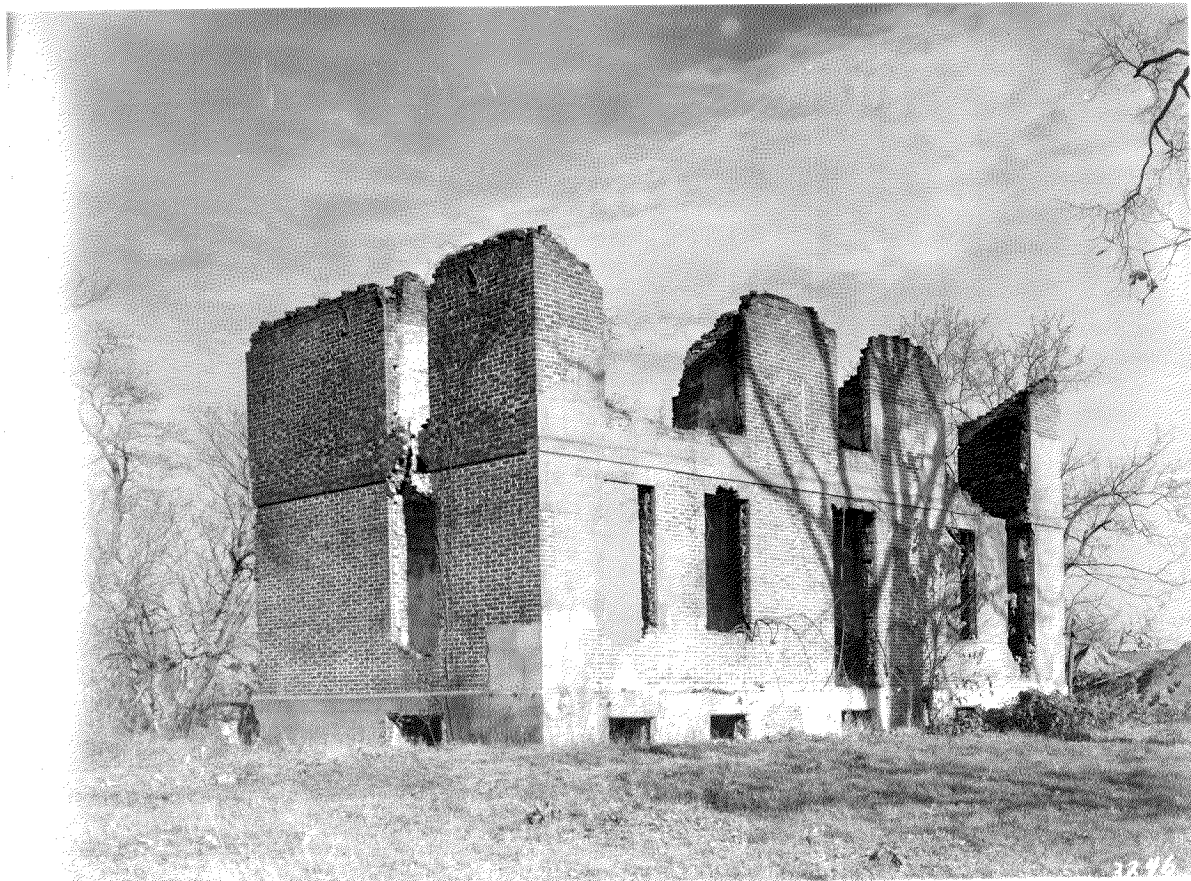
Photograph #4 - Ambler House, Jamestown Island -  
South (front) wall and southwest end.

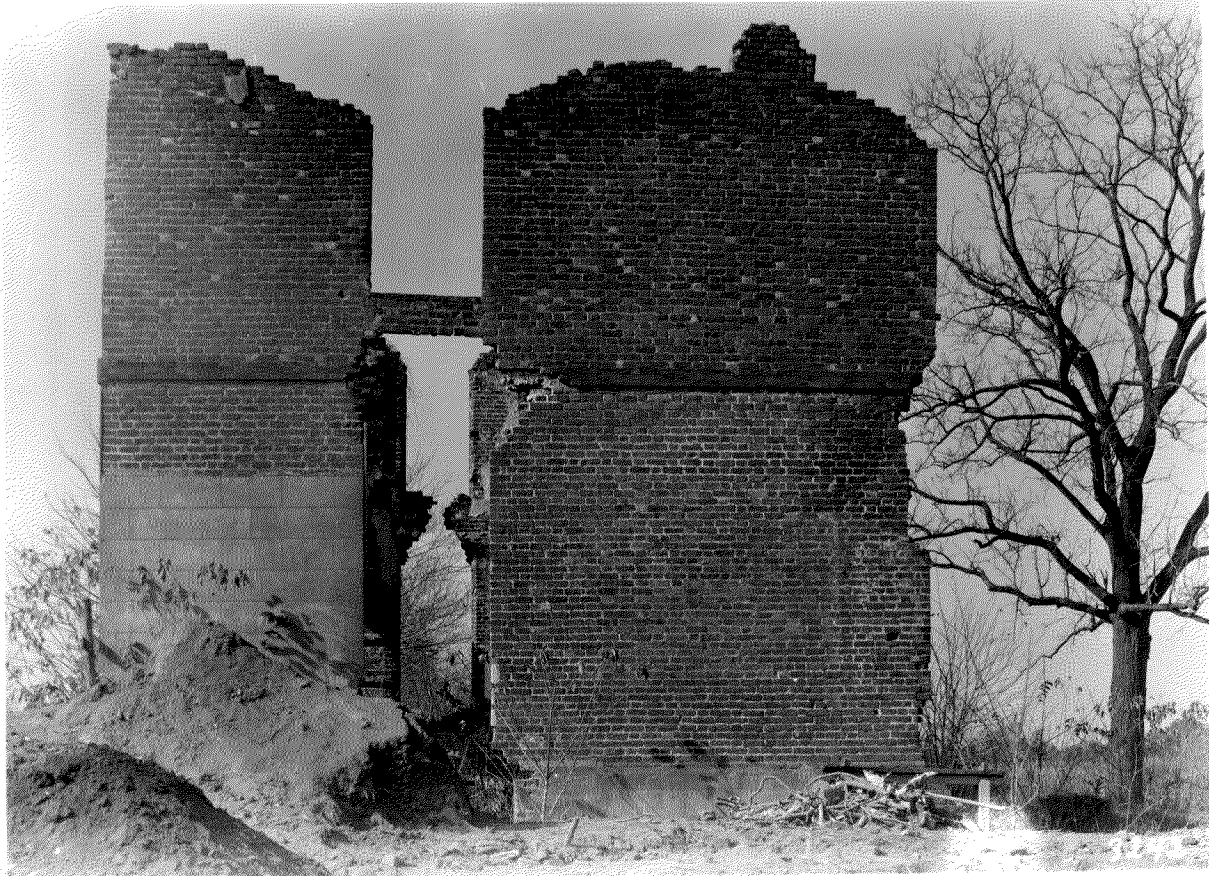
Photograph #8 - Ambler House, Jamestown Island -  
East wall. Notice the four and one-half courses of  
brick connecting the two sections of wall, and see photo-  
graph #1 taken in 1911. The window on the first floor was  
made into a doorway during the modernisation.

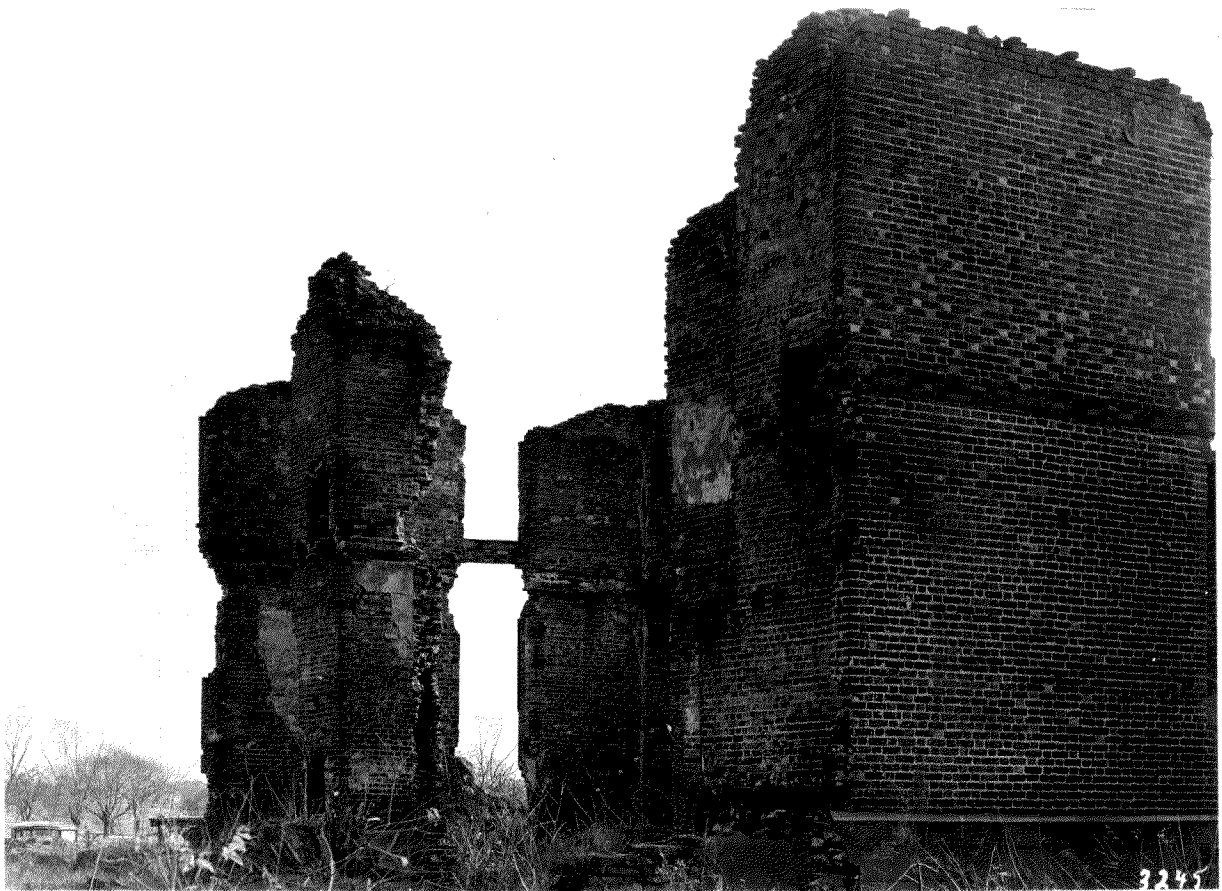
Photograph #6 - Ambler House, Jamestown Island -  
The west wall, showing northeast chimney left of center.  
This wall leans  $6\frac{1}{16}$ th inches west.

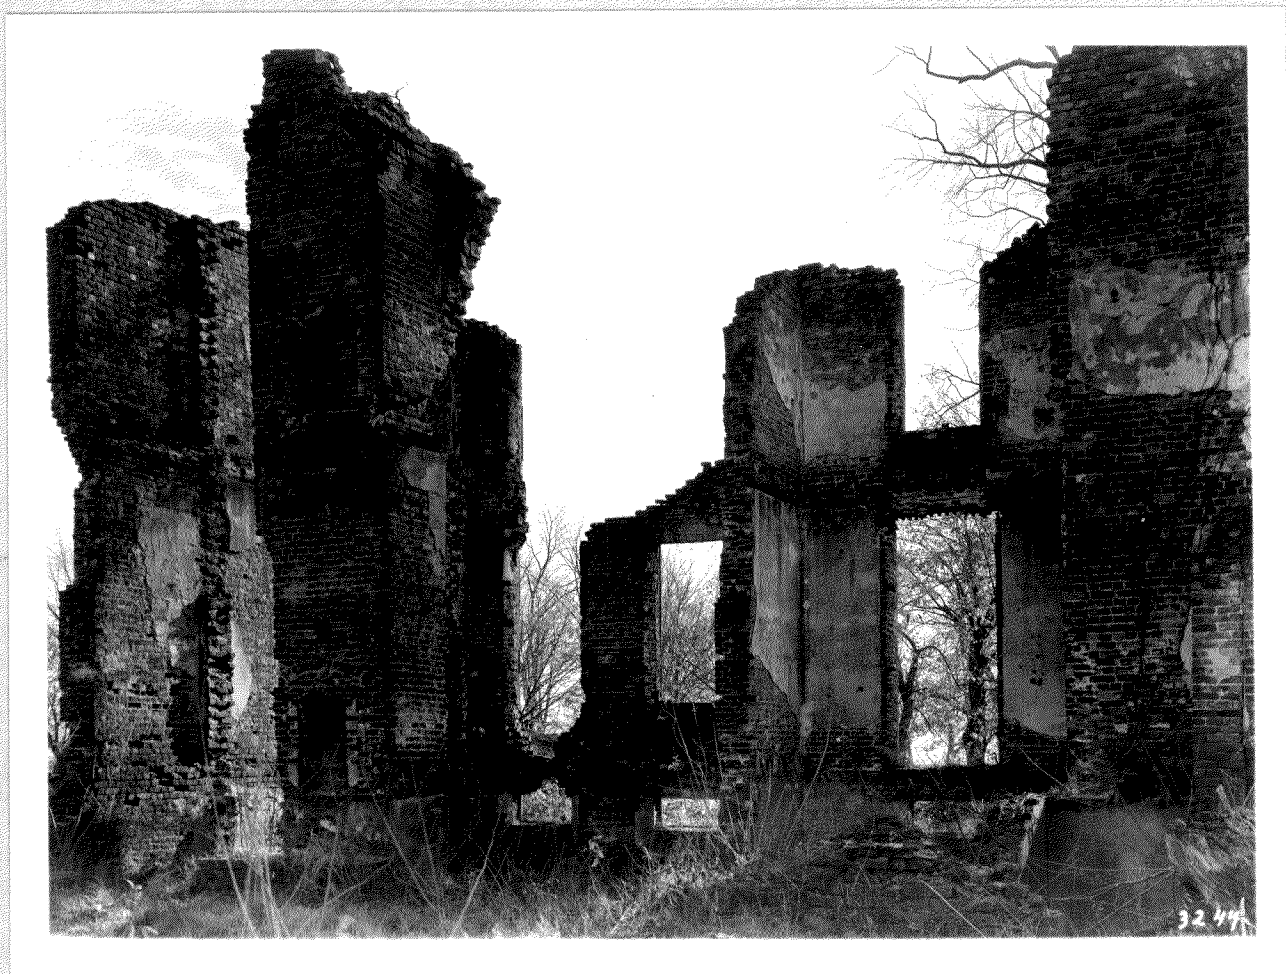
Photograph #7 - Ambler House, Jamestown Island -  
Interior view of rear. Taken from northwest corner.

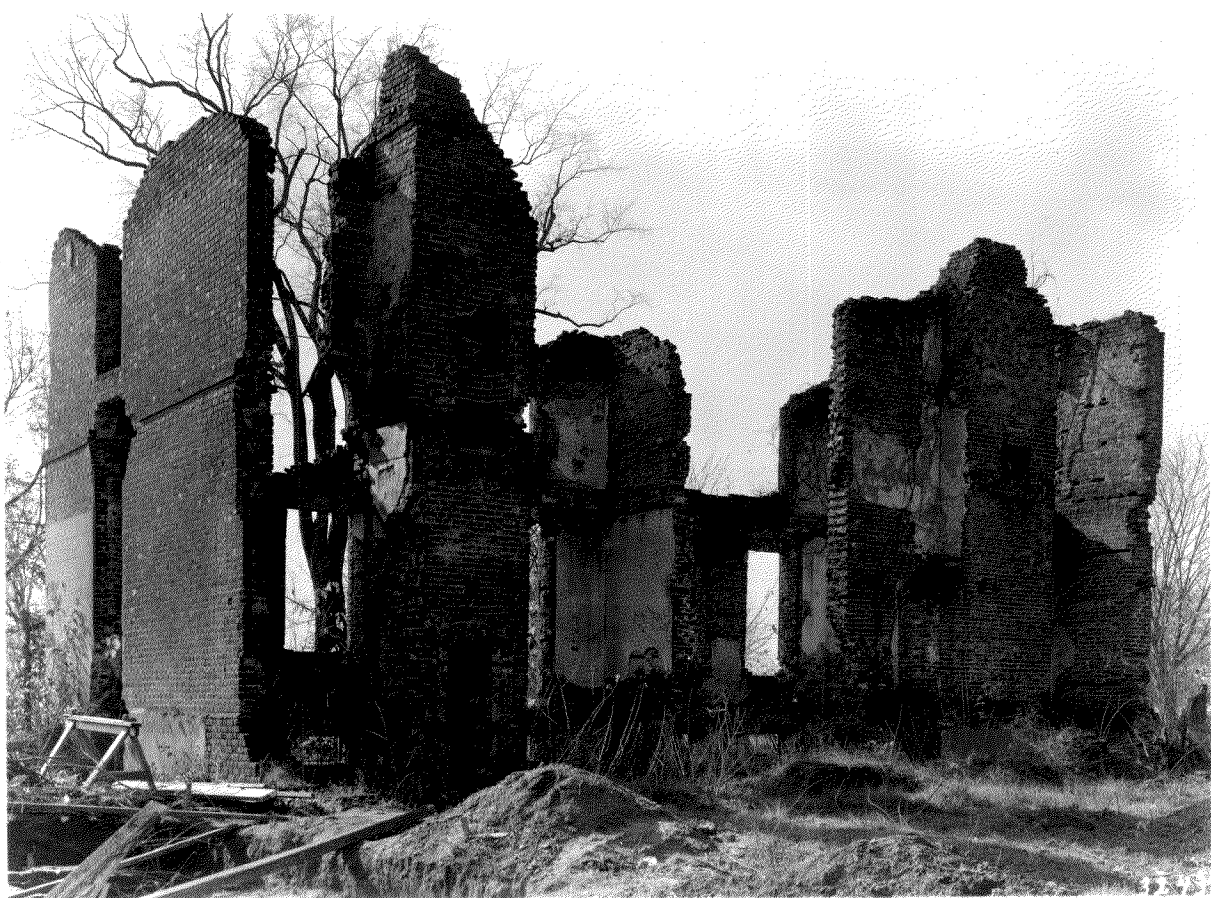
Photograph #8 - Ambler House, Jamestown Island.  
Interior view of rear. Taken from northeast corner.

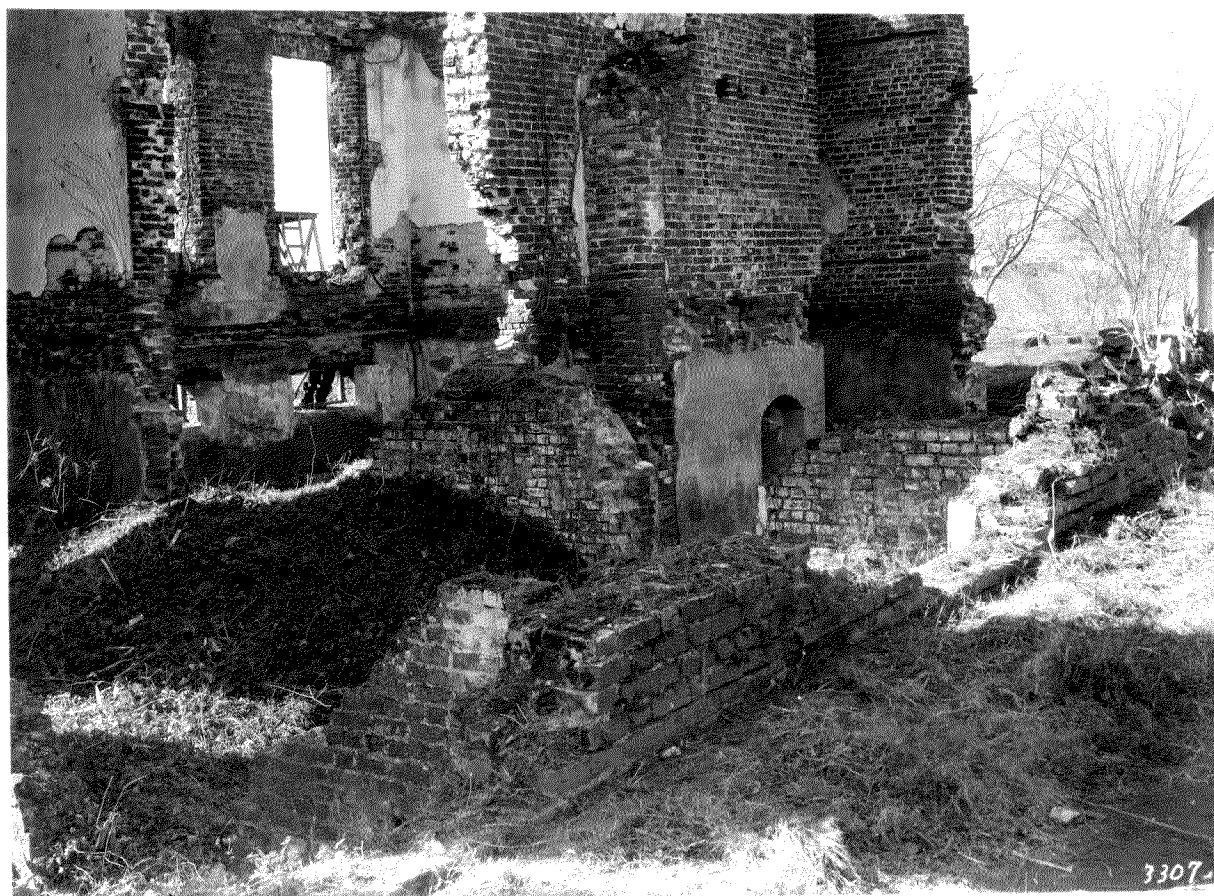
Photograph #9 - Ambler House, Jamestown Island -  
The rear wall in its present condition.

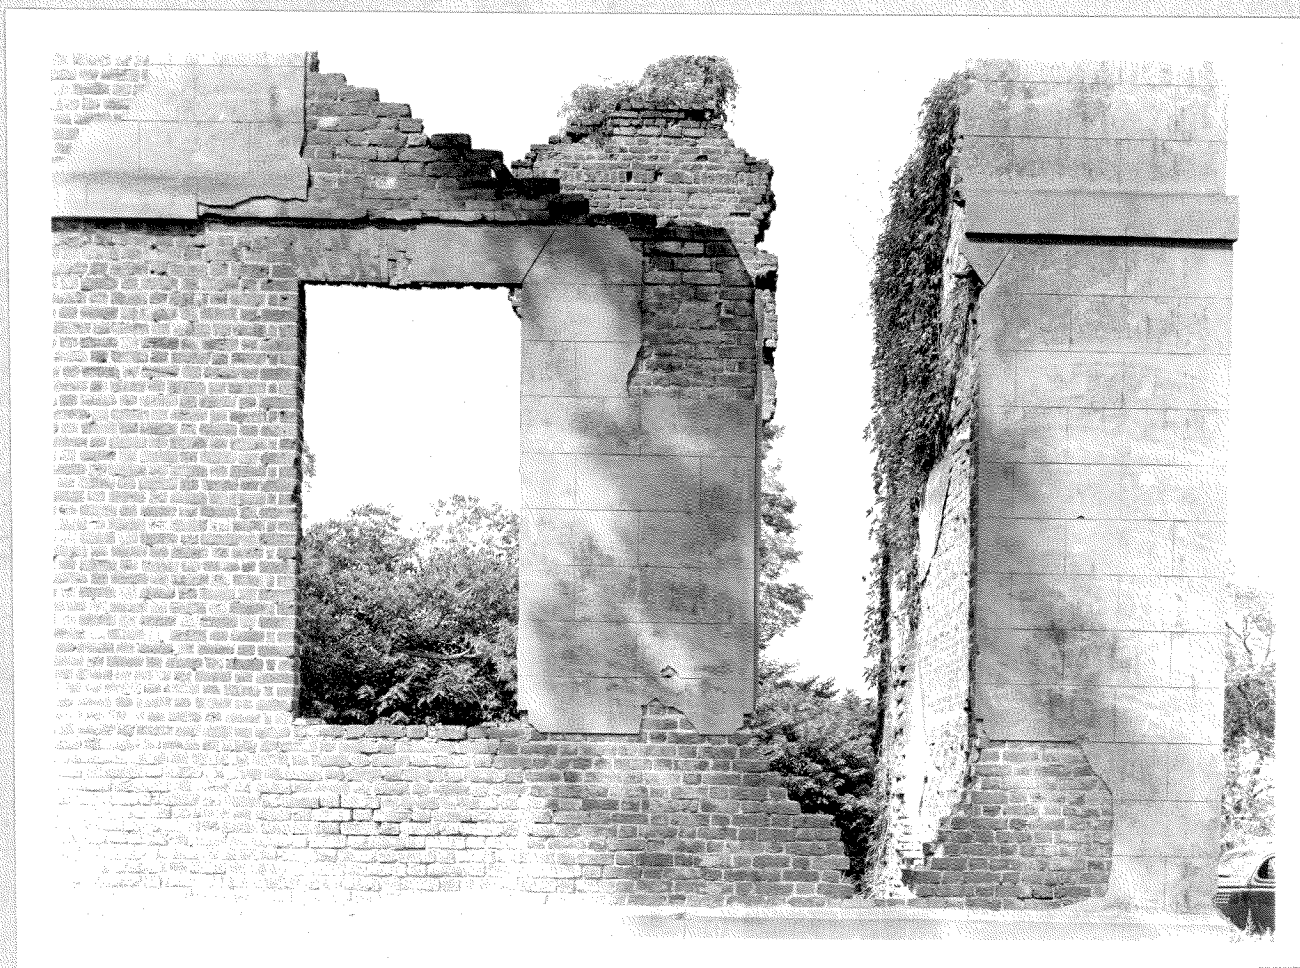
Photograph #10 - Ambler House, Jamestown Island -  
Detail of window, showing the cement plaster in imitation  
stone effect. For preservation, see Drawing NHP COL 10017,  
Sheet 2 of 6, and detail Sheet 6 of 6.

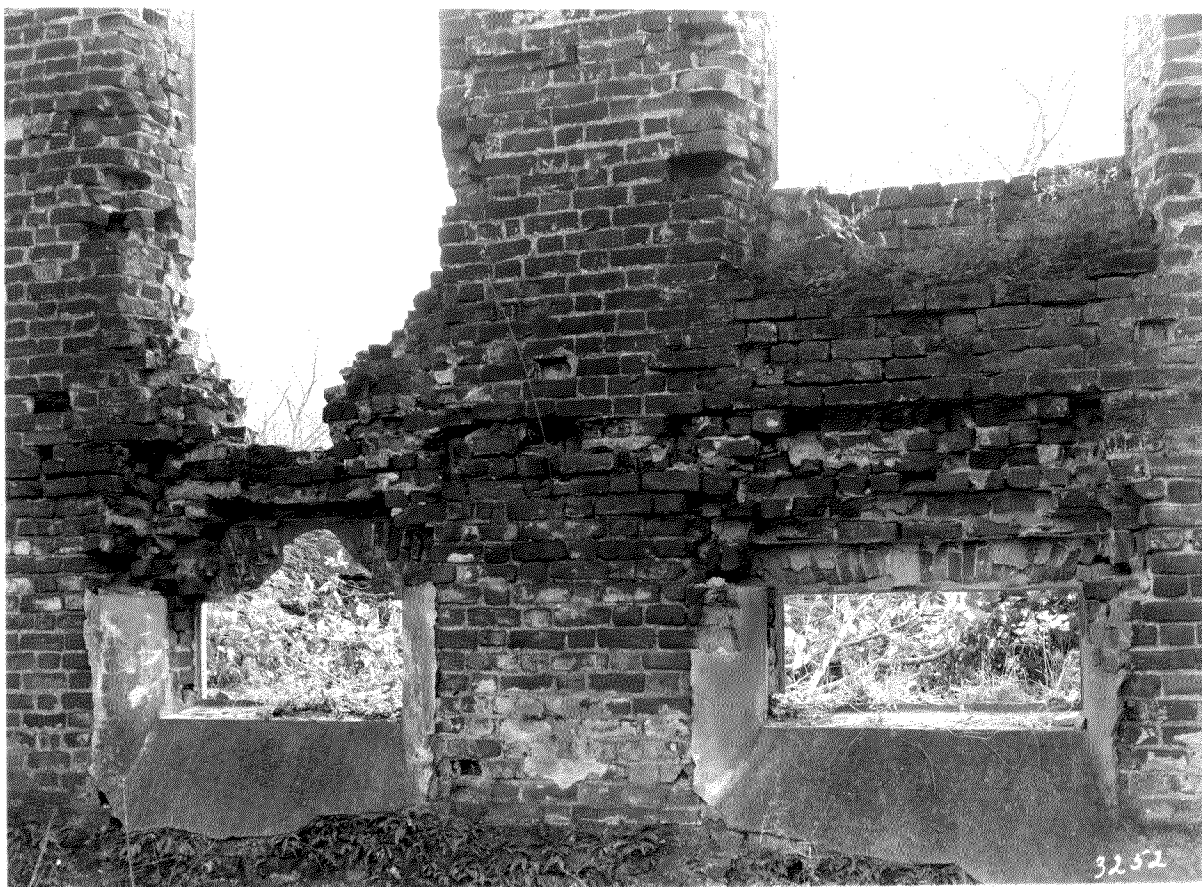
Photograph #11 - Ambler House, Jamestown Island -  
Interior of window in photograph #10, showing the first  
floor joist ledge and basement floor.

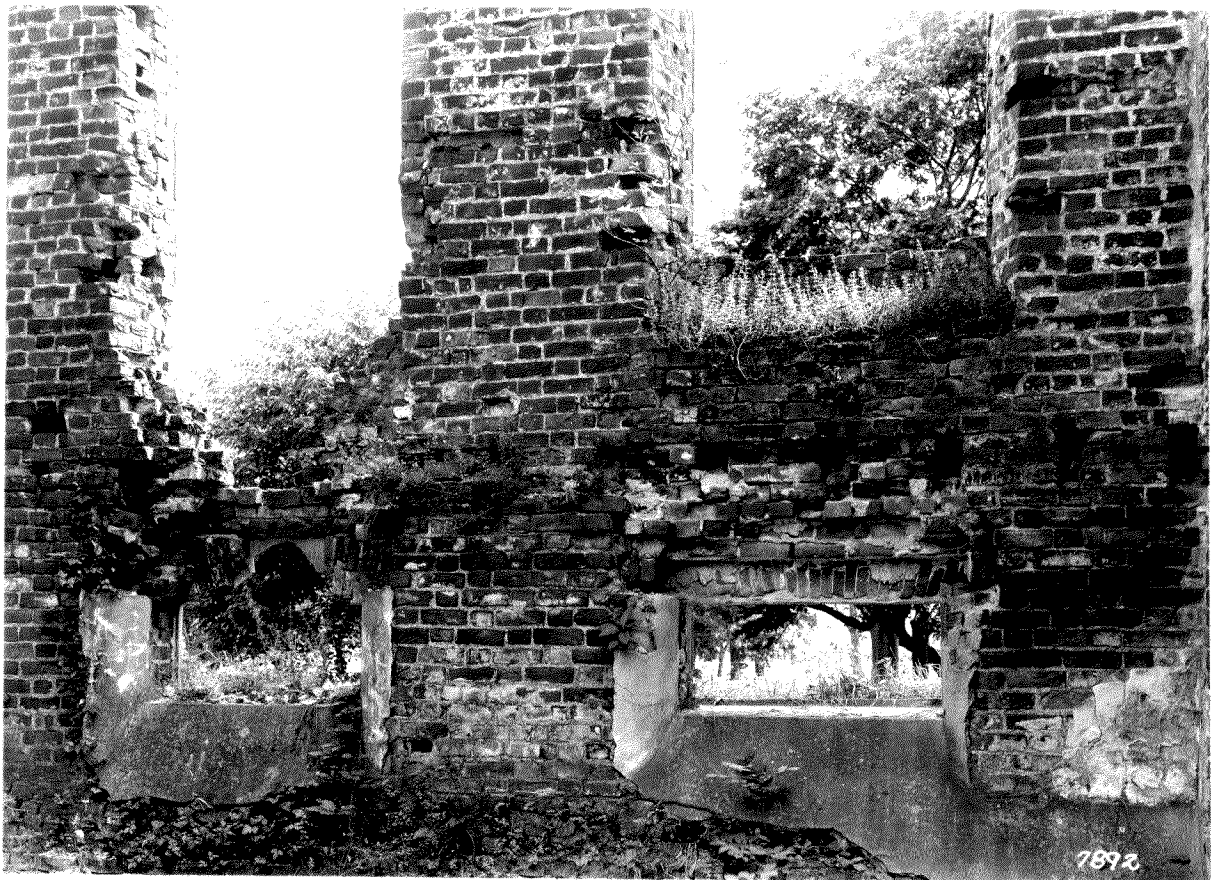
Photograph #12 - Ambler House, Jamestown Island -  
The same as photograph #11, showing deterioration over a  
period of four years.

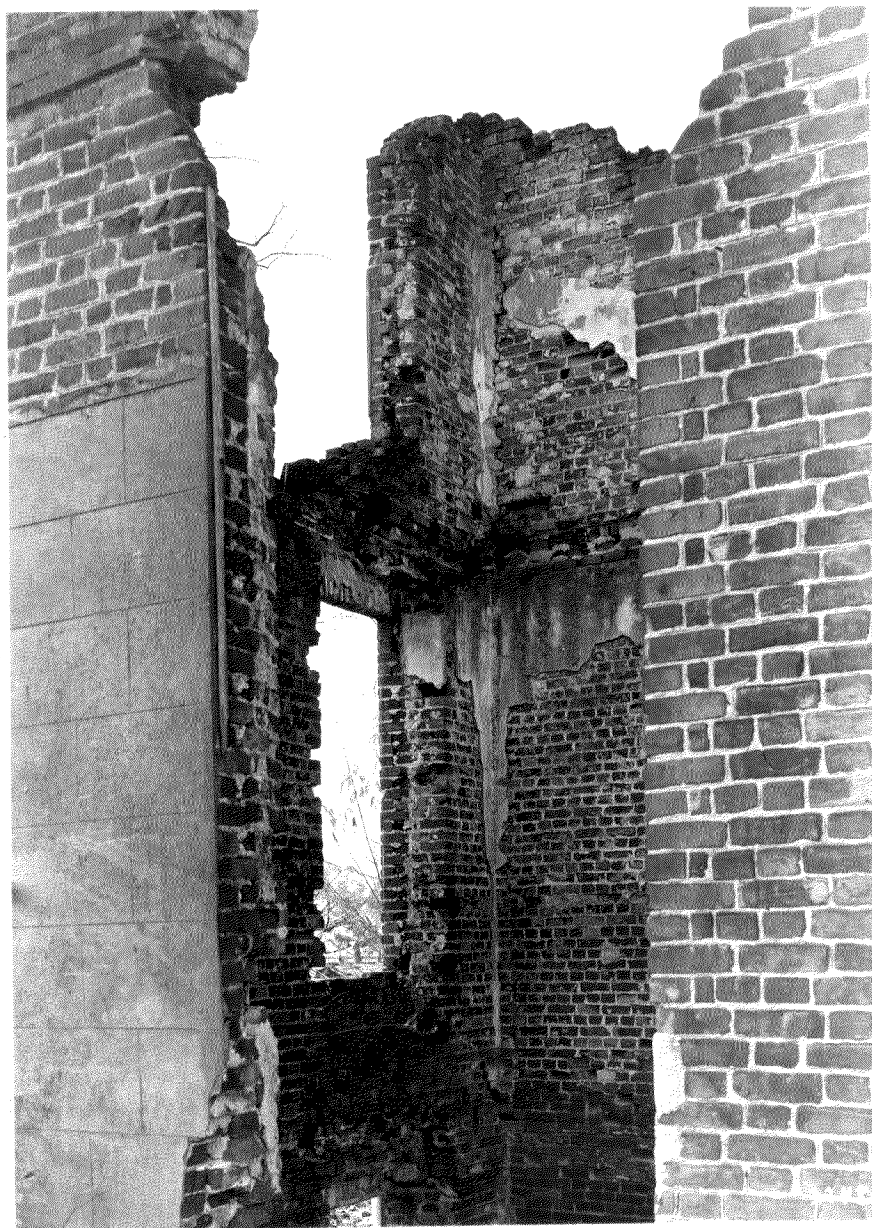
**Photograph #13 - Ambler House, Jamestown Island -**

This is the same window as shown in photographs #'s 10, 11 and 12. Picture taken to show the condition above the first floor window.

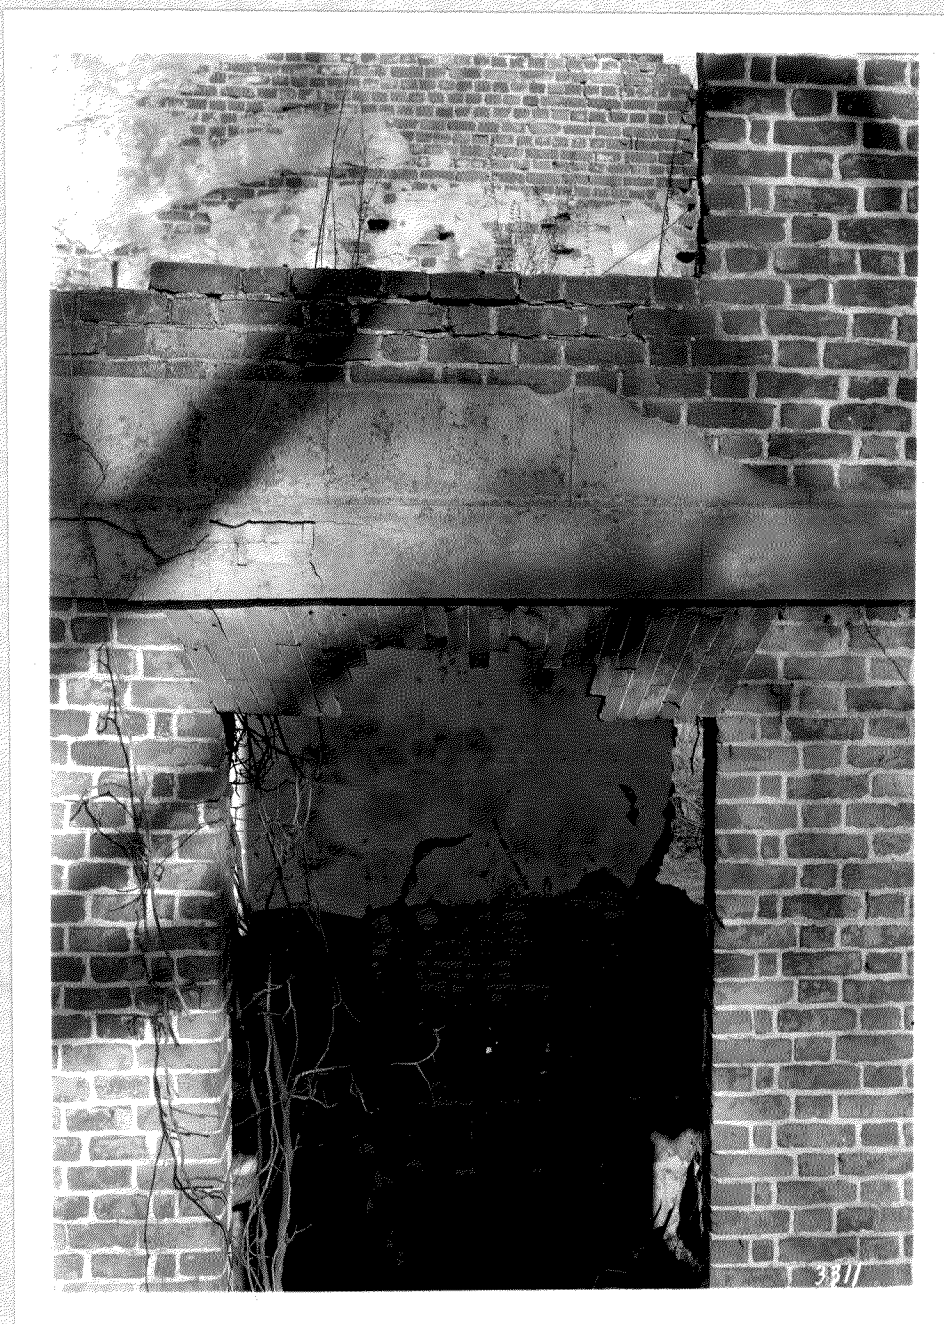
Photograph #14 - Ambler House, Jamestown Island -  
Detail of arch above the window and the lower part of  
the second floor window.

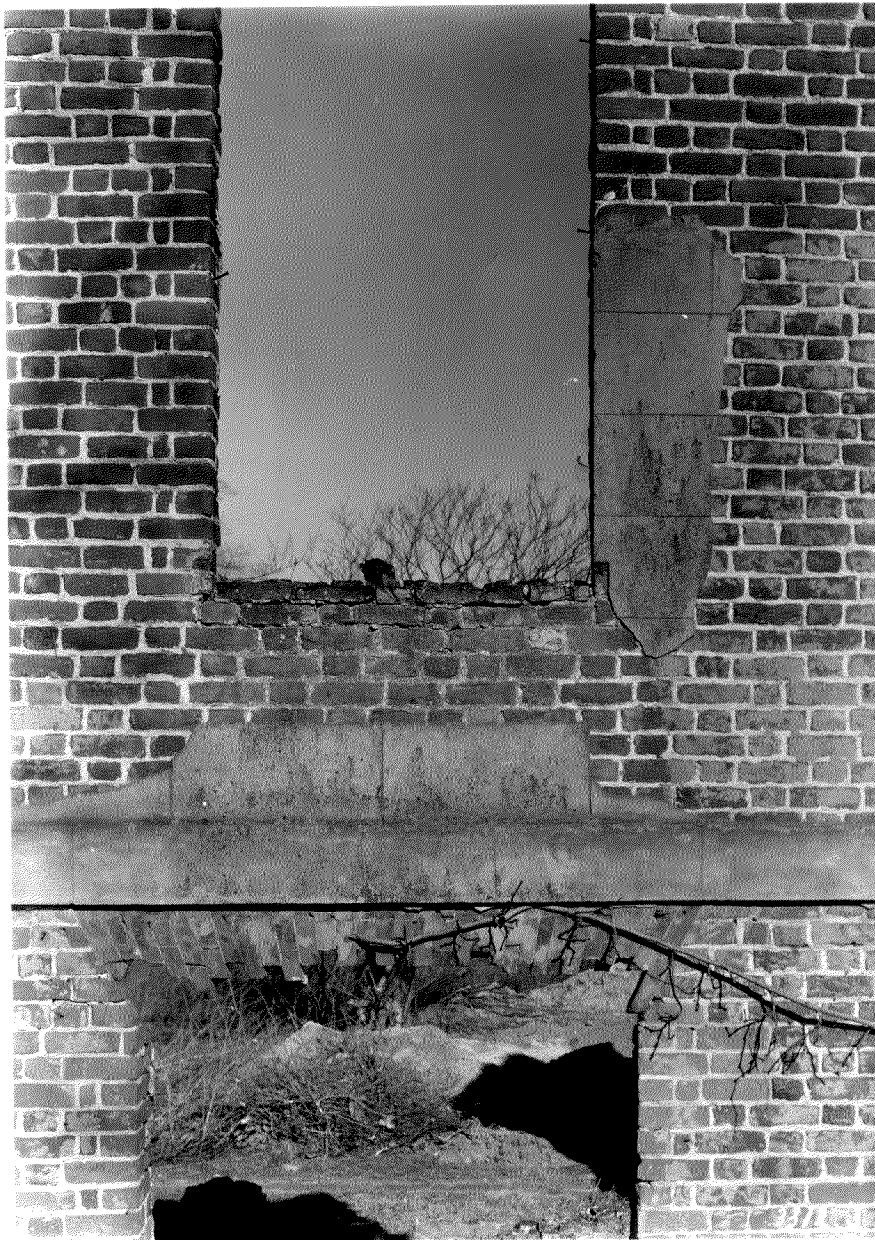
Photograph #15 - Ambler House, Jamestown Island -

What is left of the arch above the main door; also, the detail of brickwork around the window jambs.

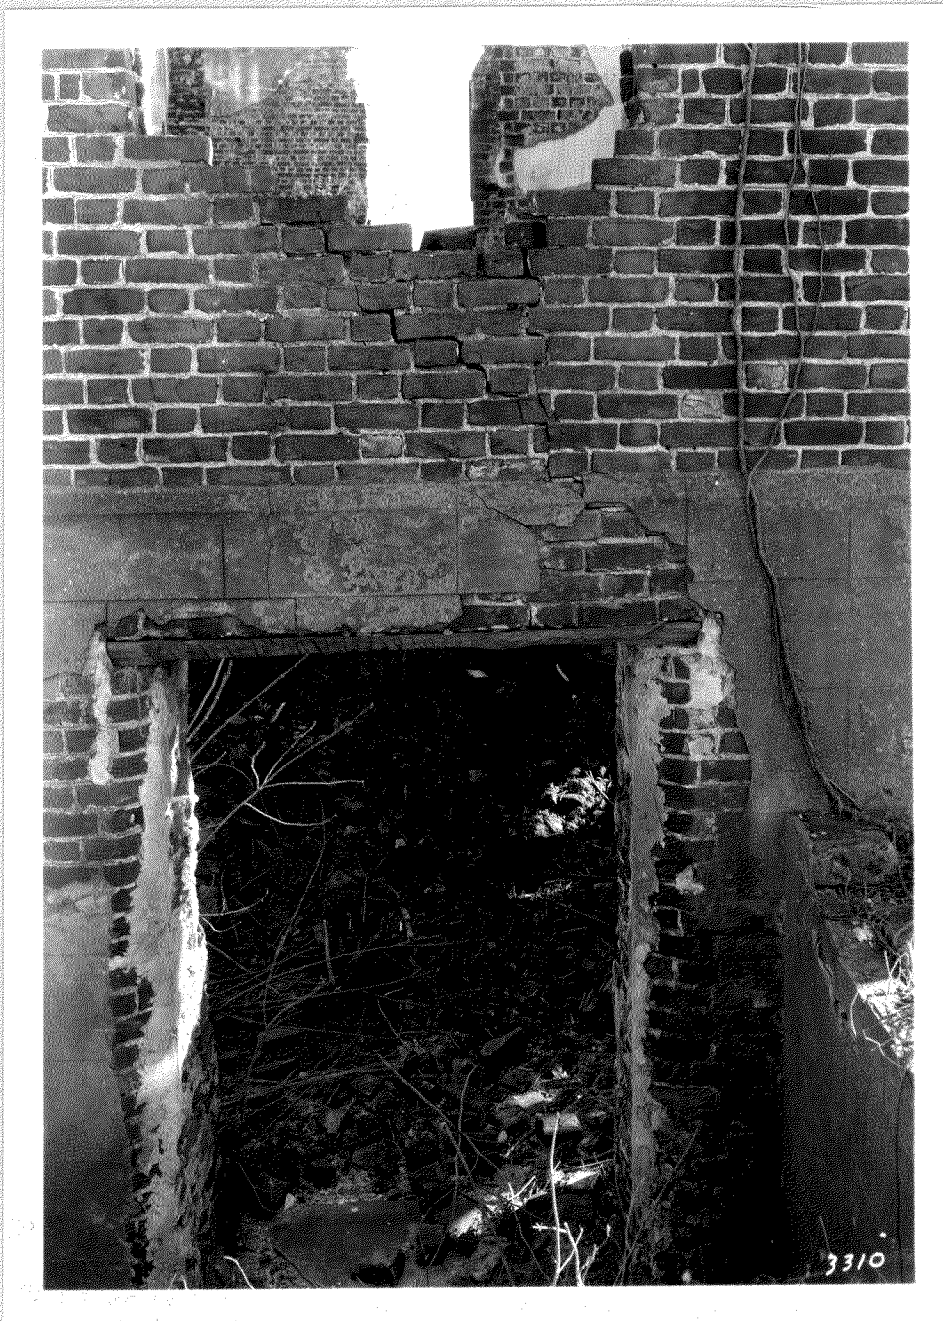
Photograph #16 - Ambler House, Jamestown Island -

The basement door in the west end wall, southwest corner. Shows bricks cut in order to form a round corner for the door jamb. Note 3 inch by 22 inch oak header which existed above all basement doors. This lintel or header was placed behind the arch of doors and windows on the main floors.

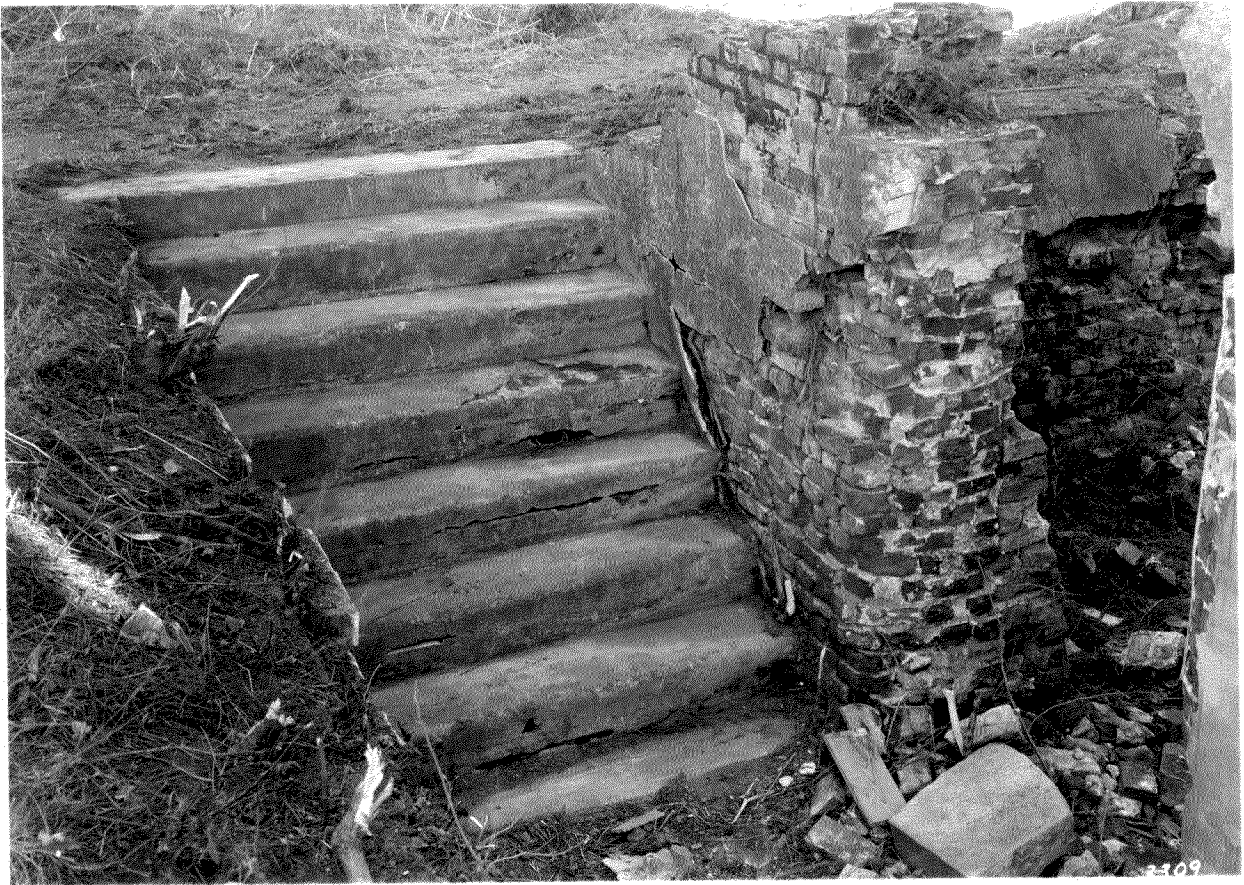
Photograph #17 - Ambler House, Jamestown Island -  
Steps leading down into the basement on the west side of  
building. The doorway showing is the basement door at the  
northwest corner of the building.

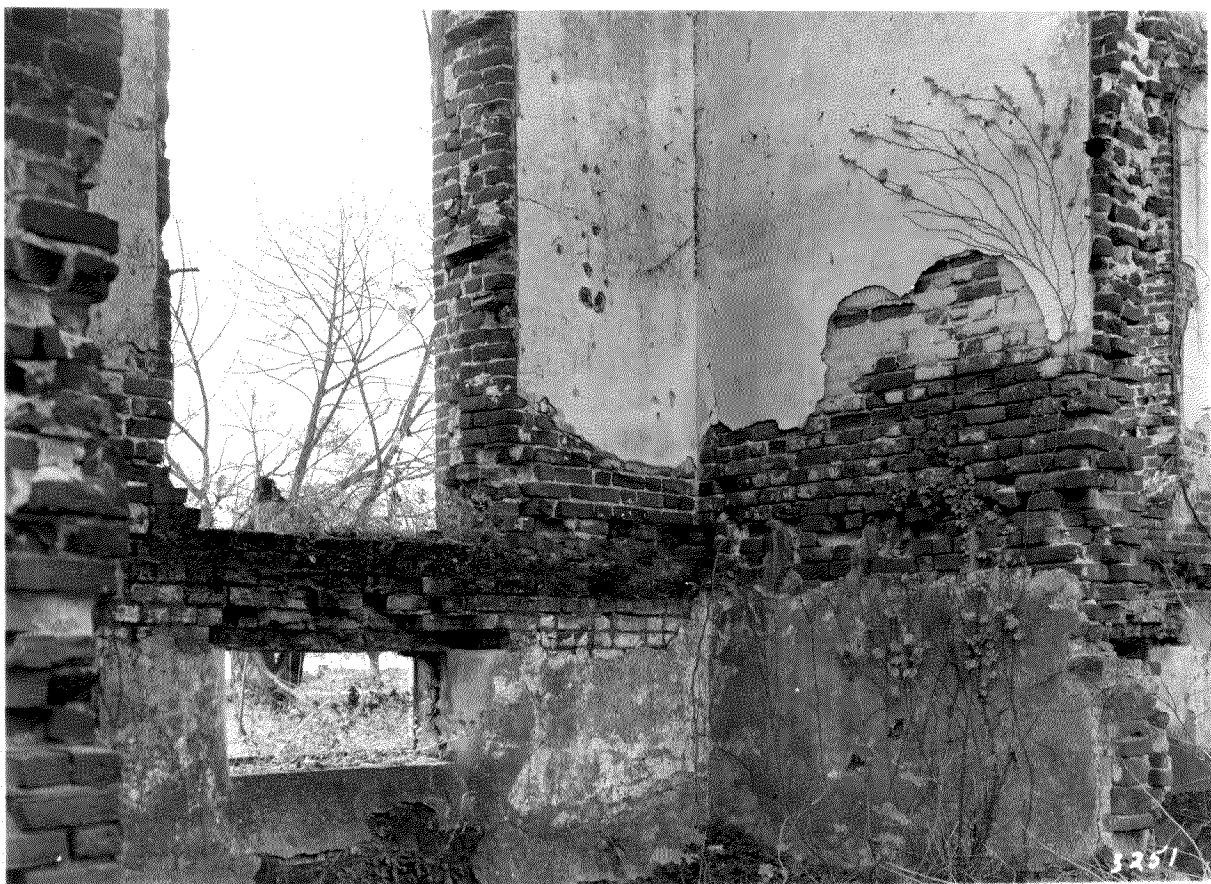
Photograph #18 - Ashler House, Jamestown Island -

The interior at the first floor level. Taken at the central hallway. Notice deterioration where floor joists were inserted into the wall; the first set of floor joists ran north and south, the second, east and west. Imprints of ends of joists left in the plaster show a 3 inch by 9 inch joist was used.

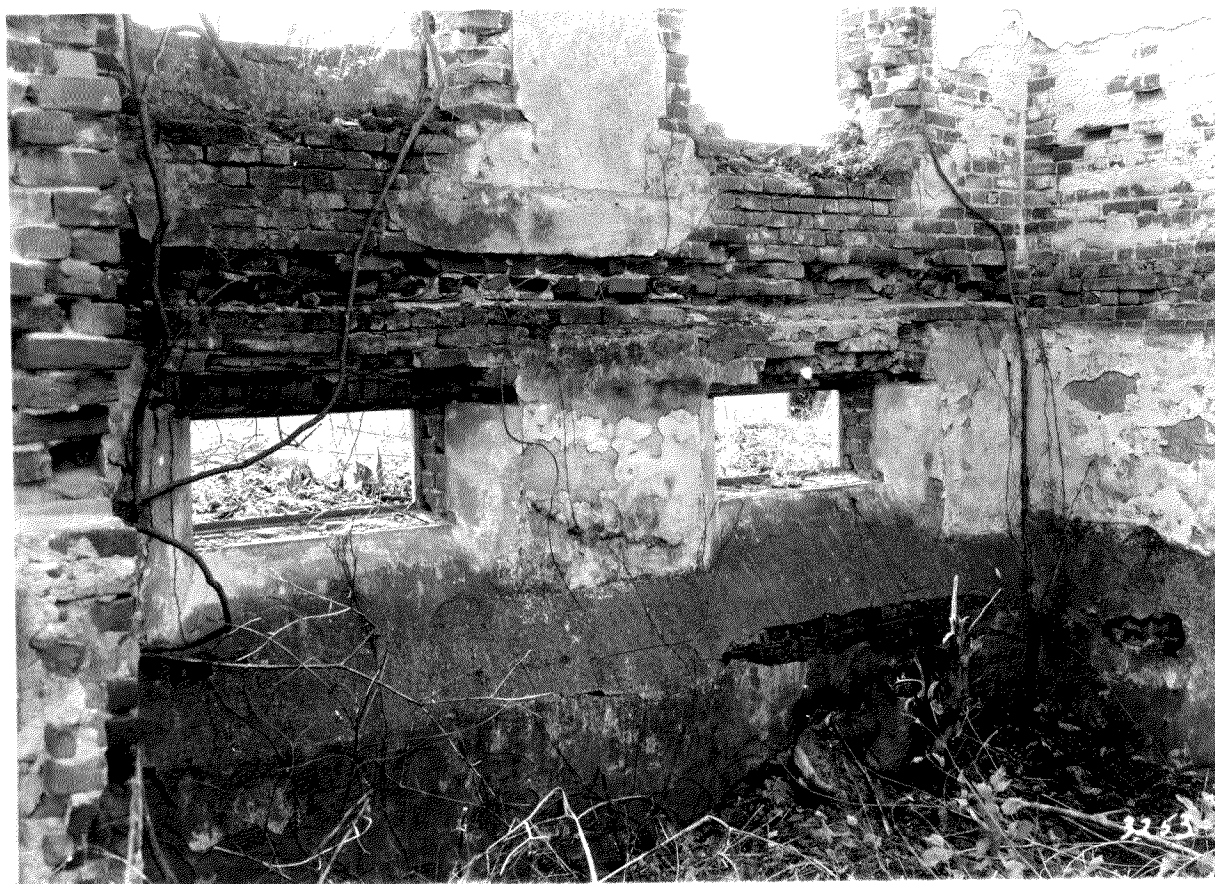
Photograph #19 - Ambler House, Jamestown Island -

Another photograph showing the deterioration which has taken place. Where floor joists were formerly located; the original holes were only 3 inches by 9 inches x 4 inches. It also shows how bricks have been cut to permit rounding corners of window jambs for the basement windows. This cutting of brick happened at a later date.

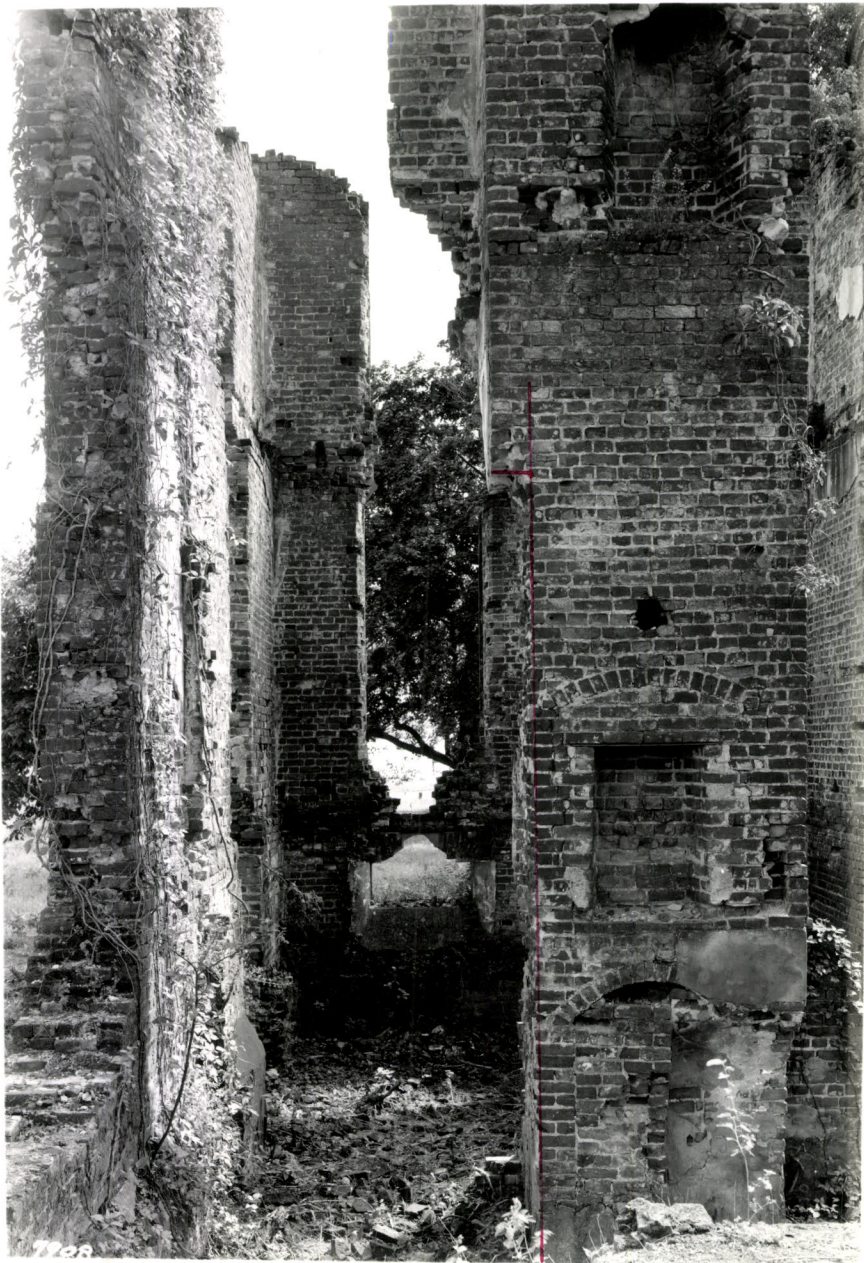
Photograph #20 - Ambler House, Jamestown Island -

The northeast chimney. This photograph shows how nearly 12 inches of the chimney was removed to permit a wider opening between the two rooms. A door was also cut through at the second floor.

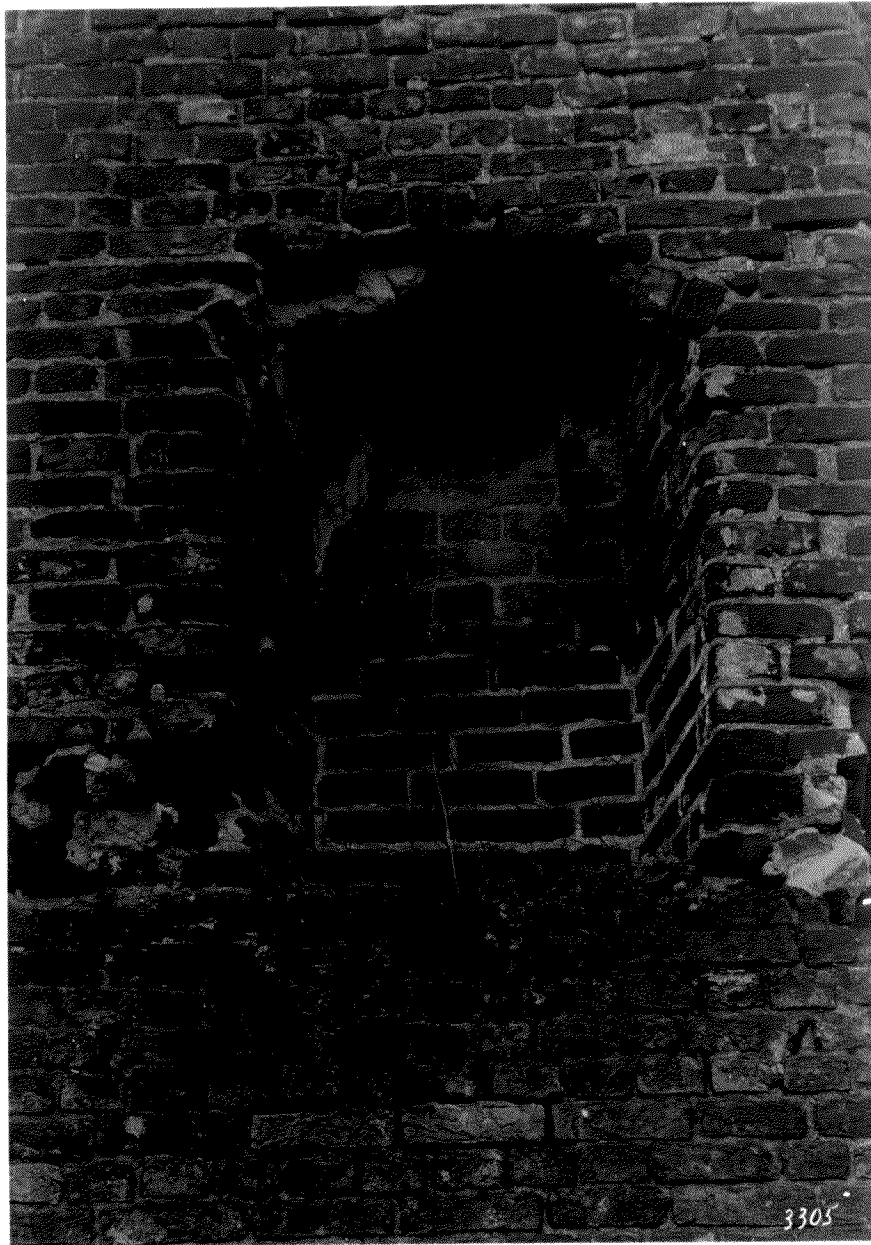
Photograph #21 - Abler House, Jamestown Island -  
Second floor fireplace, northeast chimney. Note deterioration which has taken place where floor joists were located.
