AMBLER HOUSE RUIN,

JAMESTOWN ISLAND.

By: Thor Borresen  
October 4, 1939

Memorandum for Superintendent Cox:

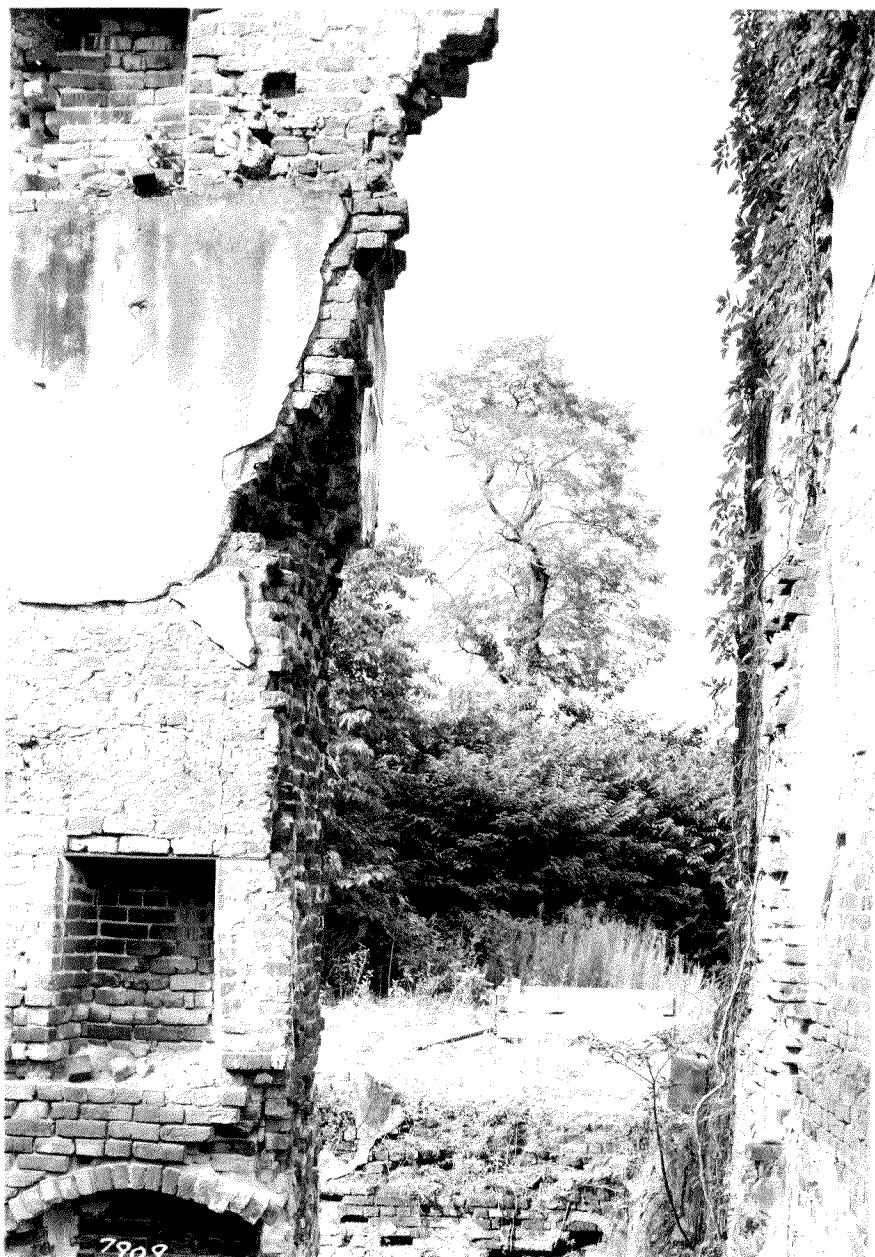
Photograph #22 - Aubler House, Jamestown Island -

The south side of the northeast chimney. The cut made for wider opening between the north and south rooms left only 3/4ths of a brick for protection against fire. The flue turns slightly to the right (east) to clear second floor fireplace.

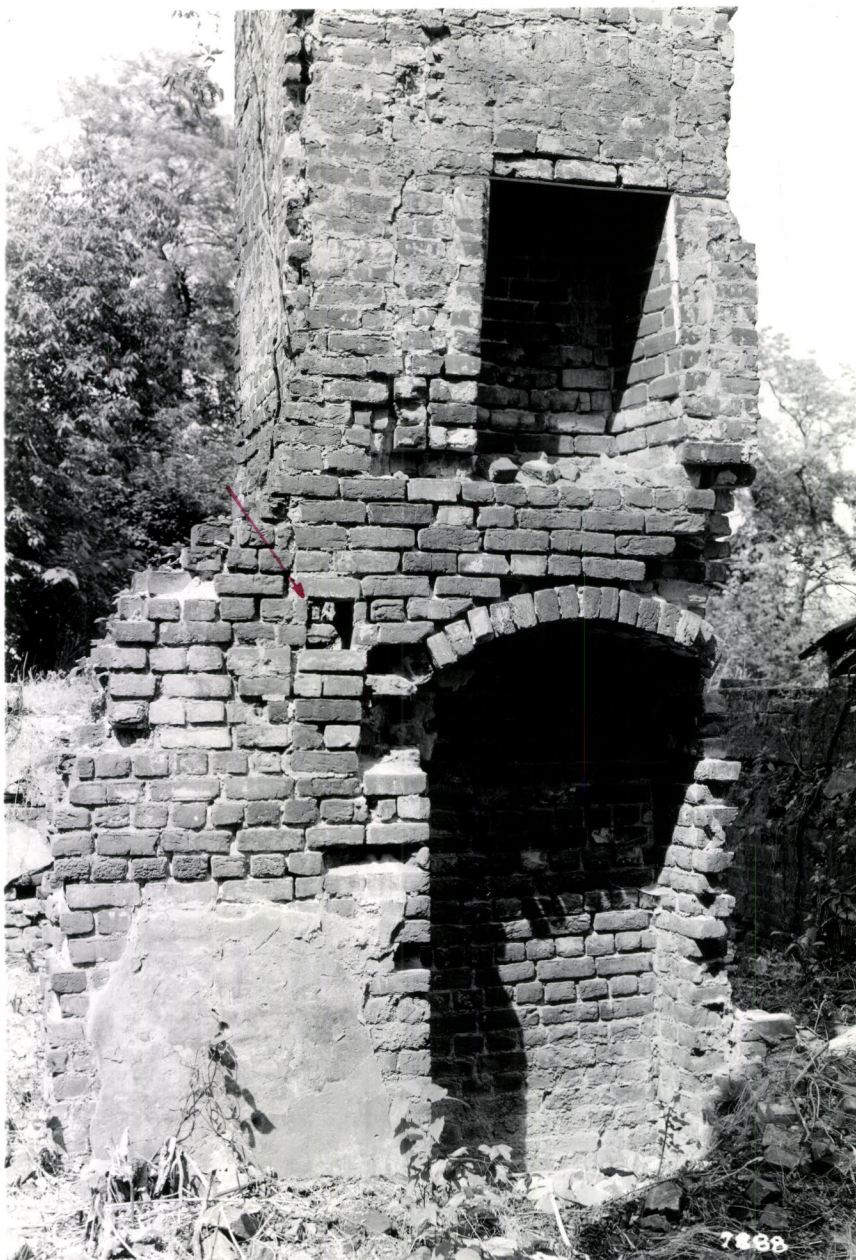
Photograph #23 - Ambler House, Jamestown Island -

The basement section of the south side of northeast chimney; also, fireplace, first floor. Arrow points to new flue and outlet for stove which was cut at a later date. Only 1/2 course of brick protects the building against fire.

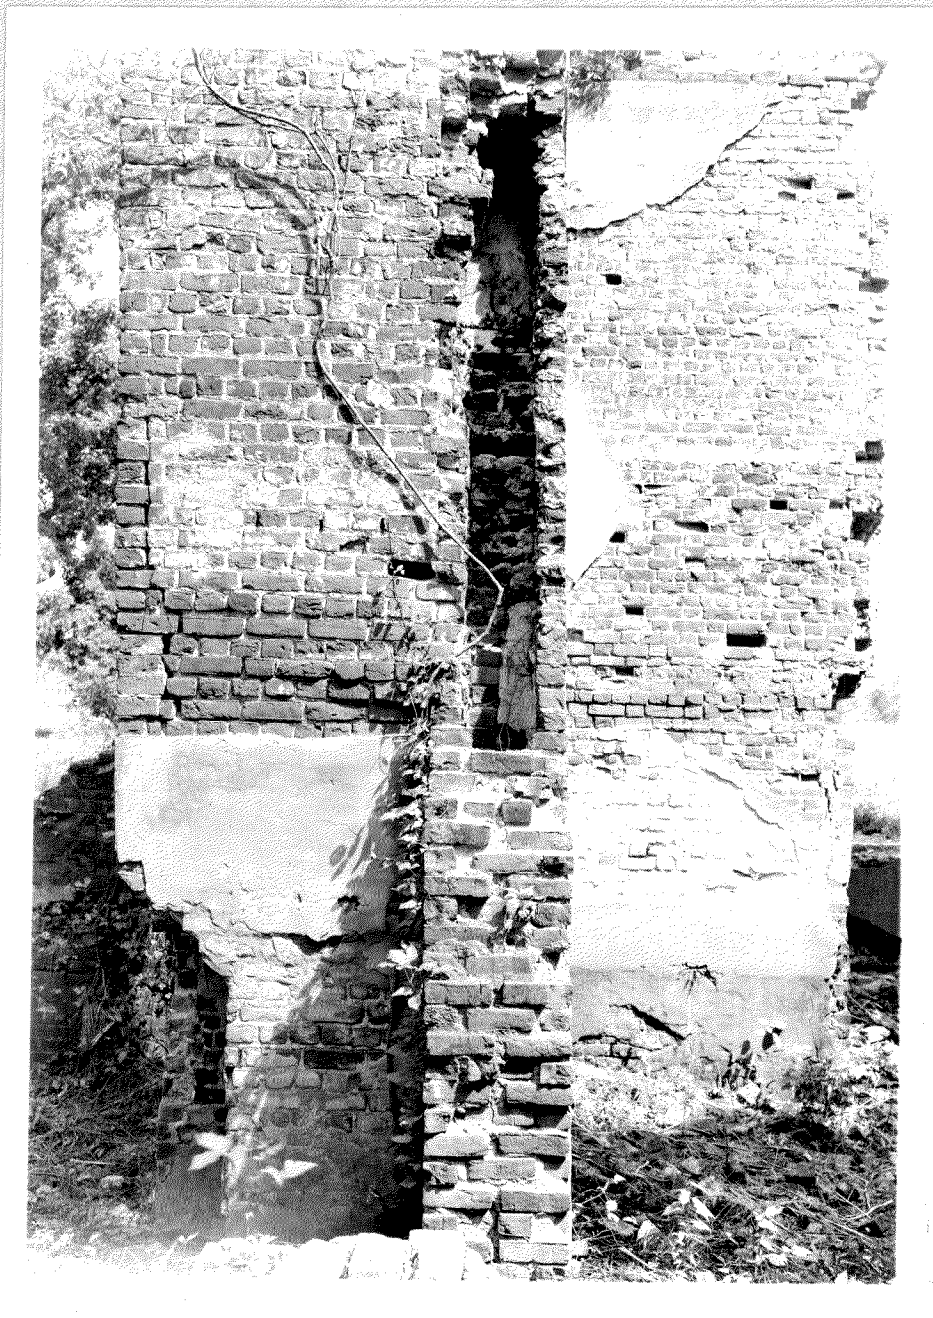
Photograph #24 - Ambler House, Jamestown Island -  
Flue cut during the modernization. This flue was cut  
partly in the chimney and partly into the partition wall.  
See photograph #23.

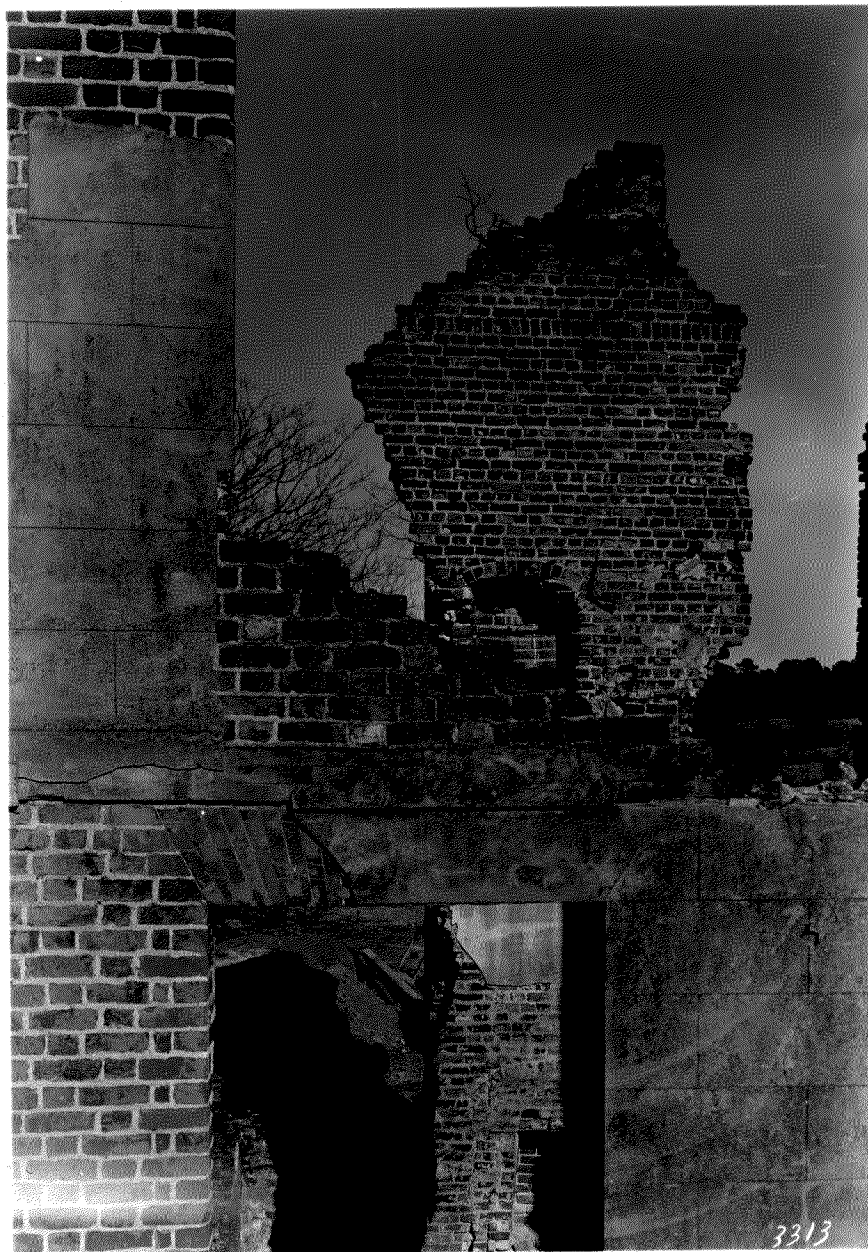
Photograph #25 - Ambler House, Jamestown Island -

The top of the northeast chimney, south side. The vertical course of headers extends around the entire chimney and is probably the plate line of the building. See photograph #7.

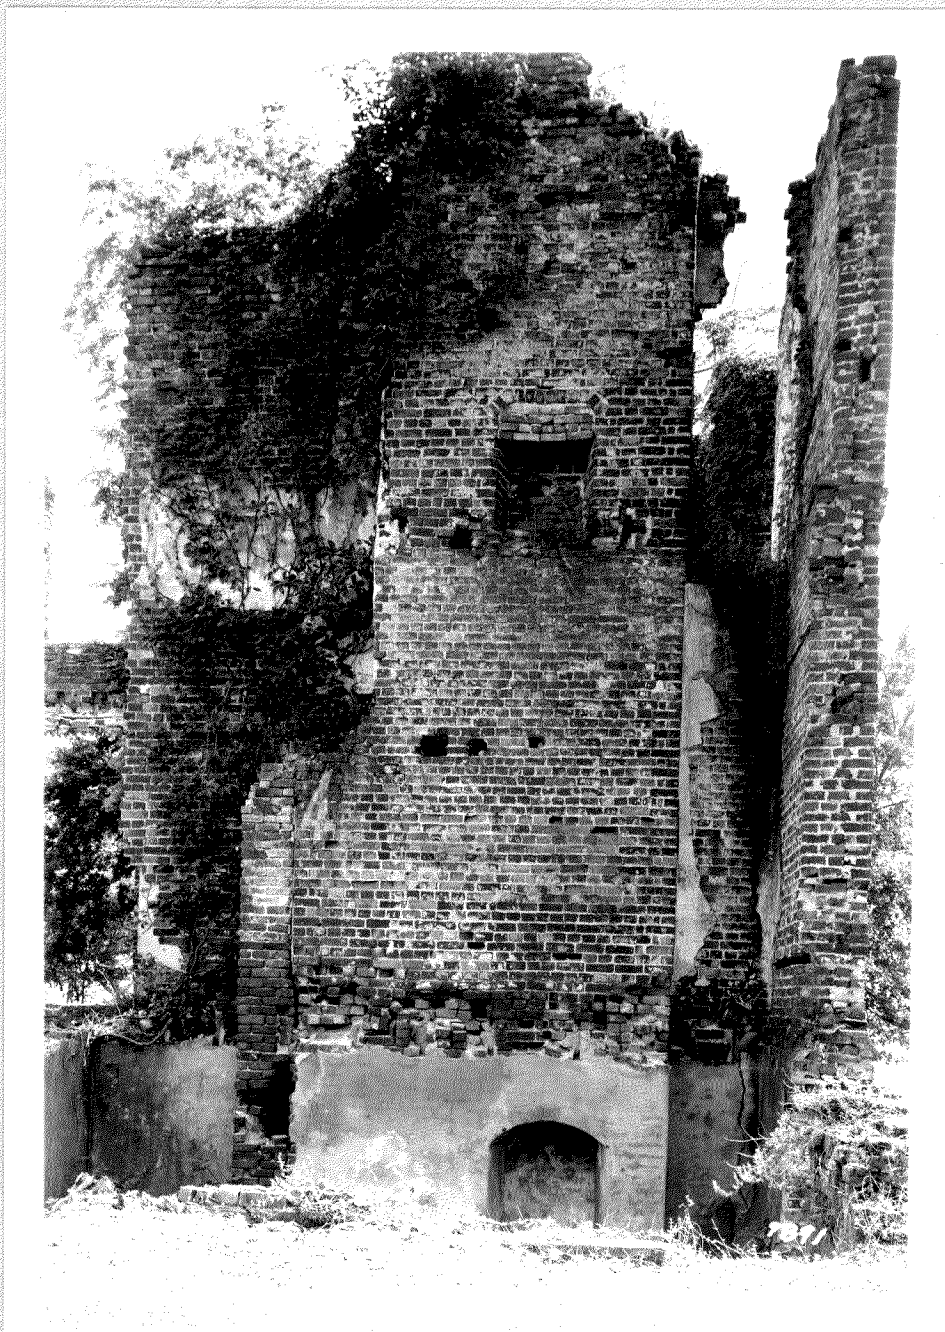
Photograph #26 - Ambler House, Jamestown Island -

The north side of the northwest chimney. Notice opening cut at a later date through partition wall between chimney and wall; also, extra chimney placed side of main chimney (left). Notice the outward leaning of exterior wall, which is  $3 \frac{1}{16}$  inches out of plumb.

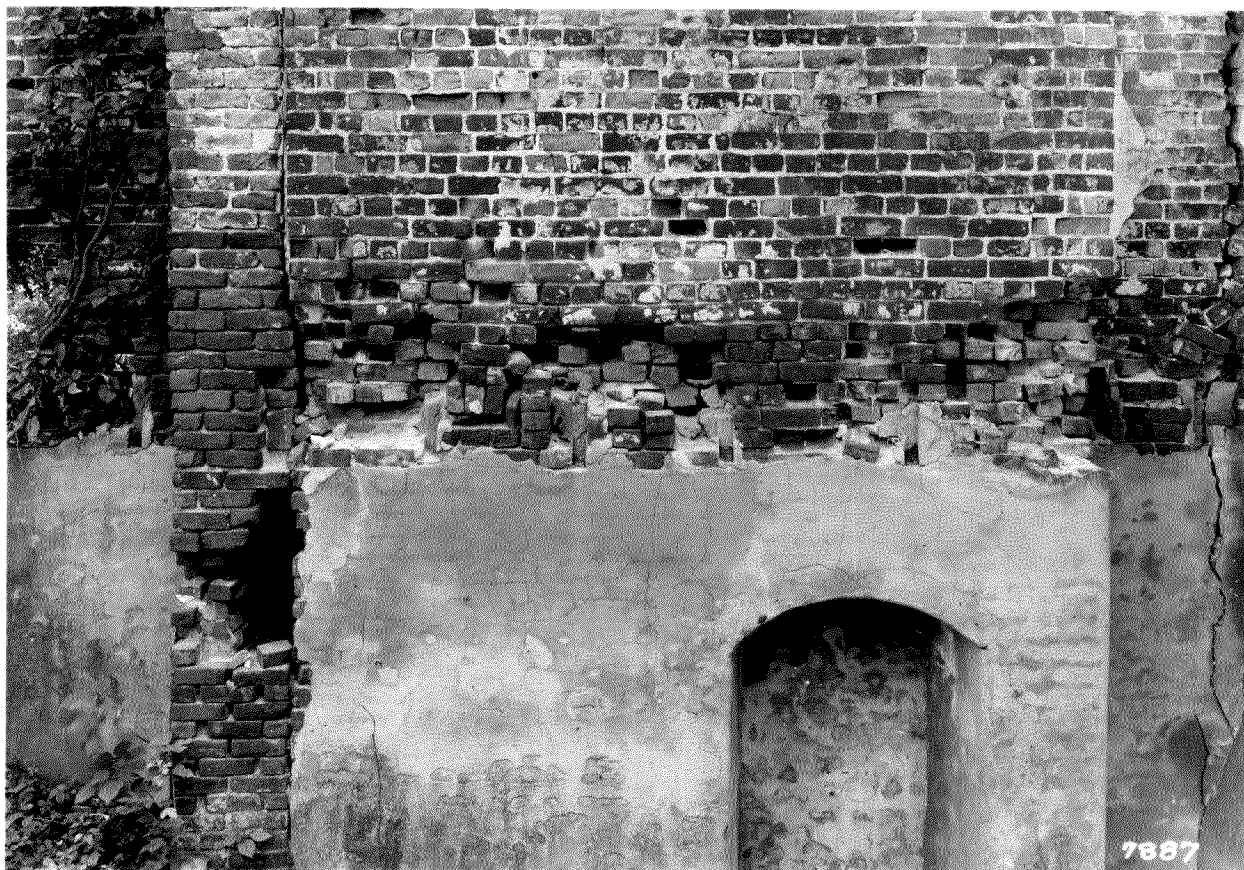
Photograph #27 - Ambler House, Jamestown Island -

The lower part of the north side of the northeast chimney. Notice the deterioration where floor joists were placed. Many of the holes shown go through the chimney. Three different periods of floor joists are discernible. Notice additional chimney on the left.

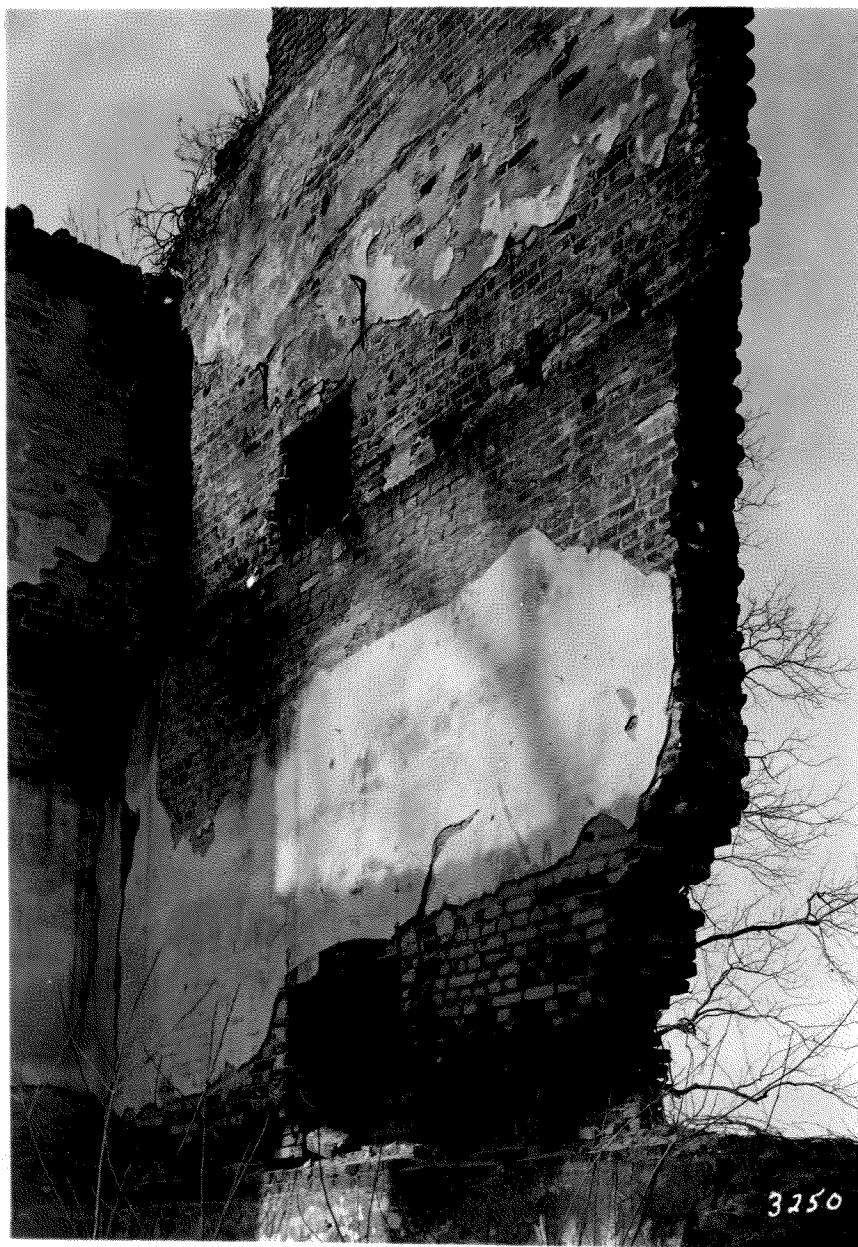
Photograph #28 - Ambler House, Jamestown Island -

The south side of the northwest chimney. Here, the deterioration is plainly shown where floor joists were formerly located. Many of these holes go through the partition walls and chimney.

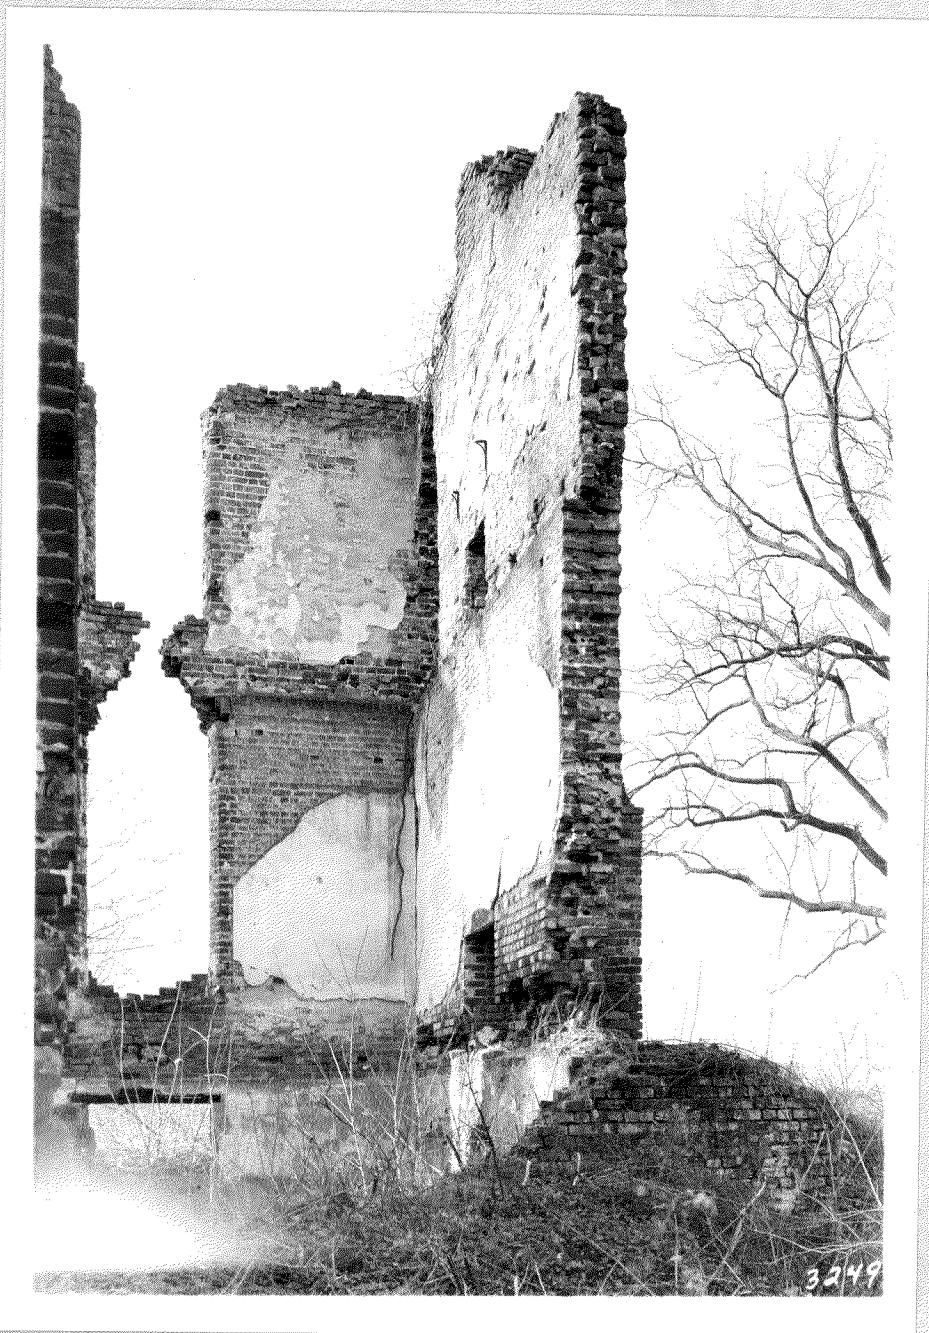
Photograph #23 - Ambler House, Jamestown Island -  
Practically the same view as shown in photograph #26.  
The west wall, here shown, leans  $3 \frac{1}{16}$  inches to the west.
