THE "ARCHER COTTAGE"  
COLONIAL NATIONAL HISTORICAL PARK  
YORKTOWN, VIRGINIA

AN ARCHITECTURAL SURVEY REPORT

Prepared June 2, 1958

GEORGE F. BENNETT, ARCHITECT  
WILLIAMSBURG

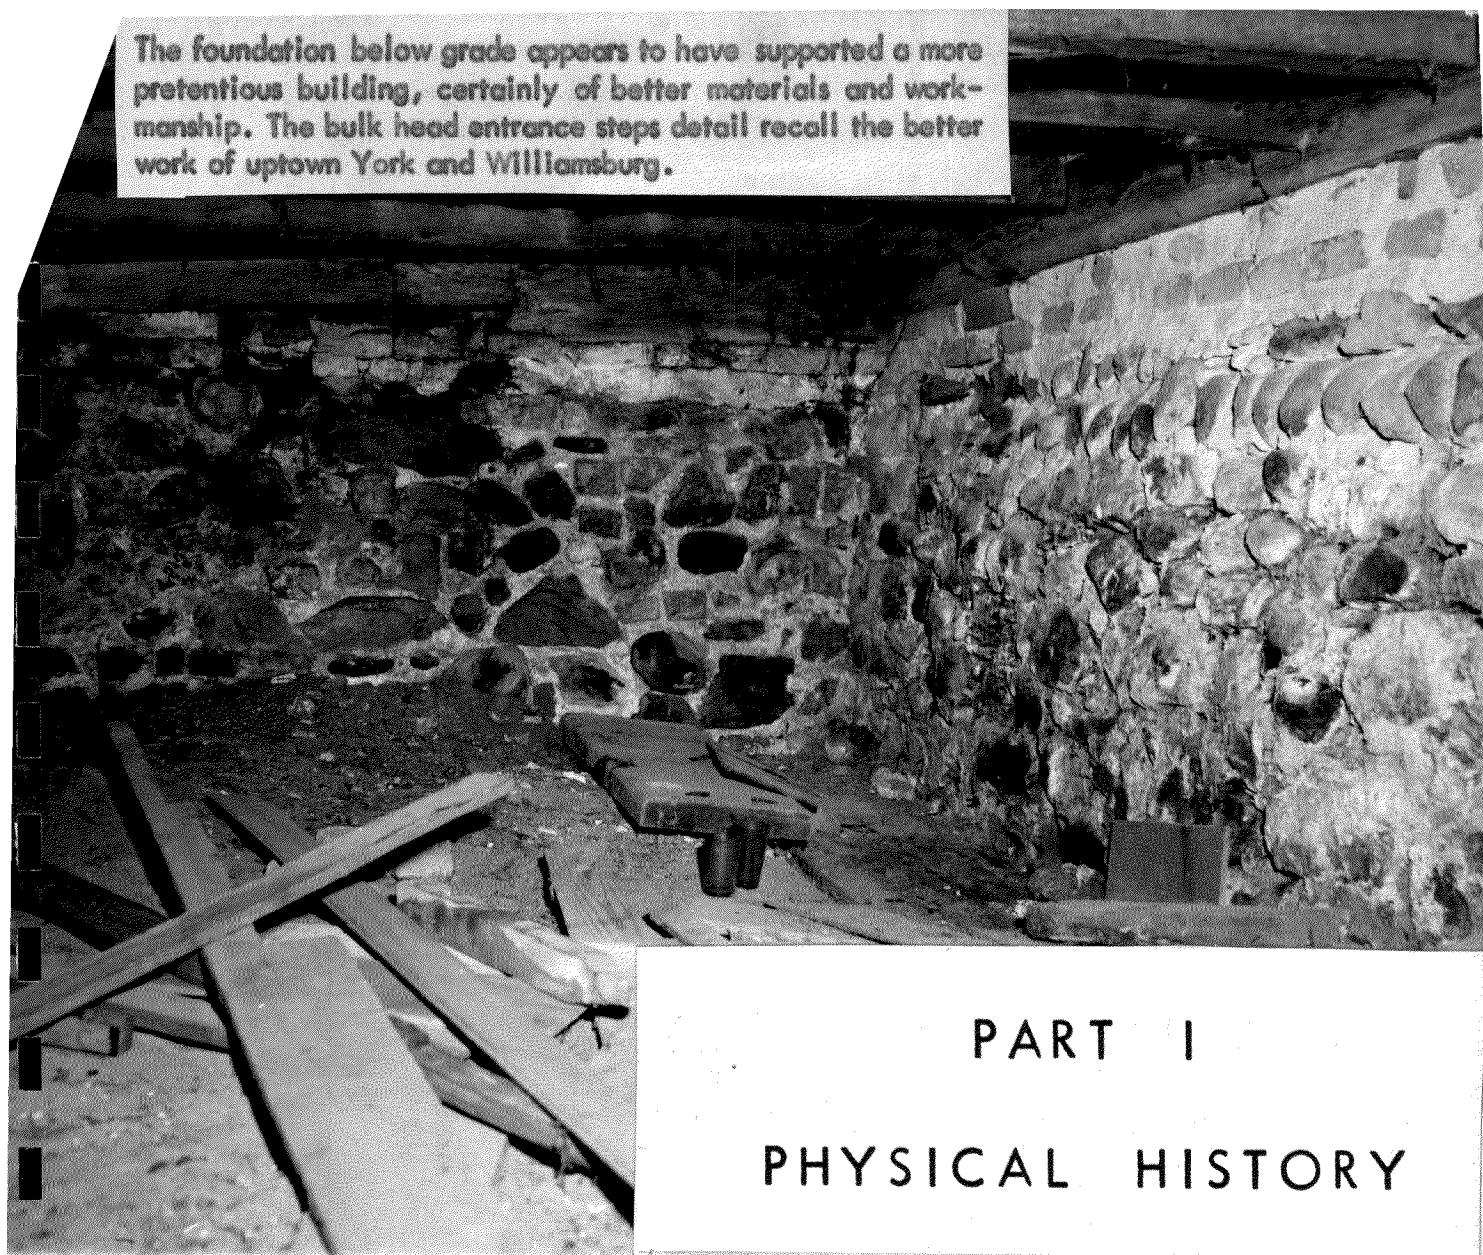
The foundation below grade appears to have supported a more pretentious building, certainly of better materials and workmanship. The bulk head entrance steps detail recall the better work of uptown York and Williamsburg.

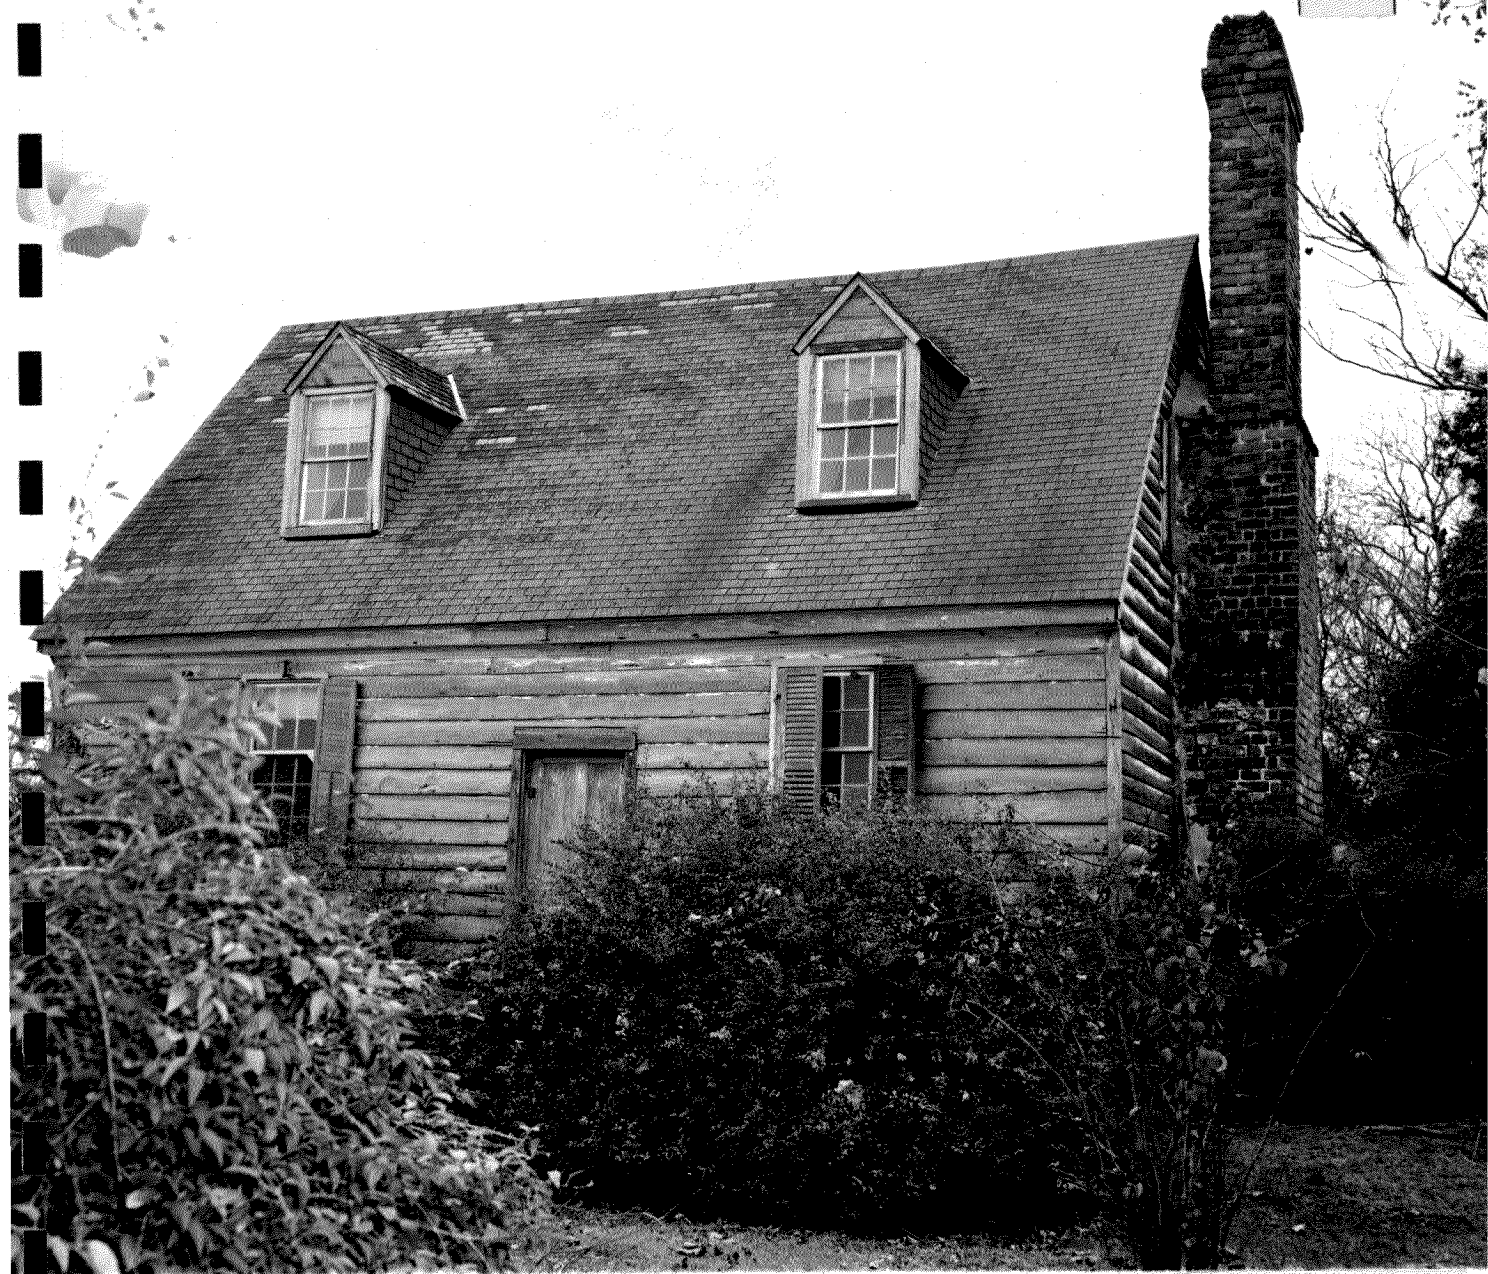
The west end and north front elevations present a pleasing composition typical of the small house dating from late 18th century to first quarter of the 19th century. The historical records and architectural research indicates the whole structure above ground was built after the fire of 1814 on an earlier foundation of about same dimensions.

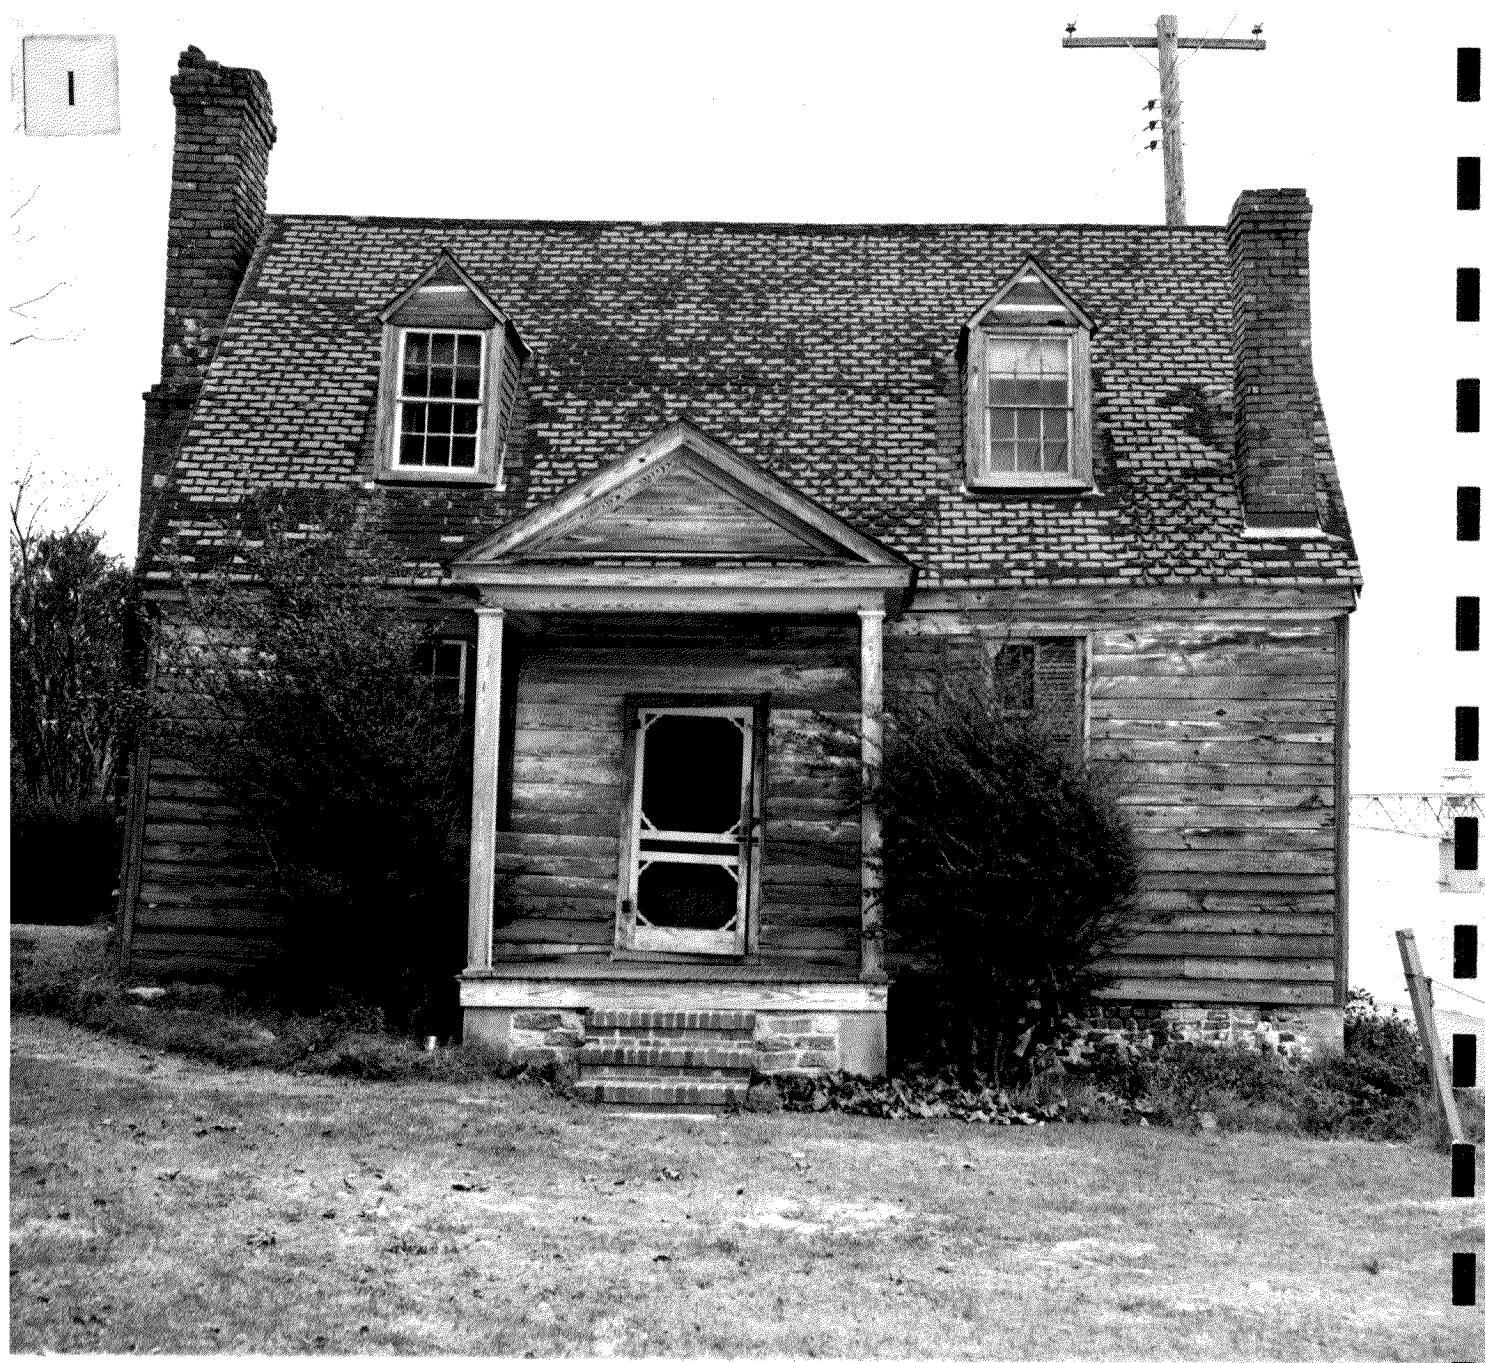
The south front elevation may have been the "entrance" since the door opening on north front appears to have been added, at least it is not framed like the above. The "modern" porch and riverside chimney were removed during the architectural investigation (middle of April 1958).

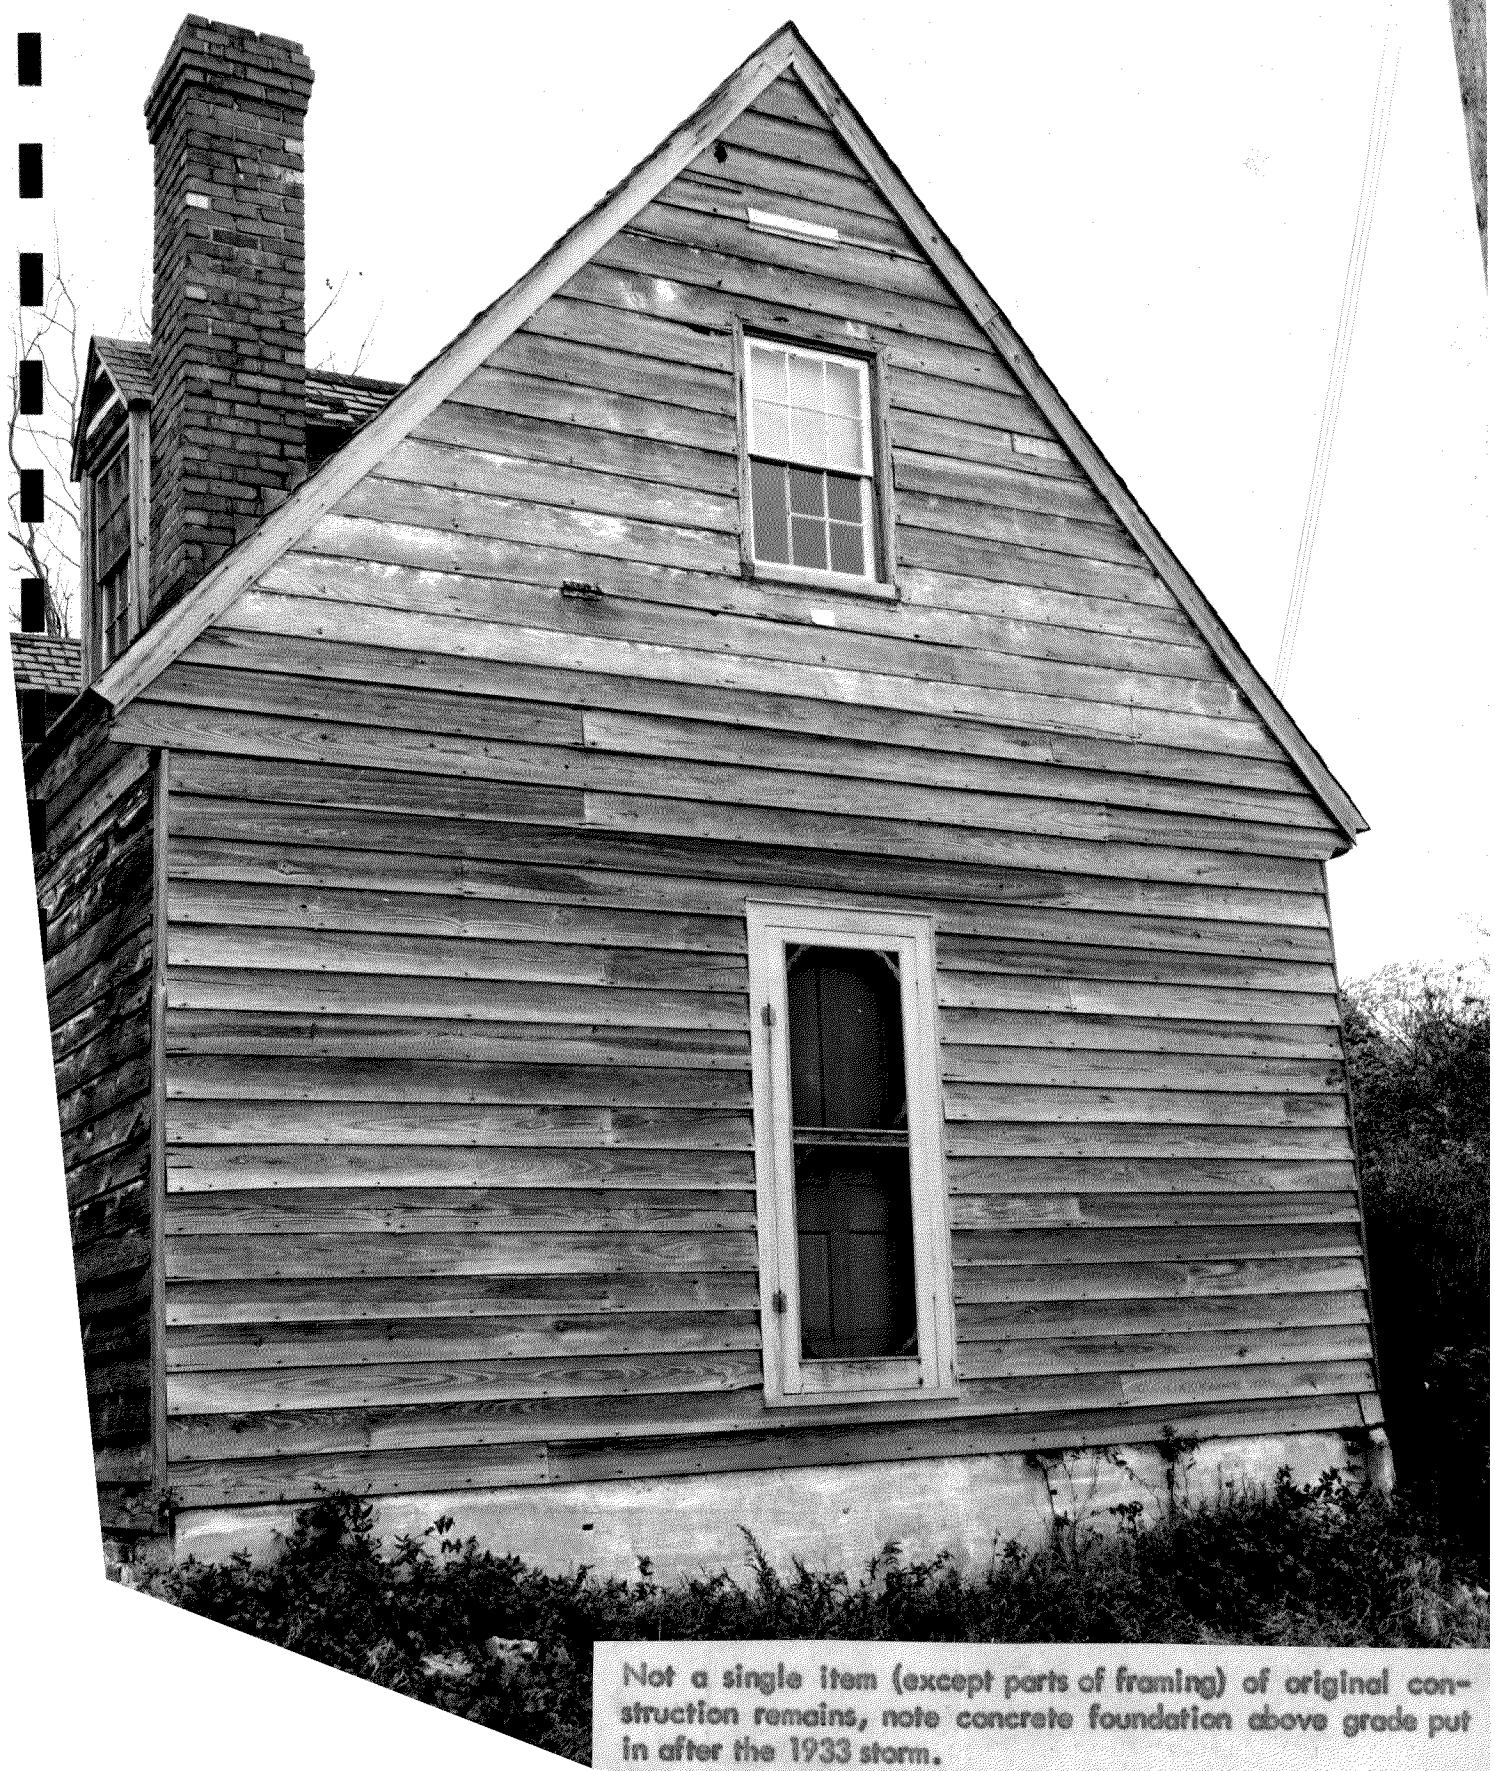
Not a single item (except parts of framing) of original construction remains, note concrete foundation above grade put in after the 1933 storm.

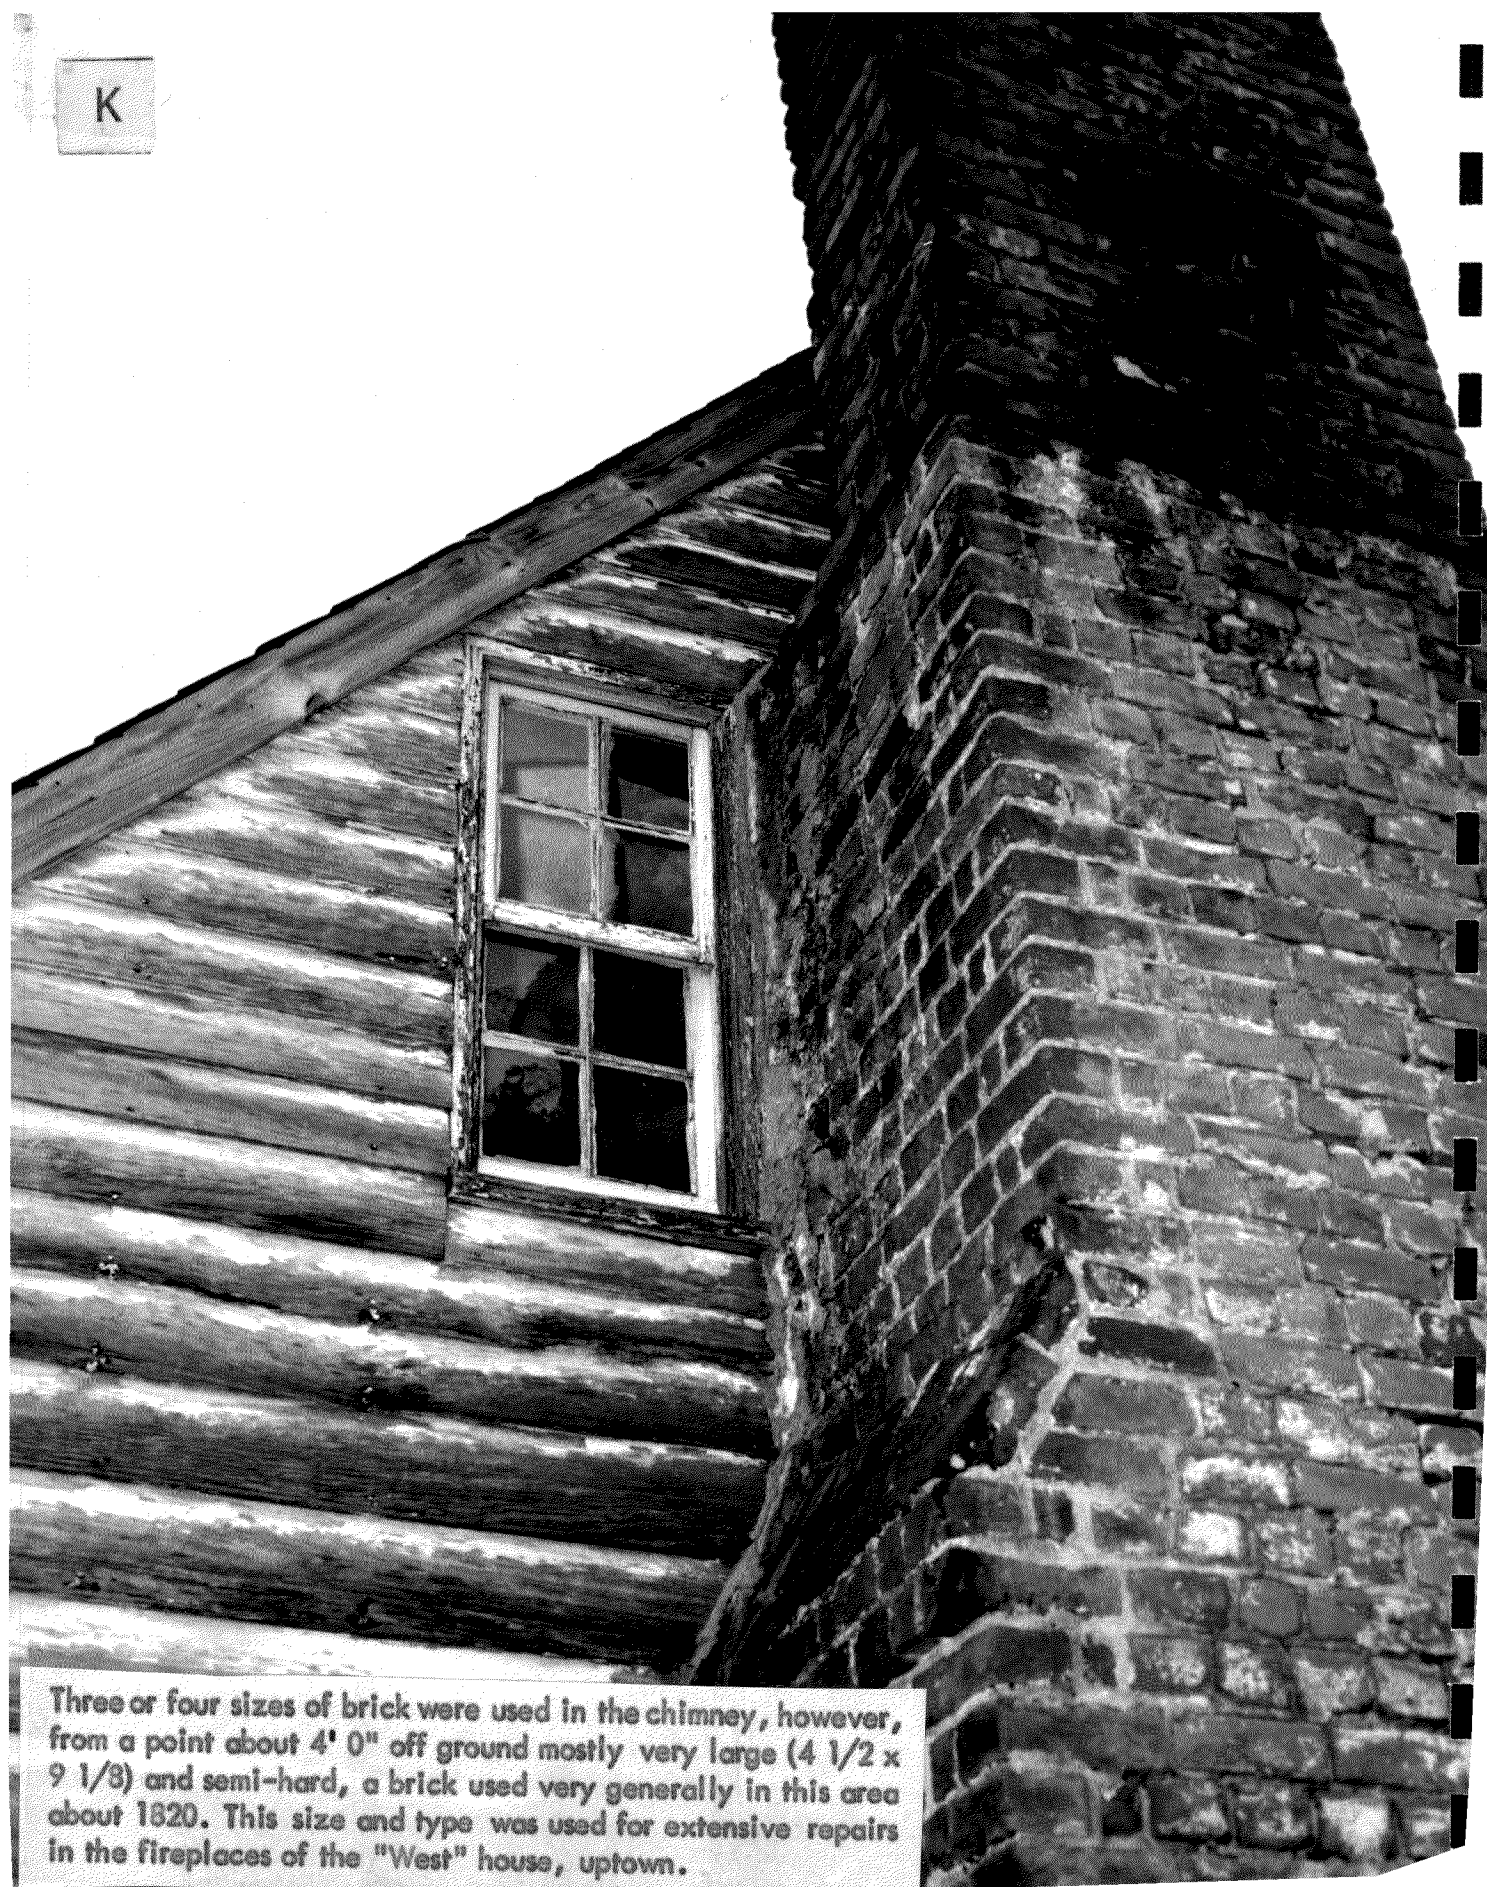
K

Three or four sizes of brick were used in the chimney, however, from a point about 4' 0" off ground mostly very large ( $4\frac{1}{2} \times 9\frac{1}{8}$ ) and semi-hard, a brick used very generally in this area about 1820. This size and type was used for extensive repairs in the fireplaces of the "West" house, uptown.

The large brick as mentioned appears to have been new at the time of construction, the other sizes, however, are reused brick and had been in fire, and at lower levels are mixed with the larger "new" brick thus indicating a rebuilding after a fire (the writer thinks the fire of 1814).

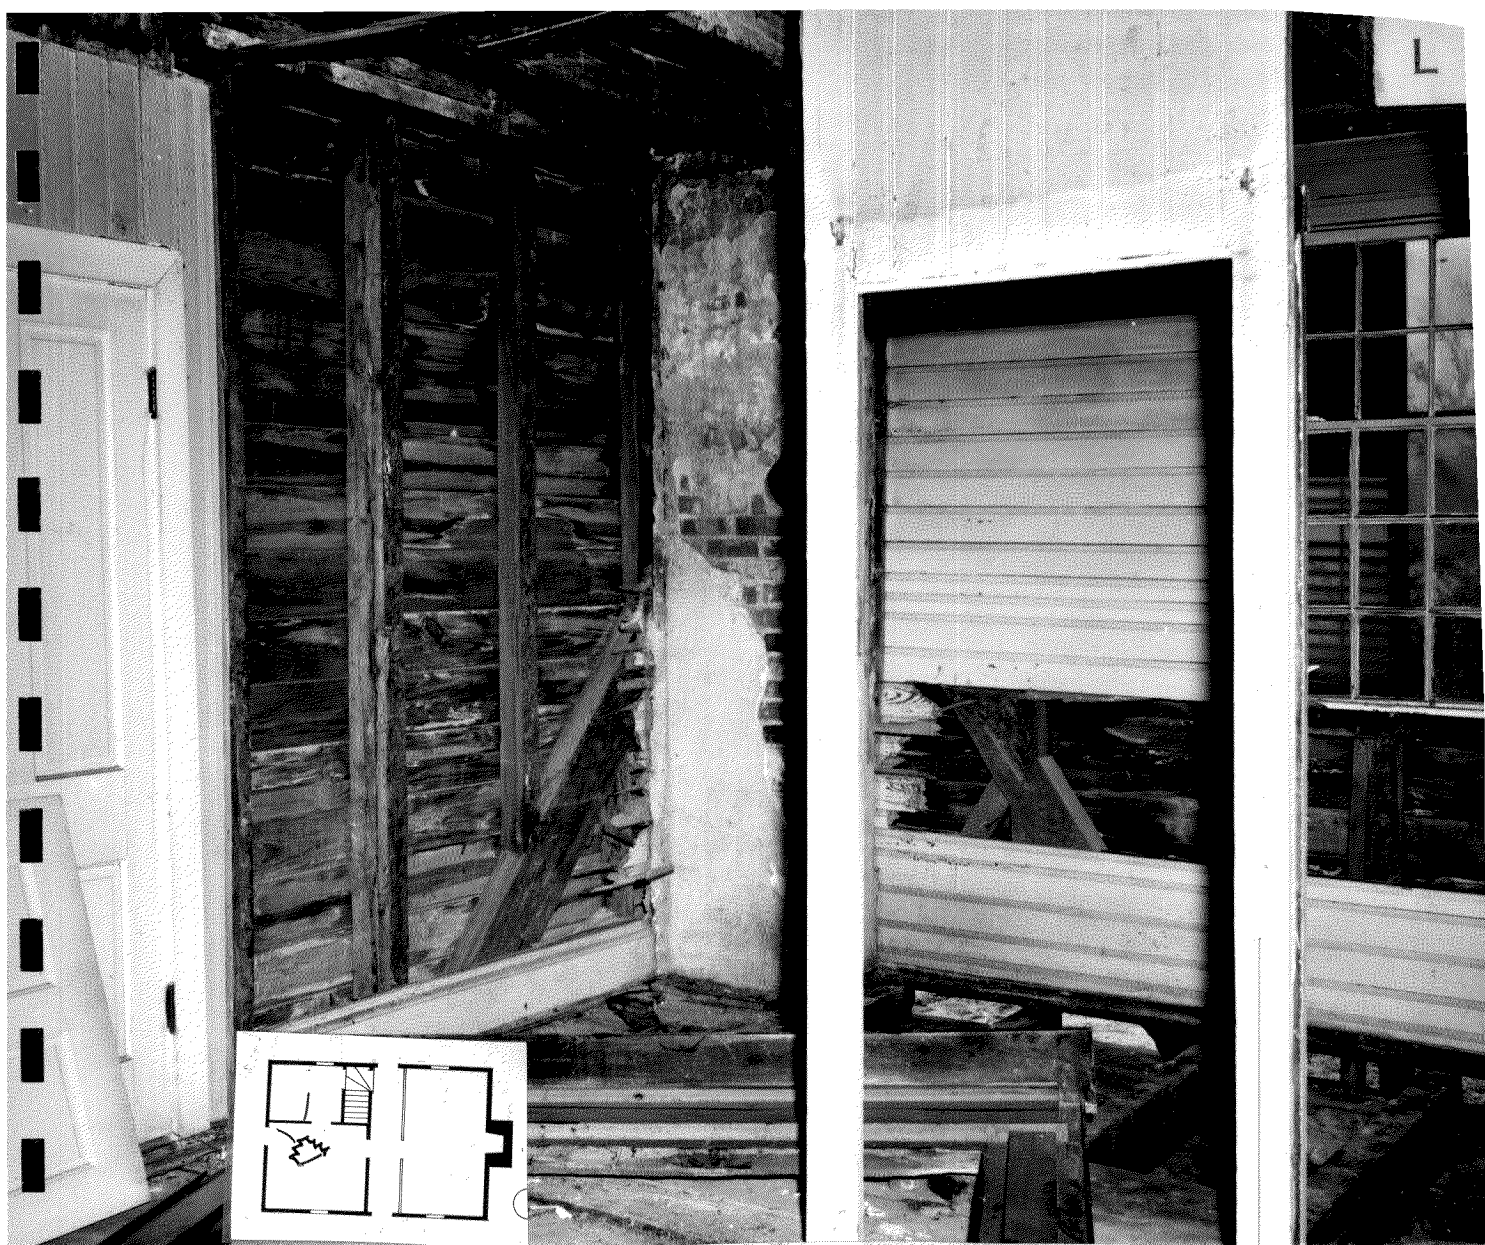
Originally a window had been at door location, and the window at right is right for location but was not "trimmed". This room was ceiled with beaded boards about 1913 (removed April 1958). For a long time this room may have been a store or shop since all the timbers are smoked and aged, also only one set of nail hobs remain after removal of beaded siding.

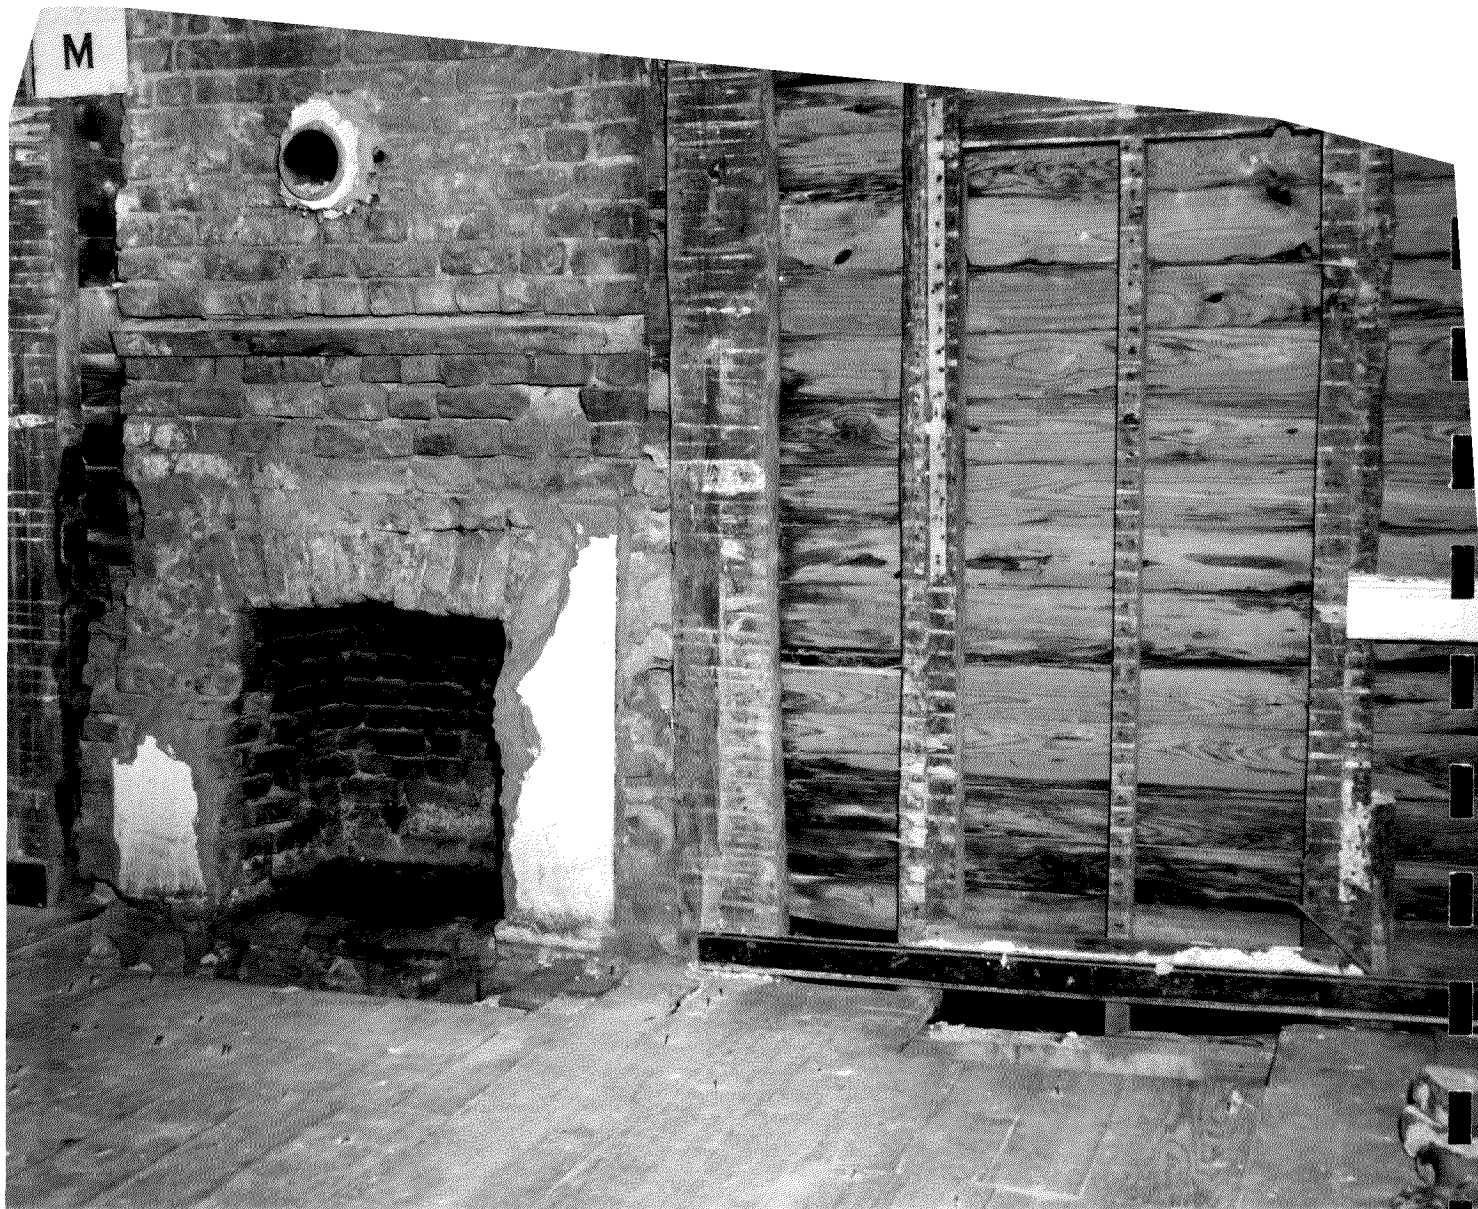
M

The main posts at side of chimney are salvaged timbers as are all structural members except rafters. The studs and headers show two sets of lath nails, indicating plaster replacement, that is, side walls only. The ceiling has been plastered once and more recently "ceiled" with beaded boards. The poplar nailing block strip over fireplace opening has one set of nail holes matching a very late type mouth which means that for a long time no mouth was used.

The framing for "late" door opening mentioned elsewhere is plainly shown.

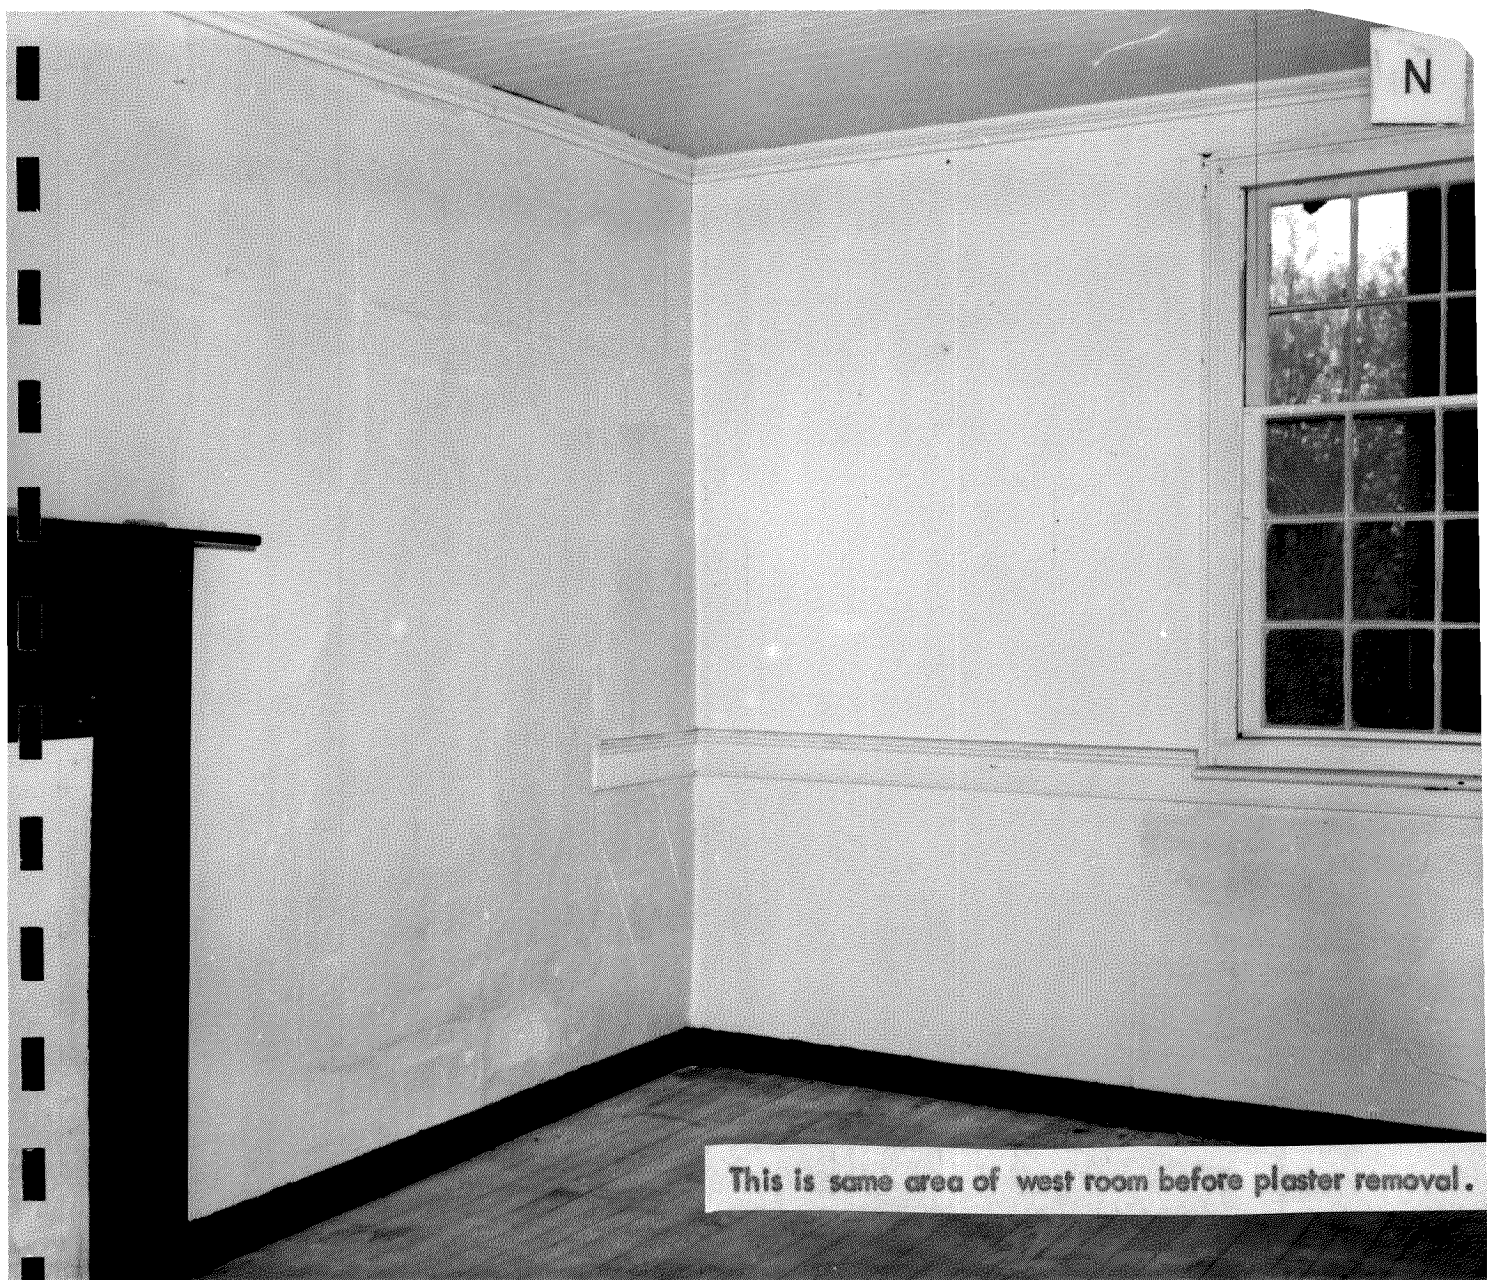
N

This is same area of west room before plaster removal.

The glass is 8 x 10, some sash are replacement and mutins and rails shapes and dimensions vary.

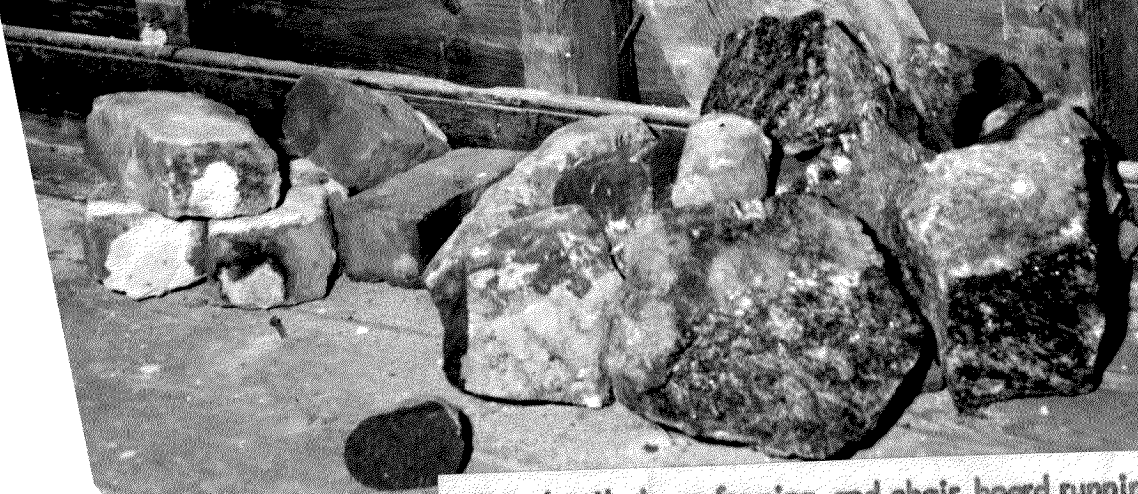
O

This detail shows framing and chair board running in-  
to window sill. The brick and stone fragments - from  
the foundation wall shown here indicate typical fire  
damage to material reused in this structure.

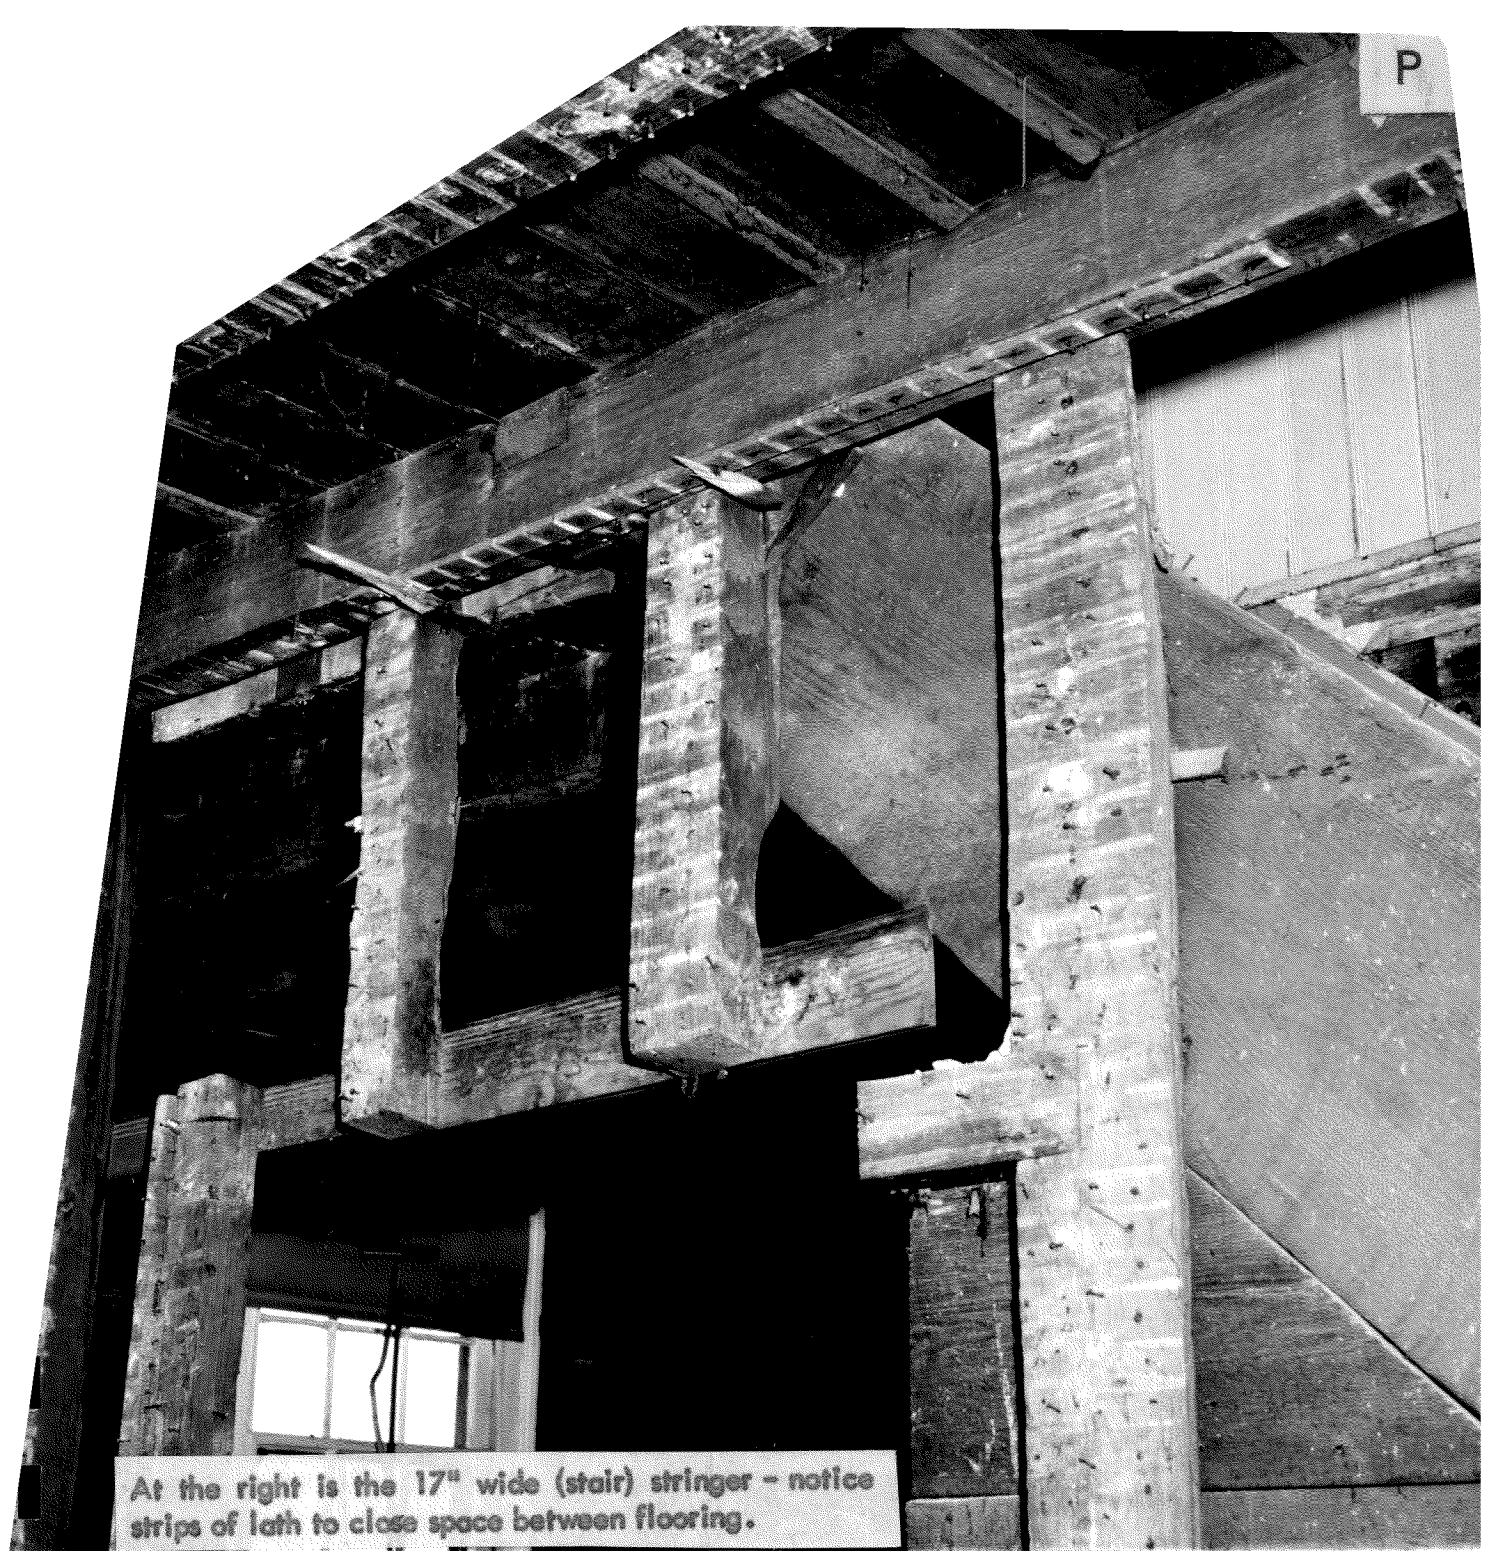
At the right is the 17" wide (stair) stringer - notice strips of lath to close space between flooring.

At the right, part of freader is still in place, it has been removed at left, but the stud is a continuation of the piece to its left, this of course determines the door framing width.

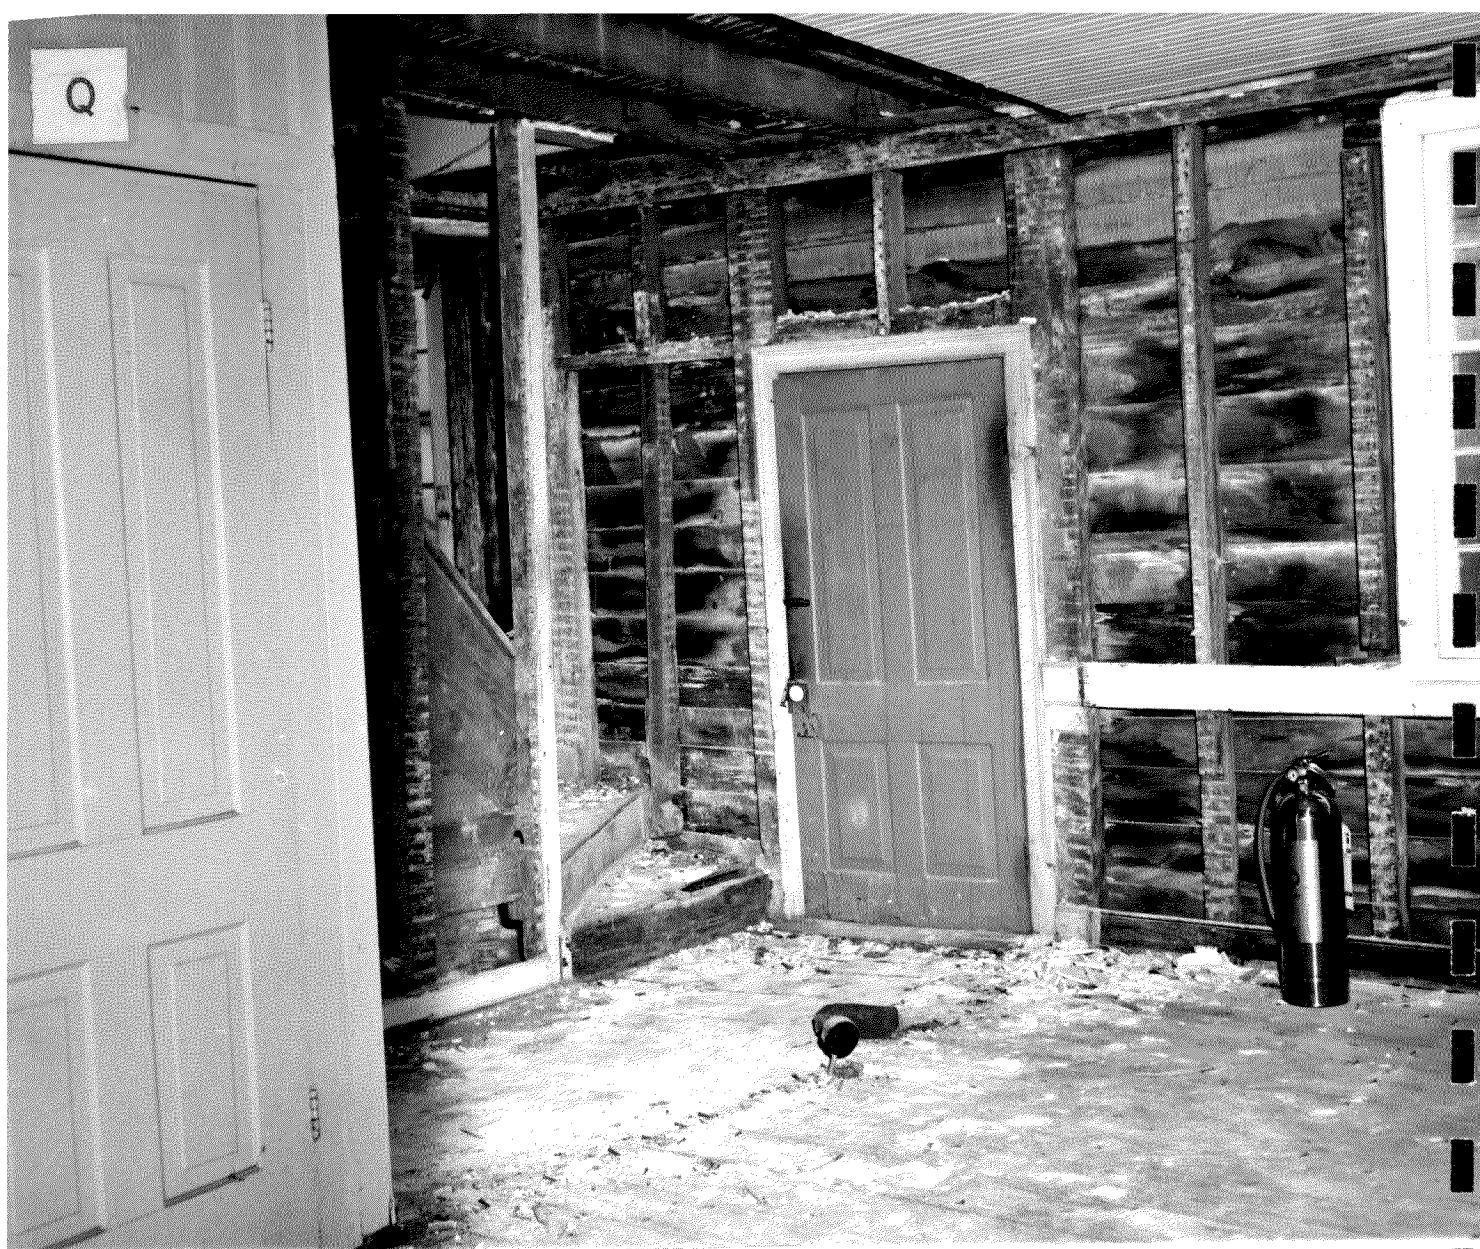
Q

West room, looking toward entrance door, the partition and door at left are of the 1913 remodelling.
