THE "ARCHER COTTAGE"  
COLONIAL NATIONAL HISTORICAL PARK  
YORKTOWN, VIRGINIA

AN ARCHITECTURAL SURVEY REPORT

Prepared June 2, 1958

GEORGE F. BENNETT, ARCHITECT  
WILLIAMSBURG

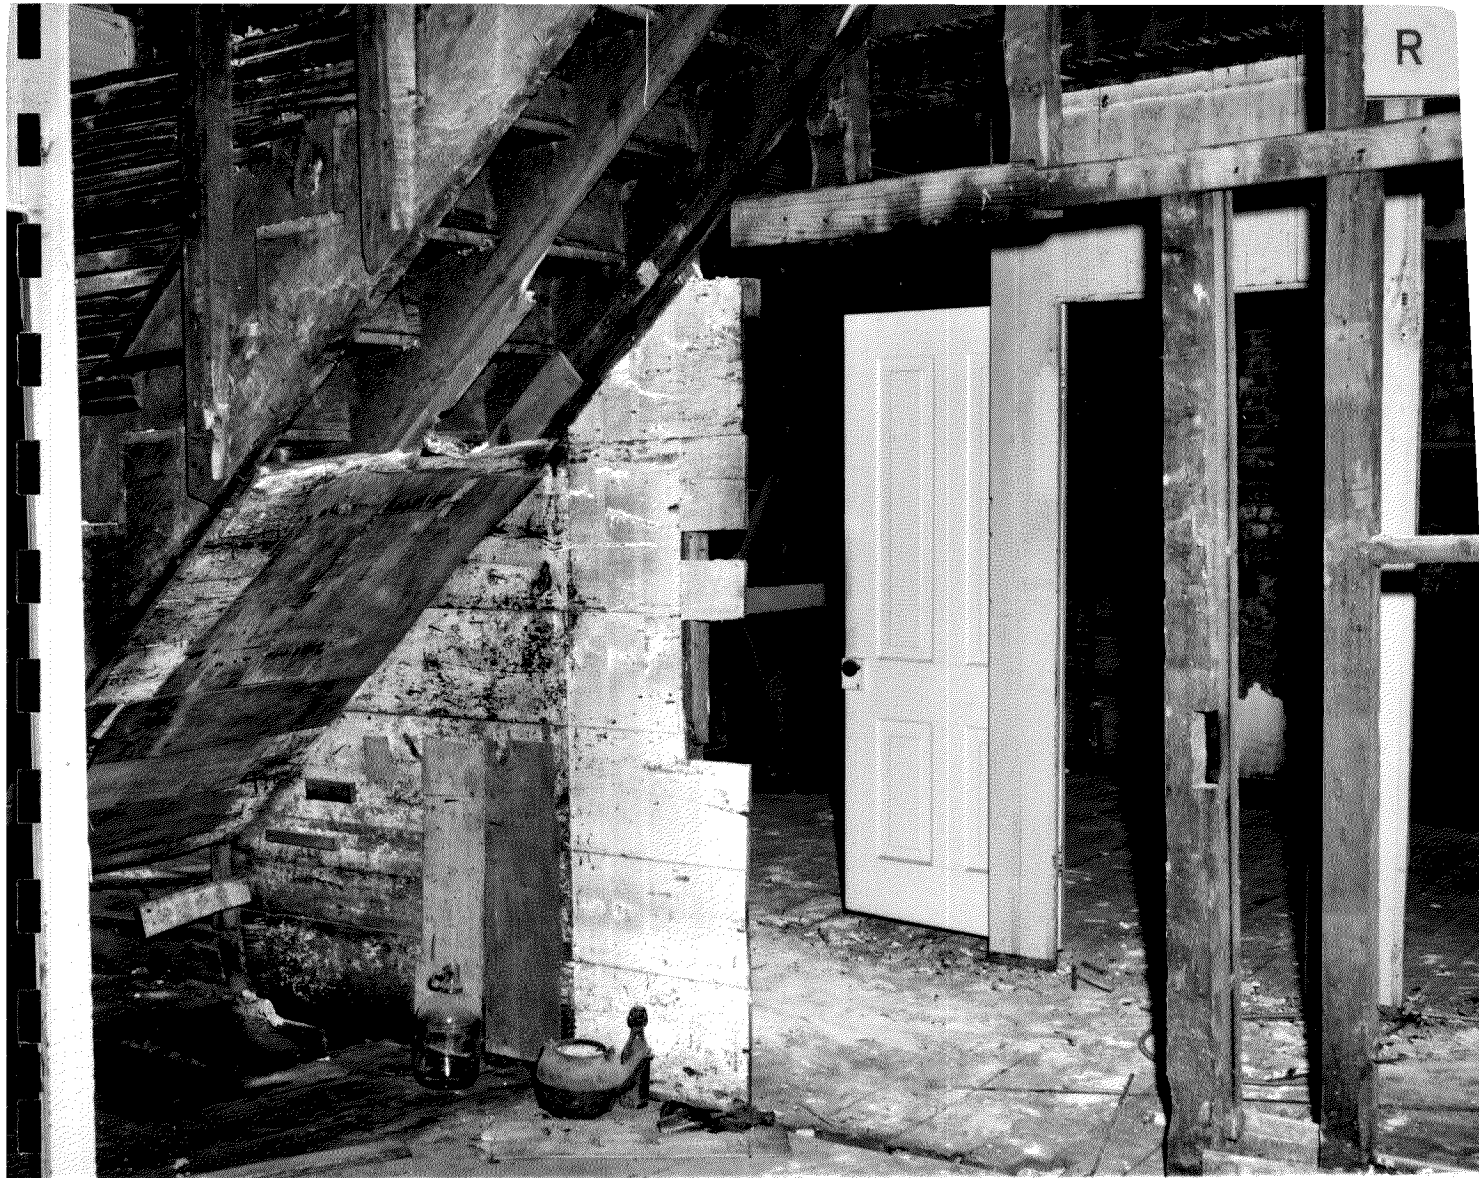
This room was the store or shop. The far door is same as shown here then later boarded in as shown by several pieces left for the illustration.

The far partition is part of the 1913 remodelling.

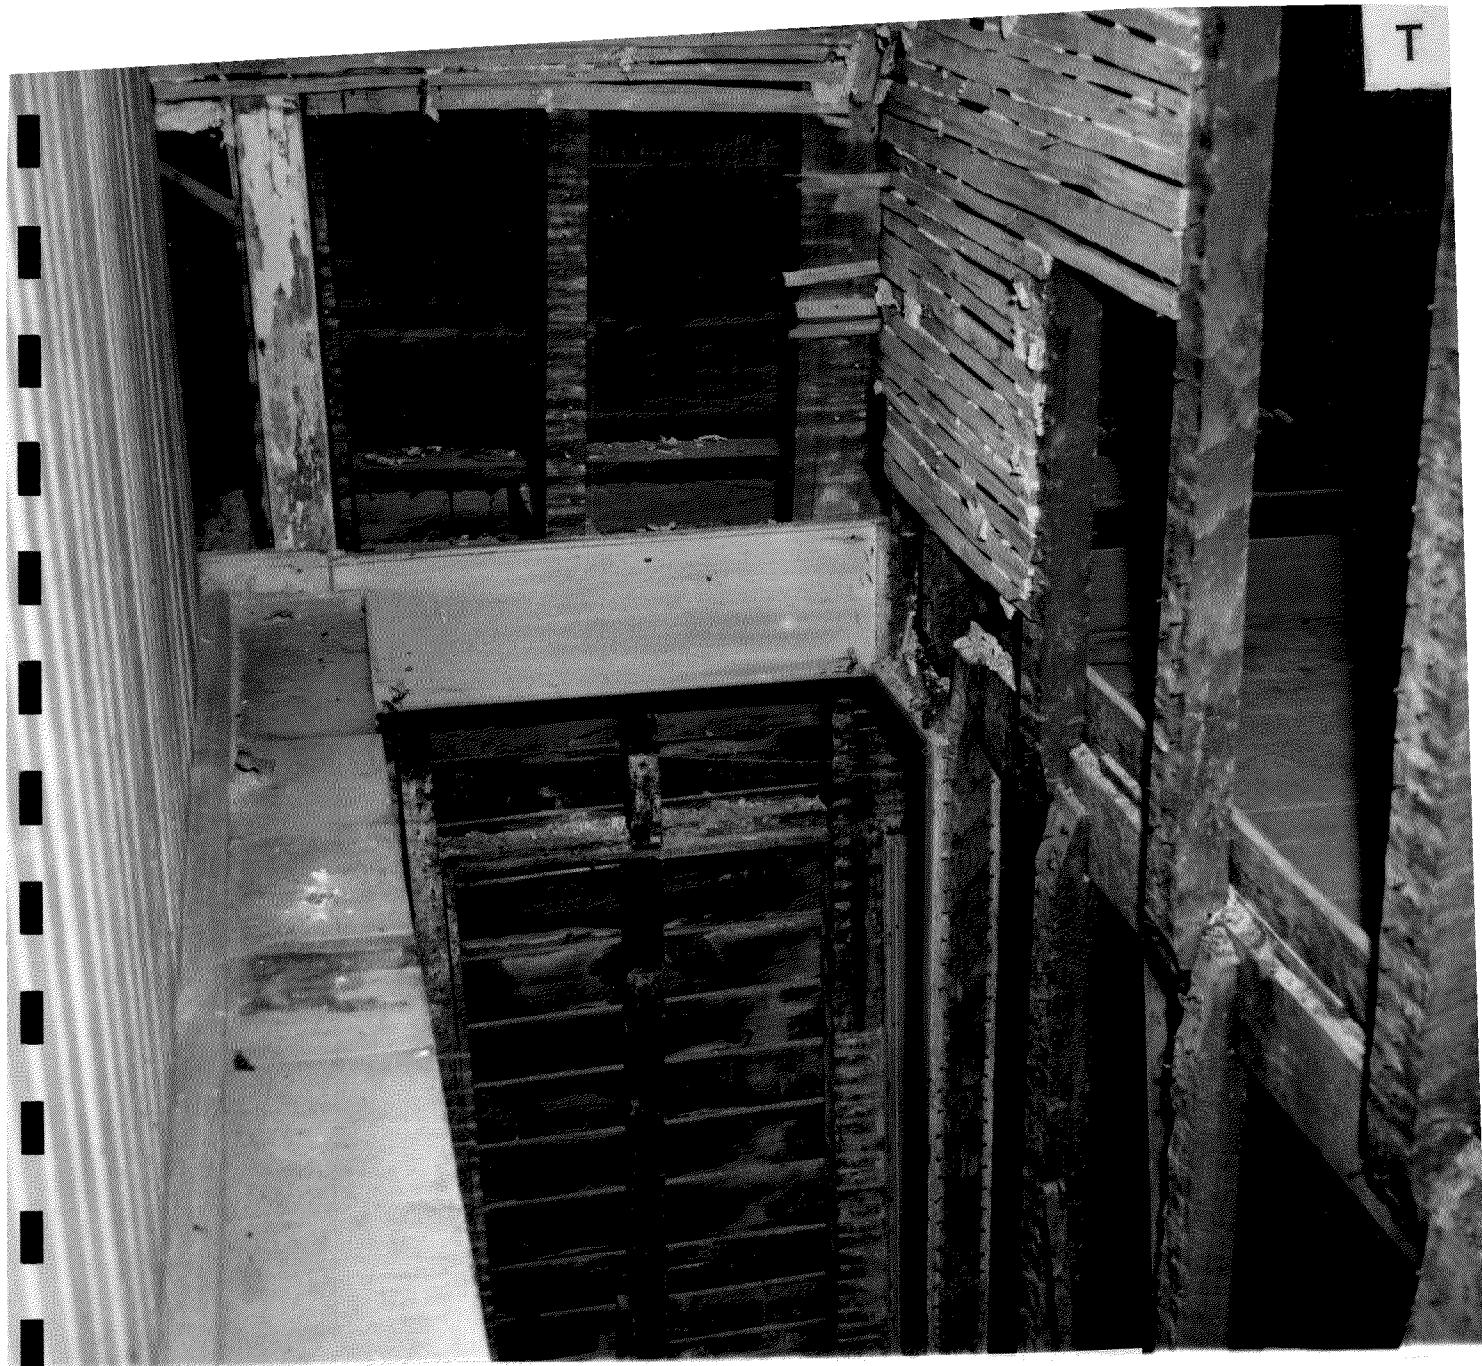
The stair entrance is at the front door, and another door to stair from store or shop is shown landing at the third winder step.

At left evidence remains of the original "hand rail."

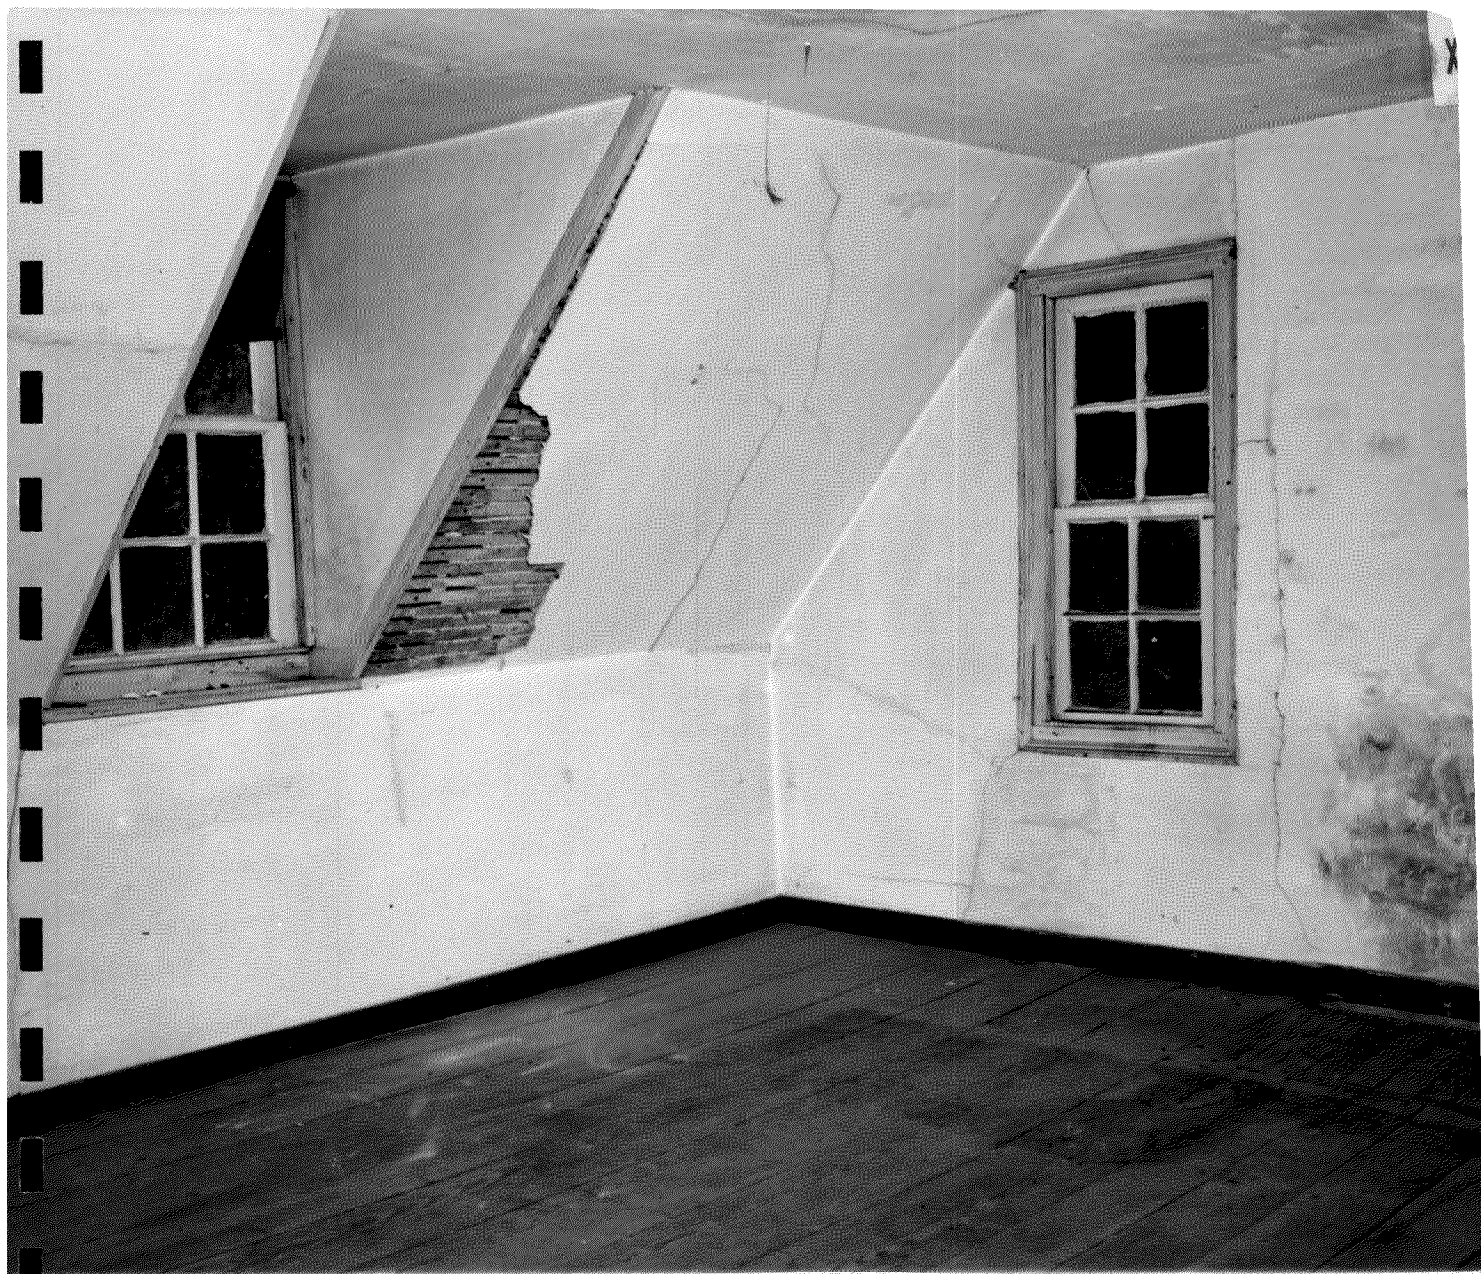
Same room before plaster removal, the fireplace plastered over as shown. The window and door trim has the profile shown in sheet 3 of the measured drawings.

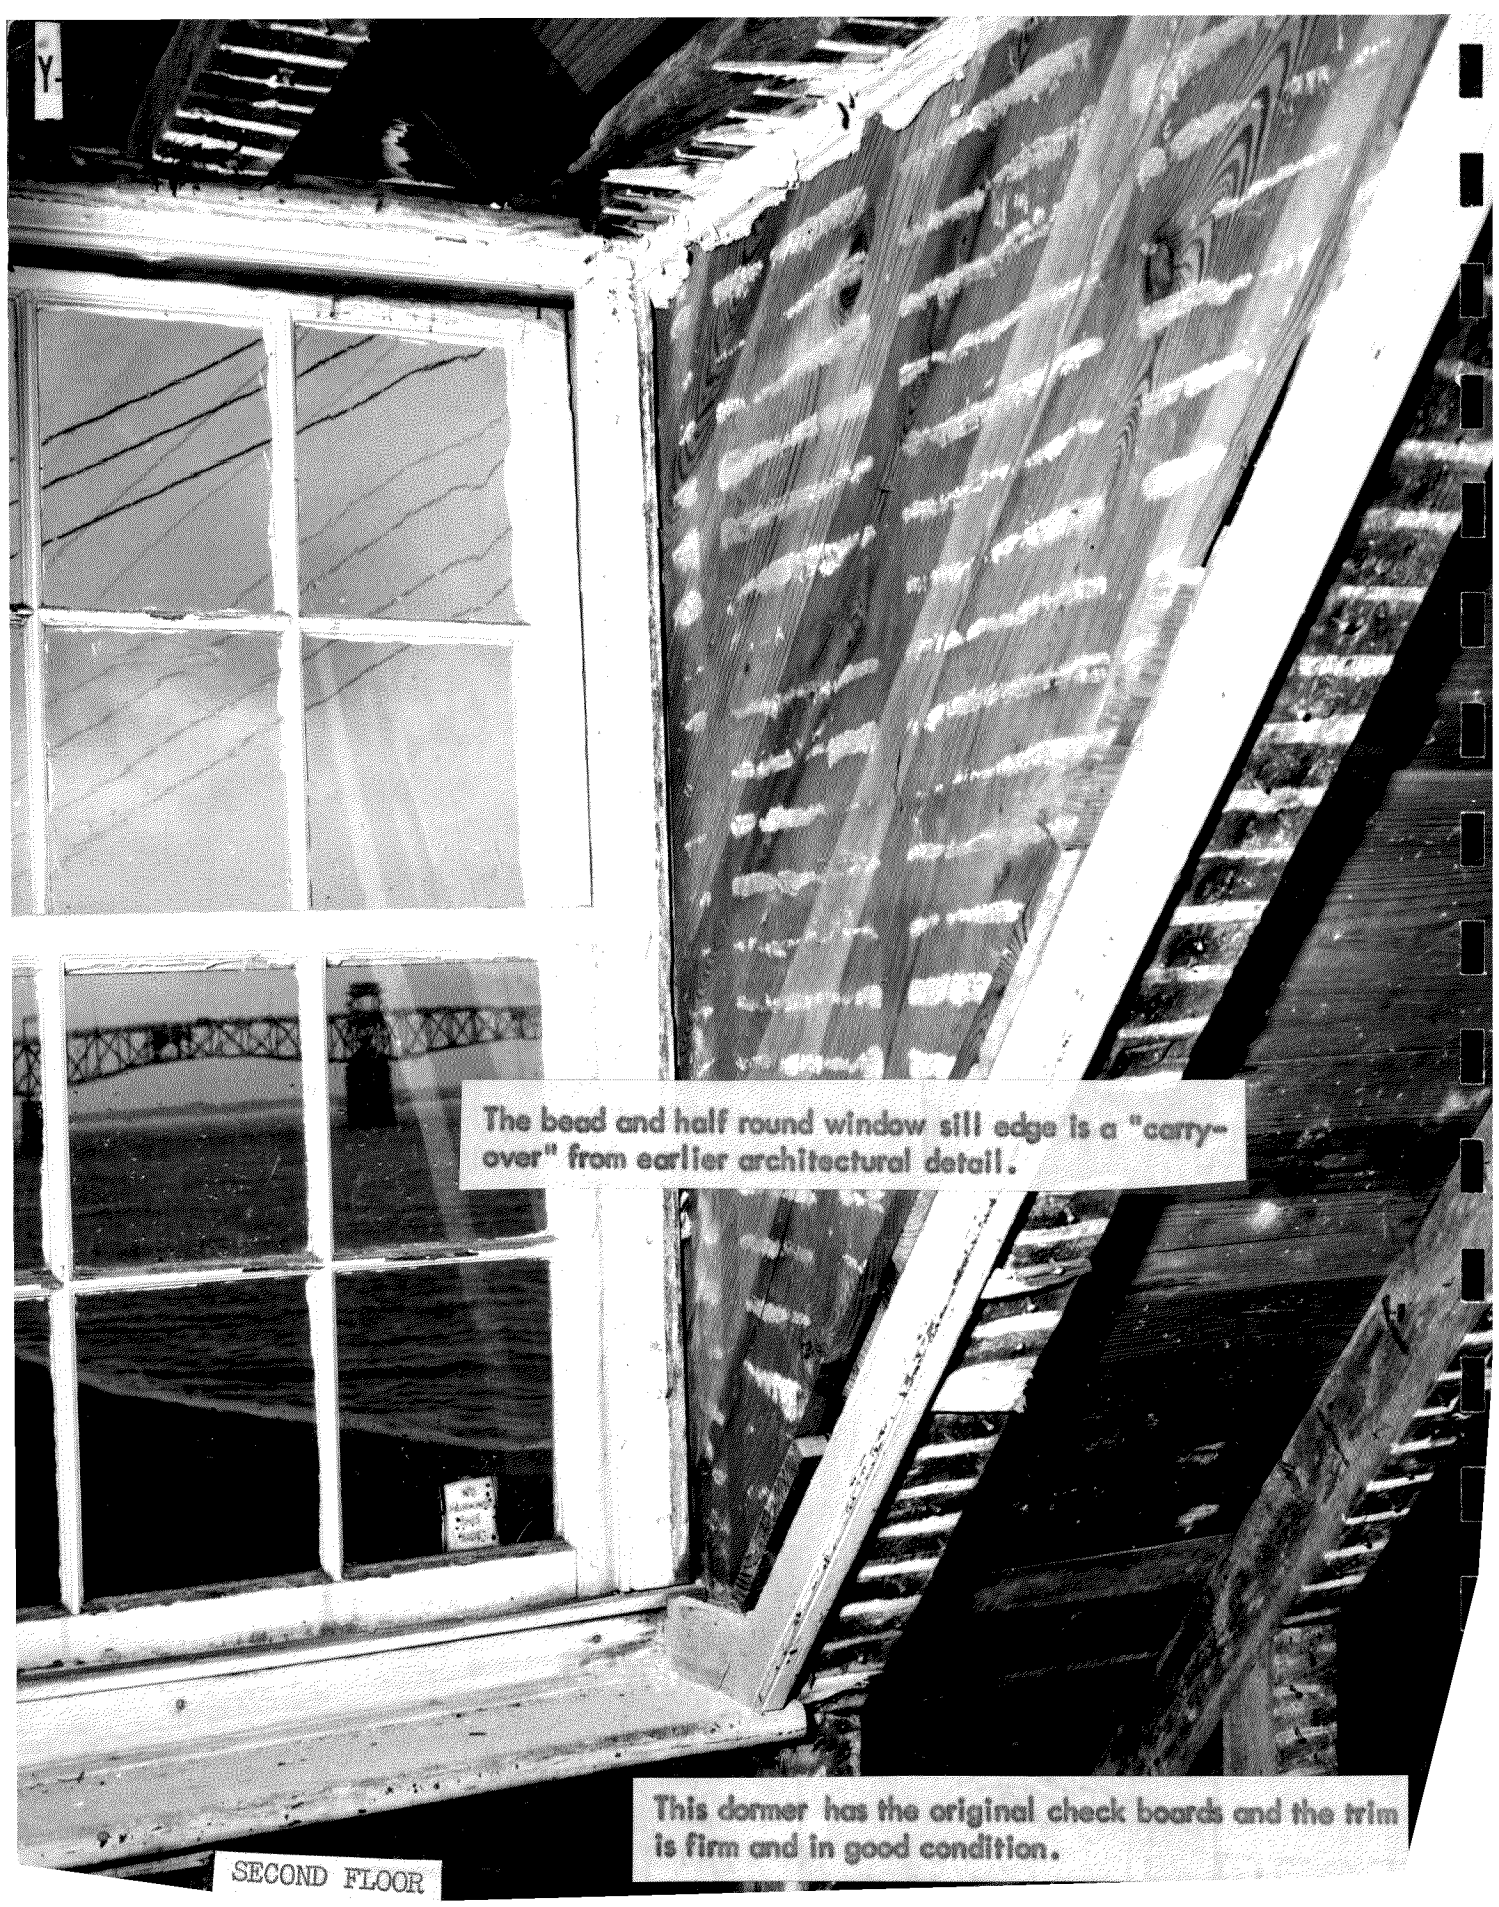
Y-

The bead and half round window sill edge is a "carry-over" from earlier architectural detail.

This dormer has the original check boards and the trim is firm and in good condition.

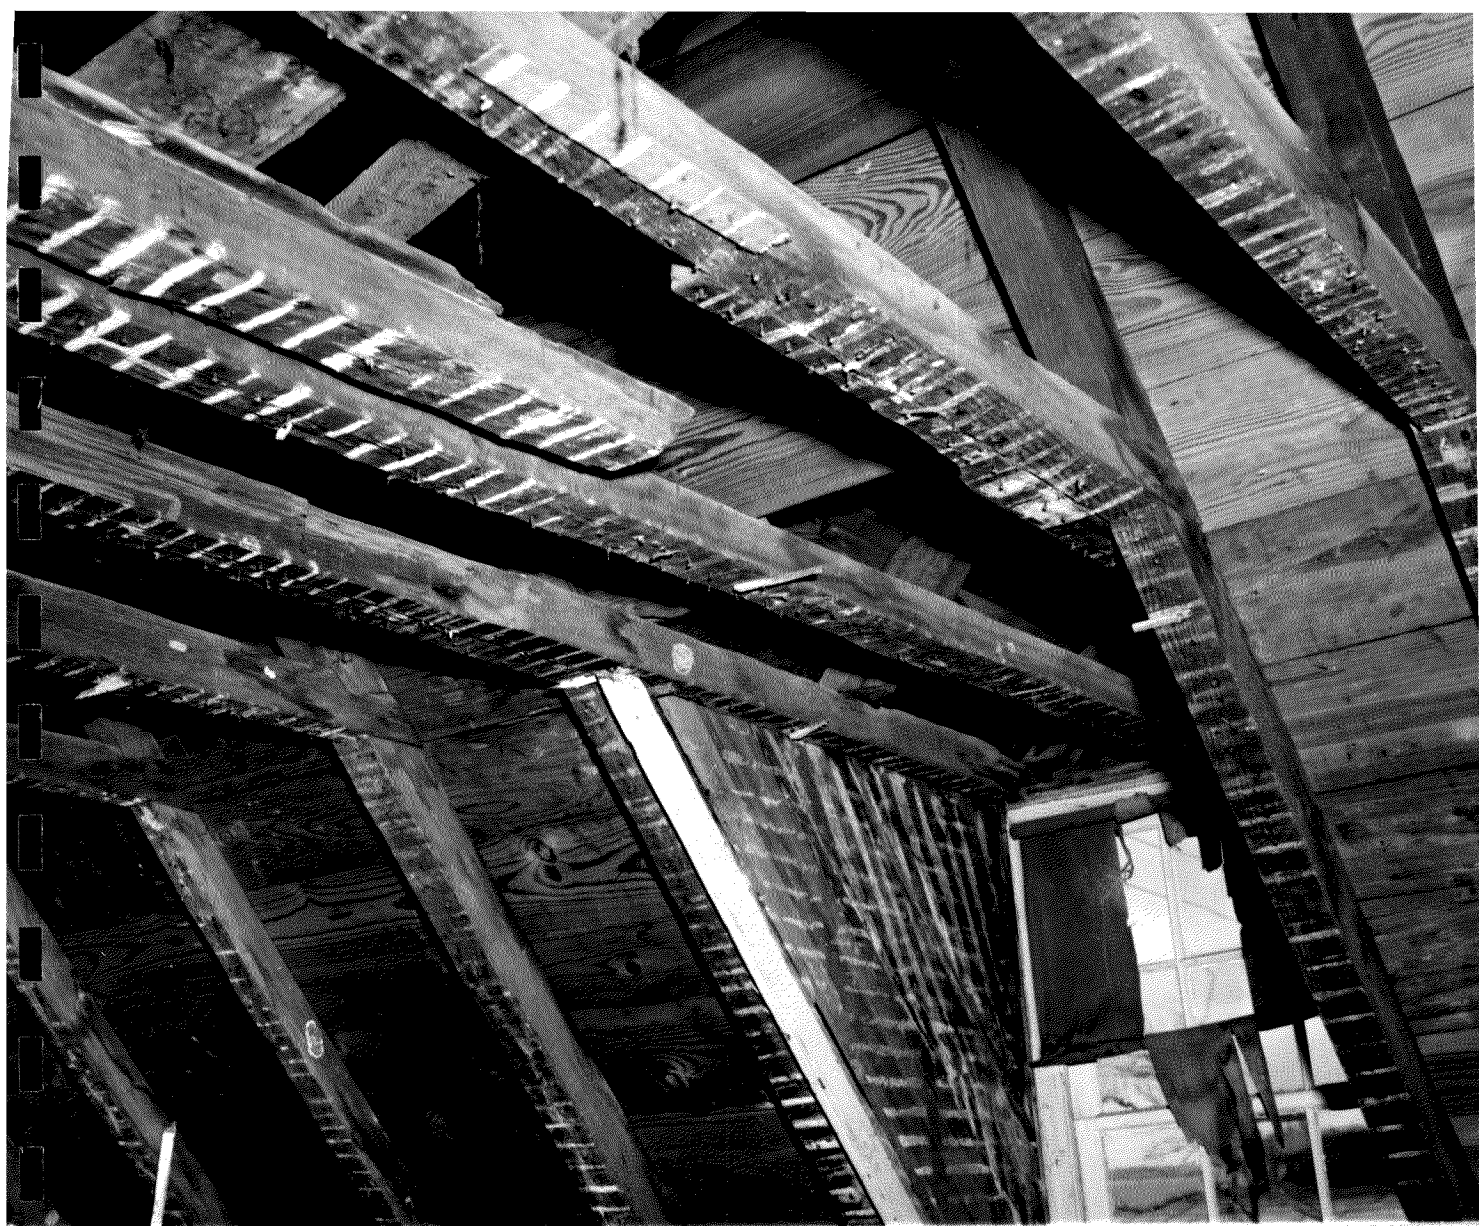
The lower cord of the "new" rafter truss is the ceiling, however, at the dormer points they have used (old rafters) salvage material to catch or support lath.

Another guess would be that the second floor walls did not have plastering from the beginning as witness the poor workmanship at all points other than rafters.

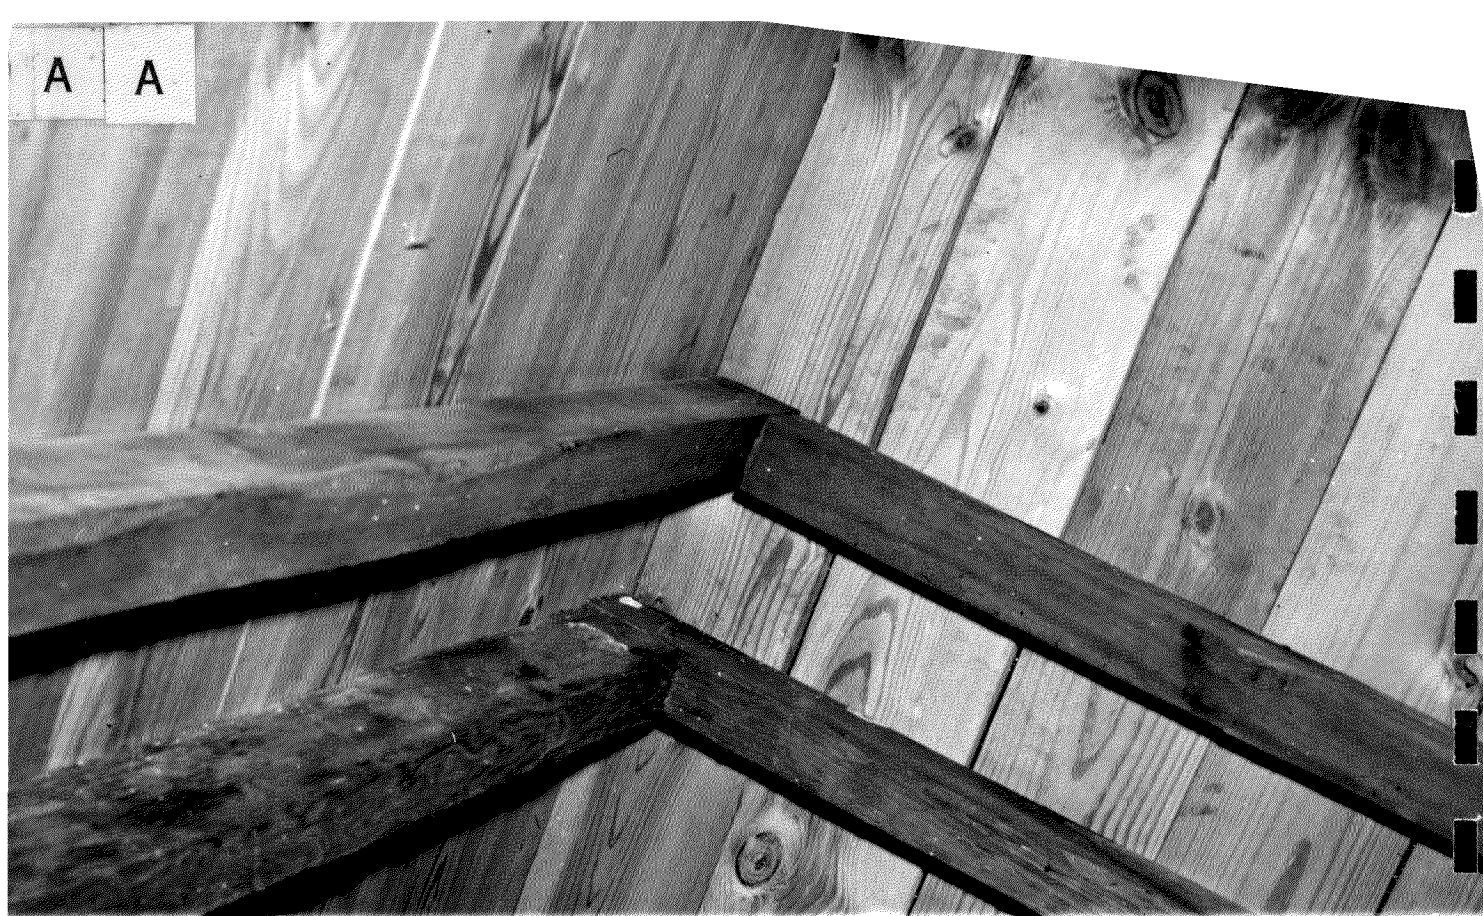
The rafters appear to be the only building parts which can be reused without repair, additions, or alteration, simply because they were made for the building while all other timbers are salvage parts and difficult to repair.
