HISTORIC STRUCTURES REPORT, PART III

ARCHITECTURAL DATA SECTION

ARCHER HOUSE

Yorktown, Virginia

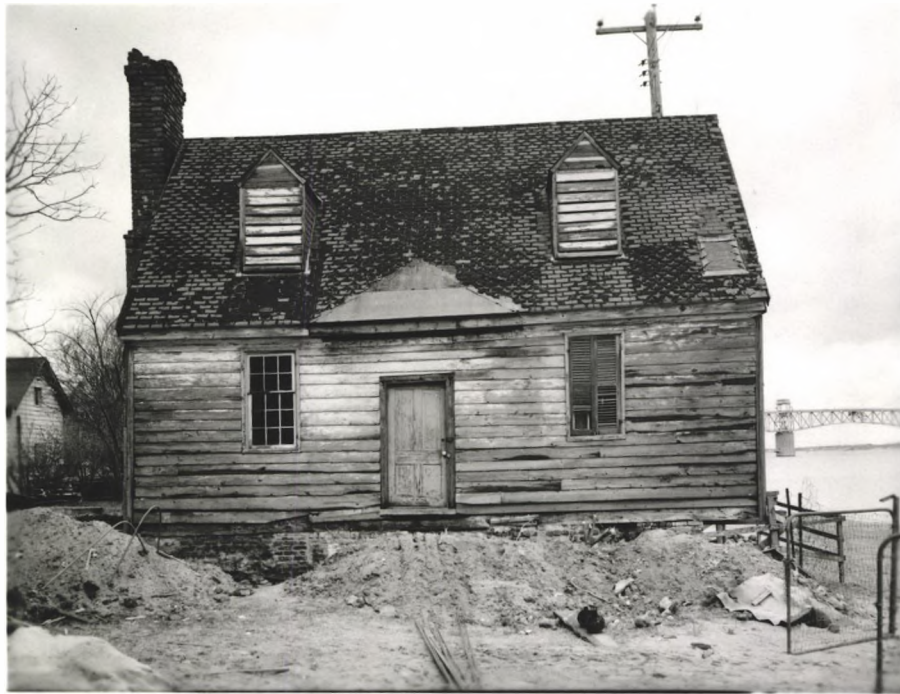
Front (southeast) elevation showing condition  
of house during initial stages of restoration.

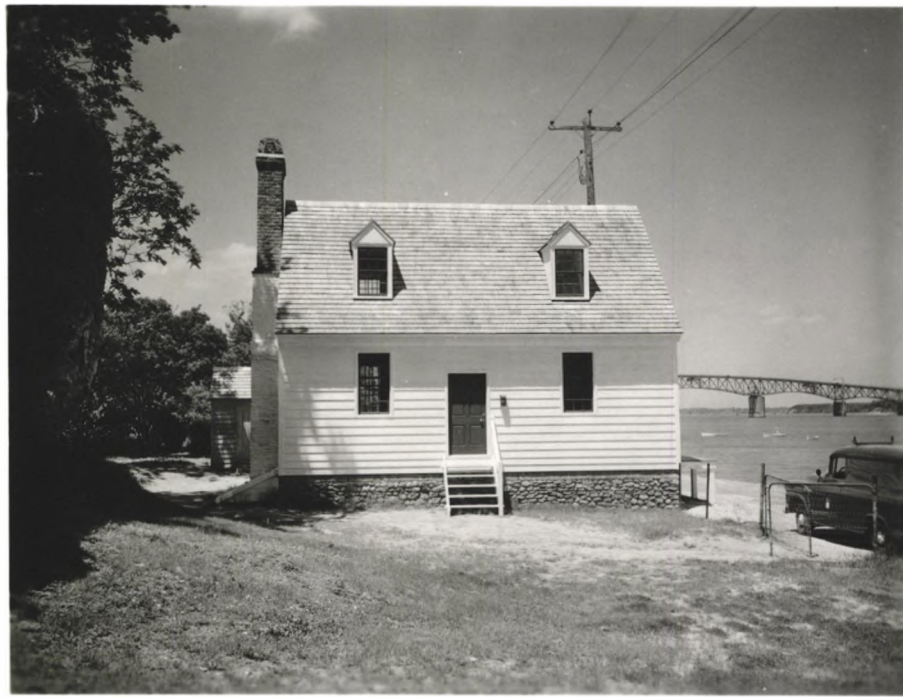
ILLUSTRATION NO. 2

Front (southeast) elevation after restoration.

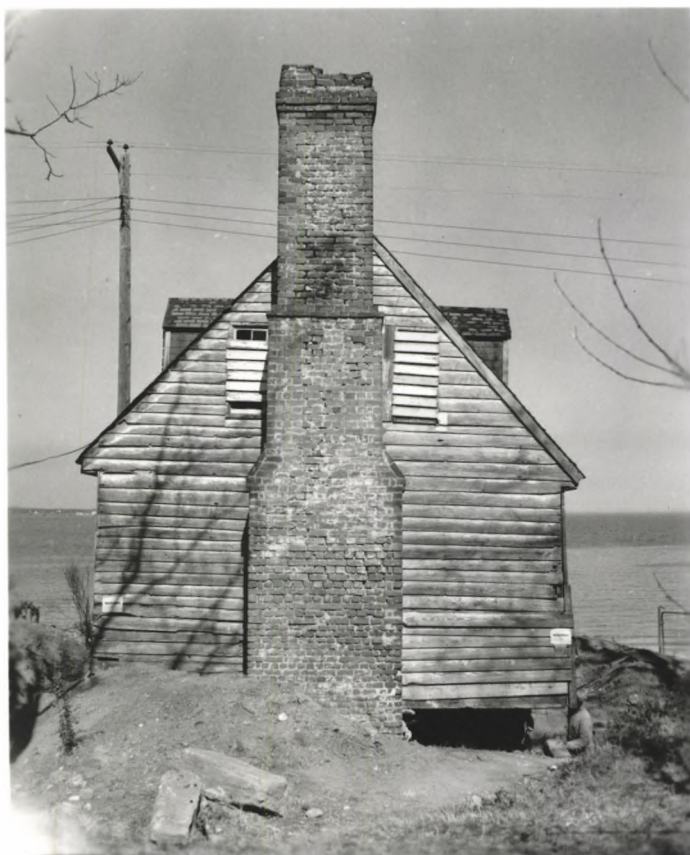
ILLUSTRATION NO. 3

Southwest elevation showing condition during  
initial stages of restoration.

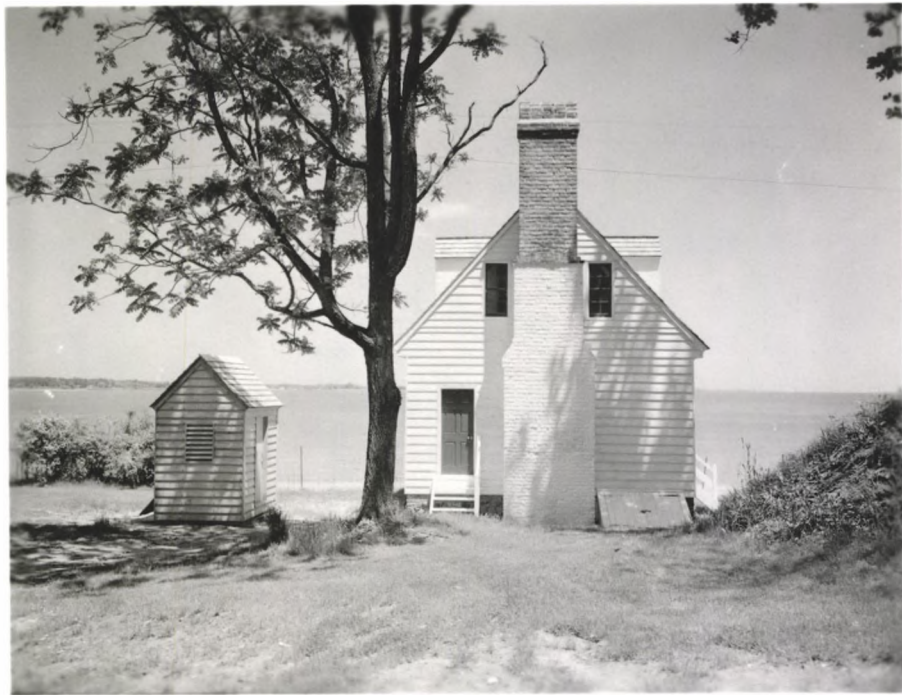
ILLUSTRATION NO. 4

Southwest elevation after restoration. Out-building for heat-pump is located to the left. White-washing of chimney to corbel was a fairly common practice in the 18th century.

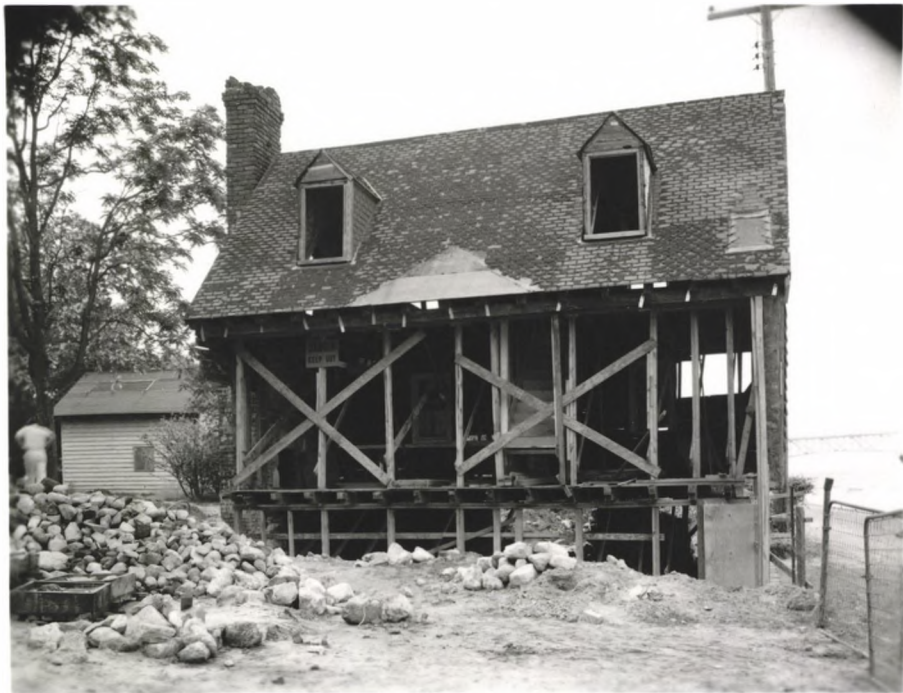
ILLUSTRATION NO. 5

Front elevation, with shoring in place, ready  
for rebuilding of above grade masonry.

Before the concrete wall could be built, the entire river end of the house was shored up with sheet plywood trusses, nailed to the first floor studs. This method of shoring is very simple, spanning 20 feet in this case, and allowed us to reuse the plywood at a later date. By April 8, the formwork, placement of rebar, and pouring of concrete completed the work for a new river end foundation wall.

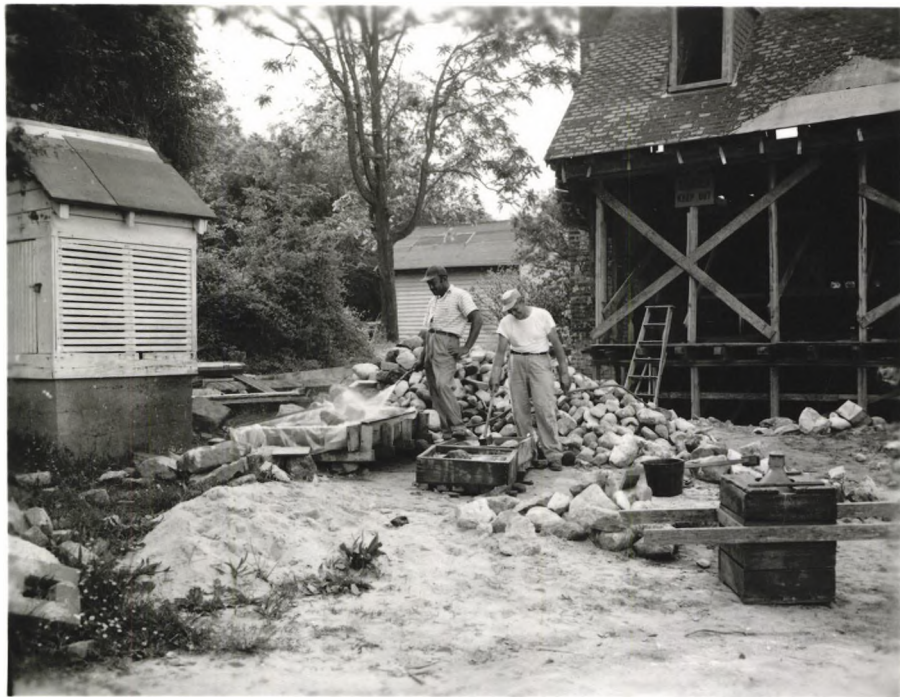
ILLUSTRATION NO. 6

Stone cleaning process. Old lime mortar was removed by immersing stones in a strong solution of muriatic acid. Note carboy of acid at right. Agitation and brushing accelerated the process. After removal of the mortar, the stones were immersed in water to remove any residual traces of acid. The stones were then graded as to size and ready for use.

The uniqueness of the foundation, that is, the use of imported ballast stone, caused unexpected difficulties. No stone or river rock of a similar character was available, which left us no alternative but to salvage the original stone for reuse by removing the old mortar. This was accomplished by immersing the stones in a very strong solution of muriatic acid, and subjecting them to continuous brushing and scraping. This method succeeding in completely removing the old mortar, but it was a slow process.

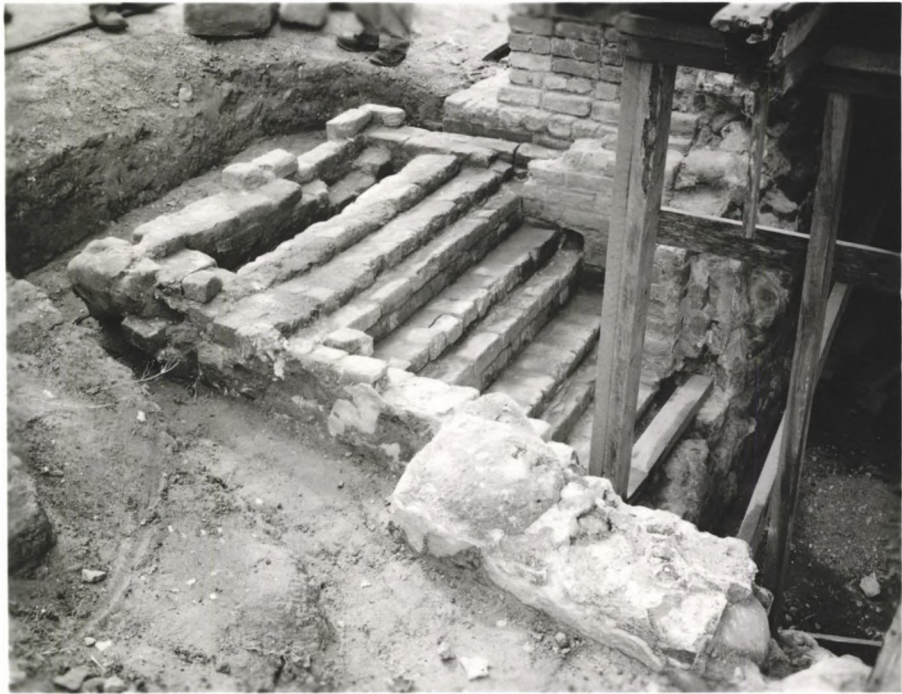
ILLUSTRATION NO. 7

Remains of cellar bulkhead and brick entrance steps before restoration. Brick curb around steps was repaired and the steps relaid using the original brick. Step nosings of aromatic cedar were used in the restored steps, thereby matching a fragment unearthed in place. Cedar has especially good resistance to rot.

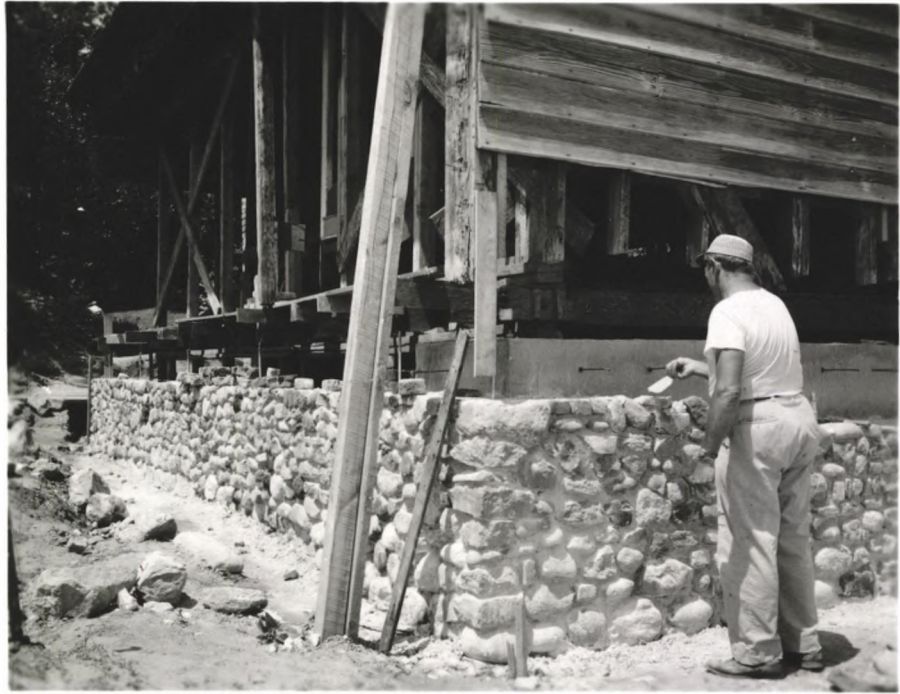
ILLUSTRATION NO. 8

Rebuilding of the storm damaged walls. The two walls visible in this photo had been completely rebuilt of brick rubble and concrete following the 1933 hurricane. Much of the old stone still lay about the grounds or in the cellar and was reused in the rebuilding. See Illustration No. 6 for the method used in removing the old lime mortar. Note the concrete wall used along the river end of the house, intended to resist future storm damage. John Hedgebeth, Williamsburg mason, is shown here.

We then commenced removal of the above grade stone and brick patchwork resulting from the 1933 storm damage. In view of future storm damage and frequent high tides, we constructed a concrete foundation along the river end of the house, designed to receive a stone veneer so as to match the older masonry. That concrete wall was reinforced with steel so as to resist the buffeting waves in times of high water, and the ramming effect of floating timbers which did so much damage in 1933.

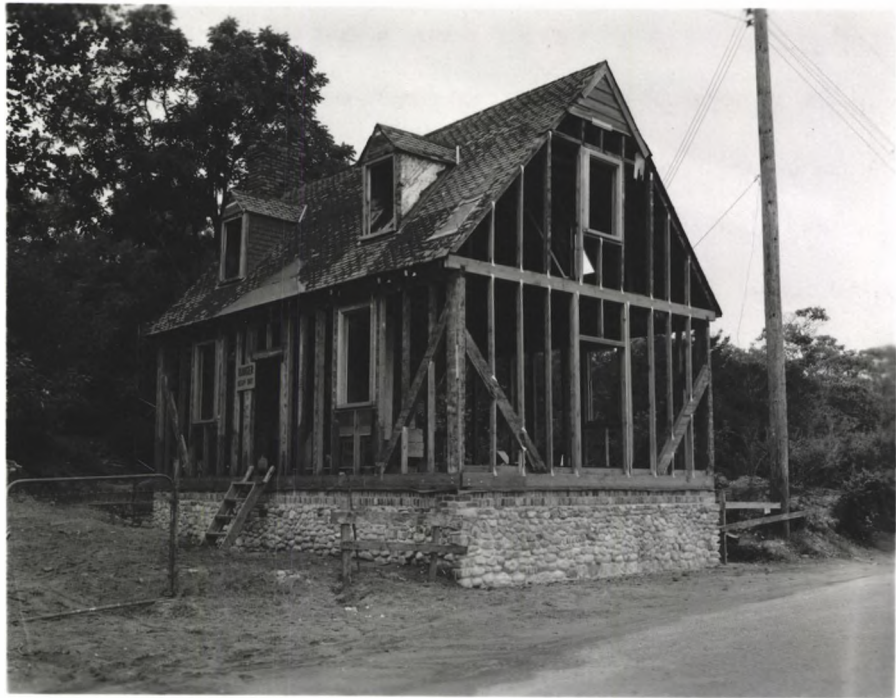
ILLUSTRATION NO. 9

View of repaired structure leveled and resting upon the rebuilt foundation walls. With several exceptions, the framework was preserved intact. Wood sills, first floor joists, and a second floor plate had to be replaced because of advanced decay and termite damage. Most of the studding, corner posts and corner braces were repaired for reuse. The attic structure was in good condition. Several new window frames are visible here.

On April 10, shoring of the front wall was started and the entire house brought back to level. Natural forces and storm damage had created a maximum settlement of eight inches at the east corner of the house. The north and south corners had settled about three inches, while the west corner remained undisturbed and served as reference point for the leveling operation.

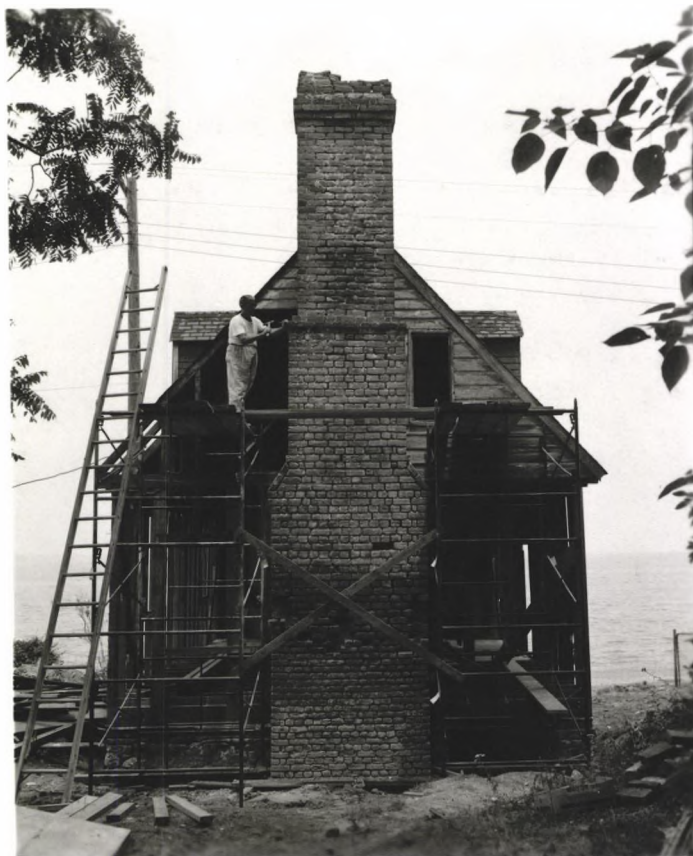
ILLUSTRATION NO. 10

Southwest elevation showing chimney repair work. Dead mortar and frost damaged bricks were removed. Bricks were replaced, using fireplace bricks which saved the expense of hand made reproductions. The chimney was repointed with mortar matching the original as to color and texture.

Although the chimney appeared structurally unsound, and the writer recommended its reconstruction in the Part II Report, we decided upon closer inspection that the chimney could be saved by careful repointing. Most of the mortar had lost its strength to a depth of about two inches, and was removed without difficulty. The upper section of the chimney, having walls only four inches thick, was structurally precarious, and called for considerable caution. Only the chimney bonnet required reconstruction. By the 17th of July, all chimney repair work was complete, including fireplaces and hearths, using the same mortar mixture previously cited. The chimney and hearths were also flashed against termites. A damper was later installed in the first floor fireplace, and the upper fireplace was sealed off and made inoperable.

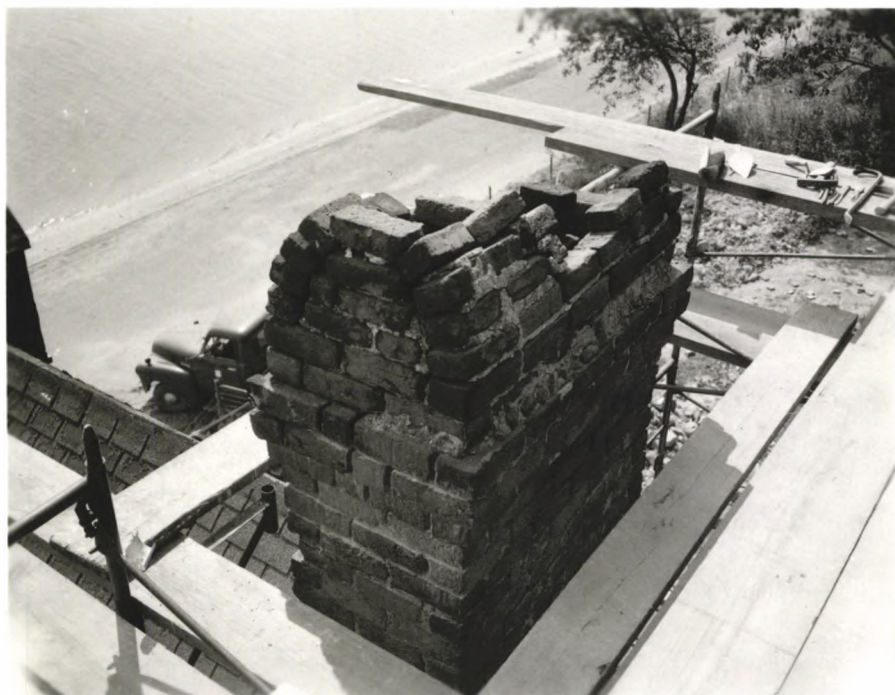
ILLUSTRATION NO. 11

View of chimney bonnet. The sealed bonnet ends are certainly unconventional. The smoke was not intended to come out the ends as is usual with a bonnet, but rather out the top through reduced flue openings. The sealed bonnet ends utilize brick similar in size and color to the main chimney. The mortar is similar and exhibited the same exterior fire damage (1814) as the entire chimney. Furthermore, the brick partition walls between the three flues extended to the bonnet top and were bonded in place. Altogether, there was no evidence to indicate that the bonnet was an addition or had been altered in detail. Due to its high unstable condition, the bonnet was removed and rebuilt.

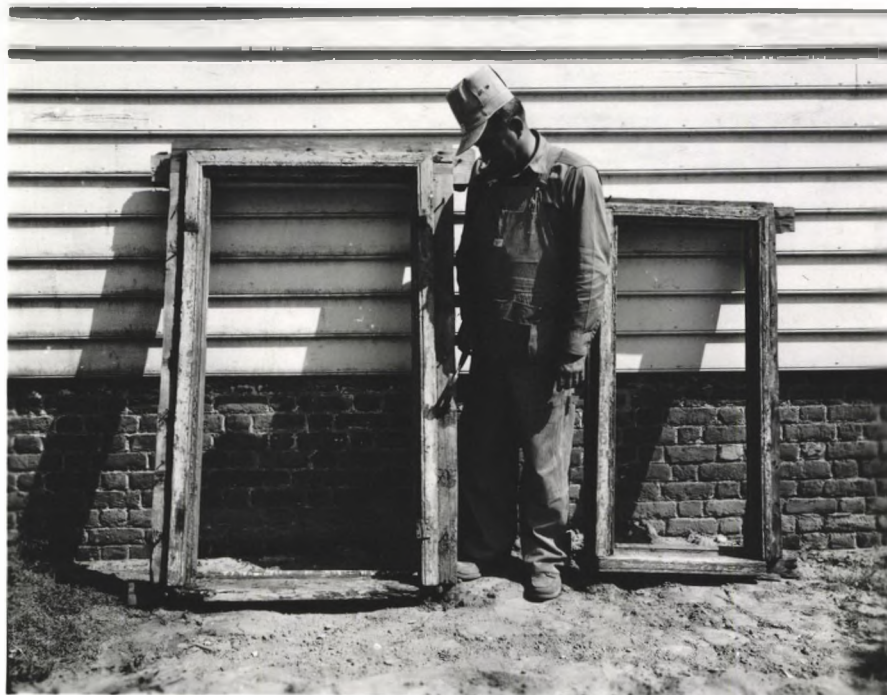
ILLUSTRATION NO. 12

At left is a typical frame from the first floor, and a second floor window frame is at the right. The advanced state of rot was evident throughout, especially in the sills. Buildings Restoration Specialist Whittington, shown here, reproduced most of the original parts which were beyond reuse.

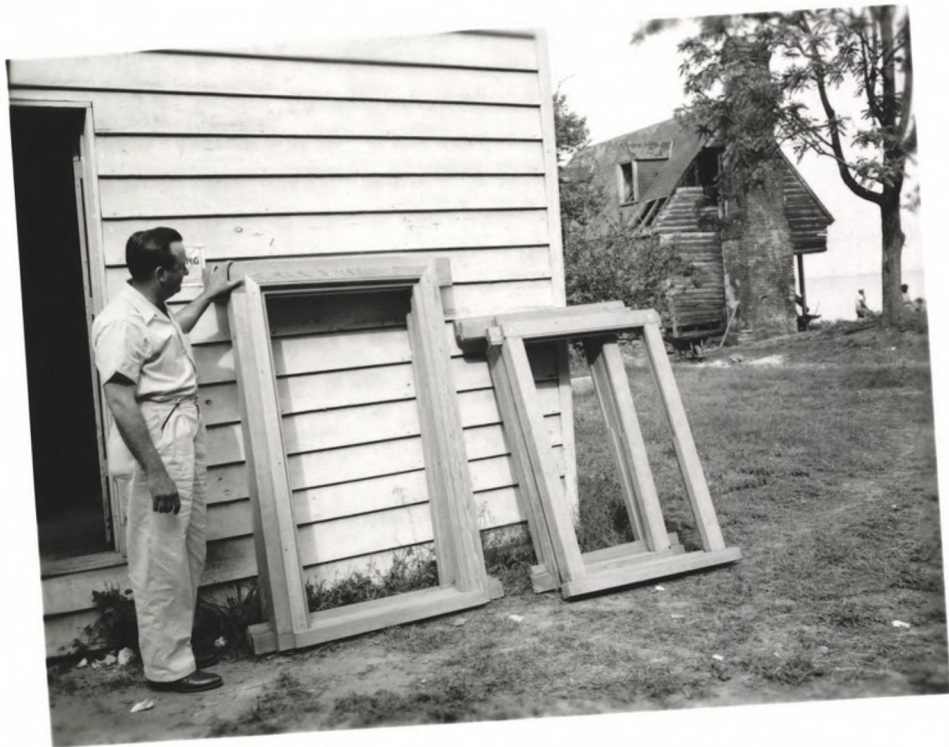
ILLUSTRATION NO. 13

Buildings Restoration Specialist Gordie  
Whittington, shown here with window frames reproduced  
to match those shown in Illustration No. 12. Archer  
House in background.

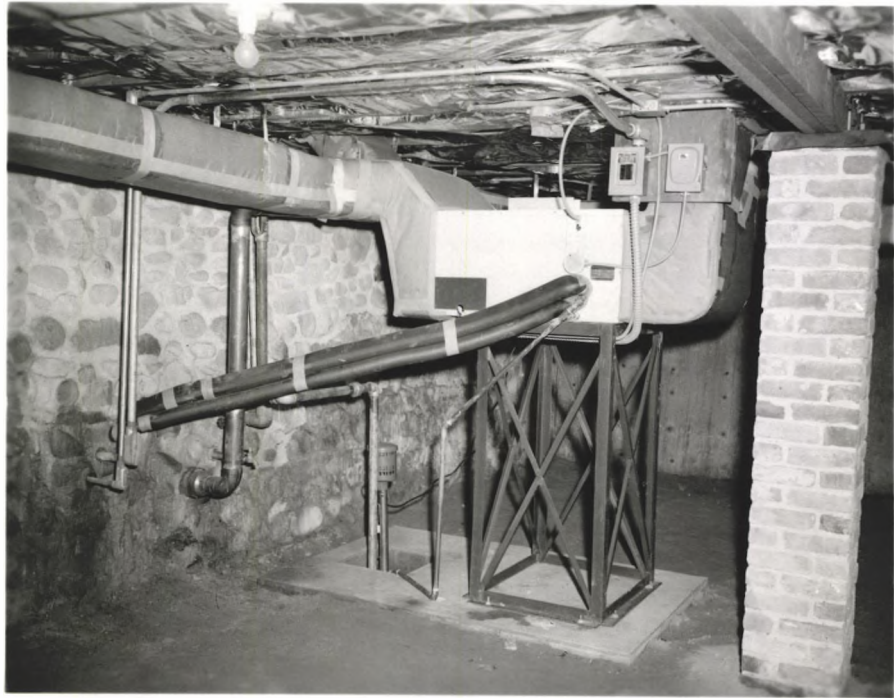
ILLUSTRATION NO. 14

Indoor section of three-ton capacity heat pump. Note refrigeration and utility lines which enter cellar via pipe sleeves. Duct work is insulated with one inch of Kraft-faced fiberglass. Refrigeration lines are insulated with  $1\frac{1}{2}$ " of foam rubber. Sump pump ejects accumulation of condensate water. Aluminum-faced fiberglass insulation is visible between floor joists. Brick pier at right supports new center sill.

To reduce costs, the heat pump was supported with steel instead of the concrete shown on working drawings. The concrete cellar floor was omitted because of the water table encountered several inches below the floor line, and the static pressure caused by high tides.

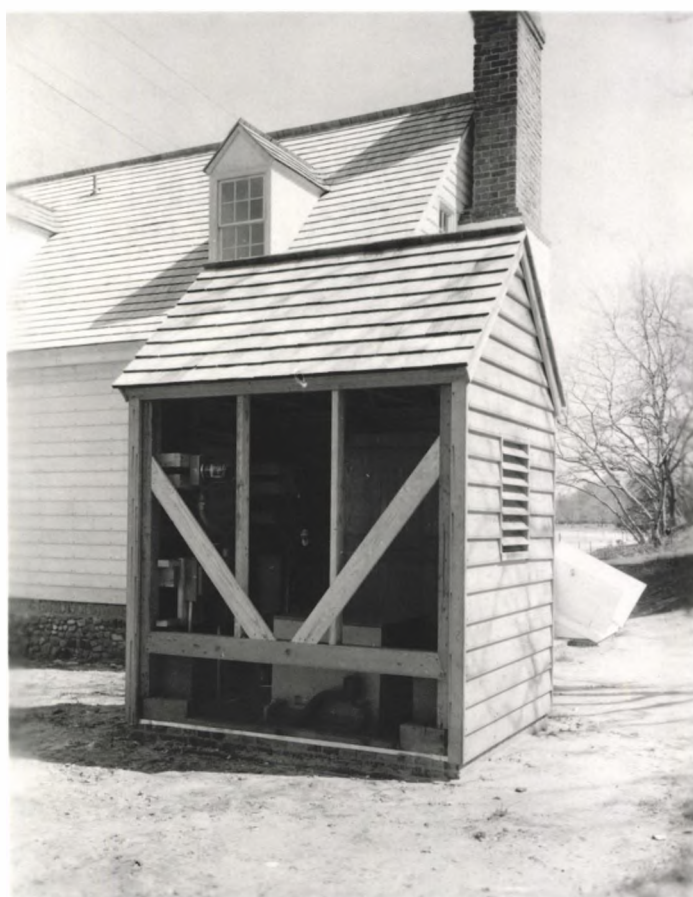
ILLUSTRATION NO. 15

Outdoor section of heat-pump shown housed in colonial type outbuilding, before application of weatherboarding. Fresh air enters side louvers. Discharged air is ducted to "cleanout" door opening. Duct work was removed for this photo so as to show heat pump. All electrical entrance switch boxes and meters are also housed in outbuilding.

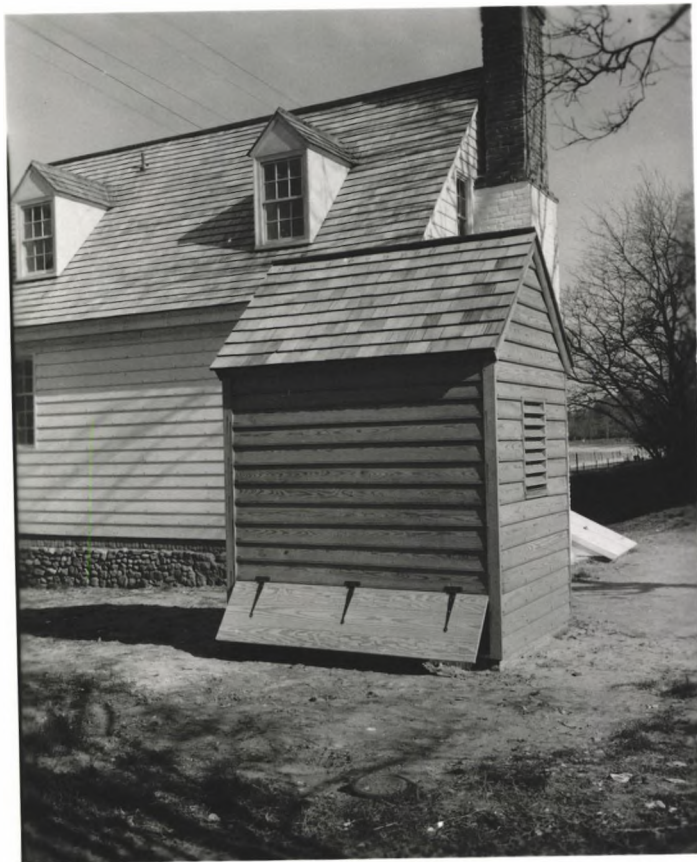
ILLUSTRATION NO. 16

Outbuilding for heat-pump installation completed. Air is discharged through "cleanout" door, permanently fixed in the position shown here.

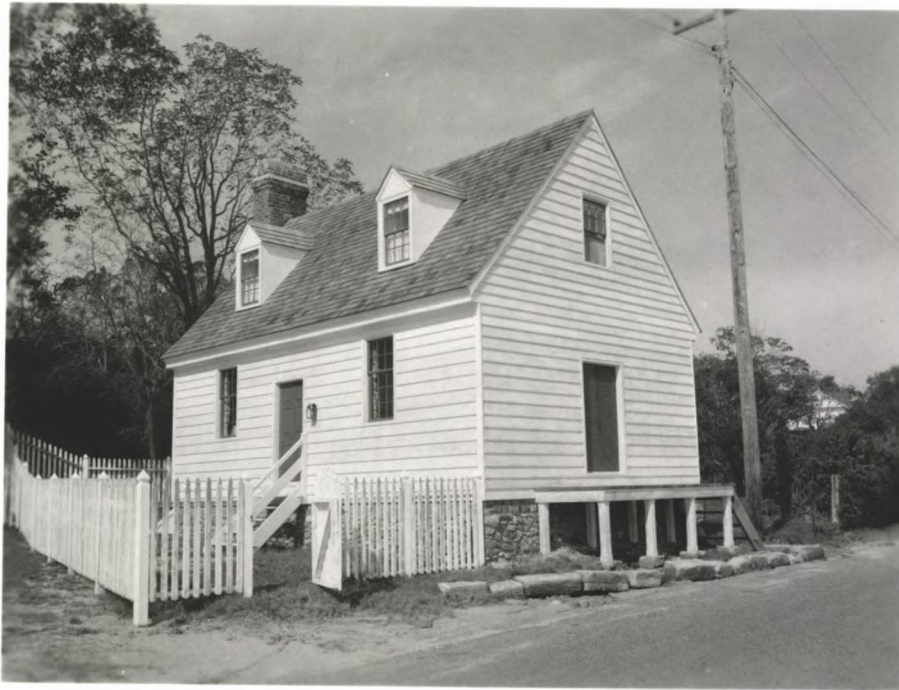
ILLUSTRATION NO. 17

Northeast end of house (facing the river) showing "loading dock". The early existence of this feature is problematical. Since there was some evidence that the river end of the building had been used as a shop, access to that portion posed a problem, as the nature of the "business" is unknown.

The present "loading dock" was suggested by Charles E. Peterson, Supervising Architect, Historic Structures, as a possible solution to the problem. Since 18th century prototypes for such platforms have not survived to the present day, the design is conjectural.
