HISTORIC STRUCTURES REPORT

THE BALLARD HOUSE  
YORKTOWN, VIRGINIA

COLONIAL NATIONAL HISTORICAL PARK

May 1972

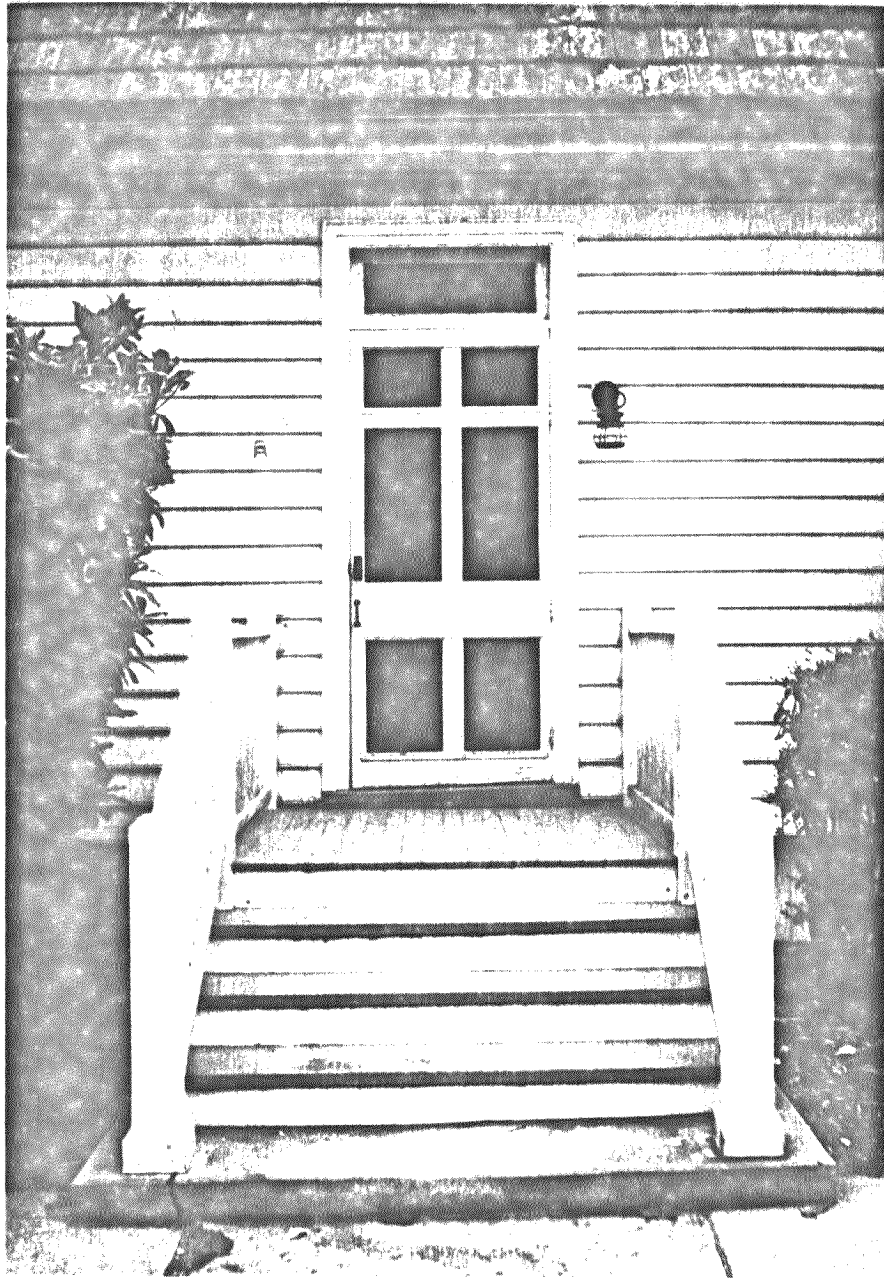
PLATE 5  
DETAIL OF FIRST FLOOR ENTRY AT  
THE SOUTH ELEVATION

The wood platform and stairs are in good repair, but in need of paint. They are a recent addition to the structure.

The front wood stoop and steps are also a recent addition, but they can be altered to conform with the historic period. The stoop and steps are in need of painting.

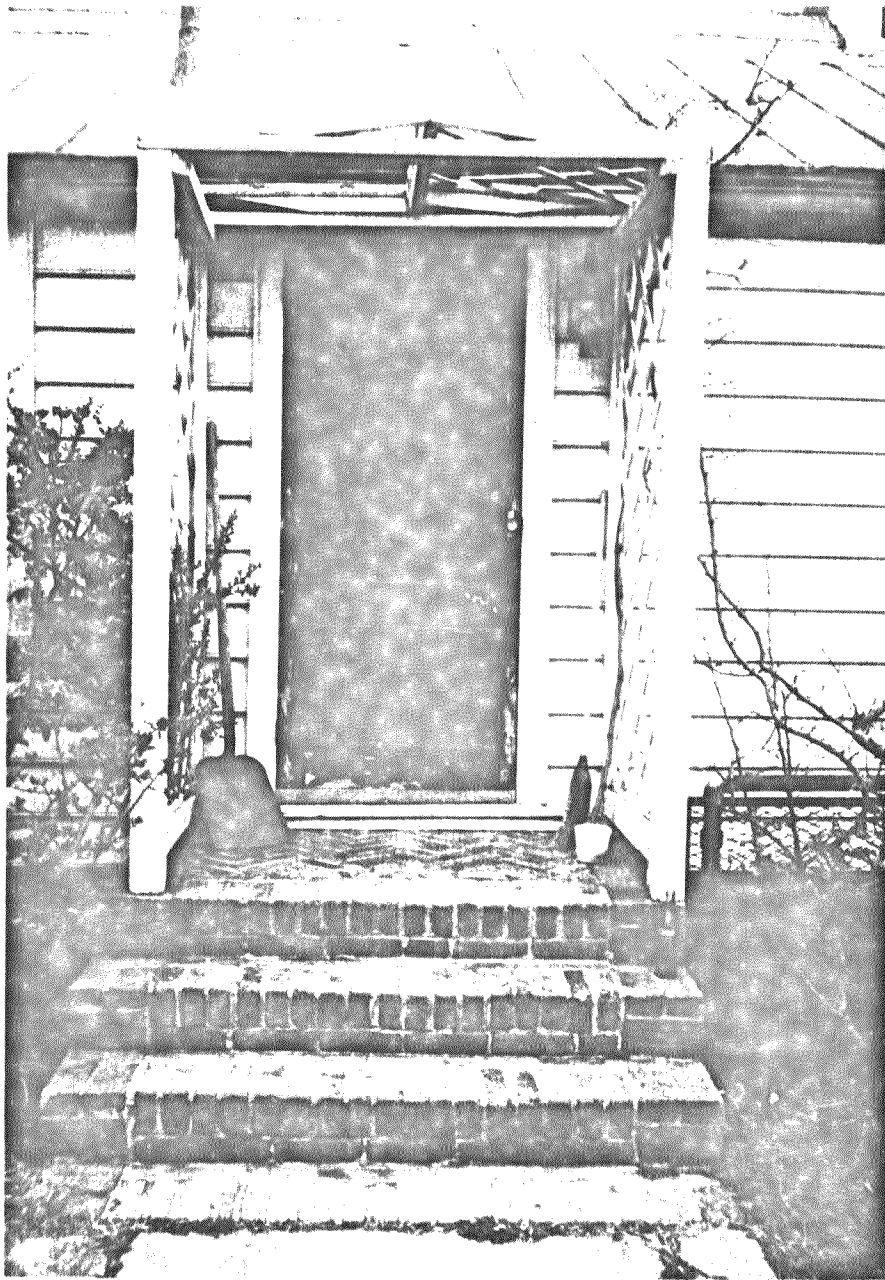
PLATE 6  
DETAIL OF FIRST FLOOR ENTRY  
AT THE NORTH ELEVATION

The two rear entries with this treatment are in fair condition, and are a relatively new addition to the structure.

The two rear brick stoops are recent additions, and are not in accord with the historic period of the structure. They should be removed, and the existing lattice work over them. New stoops should be designed and installed to be in keeping with the restoration.

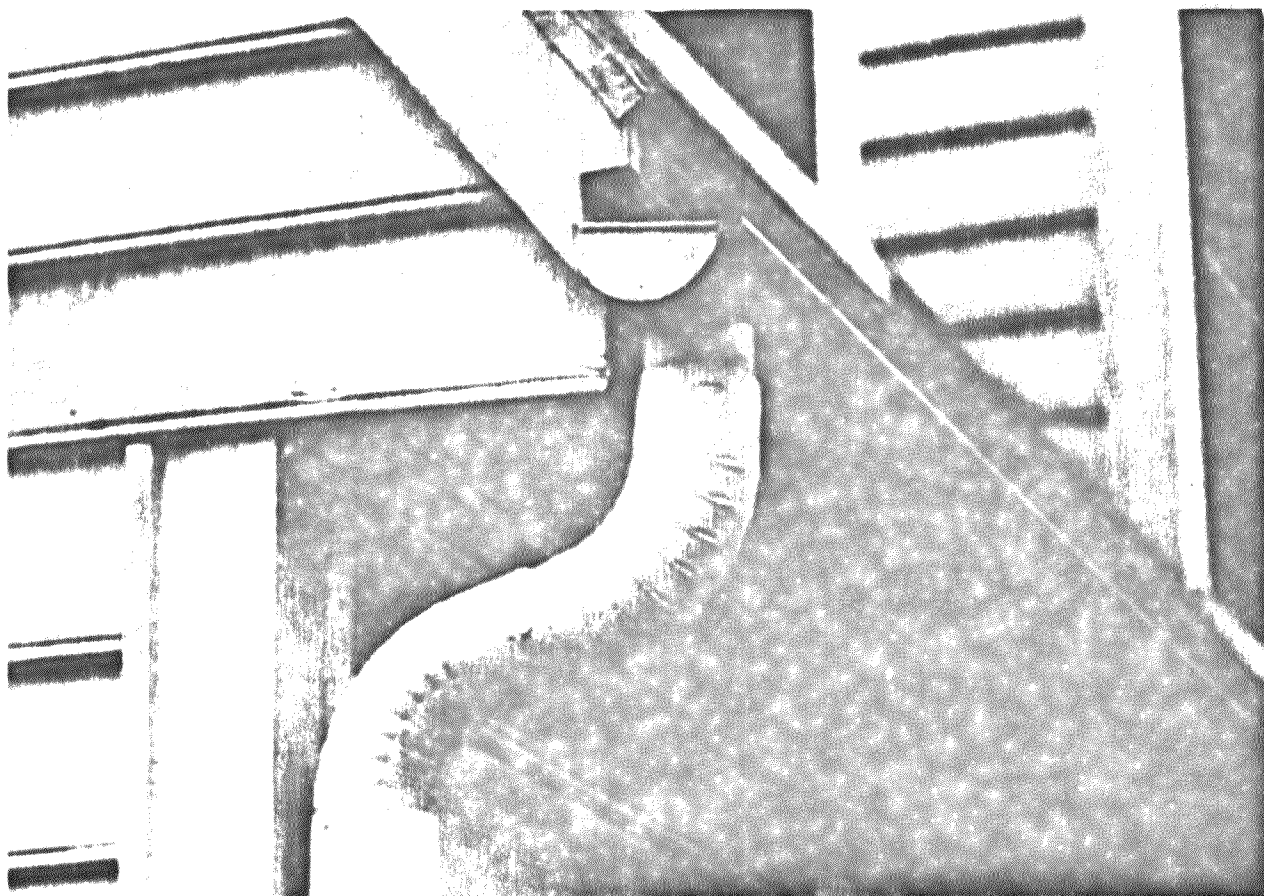
PLATE 7  
DETAIL OF CORNICE-EAVE AT THE  
SOUTH ELEVATION

The wood cornice and galvanize iron guttering are in poor repair at the present time.

The cornice should be redesigned and rebuilt to be in keeping with the historic period. Of course, the design shall hinge on further physical investigation of the historic design of the original cornice and rake.
