HISTORIC STRUCTURES REPORT  
PART I  
ARCHITECTURAL DATA SECTION  
ON THE  
BARN AT GLENMONT  
Edison National Historic Site

Prepared by  
Norman M. Souder  
Architect  
May 1965

United States Department of the Interior, National Park Service  
Eastern Office, Design and Construction  
Division of Architecture

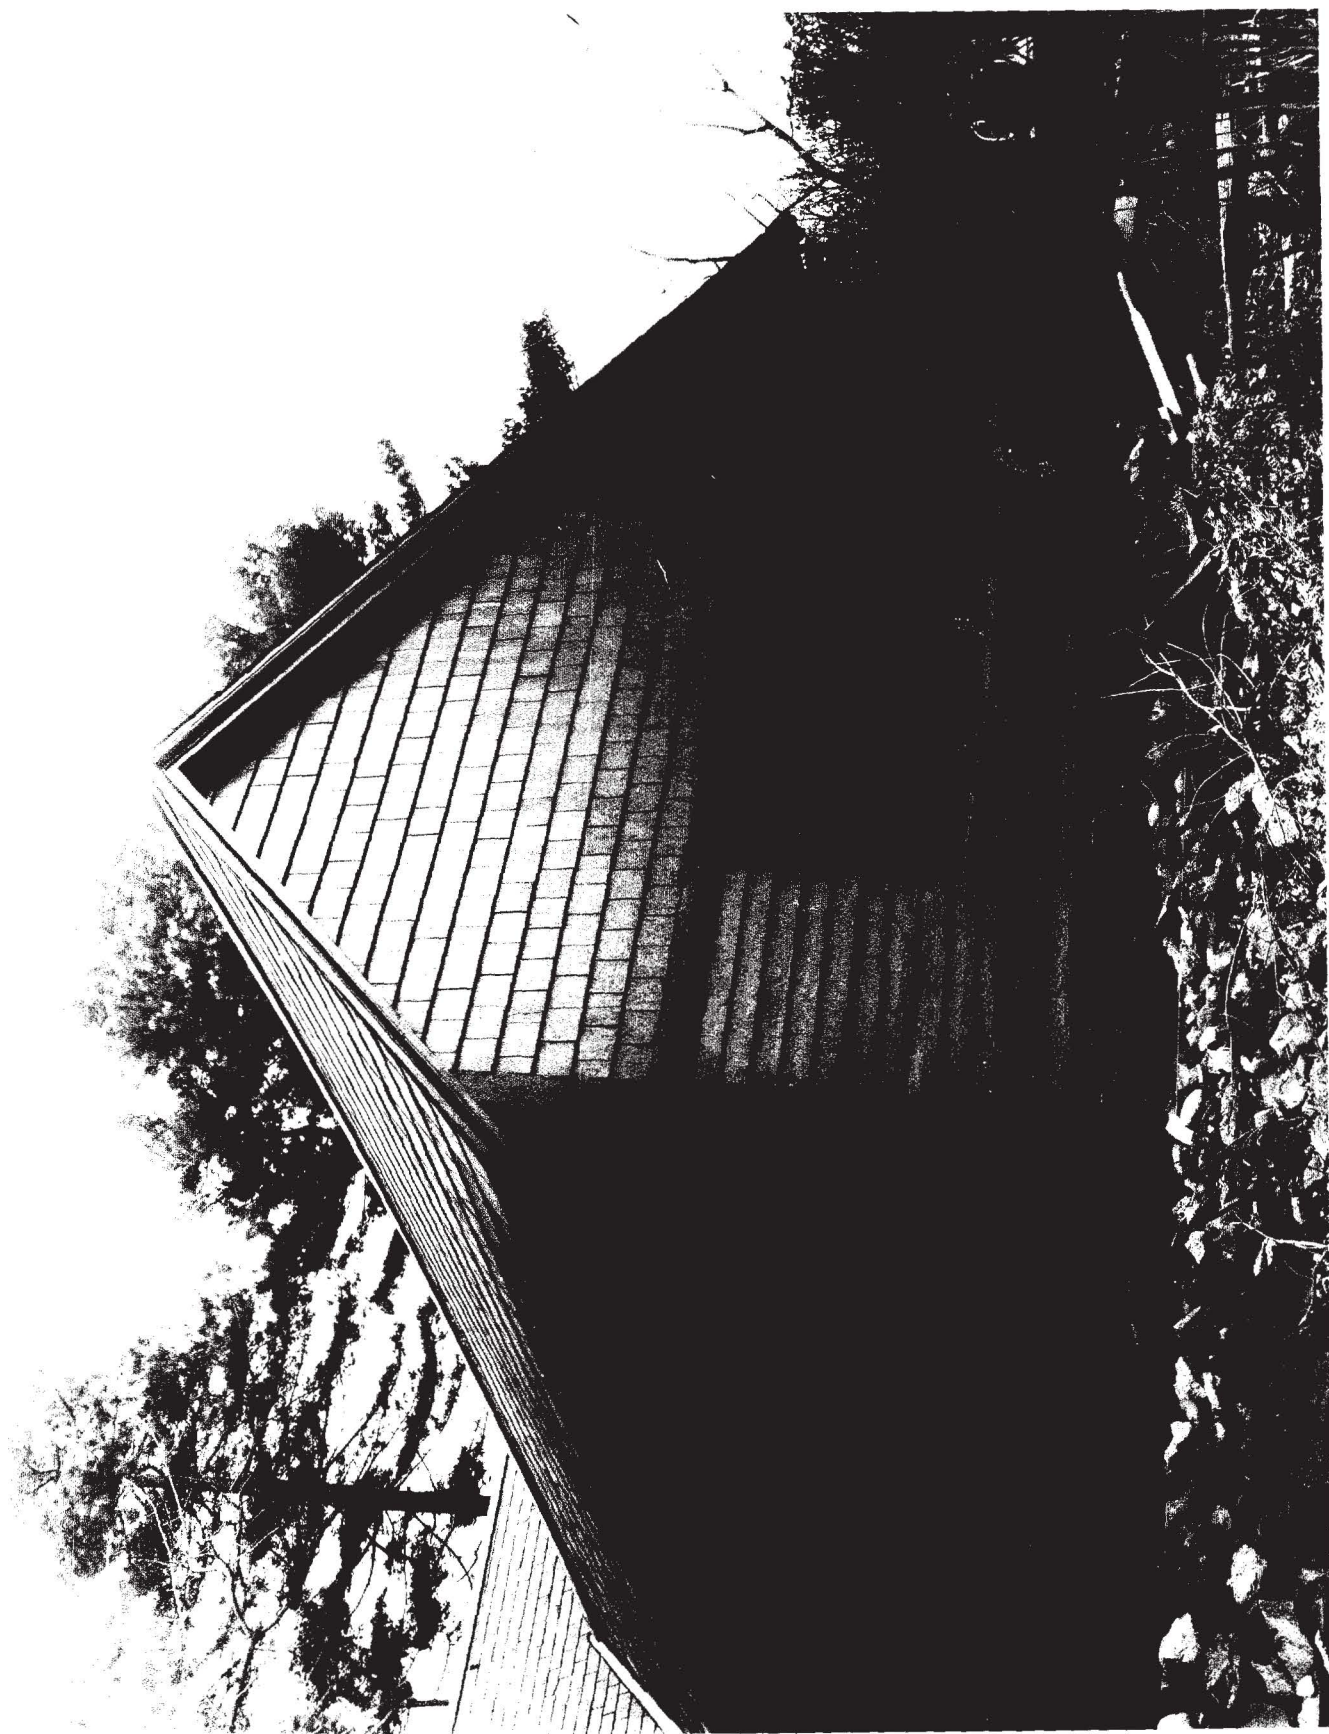
ILLUSTRATION NO. 2

The northwest corner of the chicken house wing showing the unequal roof pitches and change in the exterior treatment levels. The stone fence against the building is the north property line and a factor in the decay of the sill plate.

1. The sill plates in the chicken house and calf shed have deteriorated from long contact with the ground. It will be necessary to remove the siding and plates and elevate the buildings to correct the sag.

2. New concrete foundations and sill plates will be required on the north and west walls of both the chicken house and calf shed. When this is completed matching siding and repairs will be required at the grade level.
