EDIS.019 HISTORIC STRUCTURES REPORT  
CRBIS # 401132 PART I

GARAGE

Edison National Historic Site

Prepared by  
Norman M. Souder  
Architect  
August 1964

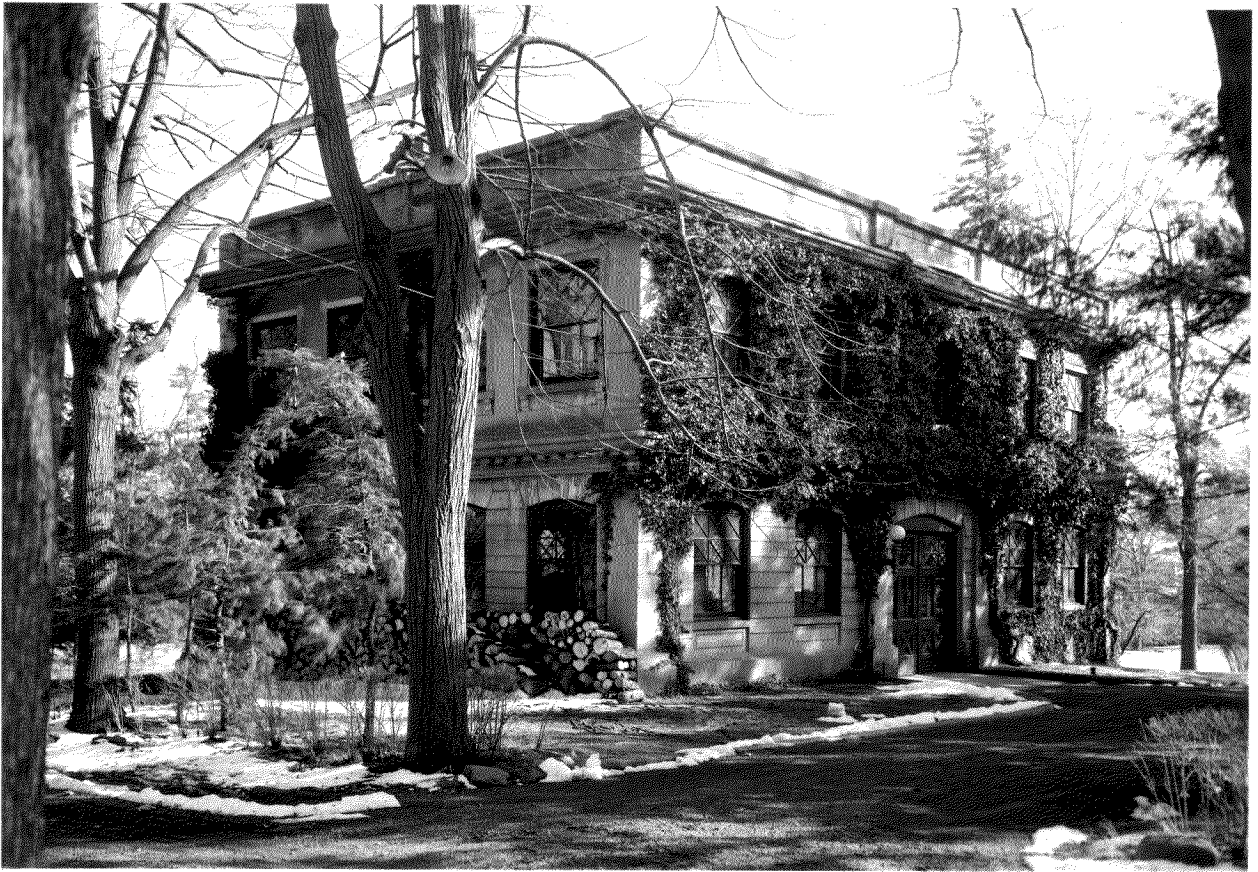
ILLUSTRATION NO. 1

The Garage at "Glenmont" from the northwest.  
Note the moulding of the concrete, simulating stone  
jointing. The upper section of the double hung sash  
is unusual in design.

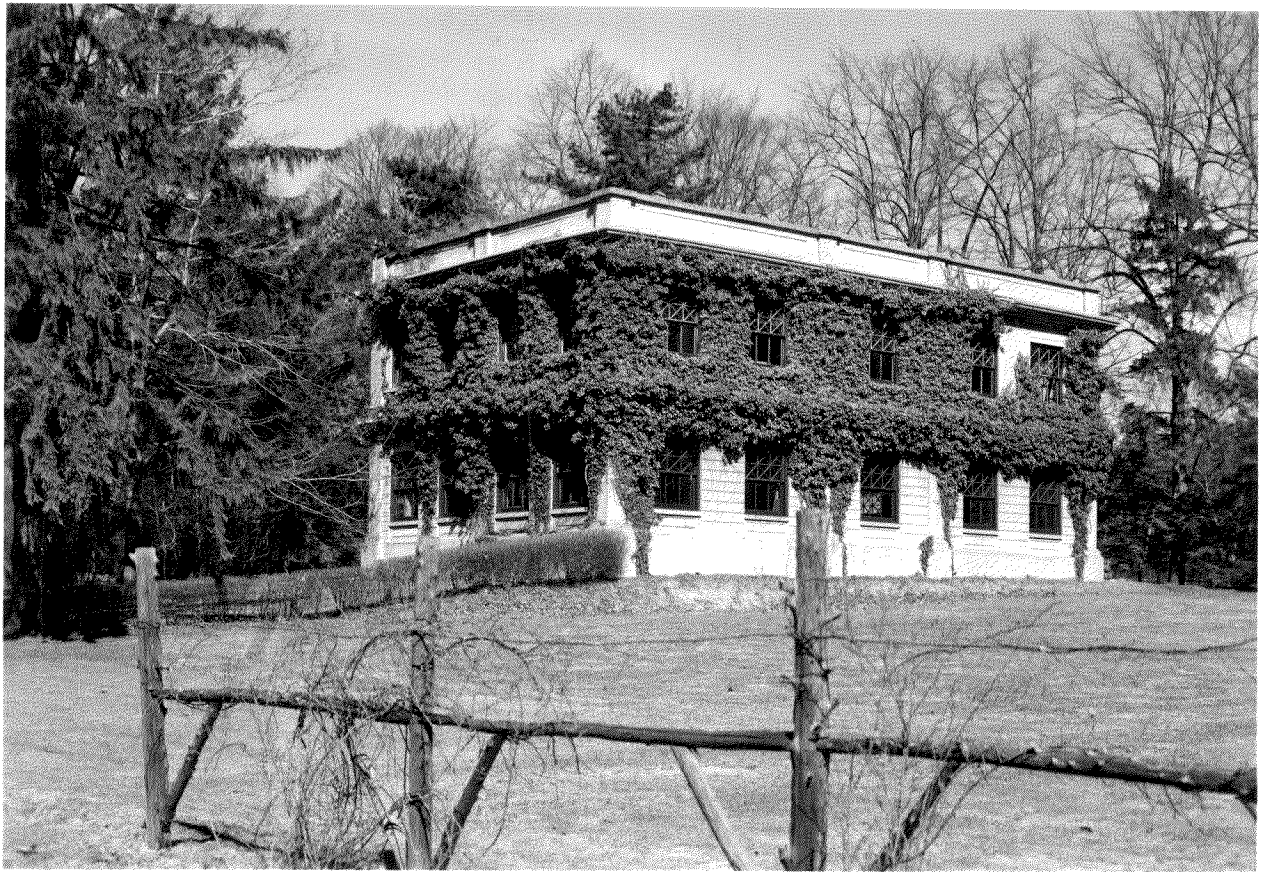
ILLUSTRATION NO. 2

The reinforced concrete Garage at  
"Glenmont," from the southeast.
