HISTORIC STRUCTURES REPORT - PART I 403/D-9A

BUILDING NO. 16, FRAME BARN

EDISON NATIONAL HISTORIC SITE

HISTORIC STRUCTURES REPORT  
PART I  
ARCHITECTURAL DATA SECTION  
ON THE  
BARN AT GLENMONT  
Edison National Historic Site

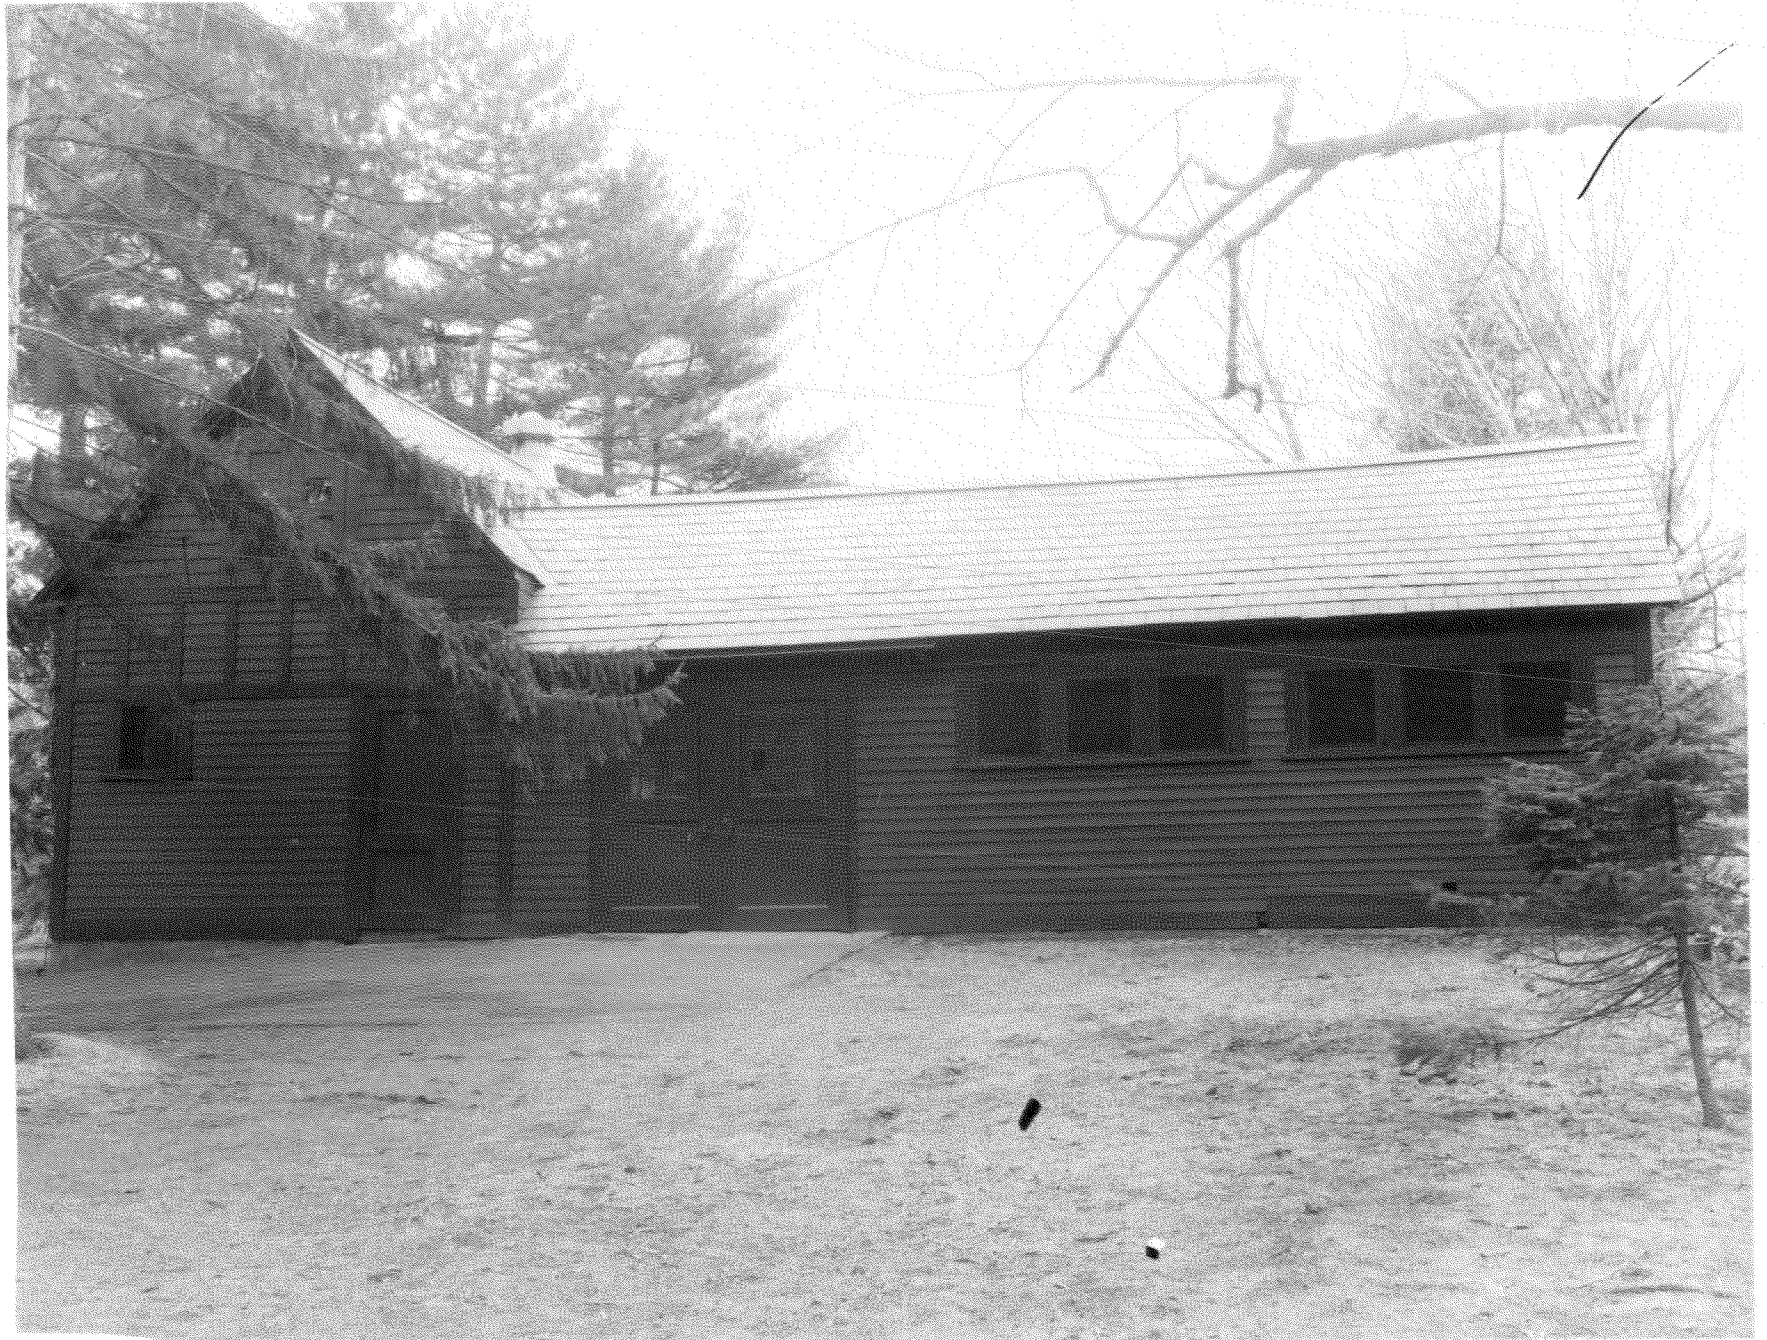
ILLUSTRATION NO. 1

The east, or front, of the Glenmont Barn. The entrance is on the left. The double sliding doors open into the pony stable. The two banks of screened openings on the right are part of the chicken house portion of the barn. Note the decorative treatment of the main building at the right with clapboard panels and shingle above at the loft level.

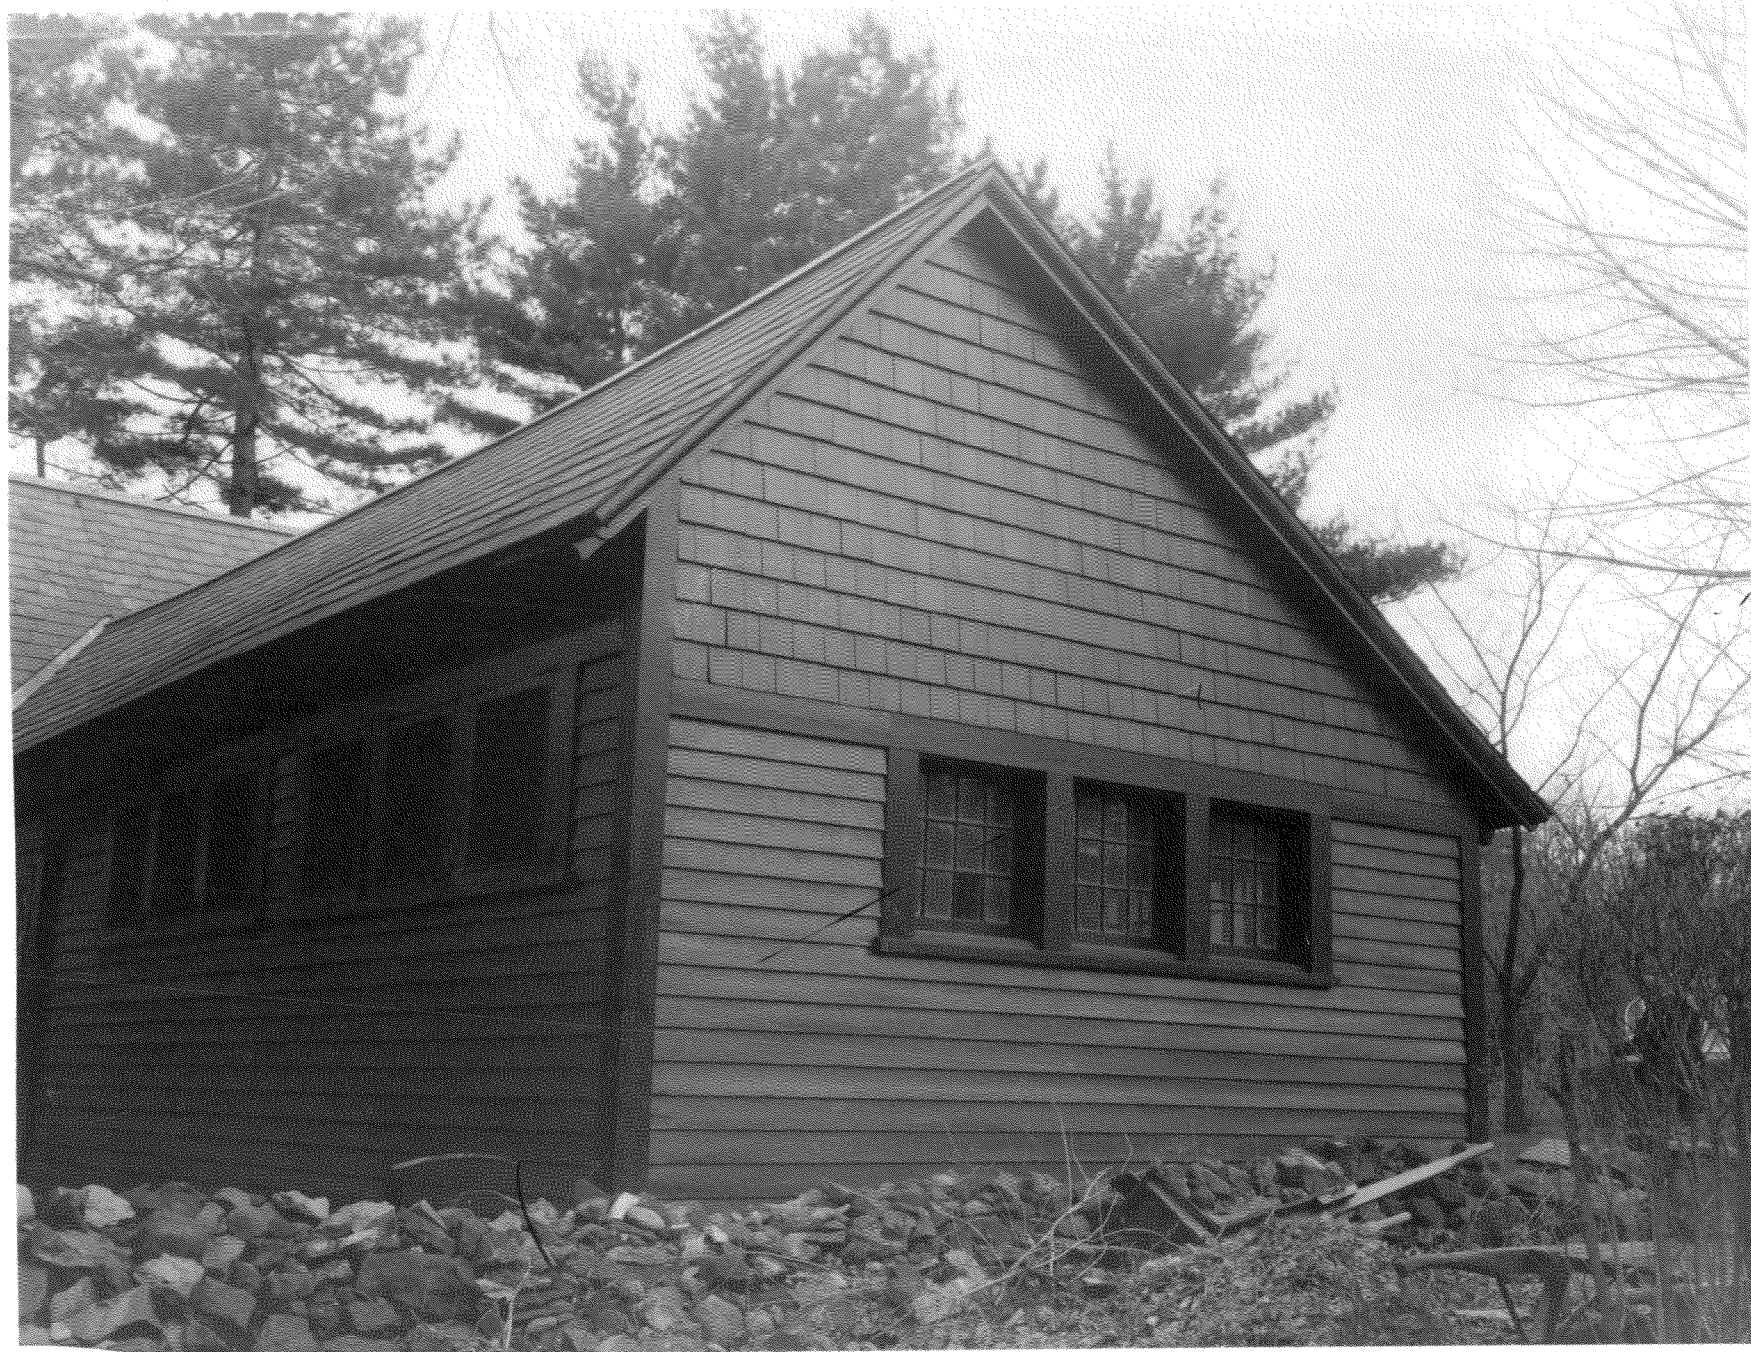
ILLUSTRATION NO. 2

The northwest corner of the chicken house wing showing the unequal roof pitches and change in the exterior treatment levels. The stone fence against the building is the north property line and a factor in the decay of the sill plate.

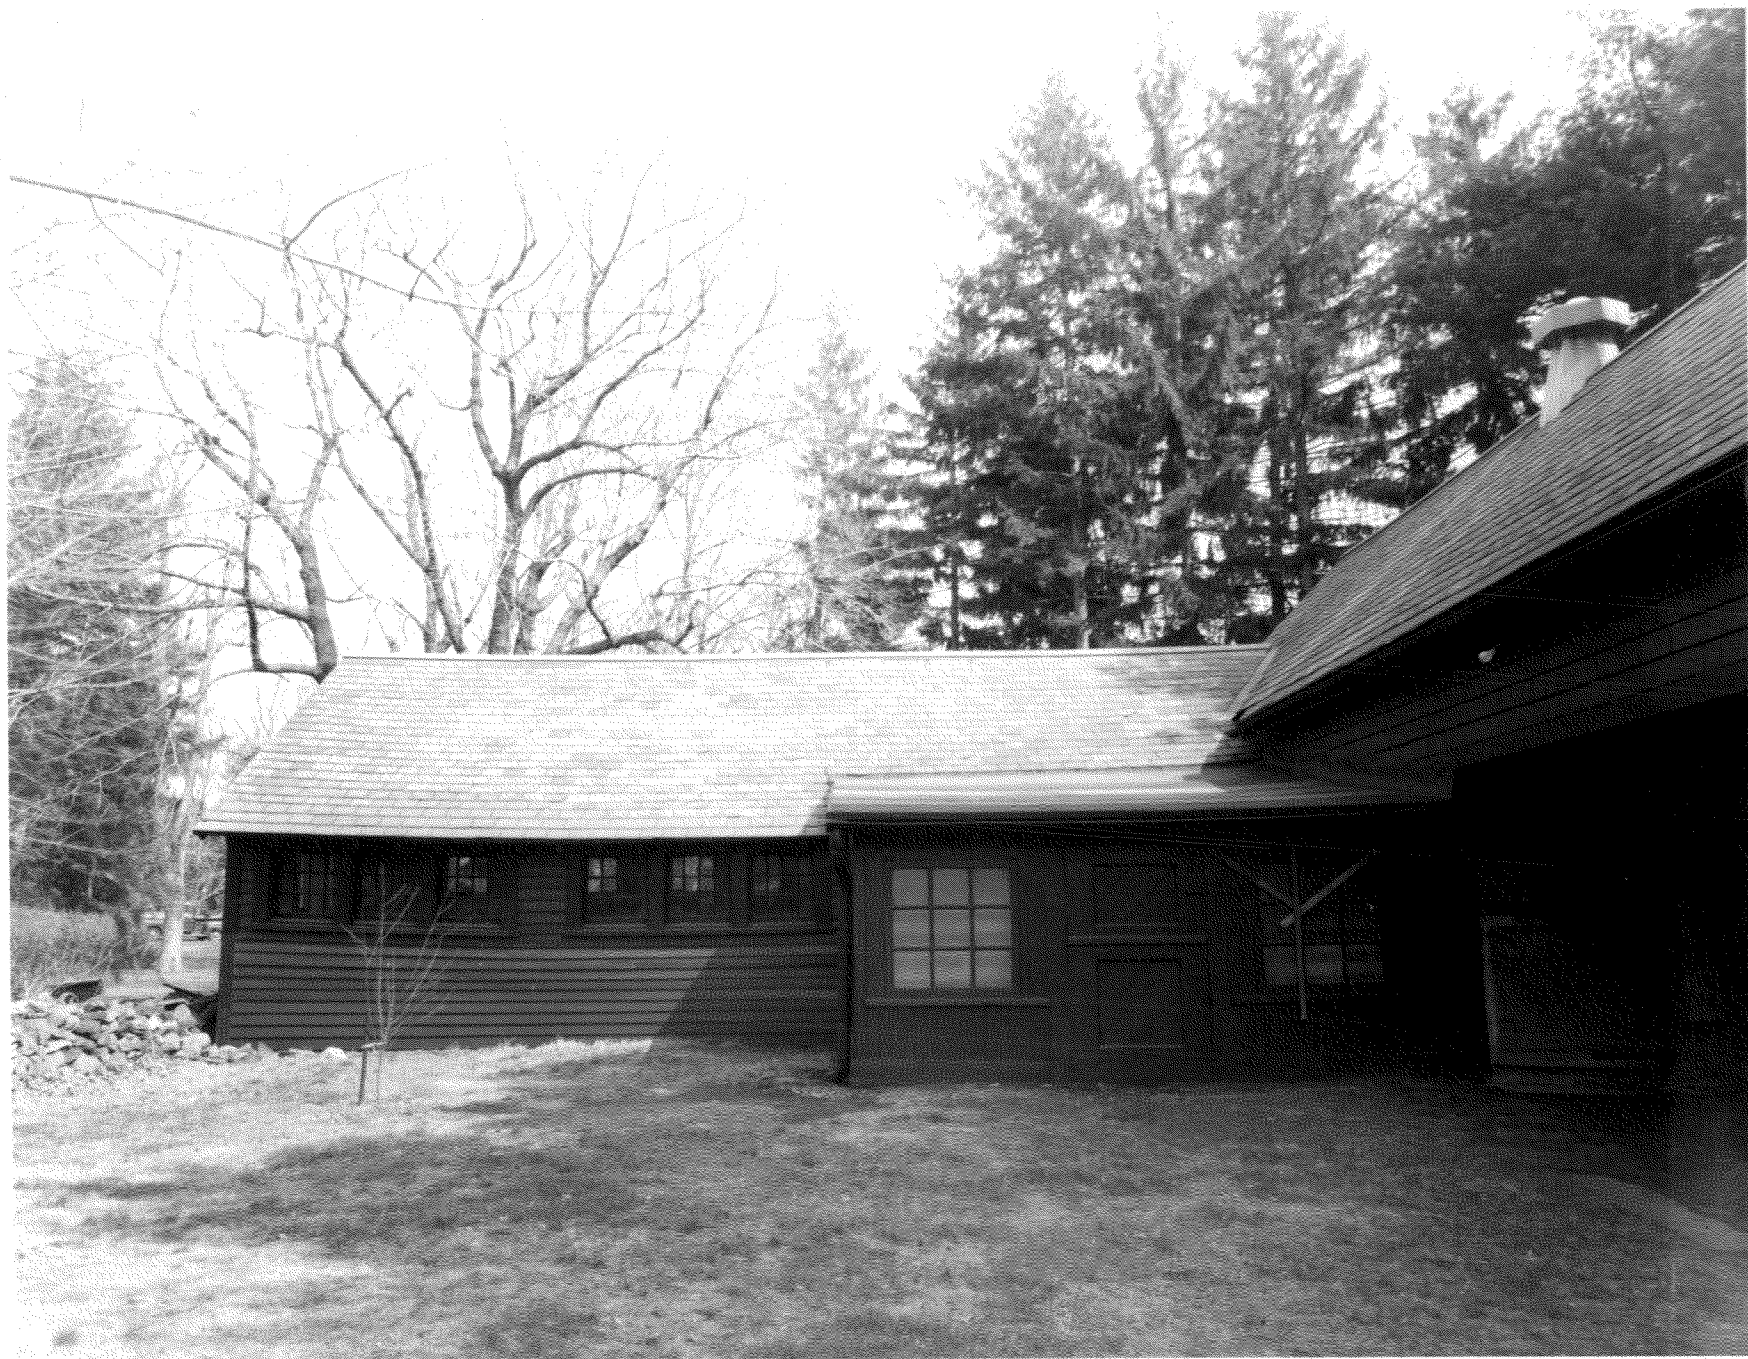
ILLUSTRATION NO. 3

The comparatively rude construction of the calf shed is exposed on the interior. The sill plates are resting directly on grade and are in a decayed condition. The clapboard sidewalls of the barn structure are also exposed in the shed.

West elevation of the chicken house and calf shed. These sides of the buildings have no foundations and as a result the sill plates have decayed causing settling which can be seen in the sagging eave line. It is this area and the north side of the chicken house shown in Illustration No. 2 that will require a new concrete foundation. The long slope of the chicken house roof at the left has two skylights composed of three sections each, now covered by the slate roofing.

1. The sill plates in the chicken house and calf shed have deteriorated from long contact with the ground. It will be necessary to remove the siding and plates and elevate the buildings to correct the sag.
2. New concrete foundations and sill plates will be required on the north and west walls of both the chicken house and calf shed. When this is completed matching siding and repairs will be required at the grade level.
3. To protect the interior of the building it would be advisable to replace the six sash missing on the east side of the chicken house with sash matching the 12 light sash in the remainder of the building.
4. In the process of repairing the barn the three quarter round mouldings on the door panels should be replaced.

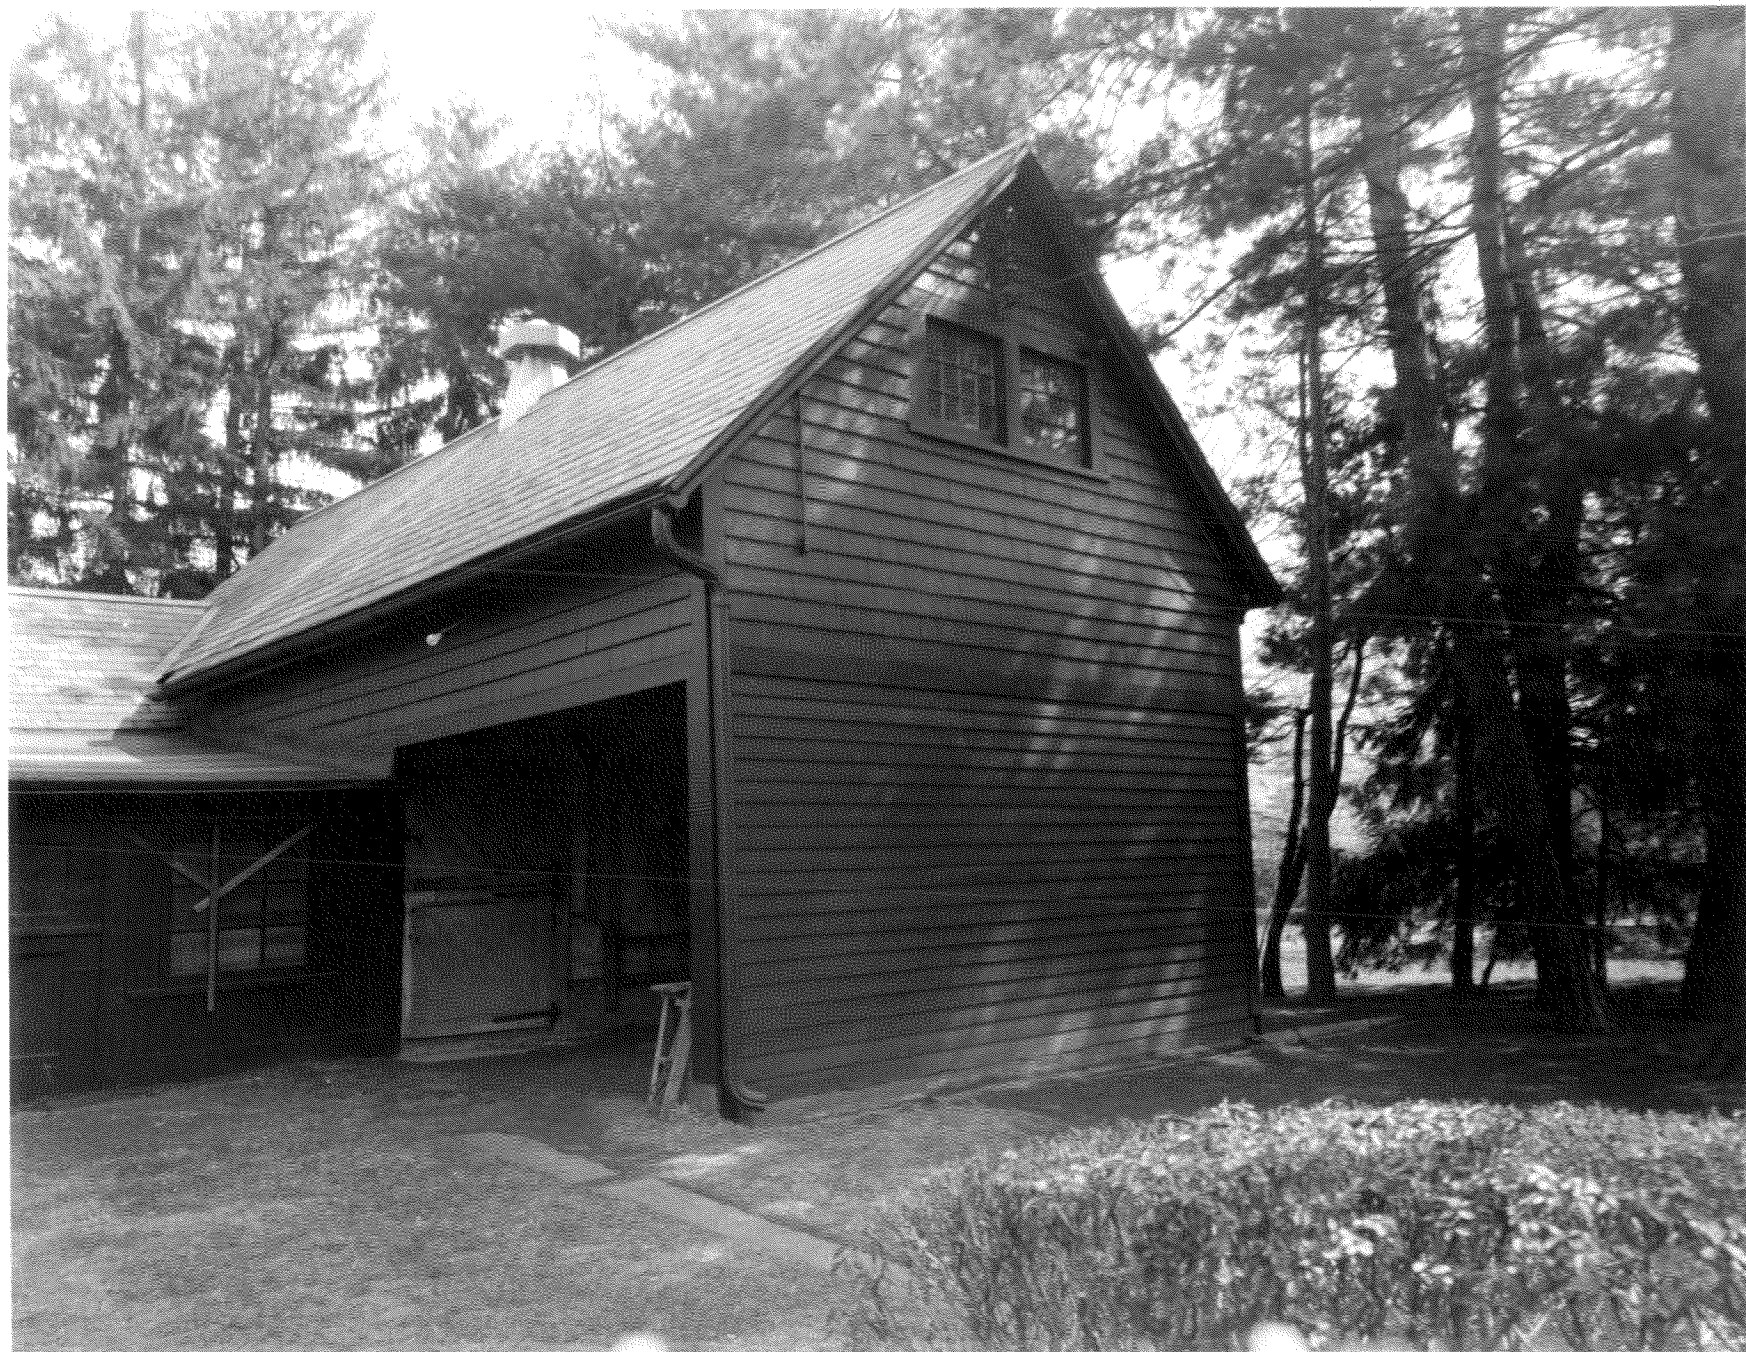
ILLUSTRATION NO. 4

The northwest corner of the main section showing the open shed. The wide, light painted door leads to the cow stable. The double window in the gable lights the long narrow loft. Note the quadruple beading on the post at the corner. This feature also appears on several of the post on the interior of the building suggesting a possible change in the plan when the building was moved from its original site to the present location.

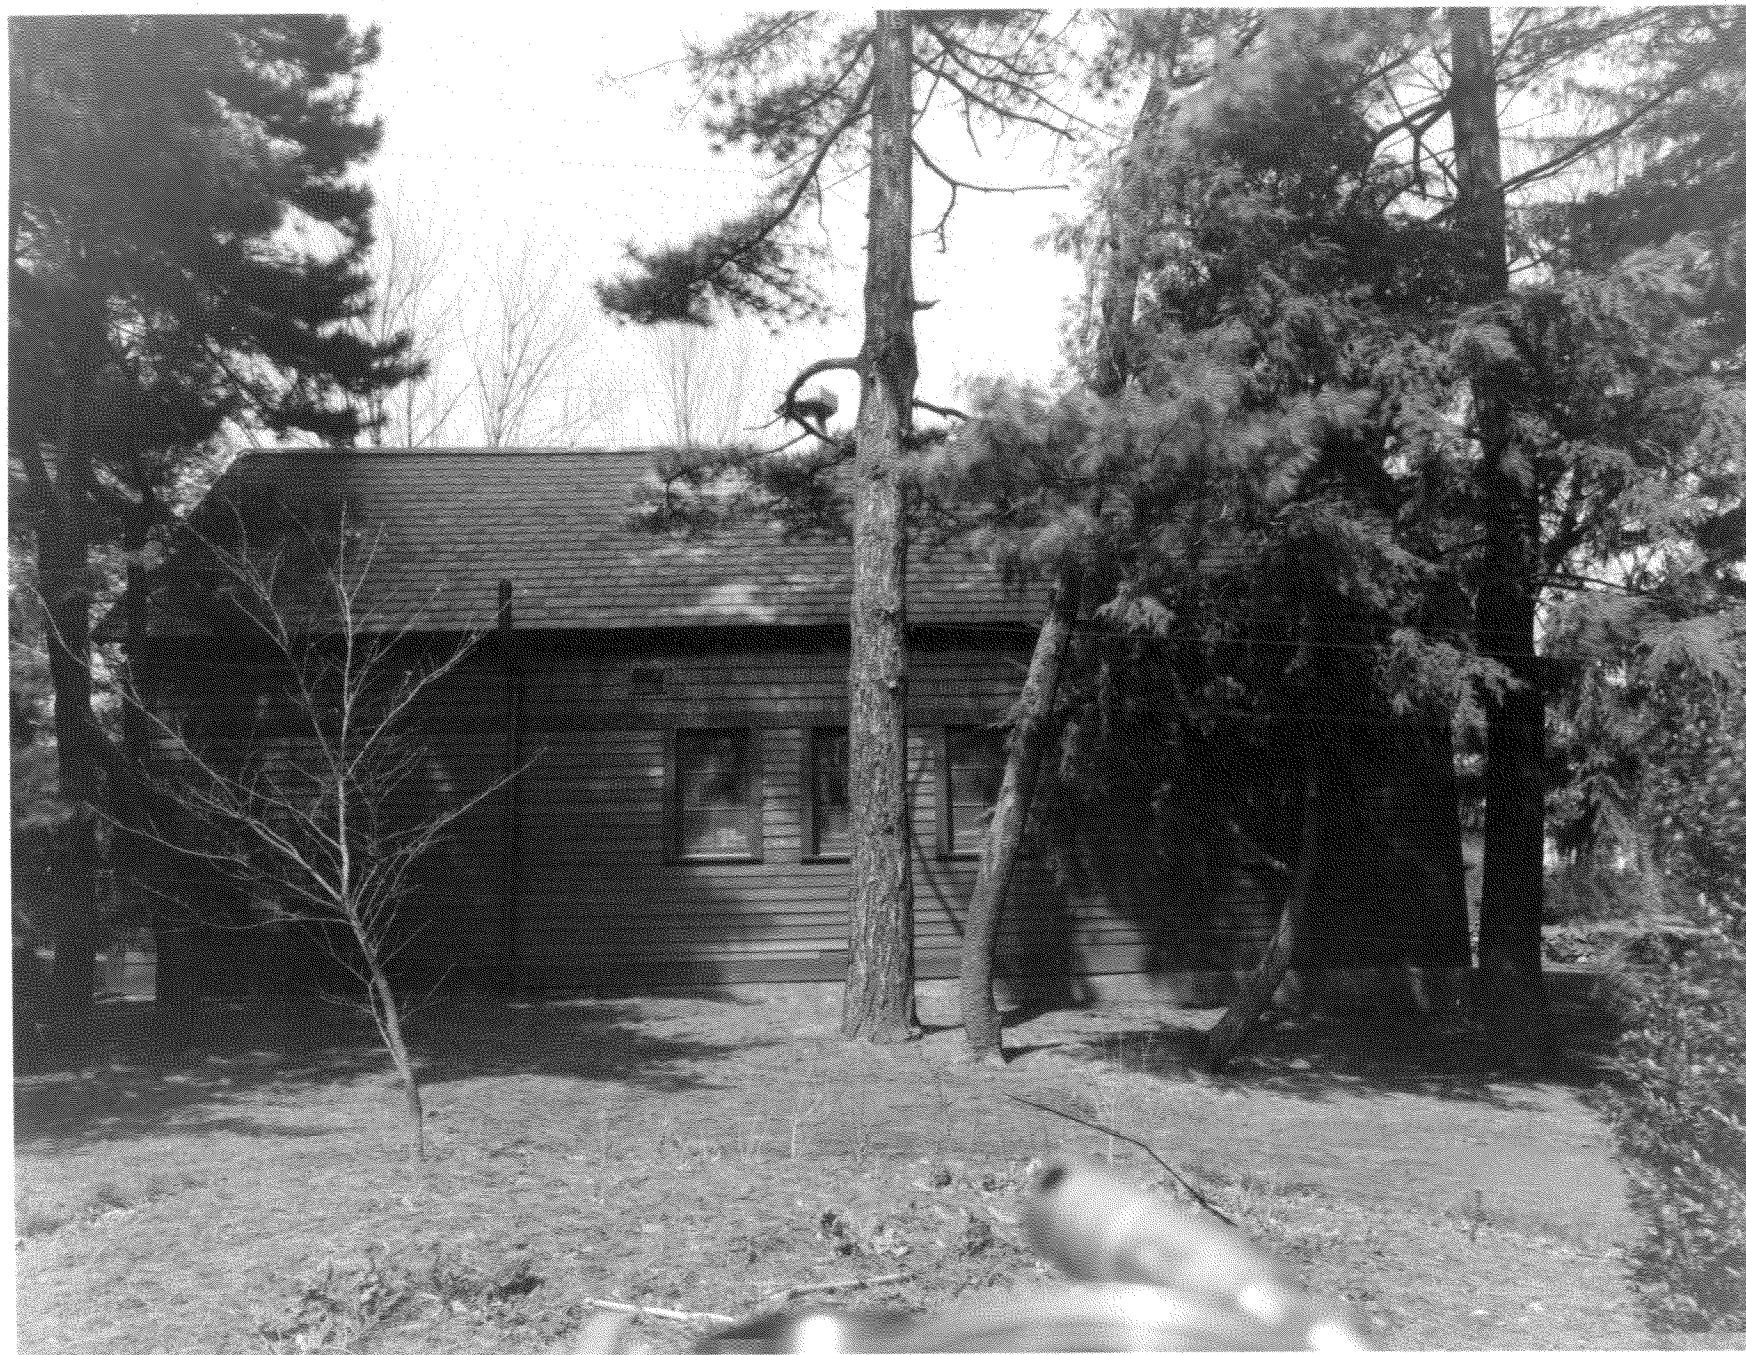
ILLUSTRATION NO. 5

The south side of the barn showing the three later windows in the cow stable. An earlier double hung window on the right is obscured by the trunks and shadows of the trees planted to screen the barn from view.
